A document prepared for JOURNAL OF NUCLEAR MATERIALS SYMPOSIUM ON EFFECTS OF IRRADIATION at Sun Valley, Idaho from 6/20/94 thru 6/23/94.

WELDING IRRADIATED STAINLESS STEEL

Abstract

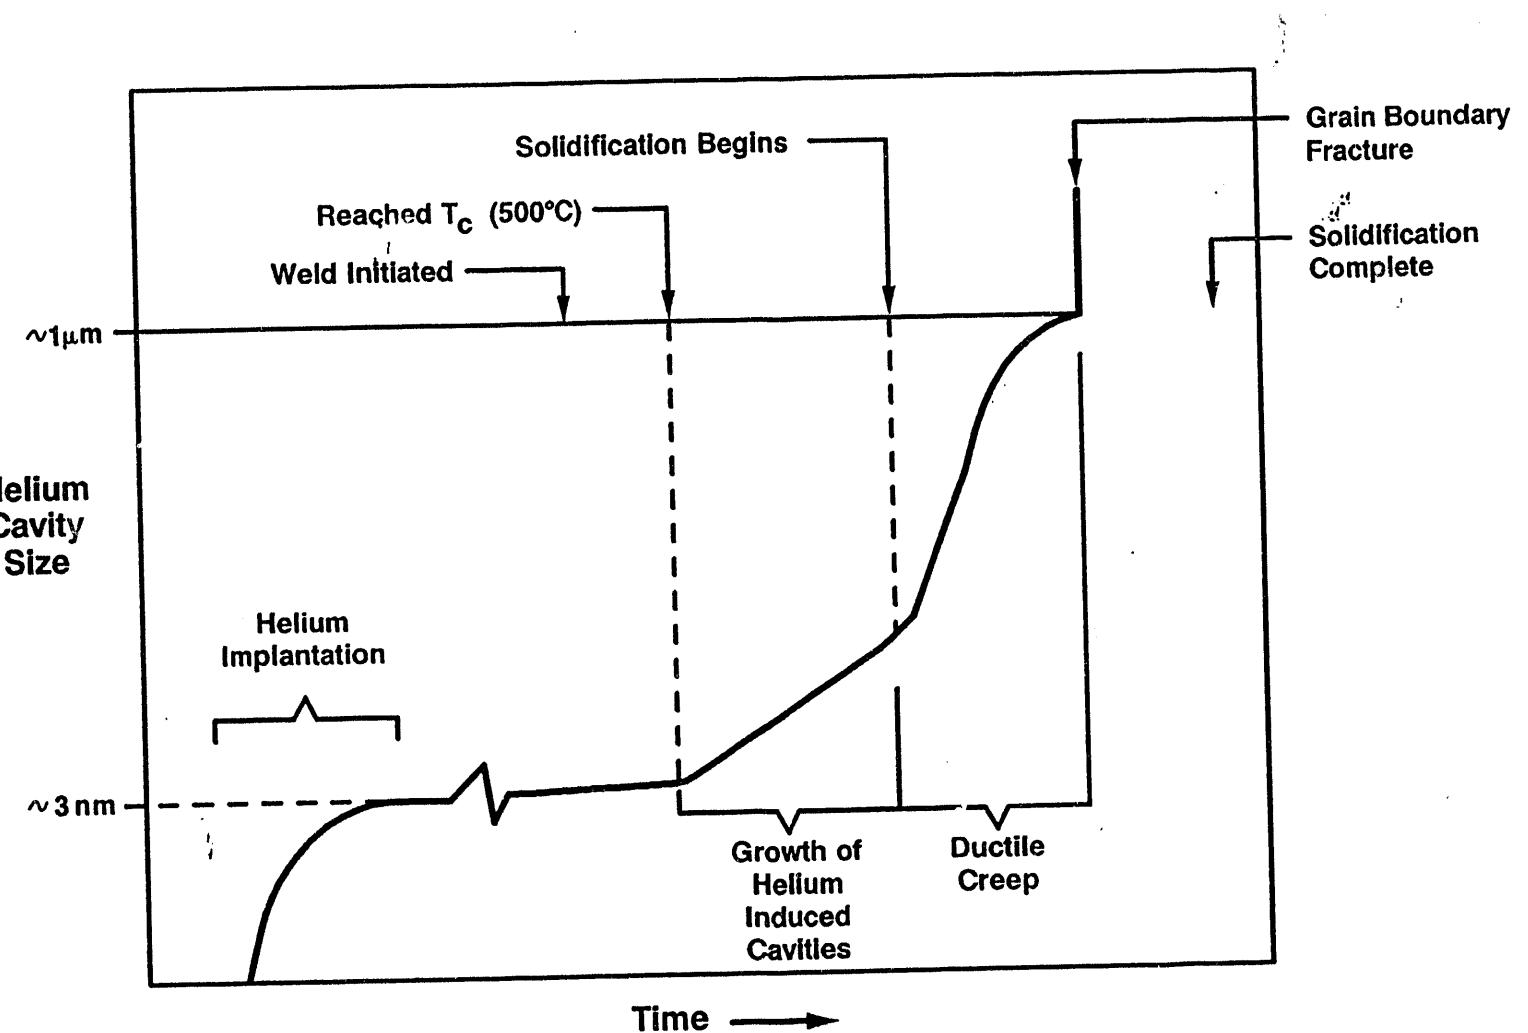
F16. 1

Figure 1. Progression from helium bubble formation to grain boundary cracking during welding.

The heat-affected zone (HAZ) of repair welds cracked when patches were welded to the tank wall of a nuclear reactor at the Savannah River Site. The cracking was caused by helium embrittlement [1]. Helium was present in the type 304 stainless steel reactor tank wall due to neutron capture by alloy and impurity elements. The mechanism for this embrittlement was attributed to the nucleation, growth and coalescence of helium induced microvoids during the welding process. Scanning and transmission electron microscopy showed the formation of small helium bubbles on grain boundaries in the steel and the presence of dimples on fracture surfaces [2,3]. Similar helium induced microstructures have been found in type 316 stainless steel samples that were welded after helium was introduced into the material [4,5]. Dimpled fracture is believed to result from bubble coalescence during a creep like fracture of the grain boundaries in the weld HAZ.

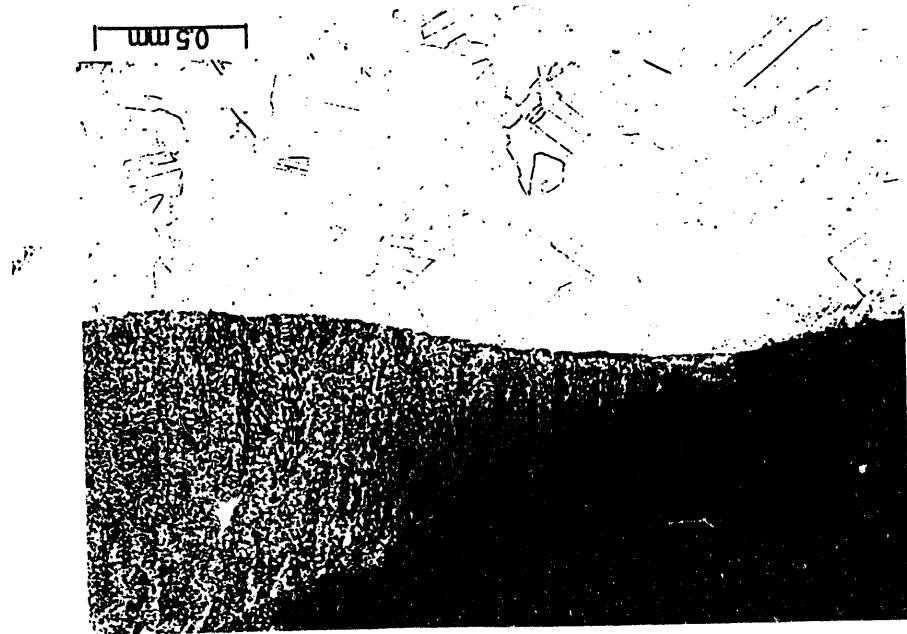
FIG. 2

Figure 2. Comparison of cracking in welds made on tritium charged and aged 304 stainless steel containing 17 appm helium. Note the absence of cracking in the overlay.

- A. Low penetration gas metal arc overlay weld.
- B. Toe cracks in conventional gas tungsten arc weld.

Surface examination of the welded helium charged plates revealed no toe cracks or porosity associated with the overlay welds. However, welds made by conventional GTA or GMA processes had both types of defects. Toe cracks for the highest heat input conventional welds were typical of those seen during repair of the reactor tank. Metallographic examination of test welds in tritium charged and aged stainless steel confirmed the lack of toe cracking in overlay welds compared to conventional welds (Fig. 2).

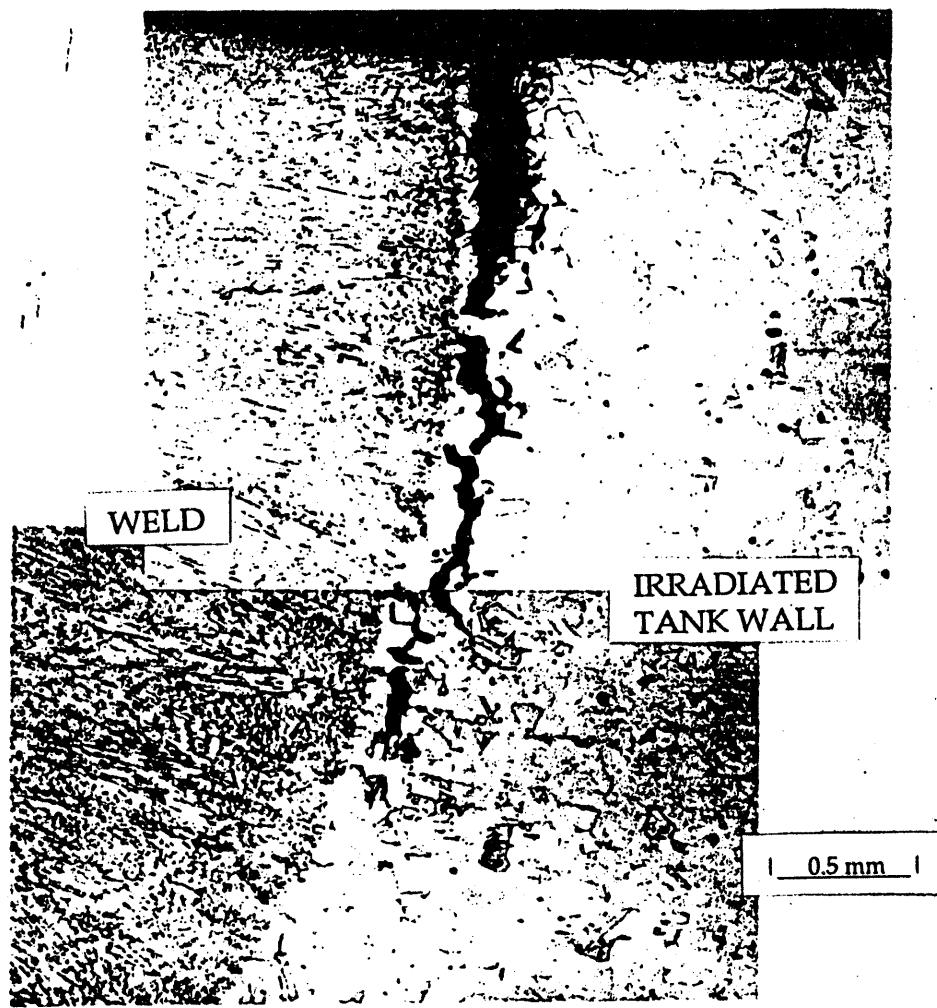
F16. 3

Figure 3. Conventional gas tungsten arc weld on irradiated 304 stainless steel containing 1.5 appm helium.

Helium induced weld cracks around conventional welds caused leaks during an attempt to repair the irradiated tank wall of a Savannah River reactor in 1986 and resulted in permanent shutdown of that reactor [1]. Welds made robotically in the reactor tank had surface toe cracking along with extensive underbead cracking. Dye penetrant testing of the welds in the reactor tank dramatically indicated the presence of the cracks. Electro discharge machining was used to remotely remove tank wall material containing the welds so that metallurgical examination could be performed. Helium concentration of this material was measured as 1.5 ppm, a result of the lowest thermal and fast fluences given above. Metallographic sectioning of the welds showed the extent of the intergranular cracking in the weld heat-affected zones, Fig. 3.

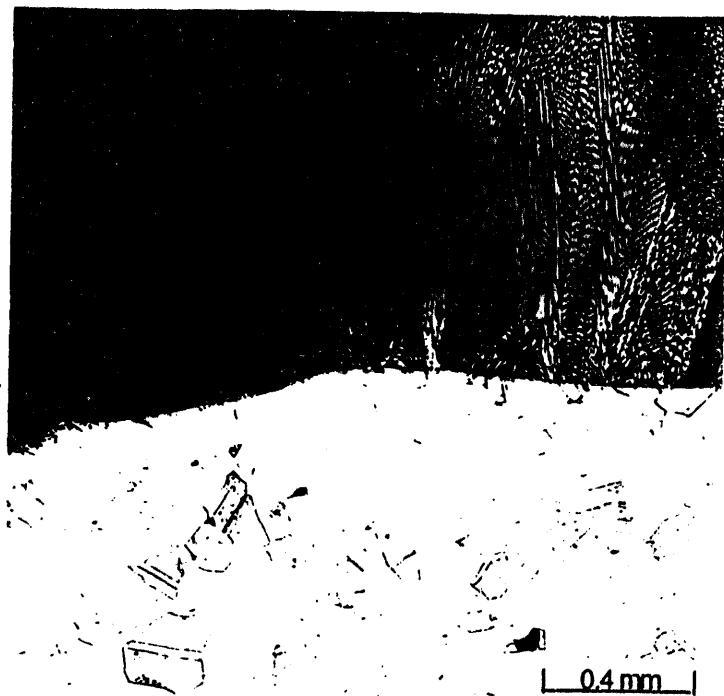
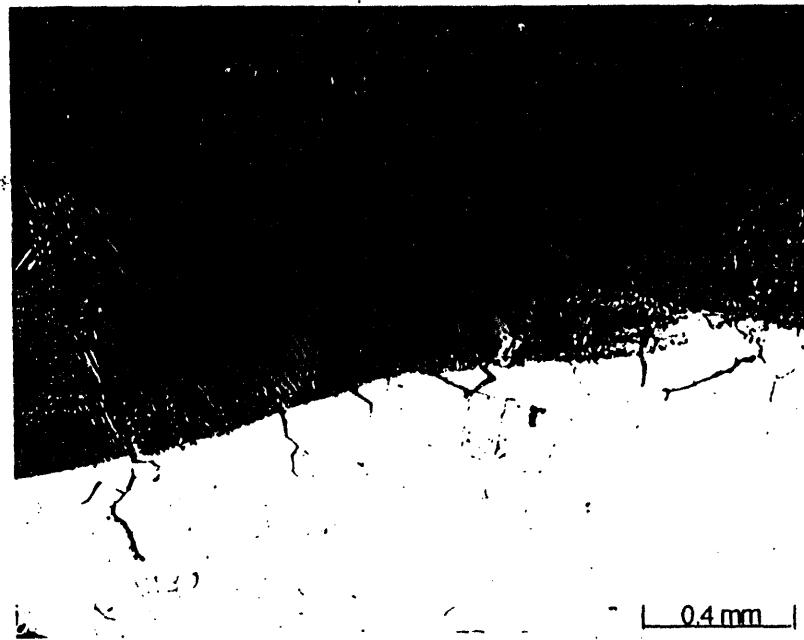
FIG. 5

Figure 5. Metallographic sections of low-penetration overlay welds made on irradiated 304 stainless steel containing 10.4 appm helium. Dark area on top is

weld metal and light area in lower half is base metal including the heat-affected zone.

- A. Edge location. Note the absence of toe cracking in the overlay weld.
- B. Underbead at location of maximum cracking. Note that some cracks extend from the heat-affected zone into the weld metal.

Dye penetrant testing and metallographic examination of overlay welds on the irradiated disc showed no surface cracks. Metallographic sectioning of the edges of the overlay welds, Fig. 5A, confirmed the absence of toe cracks. Compare this to the conventional welds that resulted in deep surface cracks and underbead cracks (Fig. 3) in the heat-affected zone of welds even when the helium content was 3.3 appm or less. The overlay method therefore avoids toe cracks, present in conventional welds made in irradiated material at much lower helium concentrations.

Analysis of the welds was completed by counting the number and length of cracks in metallographic sections of each overlay weld. Measurements showed approximately twice the amount of cracking beneath the overlay weld made on the material with 10.4 appm helium as on the material containing 5.0 appm helium. The area with the greatest concentration of cracks observed for the overlay welds is shown in Fig. 5. Cracks were observed in the weld heat-affected zone and, at several locations, these cracks extended into the weld metal.

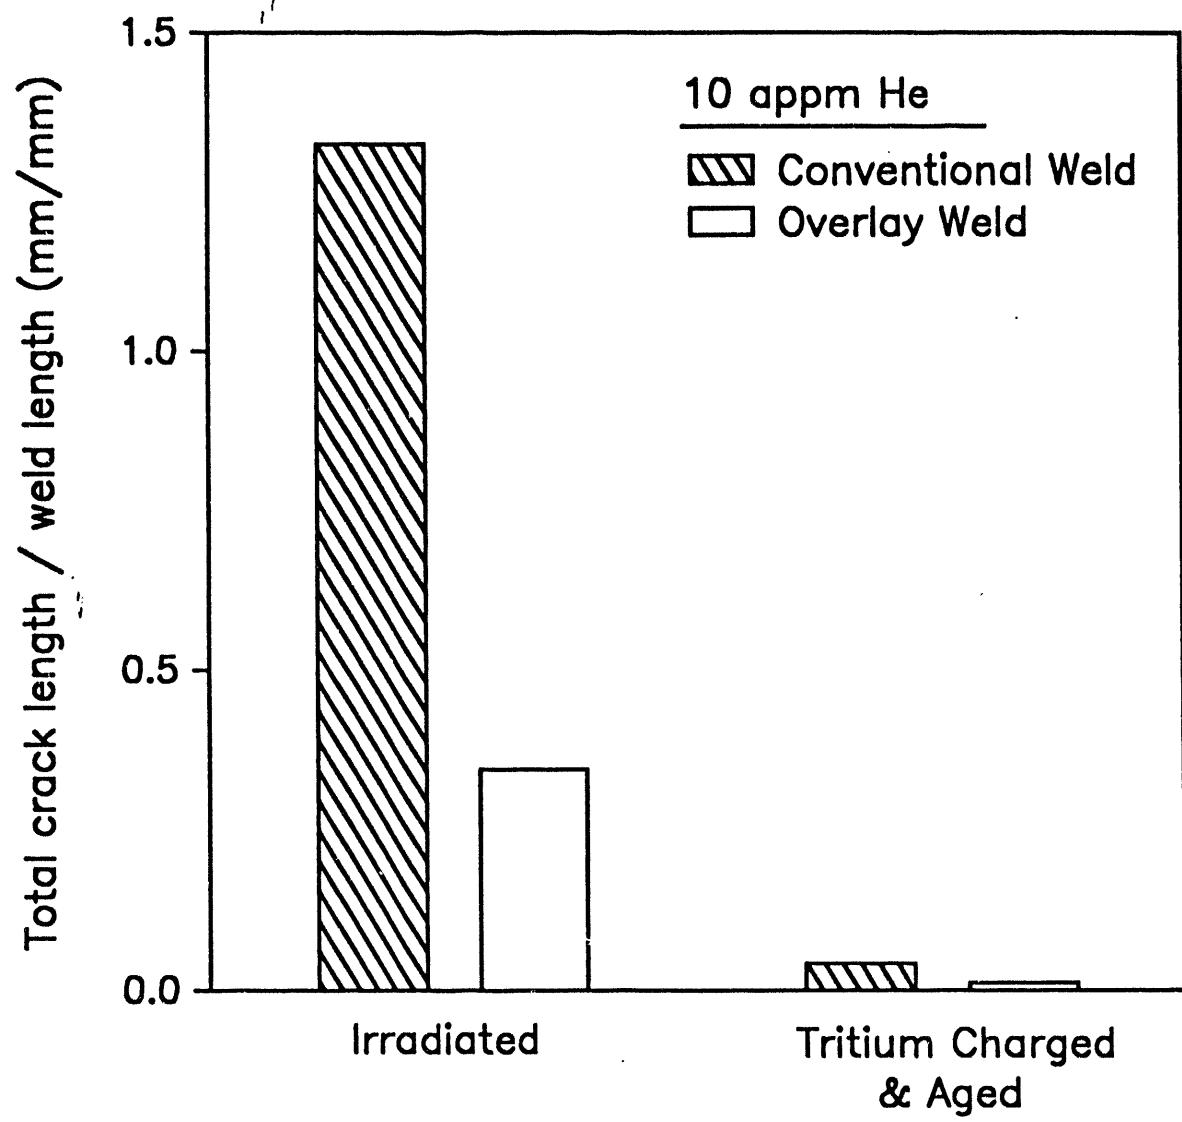
Fig. 6

Figure 6. Bar chart summarizing quantitative analysis of underbead damage due to helium embrittlement cracking of 304 stainless steel charged to 10 appm helium. More cracking was measured for conventional welds than overlay welds. More cracking was measured for welds in irradiated material than in tritium charged and aged material.

Cracking was minor in overlays made on the irradiated material, however, it was considerably higher than that experienced for the tritium charged and aged material at the same helium concentrations. This comparison of damage holds for both conventional welds, where measured crack lengths were 31 times greater in irradiated material compared to tritium charged and aged material, and for overlay welds, where measured cracks lengths were 28 times greater. These results are based on crack lengths at a helium concentration of 10 appm, Fig. 6. Crack length data for welds at a series of helium concentrations provide additional credence for results at 10 appm helium. Measurements of cracking on tritium charged and aged material are presented in more detail in reference [9]. Measurements for overlays on irradiated material are from the present work and measurements for conventional welds on irradiated material are from unpublished work at helium concentrations up to 12 appm.
