EMBRITTLEMENT OF SURFACE MOUNT SOLDER JOINTS BY HOT SOLDER-DIPPED, GOLD-PLATED LEADS¹

Paul T. Vianco

Center for Solder Science and Technology
Sandia National Laboratories
Albuquerque, NM 87185

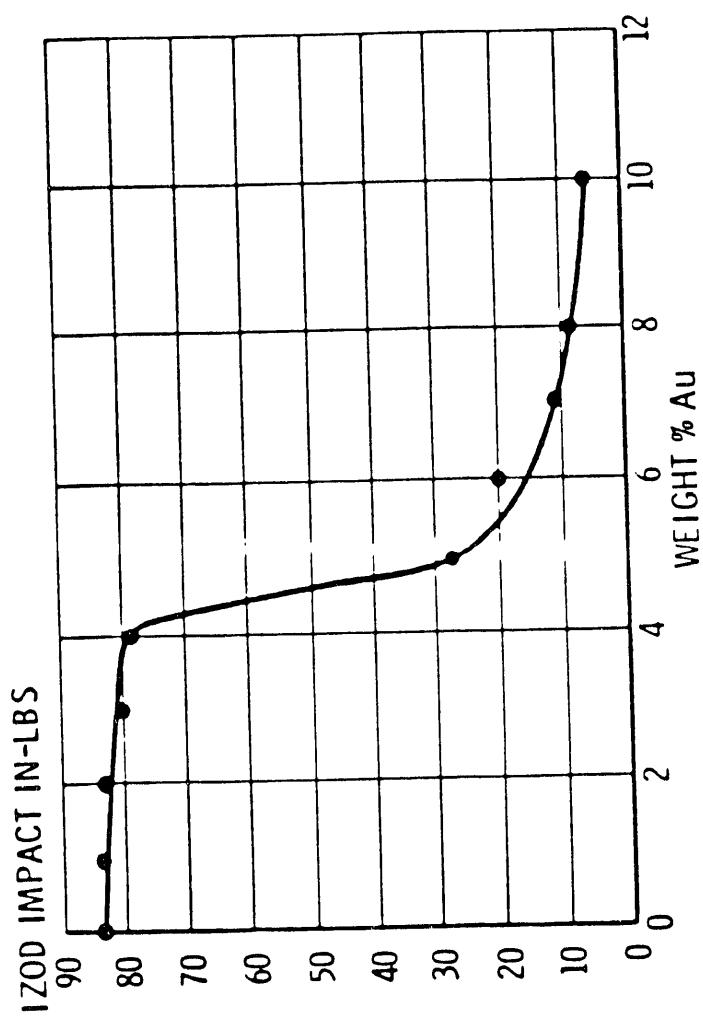
Fig. 1 Izod impact toughness of tin-lead solder as a function of gold content[4].

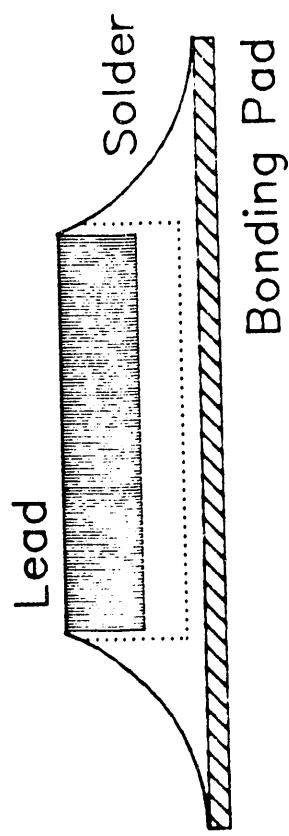
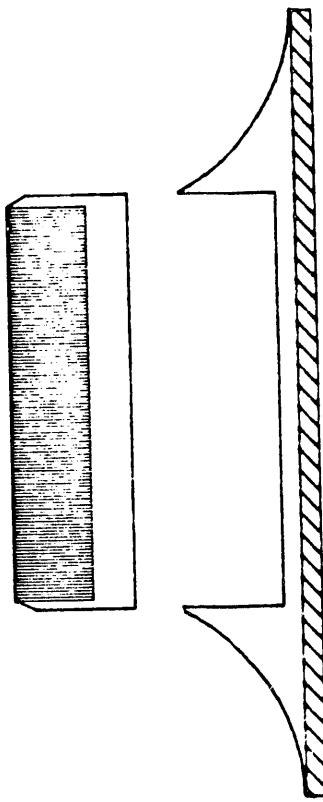
Fig. 6 Schematic diagram depicting the geometrical relationships between the lost lead and the bonding pad.

Failure Geometry of the Q1 and Q2 Transistor Leads

rate inherent in the vapor phase equipment, the gold comes out of solution as the solder solidifies, combining with the tin to form the AuSn_4 intermetallic compound which subsequently embrittles the joints. Nucleation and growth of the intermetallic crystals *within* the circuit board solder joints increases the chances of the intermetallic for having an orientation favorable for the development of a continuous fracture path surrounding each transistor lead (Fig. 6).

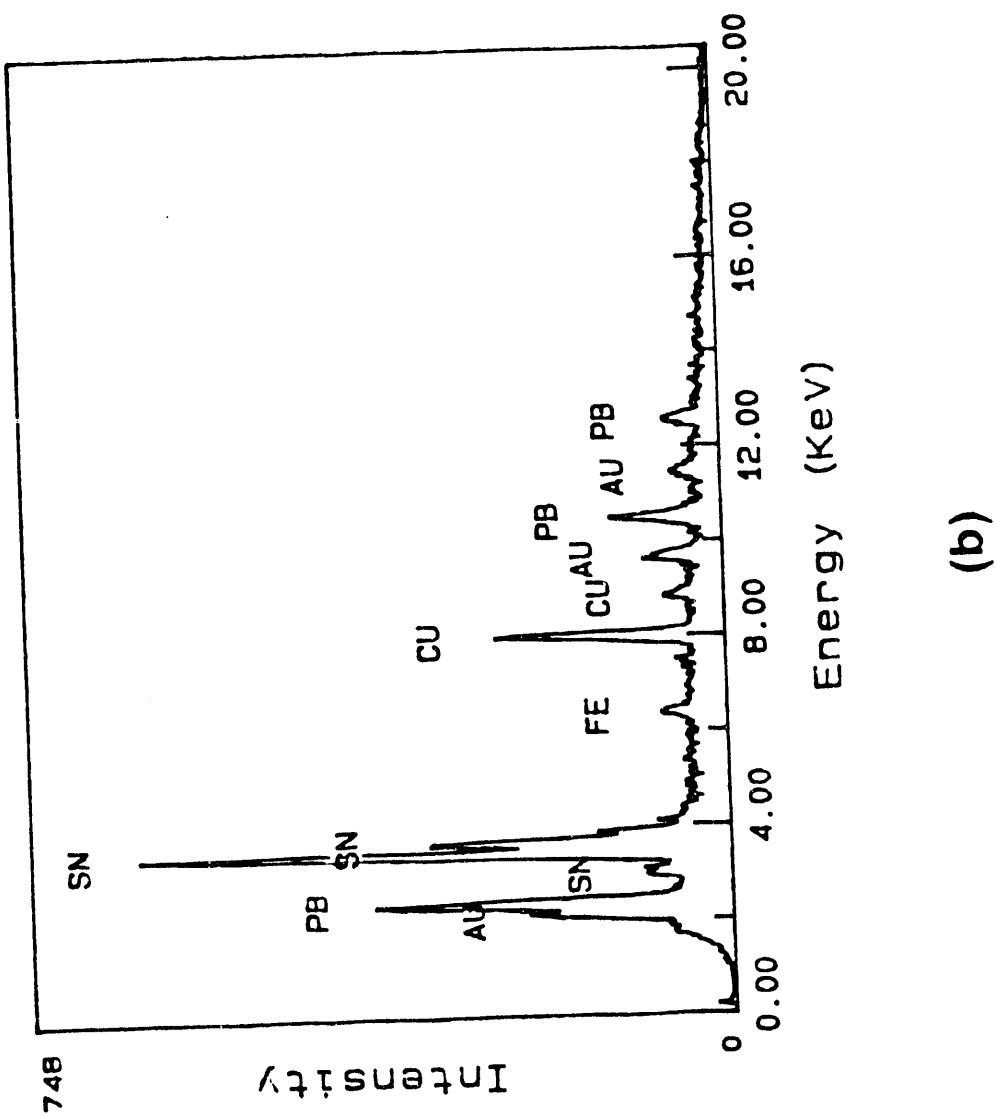
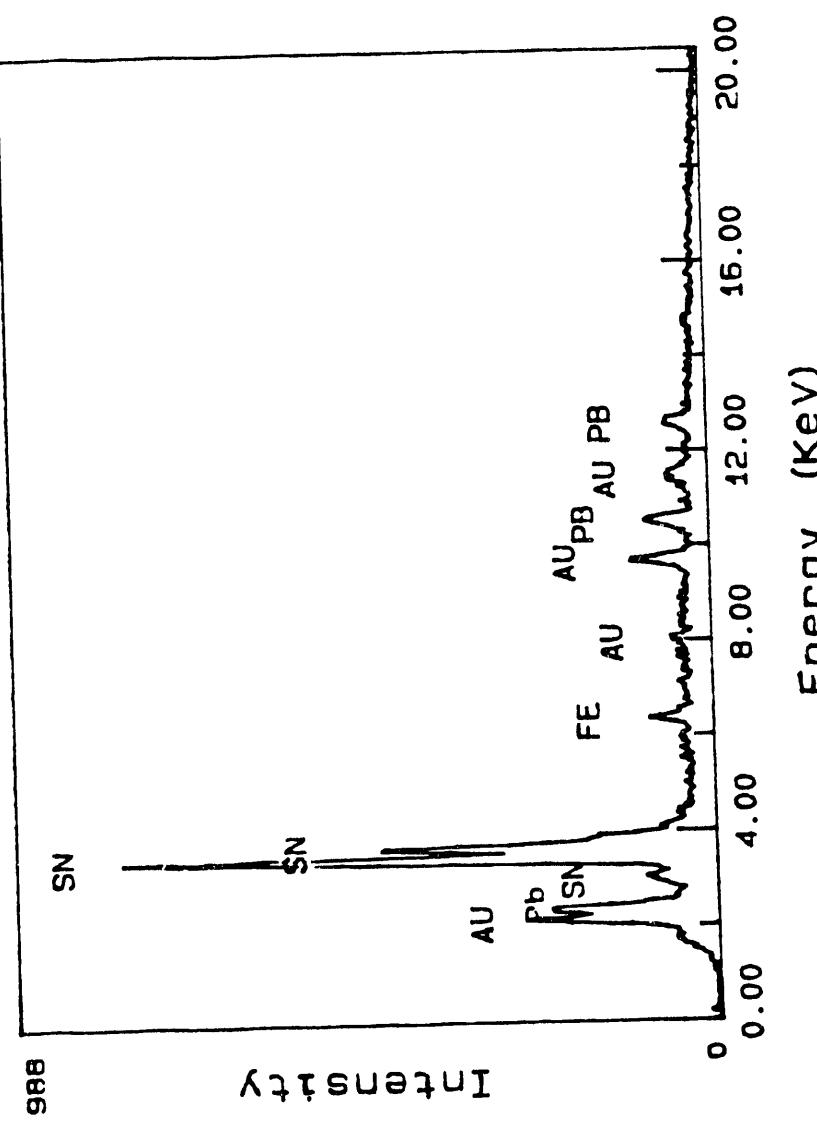
FIGURE 8

An energy dispersive x-ray analysis (EDXA) was conducted on the fracture surface of a failed collector lead bonding pad (Fig. 8a). The EDXA spectra of the bonding pad fracture surface (Fig. 8b) indicated signals of tin and lead from the solder as well as those of gold and copper. The copper signal had two likely sources: (1) the copper bonding pad under the solder film or (2) the copper-tin intermetallic layer formed at the solder/pad interface and exposed by the fracture path located through that layer. Point (2) was discounted when a similar spectrum was acquired from the complimentary surface of the transistor lead (Fig. 8c). The copper signal was absent; however, the gold signal was still quite evident.

Fig. 8 (a) Scanning electron micrograph of the collector lead bonding pad of a lost transistor. (b) Energy dispersive x-ray analysis (EDXA) spectrum of the bonding pad fracture surface. (c) EDXA spectrum of the complimentary fracture surface on the transistor lead.

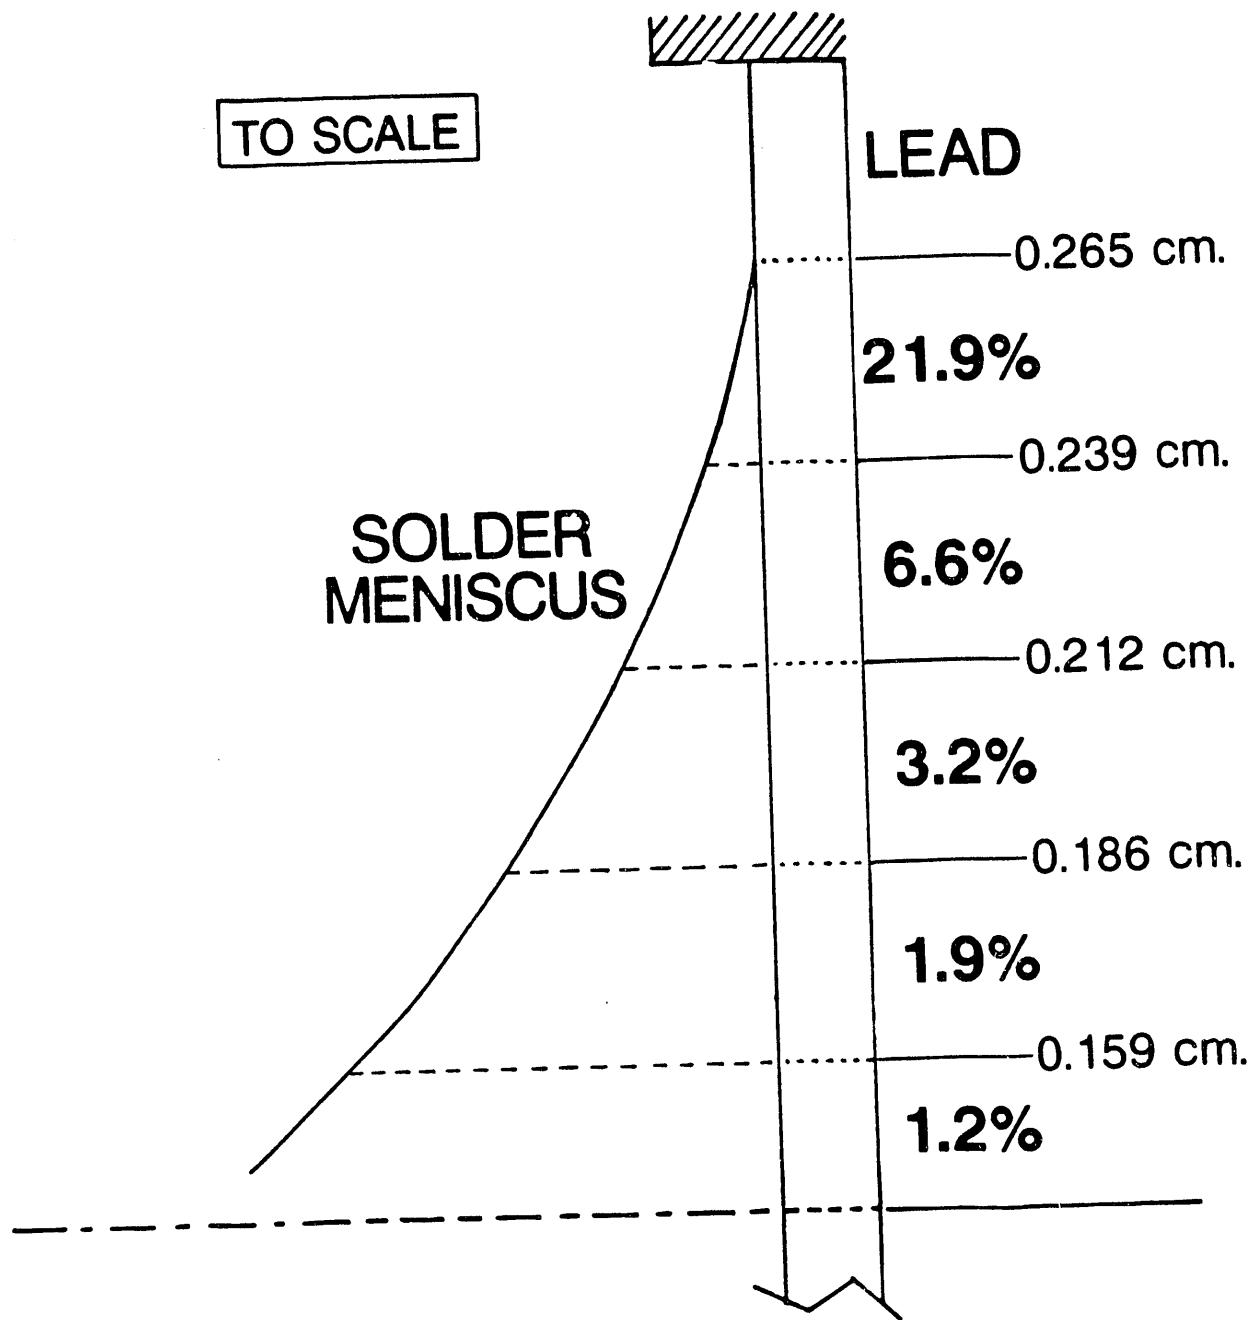
FIG. 15

Fig. 15 Computed gold concentrations in the solder meniscus formed on the transistor lead immersed into the solder. The gold thickness was assumed to be $1.1 \mu\text{m}$ (160 microin.)

In the case of the lenticular drop, the gold concentration increases from the center of the drop towards the edge. Although the data is somewhat scattered, it is observed that the gold concentrations are similar to those computed in Fig. 15; that is, the gold concentrations range from about 20 wt% at the very edge to a approximately constant value of 1-2 wt% at a distance 1500 μm (0.059 in.) from the leading edge. For the traces further out from the interface, the peak concentration diminished to about 15 wt.% at the edge of the solder film and similar values to those in Fig. 17a at the drop interior. The

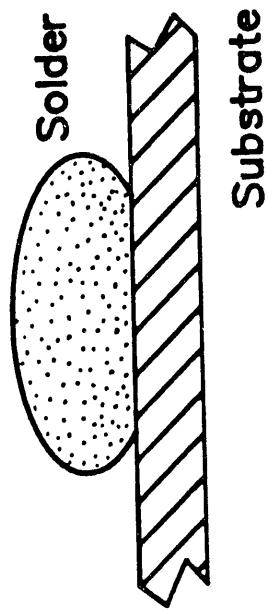
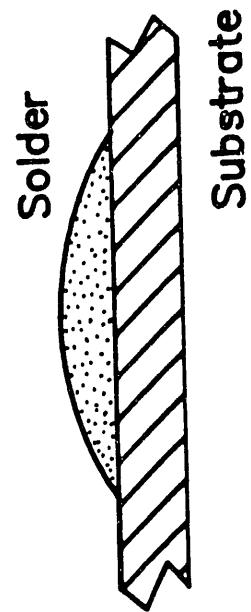
Fig. 16 Schematic diagram of the two sessile drop configurations obtained from tin-lead solder on gold-nickel-plated Kovar™ coupon: (a) lenticular geometry and (b) bulbous geometry.

Verification of the existence of a concentration gradient due to the geometry of the meniscus was determined by means of the following sessile drop experiment. A preform of tin-lead solder was placed on top of each of two KovarTM coupons which had been electroplated with nickel and gold. The gold thickness was measured to be 2.7 μm (106 microin.). A thermocouple had been spot welded to each of the coupons. Next, each coupon plus preform was placed atop a hot plate (260°C). The solder preform on the first coupon formed a lenticular sessile drop and was promptly removed from the hot plate (Fig. 16a). In the case of the second specimen, the coupon was removed from the hot plate with the sessile drop having a bulbous geometry (Fig. 16b). The two configurations in Figs. 16a and 16b represent the confined and open geometries, respectively, at the solder film edge. The geometry in Fig. 16a was similar to that of the solder meniscus formed on an immersed lead (Fig. 14). The sessile drops were cross sectioned and the surface prepared metallographically. Then, electron probe micro- analysis was performed along a line trace parallel to the interface. The traces were run at distances of 5, 10, and 25 μm (200, 400, and 1000 microin.) from the interface. The gold concentration along the line trace at 5 μm (200 microin.) is shown in Fig. 17a for the lenticular drop (Fig. 16a) and Fig. 17b for the bulbous drop geometry (Fig. 16b).

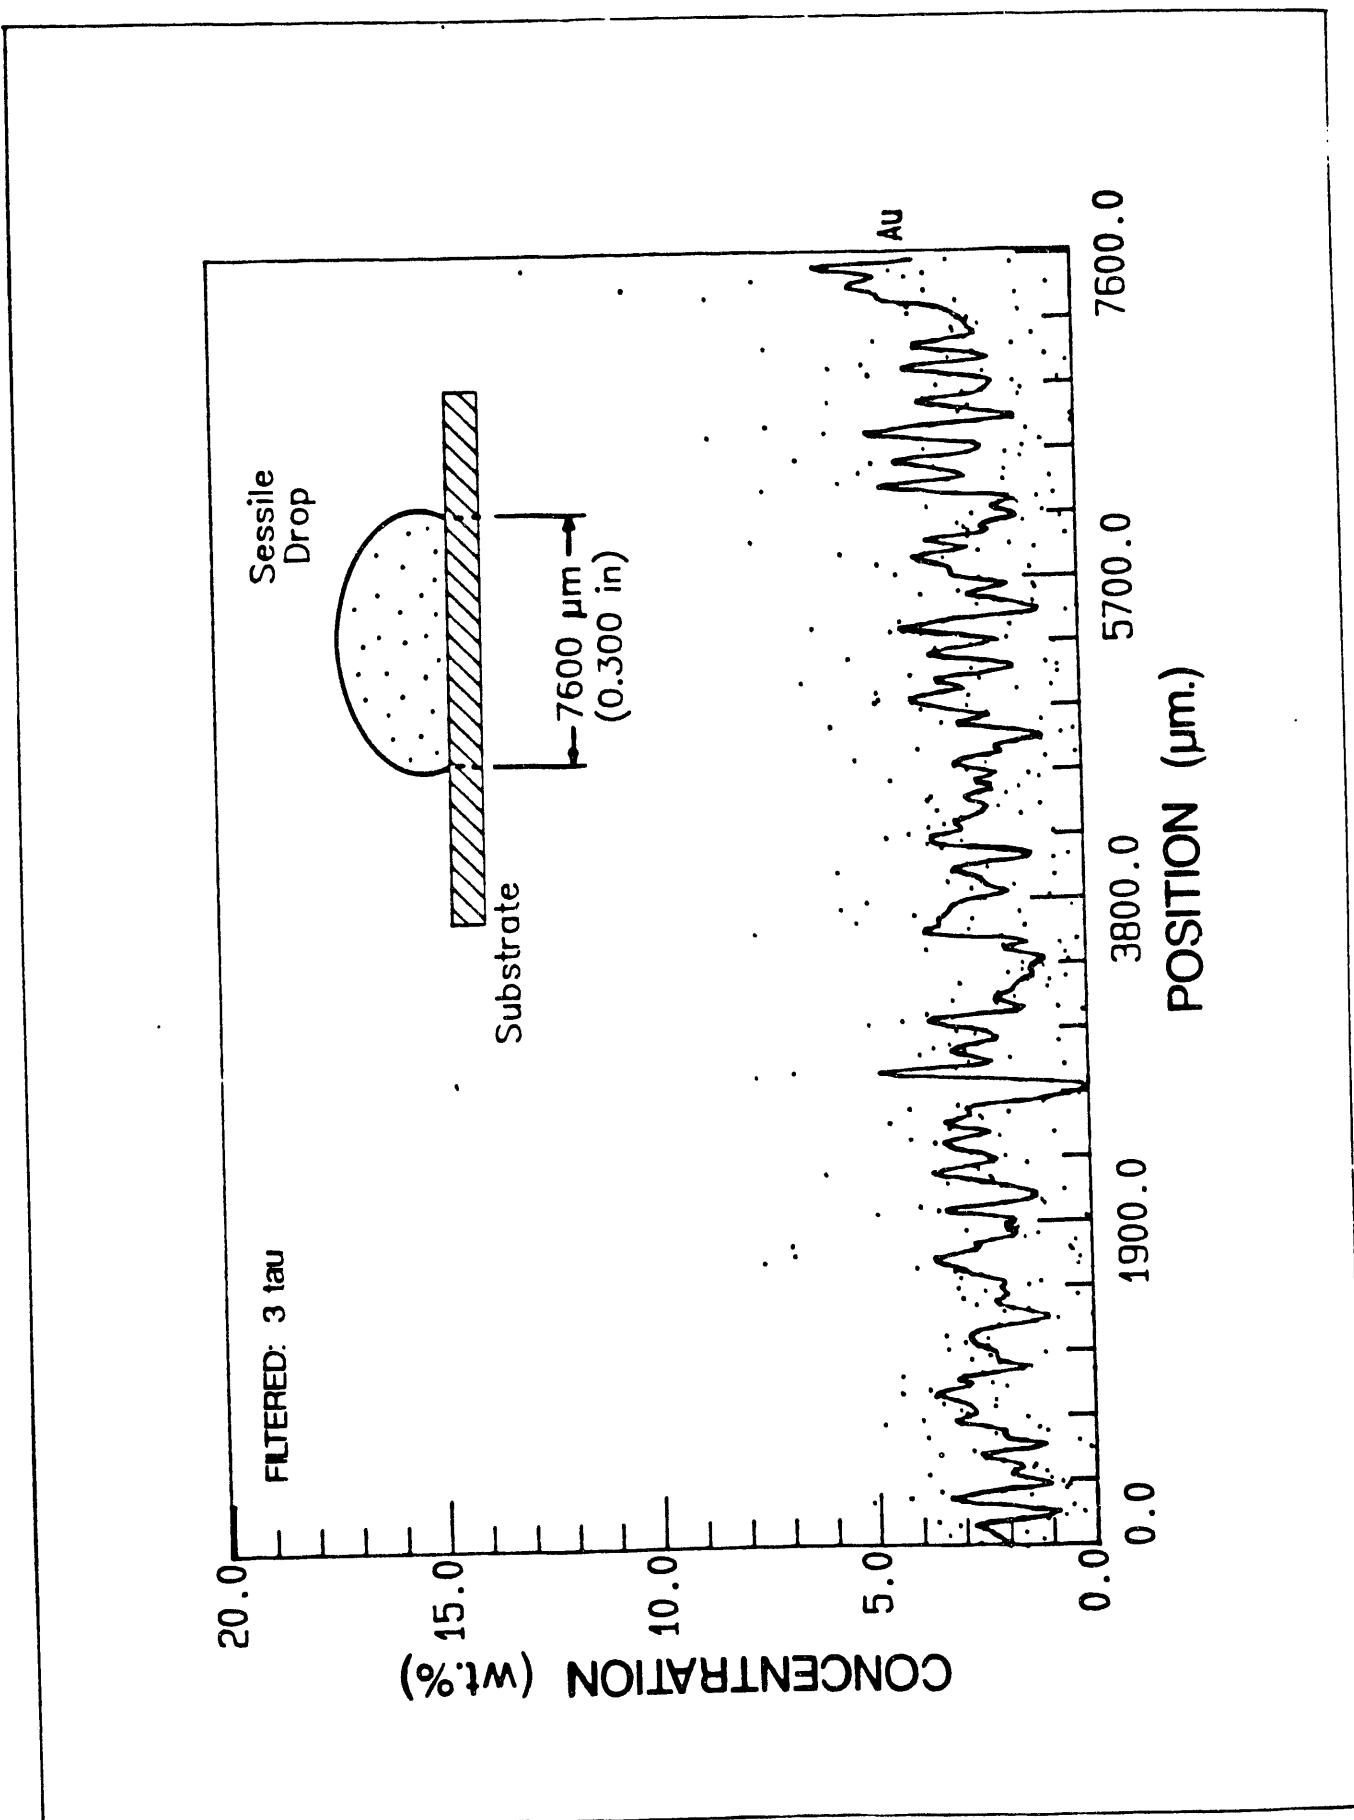
Fig. 17b

Fig. 17 (a) Electron probe micro-analysis (EMPA) gold concentration trace along the solder-substrate interface (5 μm distant) of the lenticular sessile drop geometry (Fig. 16a). (b) The EMPA gold trace for the bulbous sessile drop geometry (Fig. 16b).

effect of the bulbous configuration on the gold concentration is illustrated by Fig. 17b. In the open configuration of the bulbous joint, the gold concentration is relatively constant along the entire interface at a value of 2-3 wt%; there is no appreciable build-up of gold at the edges of the solder film. The same concentration profile was repeated for traces taken at 10 μm (400 microin.) and 25 μm (1000 microin.) from the interface.
