## **Metallurgical Evaluation of SRAM II/SRAM A Programmer Base Plates**

**Brian K. Damkroger  
Michael C. Maguire  
Charles V. Robino**

Ten MC4073/4369 programmer base plates were analyzed at the request of Jim Anastasio, Department 2314 and Ed Cull, Department 8154. This component, a programmer base plate for the SRAM II (and later the SRAM A), is specified as a Grade C quality casting made of aluminum Alloy A356, heat treated to the T6 condition. A concern was expressed regarding the choice of an A356 casting for this application, given the complexity and severity of the loading environment. In particular, concern was directed toward potential problems in highly stressed regions such as the base of the mounting feet. Preliminary tests and analyses suggested that the design was adequate, but noted the uncertainty involved in a number of their underlying assumptions. The uncertainty was compounded by the discovery that the casting used in the original series of mechanical tests did, in fact fail. In this investigation, several production castings were examined and found to be of a quality superior to that required under current specifications. Their defect content and microstruc

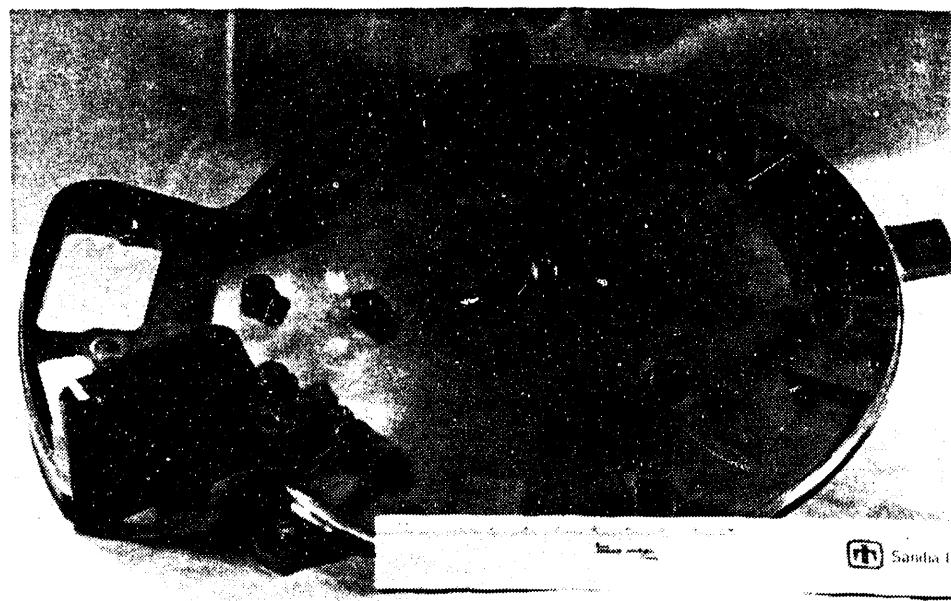
Figure 1. Photograph of a machined MC4073 Programmer Base Plate.

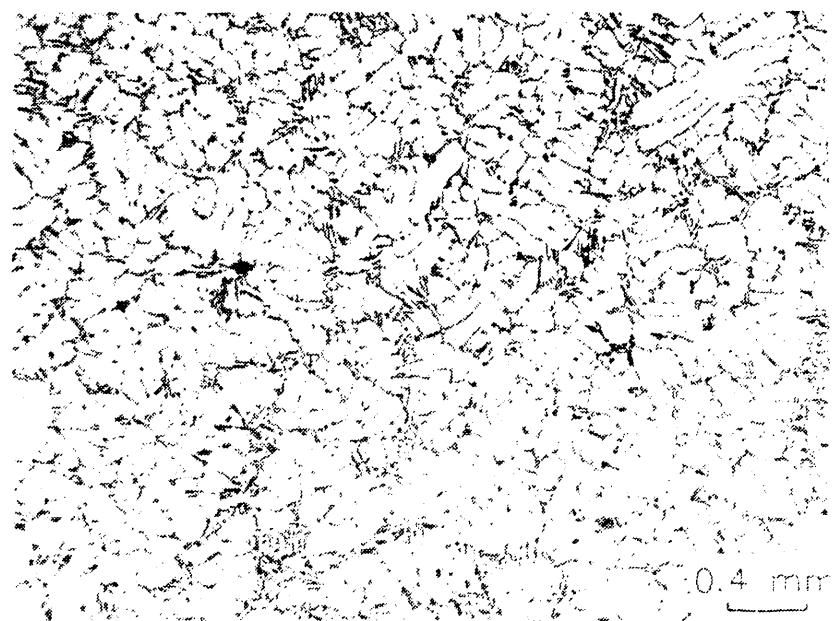
Figure 2. Photomicrograph of specimen removed from base plate mounting foot. Specimen anodized: 5 g HBF<sub>4</sub> in 100 ml H<sub>2</sub>O, 25V for ~50 sec, ambient temperature.

At cooling rates typical of castings, A356 solidifies as primary aluminum dendrites surrounded by an irregular eutectic constituent of silicon and an aluminum-rich matrix. The base-plate castings are supplied in the T6 condition. The specific heat treat sequence is called out in the casting specification (1), but a typical T6 heat treatment for A356 is 540°C for 8-24 hours, followed by a hot water quench and artificial aging for 1-5 hours at 150-250°C. During solution treatment, some silicon and any magnesium present go into solution and the interdendritic silicon becomes discontinuous and coarsens. The aging treatment causes precipitation of a relatively fine Mg<sub>2</sub>Si particles throughout the primary dendrites and eutectic matrix. Figure 2 shows micrographs of specimens removed from the mounting feet of one of the initial eight castings. The pertinent features in the micrograph are the primary aluminum dendrites, which were estimated to have a secondary dendrite arm spacing (DAS) of approximately 50-55µm, and the dark-etching regions, which are the eutectic silicon particles. The microstructures of the supplied castings are consistent with those expected for A356 investment castings, and have a DAS of 50-55µm.

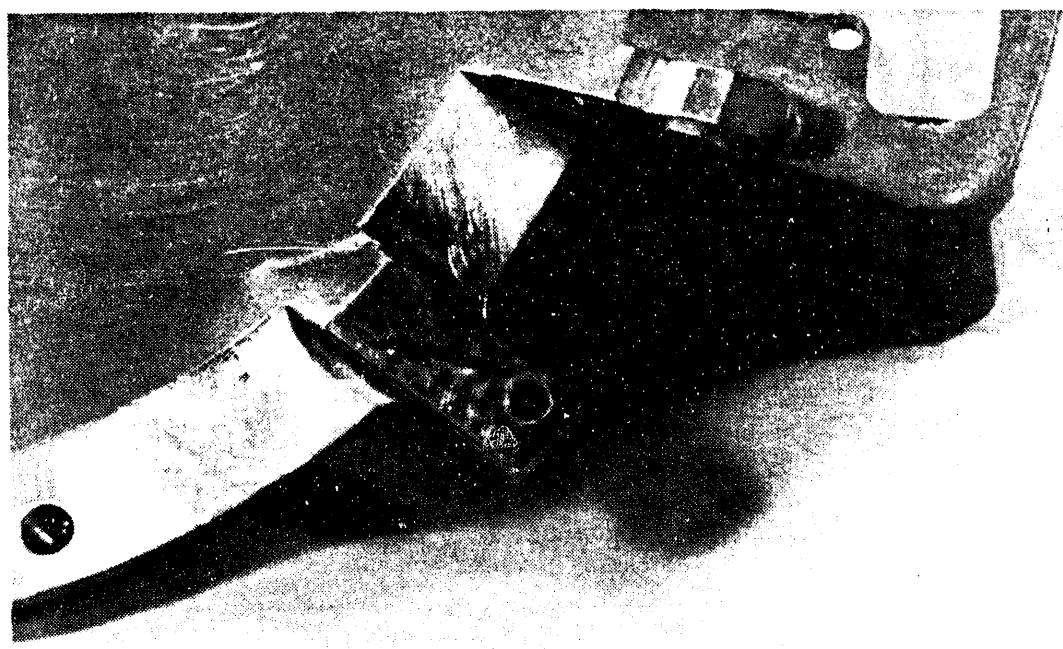
Figure 3a. Macrophotograph of the mounting foot which failed during the static tests performed by P. Stirbis, 1522 (4). Arrow indicates fracture.

A series of X-direction static tests were conducted by P. Stirbis, Department 1522 (4). In these tests, a programmer base plate was loaded to approximately 5 times what was then believed to be the maximum required load, without macroscopic failure. However, three gauged locations on the base plate were displaced in a non-linear fashion. Subsequent postmortem examination of the base plate confirmed that all three of the mounting feet had plastically deformed and revealed that one of the mounting feet had fractured.

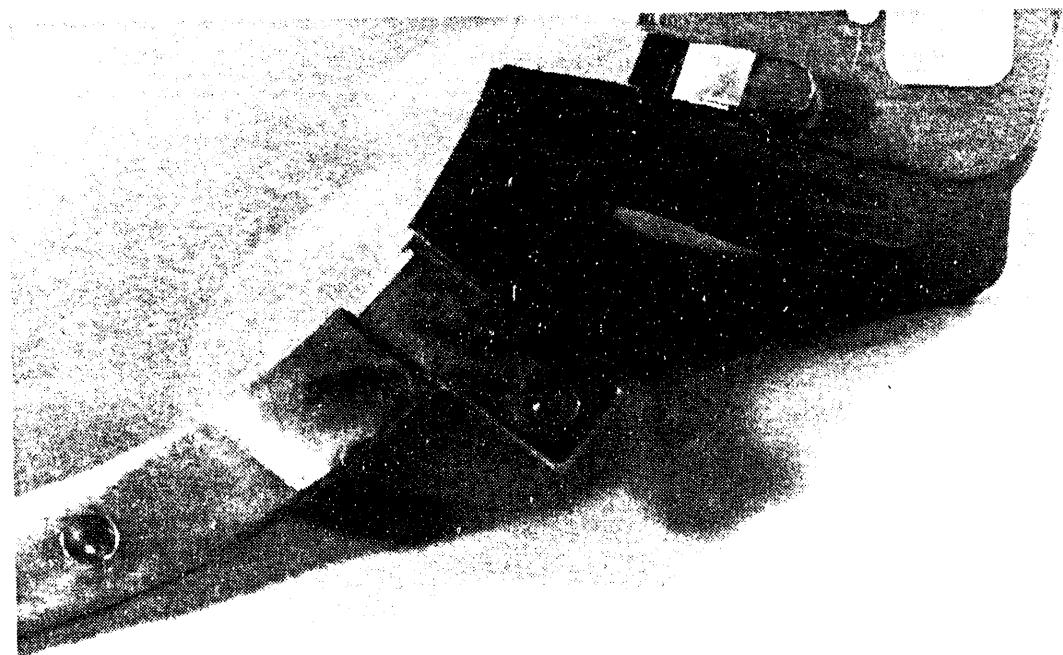
Figure 3b. Macrophotograph of mounting foot number 1 on a later base plate design. Note that the mounting hole is now centered in the foot.

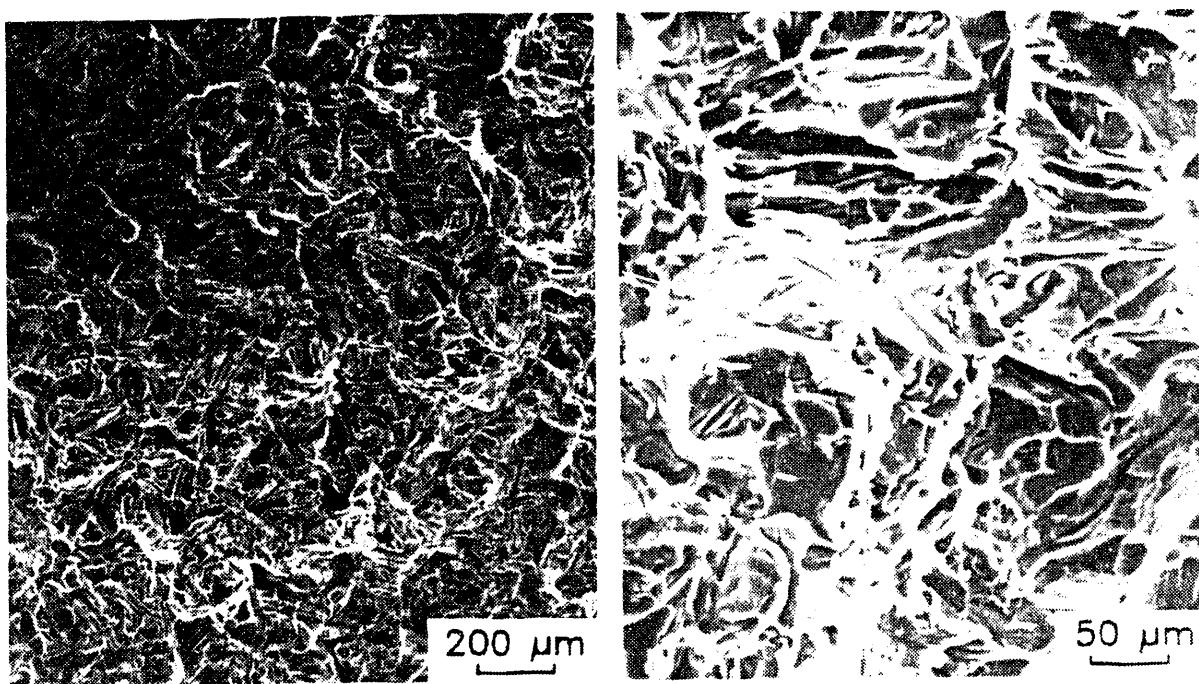
Figure 4a Scanning electron fractographs of the fracture surface shown in Figure 3. Note mix of smooth and dimpled surface, corresponding with failed silicon particles and aluminum ligaments, respectively.

In general, failure of these materials occurs in two steps, fracturing of the silicon particles followed by overload of the inter-particle ligaments. With the exception of Saigal's acoustic emission study (20), the fracture of the particles is considered to begin at relatively low strain levels. Although a detailed failure analysis study was not performed, the failure of the mounting foot which occurred in the initial static test conforms to this general failure model. Figure 3 shows macrophotographs of the failed foot, and Figure 4 shows a fractograph of the fracture surface and an optical micrograph of a section through the fracture surface. Figure 4a shows the mix of smooth facets and ductile dimples which correspond with the failed silicon particles and aluminum ligaments, respectively. Figure 4b clearly shows that a number of the silicon particles near the failure surface are fractured.

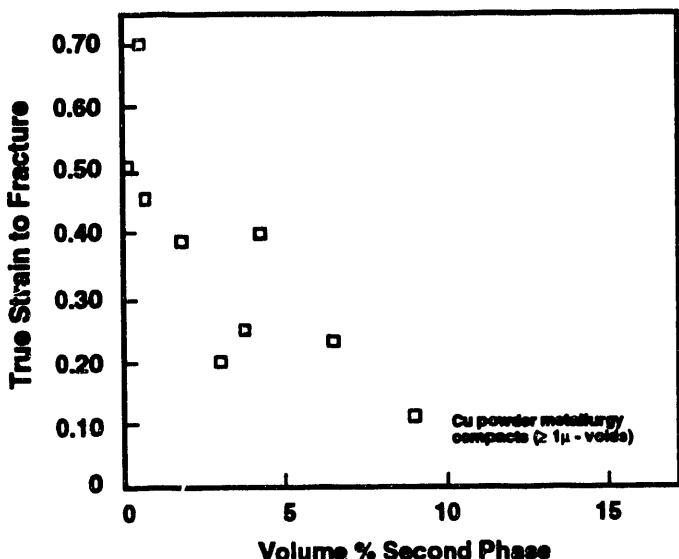
Figure 5. Mechanical property data for aluminum alloys compiled by Hahn and Rosenfield (24). Note that the presence of a small amount of porosity in (PM) copper drastically reduces the true strain to failure.

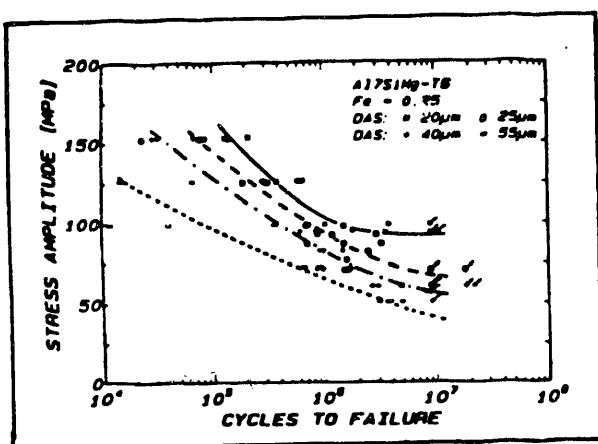
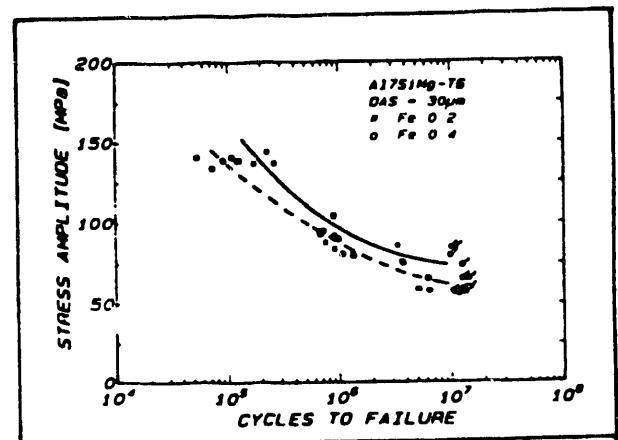
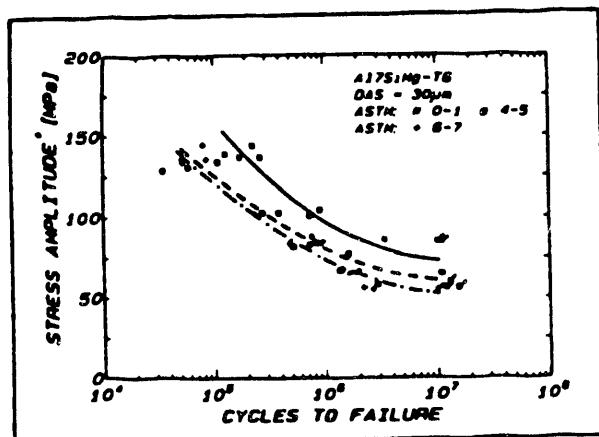
Fig 10. The influence of DAS on the fatigue strength.

Fig 11. The influence of Fe-content on the fatigue strength.

Fig 12. The influence of porosity on the fatigue strength.

Figure 6. Figures 10-12 from Wickberg (25). Stress-controlled high-cycle fatigue data showing reduction in fatigue life due to increases in DAS, iron content, and porosity, respectively.

DAS, iron content, and defect content were all found by Wickberg, et al. to have a substantial effect on fatigue life (25). Figures 10-12 from the Wickberg et al. study are presented as Figure 6. These data show that castings with a gas porosity ASTM rating of 6

Wickberg et al. also found that increased DAS and defect content reduced the slope of the SN curve and shifted the knee of the curves to higher N values. This was interpreted as implying that the crack nucleation phase was reduced and the fatigue life is determined more by crack propagation. This is consistent with the low cycle fatigue data of Stephens, shown in Figure 7. These results are for material having DAS values of 36-58  $\mu$ m. A comparison of these results with those of Wickberg shows a significantly lesser effect of DAS. This comparison suggests that the large effect noted by Wickberg is more likely due to differences in defect content. It is anticipated that the fatigue life performance of the supplied castings is most accurately represented by the Stephens et al. data, Figure 7 (26).

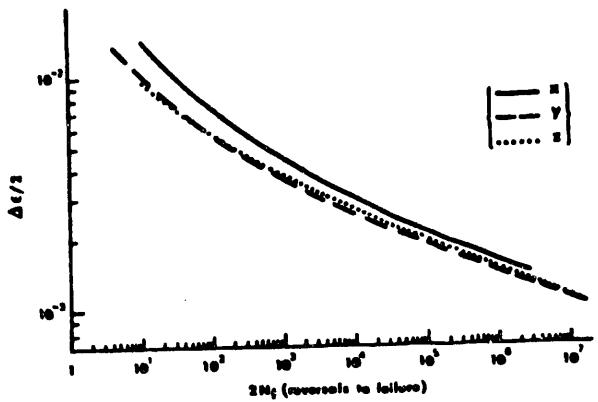
Fig. 7 - Composite All-laboratory Low Cycle Fatigue Behaviour,  
materials X, Y and Z

Figure 7. Strain-controlled low cycle fatigue data of Stephens, et al. (26), for A356 T6 having DAS values from 36 (material X) - 58  $\mu\text{m}$  (materials Y&Z). Note that DAS has a smaller effect than shown by the Wickberg (25) data, Figure 6.

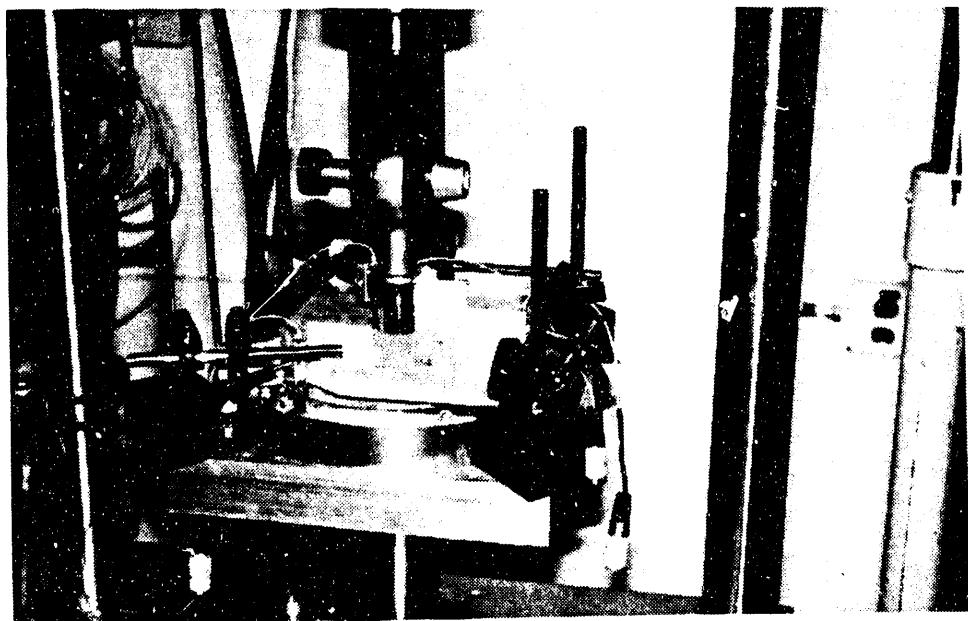
Figure 9a. Experimental setup showing base plate held between mounting fixture (below) and loading plate (above). Assembly sits on machine base plate (shown, drilled on 1" centers) and load is applied at the large central hole in loading plate. Direction of loading is upward.

The assembly of casting, mounting fixture, and loading plate is shown in Figure 9a. Figure 9b shows the location of the four displacement gauges. Figure 10 shows the location of the strain gauges. With reference to these figures, the gauges were located as listed in Table VI. Prior to static testing, the mounting feet of the selected casting (#385267-00-X0116) were radiographed and fluorescent penetrant tested by John Murray (2752). The quality of the casting was found to be consistent with those previously supplied and no surface defects were found.

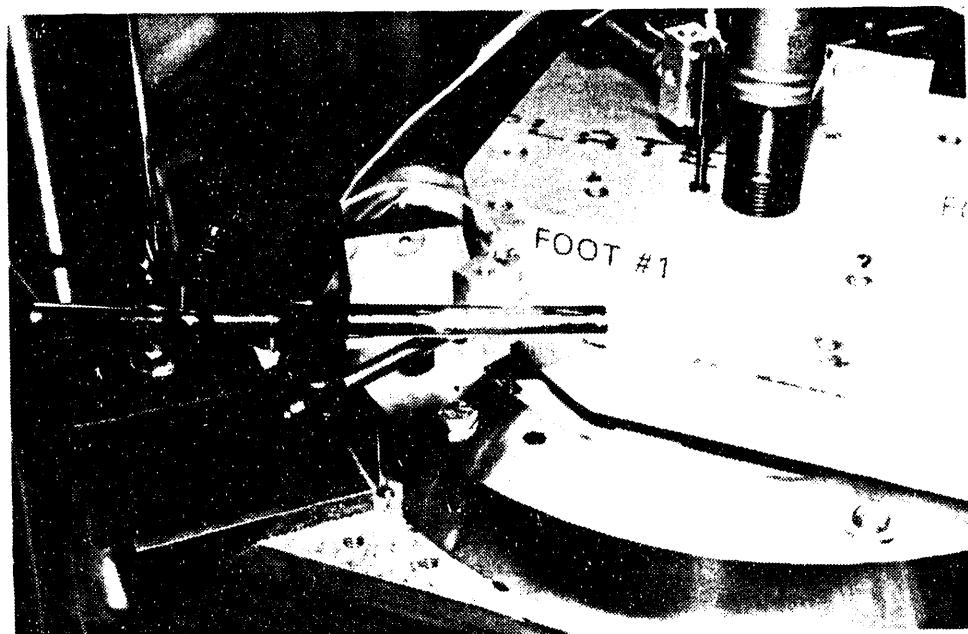
Figure 9b. Experimental setup showing location of displacement gauges and position of ram in center of loading plate.

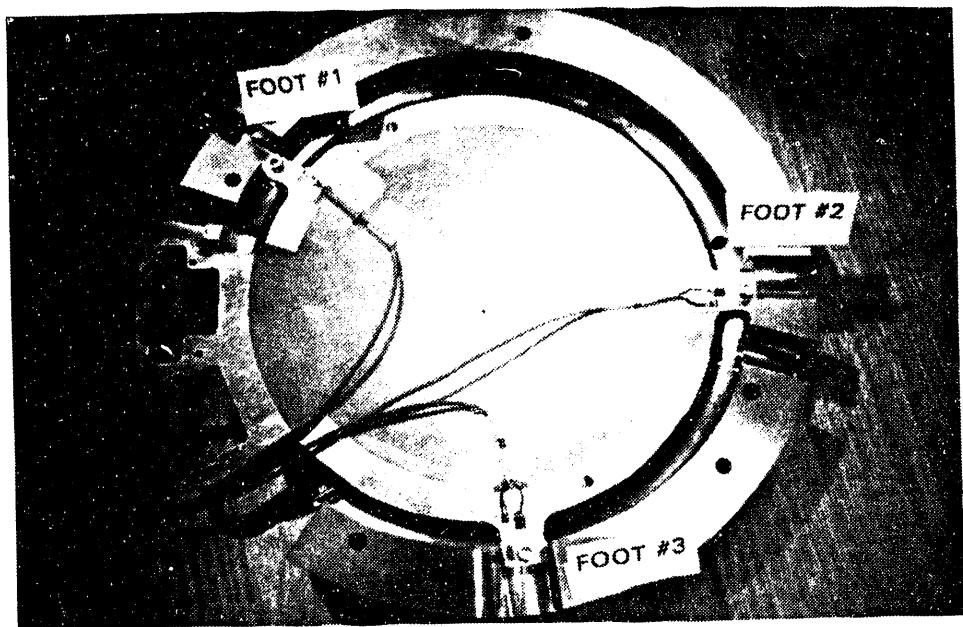
Figure 10a. Location of strain gauges on underside of mounting feet.

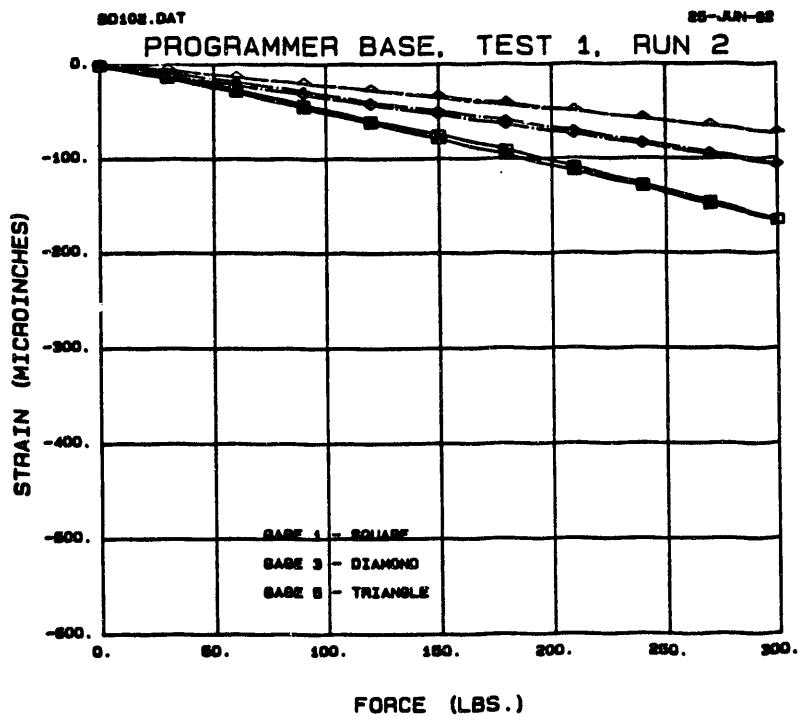
Figure 11. Output of strain gauges #1, 3, and 5 for Test Series 1, Load Cycle 2. Note that output is negative, showing that strain is compressive

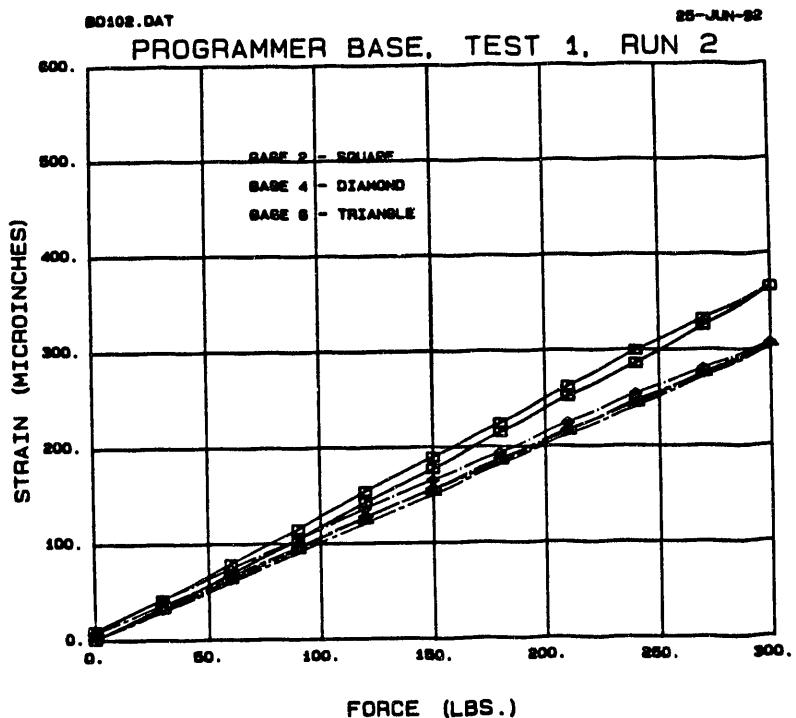
Figure 12. Output of strain gauges #2, 4, and 6. Note that all strains are tensile and that the strain is greatest for gauge #2 (mounting foot 1).

- 2) As expected, the maximum strain is seen in gauge #2, mounted at the hole end of foot 1, the narrow foot. This strain is slightly greater than that occurring at the same location on the other feet.
- 3) The maximum compressive strain is seen at the base of foot 1. The magnitude of the strain developed here is about 1/2 of that developed at the hole end of this foot, and about 1.5 - 2 X that developed at the base of the other two mounting feet.
- 4) The maximum displacement of the loading plate was found to typically be 0.038 mm (0.0015"). The displacement of the casting, just inside of foot 1, was also about 0.038 mm (0.0015"). The displacement inboard of mounting foot 3 (see Fig 9b) was found to be slightly less, and inboard of foot 2, only about 0.005 mm (0.0002").

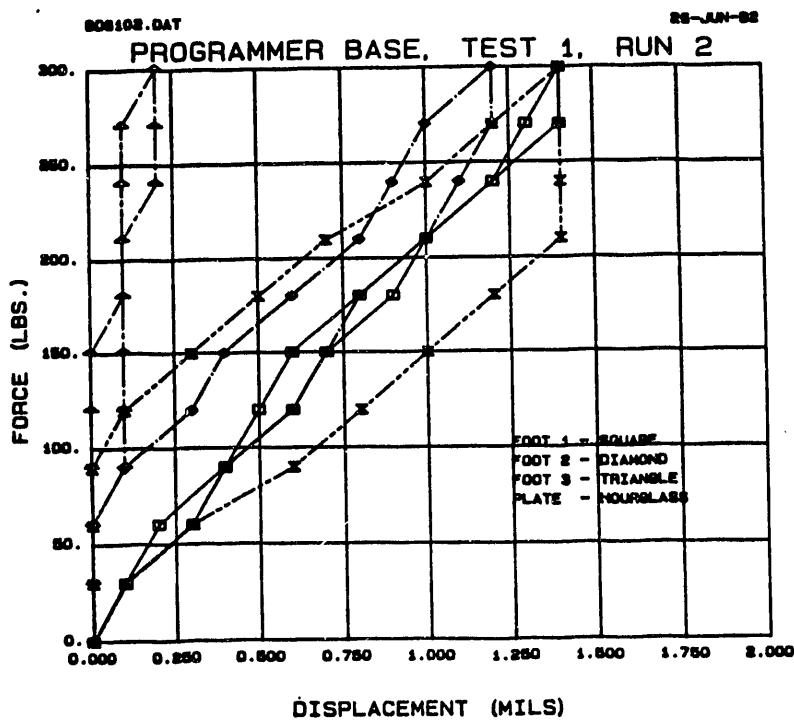
Figure 13. Output of displacement gauges for Test Series 1, Load Cycle 2. Note that displacement is greatest at location 1 (mounting foot 1) and least at location 2 (mounting foot 2). This indicates that the casting is twisting under the centrally applied load. Note also that all displacement gauges return to essentially zero.

The displacement results verify that foot 1 is deforming to a greater degree than foot 3, which in turn deforms more than foot 2. These results indicate that the casting is twisting somewhat under these loading conditions.

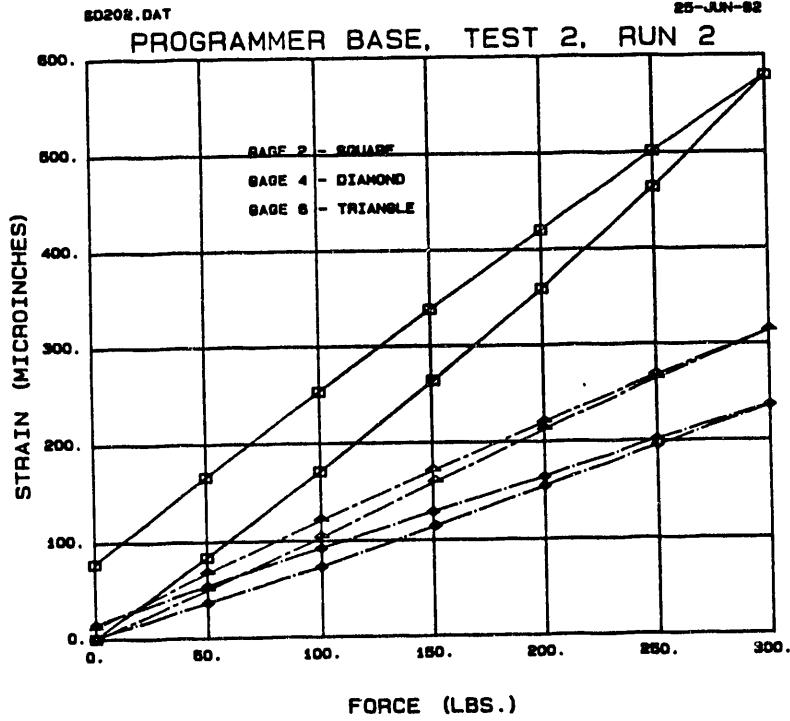
Figure 14. Output of strain gauges #2, 4, and 6 for Test Series 2, Load Cycle 2. Note that a minor non-linearity appears to occur between 100 and 150 lbs.

Test Series 2, Loading Cycle 2 was carried out in a manner identical to that used in Loading Cycle 1. Figures 14 and 15 show the output of strain gauges #2, 4, and 6, and the four displacement gauges, respectively, for Loading Cycle 2. The maximum strain and displacement levels reached in Loading Cycles 1 and 2 were similar, but the specific strain and displacement behavior was found to differ slightly. In Loading Cycle 1, all strains and displacements increased smoothly to a maximum, then smoothly returned to zero. In Loading Cycle 2, the strain seen at gauge #2 (foot 1), shows a minor non-linearity at 445-667 N (100-150 lbs), and indicates a residual strain of about 15% of the maximum level. Figure 15 shows that the displacement inboard of foot 1 increases to its maximum, then smoothly decreases as the load is removed. However, the displacement inboard of feet 2 and 3 reaches a maximum, then remains constant while the load is initially lowered. Gauges 2 and 3 also show a residual (unloaded) displacement of approximately half the maximum value.

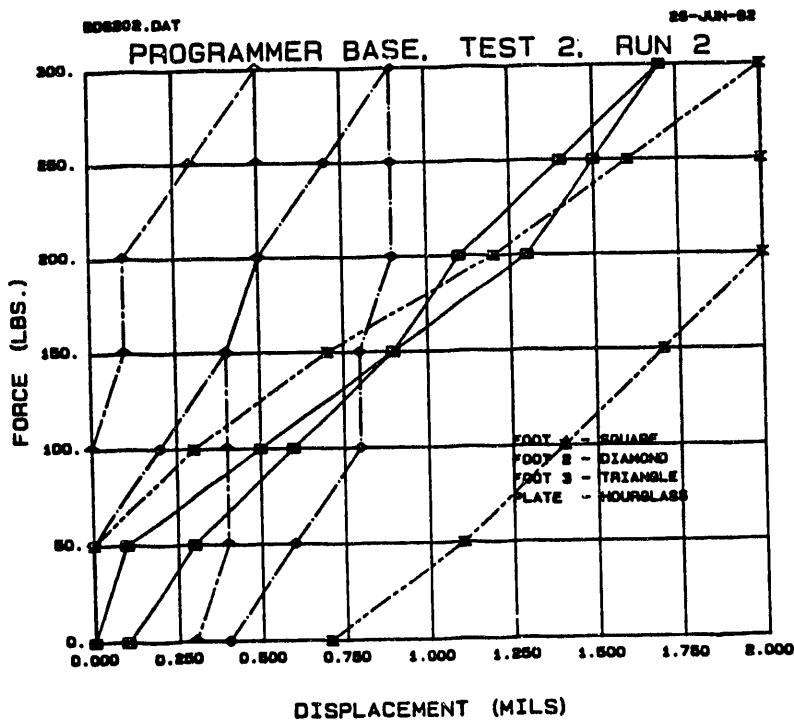
Figure 15. Load vs displacement curves for Test Series 2, Load Cycle 2. Note that the displacement at location 1 is greatest. Note also that the displacements at locations 2 and 3 remain at the maximum value as load is initially decreased, and only return approximately half way to zero.

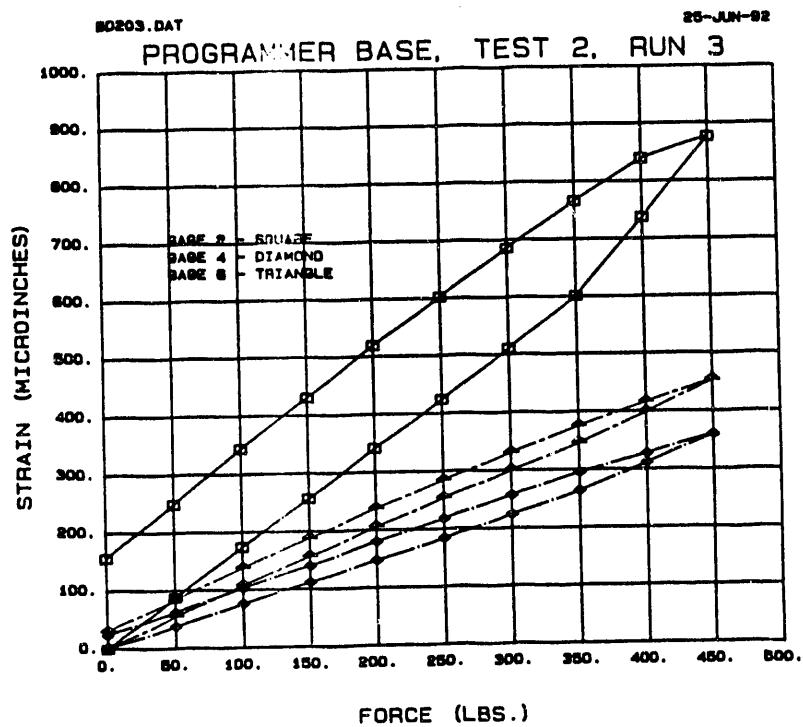
Figure 16. Output of strain gauges #2, 4, and 6 for Test Series 2, Load Cycle 3. Note that plastic deformation appears to begin between 350 and 400 lbs.

The results of Test Series 2, Loading Cycle 3 are shown in Figures 16-18. These results show that up to 1.335 kN (300 lb), the casting deformed in a manner identical to that observed previously. However, the casting began deforming in a non-linear manner between 1.56 and 1.78 kN (350 and 400 lbs), which agrees reasonably well with the data of Stirbis (4).

Unlike Loading Cycle 2 however, no residual displacement was detected at any of the displacement gauges. Strain gauge #2, Figure 16, clearly indicates a deviation from linear behavior between 1.56 and 1.78 kN (350 and 400 lbs). However, the lack of any residual displacement suggests that the yielding occurring in the region of strain gauge #2 was a local phenomenon and not sufficient to cause significant overall deformation of the casting.

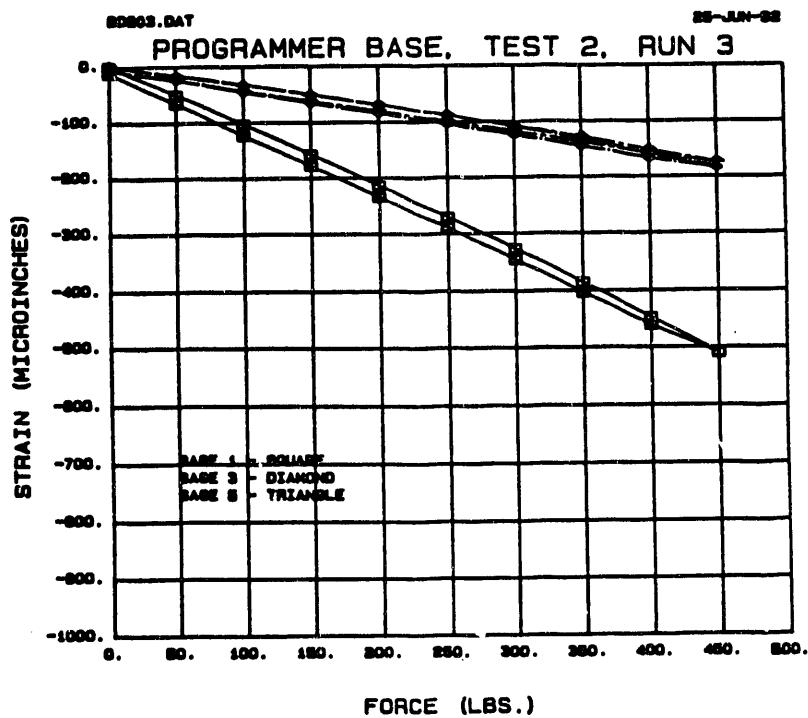
Figure 17. Output of strain gauges #1, 3, and 5 for Test Series 2, Load Cycle 3. Note that no plastic strain was detected.

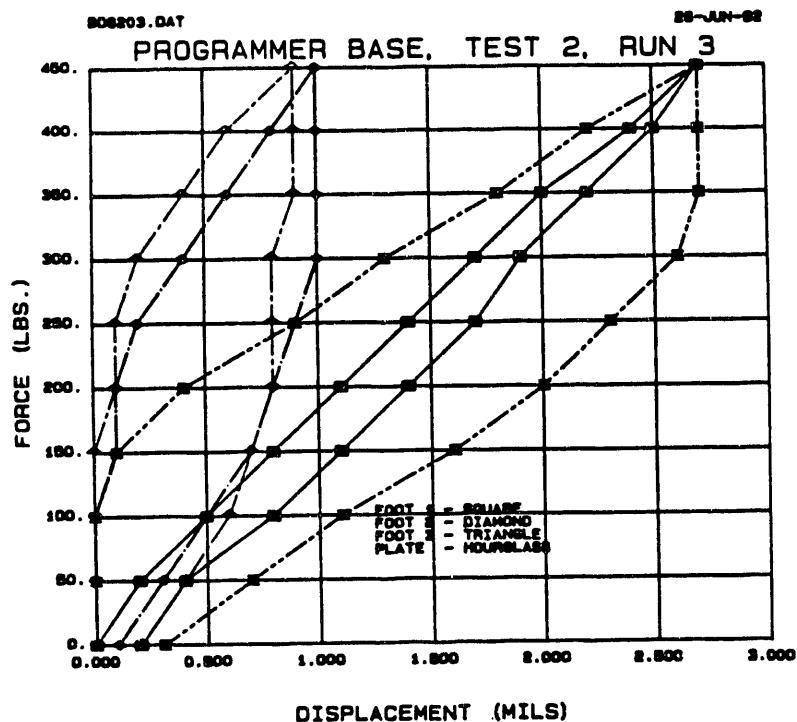
Figure 18. Load vs displacement curves for Test Series 2, Load Cycle 3. Note that no permanent deformation occurs.

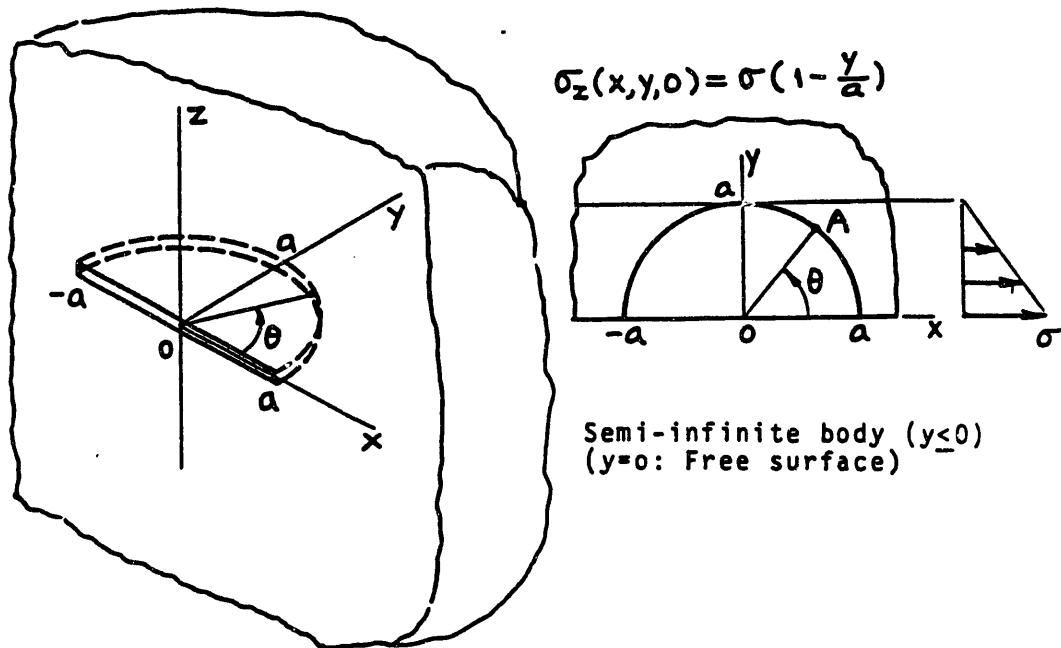
$$K_{IA} = \frac{2}{\pi} \sigma \sqrt{\pi a} \cdot F(\theta)$$

Figure 19a Schematic and calculation procedure for stress concentration factor for a crack emanating from an internal pore (33).

A) Crack(s) Emanating from a Pore (Figure 19a)

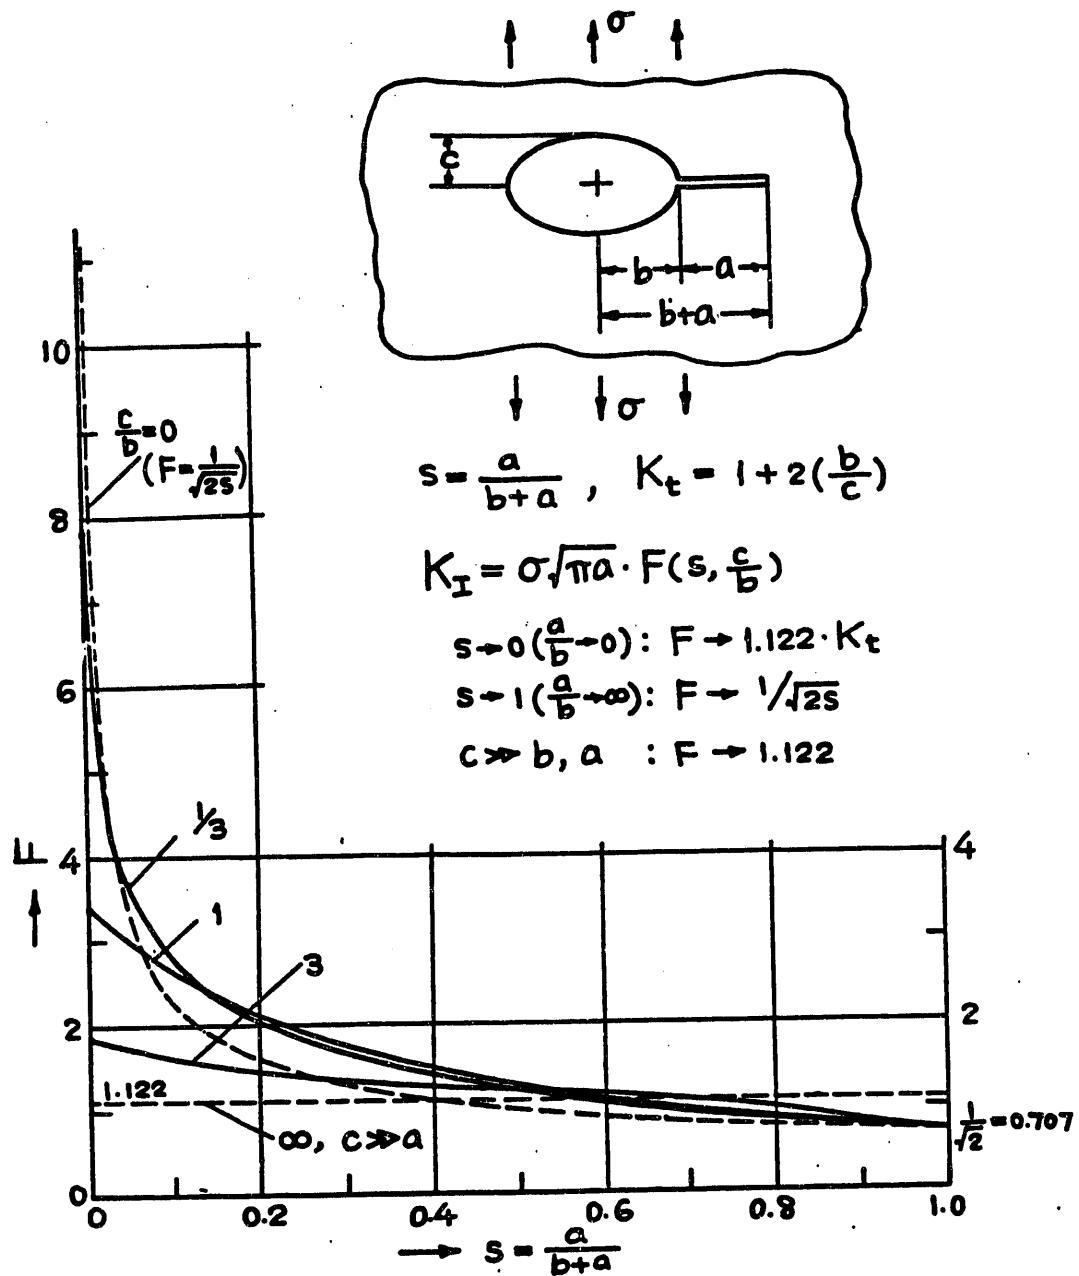
Figure 19b Schematic and calculation procedure for stress concentration factor for a surface crack (33).

B) Crack in the Specimen Surface (Figure 19b)

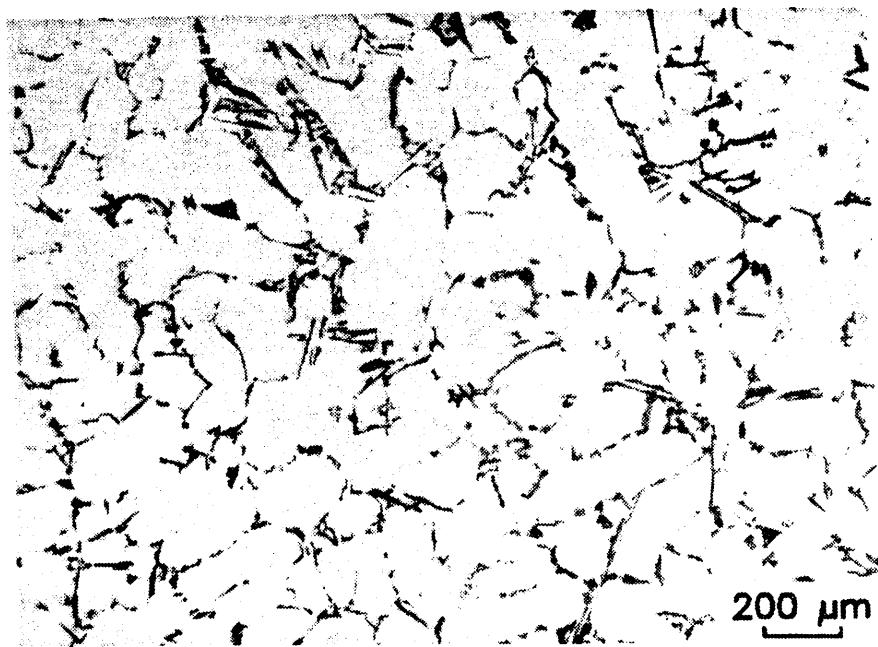
Figure 20a Micrograph of unmodified, as-cast A356. Specimen anodized: 5 g HBF<sub>4</sub> in 100 ml H<sub>2</sub>O, 25V for ~50 sec, ambient temperature.

Two general recommendations may be made for using aluminum castings in a potentially highly stressed structural application, particular in the presence of impact or fatigue loading. The first is to specify a higher grade of casting, at least in critical areas. In this case, an appropriate level would be ASTM-B-618 (or MIL-C-6021) Grade B. A second general recommendation is to replace the standard A356 alloy with a modified alloy. Figure 20 compares the microstructures of unmodified A356 with sodium modified material. Note the microstructural refinement and reduced aspect ratio of the silicon particles in the modified material. Given the role that the silicon particles and their distribution play in the failure of this type of alloy, the modified alloys would be expected to have far superior ductility, tensile strength, and fracture toughness.

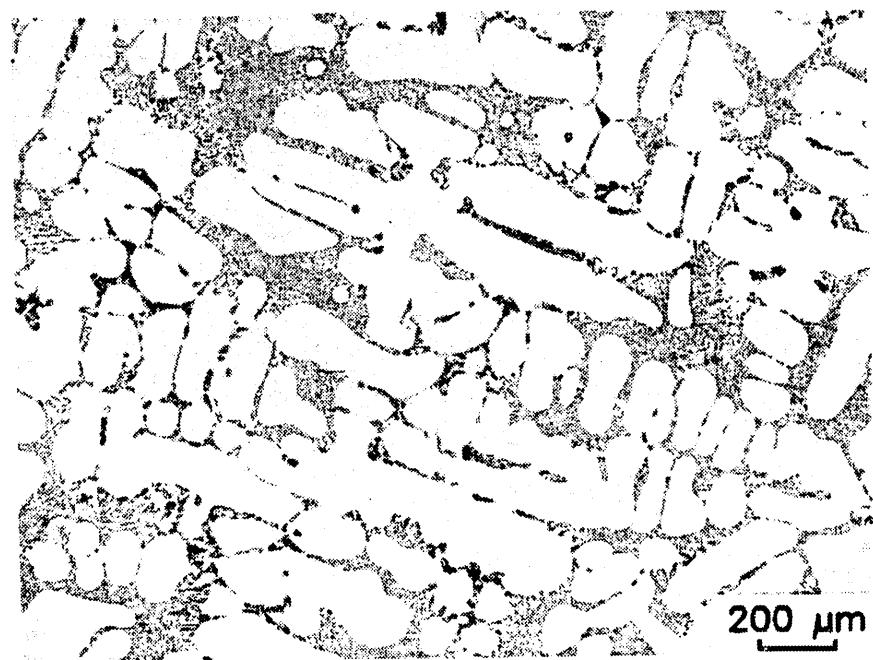
Figure 20b Micrograph of sodium-modified A356, as-cast. Nominal addition, 0.3 wt %. Specimen anodized: 5 g HBF<sub>4</sub> in 100 ml H<sub>2</sub>O, 25V for ~50 sec, ambient temperature. Note refinement of microstructure.

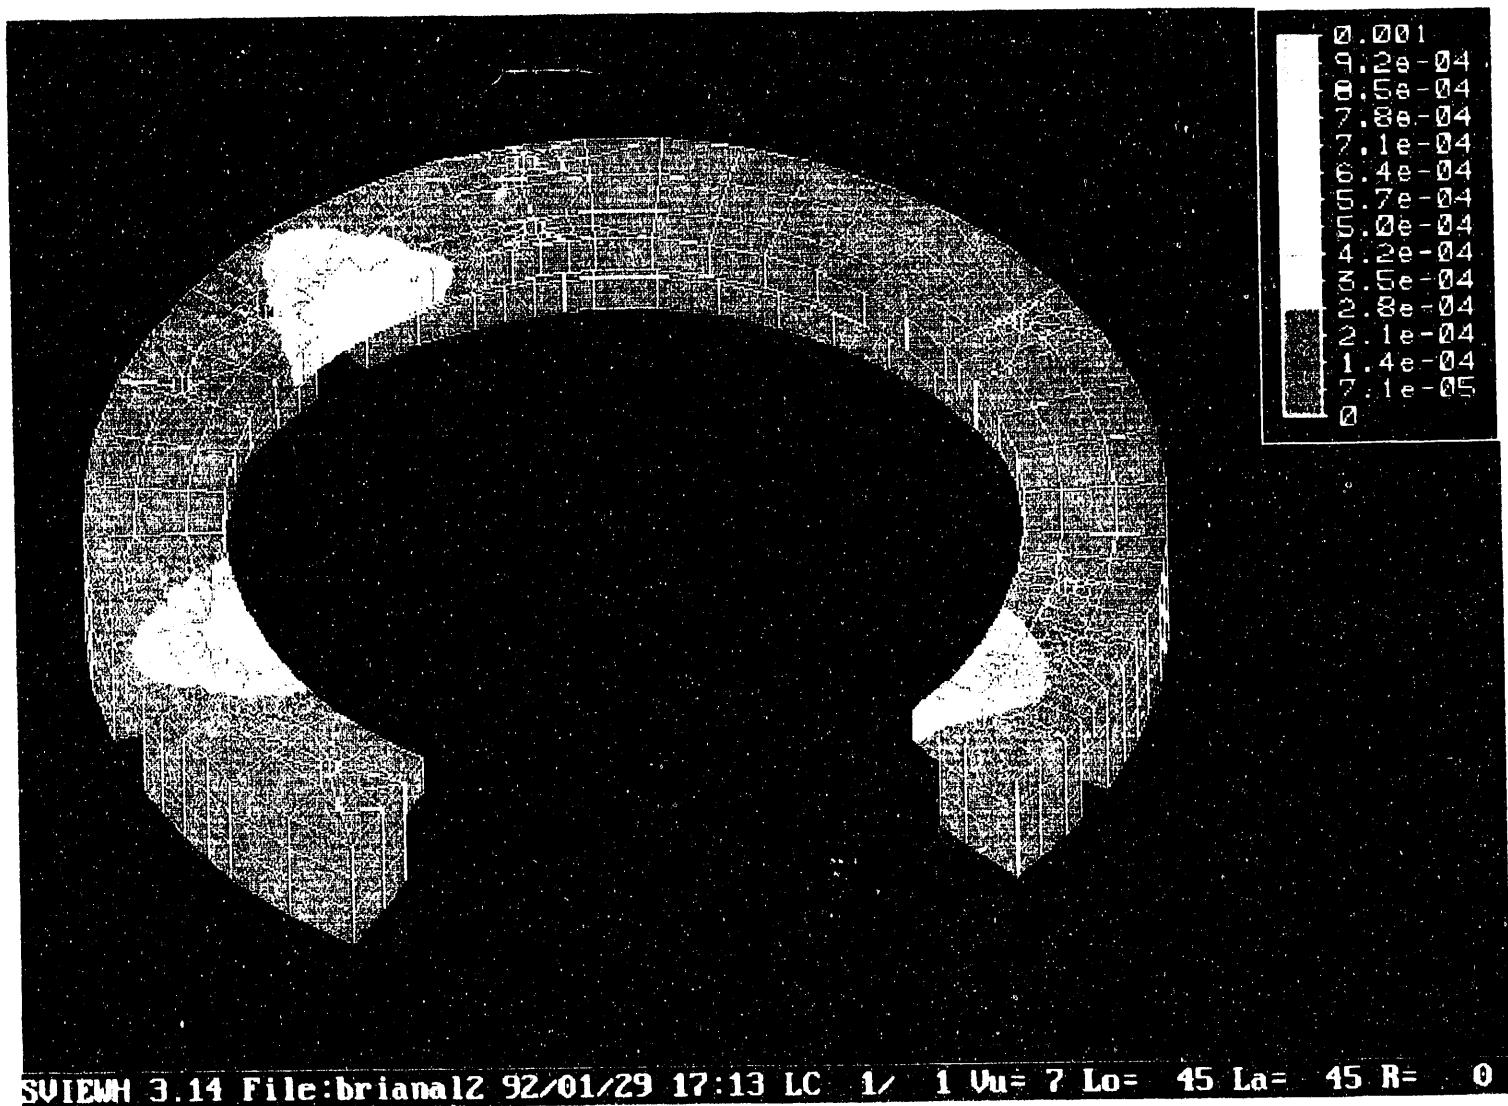
Fig.2

Bolt hole pattern for the Pulling Fixture.
