SLAC-PUB-5890

RECENT PERFORMANCE, LIFETIME, AND FAILURE MODES OF THE 5045 KLYSTRON POPULATION AT SLAC*

R. F. Koontz, T. G. Lee, C. Pearson, and A. E. Vlieks
Stanford Linear Accelerator Center, Stanford University
Stanford, CA 94309

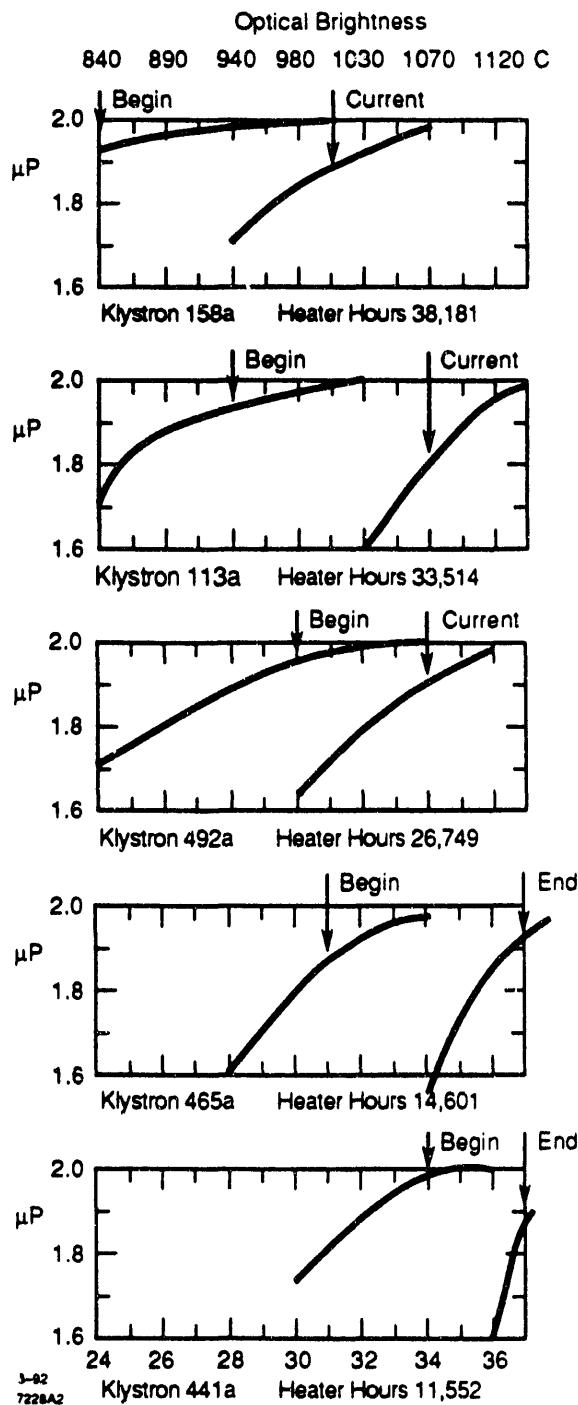
Figure 2 shows the emission characteristics of five selected klystrons removed from the gallery, and retested in the test lab. The first three tubes had "good" to "excellent" cathodes, have given long service, and are still in operation. The last two examples started out with "marginal" cathodes that required

Fig. 2. Beginning and ending emission characteristics for klystrons with "good" to "bad" cathodes.

initial high temperature operation. Both failed due to end-of-life symptoms at rather low operating hours. The pictures in Figures 3 and 4 show the anode surface of one of these failed tubes. The failure mode was arcing and gassing in the tube. Note the barium compound buildup on the anode surface, and the flaking. Most of this flaking happens after the tube is cut open.

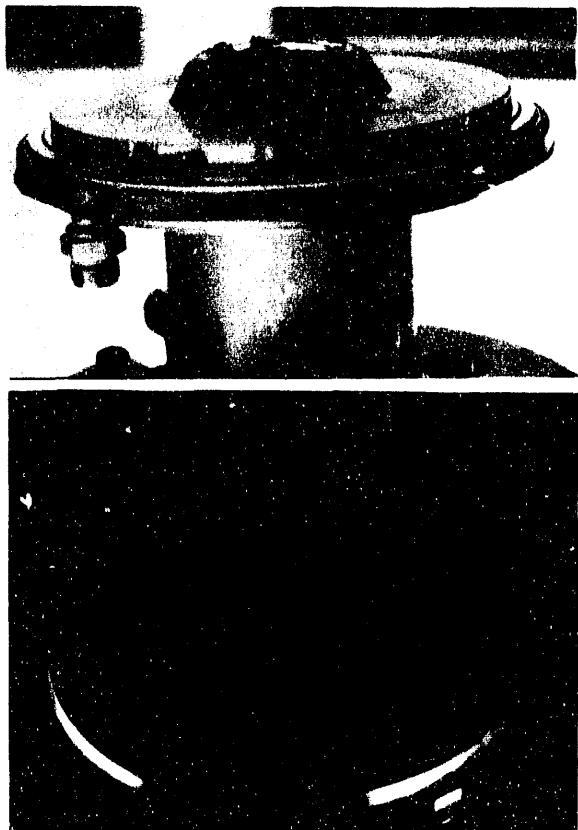
but any small break in the barium buildup tends to arc in the high-voltage gradient between the cathode and anode, and causes a massive gas burst. The barium buildup is accelerated by high operating cathode temperature. On a few high operating hour tubes that failed for reasons other than cathode problems, very little barium buildup was in evidence during autopsy. The dominant mode of failure of klystrons now operating in SLC service is cathode depletion, and the associated arcing and gassing from anode barium buildup.

Figs. 3 and 4. Barium buildup on klystron anode.

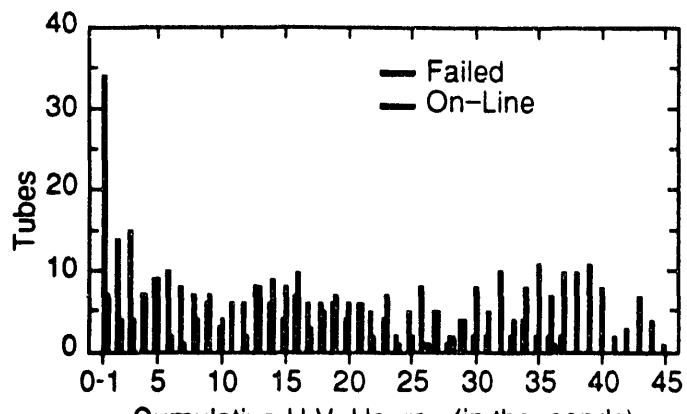
Figure 5 is a graph of cumulative high voltage hours for klystrons that have been, or are currently in operation. There is a large group of tubes that is approaching 40,000 hours of life. Most of the "infant mortality" type failures occurred during the initial installation phase seven years ago. Currently, tubes passing test lab tests do not show any serious "infant mortality" problems when put into SLC service. The average age of failed tubes returned from SLC service is 19,000 hours of high-voltage running time. The average age of operating tubes in SLC service is 23,000 high-voltage hours, and 29,000 hours of cathode heater time. The mean time between failure of SLC service klystrons is presently 52,000 hours. The history chart of these numbers is shown in Figure 6. In a random-population, steady-state-system, these three averages should converge, but even with seven years of operation, this convergence has not occurred for the SLC klystron population. During this time,

Fig. 5. Graph showing cumulative H.V. hours of online and failed 5045's.

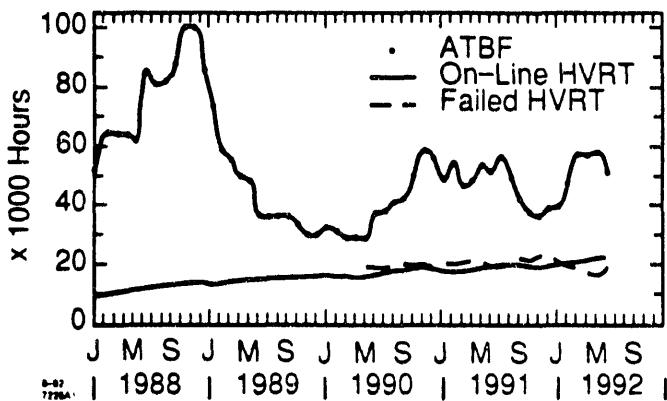
Fig. 6. 12-month average time between failures, average HVRT of failed 5054 klystrons, and average HVRT of online 5054 klystrons.
