CONTRACTOR REPORT

SAND92-7001
Unlimited Release
UC-275

Development of a Commercial Photovoltaic Concentrator Module

Shabbar T. Saifee, Gus Hutchison
Solar Kinetics, Inc.
10635 King William Drive
Dallas, TX 75220

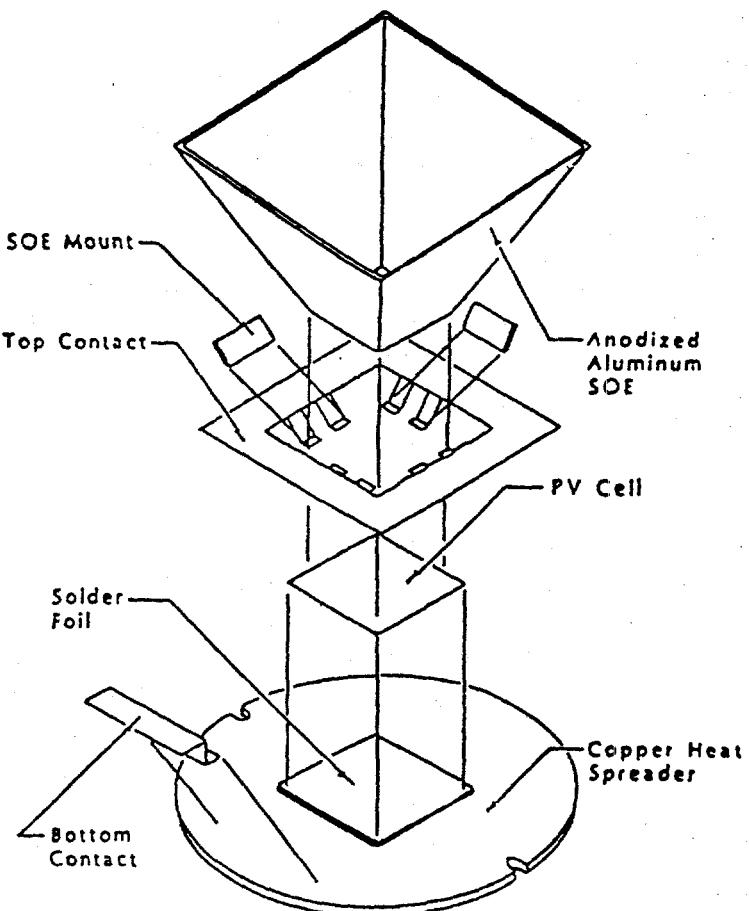
Figure 2.1 Exploded View of Concentrating PV Cell Assembly.

The solar cell assembly consists of six components. They include the PV cell, the heat spreader, the bottom contact, the top contact, the SOE, and the SOE mounting tabs. An exploded view of the cell assembly as currently executed shows the various components in Figure 2.1. Each component required fabrication and/or processing prior to assembly.

The SKI cell assembly is shown in Figure 2.1. In a complete module, twenty-four of these assemblies will be adhesive bonded to the bottom of the concentrator module aluminum housing (pan). The inside bottom of this pan will be lined with 0.002-inch thick film of (CT-412L), DuPont Tefzel with acrylic adhesive and a release liner. The cell assemblies will be bonded to the Tefzel film with approximately 0.005-inch thick layer of Shin Etsu X-31-751 thermally conductive dielectric moisture cure RTV. This adhesive and the film provide the electrical isolation between the cell assemblies and the pan while providing high thermal conductivity.

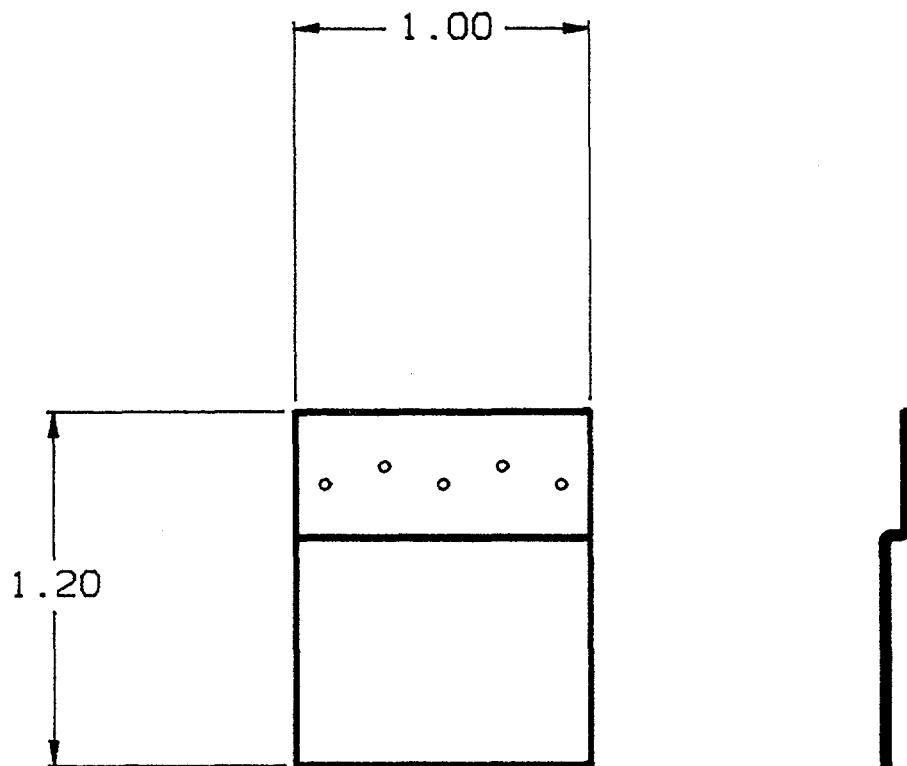
Figure 2.2 Fabrication Drawing of Bottom Contact.

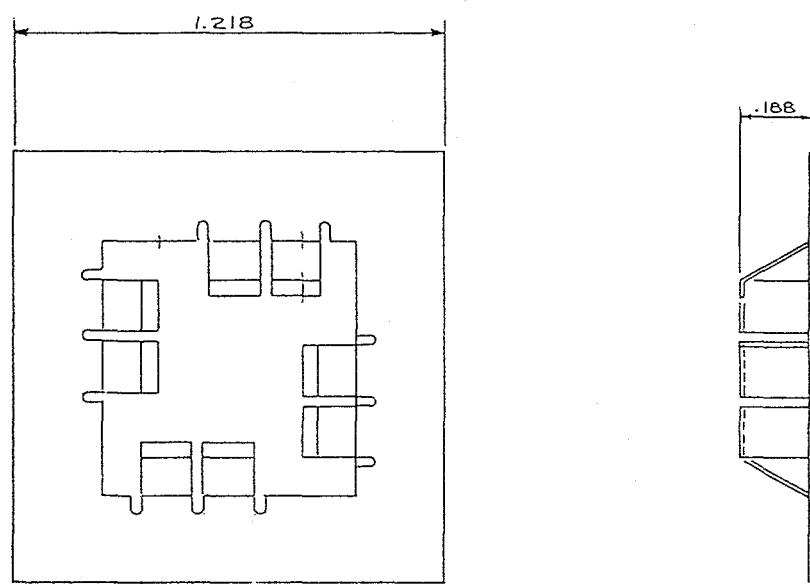
Figure 2.3 Fabrication Drawing of the Top Contact.

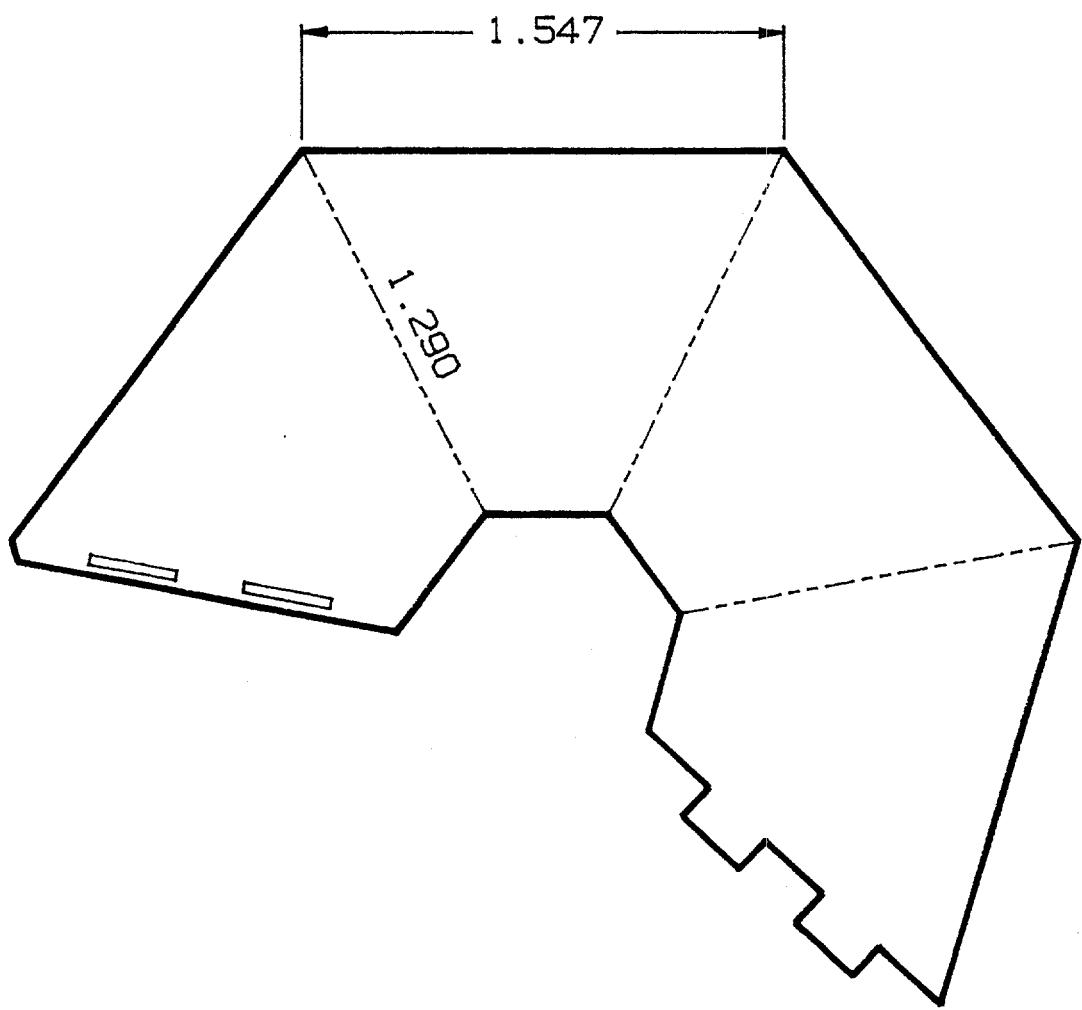
Figure 2.4 Flat Pattern of the Secondary Optical Element.

Secondary Optical Element (SOE): The SOE material is delivered pre-polished with a thick clear anodize coating in sheet form with a sheet plastic premask. This chemically polished aluminum is 0.012 inch thick and has average specular reflectivity in the silicon cell response spectrum of 82-84%. A sketch of the flat pattern of the SOE is shown in Figure 2.4. At SKI, the flat parts for the pyramid final shape were blanked out most of the way on the CNC turret punch. The turret punch press used for the fabrication of the top contact, the heat spreader and the SOE are shown in Figure 2.5. Connecting fingers were left in place to allow a sheet's worth of parts to be removed from the punch as a single piece. The individual pieces were separated by simple shearing of the connecting tabs.

In the current operation, each SOE was bent using custom Delrin bending dies in a small press brake. This polymer tooling was used to avoid marking the polished SOE material through the protective sheet premask. The locking tabs were inserted through the slots and bent over and crimped to finish the assembly. The premask was not removed until the fabrication of the cell assembly and its placement were complete inside the module. The plan was to remove the premasks from all the 24 cell assemblies before the placement of the Fresnel lens parquet, thus eliminating the possibility of contamination of the reflective surface due to handling and ambient dust.

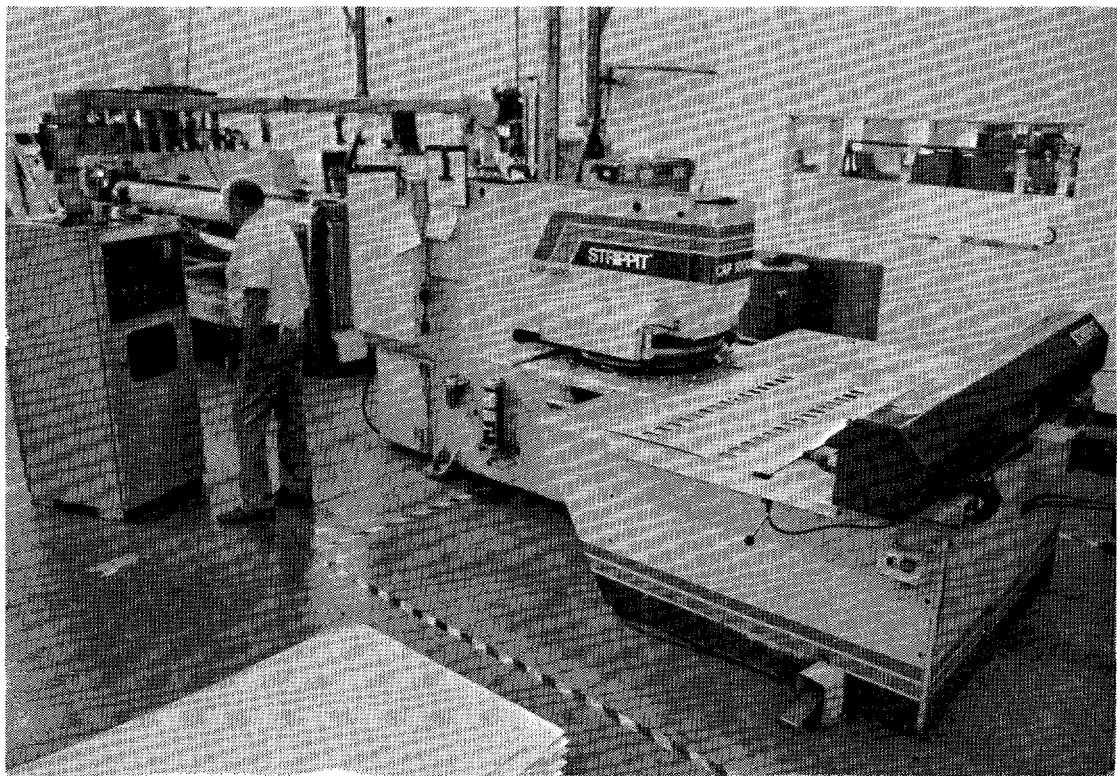
Figure 2.5 Turret Punch Press Used for Fabrication of Heat Spreader, Top Contact, and SOE.

Heat Spreader: The material for the heat spreader was received in sheet form. It was 0.060-inch-thick oxygen-free high-conductivity (OFHC) copper. In the first operation, the sheets were loaded onto a CNC turret punch. The control of the punch die stroke was such that the heat-spreader disk was not entirely separated from the sheet. It was sheared all the way around the perimeter, but the punch stroke stopped before the disk separated through the parent sheet. The sheet was taken off the press, and the parts manually separated from the sheet. This was done to prevent potential damage, such as nicking or bending that could occur if the press ejected the parts in the normal manner. The spreaders were manually deburred immediately after removal from the sheet.

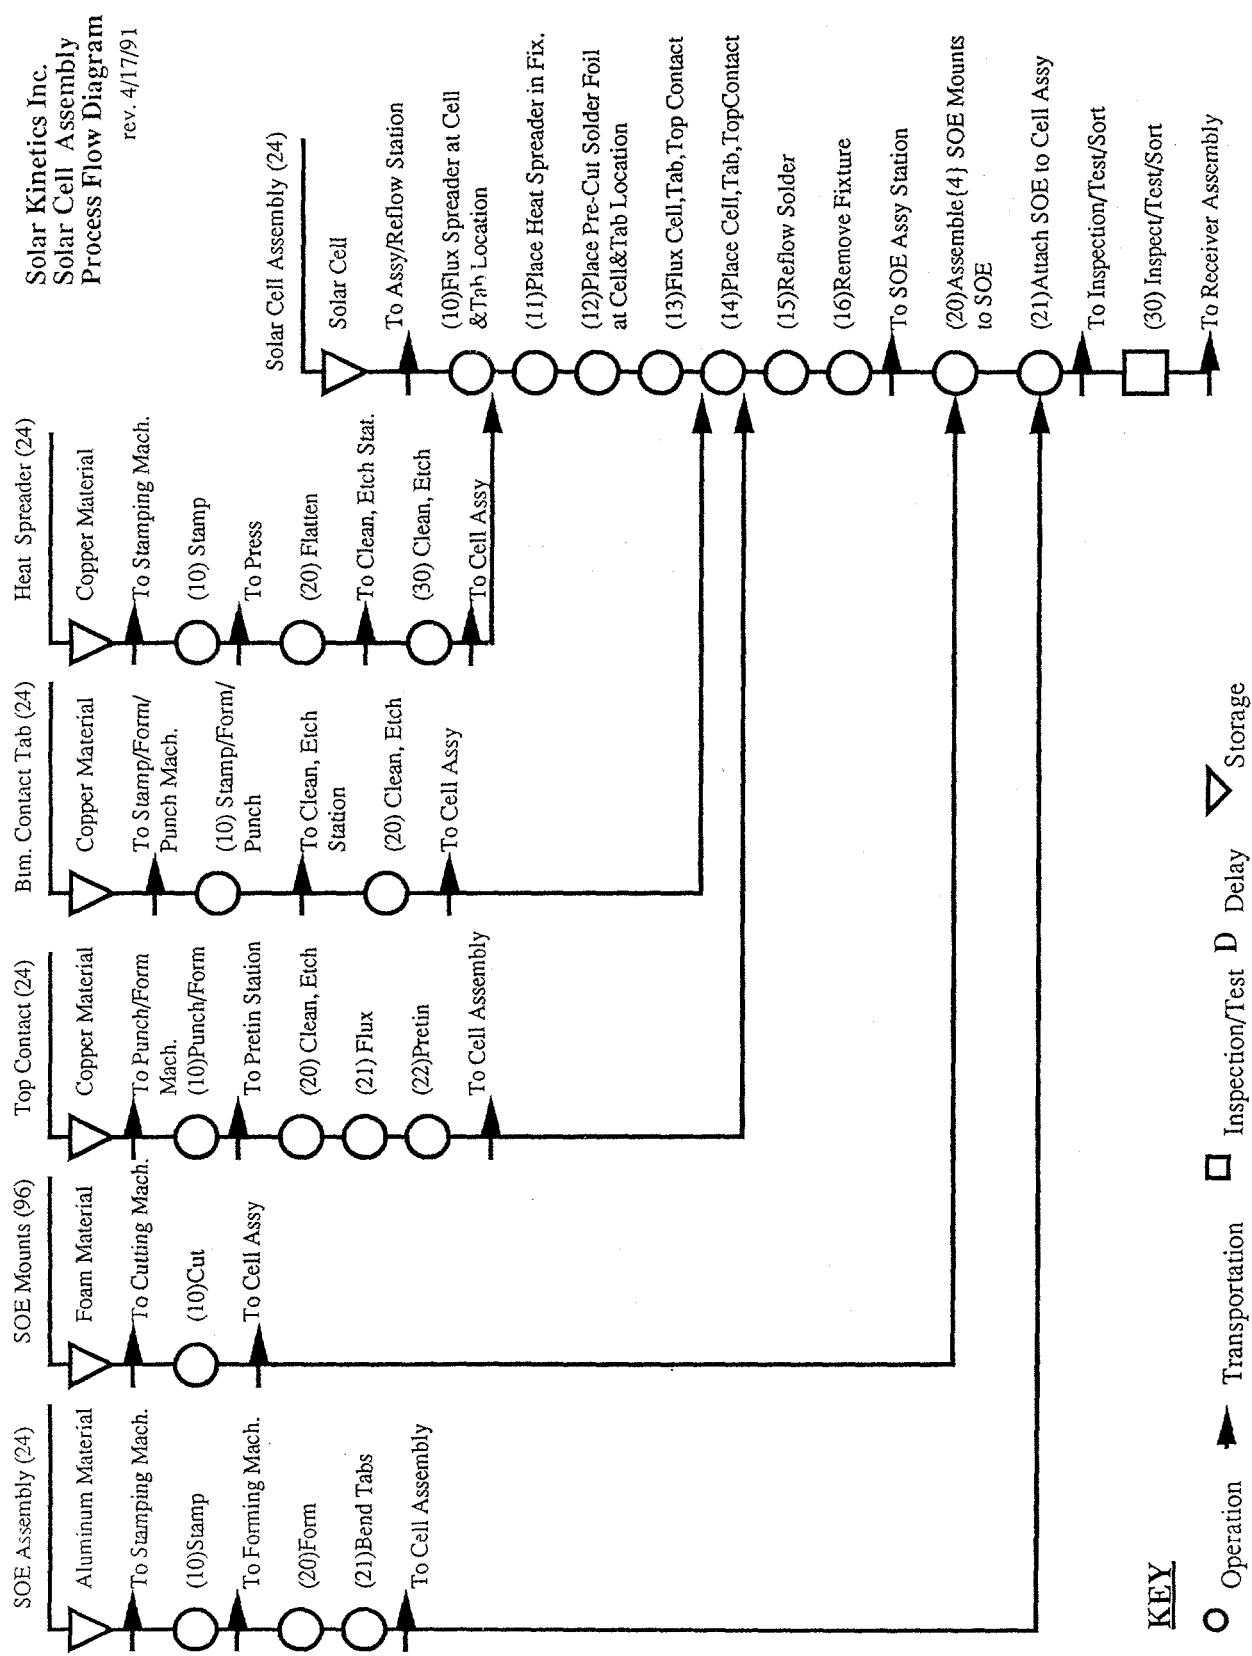
Figure 2.6 Process Flow Diagram for Cell Assembly Fabrication.

The solder reflow of all the interfaces of the cell assembly was achieved simultaneously with a tooling fixture using a hot plate. The surface preparation steps used for cleaning the heat spreader, top contact, and bottom contact included degreasing and acid etch. The PV cell was cleaned using isopropyl alcohol. Next, the assembly stack was configured in the fixture tooling. First, the heat spreader was placed, followed by application of a mild rosin flux in the area where the PV cell would be positioned. The back of the PV cell was fluxed using a water-soluble acid flux (SF 30). A 0.0005" foil of precut solder was placed on the back of this PV cell. Then, this cell was placed in the center of the heat spreader, guided by the fixture. Next, the top contact and bottom contact were placed and the fixture was assembled. The tooling fixture with the cell assembly was placed on a hot plate at 525 °F. It took about 2 minutes and 30 seconds for the solder to reflow. At this moment, the cell assembly was removed from the hot plate. It took about 4 minutes for the fixture to cool, and then the fixture was disassembled.

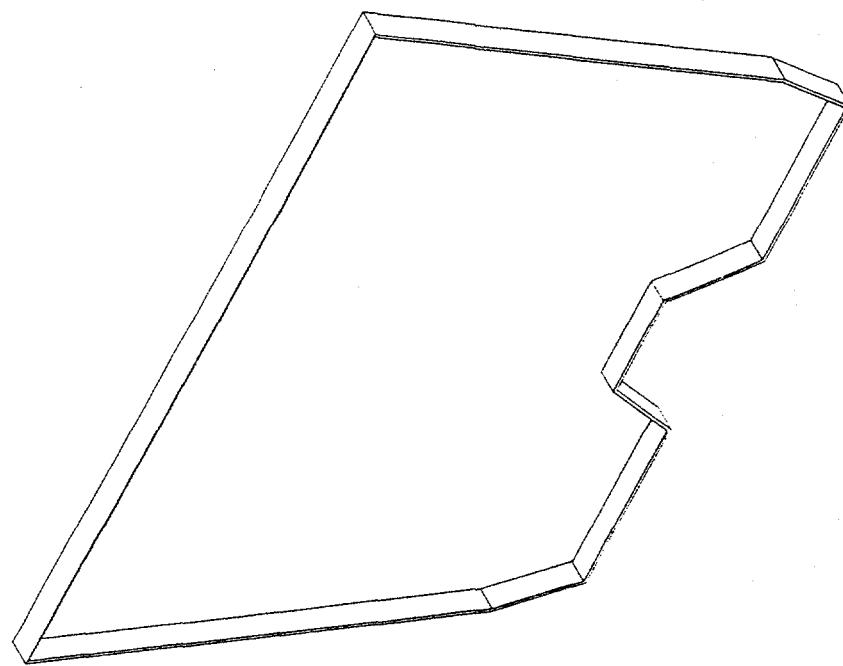
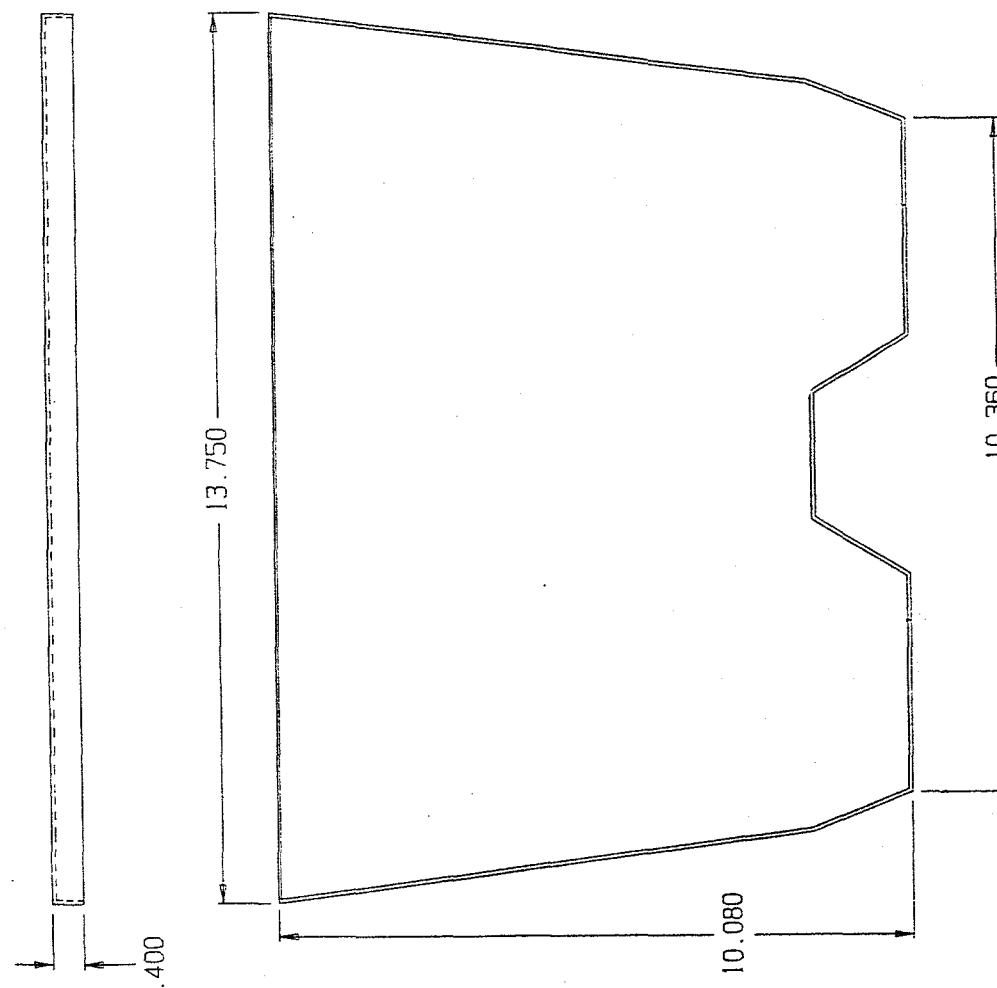
Figure 3.1 End Cap Outline Drawing.

The housings were set in a fixture to maintain the cross-sectional shape as required. The end caps were fixed in place with their lips flush with the outer edge of the housing edge. A temporary cooling medium was placed on the inside corner where the housing and end cap meet to serve as a heat sink during the next welding step. The edges of the housing and end cap were continuously fused without use of additional filler metal using a Gas Tungsten Arc Welding (GTAW) weld process. The cooling medium was removed, and the laminate edge smoothed down against the cooled metal. Additional

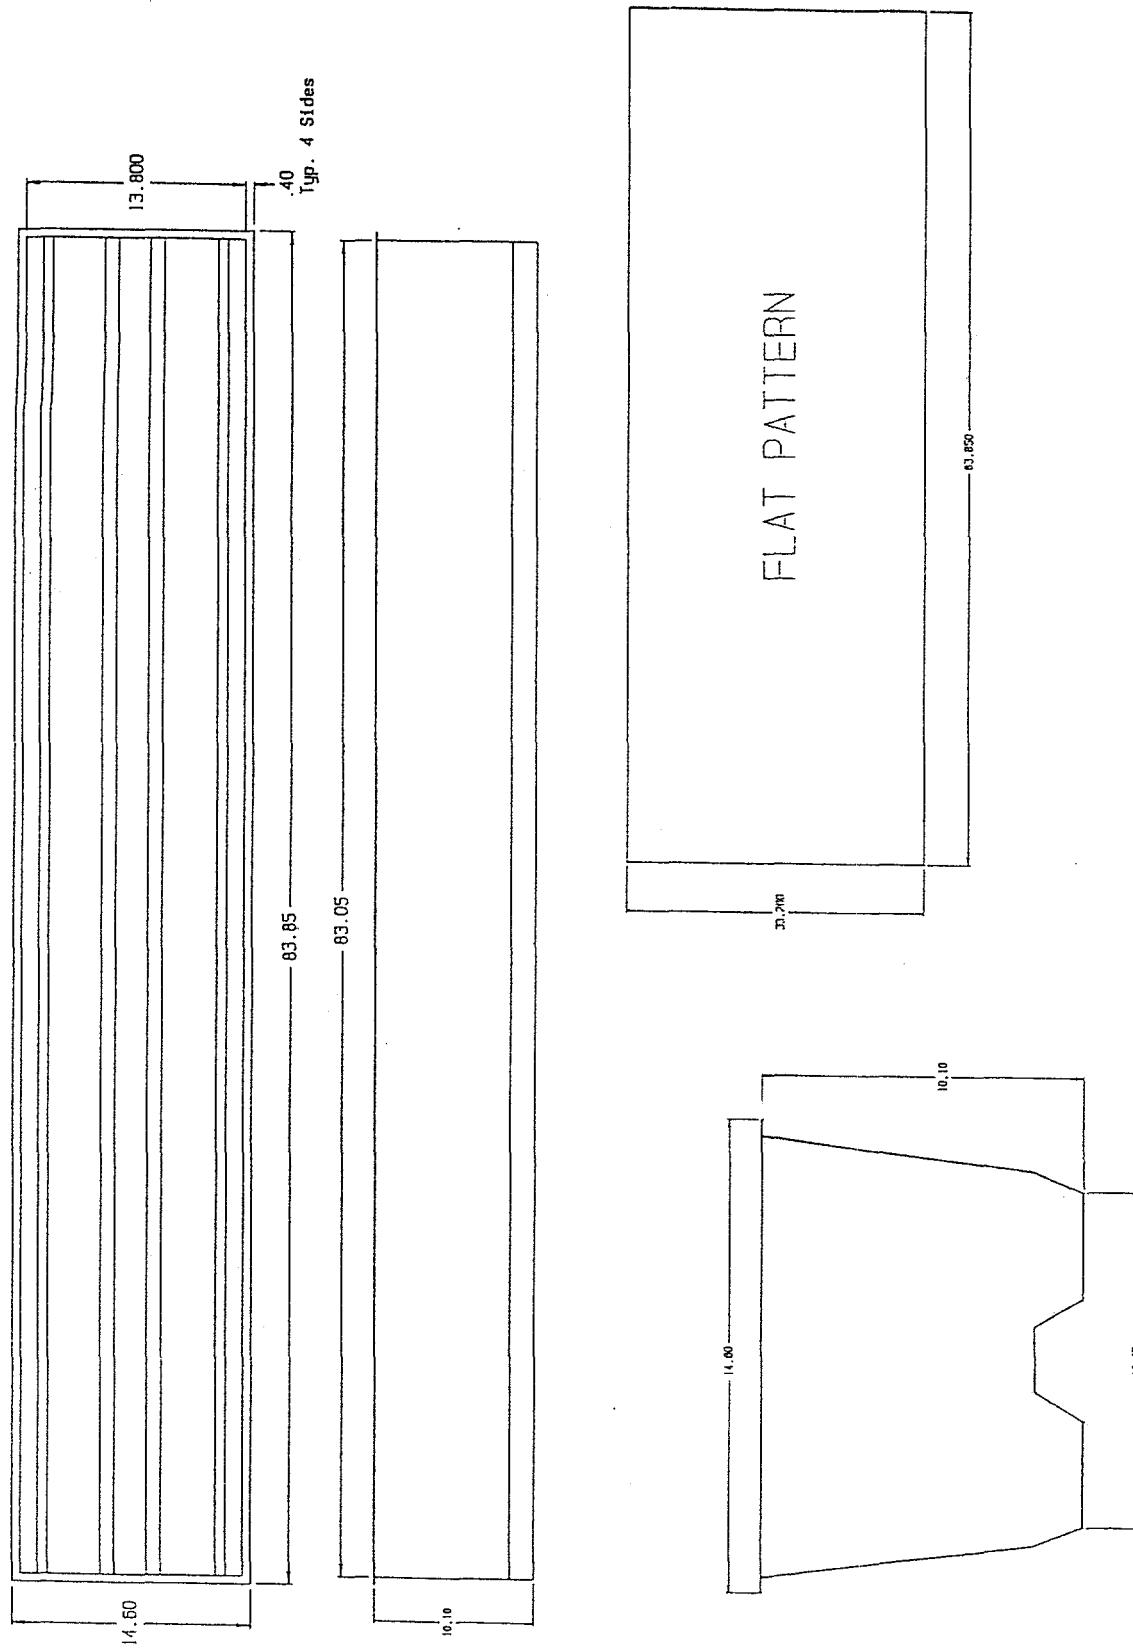
Figure 3.2 Module Housing Fabrication Drawing.

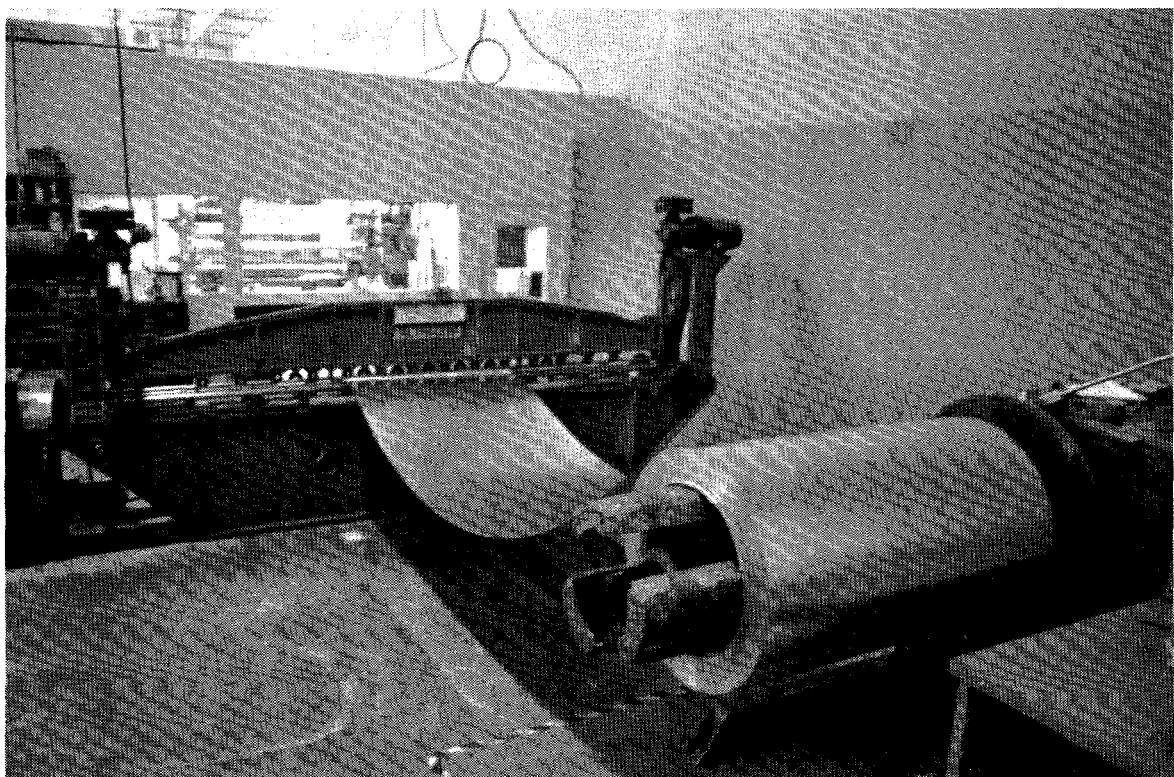
Figure 3.3 Module Housing Lamination Process.

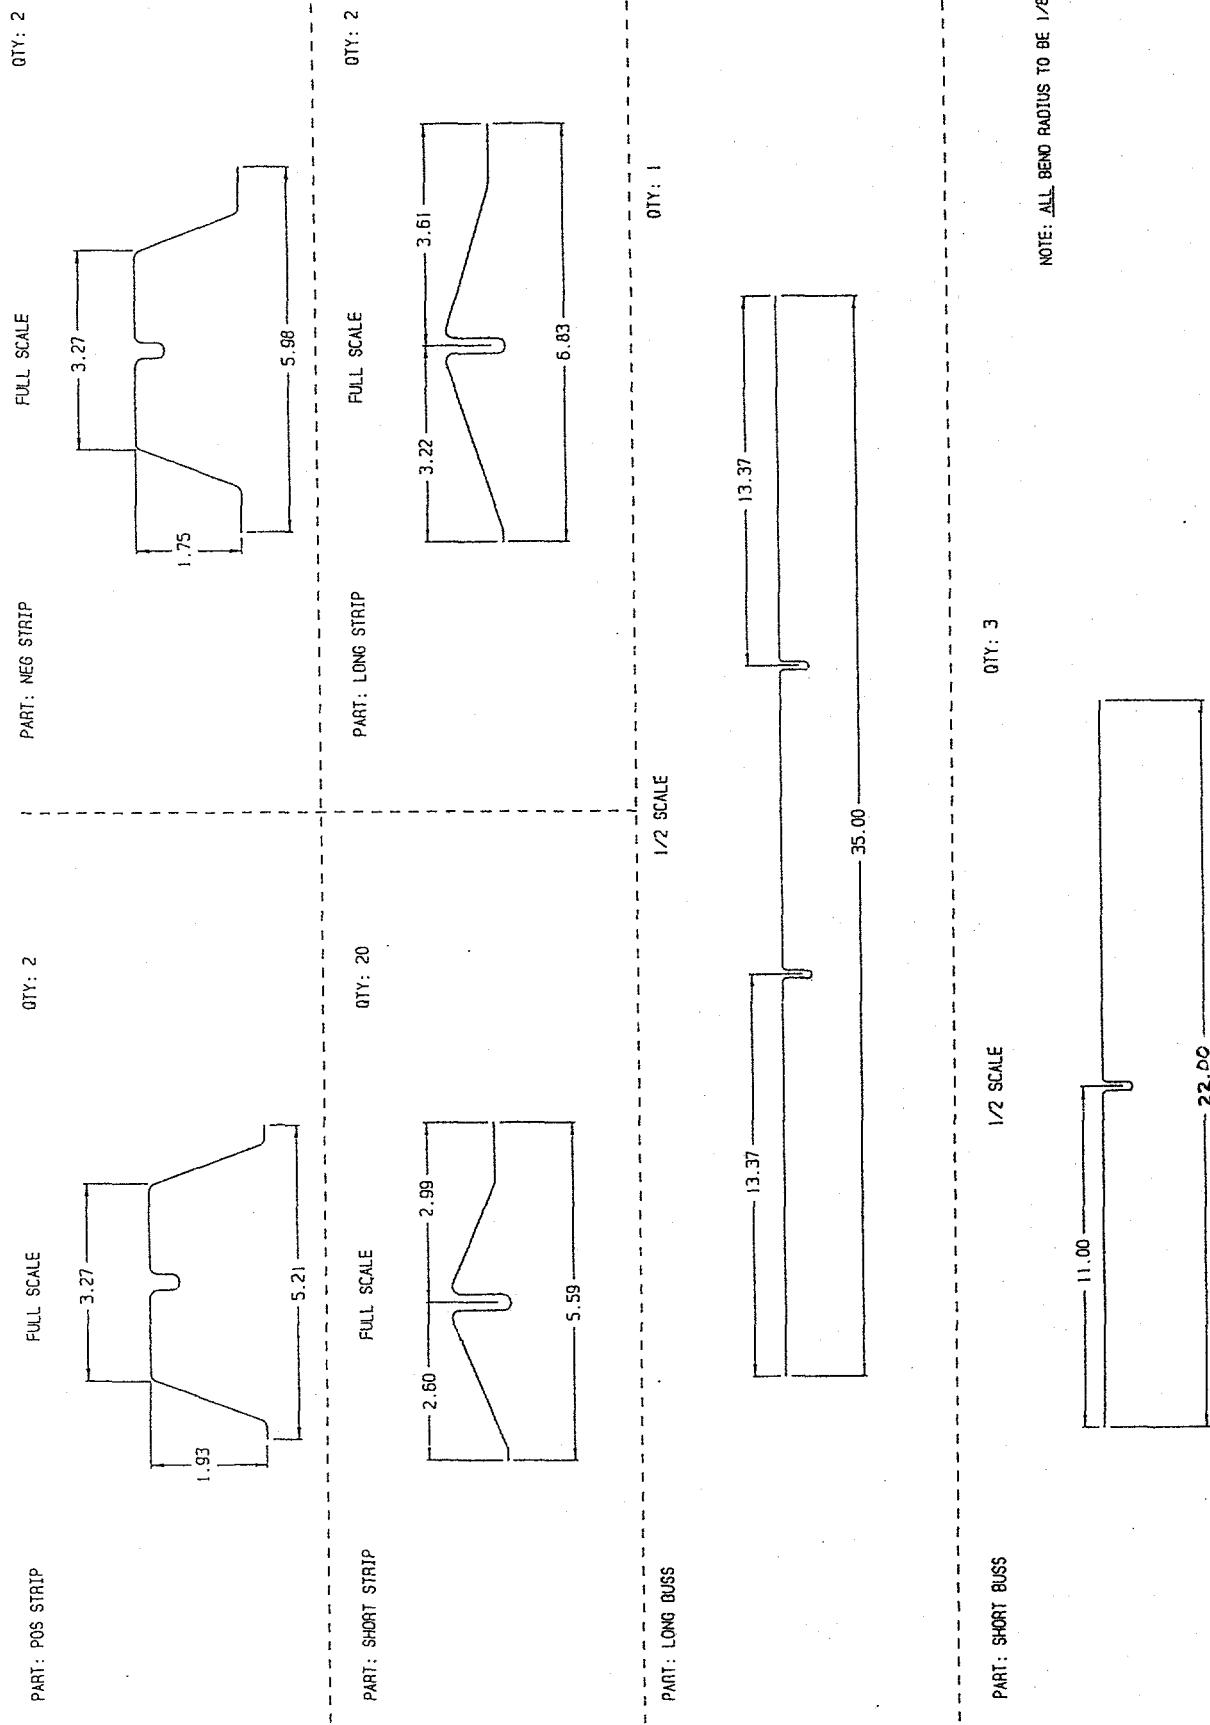
Figure 3.4 Various Interconnects Used in the Module.

The receiver assembly process includes placing the cell assemblies and diode assemblies in the module pan and then attaching the electrical interconnects.

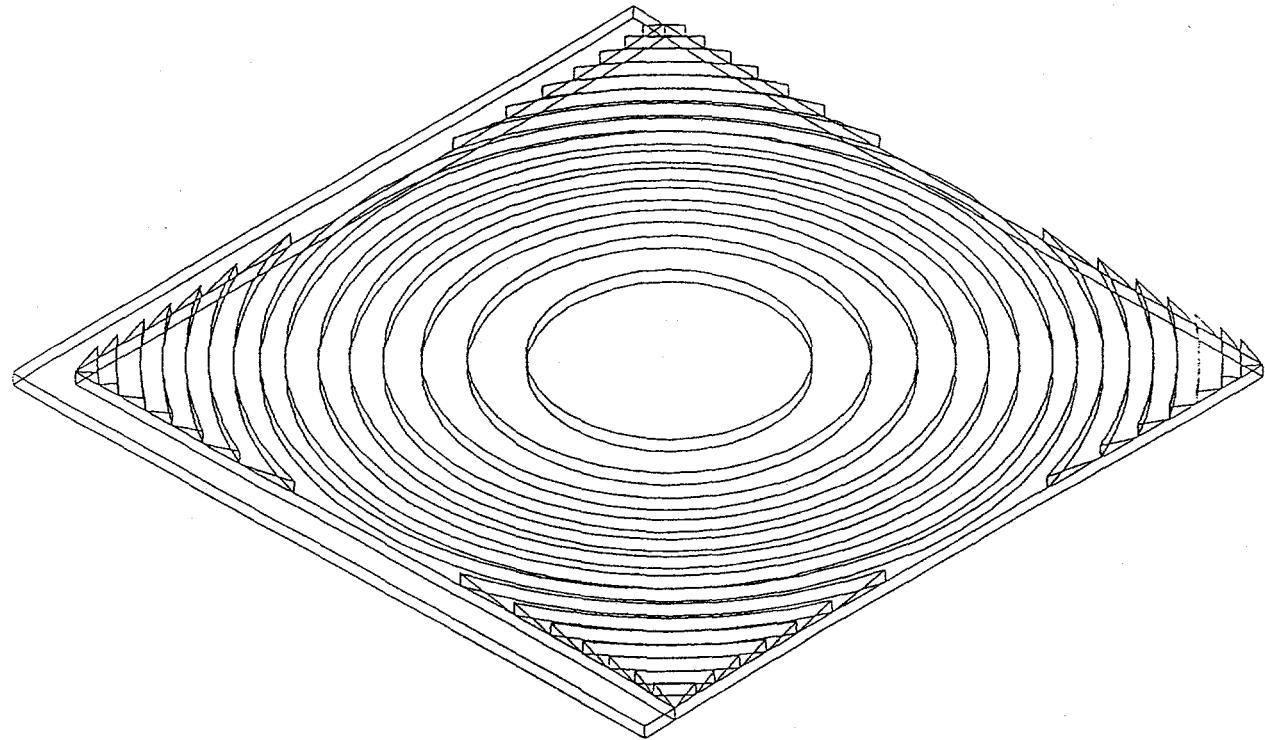
Figure 3.5 Single Injection-Molded Fresnel Lens.

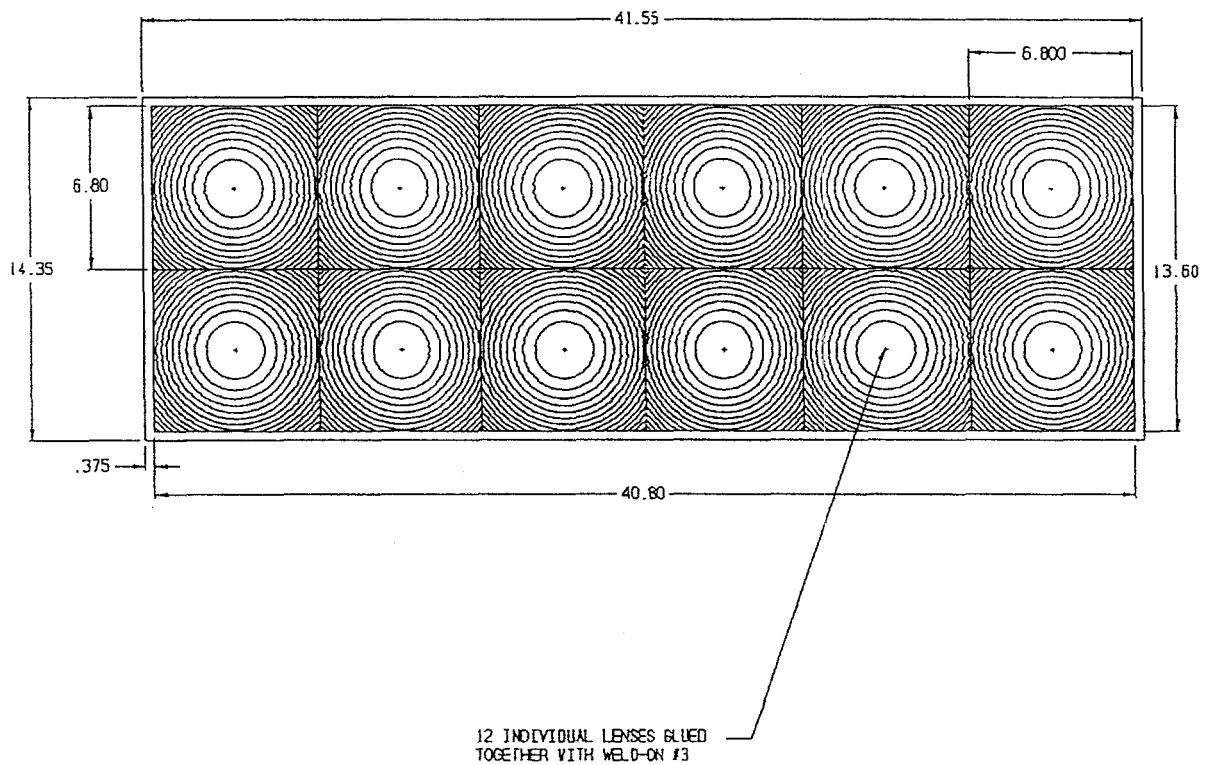
Figure 3.6 Solvent-Bonded 2x6 Fresnel Lens Parquet.

SKI purchased 300 single lenses from AO because parquets were not available. The plan was to solvent-bond these lenses to form a 2 x 6 parquet, as shown in Figure 3.6, for use in the prototype module. The single-piece lenses as received had various defects. These included a few small melt/run marks on the curved surface of the facets, and the flat back surface of the lens was convex due to facet shrinkage stresses. These defects did not significantly reduce the optical performance of the Fresnel lens, but did change the optimum lens-to-cell spacing from 10.0 to 10.1 inches.

To fabricate the 2 x 6 lens parquet, we first thermally stress relieved each lens in an oven at 175 °F by placing the non-faceted (flat) side onto a glass plate for 3 hours. This made the Fresnel lens flat to within +/- 0.020 inch and was acceptable for the purpose of assembling the parquet. There was a 20% rejection of these reworked lenses. This step will not be necessary when 2x2 parquets are available. Next, some of the lenses were milled along one of the two edges with the 0.375-inch flange. This flange was machined off so that these lenses could be used as the inside lenses of the solvent-bonded parquet. The solvent bonding was achieved using the acrylic solvent Methylene chloride. Once the 12 lenses required to make a single 2 x 6 lens parquet were

machined, they were assembled into a parquet fixture on a T-slot surface table. Next, methylene chloride was injected along the seams with a medical syringe. This procedure was done first on the faceted side and then on the opposite side. The overall dimension of the parquet was within +/- 0.030 inch.

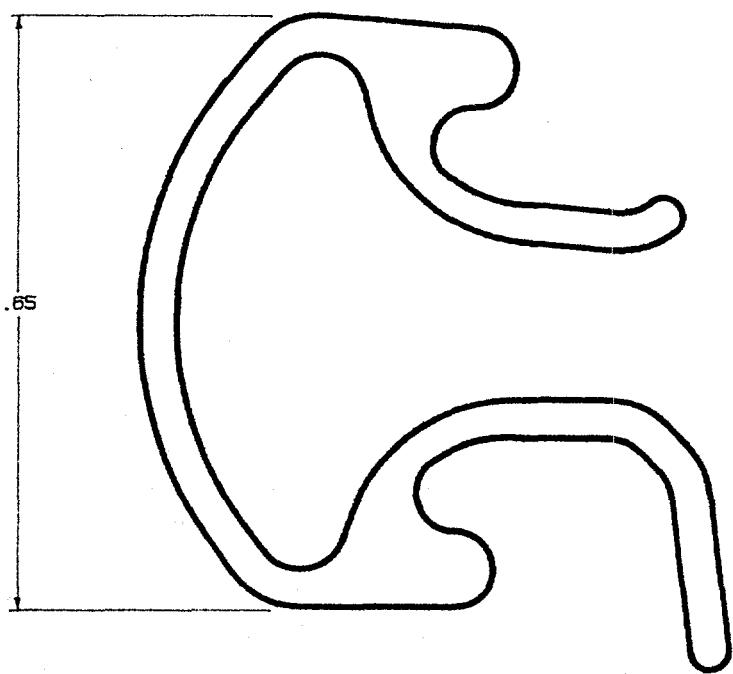
Figure 3.7 Cross Section of the Extruded Edge Clip.

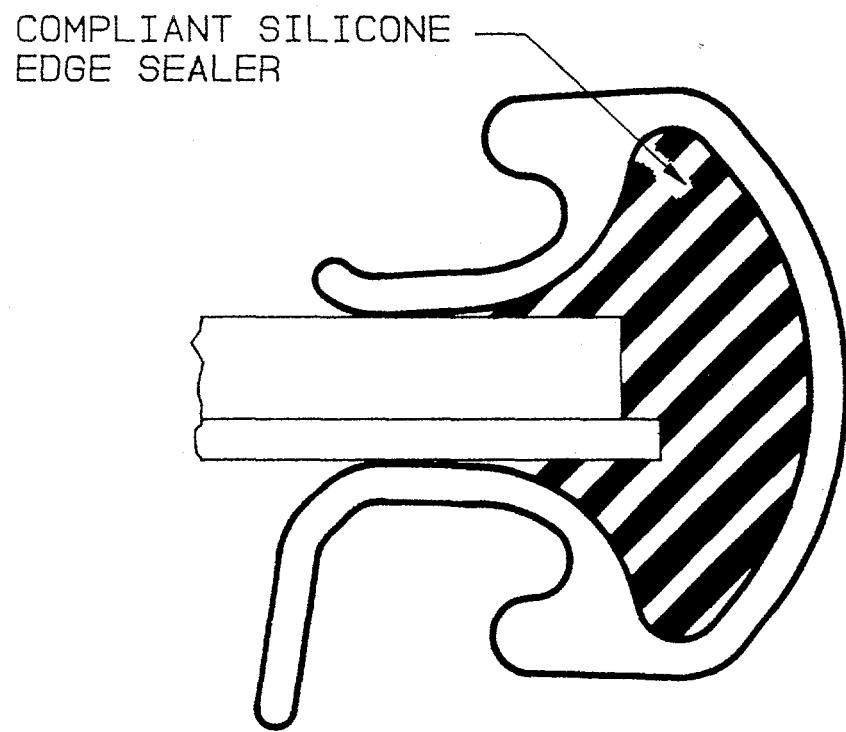
Figure 3.8 Placement of Edge Clip and Edge Sealer.

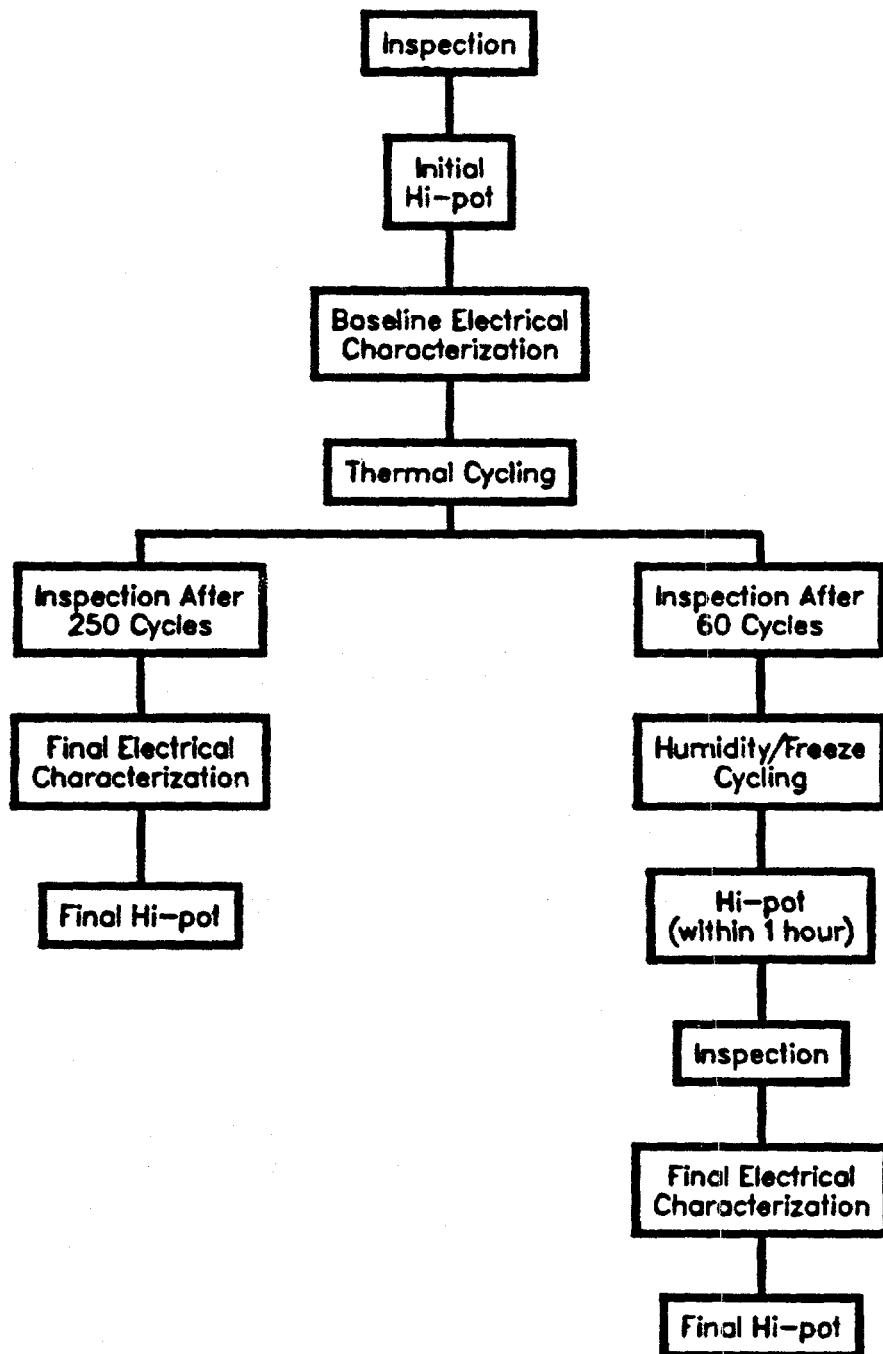
Figure 4.1 Test Sequence for Cell Assemblies.

To evaluate the various bonds and layers of the cell assemblies, partial cell assemblies were fabricated for submittal to Sandia. Figure 4.1 shows a flow diagram for the sequence of the evaluation tests. Such partial or layered fabrication helps in detailed diagnostics of appropriate interfaces by bond evaluation techniques like radiography and ultrasonics.

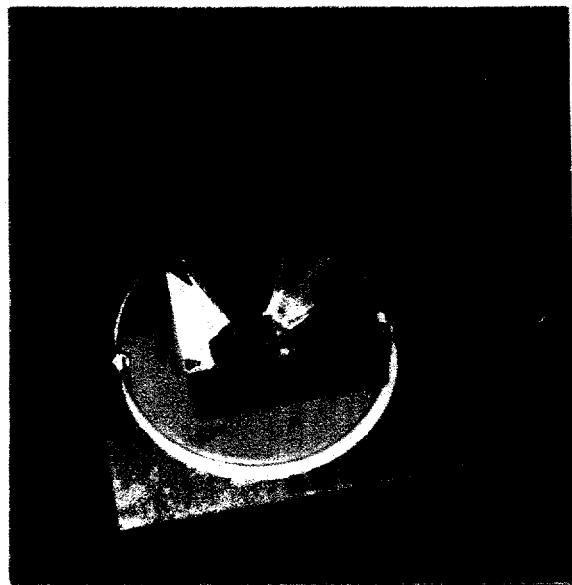
Figure 4.2 Cell Assembly - Configuration 1.

Configuration 1: In general, the cell assemblies (CA-80 thru 84) looked good. The base of the SOEs had a slight lip that protruded inward in a way so as to reflect a small portion of light that should impinge on the cell. This lip was caused by the stamping process of the turret punch tool/press. There was some excess solder around the periphery of the cells. On a couple of the cell assemblies, there was lack of the adhesive on the small section of the periphery of the heat spreader. This could allow debris to accumulate and cause a failure in the Hi-pot test. There was discoloration on some of the cells, indicating some solder flux had probably run onto the cell active area and was not cleaned off.

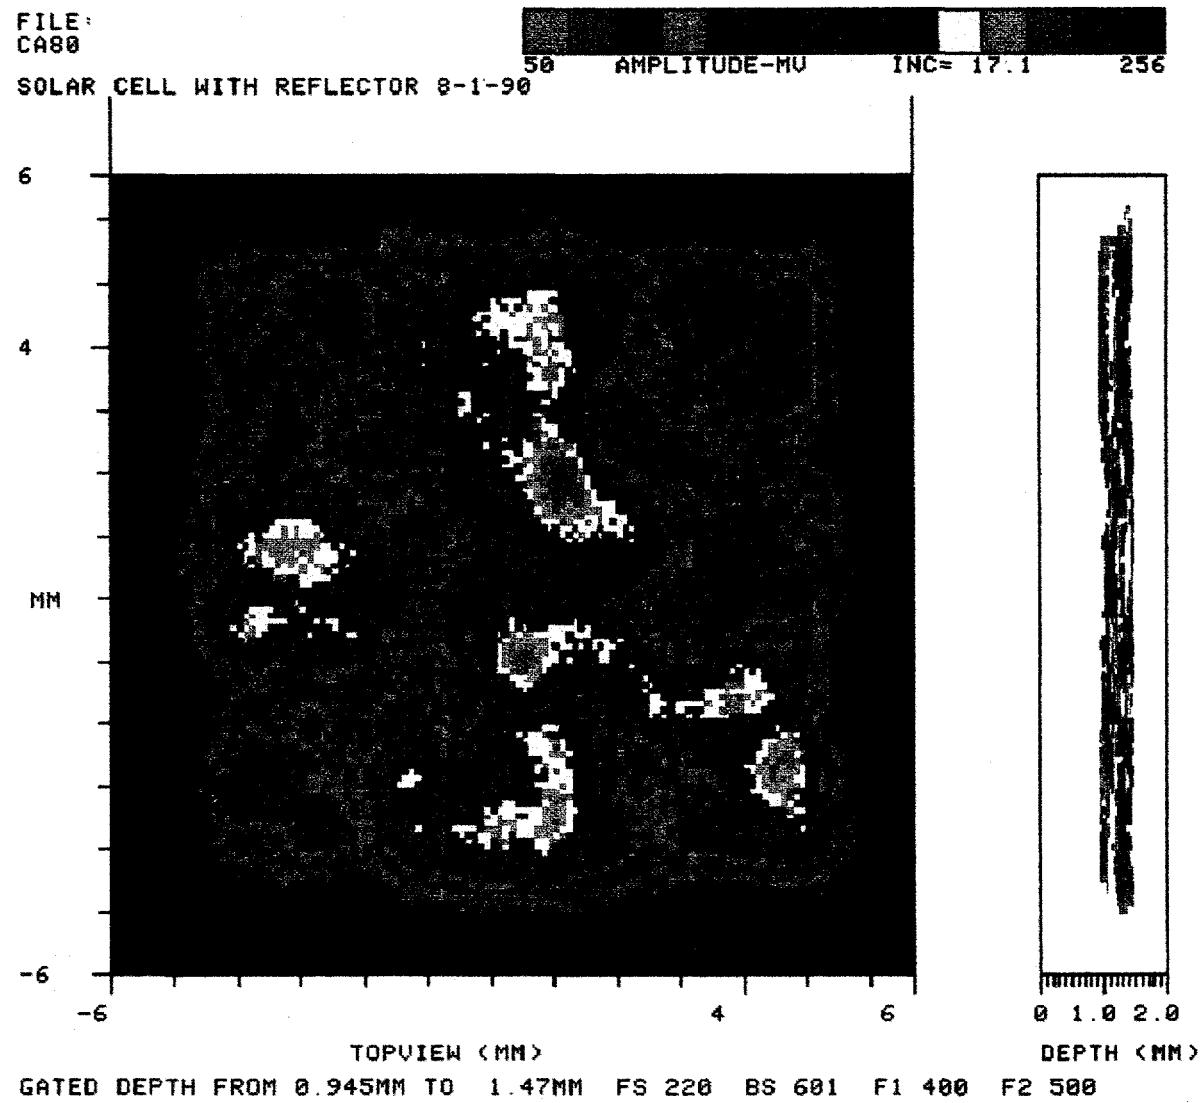
Figure 4.5 Initial Reflecting Ultrasound Picture, CA-80.

Radiographic pictures were taken of all the configuration 1 and 3 cell assemblies. A careful review of all these x-ray pictures did not show any large void areas in the cell/heat-spreader solder bond. Generally, the x-ray pictures indicated presence of a fine dispersion of many small voids in all the cell assemblies. The ultrasound pictures were more revealing of the solder bond. Ultrasound pictures for configuration 1 are presented in Figures 4.5 to 4.9. The pictures (originals in color) are obtained by reflection-type ultrasonic evaluation. The voids are indicated by the white boundaries with white or dark interiors (on black and white copies). The configuration 3 ultrasound pictures, Figure 4.10, are transmission-type ultrasound pictures. In the three pictures, the black regions indicate void areas. Large voids are indicated on the three cell assemblies. The voids seem to be more pronounced in the center of the cell as opposed to the periphery where the top interconnects are attached. The transmission-type ultrasound pictures of configuration 2 samples are shown in Figure 4.11. They

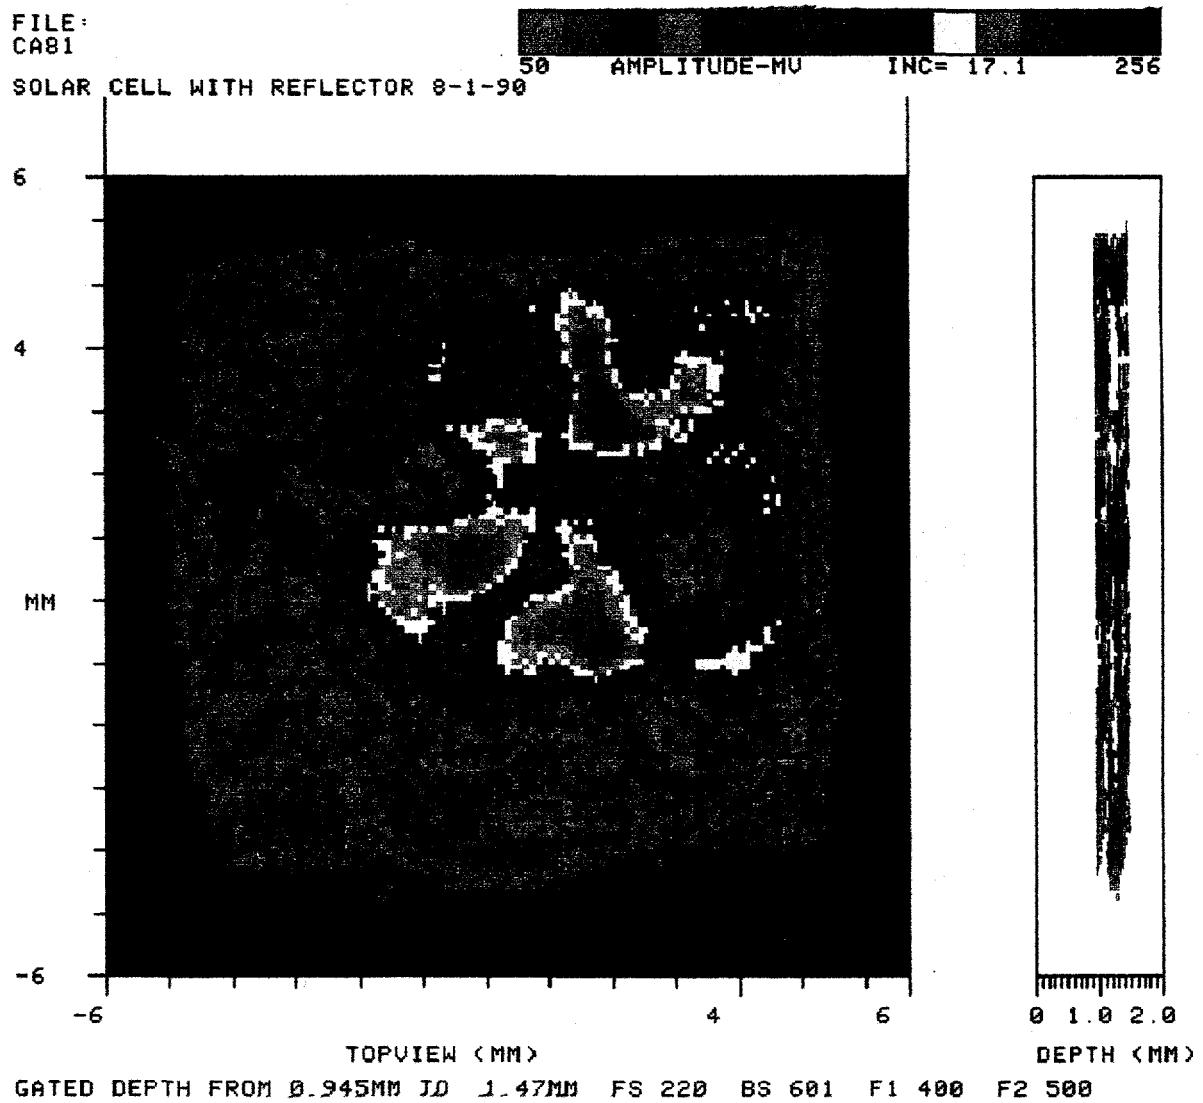
Figure 4.6 Initial Reflecting Ultrasound Picture, CA-81.
