CONTRACTOR REPORT

SAND92-7001
Unlimited Release
UC-275

Development of a Commercial Photovoltaic Concentrator Module

Shabbar T. Saifee, Gus Hutchison
Solar Kinetics, Inc.
10635 King William Drive
Dallas, TX 75220

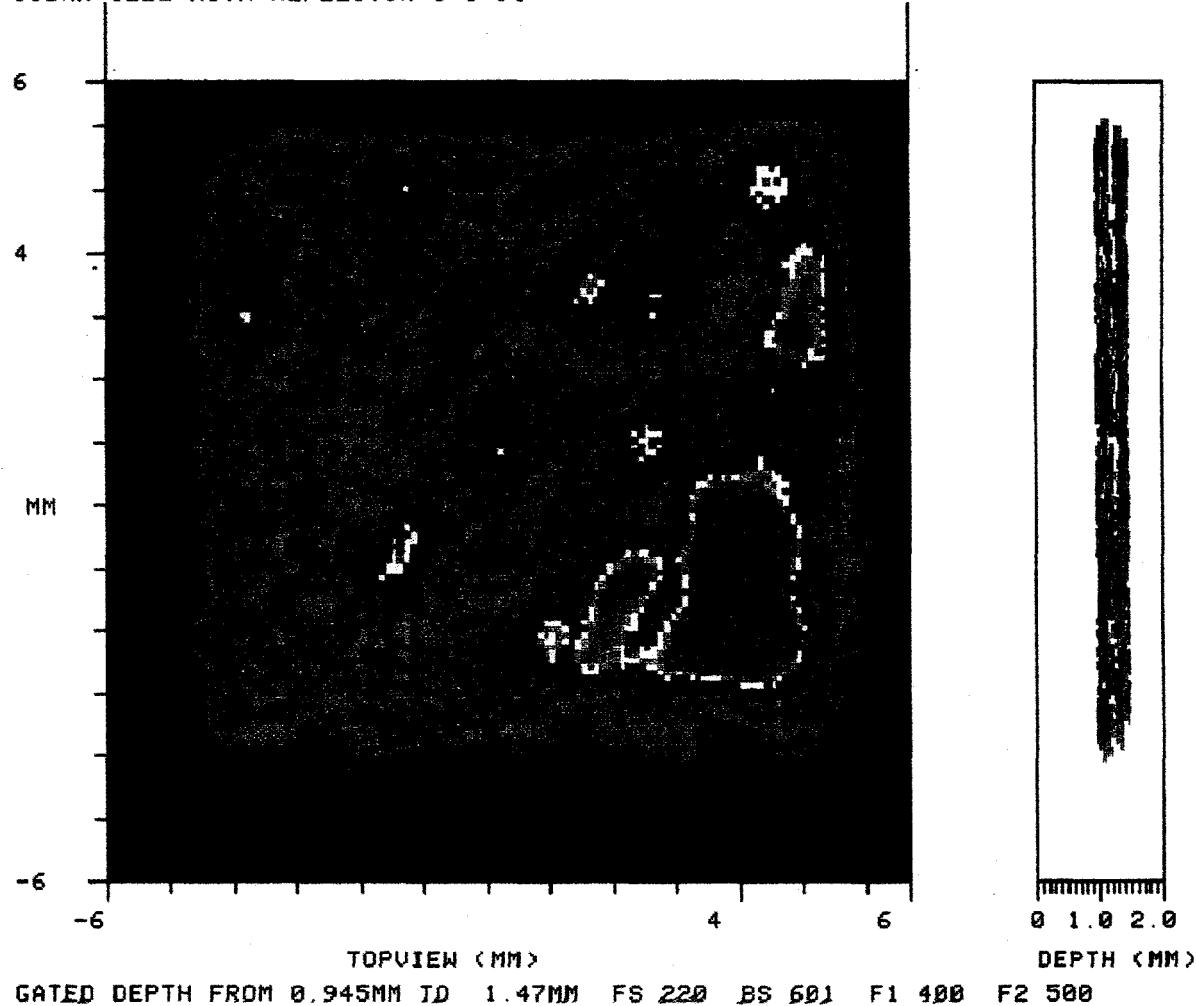
Figure 4.7 Initial Reflecting Ultrasound Picture, CA-82.

Radiographic pictures were taken of all the configuration 1 and 3 cell assemblies. A careful review of all these x-ray pictures did not show any large void areas in the cell/heat-spreader solder bond. Generally, the x-ray pictures indicated presence of a fine dispersion of many small voids in all the cell assemblies. The ultrasound pictures were more revealing of the solder bond. Ultrasound pictures for configuration 1 are presented in Figures 4.5 to 4.9. The pictures (originals in color) are obtained by reflection-type ultrasonic evaluation. The voids are indicated by the white boundaries with white or dark interiors (on black and white copies). The configuration 3 ultrasound pictures, Figure 4.10, are transmission-type ultrasound pictures. In the three pictures, the black regions indicate void areas. Large voids are indicated on the three cell assemblies. The voids seem to be more pronounced in the center of the cell as opposed to the periphery where the top interconnects are attached. The transmission-type ultrasound pictures of configuration 2 samples are shown in Figure 4.11. They

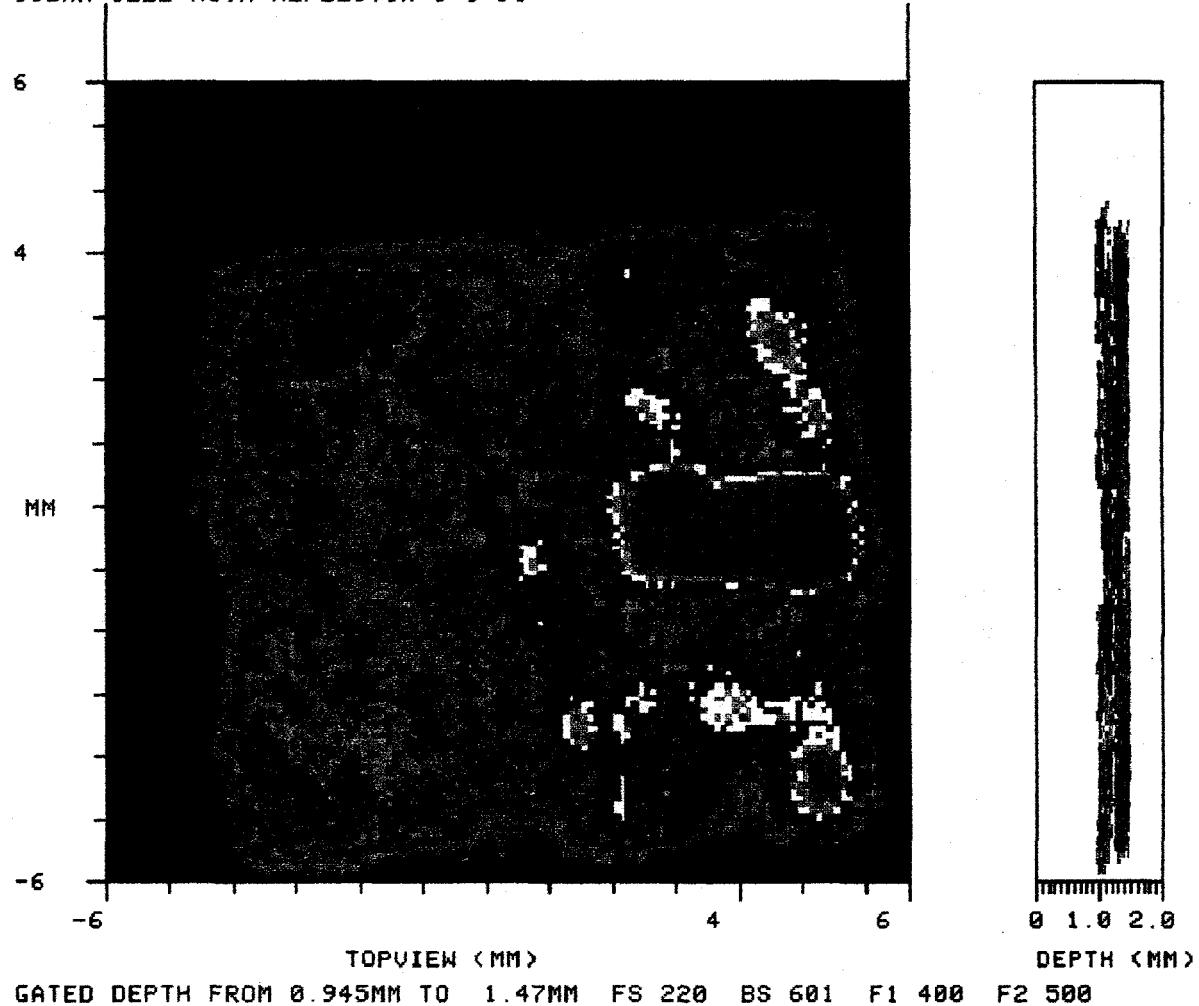
Figure 4.8 Initial Reflecting Ultrasound Picture, CA-83.

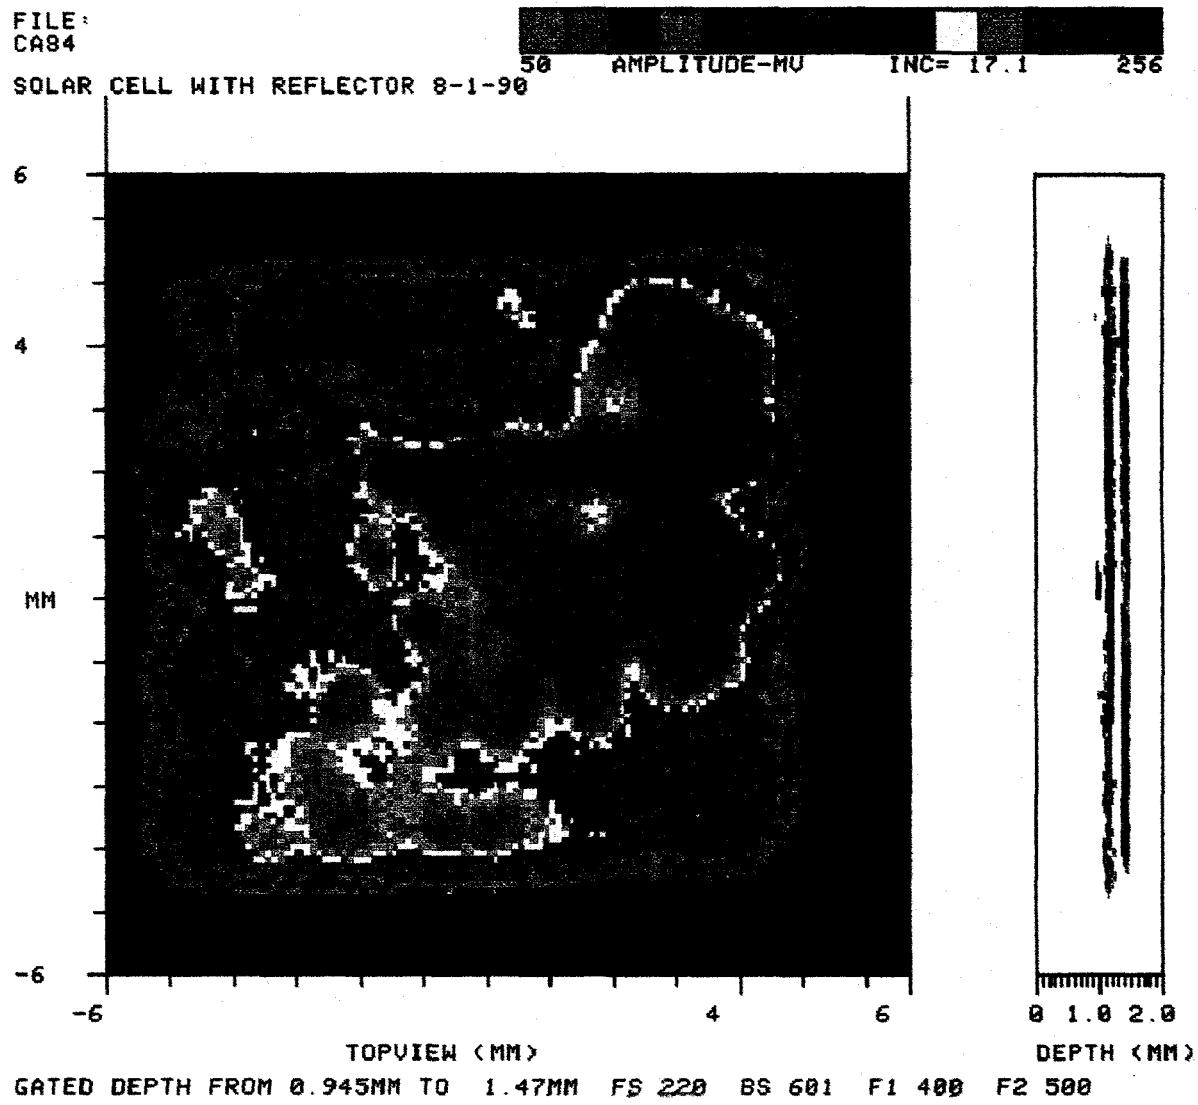
Figure 4.9 Initial Reflecting Ultrasound Picture, CA-84.

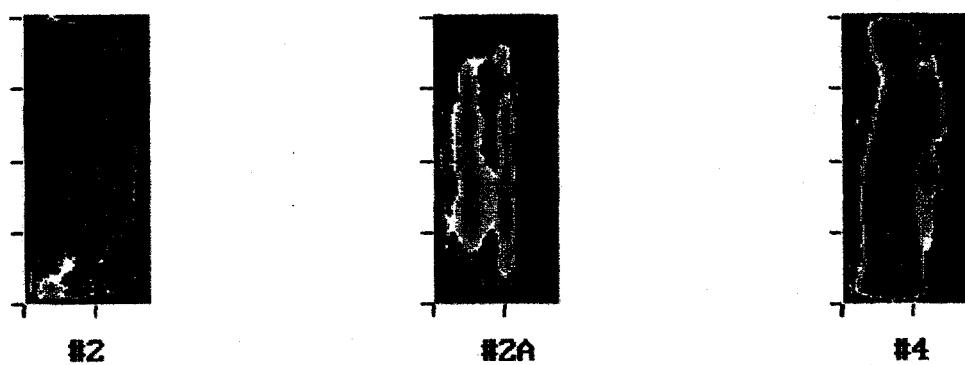
**Figure 4.13 Final Transmitting Ultrasound Pictures
Partial Cell Assemblies CA-2, 2A, & 4.**

The ultrasound pictures in Figure 4.13 implied that all of the partial cell assemblies CA-2, CA-2A, and CA-4 experienced little change in the bottom contact/heat-spreader solder bond. Prying under the bottom contact of the cell assembly CA-4, with a screw driver, led to the peeling up of the bottom contact. This indicates improper surface preparation and/or selection of flux.

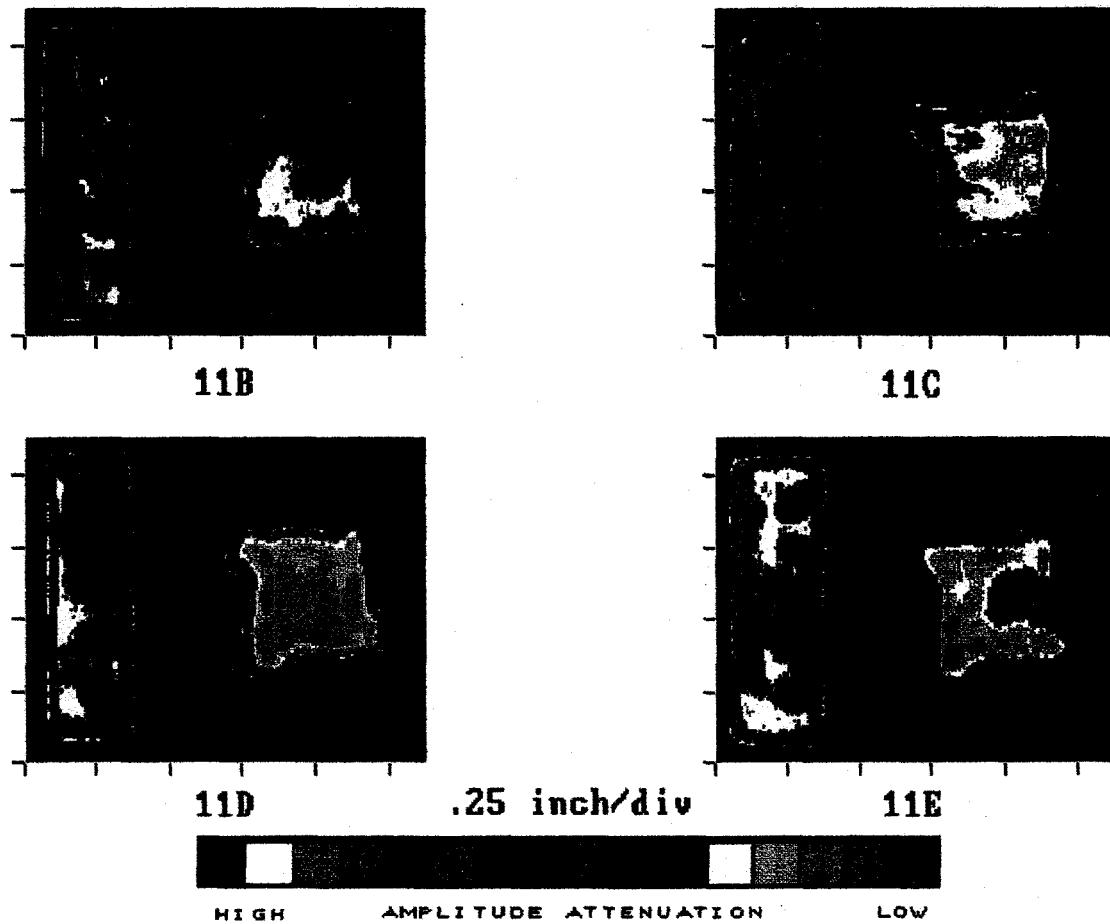
Figure 4.15 Initial Transmitting Ultrasound Pictures Cell Assemblies CA 11B through 11E.

X-rays of the four CA-11 cell assemblies were taken by a local laboratory. These (x-rays) were observed by Sandia personnel at SKI and confirmed the SKI observations. SKI read the x-rays as showing only small voids in the solder interface. Sandia took transmission-type ultrasound pictures. They are shown in Figure 4.15. From these pictures, it was observed that there is a significant variation in the condition of the cell-to-heat spreader solder bond. Ultrasound of cell assembly CA-11D looked very uniform without voiding. Ultrasounds of cell assemblies CA-11C and CA-11E looked

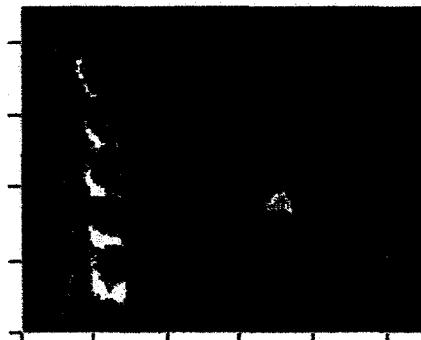
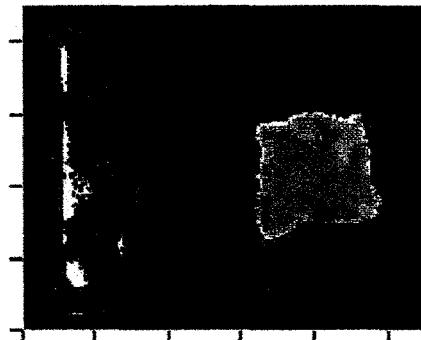
Ultrasound pictures taken after the environmental exposures are presented in Figure 4.16. The bond in the cell assembly CA-11D was essentially unchanged, but the others exhibited delamination at the cell-to-heat-spreader interface. Clearly, the environmental exposure made the poor cell assemblies worse. The test results also showed that a good continuous solder bond survived the environmental exposures. Further fine tuning of the process should solve these problems. The bond between the heat spreader and the bottom contact survived the environmental exposure with no change in bond quality.

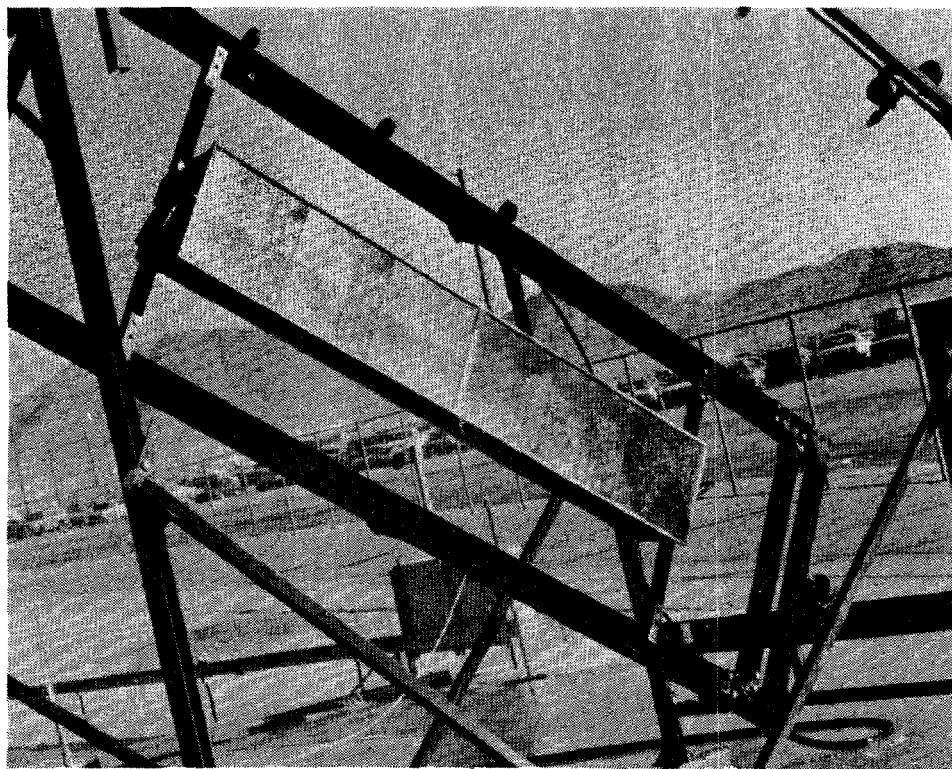
Figure 5.1 Mock Module Under Rain Test.

A mock module was fabricated for Sandia environmental testing of the SKI module design. This mock module was subjected to the humidity/freeze environmental cycling to assess the performance of the lens mounting design. Another objective was to subject the module to the Sandia standard rain test after the humidity/freeze cycling and check for water leaks. Figure 5.1 shows the mock module under rain test (5).

After the module came out of the humidity/freeze cycling chamber, it was subjected to the rain test. For the rain test, the module was positioned on the tester with the long axis in the N-S direction and with the north end of the module raised about 30°. The testing was performed by placing the module in three different orientations, lens up, lens west, and lens down. Simulated rain sprayed on the module for one hour in each orientation. Table 5.1 summarizes the test results. In the lens-up position, no water leaked into the module. In the lens-west position, about a tablespoon of water collected in the lowest point of the module. The module was left for three days to dry out. In the lens-down orientation, about a teaspoon of water accumulated in the bottom of the module, next to the acrylic sheet. The entry point(s) for the water was not apparent for either of the leaks.

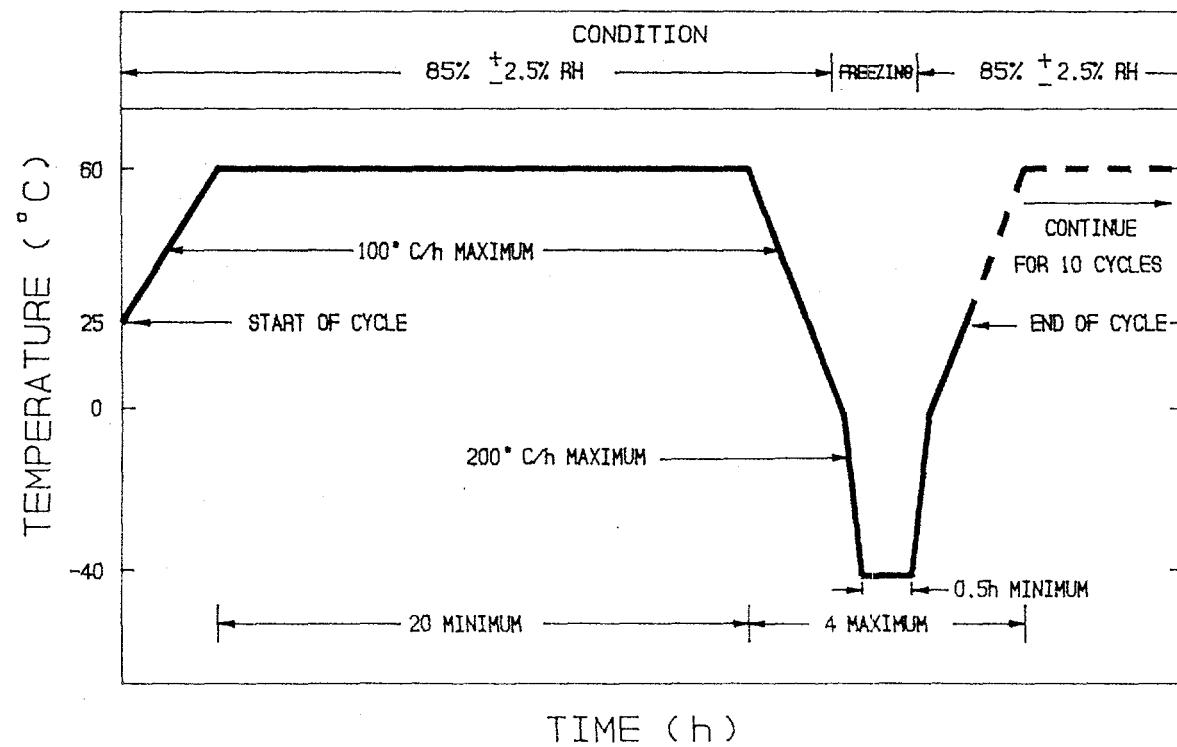
Figure 5.2 Humidity/Freeze Cycle for Module.

The module was subjected to total of 10 humidity/freeze cycles as specified in the module qualification document (3), and shown in Figure 5.2. The module was retrieved from the cycling chamber after 4 cycles, measured for various scribe mark displacements and then placed in the chamber again to complete the rest of the cycles. The slippage/expansion of the acrylic sheets after 4 cycles varied from zero to 0.06 inch when measured with reference to the various scribe marks on the clips. The vertical displacements from the original plane, varied as much as 0.20 inch. Some rotation of the acrylic sheet was also observed. This suggests that two alignment pins are inadequate for holding the lens parquet in proper alignment. A four-pin scheme is to be investigated.

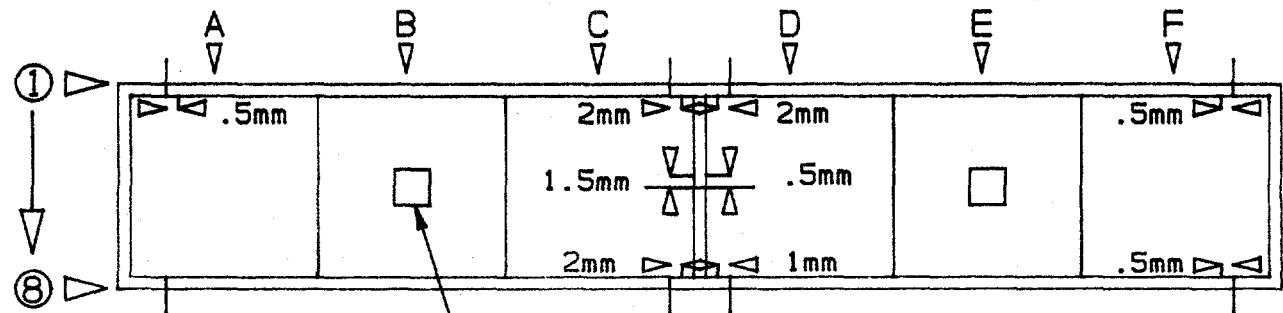
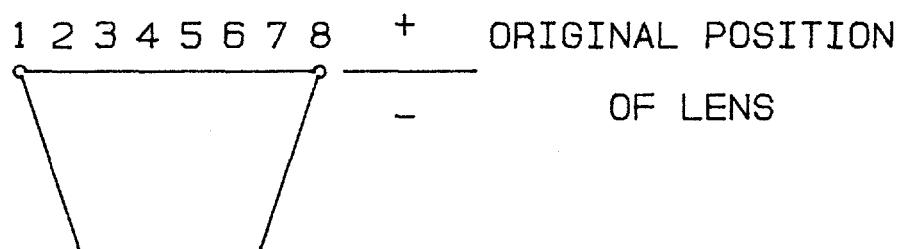
**Figure 5.3 Displacements of "Mock" Lens after Humidity/
Freeze Cycles.**

The slippage/expansion of the acrylic sheets after 10 cycles ranged from zero to 0.080 inch with reference to the scribes on the clips. Figure 5.3 shows the module (plan view and end view), the position of the scribes, the displacements in the plane of the acrylic sheets, and the vertical displacements are also tabulated. The vertical displacements, from the original plane, ranged as much as +0.20 inch and -0.25 inch. To minimize this deflection in future modules, we plan to use American Optical injection-molded 2x2 lens parquets, which are approximately 0.25 inch in effective thickness including facets. Thus, working with 1/3 the lens parquet length and twice the thickness, it is Sandia's opinion that the lens bowing will be significantly less, if any, as a result of the humidity/freeze cycling.
