# Laser Soldering of Sn Plated Brass Integrator Assembly Housings

D. M. Keicher  
Physical and Joining Metallurgy Department  
G. A. Poulter and N. R. Sorensen  
Mechanical and Corrosion Metallurgy Department  
Sandia National Laboratories  
Albuquerque, New Mexico 87185

## Abstract

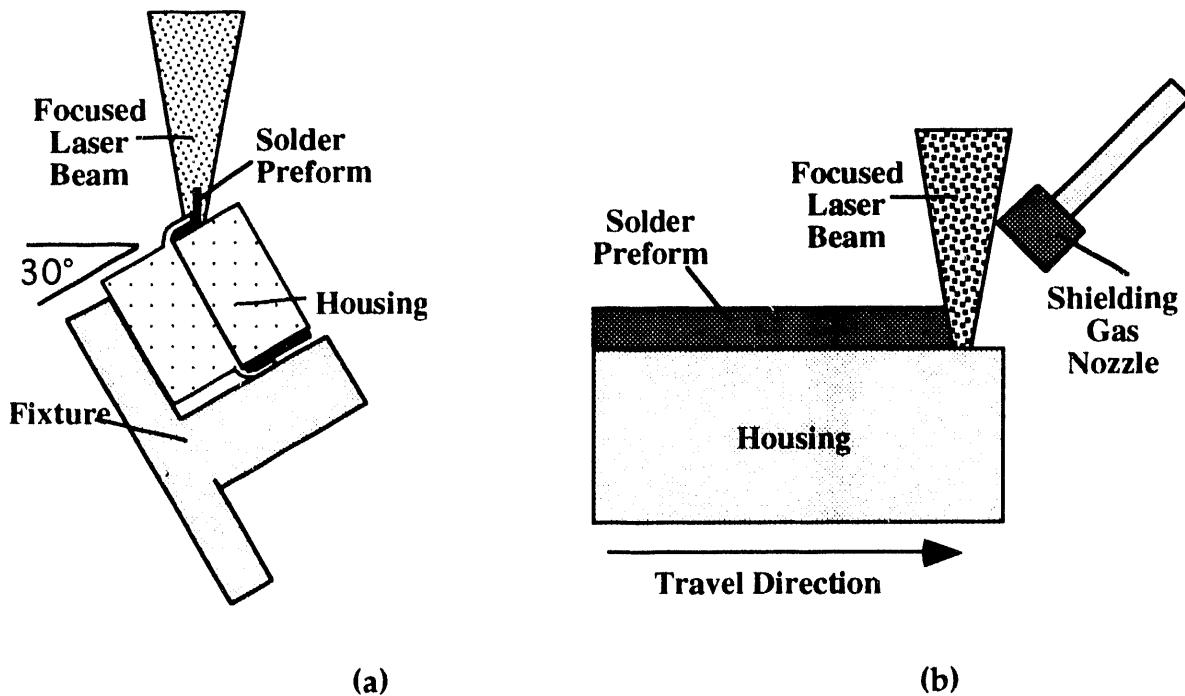
**Figure 1.** Experimental apparatus configuration (a) side view (b) front view.

Three empty housings and one housing containing electrical components were provided to perform these experiments. As a heat source, a CW Nd:YAG laser with a fundamental wavelength at 1.064  $\mu\text{m}$  operating at an output power of 64 watts was used. A schematic representation of the experimental apparatus is given in Figure 1. Fixturing was developed to hold the housing at 30° with respect to a horizontal plane. The housing was assembled and solder preforms were placed in the joints between the housing components. Part of the solder preform extended from the joint and was folded upward to be parallel to the incoming laser beam. The assembled housing was then placed in the fixture such that the laser beam would be incident on the joint. The beam was positioned to have one half of the beam incident on each part of the housing and slightly offset from the housing end. The laser beam was defocused to a spot diameter of 0.084". When the housing was illuminated with the laser beam, the component was held stationary for 1-2 seconds to preheat the joint to the solder melting temperature and then the joint was scanned under the laser beam at a rate of 2.0 in./min. For the soldering operation, the beam was not allowed to scan over either end of the housing assembly to avoid overheating of the edges. In addition, the housing was not preheated and thermocouples were mounted inside the housings on the support rib to monitor temperature during soldering.

A 60Sn-40Pb wt. % solder was used in these experiments and tests were performed with and without solder flux. The solder was cut into a rectangular preform with dimensions of 1.375" x 0.320" x 0.0025" which were then placed in the joint between the two housing components, Fig. 1. Initial experiments were performed without flux and only flowing a 5 vol. % H<sub>2</sub> in Ar gas around the joint to shield the molten metal from oxygen. The shielding gas was delivered to the joint from an off-axis laminar flow gas nozzle. Two empty units were also soldered using two different low solids fluxes: Kester 922CX and Multicore X32FQ/1. The solder flux was applied sparingly, using only enough to cover the housing surfaces in the immediate area around the joint. In both of the fluxed cases, the H<sub>2</sub>/Ar shield was utilized.

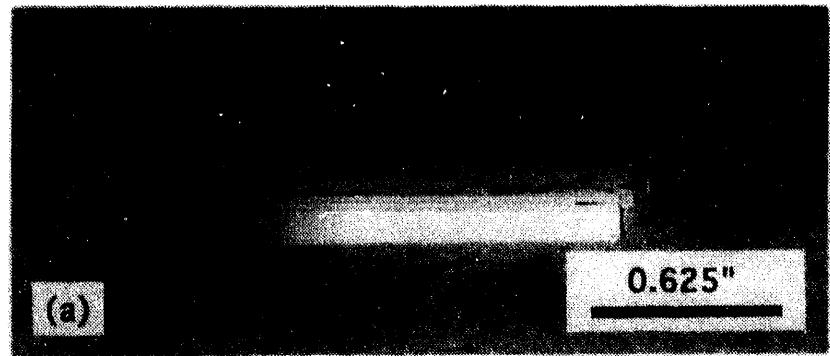
**Figure 2.** Photographs of laser soldered housing, 64 watts, 2 in./min. travel, 1.5 sec. initial dwell time, 0.084" laser beam spot diameter.

Switching to a low solids flux, joints could be produced consistently using either of the two low solids fluxes mentioned above. Figure 2 shows a joint produced using Kester 922CX flux at 64 watts with a travel speed of 2 in/min. and an initial dwell time of 1.5 seconds. The joint is continuous over the entire length of the housing with no apparent pin holes, Fig. 2a. In some areas, there is excess solder at the joint providing a larger than usual fillet. It was observed that the amount of excess solder was related to the width of the joint gap: in areas where the joint gap was greater the fillet remained small. A higher magnification view of a section of this joint is given in Figure 2b. Visual inspection of these joints from the inside of the housing show that the solder flowed through the joint to the inside of the housing.

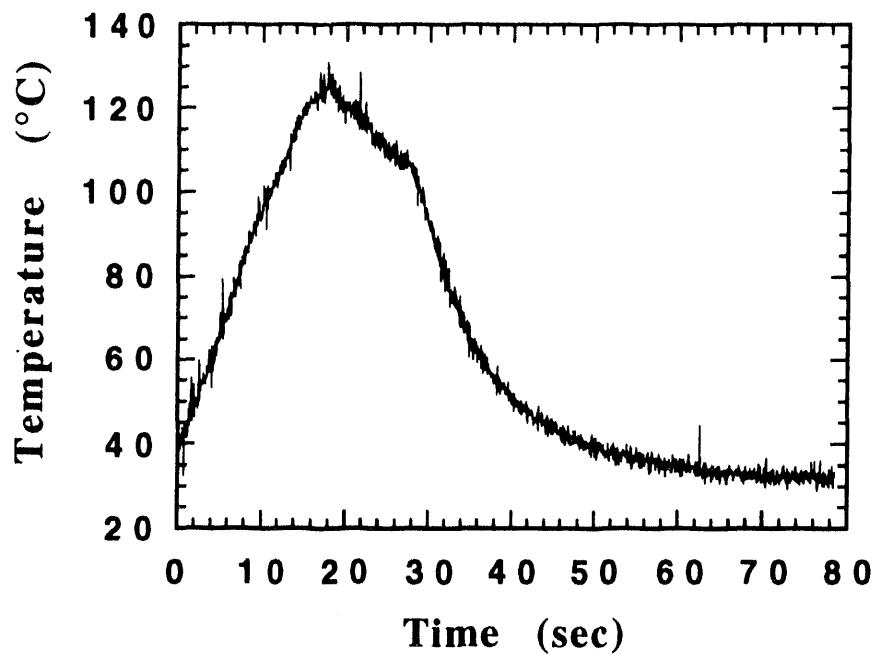
**Figure 3.** Temperature of housing inner rib measured during soldering operation, 64 watts, 2 in./min. travel, 1.5 sec. initial dwell time, 0.084" laser beam spot diameter.

Thermocouple data were used to determine the temperature excursion that the electrical components mounted in the housing would be exposed to during soldering. The measured temperature of the metal rib within the housing is given in Figure 3. The peak temperature is approximately 130°C. This indicates that the electrical components are not heated excessively and that the heat input to the housing at the joint area is quickly dissipated due to the high thermal diffusivity of the brass. In addition, since the laser provides high efficiency heat input coupling, no preheating of the housing was required. Figure 4 shows the electrical components contained within the housing after the housing has been laser soldered. Visually, there is no obvious overheating or degradation of the polymeric materials or the solder joints used in construction.

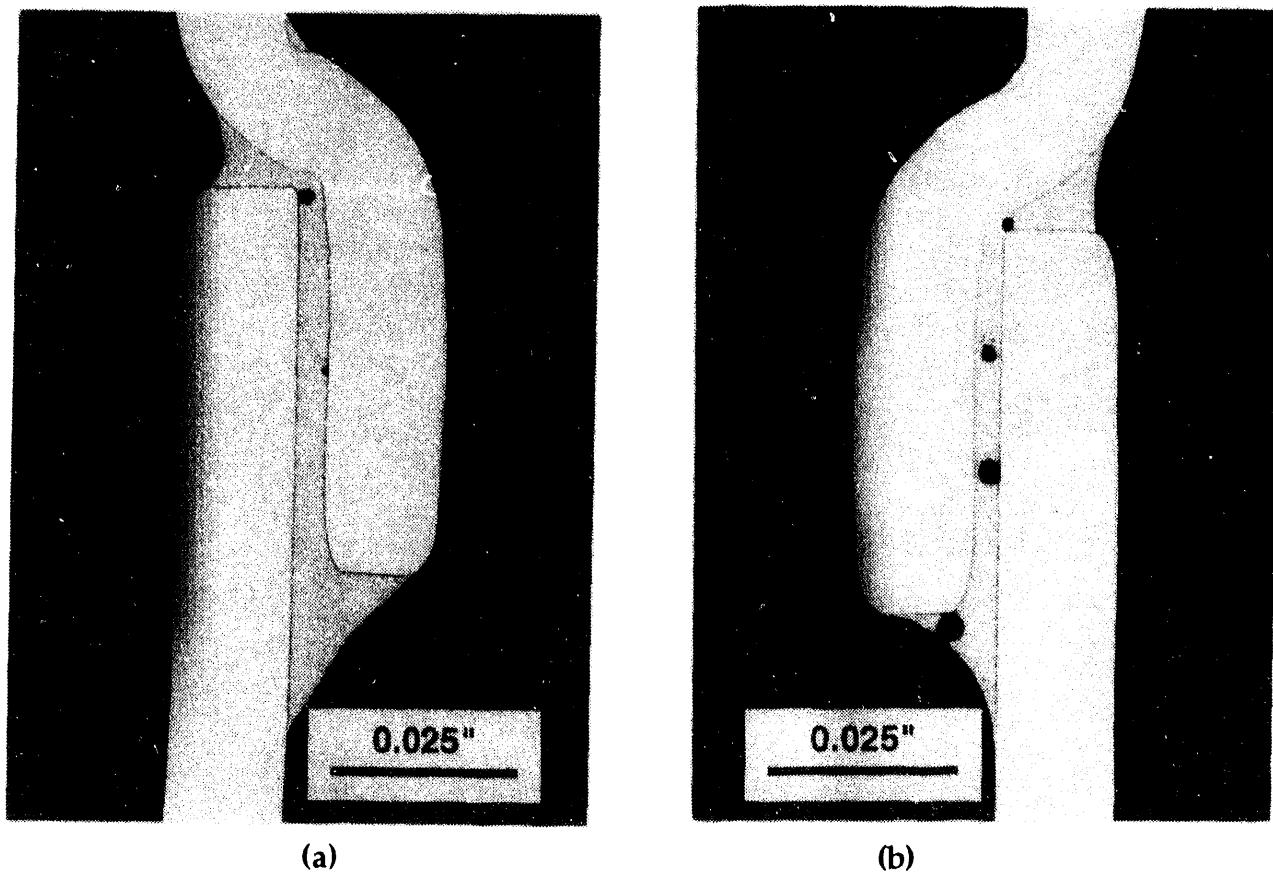
**Figure 5.** Photomicrograph of metallographic cross-sections for laser created solder joints on Sn plated brass housings, 64 W, 2.5 in/min., 60-40 Sn-Pb solder, 5% H<sub>2</sub> in Ar shielding gas, (a) with Kester 922CX low solids solder flux, (b) with Multicore X32FQ/1 low solids solder flux.

Representative photomicrographs from metallographic cross-sections of laser created solder joints using both low solids fluxes are shown in Fig. 5. The cross-sections for the joints made using the Kester 922CX flux (Fig. 5 a) and the Multicore X32FQ/1 flux (Fig. 5 b) show very good wetting on both housing components. Other cross-sections show similar wetting characteristics, although there are small areas where the solder preform did not completely wet the substrate material. These are most likely regions where an insufficient amount of solder flux was used. As mentioned previously, solder flux was applied manually and in limited quantities. However, even with these small regions where wetting was not complete, a sufficient area was wet to provide very good electrical shielding to the components contained within the housing. None of the cross-sections displayed continuous open paths from the inside to the outside of the housings.
