**CONTINUOUS REDUCTION OF  
URANIUM TETRAFLUORIDE**

**A. L. DeMint  
A. W. Maxey**

Prepared by the  
Oak Ridge Y-12 Plant  
P.O. Box 2009, Oak Ridge, Tennessee 37831-8169  
managed by  
MARTIN MARIETTA ENERGY SYSTEMS, INC.  
for the  
U.S. DEPARTMENT OF ENERGY  
under contract DE-AC05-84OR21400

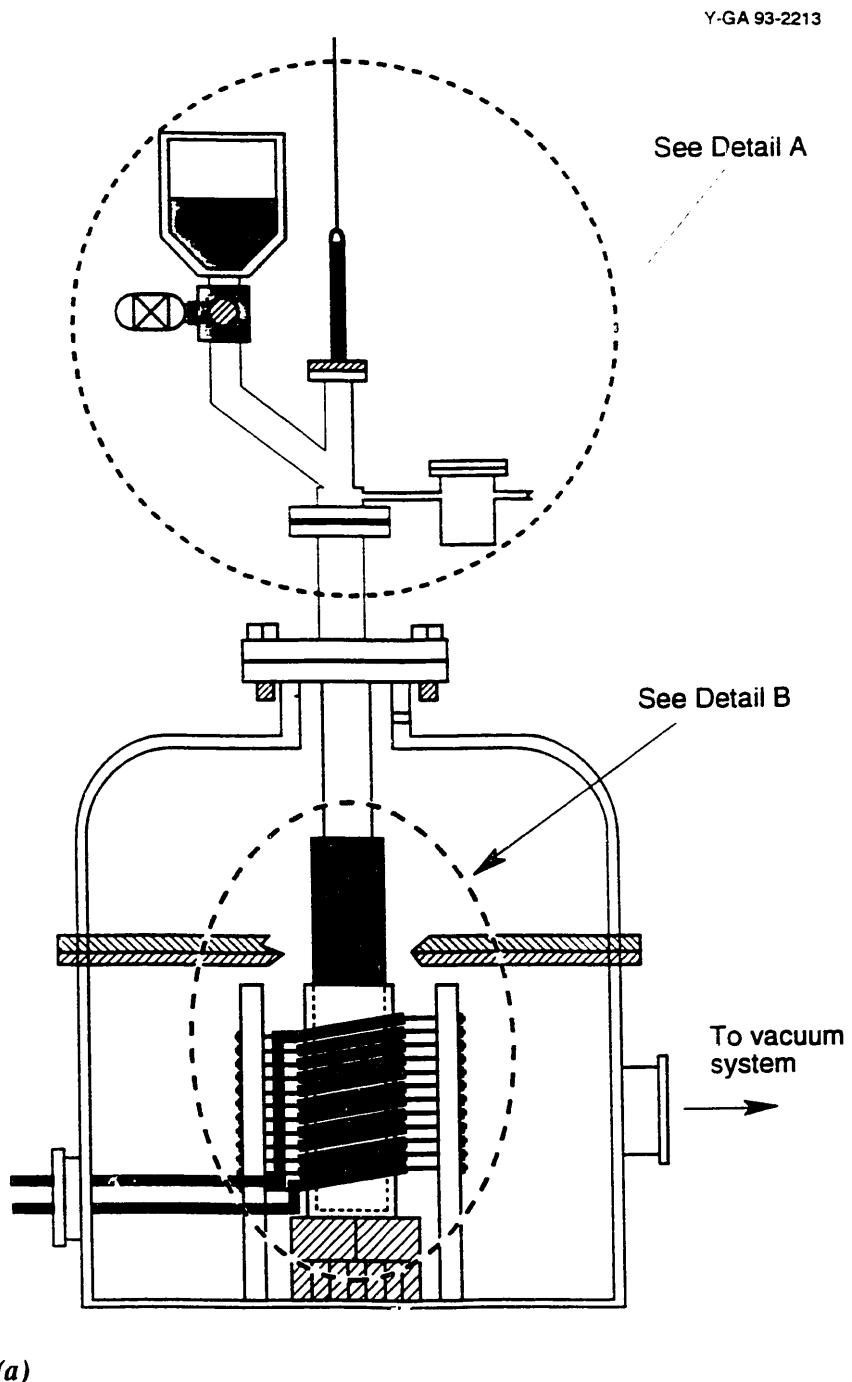
**Fig. 1. Setup for Runs 3, 4, and 5.** (a) Overall view of the furnace and feeder; (b) detail of feeder; (c) detail of reactor setup; and (d) cutaway drawing of reactor.

Three runs were made this quarter, all using the same configuration, to perfect the feed system and examine the use of crust breakers and stirrers. All three runs (3, 4, and 5) were set up as shown in Fig. 1.

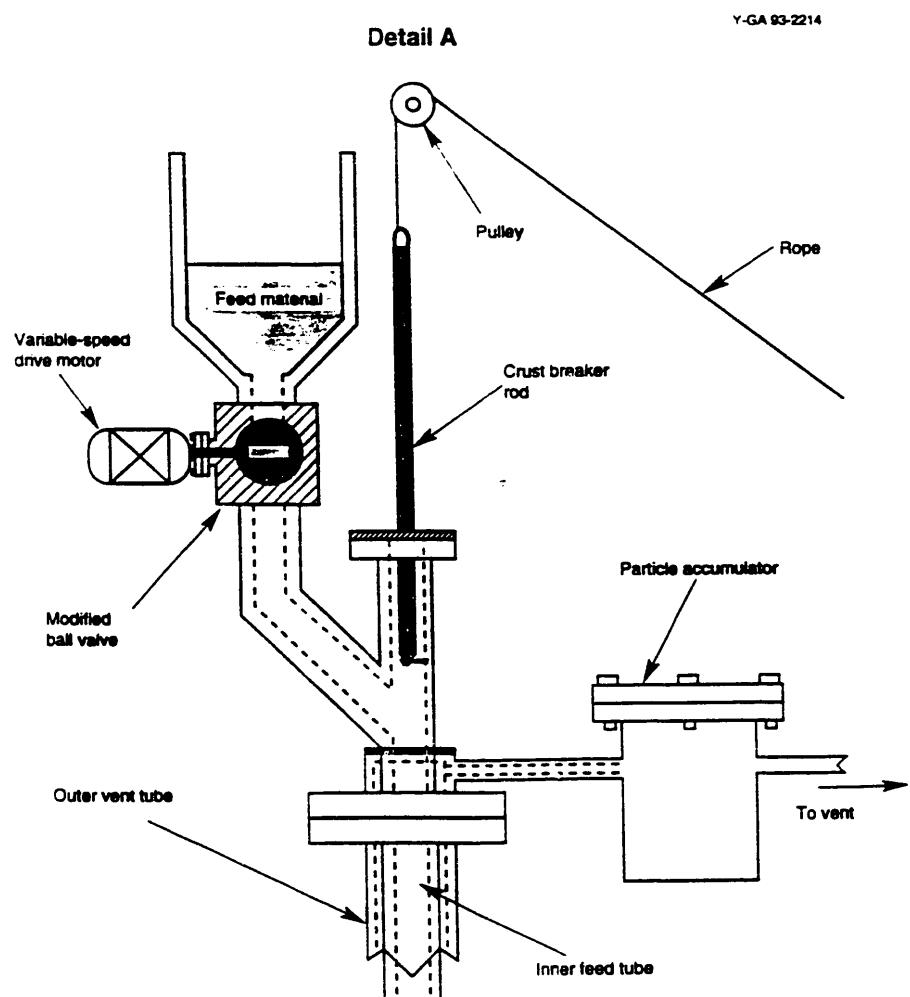
(b)

Fig. 1. Continued.

A modified ball valve feeder, shown schematically in Fig. 1(b), was used for Runs 3, 4, and 5. The valve (2 in. reducing) had a divider welded into the center, forming two pockets (Fig. 2); each full revolution of the valve then dropped two loads of feed into the reactor. The feed system delivered 1 L of blended feed in 20 revolutions. The valve was driven by a 6-rpm motor with a variable speed controller, allowing the speed to be reduced. The crust breaker, a 1-in.-diam steel rod, had a 1-in. fin welded to the bottom to give the rod more lateral range. During feeding, the breaker was pulled up out of the reactor.

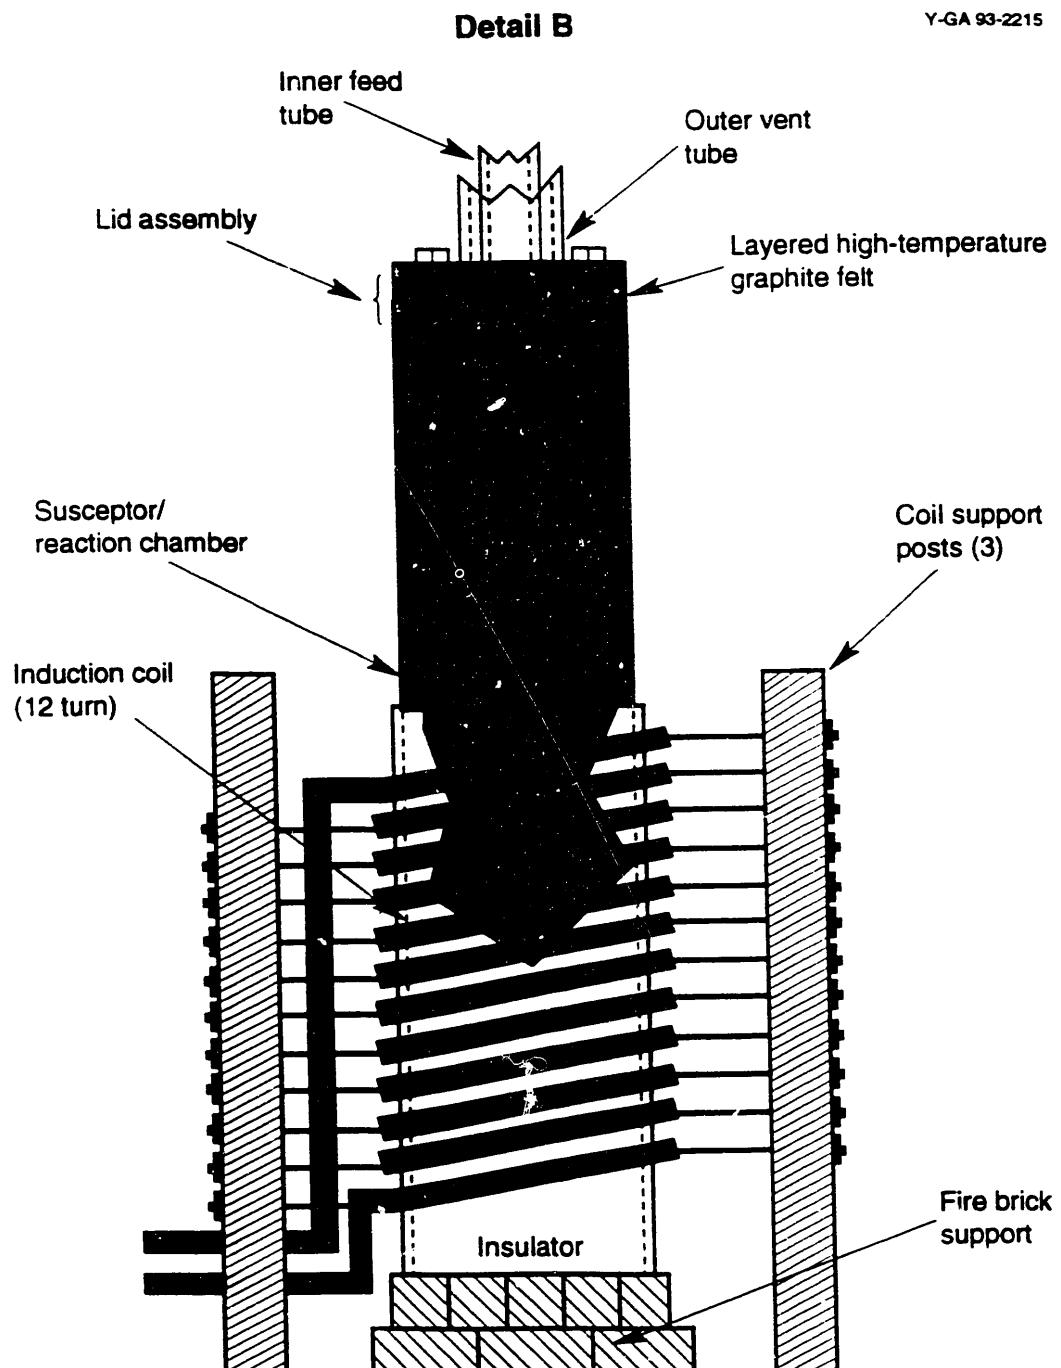
(c)

Fig. 1. Continued.

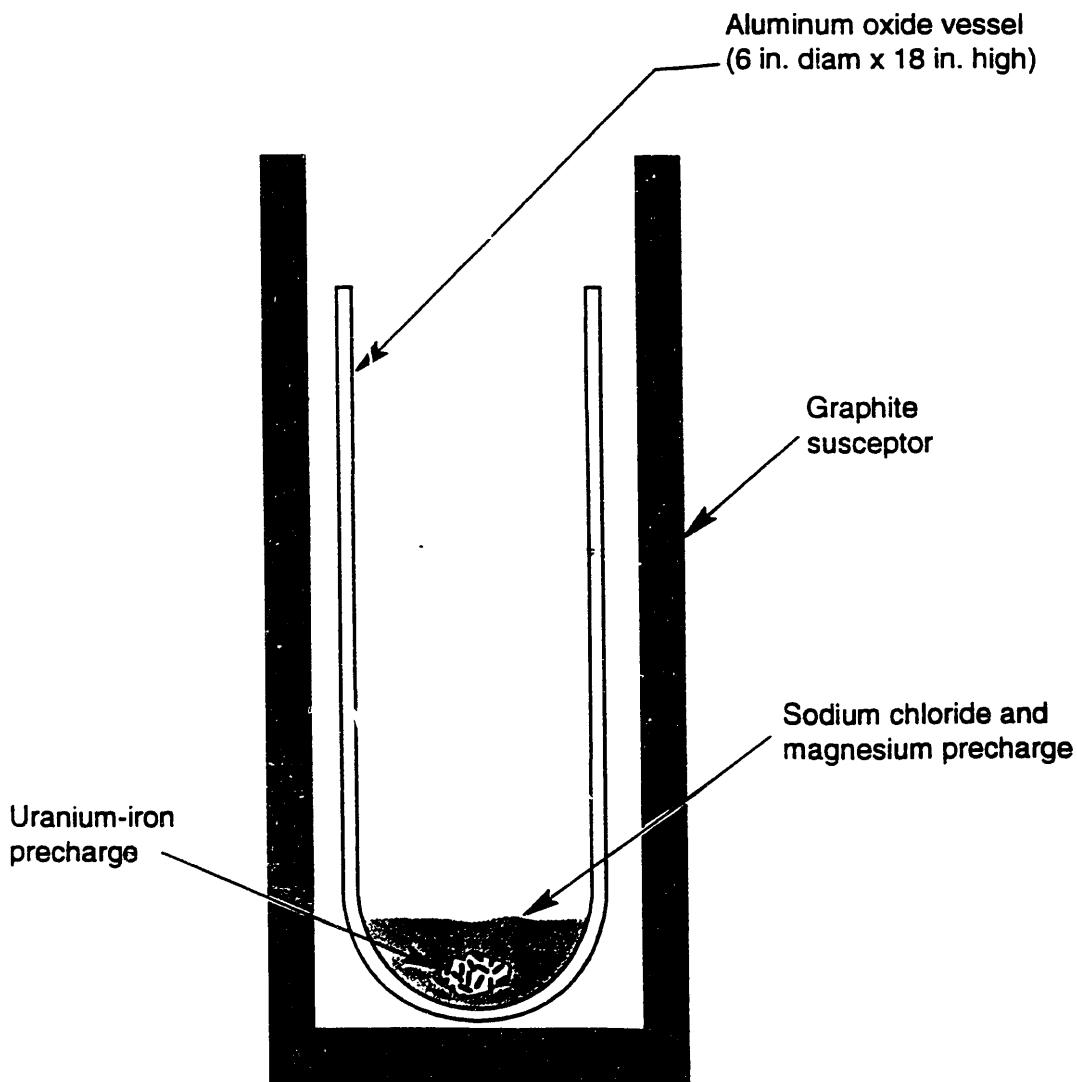
(d)

Fig. 1. Continued.

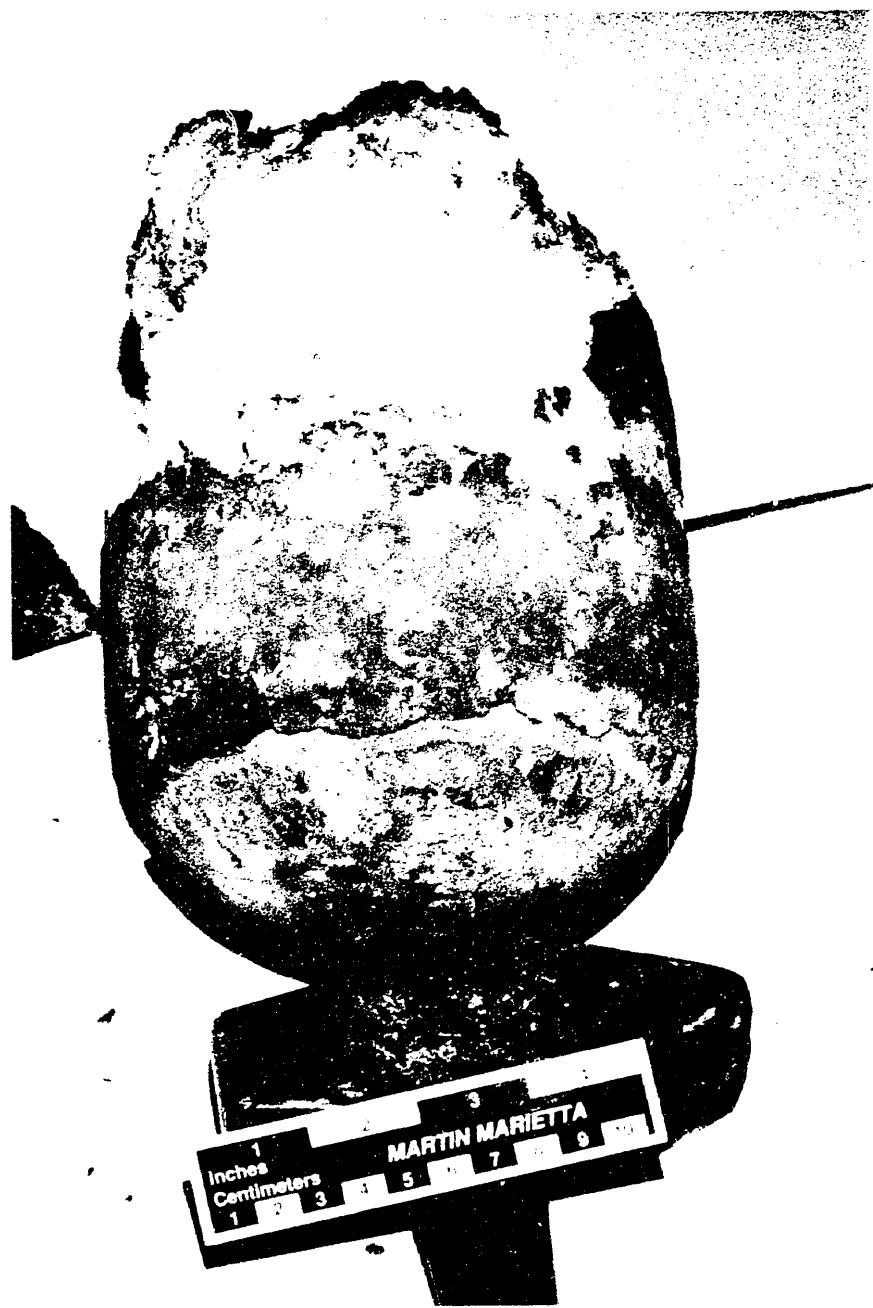
Fig. 5. Magnesium layer on top, salt with magnesium droplets, and uranium button at bottom.

Figure 5 shows the salt and metal product after it was broken out of the alumina reactor. The uranium alloy button, shown in Fig. 6, split away from the salt easily.

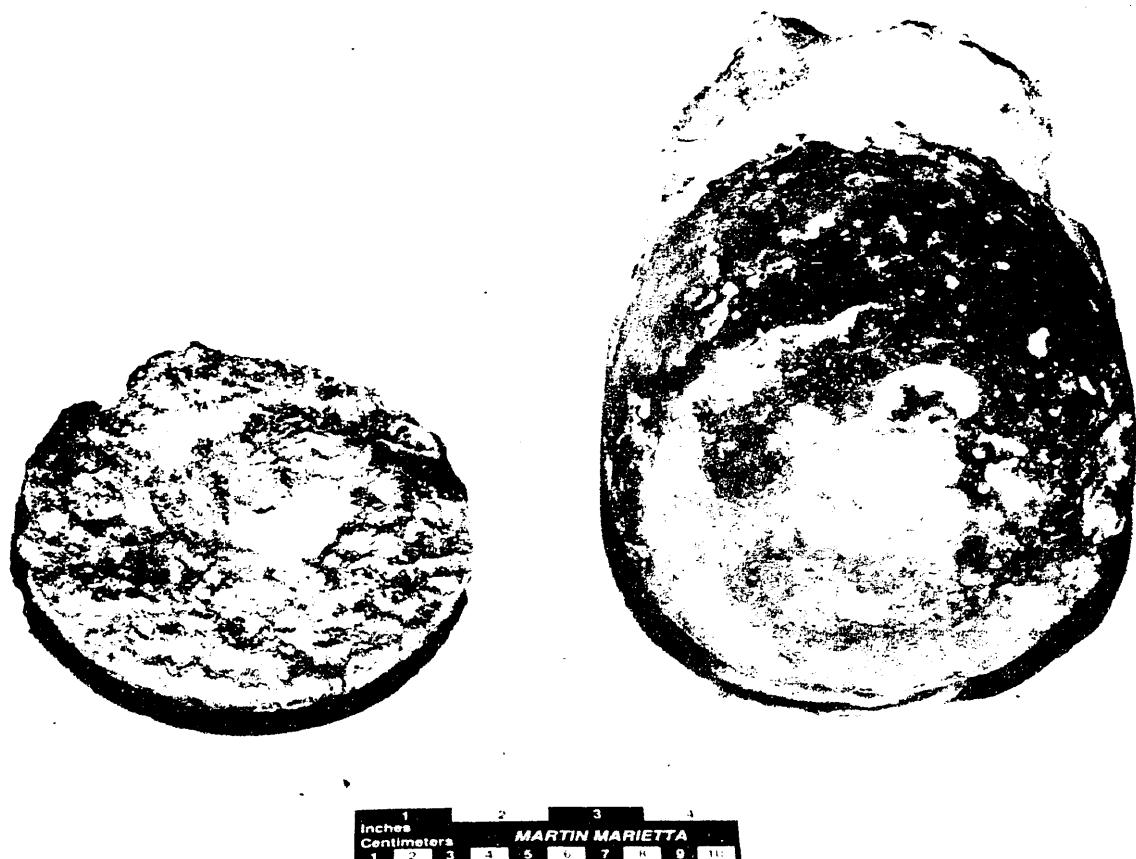
Fig. 6. Product from Run 3. At left, top of uranium button; at right, bottom of salt layer.

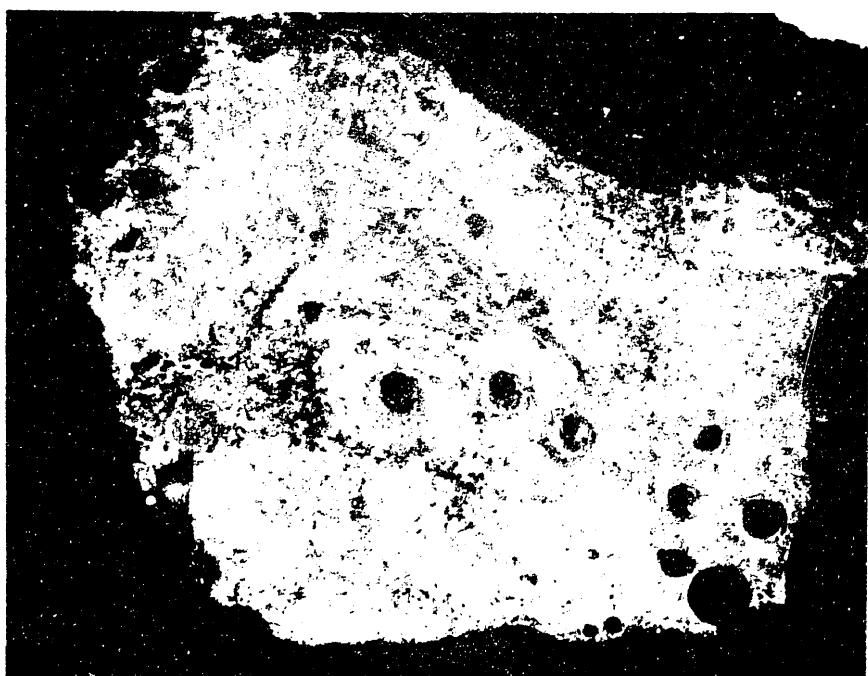
Fig. 8. Macrograph of a polished fragment of salt from Run 3. The black circles are uranium, and the gray magnesium that encircles the droplets can be seen on some.

The salt appeared to be dirty and impure (Fig. 7). Figure 8 shows a polished fragment of the salt. Uranium droplets of varying sizes were found in the salt, one of the larger of which is shown in Fig. 9. A droplet entrapped in the salt was analyzed by electron microprobe. Although at first glance the droplets appear to be 2 phase (Fig. 10), most of them actually consist of alpha-uranium grains in a matrix of fine Fe<sub>2</sub>U + FeU<sub>6</sub> (Fig. 11). Rims of FeU<sub>6</sub> surround the alpha uranium grains.

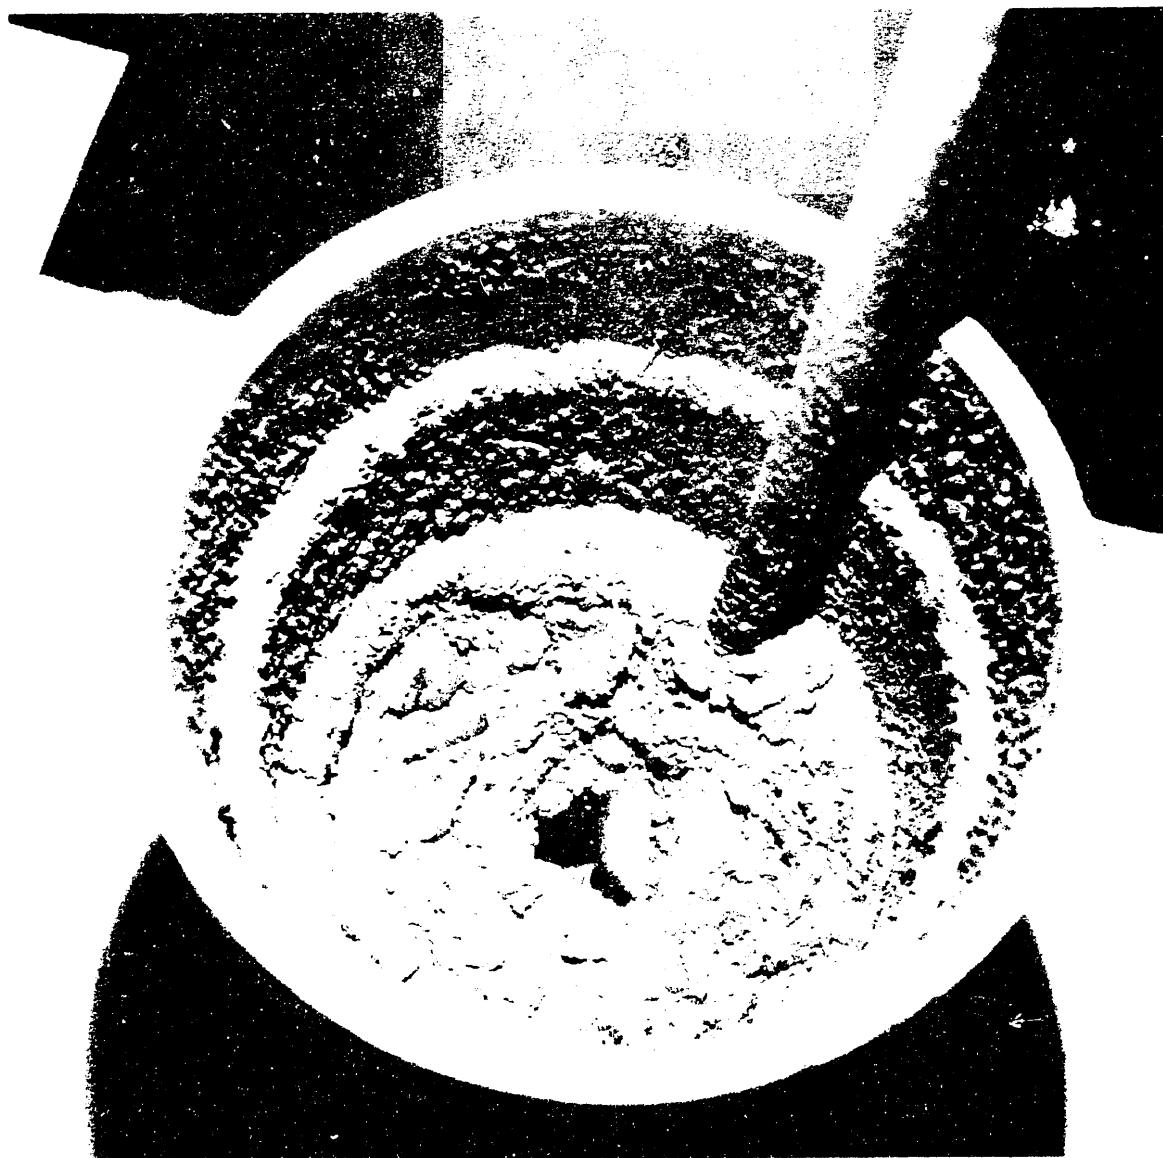
Fig. 12. Reactor and susceptor from Run 4. The hole in the center is where the crust breaker rod was inserted at the end of the run. High oxygen levels in the furnace caused an orange uranium oxide coating.

Figure 12 shows the reactor and the graphite suscepter as they were removed from the furnace. When the crust breaker rod had slipped at the beginning of the run, it had pierced a hole in the alumina, allowing the uranium to escape into the graphite suscepter (Figs. 13 and 14). The uranium adhered strongly to the graphite through a layer of uranium carbide. The uranium could not be broken free of the graphite (Fig. 15) and was eventually sawed off.

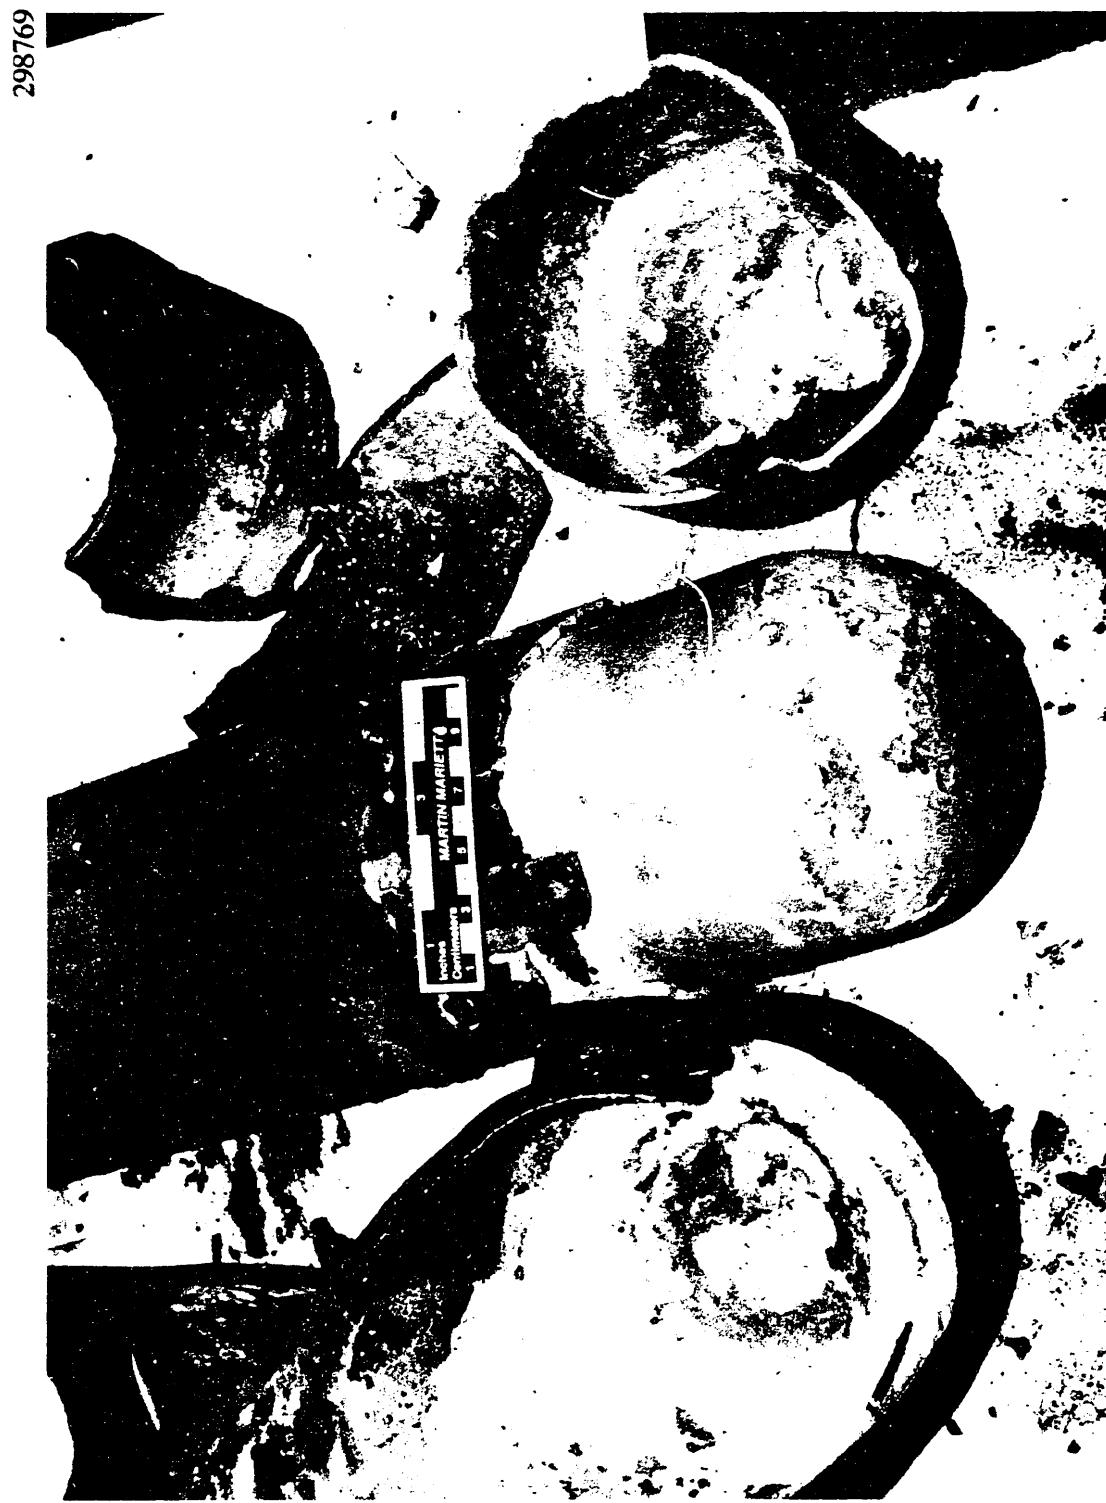
Fig. 13. Fixturing and product from Run 4. At left, bottom of graphite susceptor filled with uranium alloy and slat; middle, by-product salt with the lower portion of the alumina crucible broken away; right, bottom of alumina crucible with hole where the crust breaker pierced it.

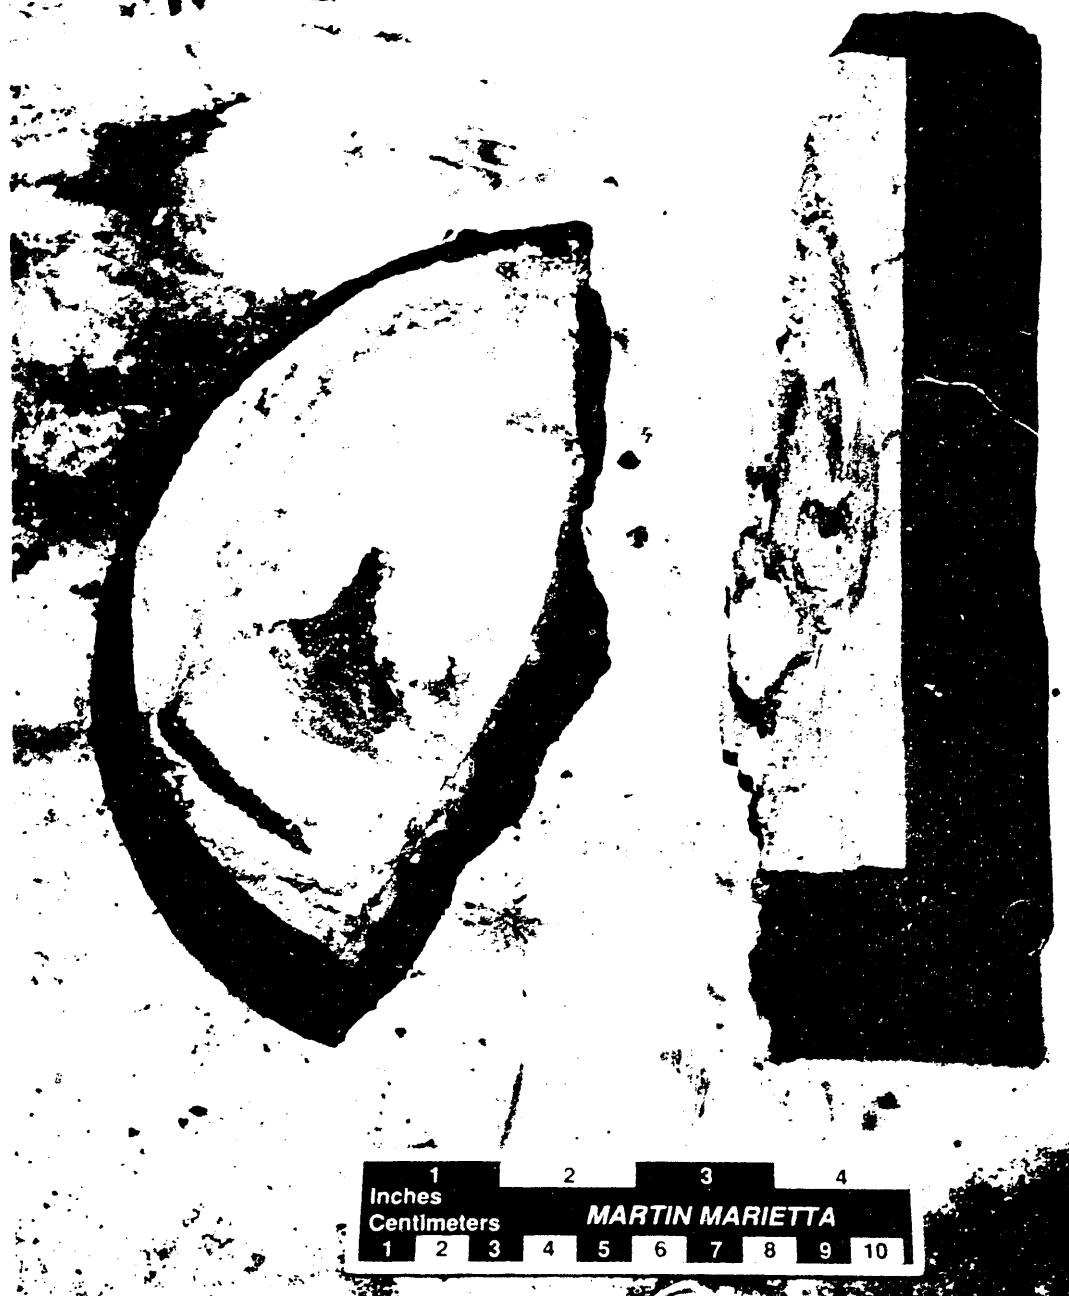
Fig. 14. Uranium alloy in the bottom of the graphite susceptor.

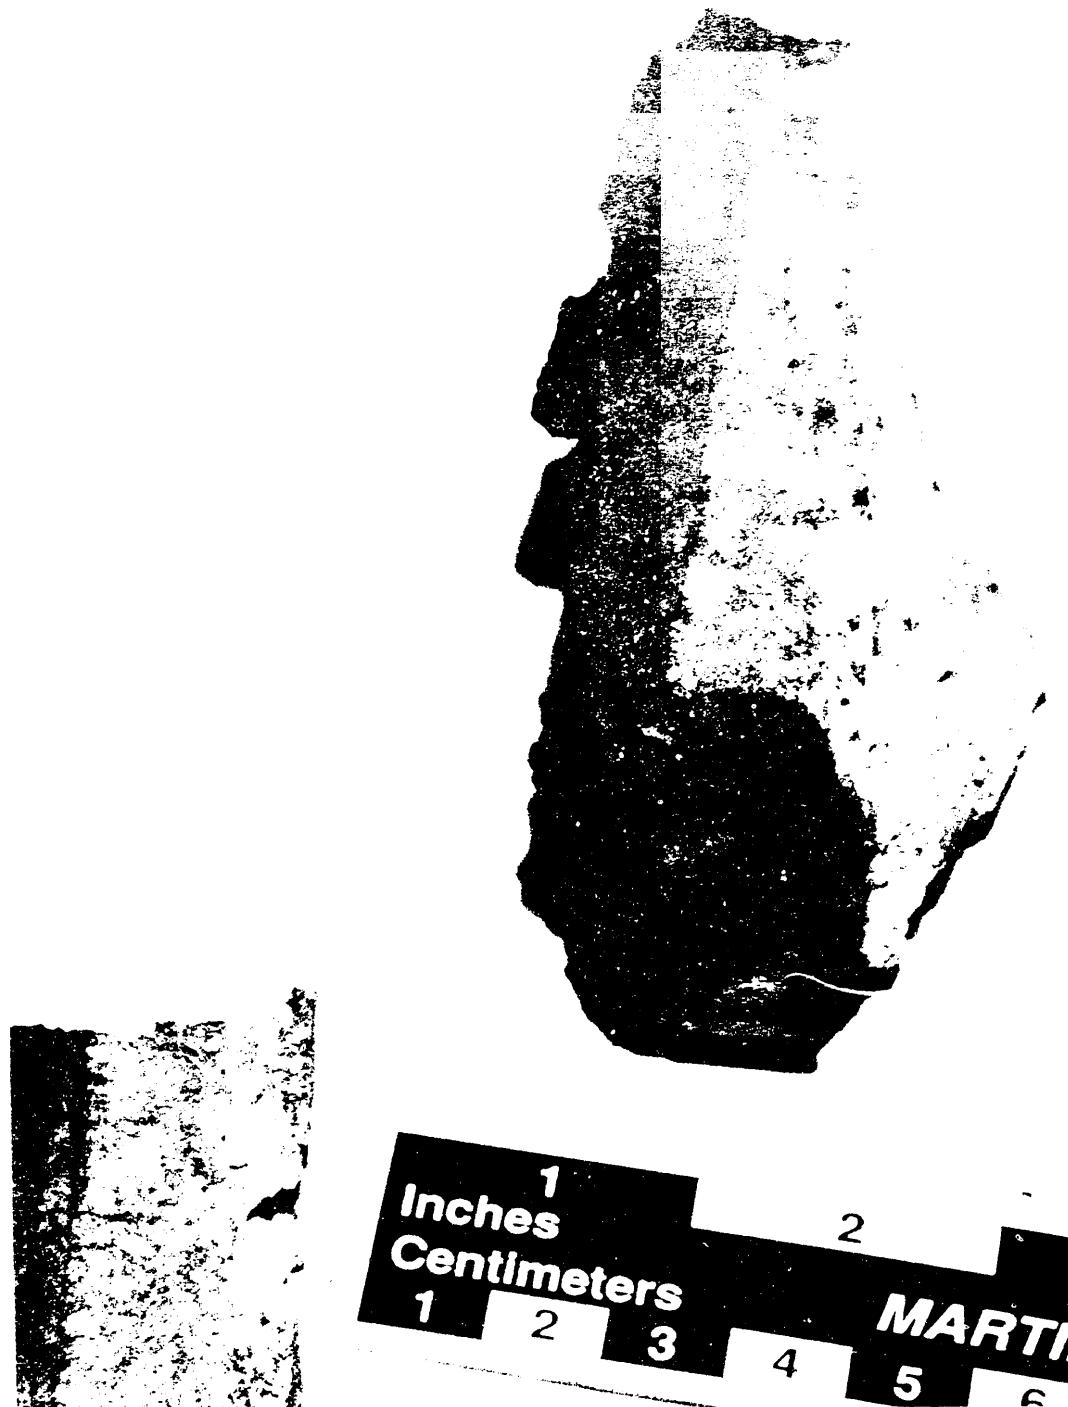
Fig. 15. Uranium alloy adhering to the bottom of the graphite susceptor. The graphite would not break free from the uranium, but instead broke into smaller pieces of graphite and uranium.

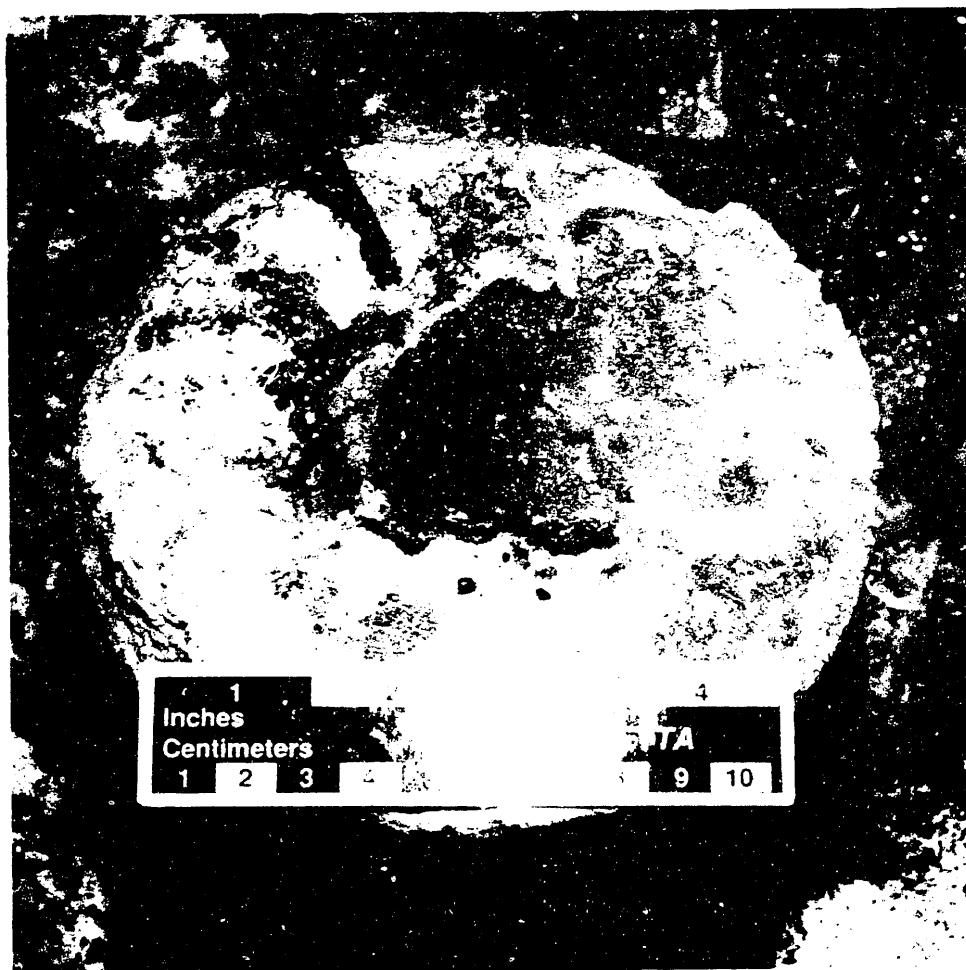
Fig. 17. Below the protective covering of unreacted feed, the magnesium pool was bright and shiny.

When the reactor was broken open, a layer of reacted but unmelted feed several inches thick was found (Fig. 16). Below this "crust" was a void, then the magnesium pool (Fig. 17), followed by gray magnesium fluoride-sodium chloride salt (Fig. 18). Constituents of these layers, as determined by X-ray diffraction, are shown in Table 3.

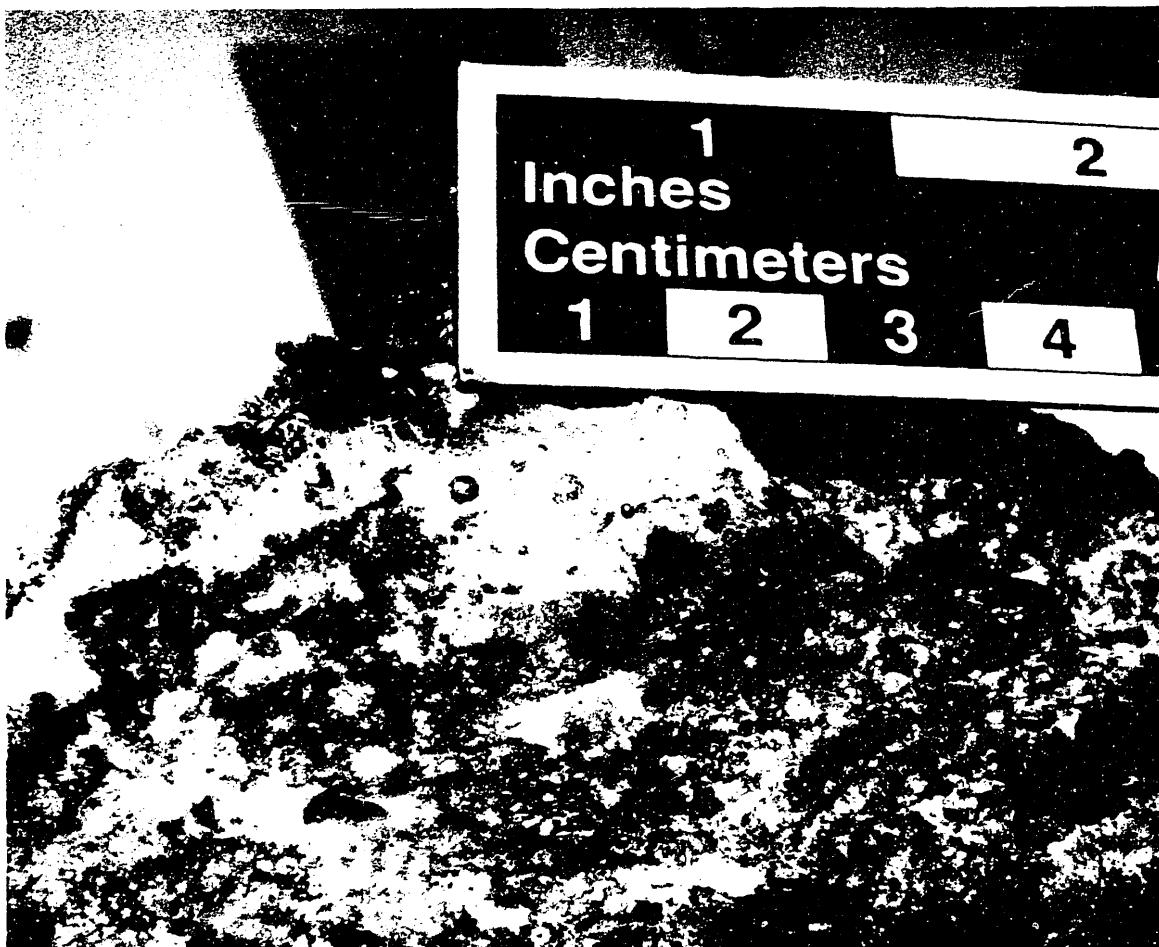
Fig. 20. Impure salt from Run 4. Not allowed sufficient time at temperature for settling to occur, the salt is riddled with droplets of metal.

Because feeding was completed within about 30 min, after which the power to the system was cut, the salt did not have sufficient time at temperature for settling of the uranium to occur (Fig. 20). With the salt withdrawal system in place, these droplets would be swept out of the withdrawn salt because the magnesium-coated uranium alloy pool acts as a filter, entrapping and coalescing droplets of both magnesium and uranium alloy.

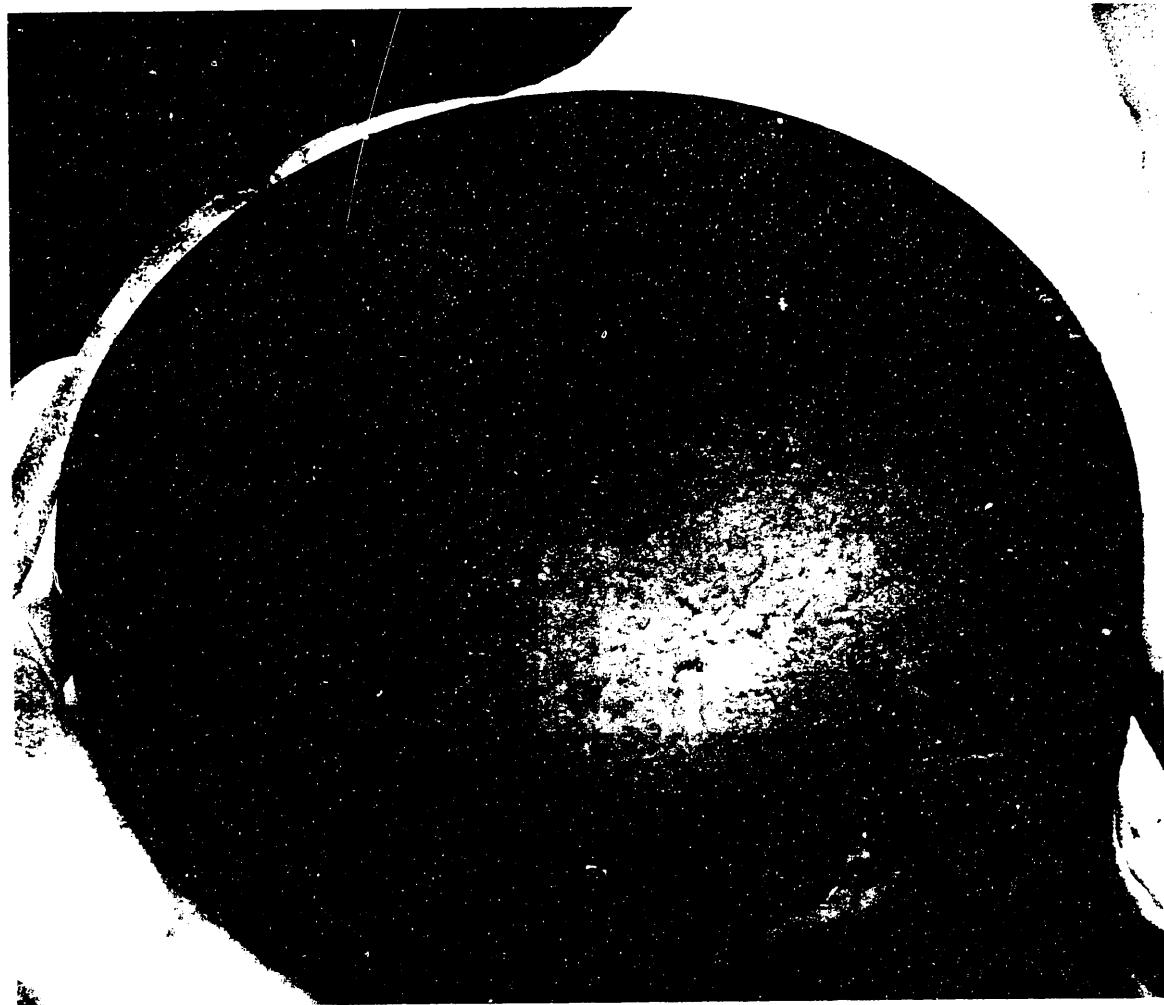
Fig. 21. Run 5 shows alumina vessel with layer of green unreacted feed on top.

Sintered material again was built up in the top of the vessel, but this time the surface appeared to be clean and oxide-free (Fig. 21). Again, a void existed between the unreacted feed layer and the magnesium pool. The salt layer was white, except for the bottom 1/4 in. or so, which still contained metal droplets (Fig. 22). Some gray banding was also present at the bottom of the white salt layer (Fig. 23). Figure 24 shows the uranium button.

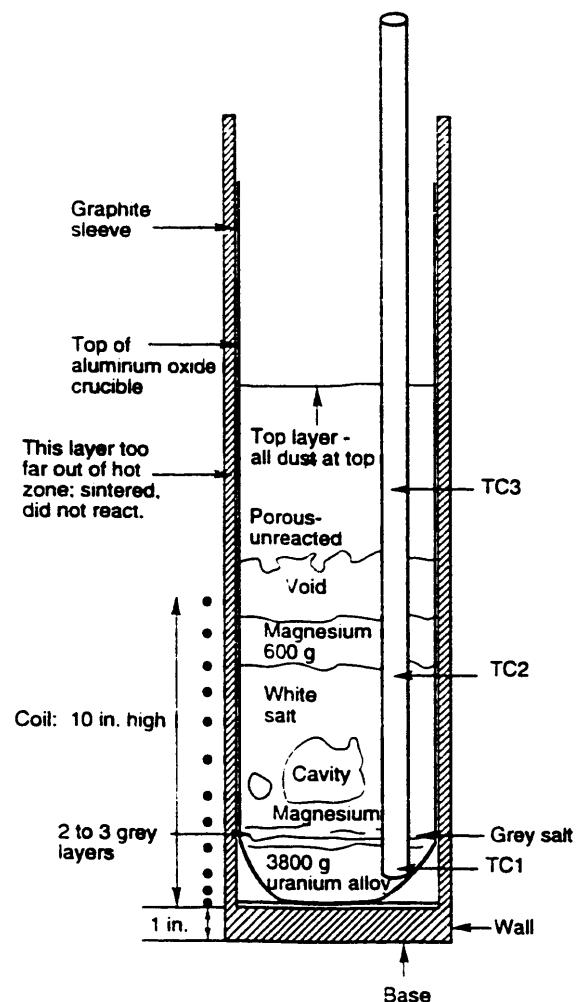
**Fig. 25. Scale drawing of the reactor setup and products formed in Run 5.**

The scale drawing of Run 5 (Fig. 25) shows that the reason for the crust layer buildup is that the reaction products rise to a height at which the incoming reactants are out of the heat zone. The temperature at the top thermocouple never exceeded 900°C. Until the magnesium level rose to this point, the reaction proceeded well with no stirring required. Turbulence in the magnesium, visible from the sight port, prevented any skinning over. Had the uranium alloy and by-product salt been drawn off during the reaction, the product height in the reactor could have been controlled, and the reaction could have been kept at the proper temperature indefinitely.
