FULL LIFE WIND TURBINE GEARBOX LUBRICATING FLUIDS

DOE AWARD # DE-EE0001364

Recipient: Dow Corning Corporation

FINAL REPORT

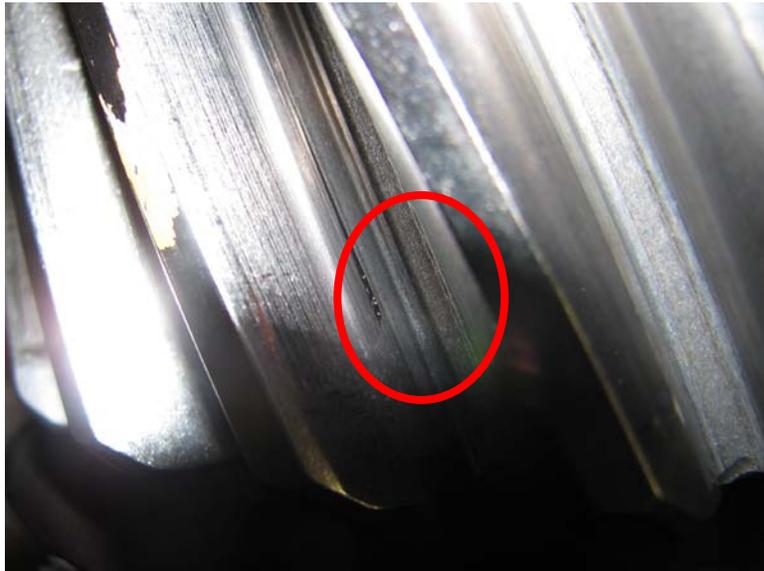
After the inspection of progressive stage 3 small pits were found near the root of the tooth on 2 of the 4 high speed pinions. As this was expected to be the onset of a failure mode, the pits were documented with photographs to help determine their progression, if any, in the next load stages. The initial hypothesis was the low rotational speeds of this stage contributed to the pit formation. To verify this theory, the originally proposed load conditions of stage 4 were altered to utilize a higher speed and temperature combination while maintaining a film thickness approximately the same as stage 3. The test was resumed.

Image 7.8.2.4.1-2 Images of pits found near root of tooth

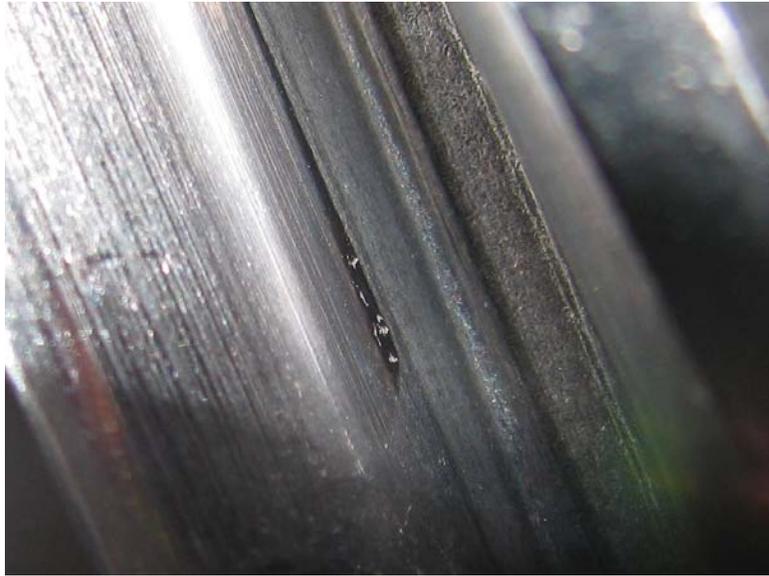
Image 7.8.2.4.1-3 **Close up of pits found near root of tooth**

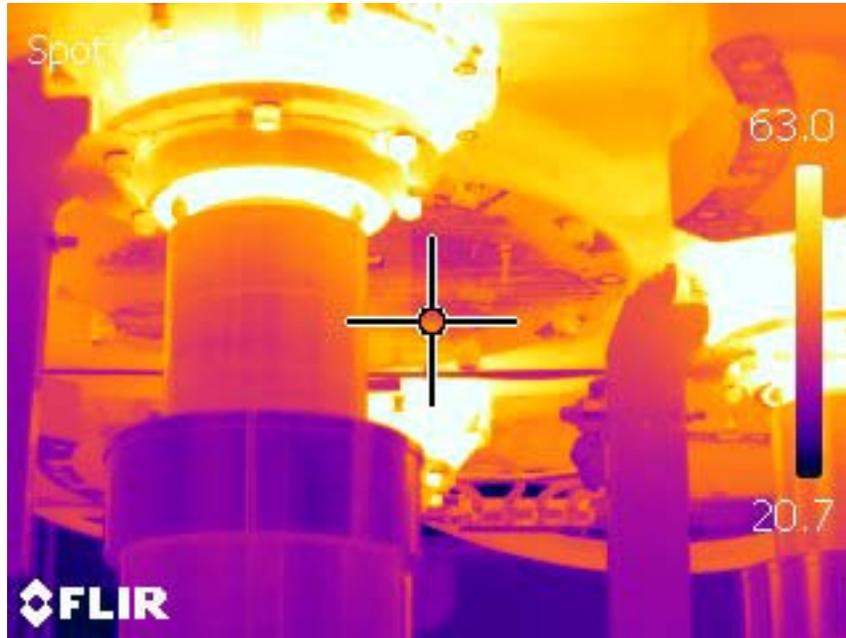
Figure 7.9.4-1: PFPE Baseline Stage High Speed Pinion Thermal Image

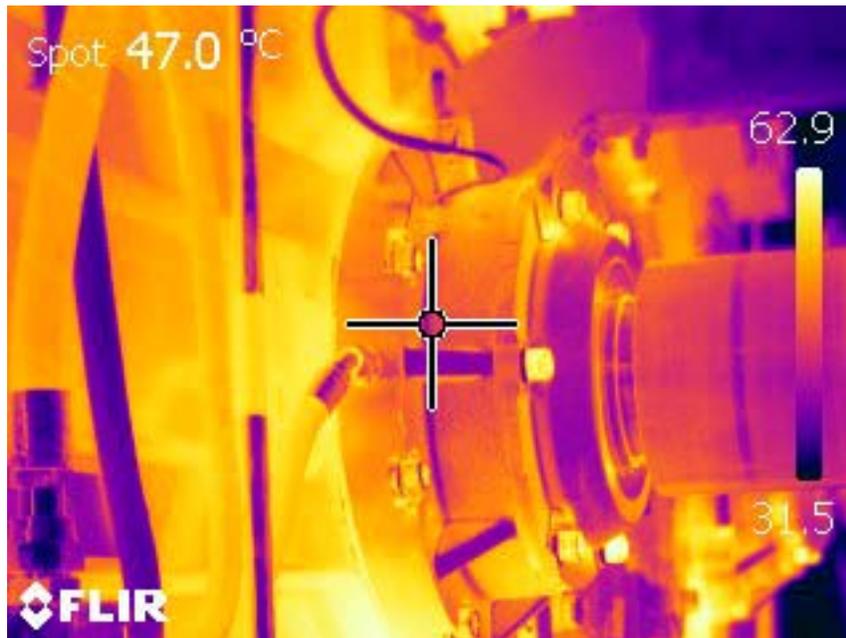
Figure 7.9.4-2: PAO Reference Baseline Stage High Speed Pinion Thermal Image
