Title: Wind turbine blade fatigue tests: lessons learned and application to SHM system development

Intended for: European Workshop on Structural Health Monitoring,  
2012-07-03/2012-07-06 (Dresden, ---, Germany)

# Wind turbine blade fatigue tests: lessons learned and application to SHM system development

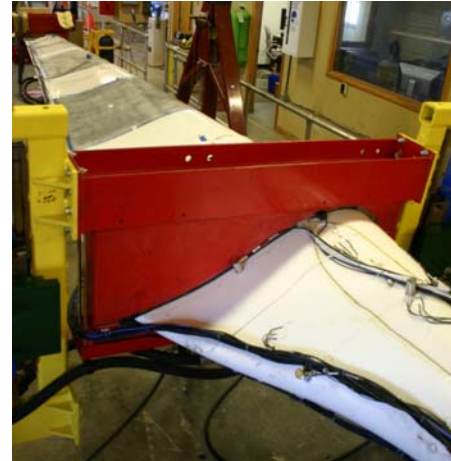
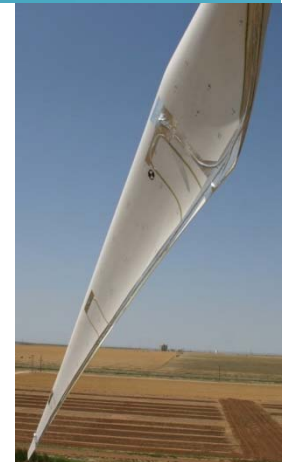
- **CX-100 wind turbine blade**
  - Research blade from SNL
  - 9m, Composite structure
- **Fatigue loading**
  - harmonic excitation
  - ~8.5M cycles to failure
- **Instrumentation**
  - Sensor Arrays
  - Hardware
- **Experimental Data**
  - Diffuse wave-field measurements
  - Ultrasonic Guided waves
- **Experimental Results**
  - Fatigue crack detection performance
  - Sensor diagnostics.
- **SHM system Deployment**

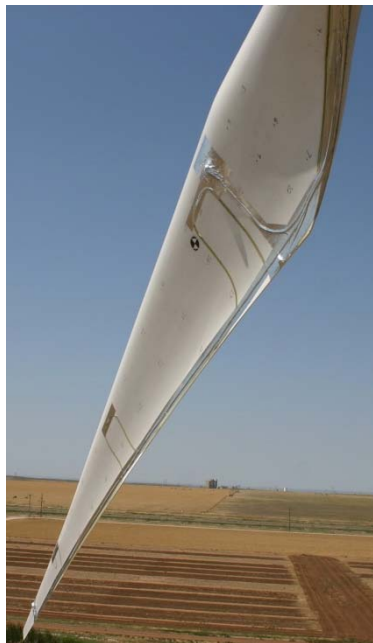
- Designed at SNL
- 9-meters long
- Balsa wood frame
- Fiberglass Body
- Carbon Fiber Spar Cap
- Thick root section

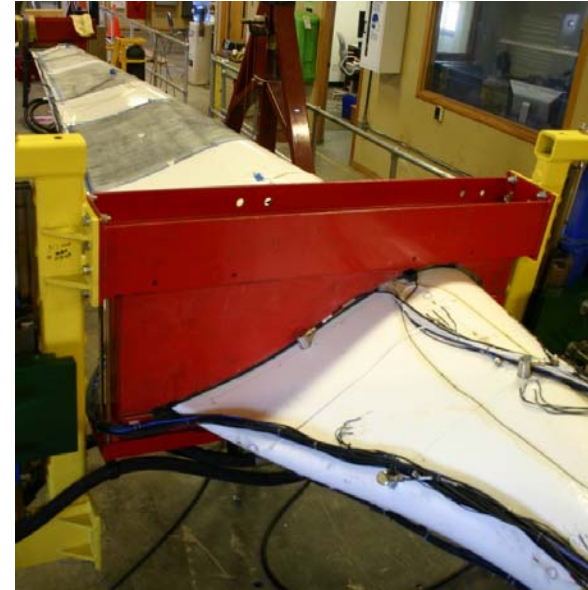
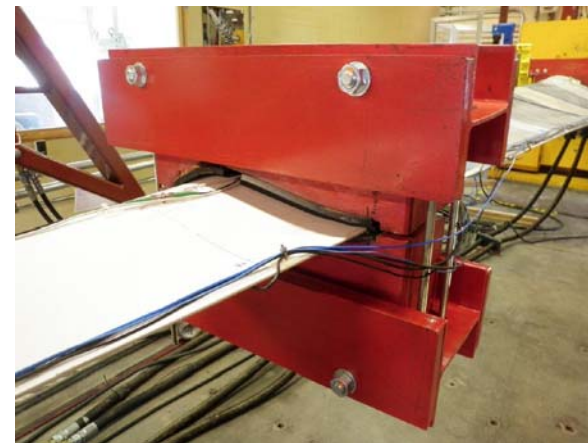
- Fatigue test conducted at NREL's National Wind Technology Center.
- Excitation using Universal Resonant EXcitation (UREX).
- Moment Distribution Saddles at 1.6m and 6.75m
- Excitation at first natural frequency (1.8 Hz)
- Multiple Sensing and Diagnostic Systems Deployed

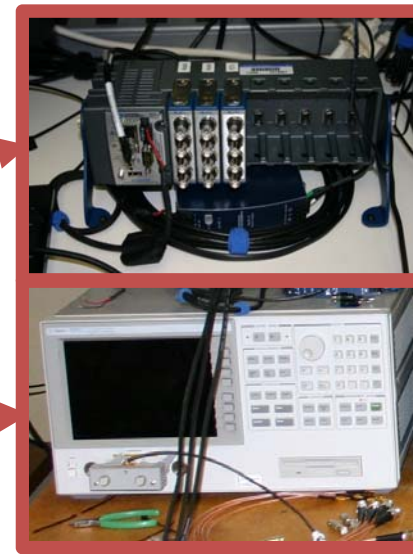
- **Passive sensing at 1.6kHz**
  - Accelerometers
  - Piezoelectrics
  - Internal microphone
- **Commercial DAQ for embedded applications**

- **Impedance measurement sweeps from DC to 30kHz**
- **Imaginary part of Admittance can indicate sensor bond condition**
- **Measurements taken approximately once/week**

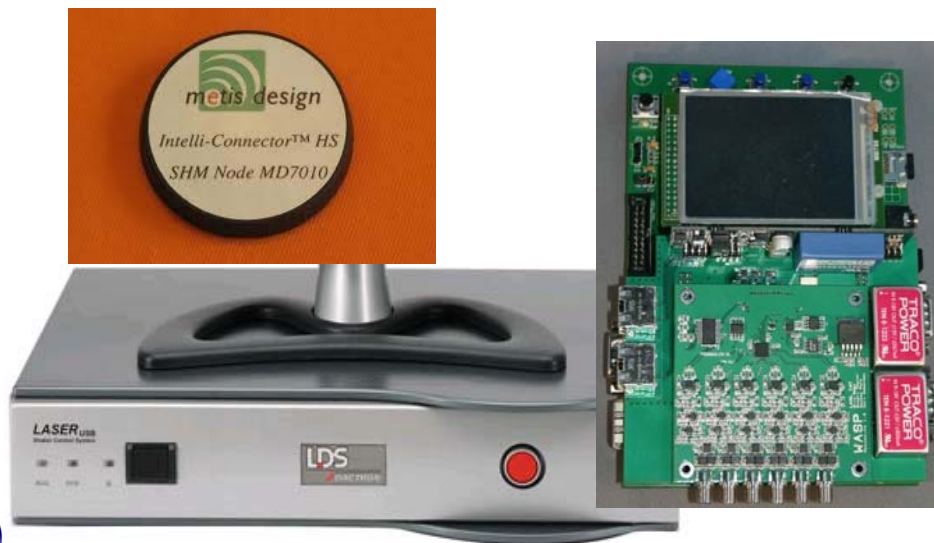
- **Metis IntelliConnector**
  - 10 MHz sampling range
  - Excited from 50-250 kHz at 25 kHz intervals
  - One sensor array on each blade surface; 0.5-m transmission distances.

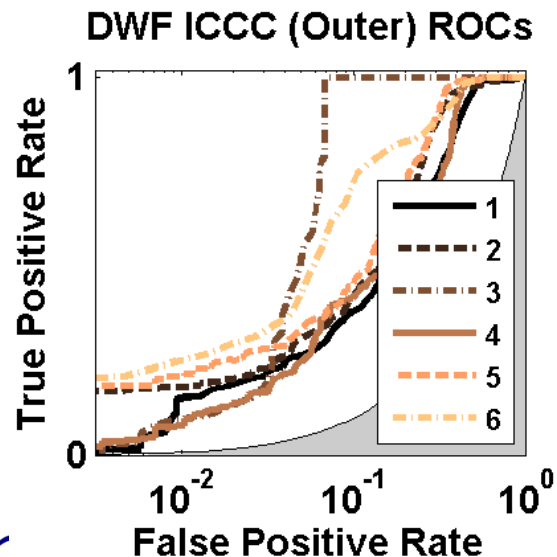
- The outer array suffers from poor relative performance.
- An actuator replacement limits the utility of data after 10/31/11
  - With the crack forming by 10/20/11, no new baseline for crack detection could be established.

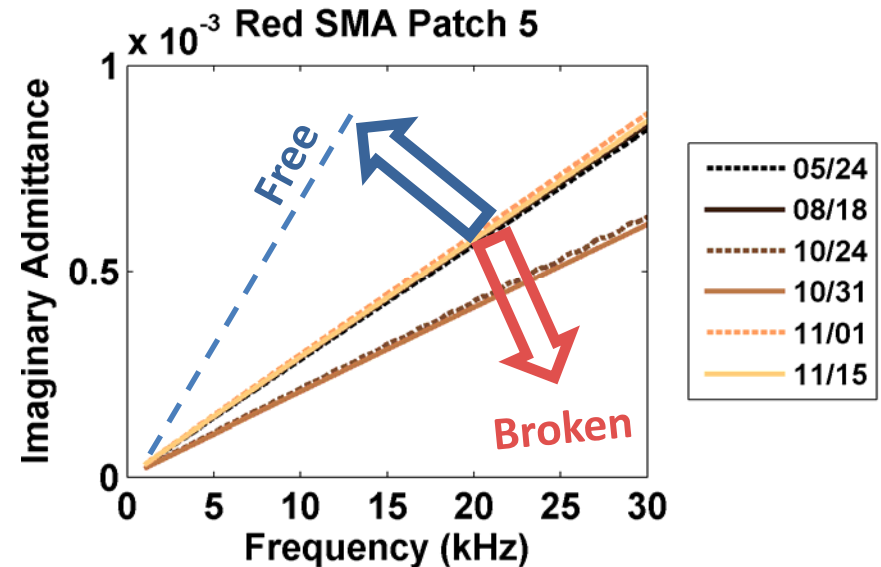
- This test utilized circular PZT patches bonded to fiberglass.
- The bonding state of the patches is reflected in their capacitive behavior.
- Changes in that behavior can be inferred from the slope of the imaginary part of the admittance curve.
- An increased slope indicates a more free-free condition.
- A decreased slope indicates a reduction in capacitance, usually a result of breakage.

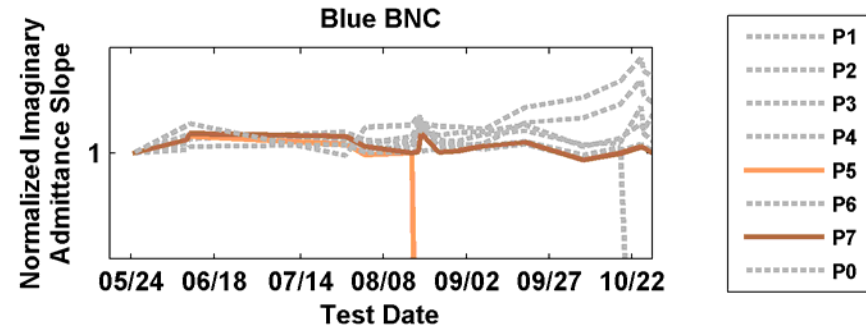
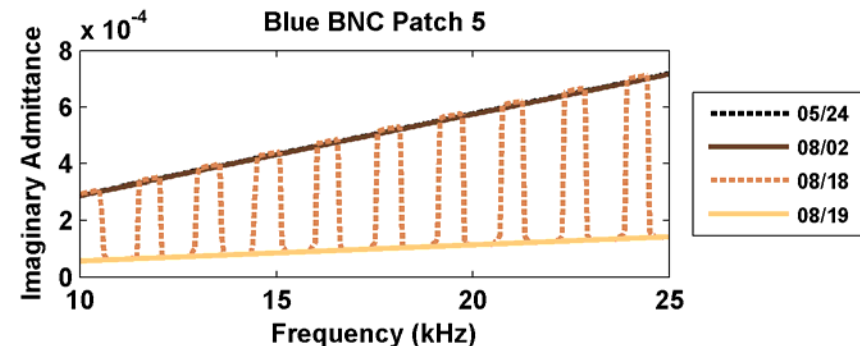
- **Patch 5 broke early in the test**
  - Some data were collected during fatigue loading
  - First example of breathing crack behavior in this test
  - The patch was not immediately replaced
  - Fully broken behavior was exhibited the next day, following the lower slope
- **Patch 7 remained healthy**
  - This patch sat at 7m, and saw very low strains

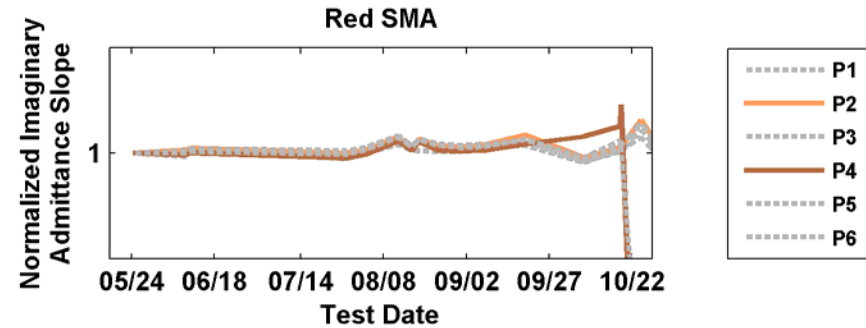
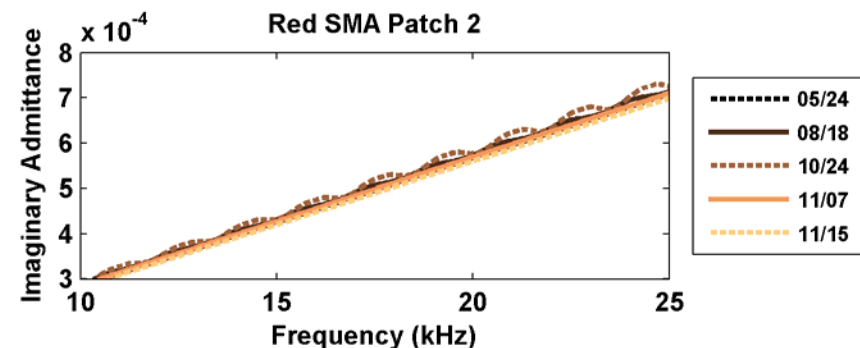
- **Patch 2 remained healthy.**
  - Some data were collected during fatigue loading
  - Located within 1m of the blade root, this patch saw high fatigue strains.
  - The structural impedance is cyclic for data collected during fatigue loading.
- **Patch 4 sat directly atop the ultimate failure.**
  - As the crack formed, the blade surface softened.
  - This patch was ultimately replaced twice.

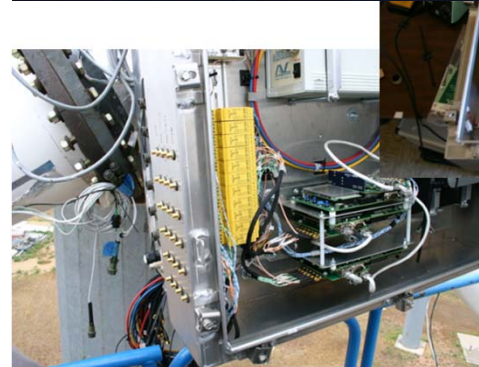
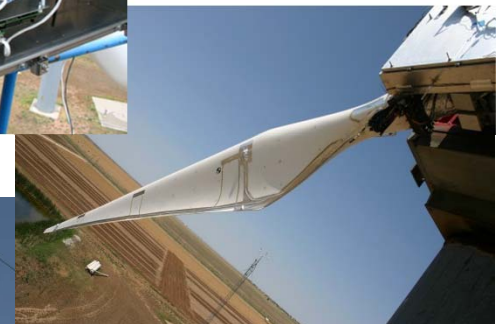
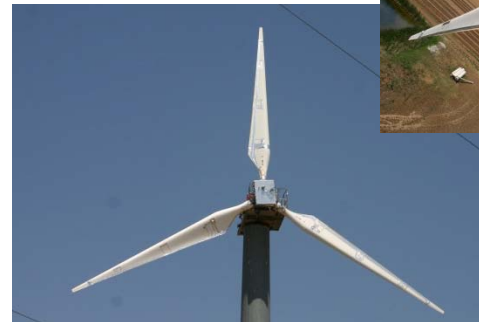
- Diffuse wave field measurements
- Six (6) software-reconfigurable, simultaneous channels
- Active/Passive sensing with 50 kHz bandwidth
- Autonomous or web-driven data acquisition
- Onboard processing capability
- Currently deployed on a wind turbine in Texas
