## Analysis Techniques Used On Field Degraded Photovoltaic Modules

Thomas D. Hund and David L. King  
Sandia National Laboratories  
PO Box 5800  
Albuquerque, NM 87185-0753

### Introduction

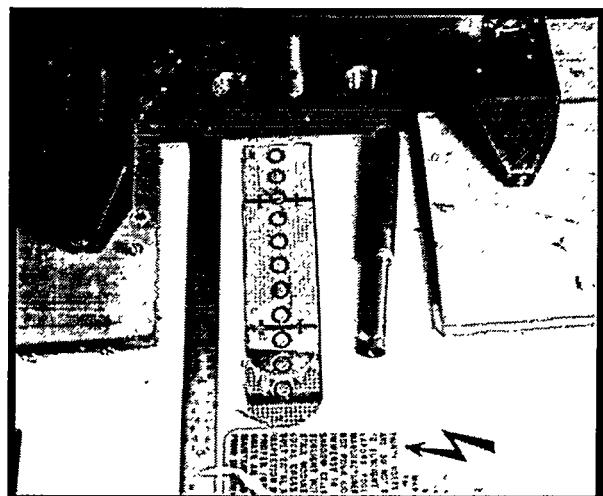
Figure 10

## ADHESION STRENGTH TESTING

- Repeatable process
- Failure force proportional to sample area
- ~900 lb/in<sup>2</sup> required for failure in new module
- Work in progress to relate failure stress to aging

Test results on new modules indicated EVA-to-cell adhesive strengths near  $620 \text{ NT/cm}^2$  ( $900 \text{ lb./in}^2$ ). Work is in progress to measure the effects of environmental aging. In addition to the adhesive strength of the EVA-to-cell interface, the extracted cell sample is available for numerous analytical techniques such as Auger, X-Ray Photoelectron Spectroscopy, and Scanning Electron Microscopy (see Figure 10).
