**Title:** Incipient Crack Detection in Composite Wind Turbine Blades

# Incipient Crack Detection in Composite Wind Turbine Blades

ASHMCS 2012  
August 29-31, Jeonju, Korea

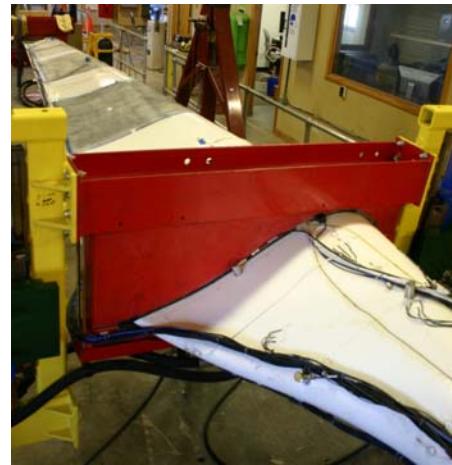
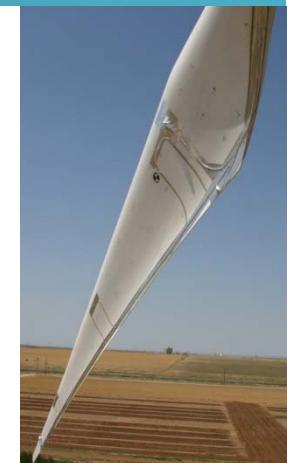
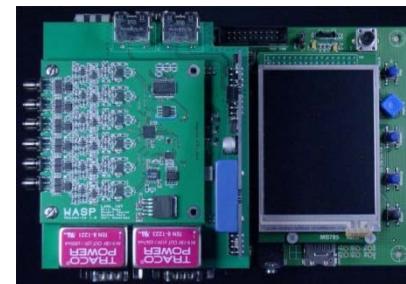
# The CX-100 Wind Turbine Blade

- Designed at SNL
- 9-meters long
- Balsa wood frame
- Fiberglass Body
- Carbon Fiber Spar Cap
- Thick root section

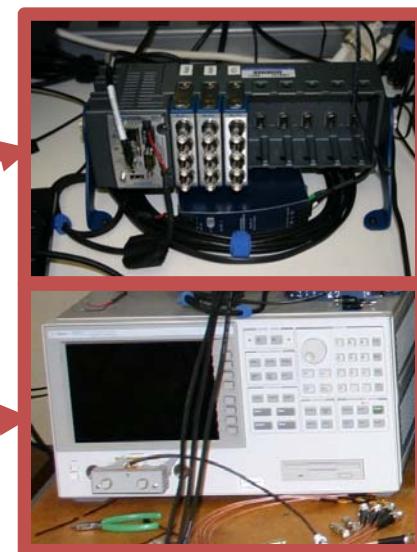
## Sensor Diagnostics (HP4291A)

- **Impedance measurement sweeps from 1kHz to 30kHz**
- **Imaginary part of Admittance can indicate sensor bond condition**
- **Measurements taken approximately once/week**

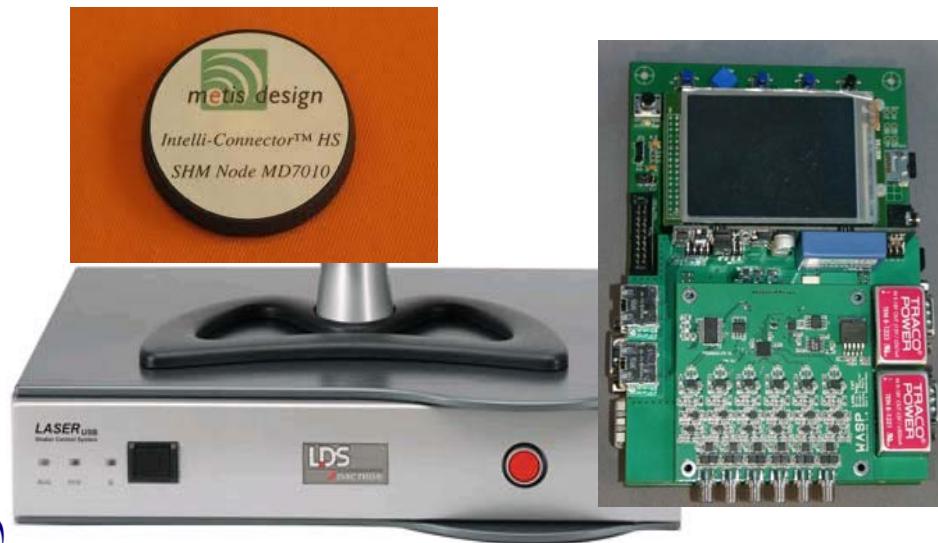
## Ultrasonic Guided Waves

- **Metis IntelliConnector**
  - 10 MHz sampling rate
  - Excited from 50-250 kHz at 25 kHz intervals
  - One sensor array on each blade surface; 0.5-m transmission distances.

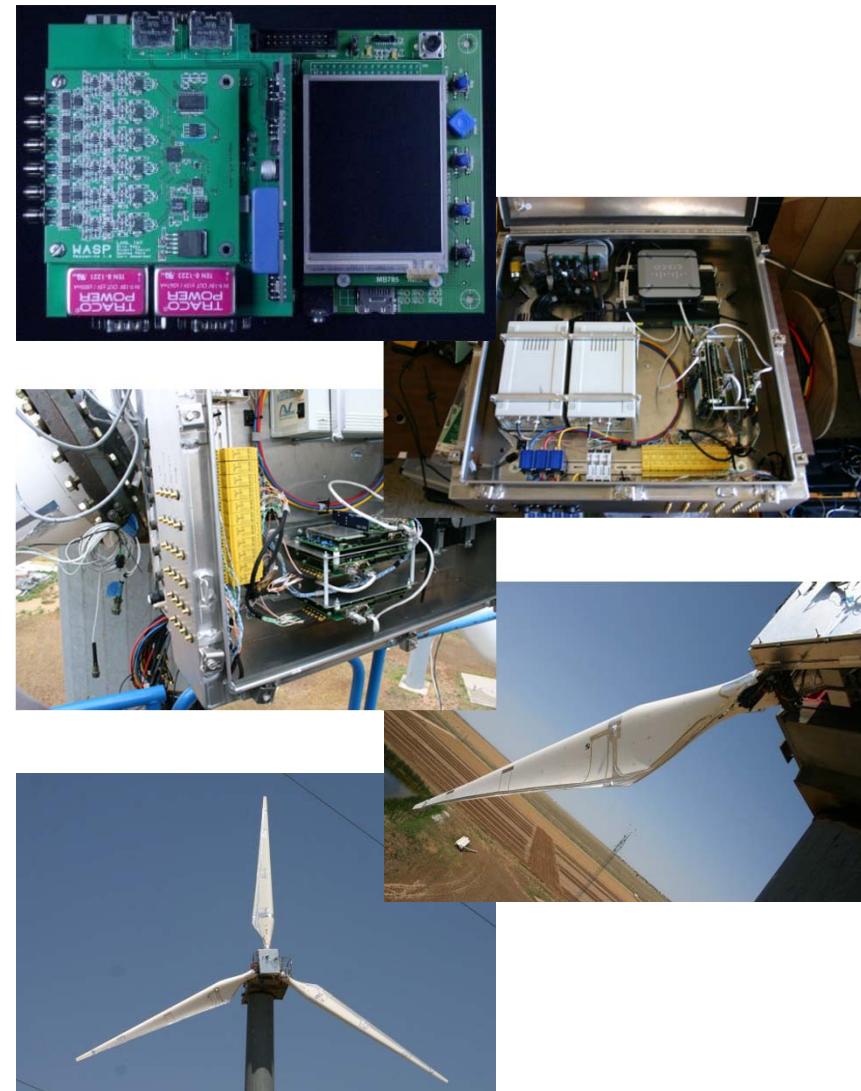
# SHM System Deployment

- PZT sensors integrated inside a CX-100 blade
- Accelerometers and fiber optic strain gauges mounted externally
- Electronics for acquisition and communications mounted on hub
- Operational data collected June 2011
