Title: 3013 Surveillance and Monitoring Program Review,  
January 25 to 27, 2011

## **3013 Surveillance and Monitoring Program Review**

### **January 25 to 27, 2011**

#### **Abstract**

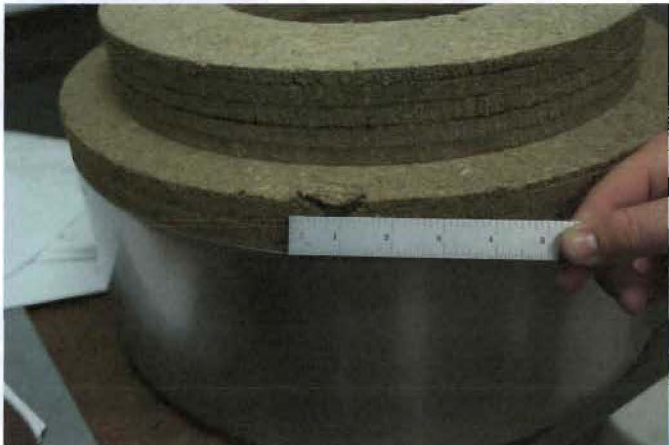
- Damage to the Celotex

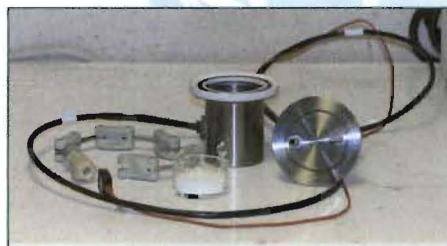
- Similar in dimensions to the test cells used in the small scale hot test
- Cell components were tested for leak tightness by a helium leak check
  - Body –  $10^{-9}$  cc/He-s @ 1 atm
  - Probe –  $10^{-3}$  to  $10^{-9}$  cc/He-s @ 1 atm
- Attempts were made to seal humidity probes with epoxy – limited success

Cell consist of stainless steel body and top with a flanged fitting, o-ring and chain clamp for sealing, humidity probe, thermocouple, and glass dish for oxide/salt mixture

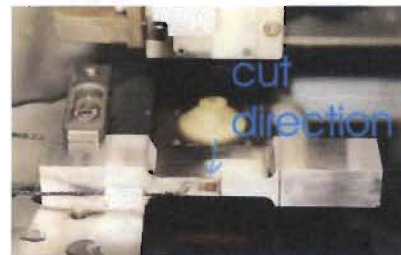
- Also known as crack compliance
- Mount one or more strain gauges
  - Prefer wire EDM cutting for metals
- Incrementally cut a slit
- Back-calculate stress profile
  - All the way through-thickness
- Why?
  - This slit approximated the SCC cracks, so measures right stresses
  - Good resolution
  - Gives  $K_I$  – so good for SCC

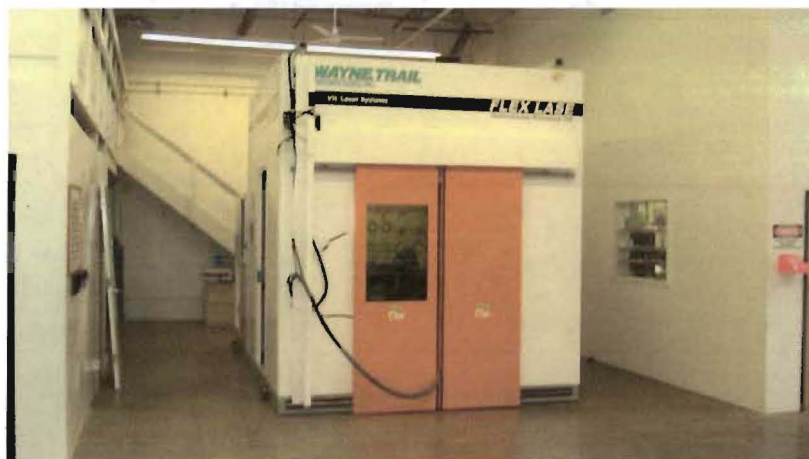
## New Laser Welder at NucFil

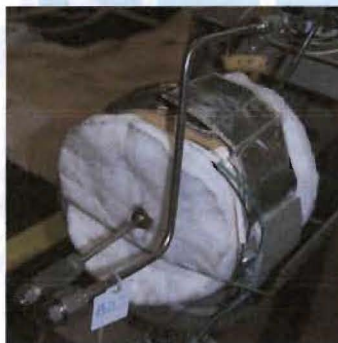
- 62 fixtures assembled with GLT O-rings, aged at 93 °C or 149 °C. Additional fixtures at 177, 204, 232 °C.
- Modified to allow testing of either upper or lower O-rings.
- Stainless steel tubing attached to leak test port via welded high pressure fitting. Threaded hole machined in the bottom of the fixture.
- Wire heaters around the fixture, insulated with fiber batting.
- LabView™ software monitoring with feedback from a type-K thermocouple attached to the PCV body.

Sealed Mock-PCV in aging storage rack
