DOE/NV--1493

**Post-Closure Report for Closed  
*Resource Conservation and*  
*Recovery Act Corrective Action*  
Units, Nevada National Security  
Site, Nevada**

**For Fiscal Year 2012  
(October 2011–September 2012)**

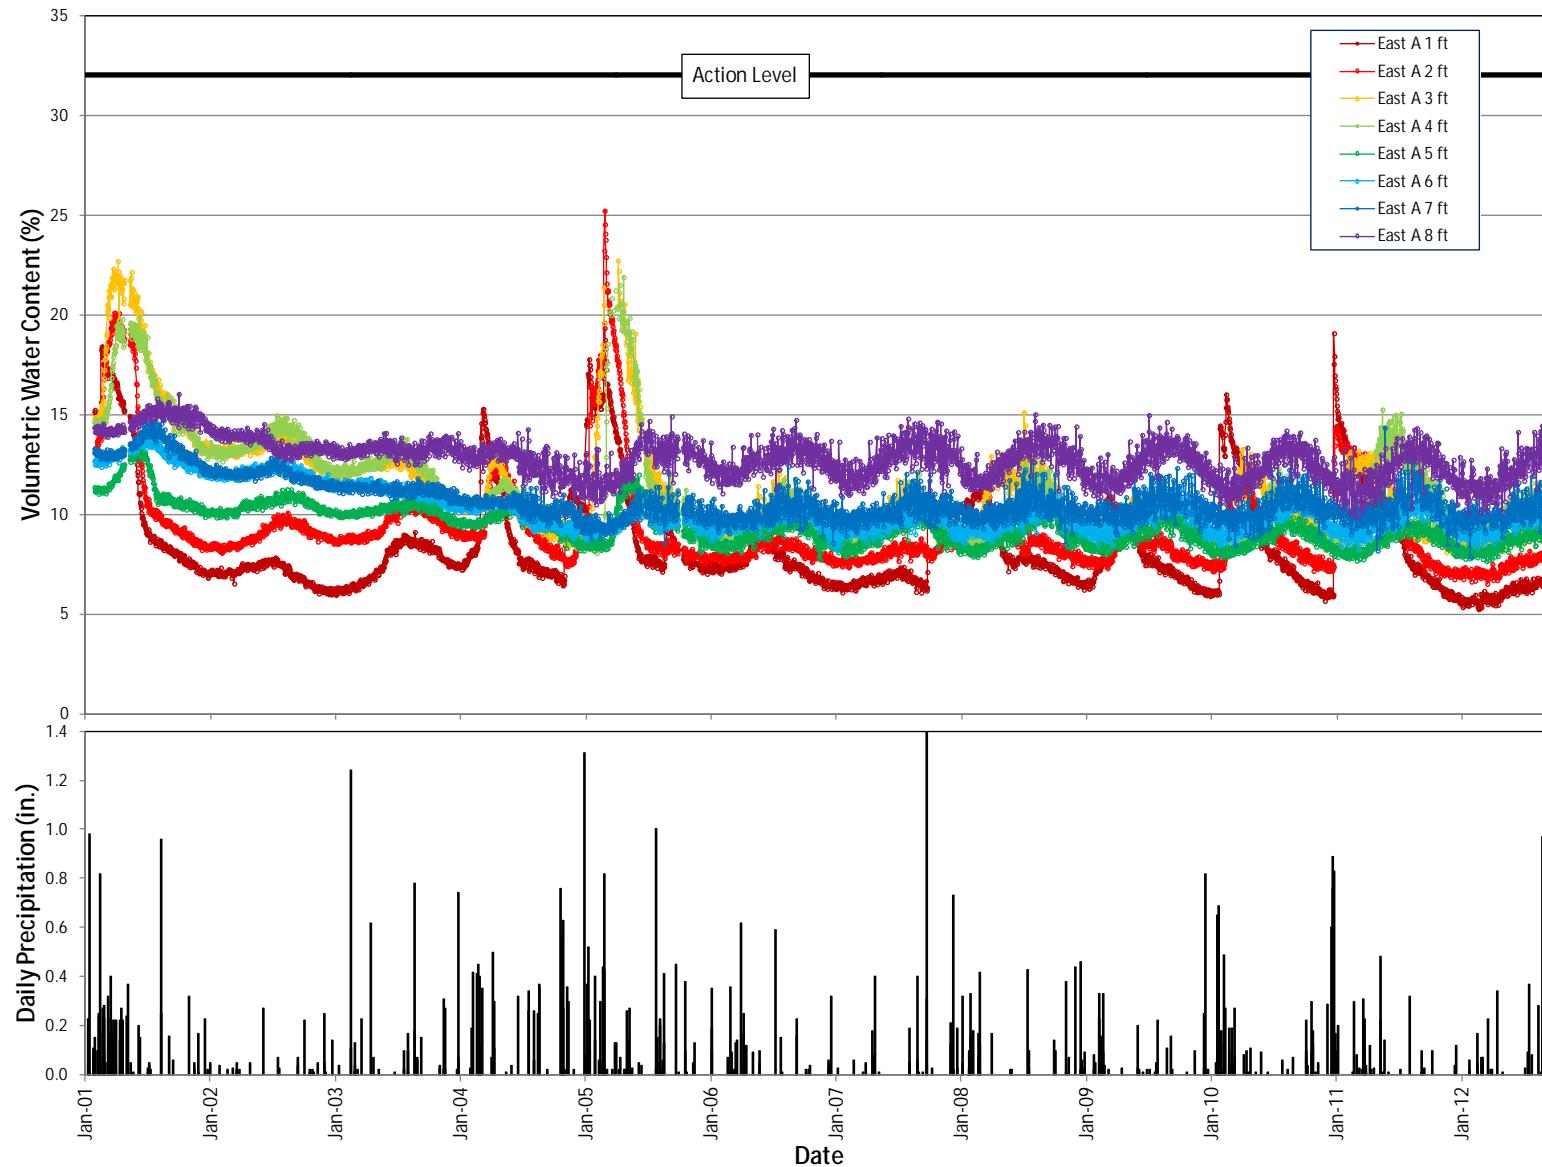
**FIGURE 3. EAST TDR NEST A SOIL MOISTURE CONTENT PROFILE**

The action level is illustrated in Figures 3 through 6. The action level was not exceeded.
