PRATT & WHITNEY ROCKETDYNE, A UNITED TECHNOLOGY COMPANY

Concentrating Solar Power – Central Receiver Panel Component Fabrication and Testing

FINAL REPORT

Project Period - September 25, 2008 thru December 30, 2012

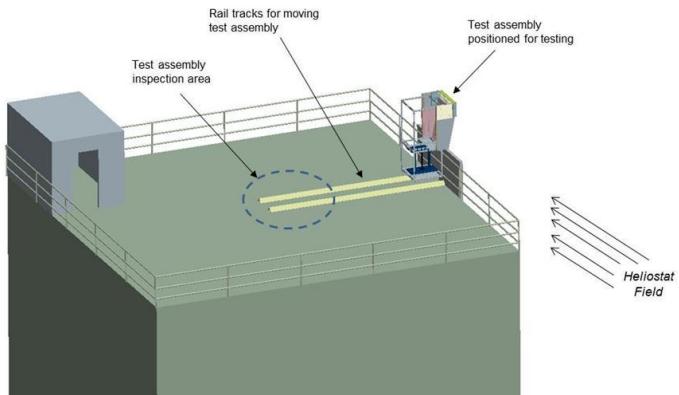
The system for this project includes both the PWR test articles (tubes and heat shields) as well as the NSTTF solar power tower. Both test articles were attached to the top of the tower at SNL for testing. They were rolled to the edge of the tower for testing and then back to the middle of the top of the tower for inspections and any work that would need to be performed on them. No salt loop is required for this testing.

Testing on top of Tower

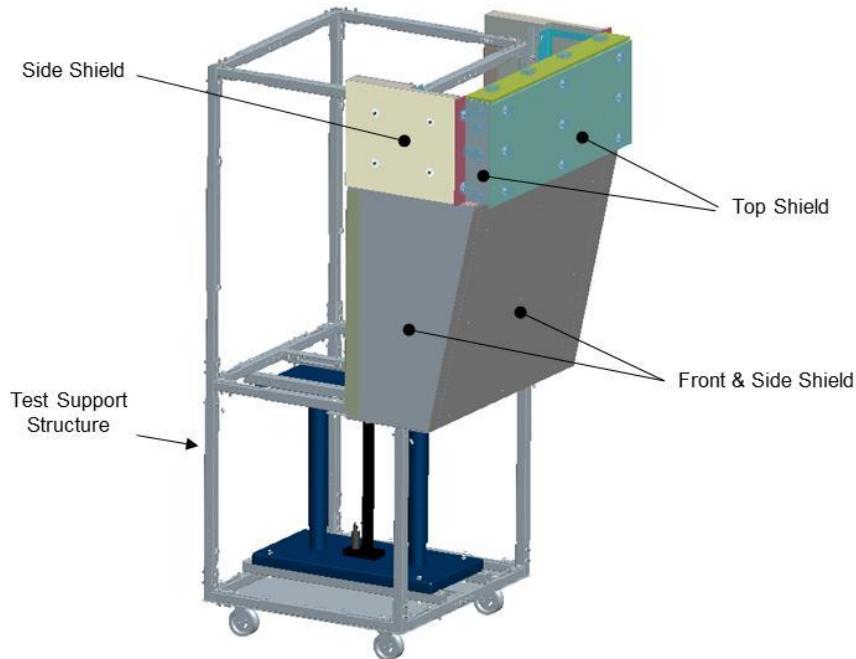
There are three different heat shield configurations that have been fabricated and tested. The double layer heat shield uses two layers of high temperature composite board material with an air gap between the layers. The front and side shield use commercial grade stainless steel sheet and the side shields use a low cost ridged insulation.

Heat Shield Test Assembly

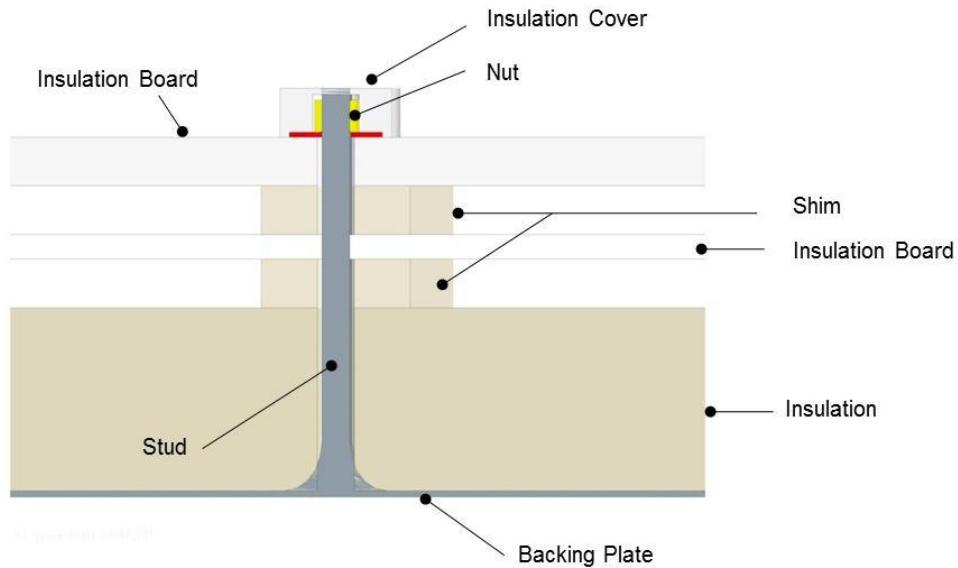
The panels on the front of the receiver will receive the largest amount of solar flux. Because of the high heat flux, these shields are located adjacent to the receiver tubes flowing molten salt. In order to reduce the impact of the high temperatures a double layer of high temperature composite board was used, with each layer being separated by an air gap. This drastically reduces the temperature that reaches the sheet metal structure.

HEAT SHIELDS

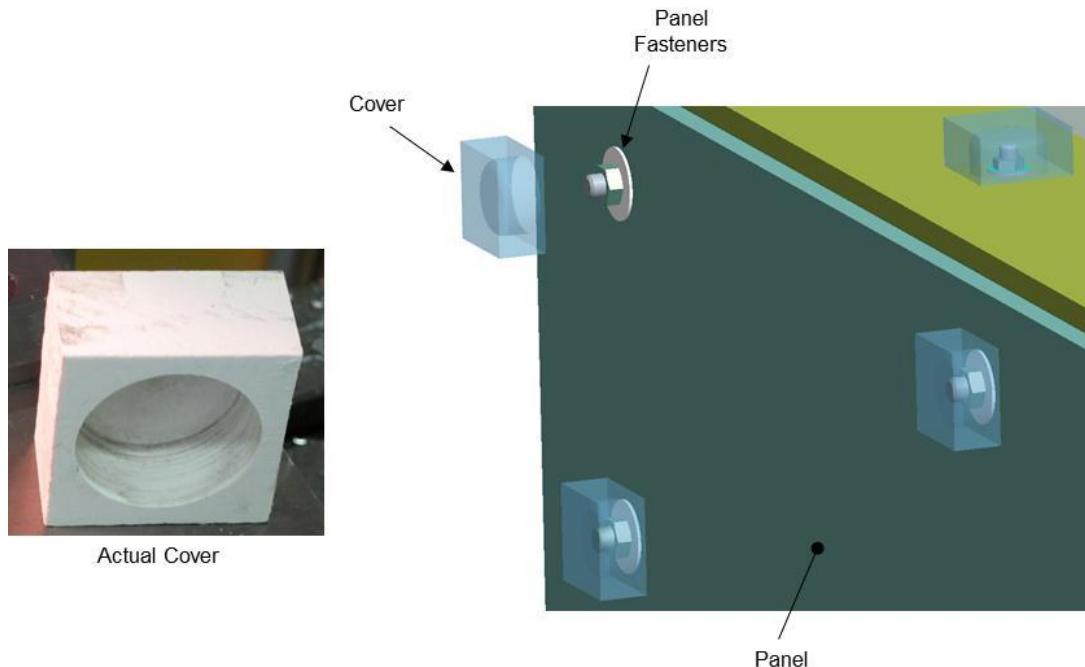
High temperature composite board material was used for these heat shields that will be exposed to the highest temperatures. The material is resistant to thermal shock with a very low thermal expansion rate (0.3×10^{-6}) and can work in temperatures up to 3,000°F. The material is also resistant to an outside environment and it should easily survive 30 years of service without maintenance or replacement. During assembly operation the panels have been very easy to work with. The high temperature composite board is commercially available and is easily fabricated into intricate shapes. Even though the fabrication requires dust prevention methods, the material can be machined using common manufacturing tools. The cost of $\frac{1}{4}$ " thick refractory sheet material is less than half the cost of a similar size piece of 321 stainless, and a similar size piece of 625 nickel alloy would be about 4 times above that amount. The cost of manufacturing either of these materials would be the comparable since the same processes would be used.

HEAT SHIELDS

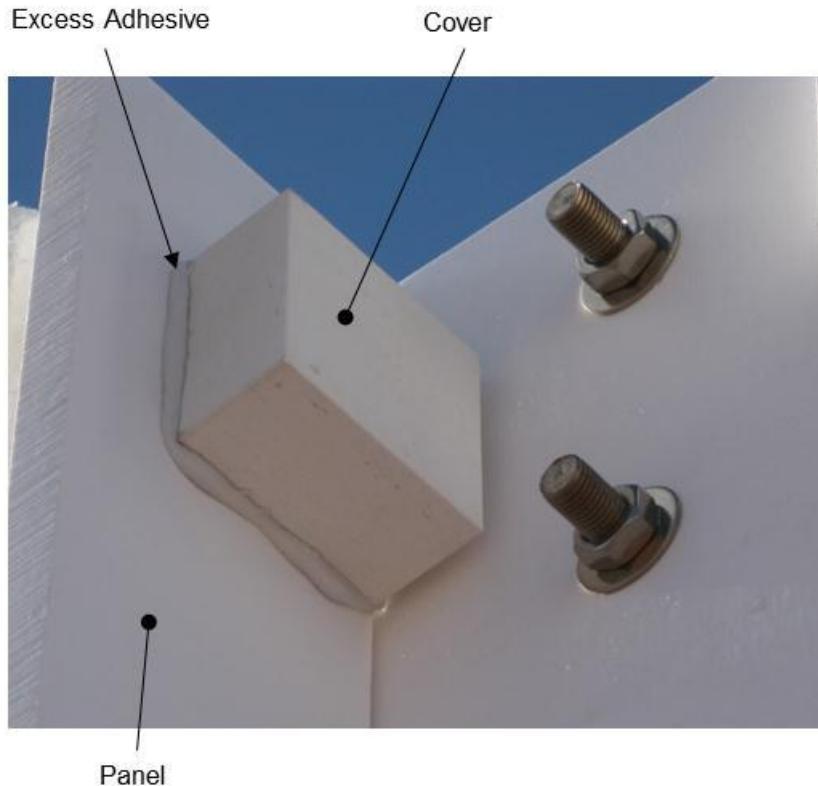
Covers are installed over the fasteners that secure the panels. This protects the fastener hardware from the high solar flux. The covers are made from the same material as used on the panels. High temperature adhesive is used to hold the covers to the panels. This adhesive has a low expansion rate, sets up in minutes, is thermal shock resistant and has excellent adhesion properties.

HEAT SHIELDS

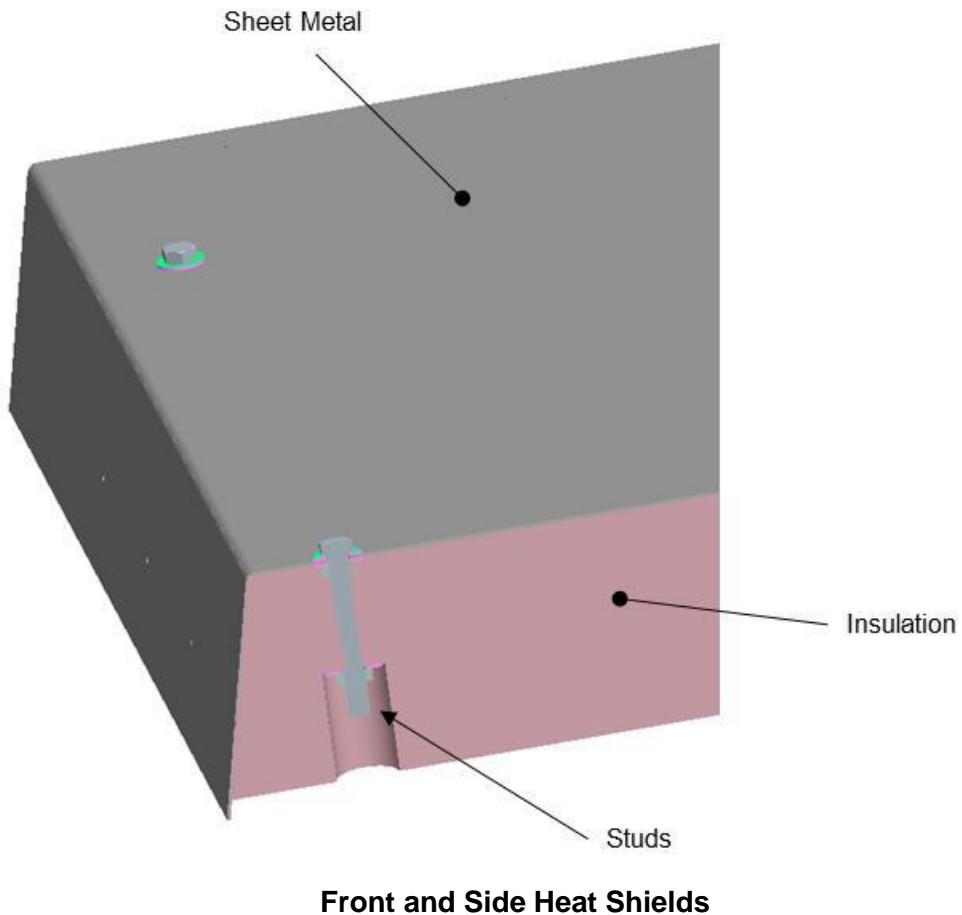
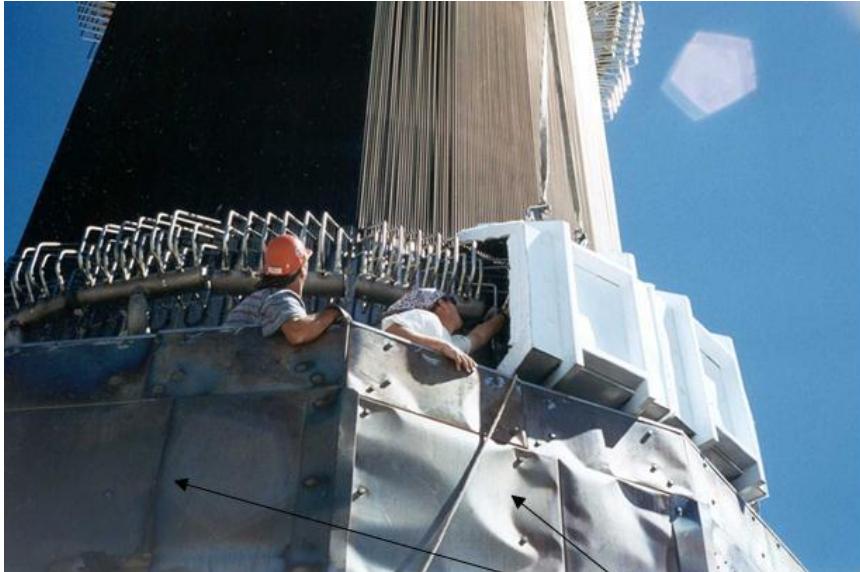
There is one panel on the front of the test setup and a side panel on each side of the test setup. The front and side shields fabricated with a commercial grade stainless steel. The material can be easily formed to any configuration. Bolts are threaded through the sheet metal to fasten soft insulation on the backside of the sheet metal. Speed nuts are installed on the threaded studs to hold the insulation panels in place. The speed nuts allow easy removal of the insulation panels. The sheet metal can work in environments around 1,700° F and the insulation behind the sheet metal will protect the support structure from the heat. The sheet metal is painted with a very thin coat of commercially available white paint to further reflex any solar spillage on the shields. A white paint was used. This paint is heat resistant up 2000°F and is normally used for high temperature applications in the auto industry.

Severely warped sheet metal shields

SOLAR 2 HEAT SHIELDS

The purpose of these sheet metal heat shields is to demonstrate that a commercial grade sheet metal shield, painted with common commercial grade paint can withstand the harsh environment of a CSP plant. Past experience showed that uncoated sheet metal will be damaged by the hot temperatures. The sheet metal shields on Solar 2 had been damaged and warped by the solar spillage. This allowed a heat leak making it difficult to start up the receiver system in the morning when trace heaters on the tubes and headers attempt to bring the system up to the minimum temperature of 550° F so molten salt can flow through the system. Local areas of the tubes with any cold spots would cause the salt to freeze, plugging the system and preventing plant operation.

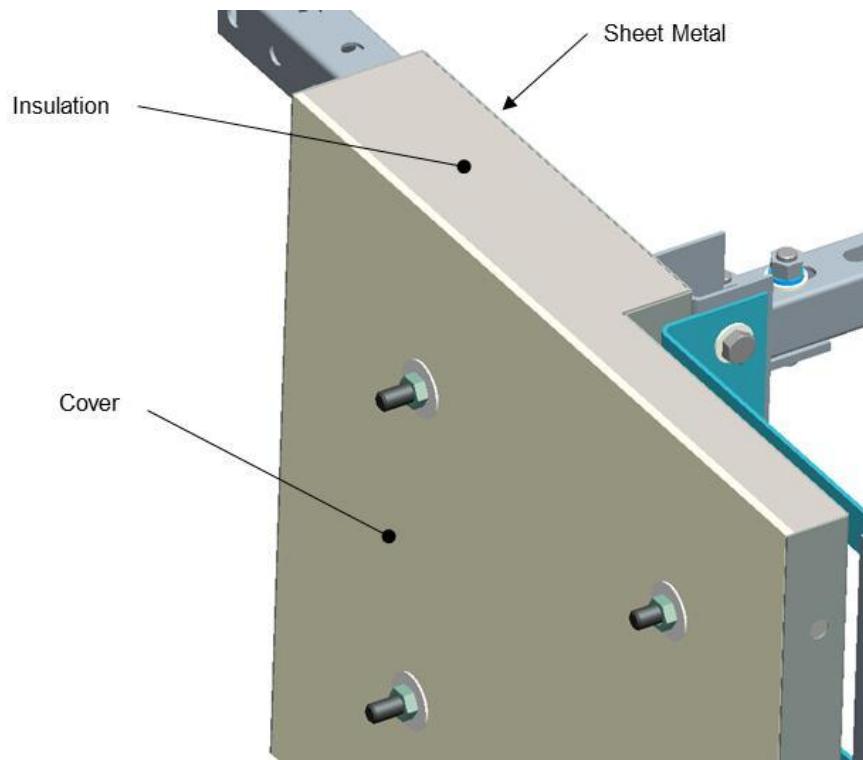
The side shields are used to protect the side areas from solar spillage. High density insulation covers a softer insulation module and also acts as an insulator. The high density insulation is better at resisting the outdoor environment and protects the internal insulation that is more susceptible to moisture. The panels are attached with threaded studs that were stud welded to a sheet metal supporting structure.

SIDE SHIELDS

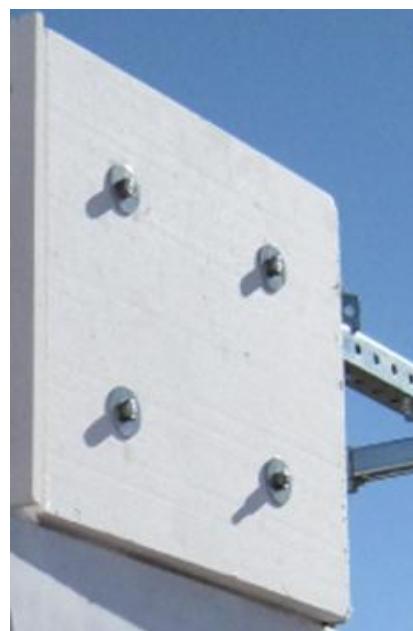
ACTUAL SIDE SHIELD

A $\frac{1}{4}$ " thick high density insulation was used. However during assembly operation the $\frac{1}{4}$ " thick board proved to be too fragile and was damaged. The thinner board was replaced with a 1" thick piece. This proved to be a better choice. The high density insulation is a commonly used product in insulation field and is readily available. It is a low cost rigid high temperature alumina-silica insulation board that can work in temperatures up to 2,300°F.

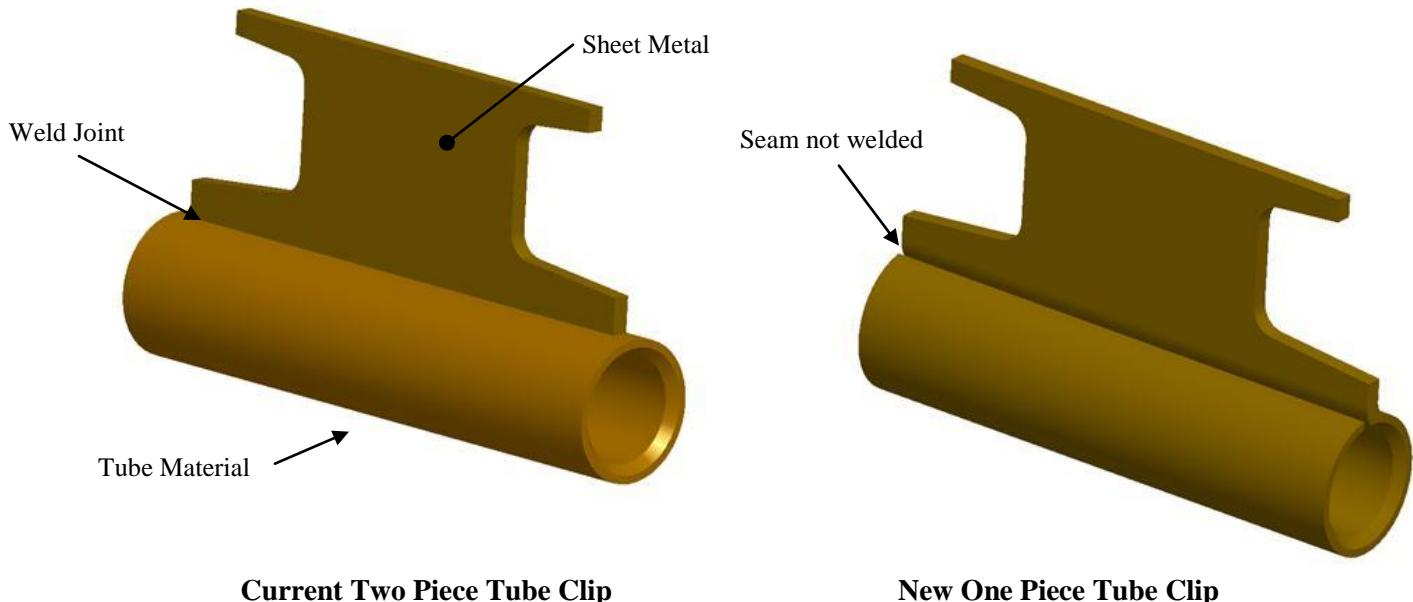
Tube clips are welded to the tubes and are used to guide the tubes along the axis of the tube as the tubes thermally expand and contract during operation. The current two piece tube clip configuration is fabricated using a machined sheet metal piece and a piece of tube stock. The 2 pieces are welded together and the weld is inspected using NDT requirements. The heat affected zone of the weld can cause some distortion to the two piece clip assembly. The new one piece clip is formed from one piece of sheet metal in one operation. No welding or weld inspection is required. Ten, one piece clips, have been fabricated. No anomalies have been noted during inspection. The cost is relatively high at but economies of scale will substantially reduce the cost when applied to a CSP production plant order. It is estimated that a typical CSP plant would require approximately 10,000 tube clips.

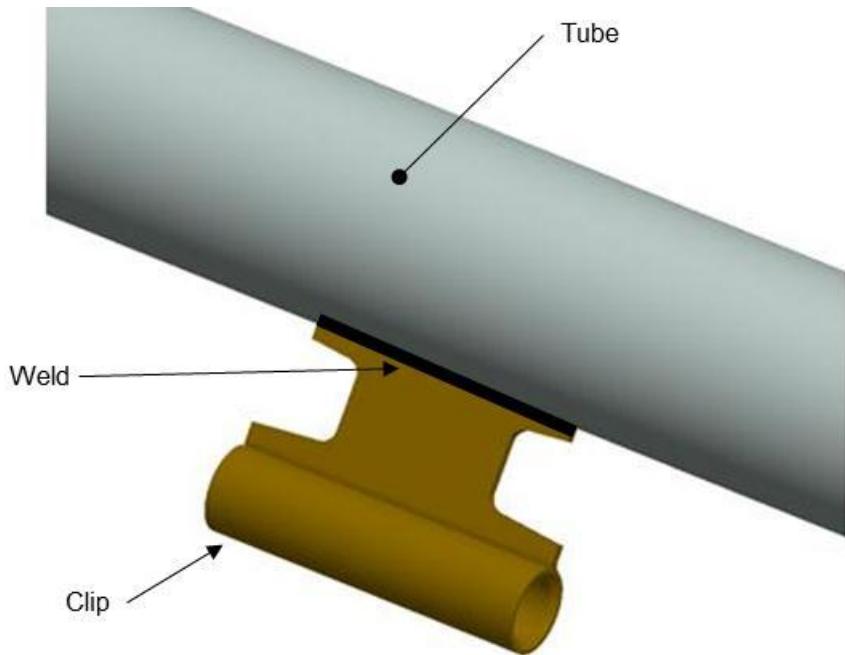
Clips are welded to the tubes and are used to guide the tubes along the axis of the tube as the tubes thermally expand and contract during operation. Currently a manual or automatic GTAW type of weld is

used to attach the clip to the tube. The tube wall thickness being thin it makes it difficult to weld. The team evaluated using a laser welding machine to weld the clips on. A metal fabricator was selected to evaluate using a laser process for this configuration. After welding a number of weld samples using their 150 watt laser welder. They noted that their equipment was not powerful enough to weld the clip to tube configuration. They suggested using a 300 watt system. PWR searched for a supplier with such equipment to no avail. This type of welder is specialized and not commonly used in industry. No further evaluation of the laser weld process was performed.

Clip to Tube Weld

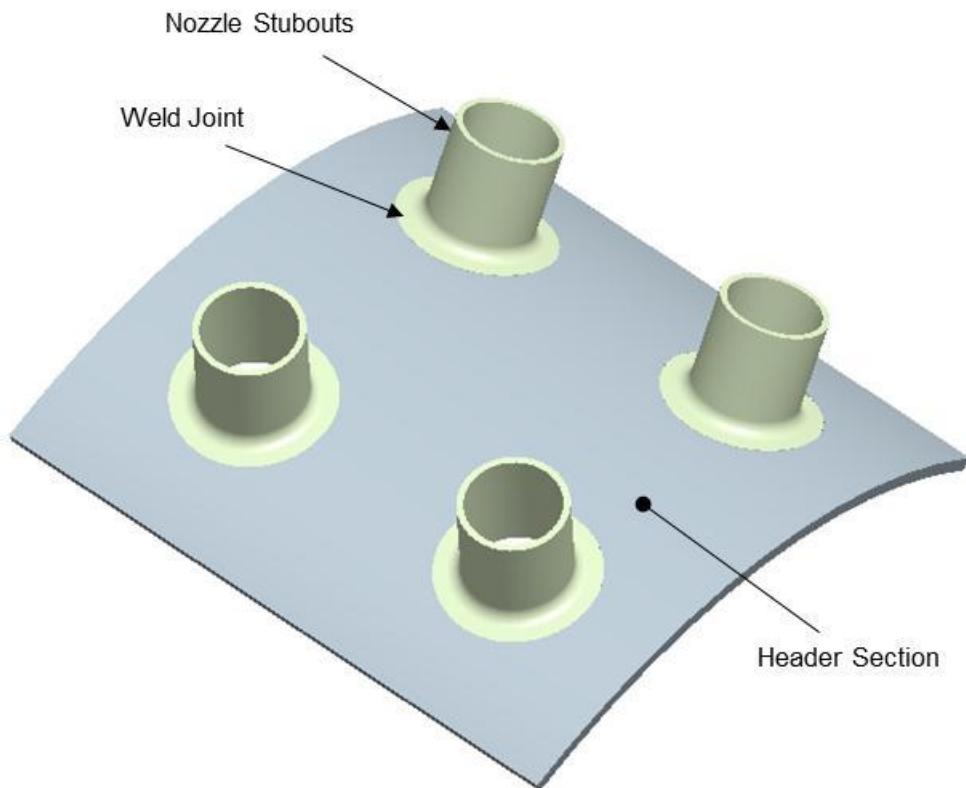
The nozzle stubouts are machined individually and welded into holes machined into the header. Currently the header stubouts are formed integral to the header during processing. The team wanted to evaluate using a laser welding machine to weld the nozzle stubouts into the header. This is because the

laser weld process will introduce less heat into the weld. This may cause more distortion to the header. After welding a number of weld samples using a 150 watt laser welder. It was discovered that the equipment was not powerful enough to weld the clip to tube configuration. This is similar to the issue note on the clip to tube weld. PWR searched for a supplier with a 300 watt system to no avail. This type of welder is specialized and not commonly used in industry. The cost to purchase such a machine would be too high. No further evaluation of the laser weld process was performed. Testing the manual weld process would require a full size header to demonstrate and it was not cost effective.

Header Test Weld

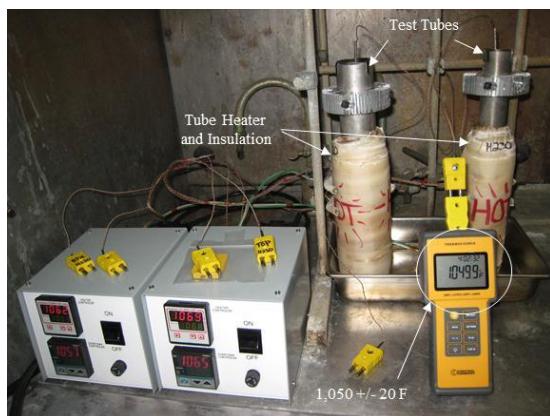
The inside surfaces of two tubes sections, approximately 12" in length, were exposed to molten salt at 1050°F for 252 hours. This is the operating temperature of a Molten Salt CSP Plant. The salt was drained from the tubes leaving behind a residual layer of salt that would be present in a typical CSP receiver tube.

Molten Salt Exposure within Tubes

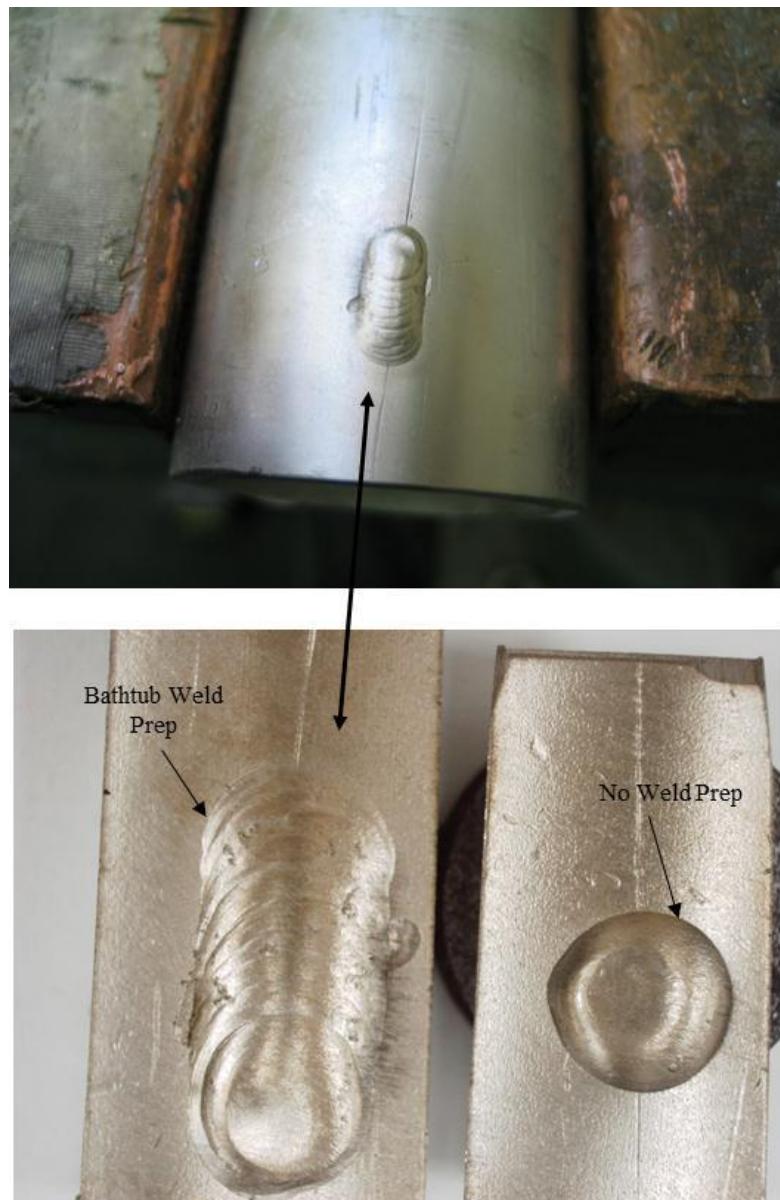
The holes in both tubes were weld filled with filler material. The tube was placed in a horizontal position along the axis of the tube and the axis of the hole was in a vertical position with the hole on top. No

purge of the inside of the tube. The “as-welded” welds passed both visual and face side surface penetrant inspection.

As Welded Welds

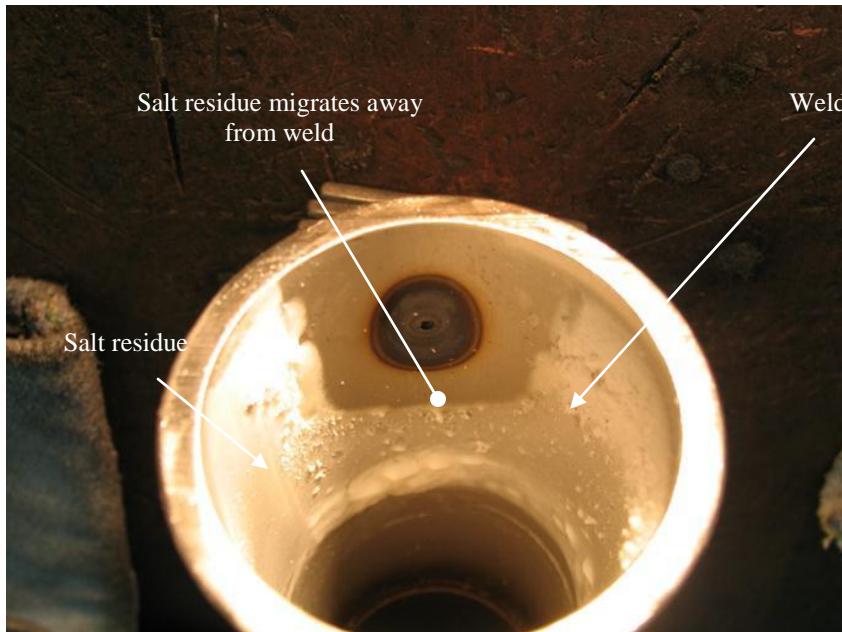
Backside of Weld, Welded in a Horizontal Position

The first weld joint was welded in a horizontal position. The salt residue melted away from the root of the weld. No negative impact to the weld joint was noted. An additional test was performed to weld the tubes in a vertical position. Again the salt residue melted away from the root of the weld. The welds were then sectioned to visually verify the integrity of the weld. Concavity at the root of the weld joint was noted. This is due to the lack of a purge on the backside of the weld (inside diameter of the tube). No purge was used because a purge would not be possible in a repair of a tube in the field.

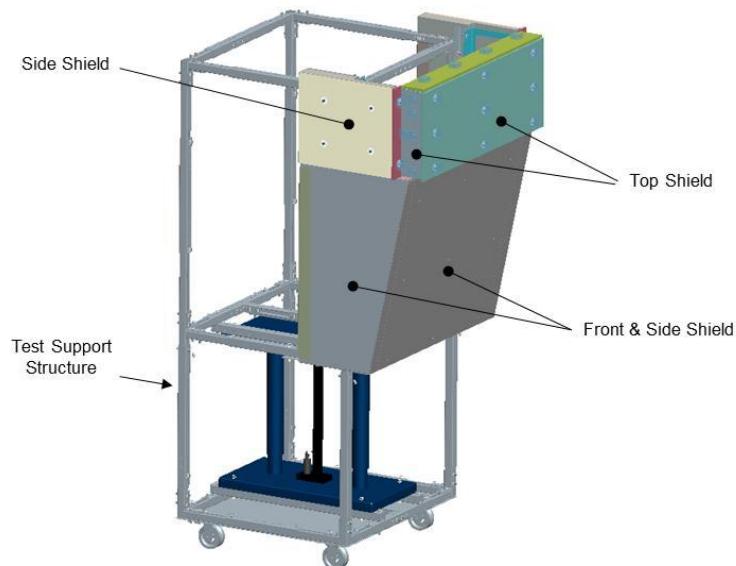
Key components of the receiver heat shields have been fabricated, shipped to Sandia National Lab CSP Test Facility and assembled for testing under actual solar conditions. Thermal couples have been installed in specific areas note in the test plan. Solar flux gauges have also been installed to measure the amount of solar flux reaching the heat shields. Thirteen tests were performed on the heat shields. The solar flux started at 50 kW/m^2 and increased with each test until the solar flux reached 500 kW/m^2 . This included two tests to test the impact of rain on the heat shields. The heat shields were soaked with water just prior to a 300 kW/m^2 test. This test demonstrated how well the heat shields will do after a rain shower and whether the receiver could be brought back on line immediately or whether a drying process would be required. An additional test was performed at a solar flux level of 625 kW/m^2 . This was performed to test the limits of the heat shields.

Heat Shield Test Assembly

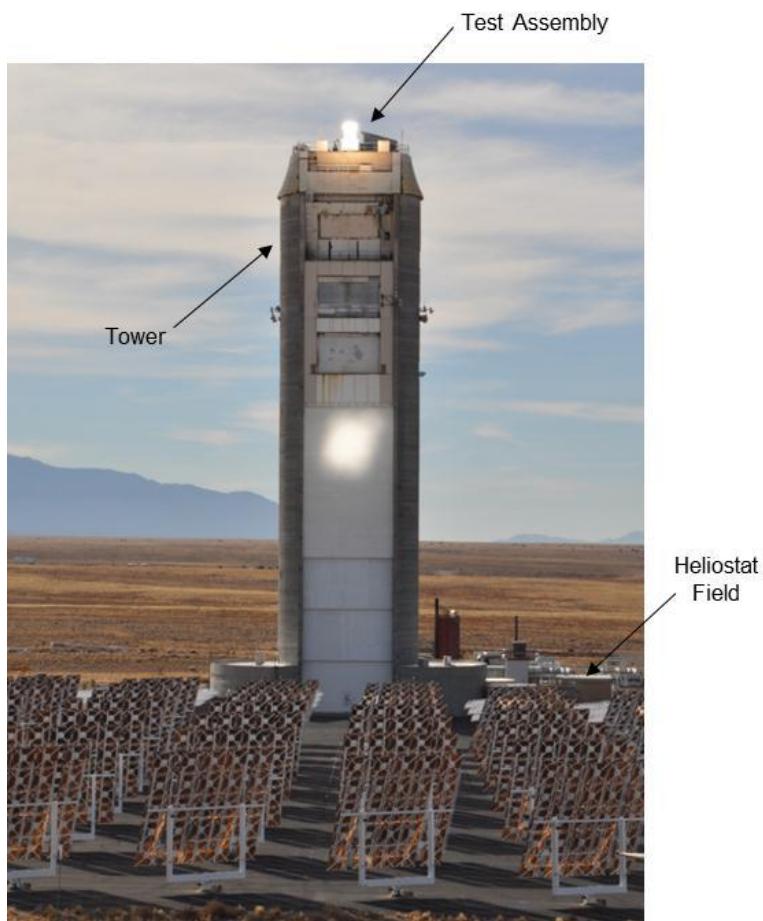
Actual Testing on top of Tower at Sandia

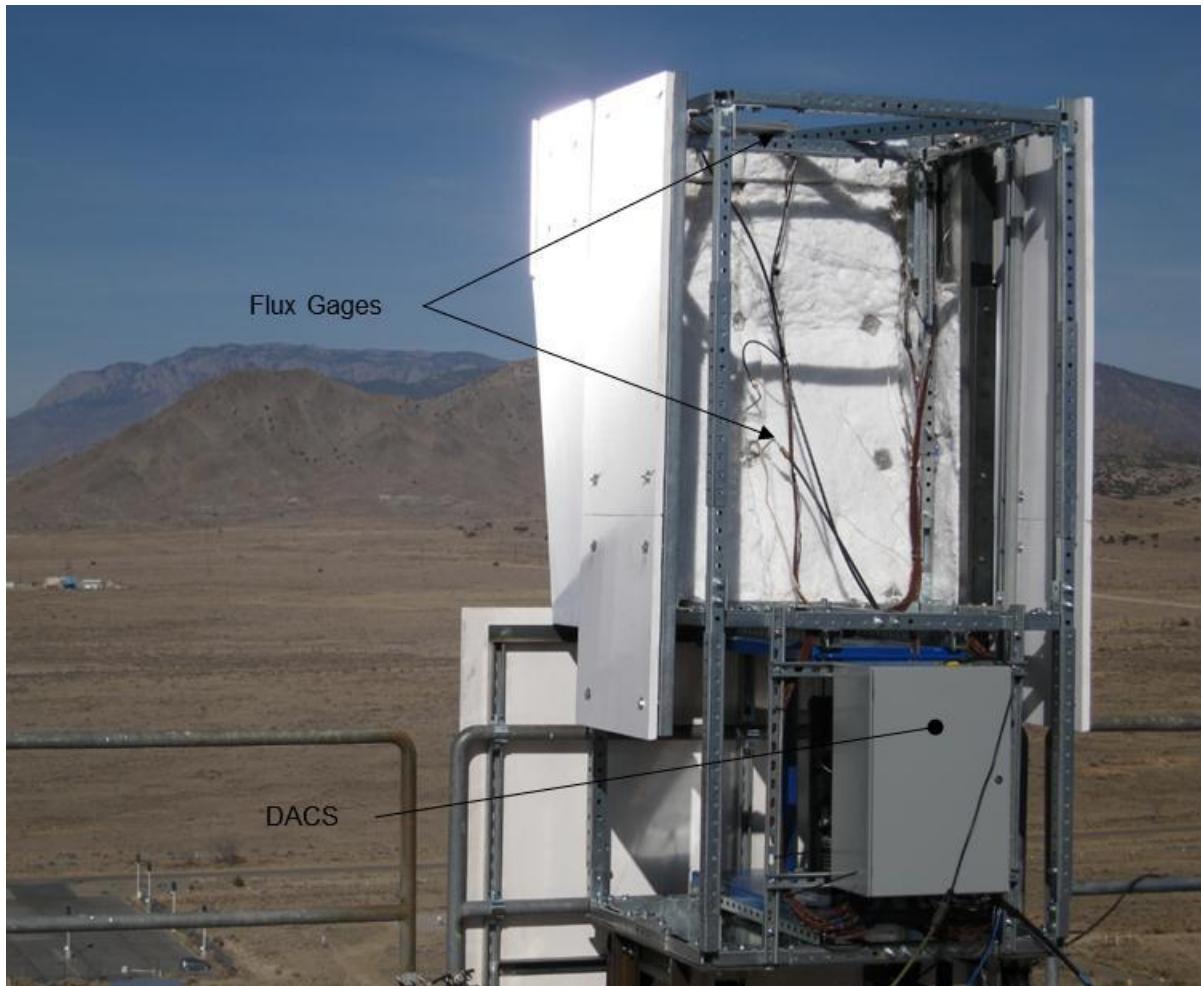
During the heat shield testing, the test article was outfitted with 62 thermocouples and two heat flux gauges. The thermocouples were installed on both the front and sides of the shielding and at different depths into the insulation. One heat flux gauge was located on top of the panel at the center of the test article and the second was located approximately at the center of the front shield. A data acquisition system (DACS) collected all the instrumentation data and directed the raw data to a computer where Lab View was used to convert the data into information.

Flux Gage and Data Acquisition System Locations

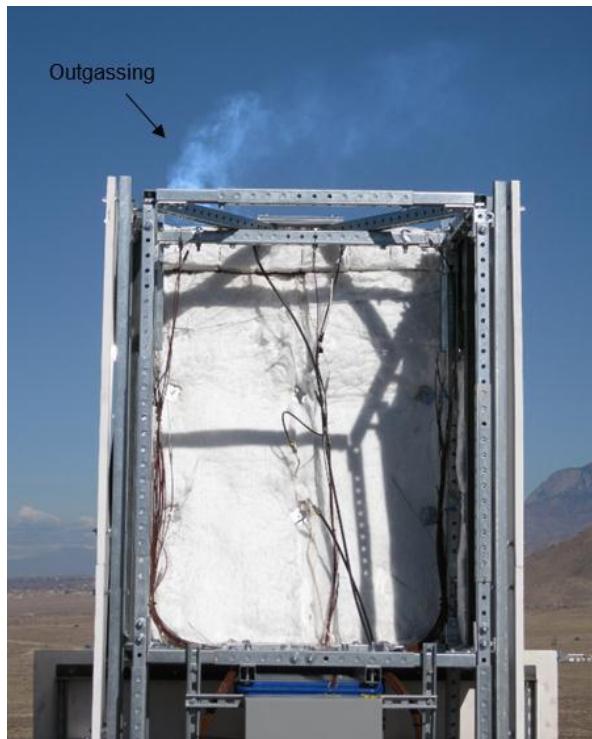
The initial testing (50 suns) was performed by bringing on the heliostats (5) to the tower at 10 minute intervals. The heliostats were targeted at the top heat flux gage, which was approximately 2 inches above the panel. The instrumentation checkout showed that all of the TCs were functioning and that there was a lag for the internal sensors due to the insulation. There was a fair amount of smoke / outgassing coming from the insulation between the high temperature composite board and the structure. The peak temperatures were shown at the front, metal shield. The heliostats were brought off the tower in approximately 3 minute intervals. There were no noticeable changes to the structure or insulation after the testing.

Outgassing During test

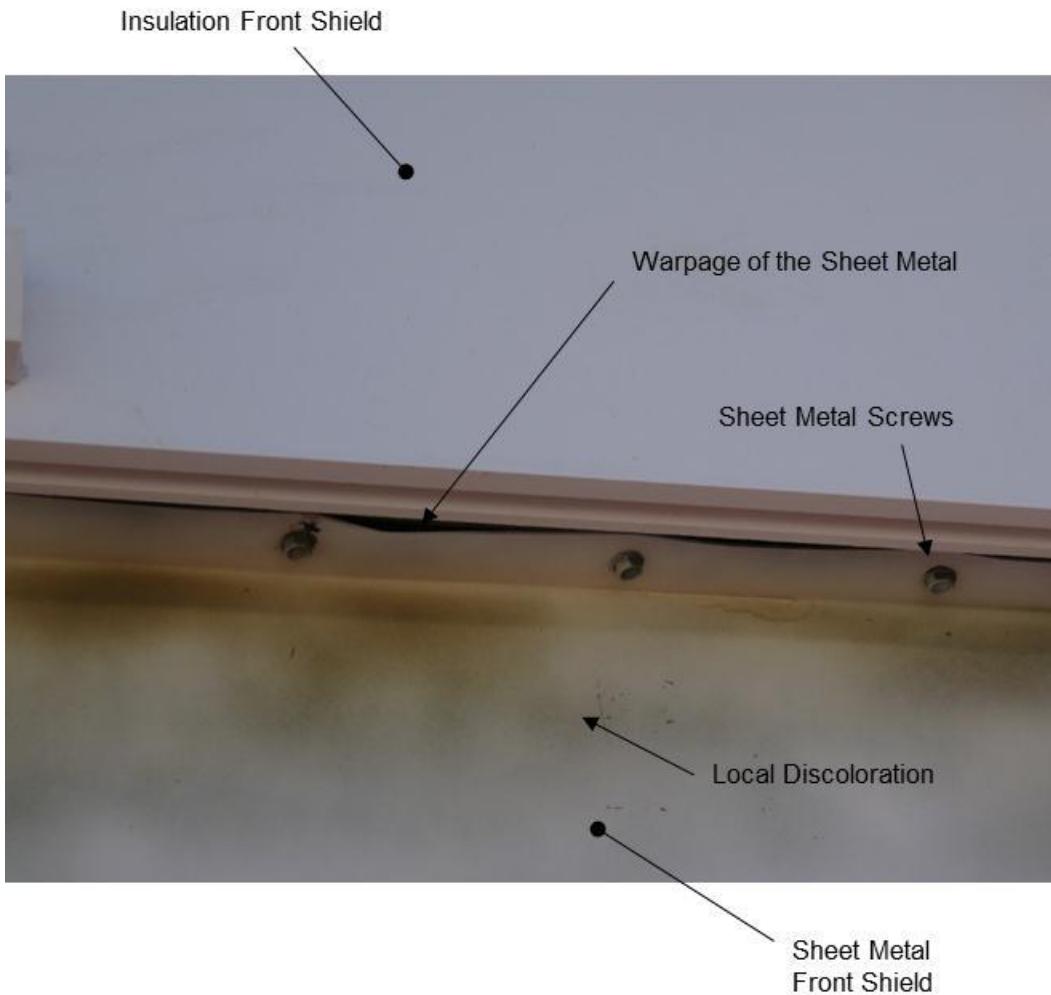
The sheet metal shields held up very well during the testing. The peak temperatures were approximately 1,435°F. The sheet metal only showed slight warpage between attachment bolts. Maximum operation temperature of 300 series sheet material is 1,700°F so the temperatures during the testing did not exceed the maximum operating temperatures of the material. The overall front sheet metal shield darkened

slightly in some local areas near the bolts at the top of the sheet metal shield. This is the area where the highest temperatures were recorded. This may be because to the 90° bend at the top area of the sheet metal causes a slight magnification of the solar flux. The paint seemed to be adhered well to the metal, but future testing should be done with the paint applied in a uniform fashion to get the best performance. A more uniform painting of the shield would produce even better results and would lower temperatures on the metal. The risk of too much paint is that the paint would crack and peal during operations. All the sheet metal screws functioned well following the testing.

Front Shield, Post Heat Shield Testing

During the initial low heat flux testing, no significant change to the metal heat shield was noted. During the higher heat flux tests, some warping of the front shield sheet metal was noted between the fasteners along the top and side edges of the shield. The fasteners act as a constraint against the thermal expansion of the shield and stainless steel has a relatively high coefficient of thermal expansion of approximately 10 μ in/in/F at 1200°F. During the final 625 sun heat shield test, discoloration of the upper part of the front metal heat shield was noted.

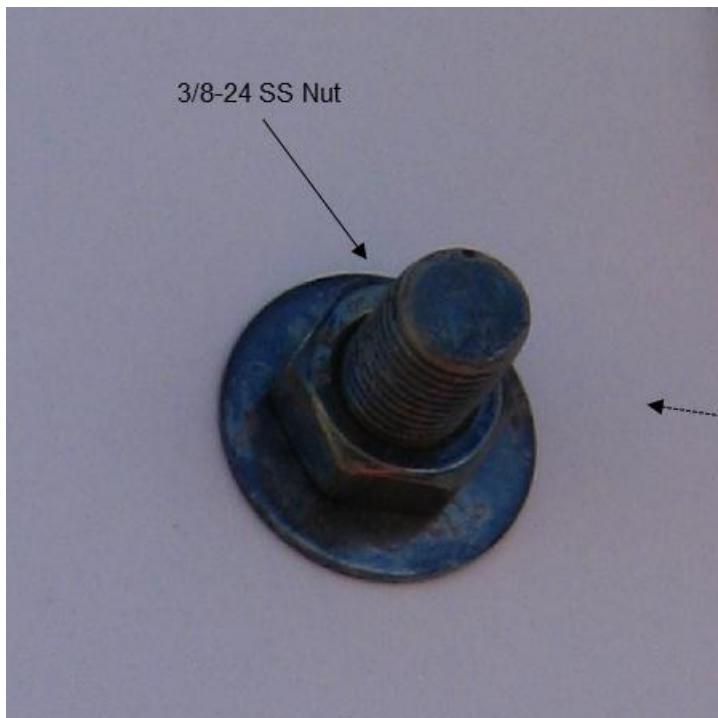
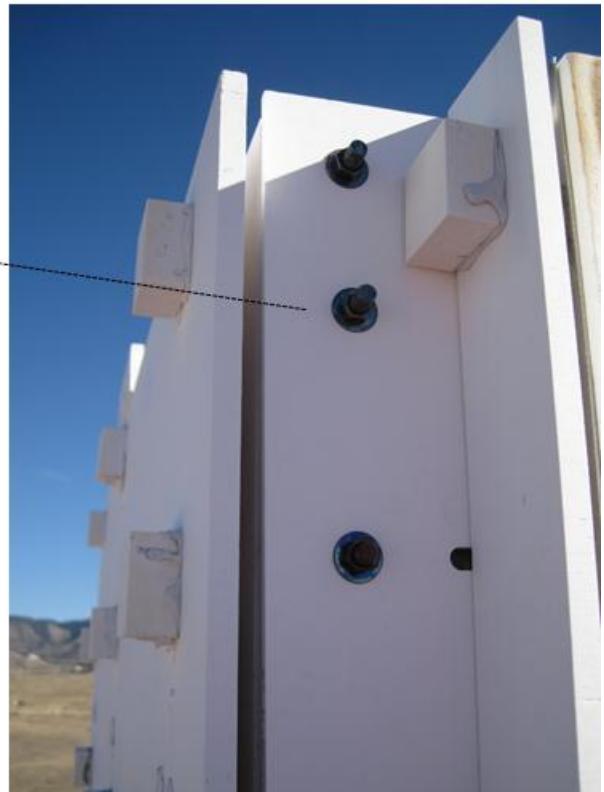
The fastener covers located on the side panels of shielding were left off intentionally to test the effects of solar flux on unprotected stainless steel fasteners. Some surface discoloration was observed. The fastener function normally and no damage was noted.

Unprotected Fastener, Post Heat Shield Testing

The stainless steel fasteners holding the front high temperature composite board shields in place were protected by caps during testing. During inspection after testing, some of caps were removed. These fasteners did not show any visible indication of degradation. The fasteners on the side panels would also typically have a cap to protect the exposed fastener, but for this test series were not protected with caps. These fasteners began to visibly darken, an indication of oxidation, beginning with the 400 sun and higher

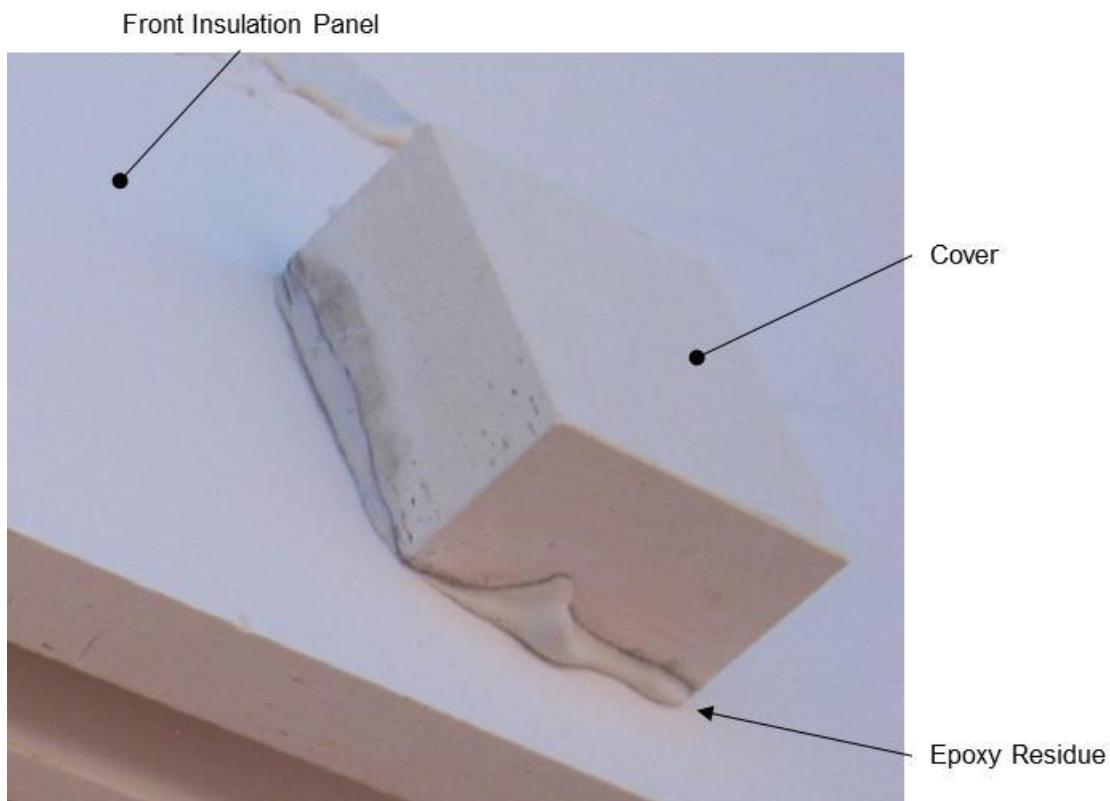
Covers were applied over the fasteners that are securing the panels to the structure. A high temperature (2,500°F) epoxy that has a low expansion rate attached the covers to the front panels. The high temperature epoxy held up well, but a more controlled process of mixing, applying, and curing should be used for longer term applications. The epoxy hardened quickly and did not allow the blocks to fall off, but the epoxy did seem to be susceptible to cracking when it absorbed water. This might be able to be reduced with a longer and more controlled curing process. Also, the epoxy might be able to replace the blocks if the bolts are sunk into the panel and can just be covered with the epoxy. The bolts that held the flux gage to the structure were covered in this fashion and there was no noticeable cracking or damage to the epoxy. In addition forming a fillet with the epoxy residue at the interface of the cover and the panel would add additional strength to cover. Following testing the covers were removed. A hammer was required. Some covers needed a good strike from the hammer while others required a slight tap of the hammer. The covers did well in protecting the fasteners located under to cover. Some surface discoloration was observed but the fastener functioned normally and no damage was noted.

Fastener Covers

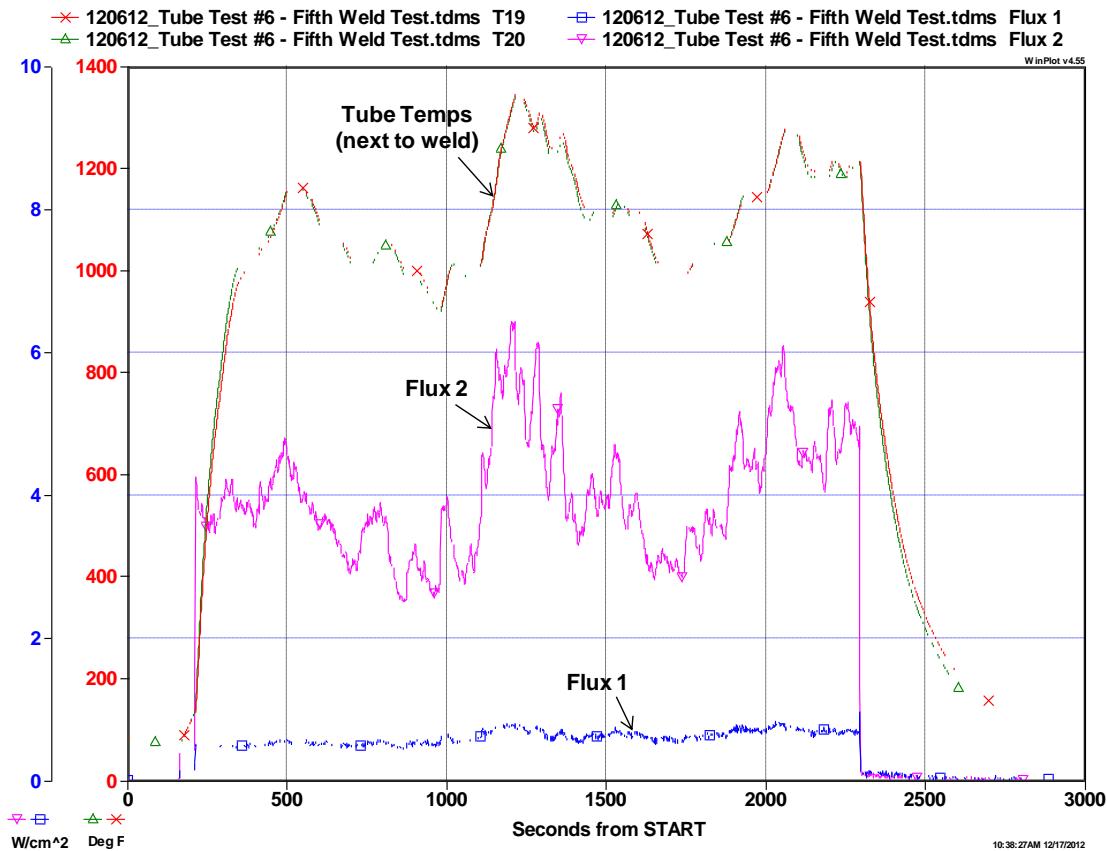
Tube Test #6 was the final weld stress test. Twenty heliostats were brought on at once and from there, several were added and removed in an attempt to hold a steady temperature. The maximum peak temperature reached 1,350F but the average temperature over the duration of the test was around 1,110F. After 30 minutes of elevated temperatures, the tubes showed no visible change from the previous test.

Typical Tube Weld Test Data

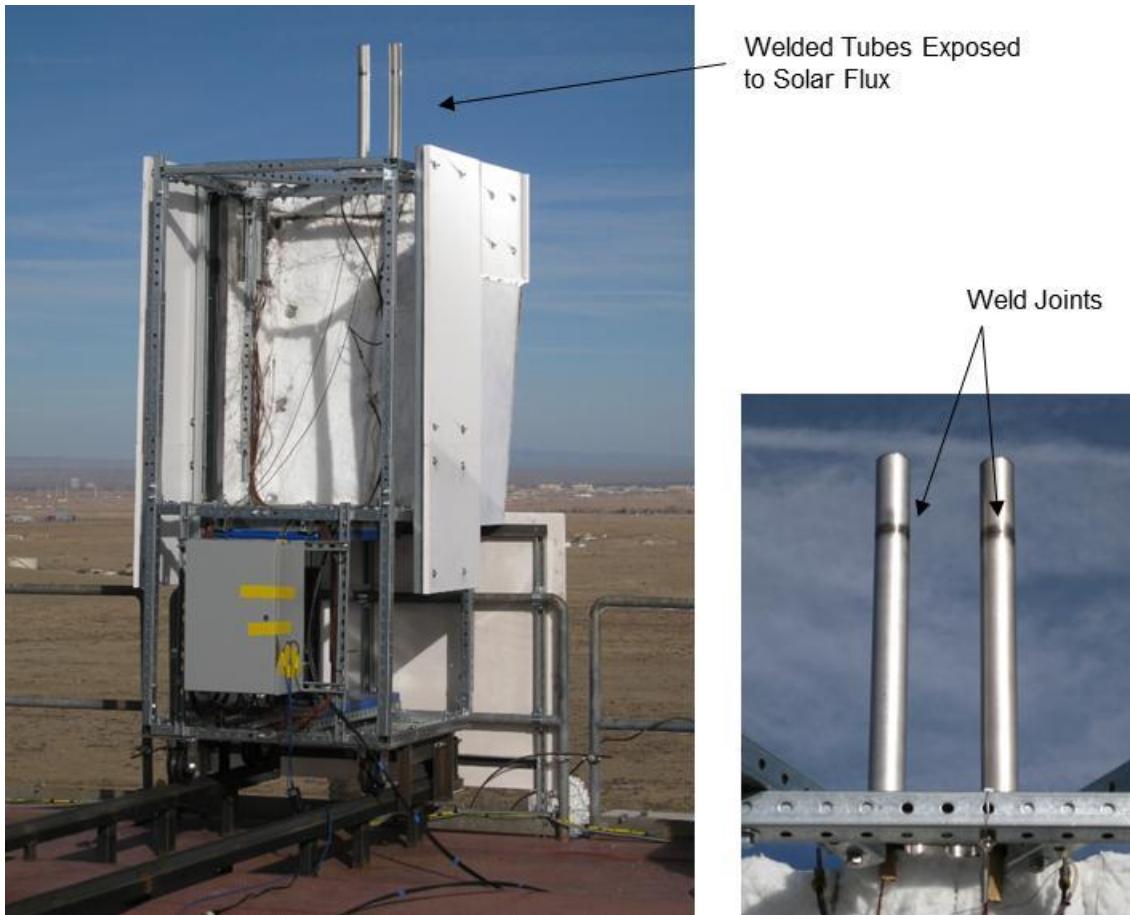
Actual Tube Weld Test

Tube weld exposure test completed with no anomalies noted in the welds. Visual inspection shows no damage to the surface of the weld.

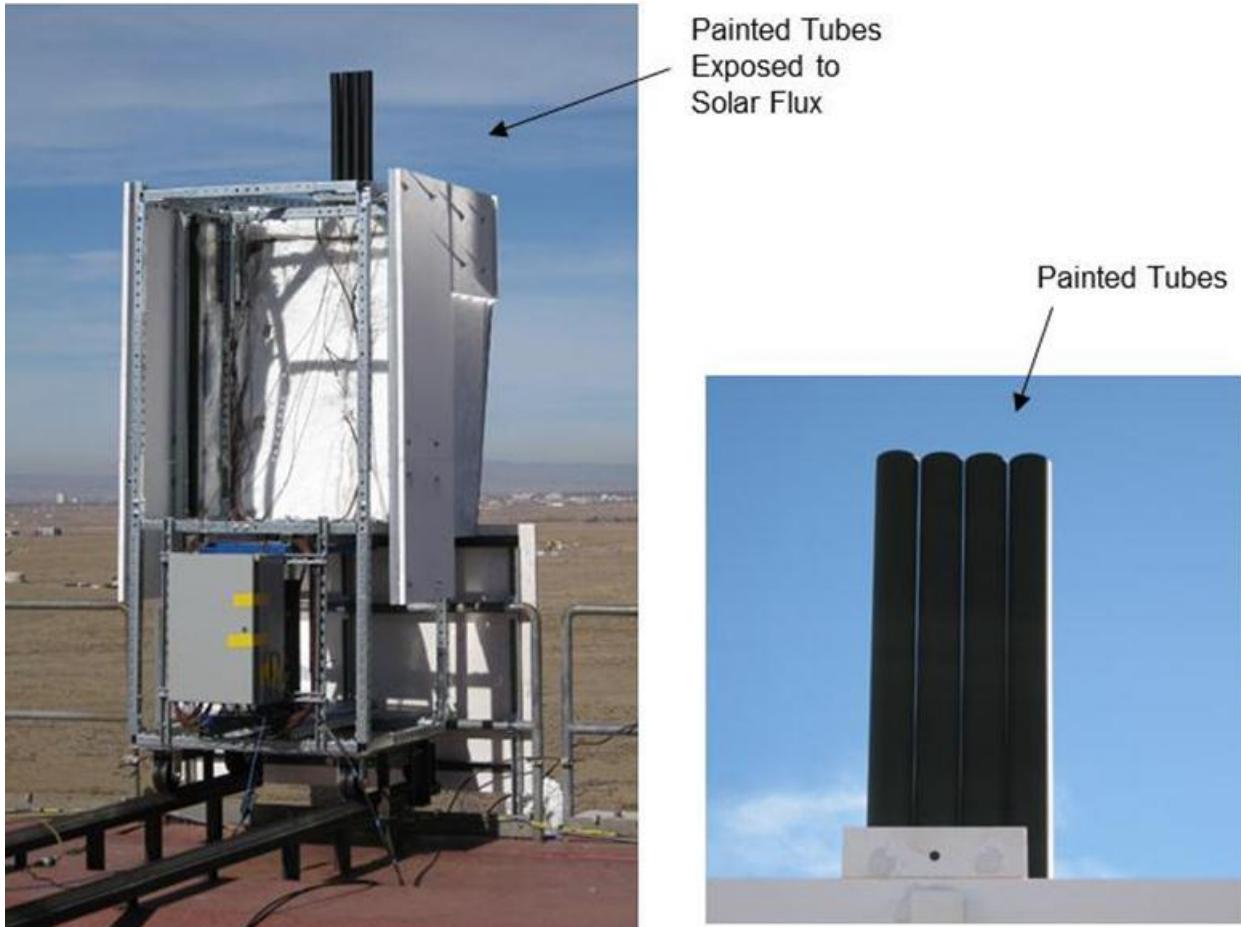
The purpose of the Pyromark paint test is to demonstrate that the paint can be cured using heliostats (note: this is listed as tube test 2 in the test matrix). A commercial CSP receiver paints the receiver tubes with a black heat absorbing paint. Typically this is Pyromark 2500 Flat Black Paint. The paint increases the efficiency of the receiver to absorb heat energy from the heliostats. During initial fabrication the tube sections go through a complex cure process using a furnace. However if a tube paint is damaged during assembly it would be impossible to cure a painted receiver tube in a furnace. This test uses heliostats to cure the paint.

Actual Paint Curing Test

Post-test visual inspections showed that the paint had gone from a shiny black to a duller finish, flat black which would indicate successful curing. A simple fingernail scratch test of the cured paint showed the paint did not flake off and was firmly adhered to both tube materials. This demonstrates that a local area of the receiver tubes can have the paint repaired on the tower and cured using heliostats.
