PRATT & WHITNEY ROCKETDYNE, A UNITED TECHNOLOGY COMPANY

Concentrating Solar Power – Central Receiver Panel Component Fabrication and Testing

FINAL REPORT

Project Period - September 25, 2008 thru December 30, 2012

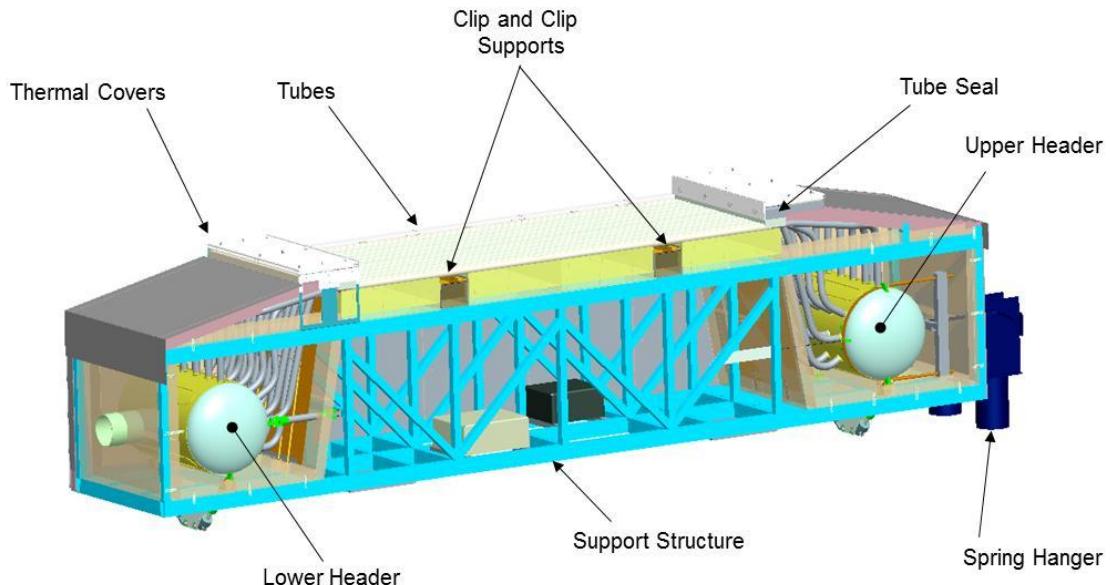
Receiver Design
