# Impact of Atmospherically Deposited Salts on the Localized Corrosion Performance of Materials Used for the Interim Storage of Used Nuclear Fuel

**David G. Enos, Charles R. Bryan**  
**Sandia National Laboratories**

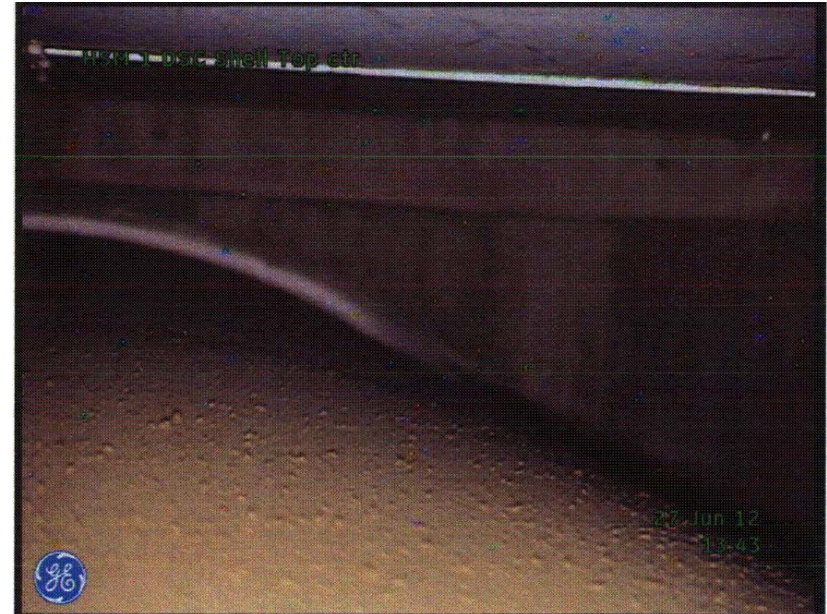
- Calvert Cliffs inspection
  - SaltSmart device used to acquire surface chloride levels
  - Single measurement made at the 0900 location
  - $543 \text{ mg/m}^2$  ( $54.3 \text{ } \mu\text{g/cm}^2$ ) for container which was in service for 19 years
  - Significant particulate visible on the surface of the container

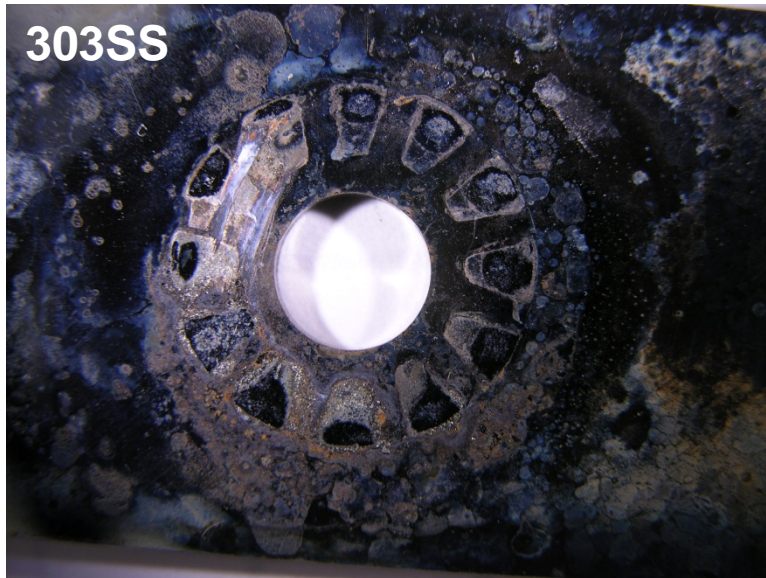
# Significant Attack observed on 303SS – effectively all crevice regions initiated and underwent extensive propagation

To alleviate concern that technique was not capable of supporting crevice corrosion even on highly susceptible materials, 303SS was introduced into the test matrix

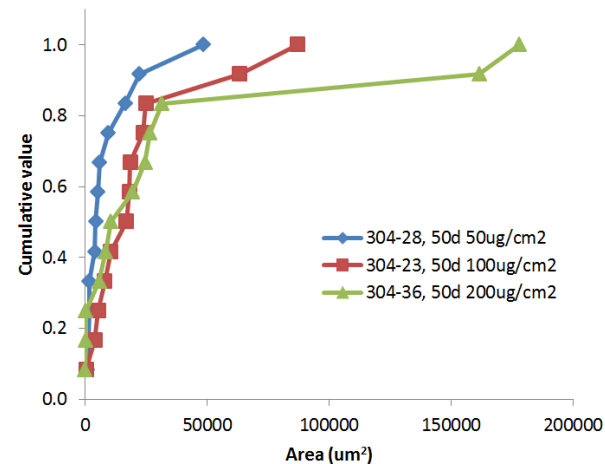
50 day samples no very shallow uniform.

2-D surface area  
of sites increases  
with mass loading  
at a given time

Each data point corresponds to a single crevice tooth on a single sample

- Number density of sites suggests that there is continuous nucleation
  - Number of sites per tooth increases with time for all of the mass loadings, but there are exceptions
  - What we are counting is a factor
- Surface area is more indicative of the extent of attack
  - Extent of attack increases with time at a given mass loading
  - Significant increase in area from 50 to 100 days
- The data has limitations...
  - Different samples for each time interval
  - Need more data...
