# **Report Title: Steam Turbine Materials for Ultrasupercritical Coal Power Plants**

**Type of Report:** Final Technical Report

DOE Award Number DE-FC26-05NT42442

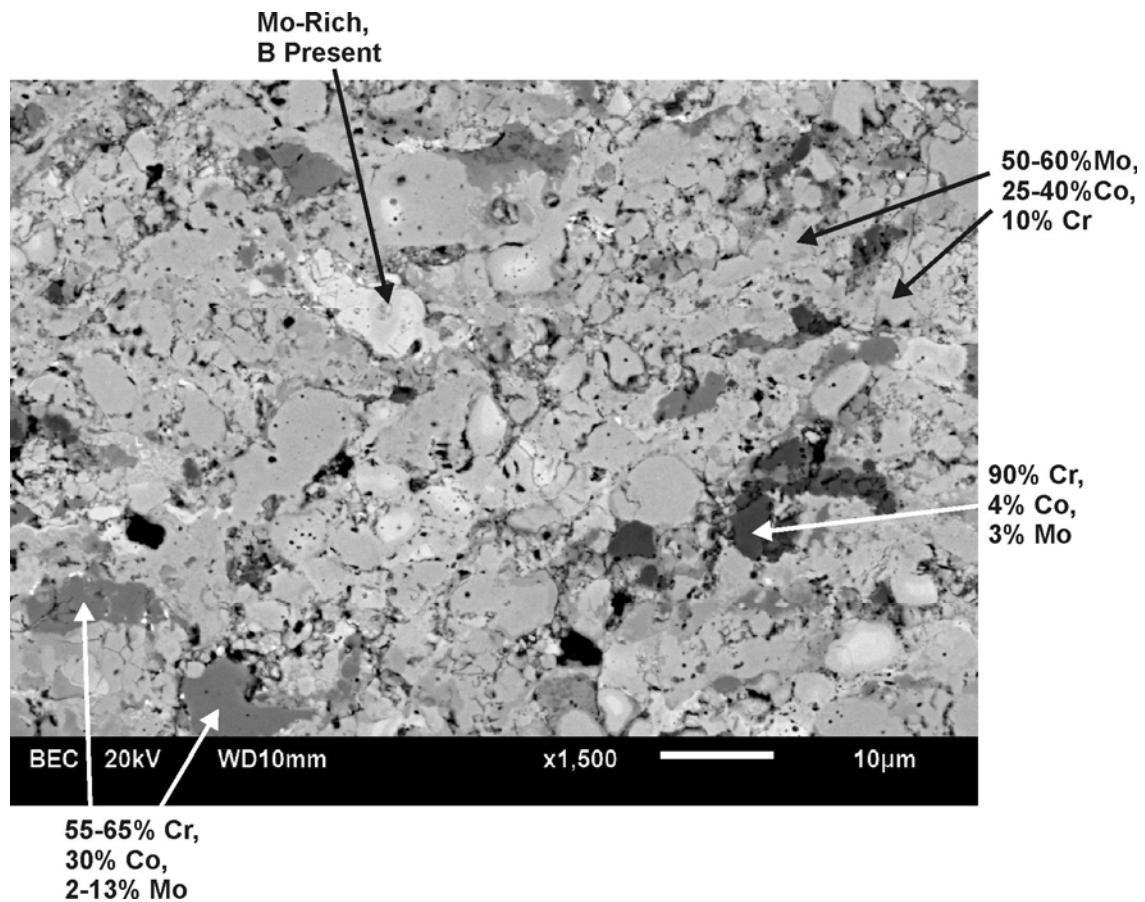
**Figure 2-10**  
**Optical and Backscattered Electron Overviews of As-Received MoB-CoCr (MB-42) Coating Microstructure. Unetched.**

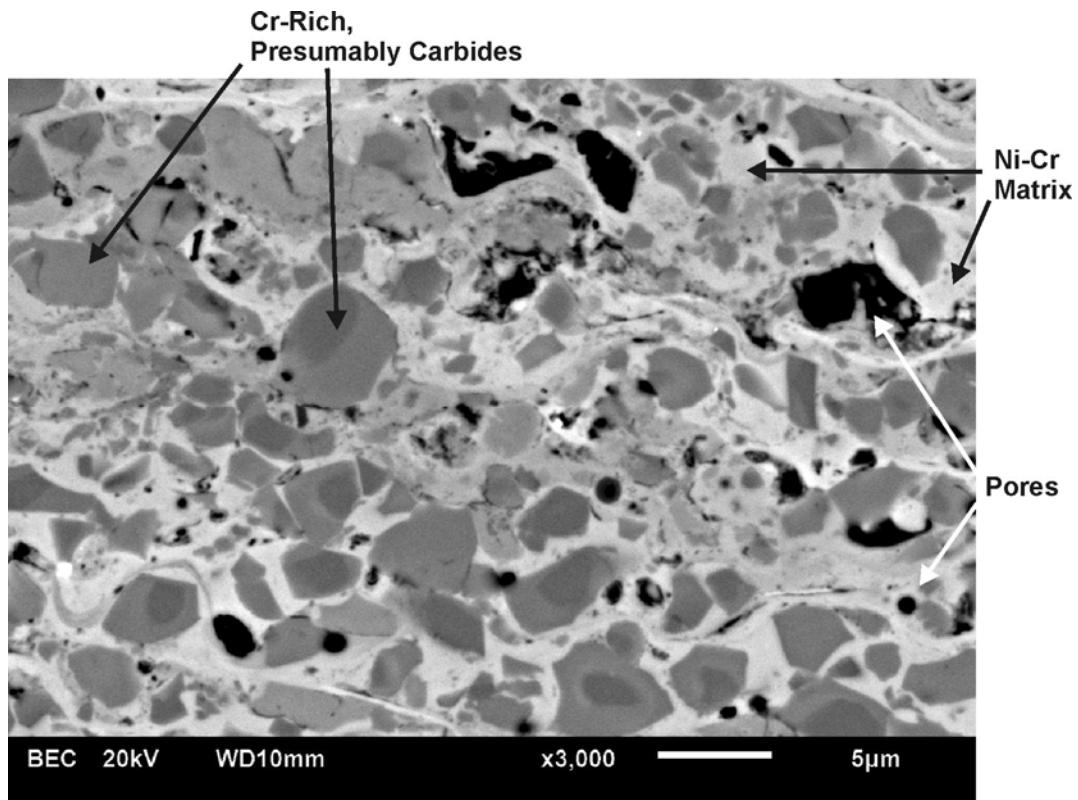
**Figure 2-12**  
**Optical and Backscattered Electron Overviews of As-Received CrC-NiCr (CRC-25) Coating Microstructure. Unetched.**

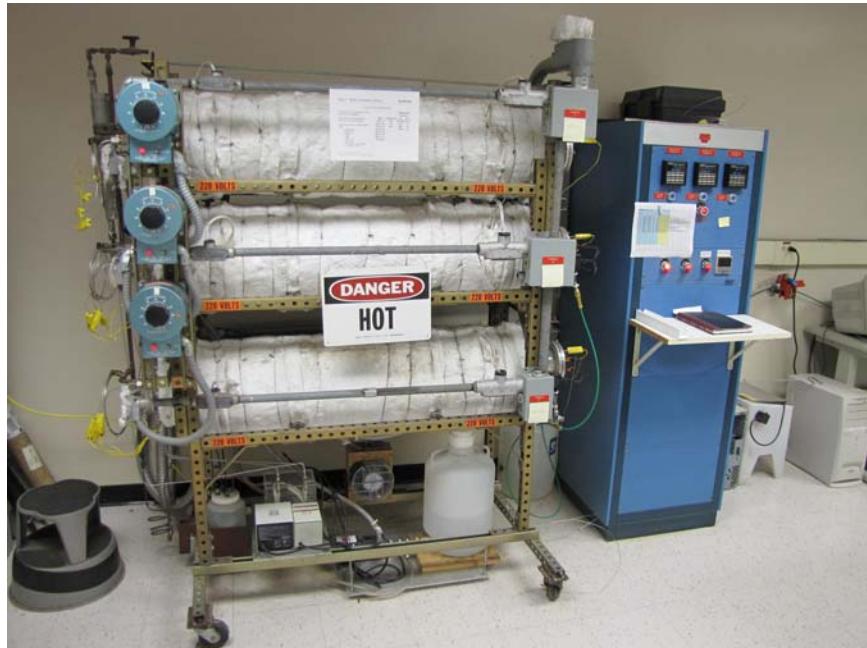
**Figure 2-15**  
**Long-Term Steam Oxidation Test Rig, Consisting of Three Horizontal Tube Furnaces (Wrapped in Insulation) with a Recirculating Water/Steam Supply (Below Furnaces).**

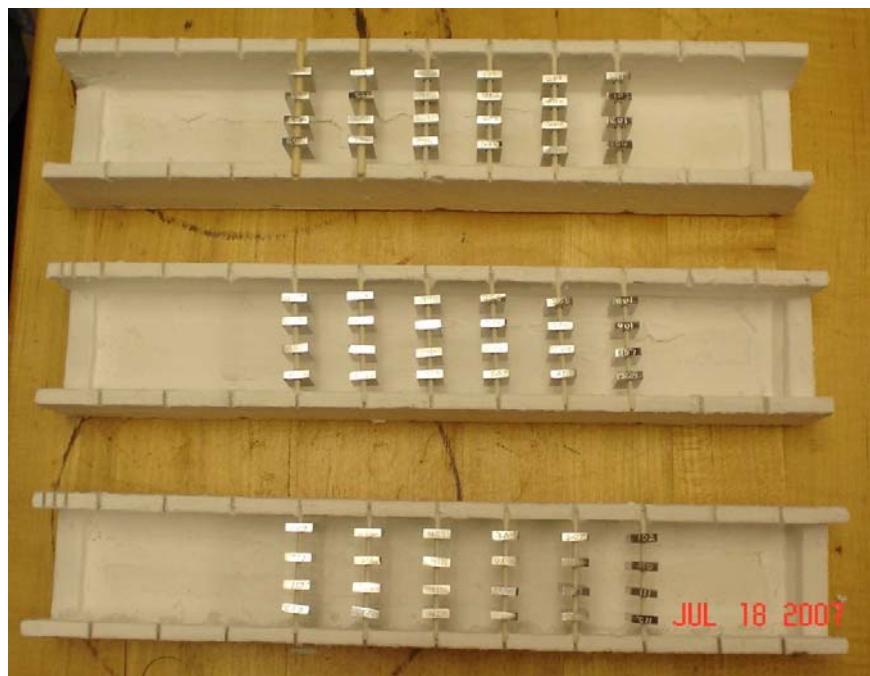
**Figure 2-16**  
**Coupon Boats Loaded with Substrate Alloy Coupons Prior to Exposure.**

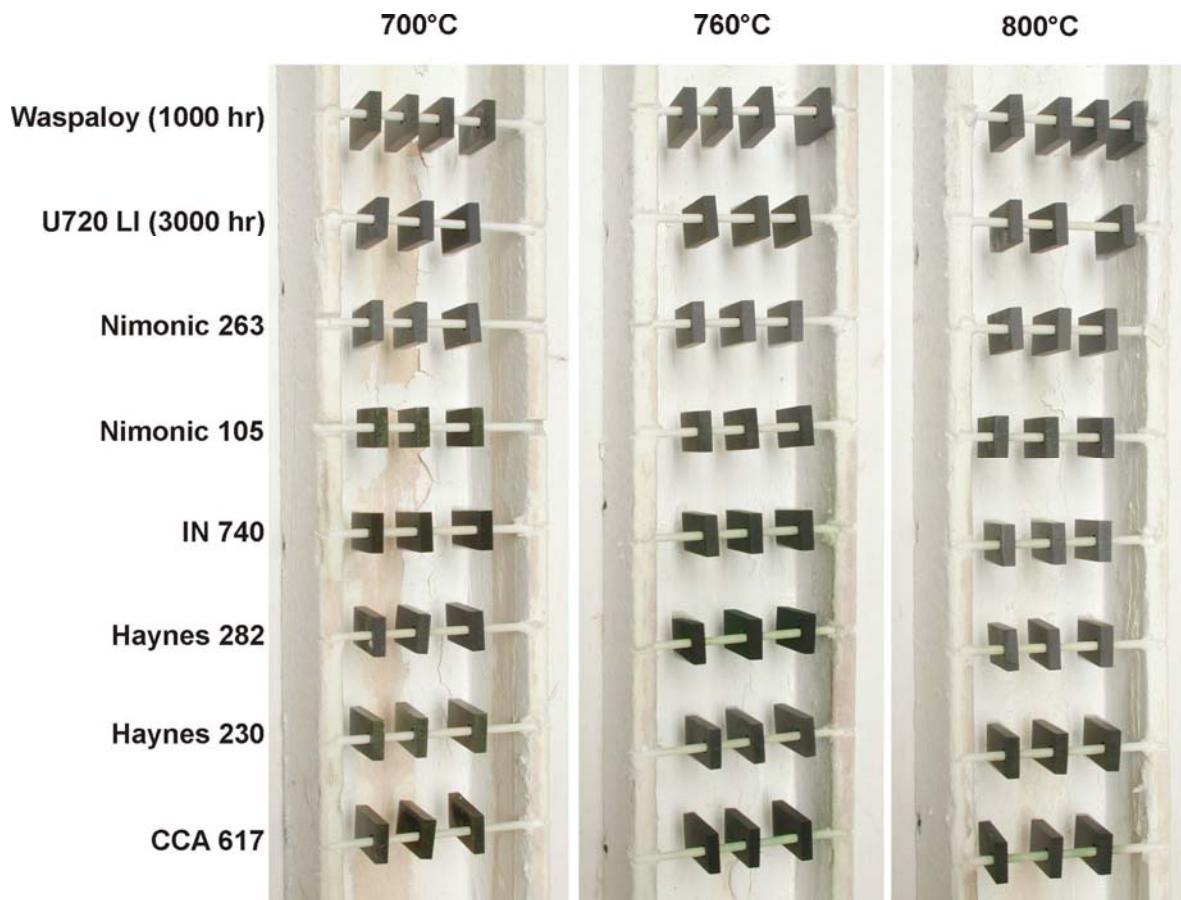
**Figure 2-17**  
**Coupon Boats After 4000 hour Exposure. The Alumina Hanger Rods of Some Alloys Have Been Stained Green and Yellow.**

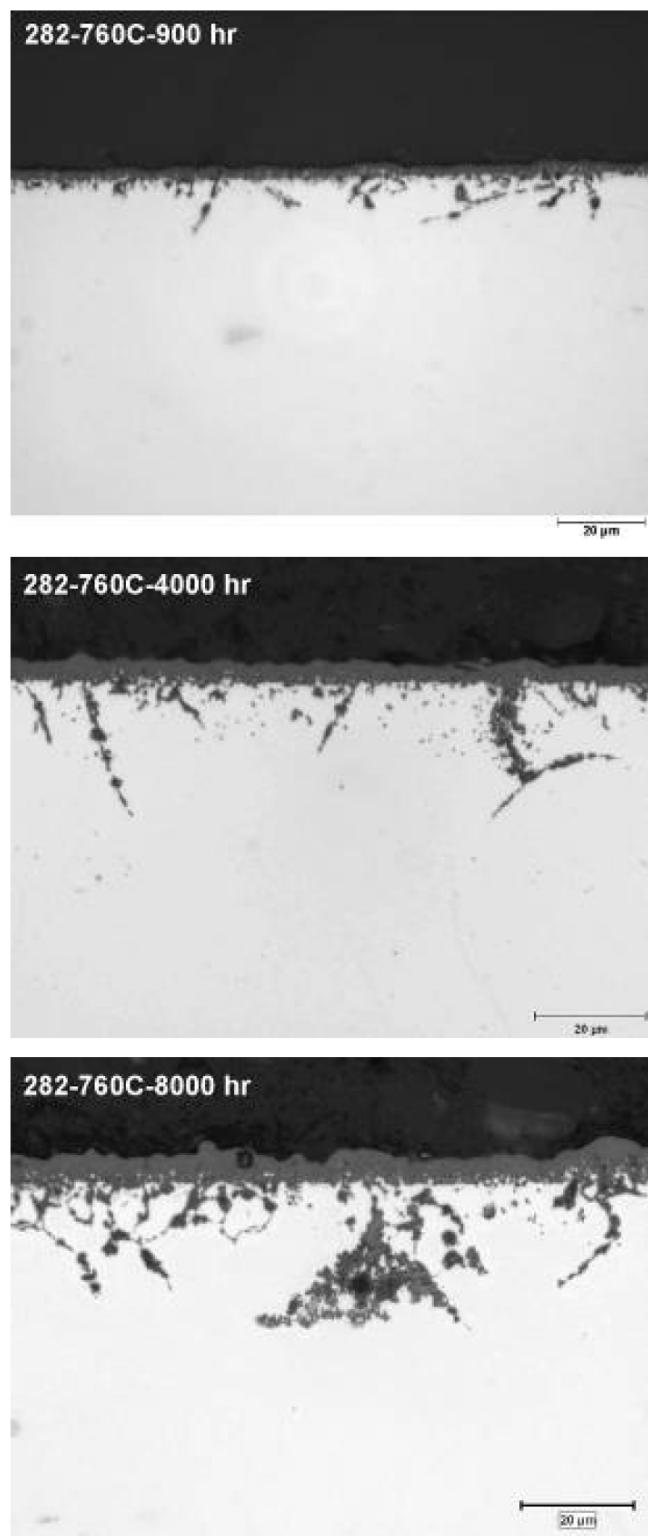
**Figure 3-12**  
**Typical oxidized surface of Haynes 282 as a function of time**

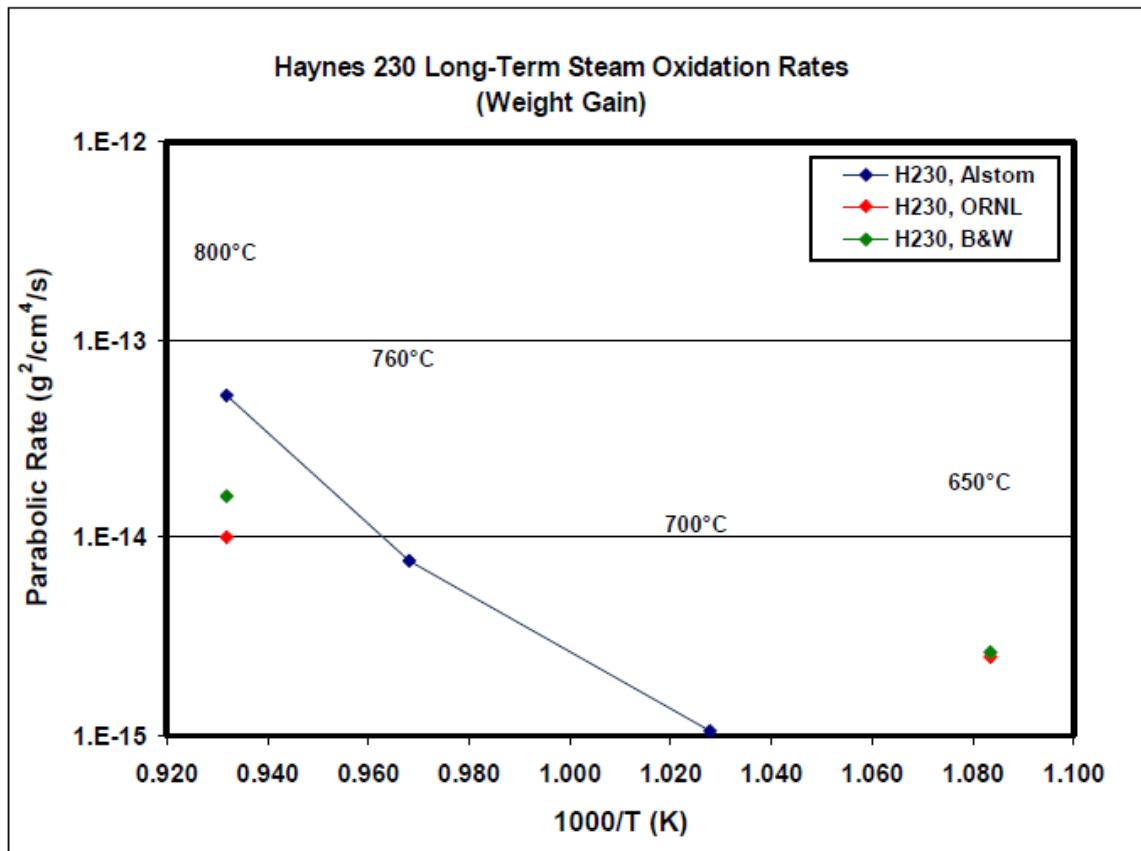
**Figure 3-29**  
Comparison of parabolic rate constants (mass gain kinetics) for this study (Alstom) and previous work from the A-USC Steam Boiler Consortium (ORNL and B&W) for Haynes 230

Figure 3-29 through Figure 3-35 compare weight-gain and total metal loss oxidation rates measured in this study with those previously reported by Babcock and Wilcox (B&W) and ORNL under the auspices of the DOE USC Boiler Materials Program. Data were obtained from program quarterly reports and the interim (unpublished) ORNL Task 3 final report. In general, reasonable agreement was observed between the different studies, *i.e.*, oxidation rate constants agreed within a factor of ten. In some cases, for example Inconel 740, very good agreement was observed, while in others (Haynes 230) the agreement was relatively poor. Considering all the variables and lack of standardization of test technique, this is not unexpected. Furthermore, it allows for relative comparison between the two programs despite minimal overlap of materials.

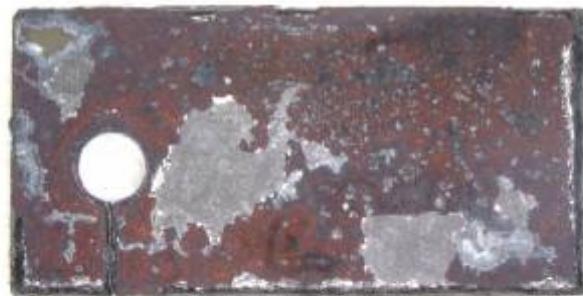
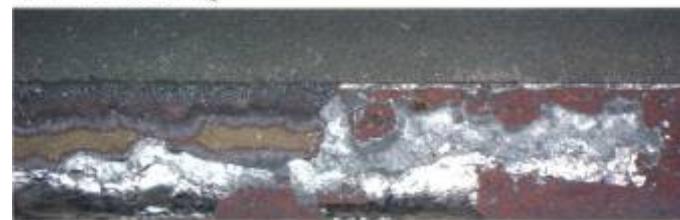
Overview of Exposed Substrate Surface

T-400C Coating

Type 304 SS Substrate

Close Side View of Exposed Coupon

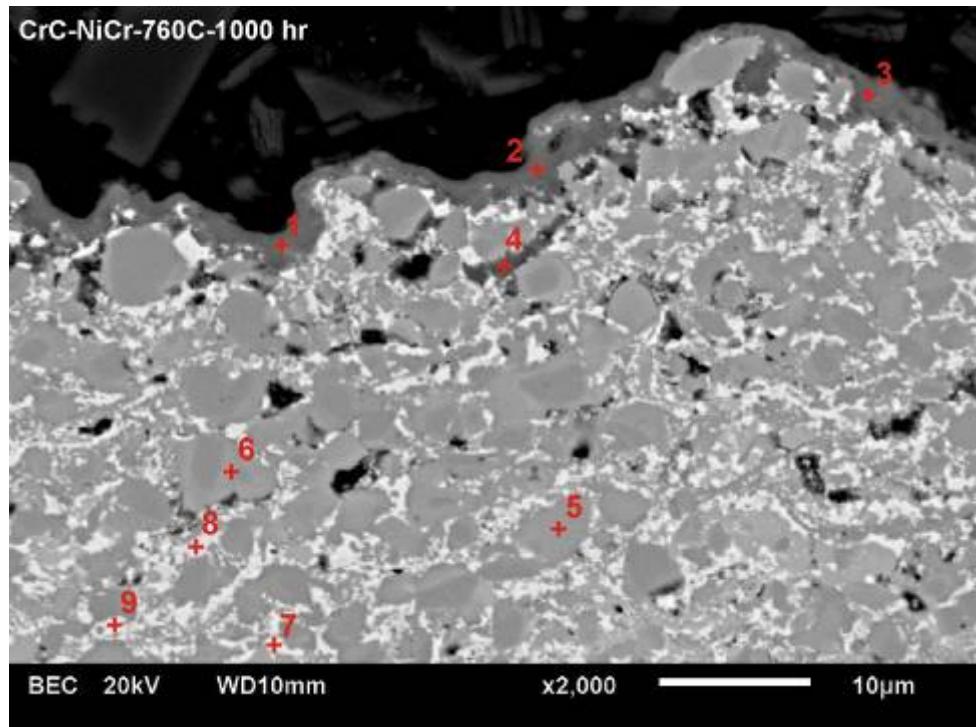
**Figure 4-24: Cracking Observed in Corner of CrC-NiCr Coating After Exposure at 760°C for 1000 hr. Cracking was Associated with Abnormal Coating Build-Up. Unetched.**

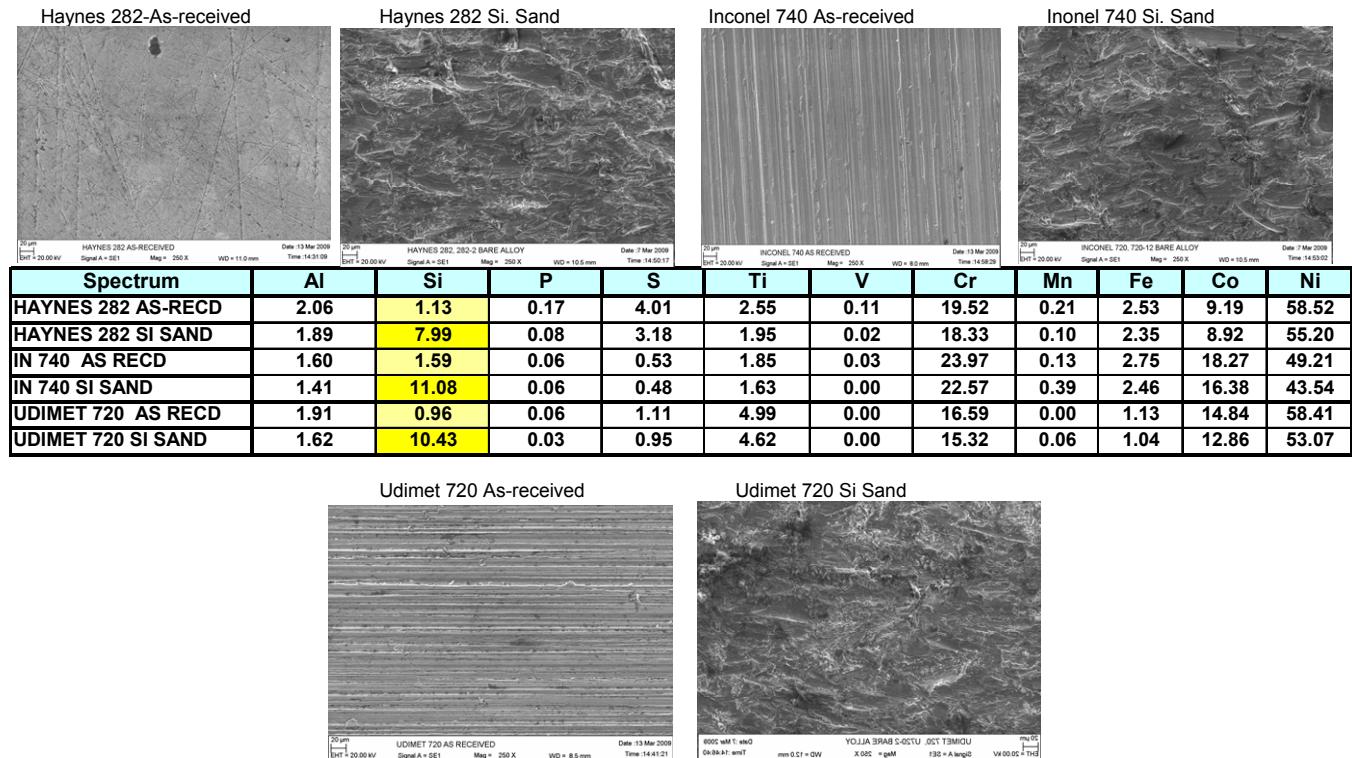
**Figure 18**  
**SEM images at 250X of the bare alloy coupons in their as-received condition and after erosion testing with silica sand. The smooth machined surfaces of the coupons have clearly been impacted and eroded by the silica sand. X-ray energy dispersive spectrographic analysis of the coupons surfaces show an increase in silicon content (yellow column) of the eroded test coupons as compared with the as-received coupons.**

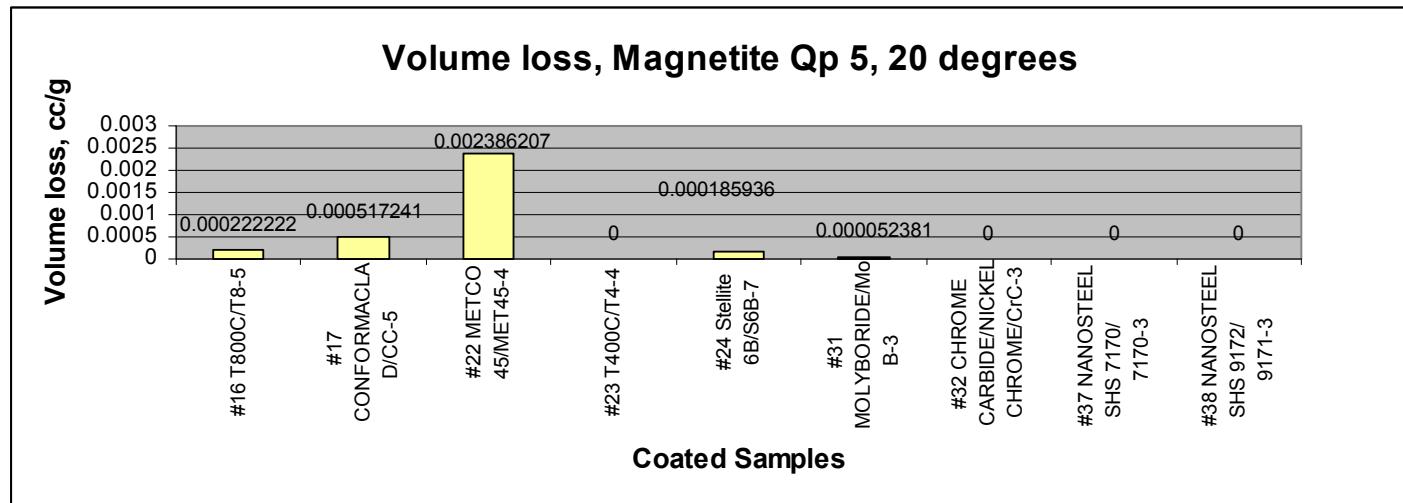
**Figure 20: Volume loss of coated samples using Magnetite, Qp 5, 20 degrees.**

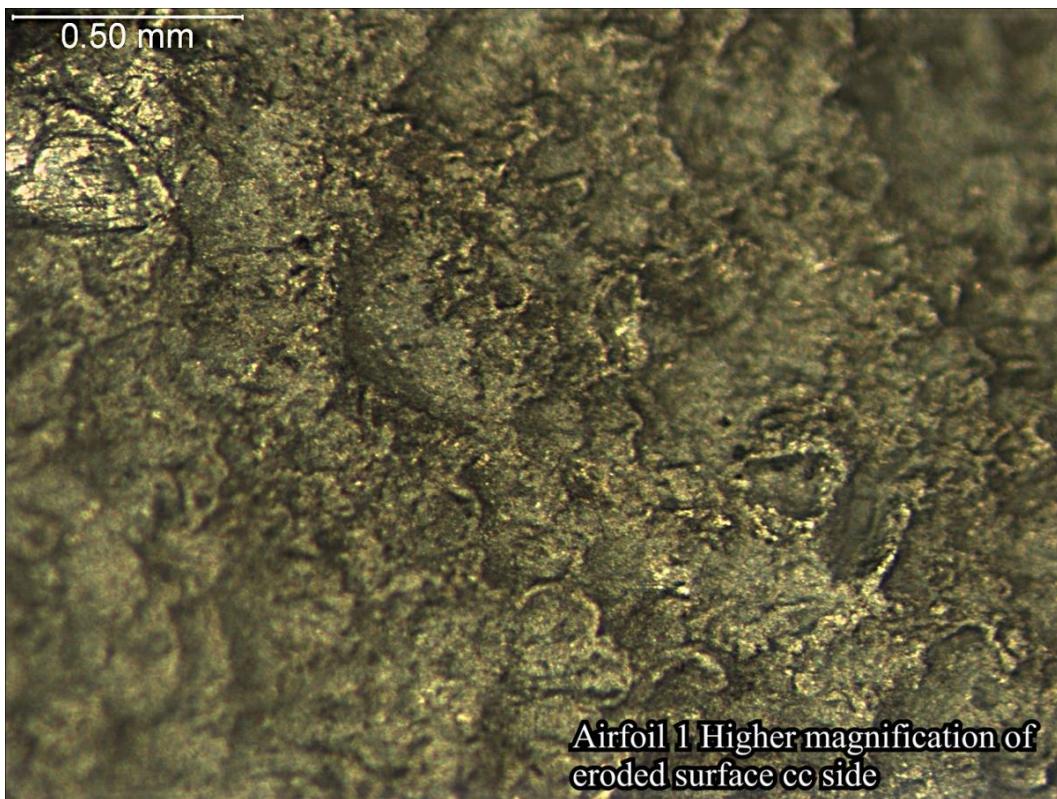
**Figure 24:** Scalloped pattern due to solid particle erosion, found on the concave side of a steam turbine airfoil.

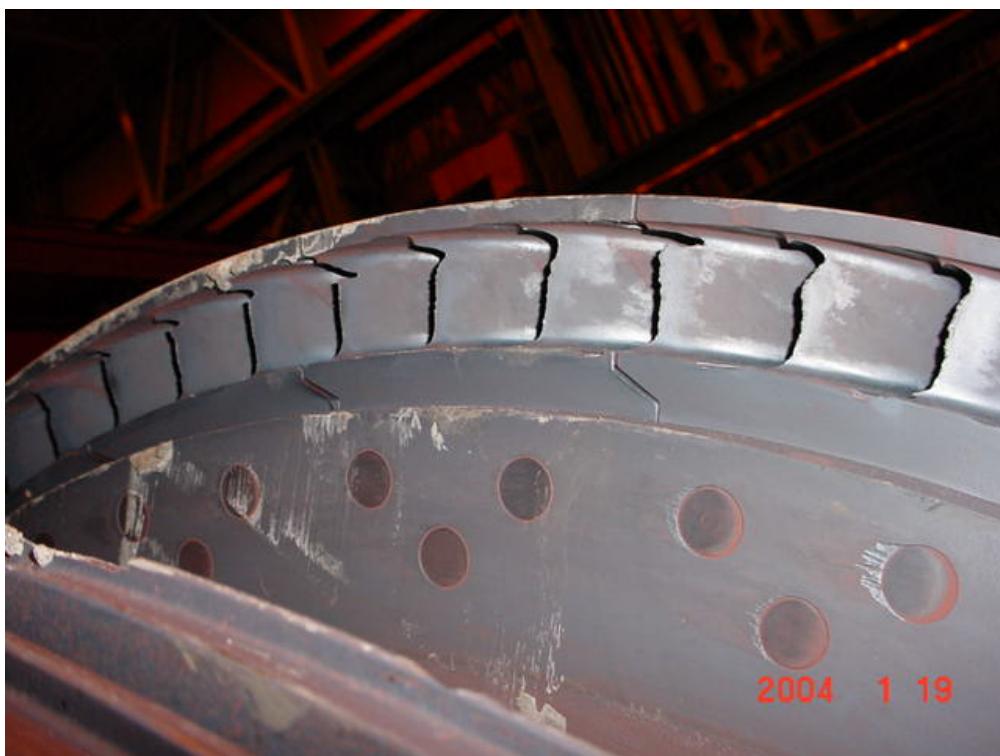
**Figure 25:** Shows a section of control stage blades from a steam turbine. Here the erosion of the trailing edge can be seen clearly.

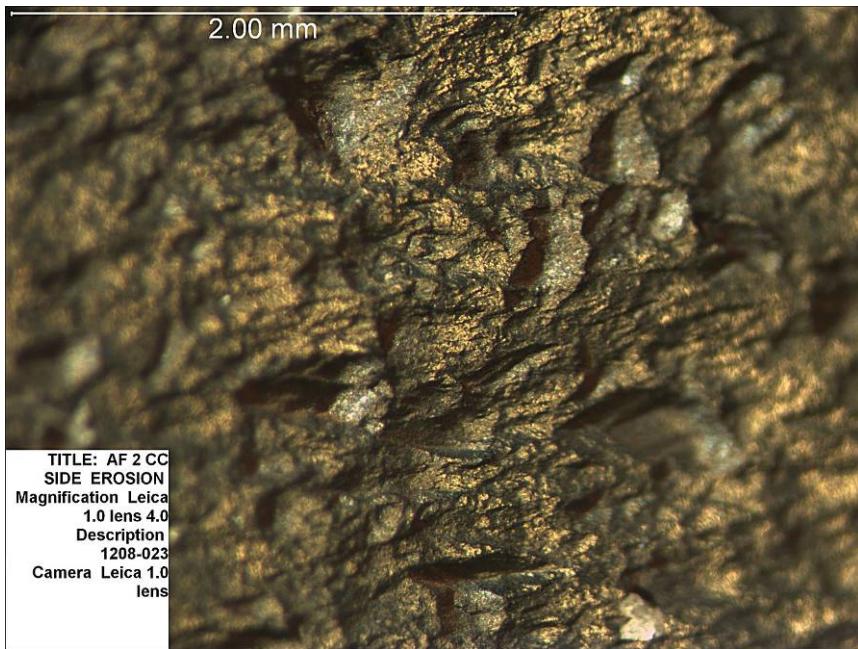
Figure 28: The scalloped pattern on the surface of the control stage blade is shown at higher magnification in this image taken with a stereoscopic camera.

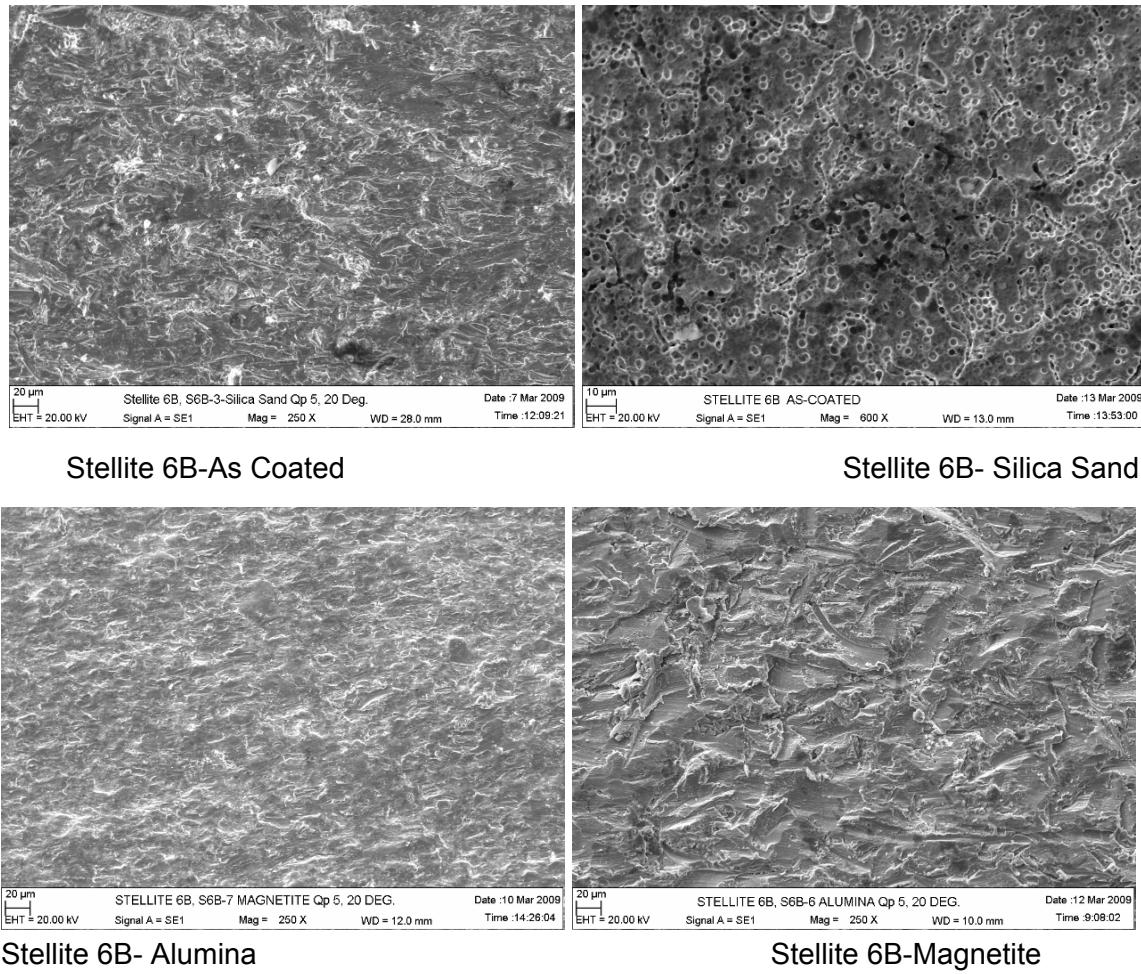
**Figure 33**  
**Stellite 6B Surface SEM Results As-coated and after laboratory erosion testing**

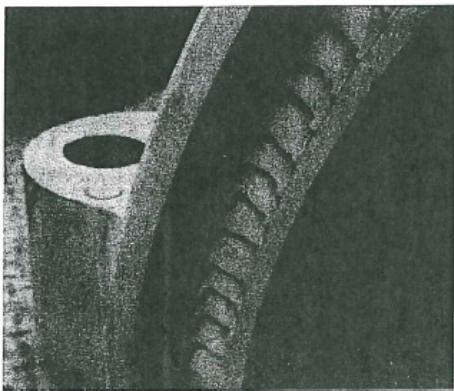
Figure 12-20. Photograph of first HP turbine stage stationary blades that experienced solid particle erosion.

accelerates the solid particles above the erosion threshold velocity (about 700 ft/sec). These high velocity particles wear the concave (pressure) surface of the first stage stationary blades as shown in Figure 12-19. Figure 12-20 is a photograph of the eroded blades.

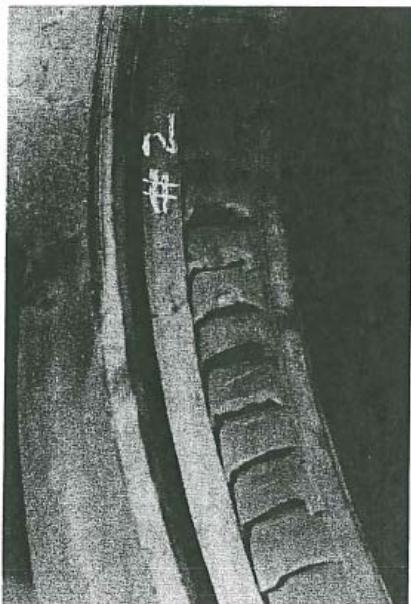
Figure 12-32. Photograph of solid particle erosion damage of original design after 18 months of operation. Courtesy of the General Electric Company.

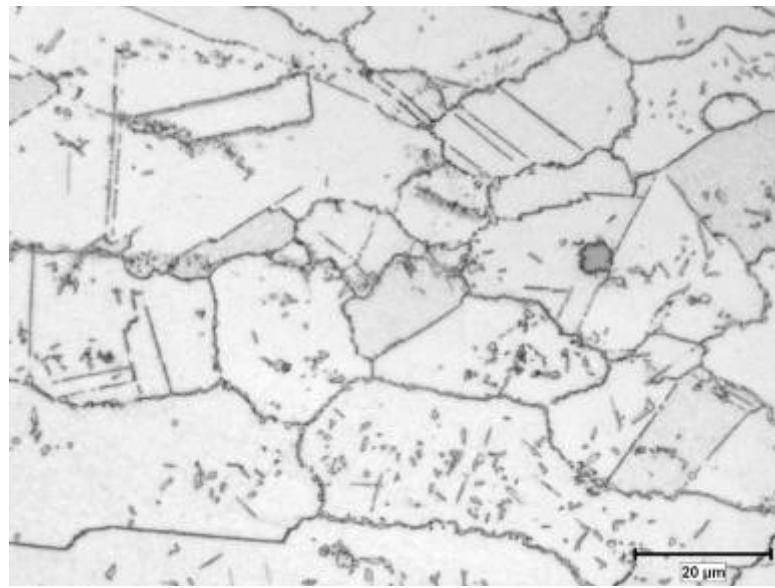
**Figure 14: Typical Microstructure of HAZ in Inconel 617 in the Area of a Fine-Grained Band After 10,000 hr Exposure at 725°C (1000X). Bromine-Methanol Etch.**

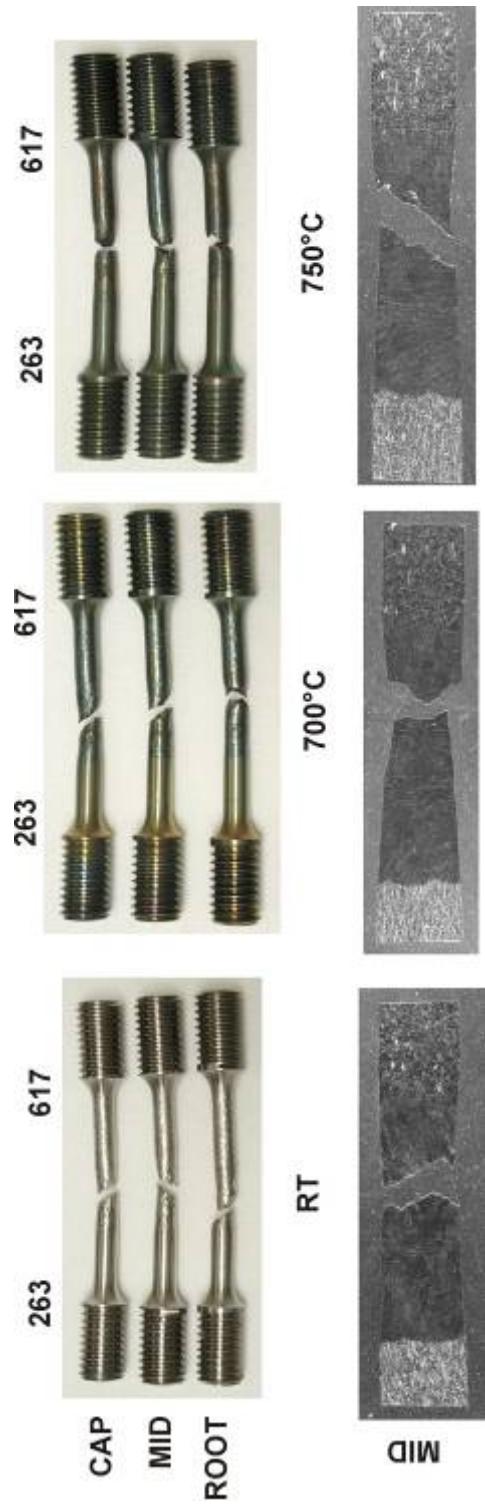
**Figure 23: Macro Views of Tested Tensile Specimens and Longitudinal Sections. Rupture Occurred in the Weld Metal for All Specimens.**

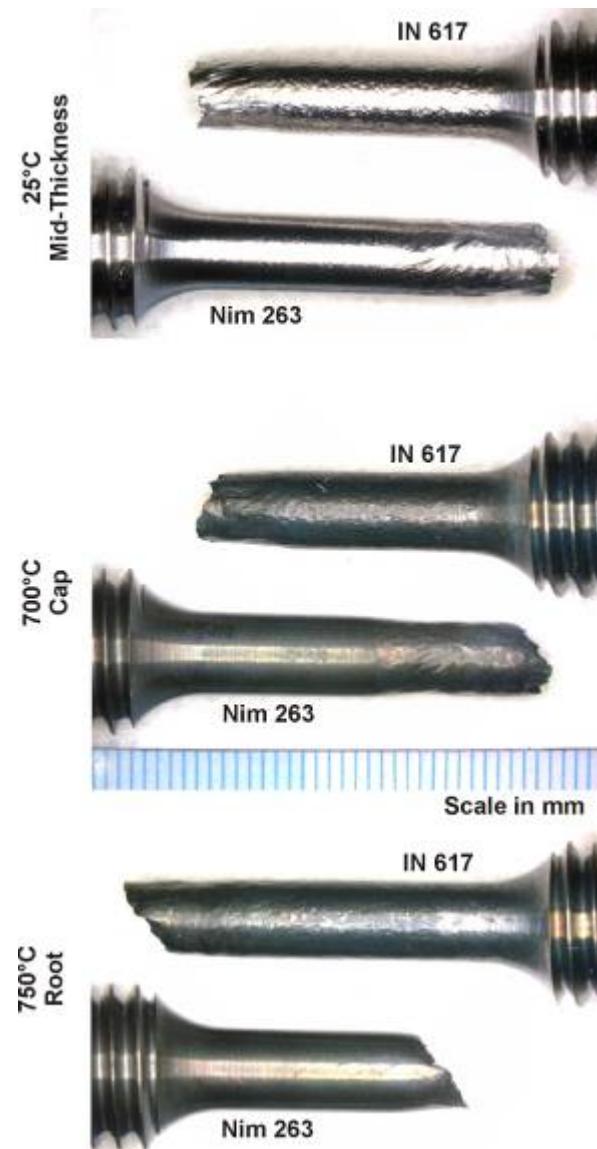
**Figure 24: Macro Views of Tested Tensile Specimens from Thermally-Exposed Weldment. Rupture Occurred in the Weld Metal for All Specimens.**

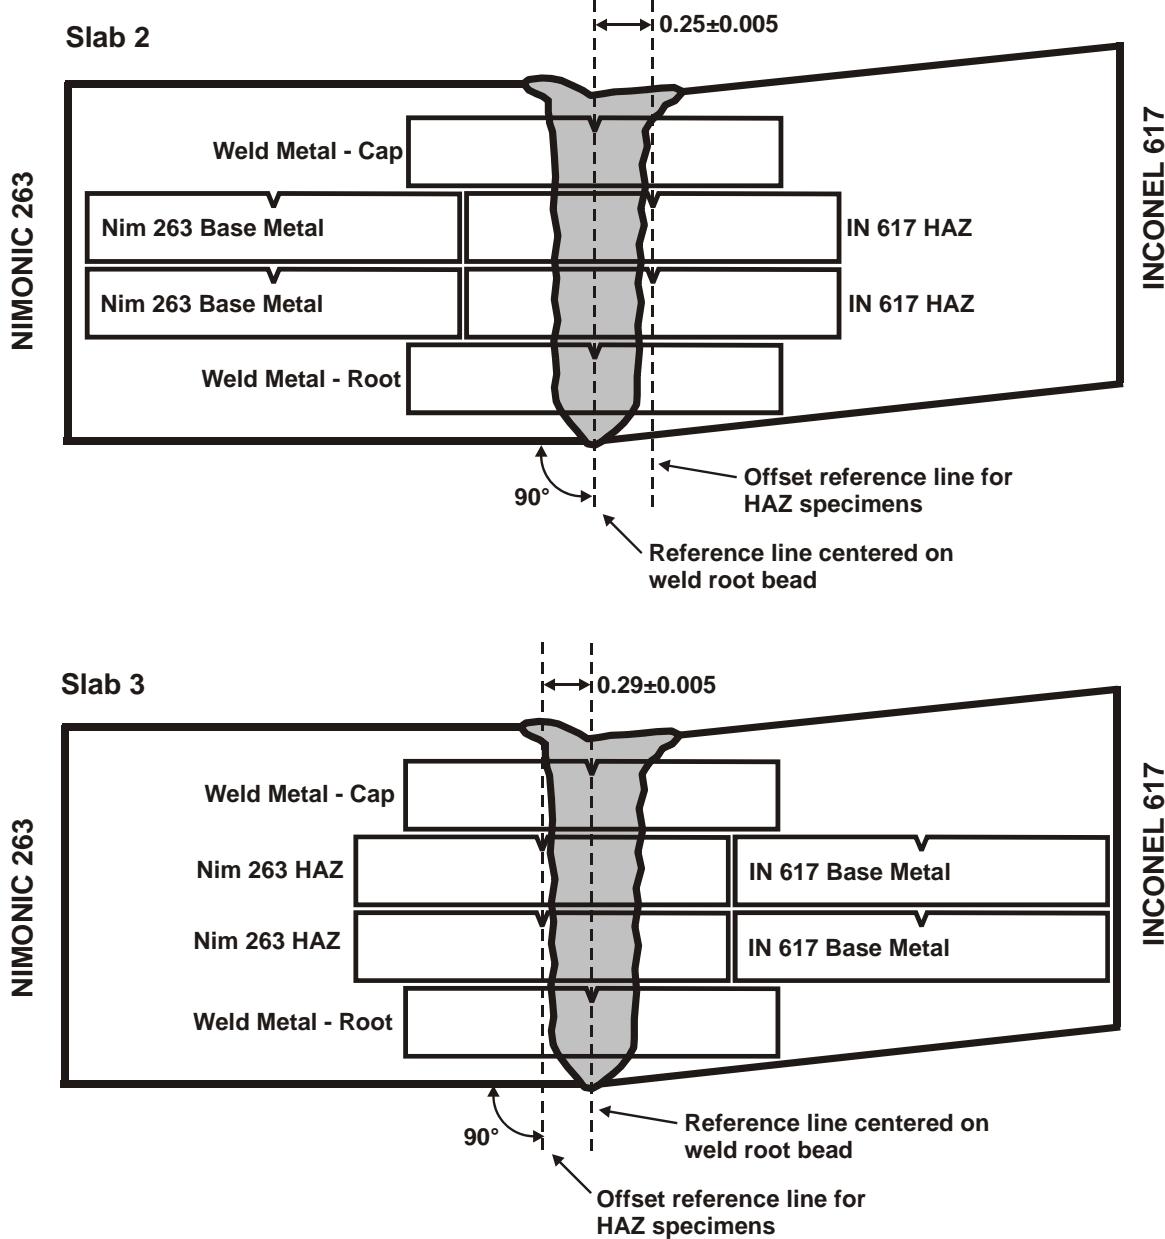
**Figure 25: Schematic Diagram Showing Location and Orientation of Charpy V-Notch Impact Specimens Located in Different Microstructural Zones.**

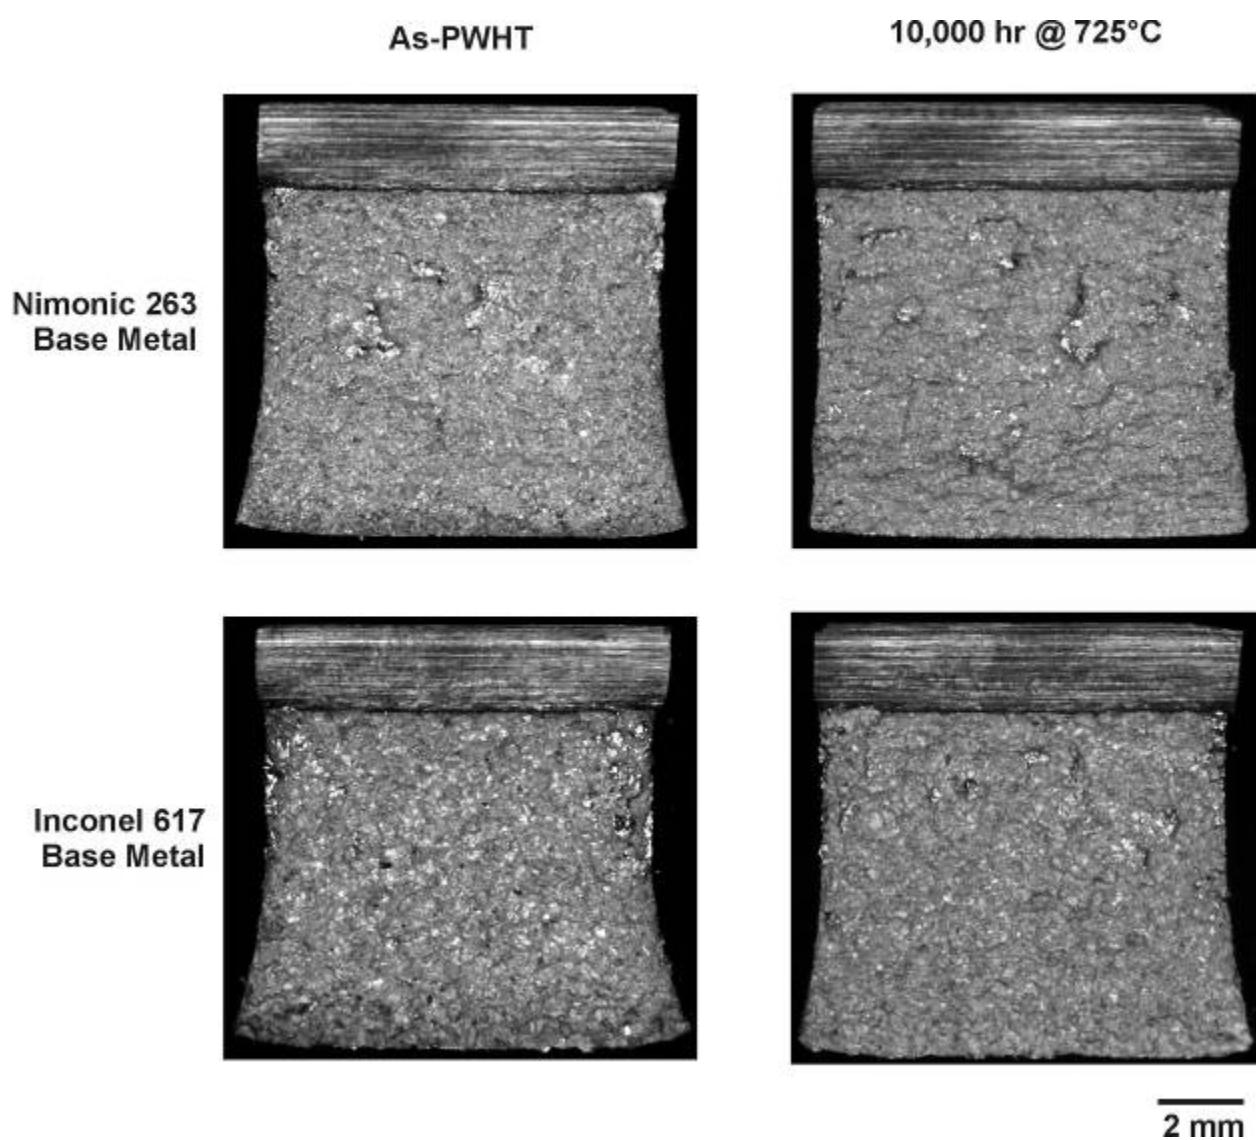
**Figure 27: Macro Views of Nimonic 263 and Inconel 617 Base Metal Impact Test Specimen Fracture Surfaces; As-PWHT Condition and After Thermal Exposure.**

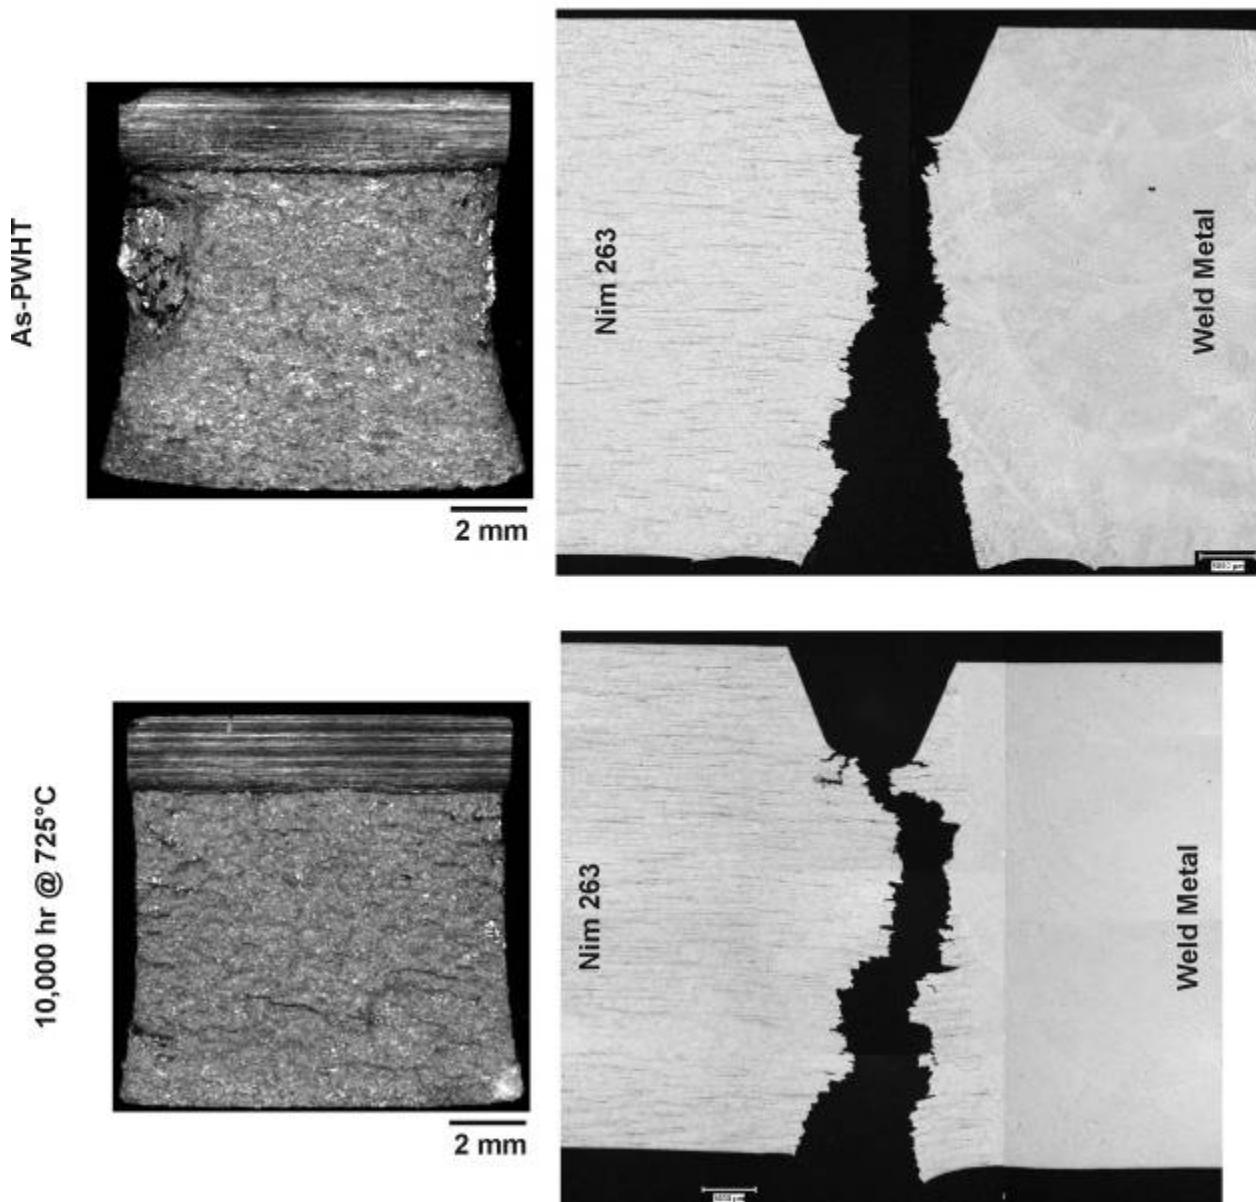
**Figure 28: Macro Views of Nimonic 263 HAZ Impact Test Specimen Fracture Surfaces and Corresponding Longitudinal Sections; As-PWHT Condition and After Thermal Exposure.**

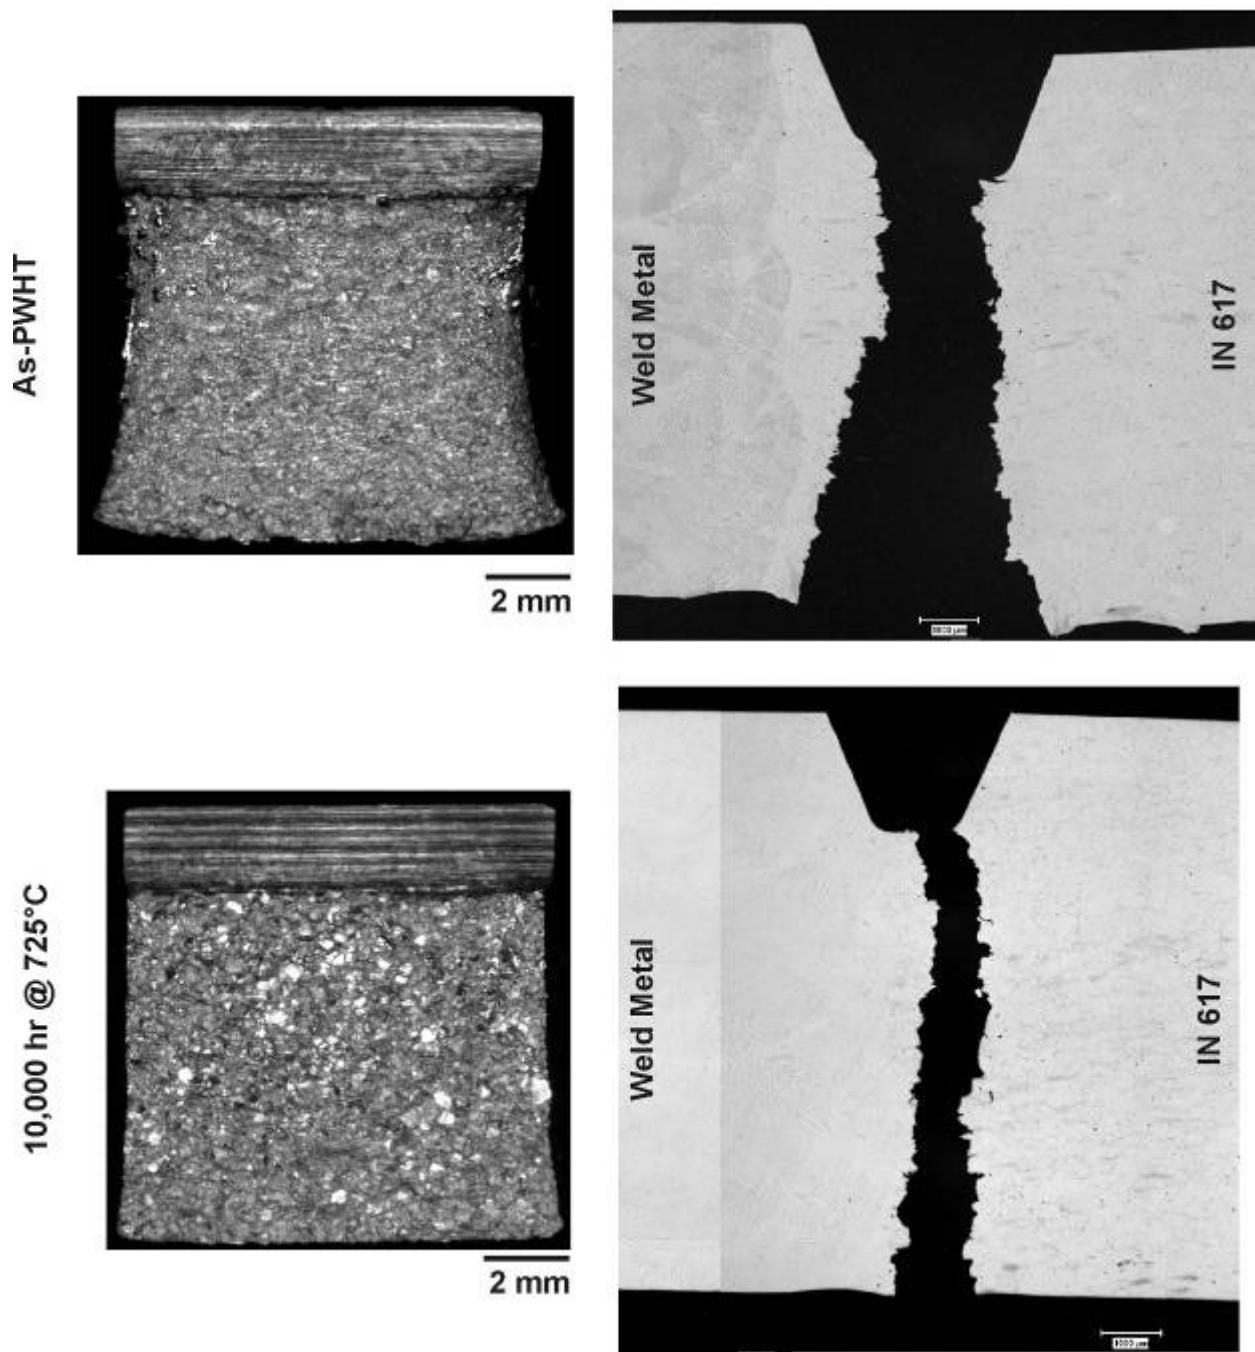
Figure 29: Macro Views of Inconel 617 HAZ Impact Test Specimen Fracture Surfaces and Corresponding Longitudinal Sections; As-PWHT Condition and After Thermal Exposure.
