# **Report Title: Steam Turbine Materials for Ultrasupercritical Coal Power Plants**

**Type of Report:** Final Technical Report

DOE Award Number DE-FC26-05NT42442

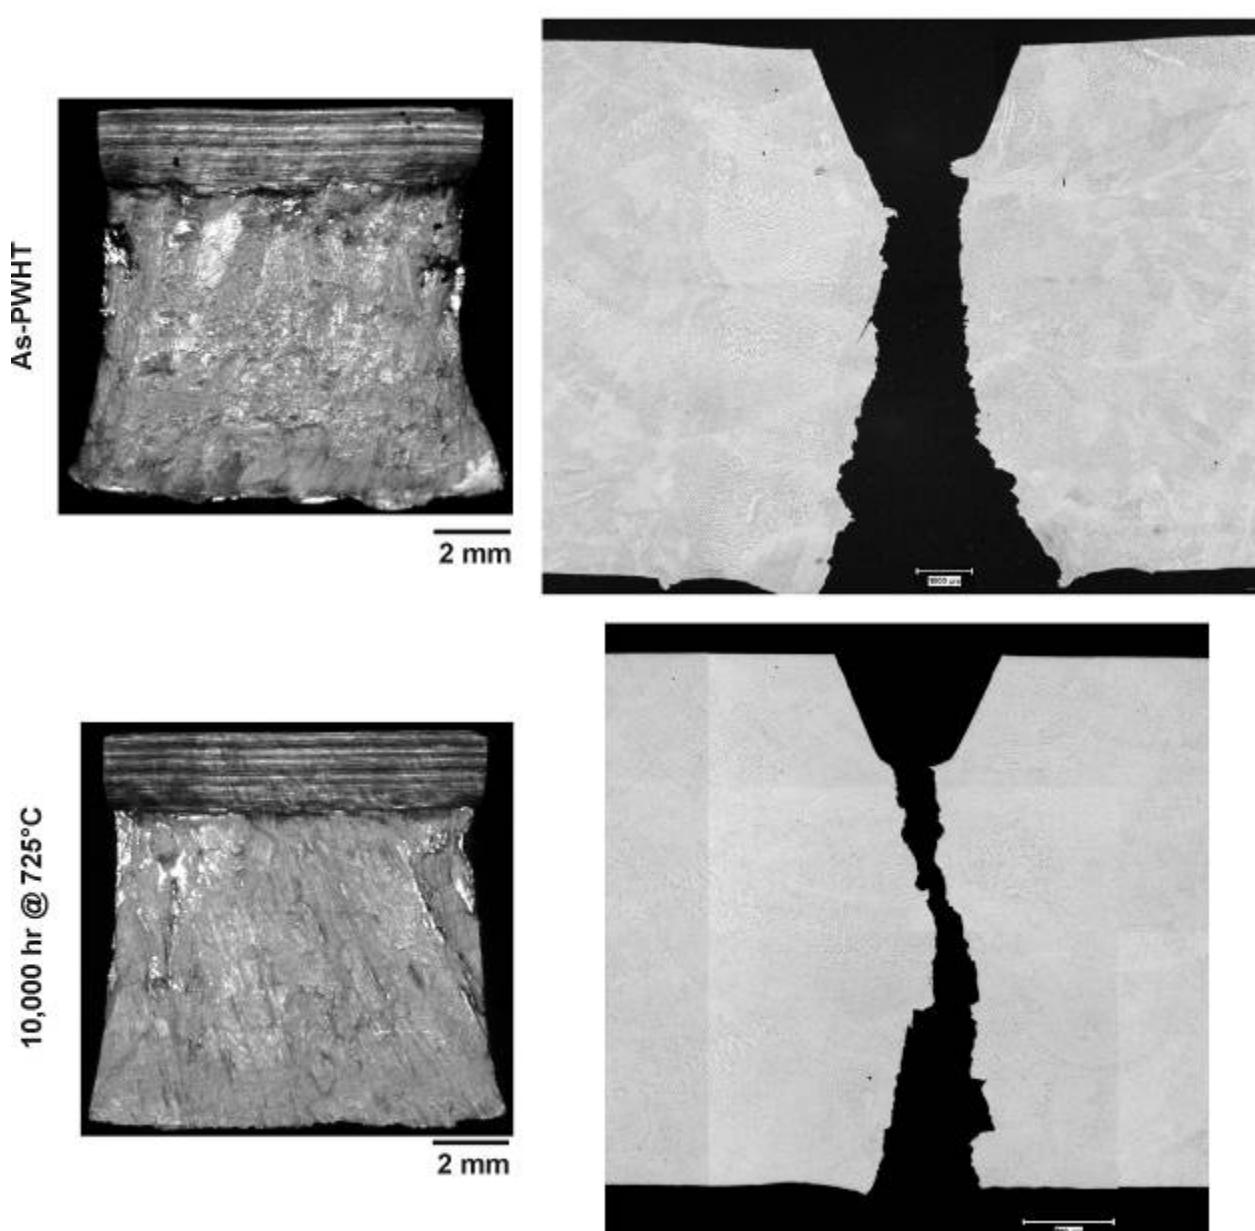
Figure 30: Macro Views of Cap Area Weld Metal Impact Test Specimen Fracture Surfaces and Corresponding Longitudinal Sections; As-PWHT Condition and After Thermal Exposure.

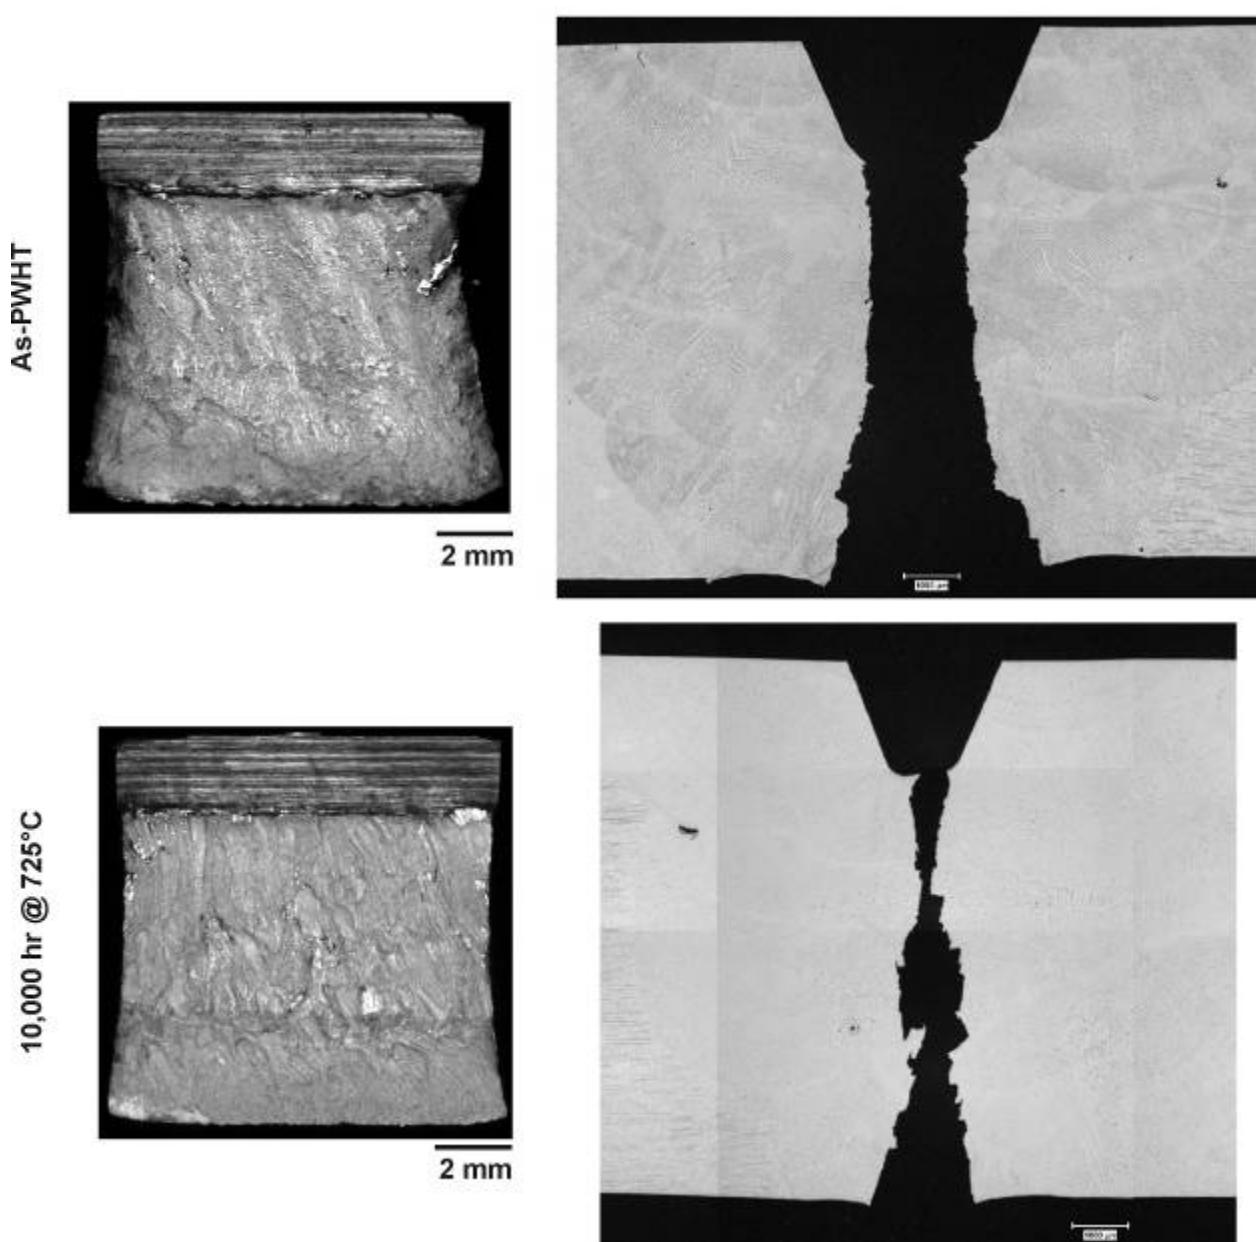
**Figure 31: Macro Views of Root Area Weld Metal Impact Test Specimen Fracture Surfaces and Corresponding Longitudinal Sections; As-PWHT Condition and After Thermal Exposure.**

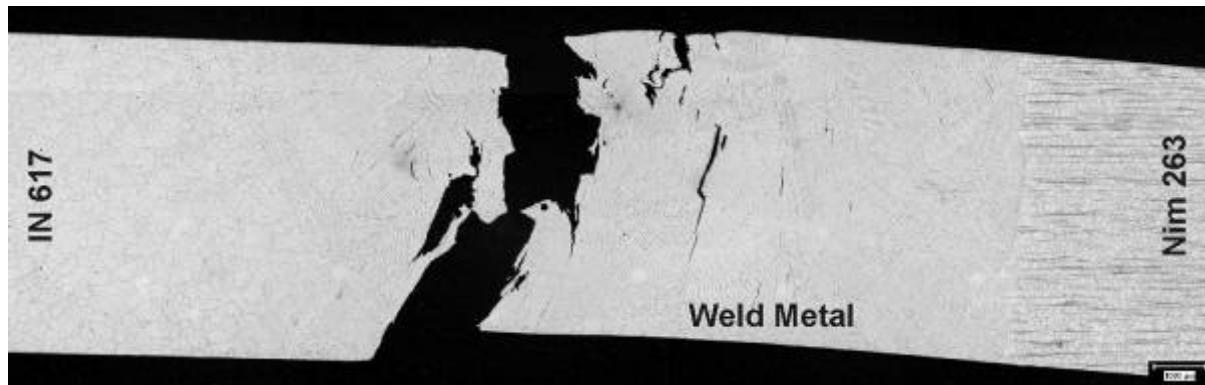
Figure 37: Overview of Longitudinal Section of Specimen TEN-4-C, Stress-Rupture Tested at 750°C and 155 MPa. Bromine-Methanol Etch.

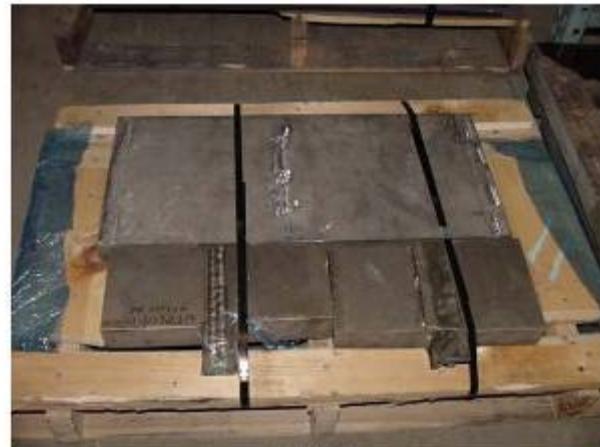
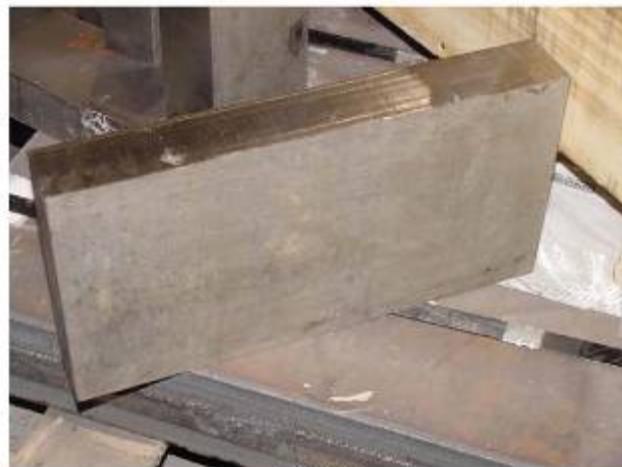
(a) IN617

(b) NI263

**Figure 1. General View of Plate Sections of Alloys Provided by ALSTOM**

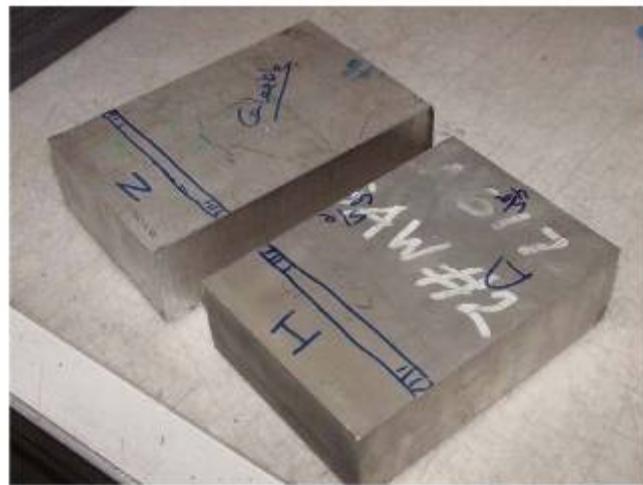
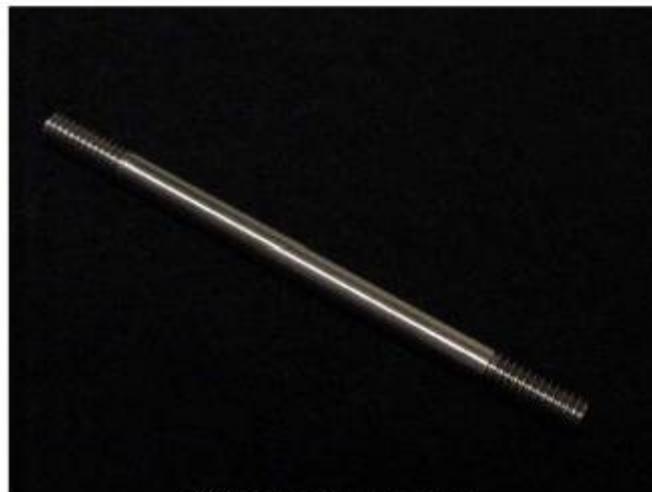
(a) Plate section

(b) Machined Gleeble sample

**Figure 2. General View of Gleeble Samples**

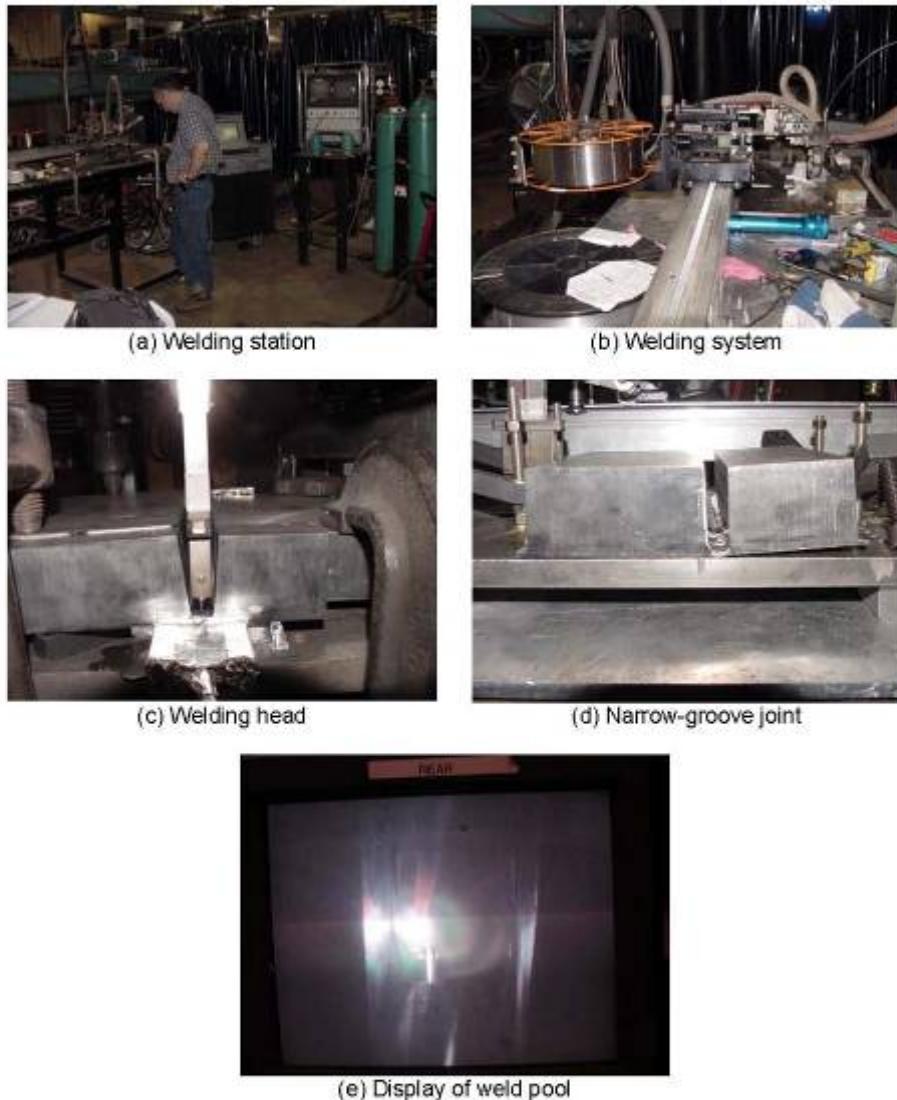
**Figure 8. General View of Welding Station, Welding System, Welding Head, Narrow-Groove Joint, and Display of Weld Pool during Welding**

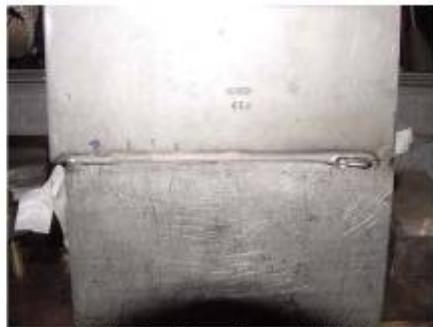
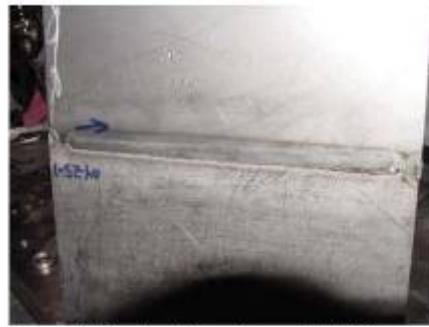
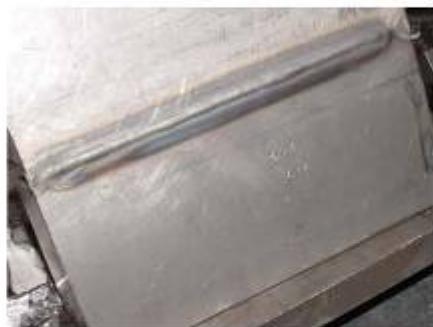
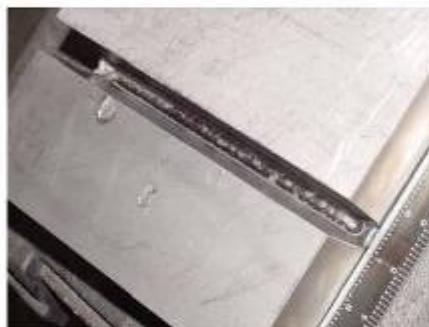
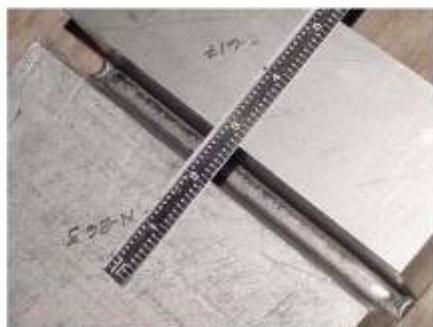
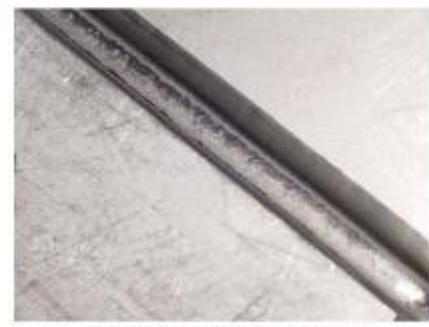
(a) Back side root pass Trial 1

(b) Back side root pass Trial 2

(c) Back side root pass Trial 3

(d) Front side root pass Trial 2

(e) Front side root pass Trial 3

(f) Front side root pass Trial 3

**Figure 9. Example of Appearance of Root Pass Achieved during Different Welding Trials**

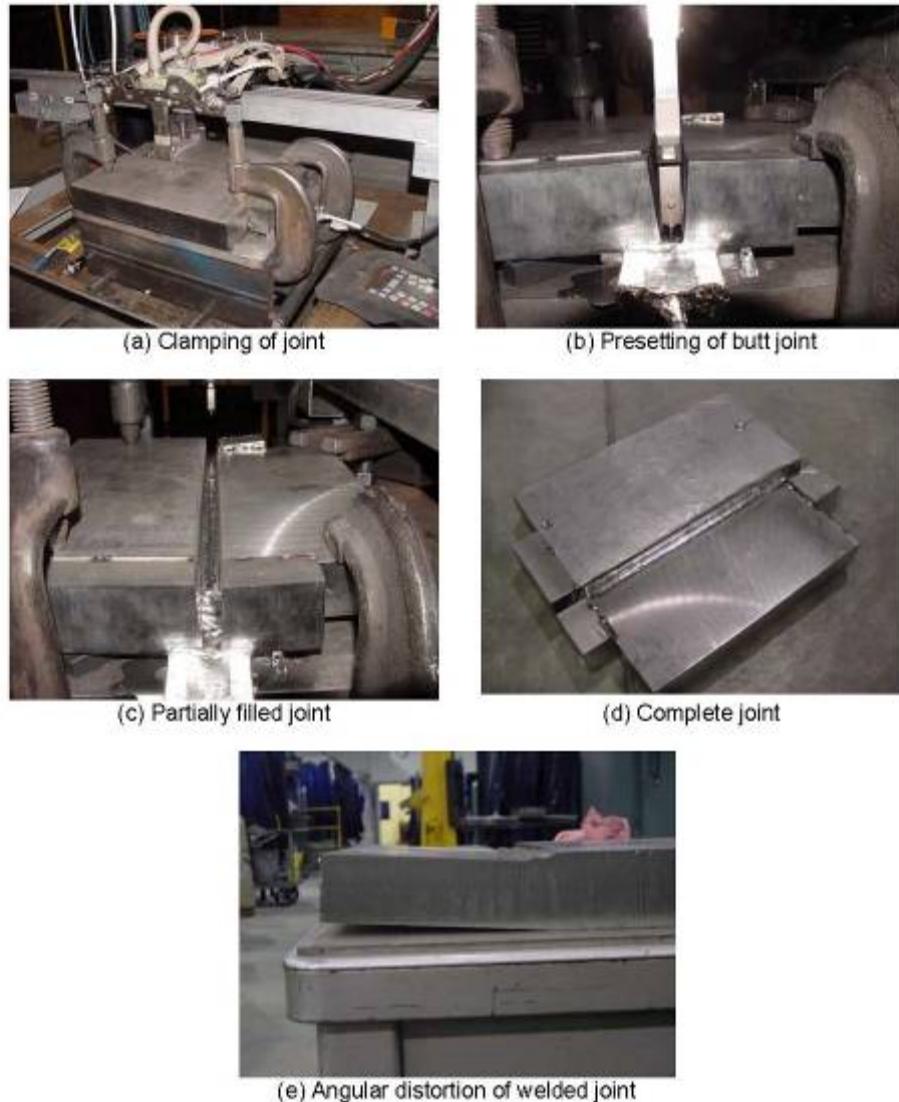
**Figure 12. General View of Restraining of the Joint, Presetting of Joint, Partially and Completely Filled Joint, and Resulting Angular Distortion of the Joint**

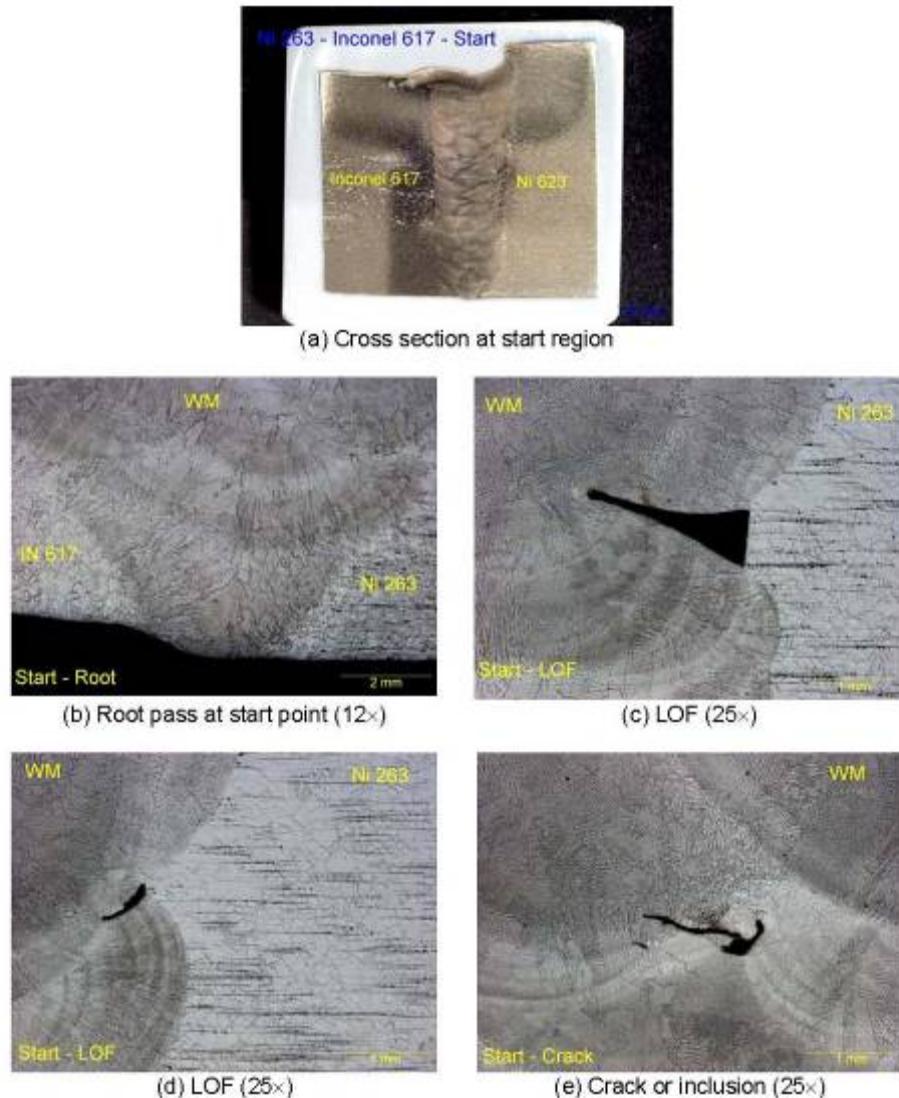
**Figure 13. View of Cross Section and Root Pass of the Welded Joint, and Defects Observed at the Start Region of the Full-Size Joint**

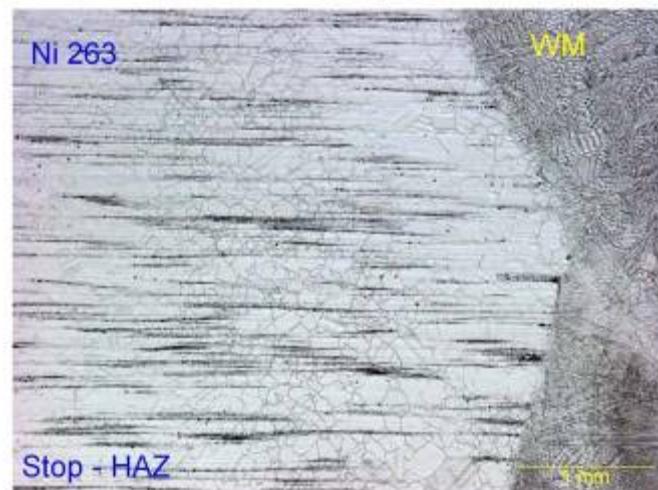
(b) NI263 side of full-size joint (25 $\times$ )

Figure 15. Micrograph of the IN617 and NI263 Sides of Full-Size Joint

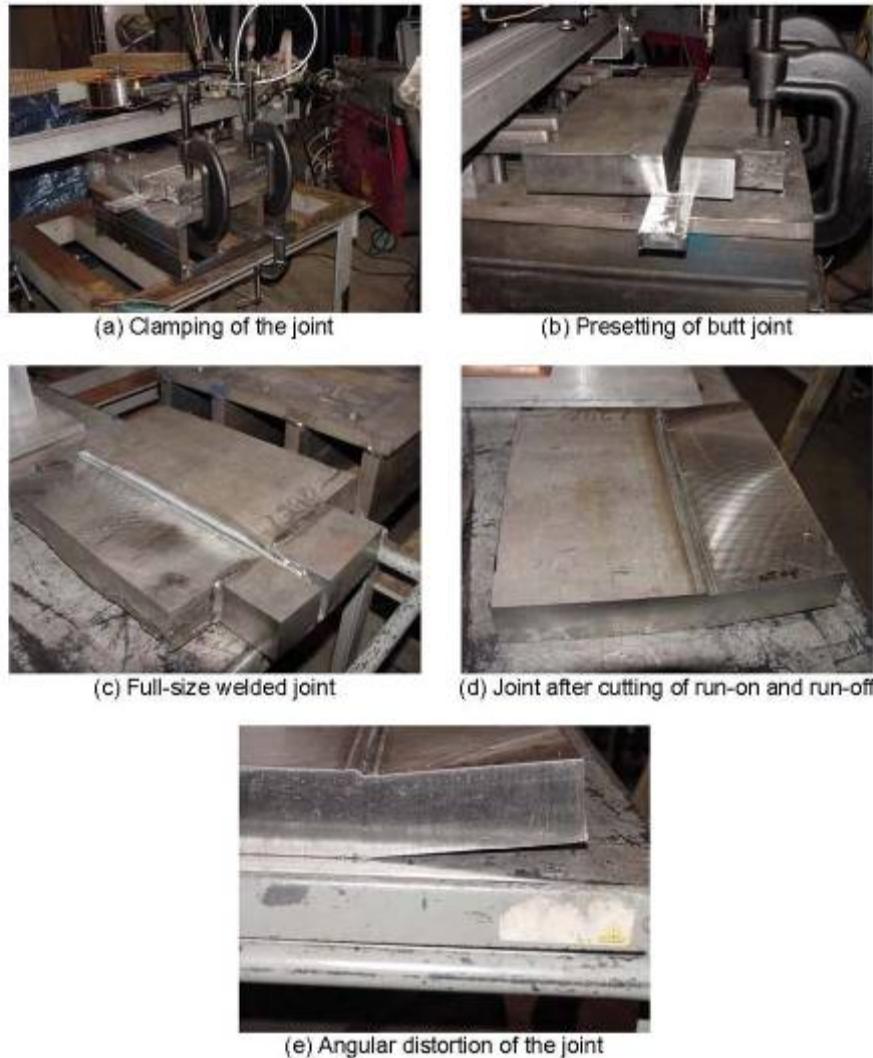
**Figure 16. General View of Restraining and Presetting of the Joint, Complete Full-Size Joint Before and After Removing Run-On/Run-Off Tabs, and Resulting Angular Distortion of the Joint**

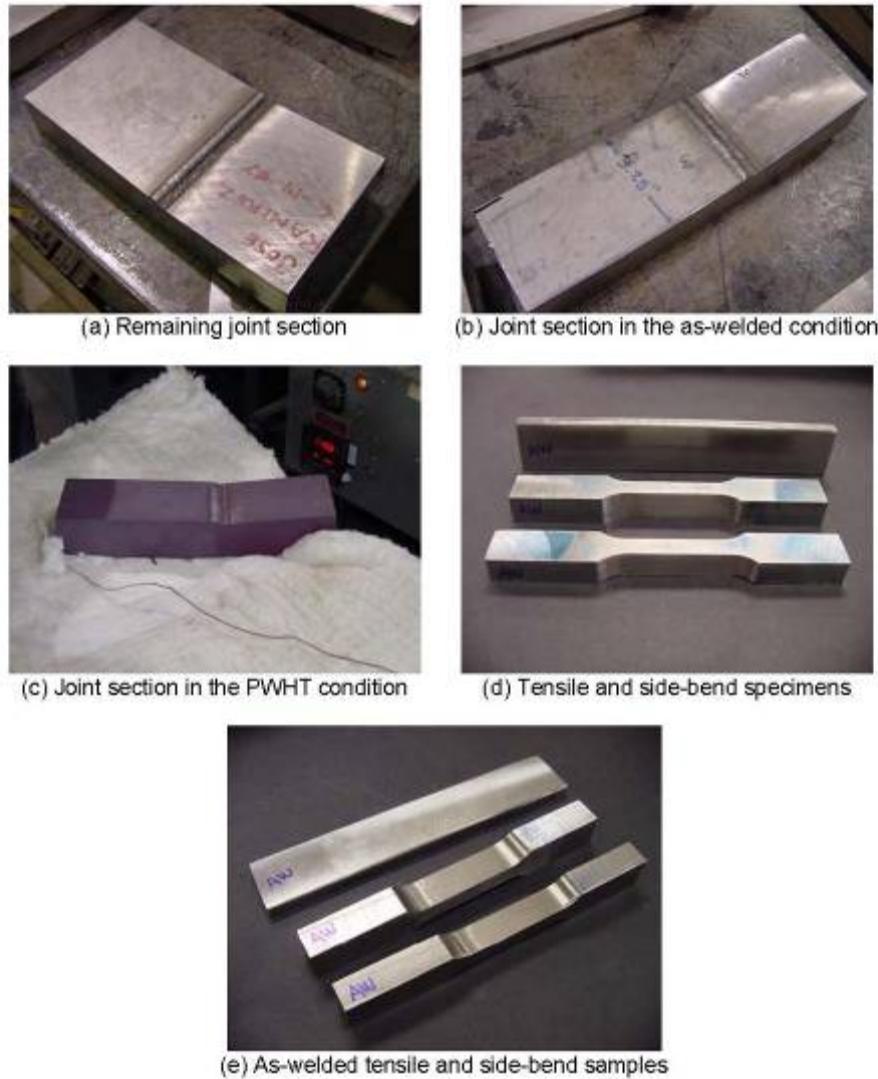
Figure 17. Preparation of Tensile and Side-Bend Samples

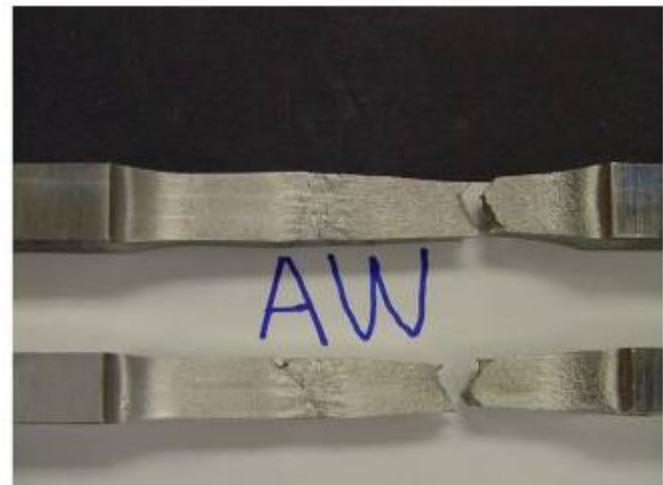
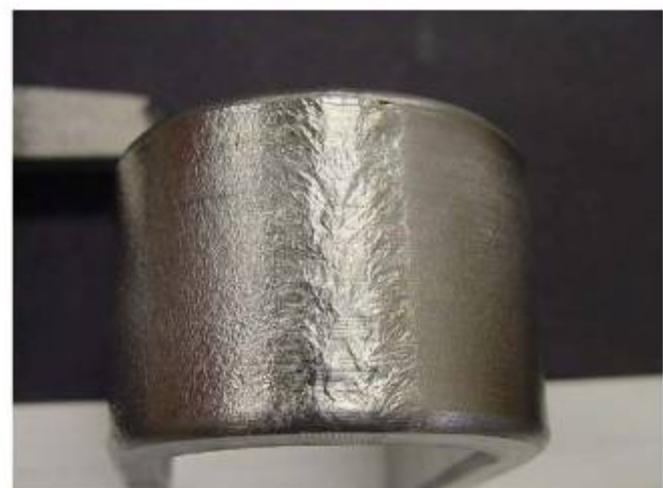
(a) As-welded tensile specimens

(b) As-welded side-bend specimen

**Figure 18. General View of As-Welded Tensile and Side-Bend Specimens after Testing**

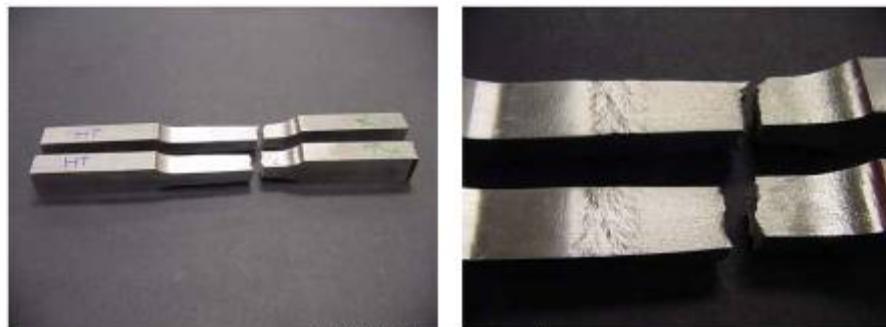
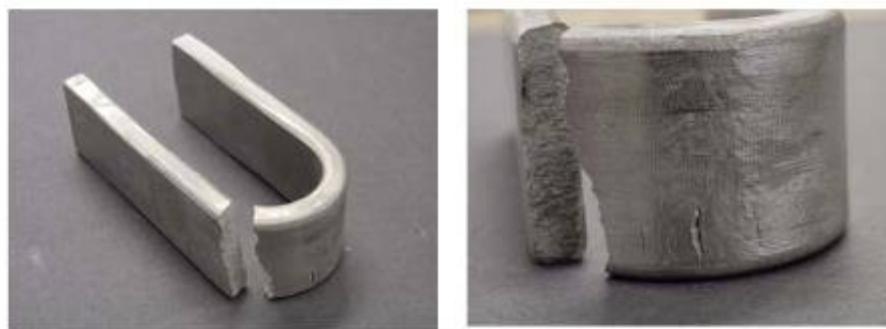
(a) PWHT tensile specimens

(b) PWHT side-bend specimens

Figure 19. General View of PWHT Tensile and Side-Bend Specimens After Testing

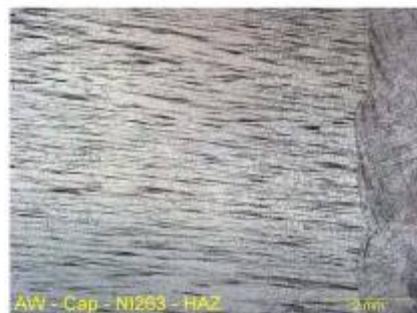
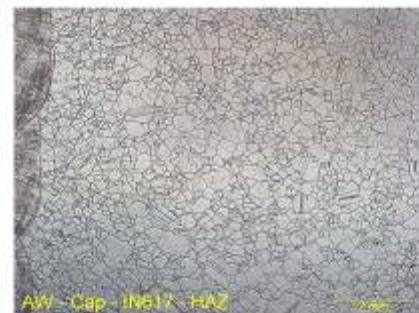
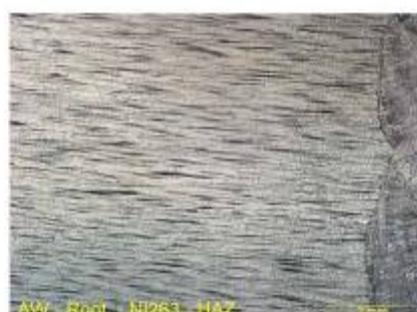
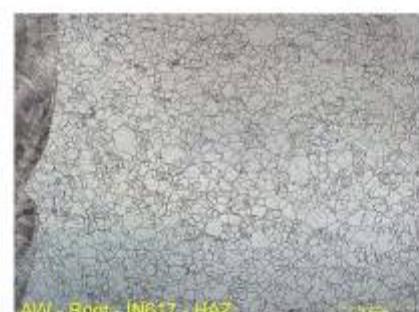
(b) Cap region – NI263 side (12 $\times$ )

(c) Cap region – IN617 side (12 $\times$ )

(d) Root region – NI263 side (12 $\times$ )

(e) Root region – IN617 side (12 $\times$ )

Figure 21. General Microstructure of the NI263 and IN617 Sides of the Welded Joint in the As-Welded Condition

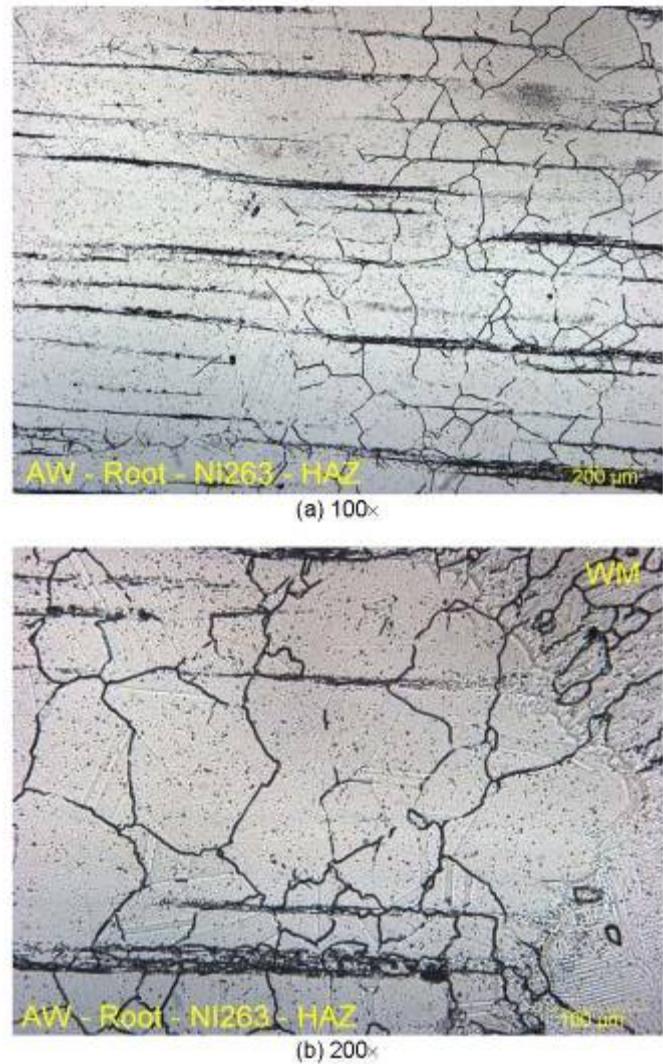
**Figure 22.** Laminar Segregation Observed in the Ni263 Base Material and Preferential Etching of the Grain Boundaries of the HAZ of the Ni263 Material in the As-Welded Condition

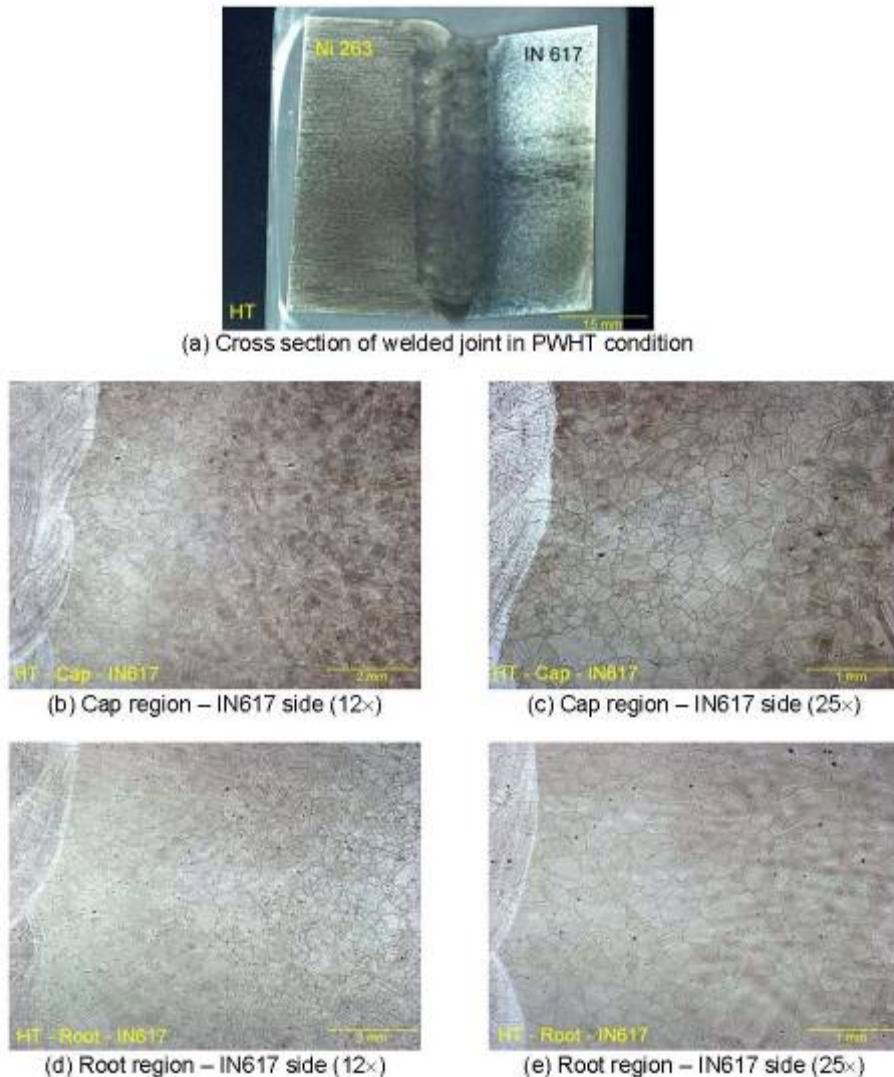
**Figure 23. General Microstructure of the IN617 Side of the Welded Joint in the PWHT Condition**

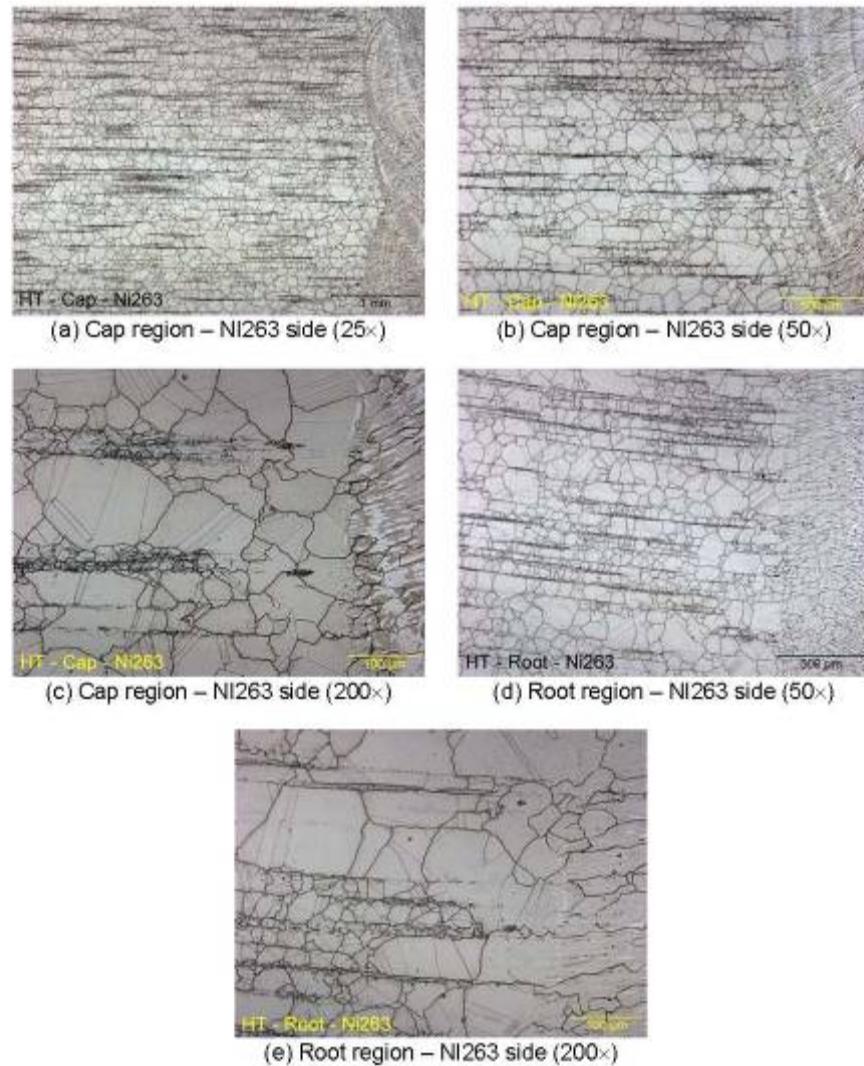
**Figure 24. General Microstructure of the Ni263 Side of the Welded Joint in the PWHT Condition**

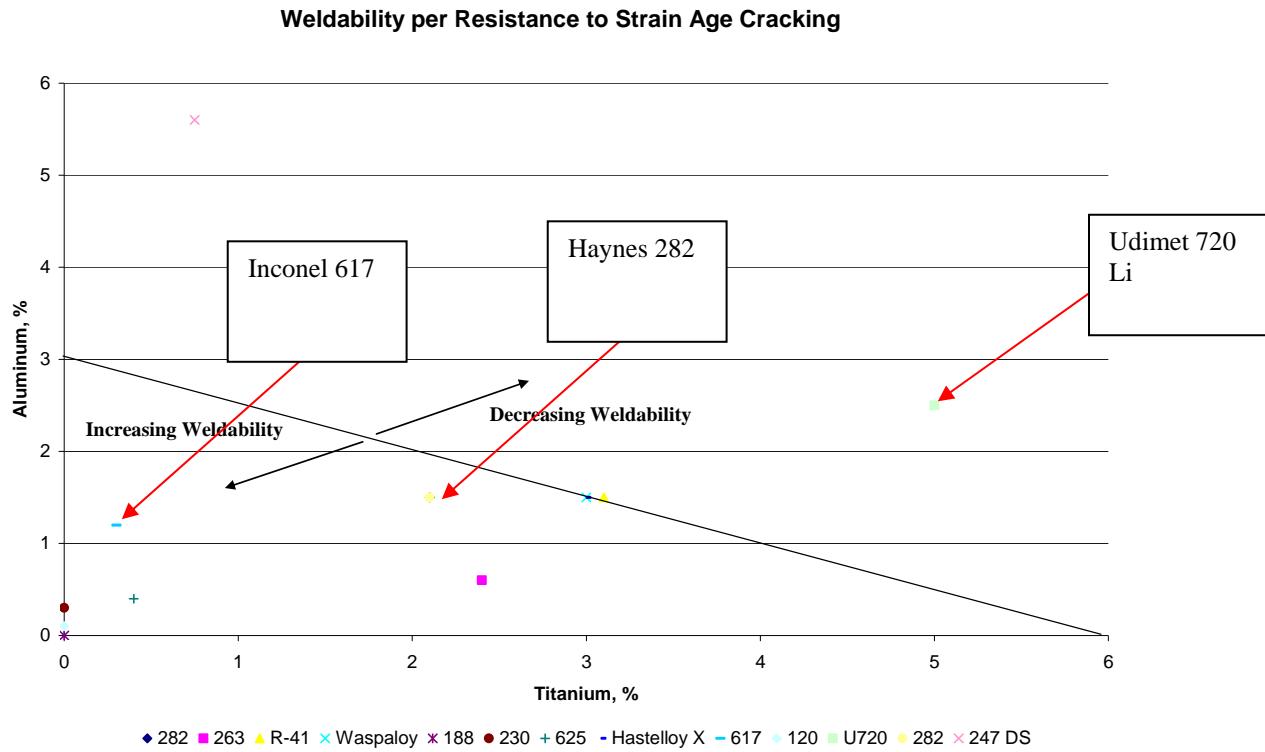
**Figure 2.** Plot shows theoretical resistance to Strain Age Cracking.

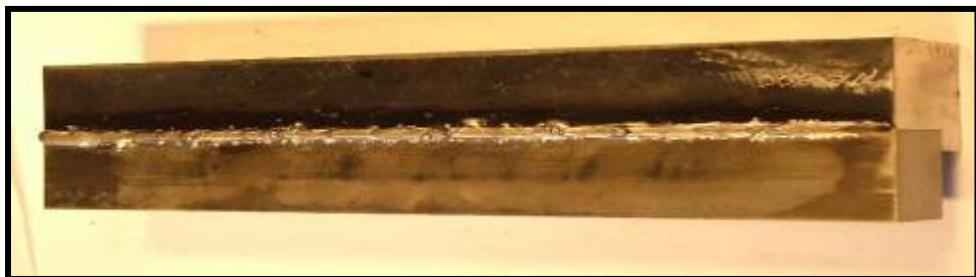
**Figure 4. Typical completed E-beam weld.**

After welding was completed, all three welds were visually inspected with favorable results. All three welds passed visual inspection. Figures 4 shows a typical completed weld.

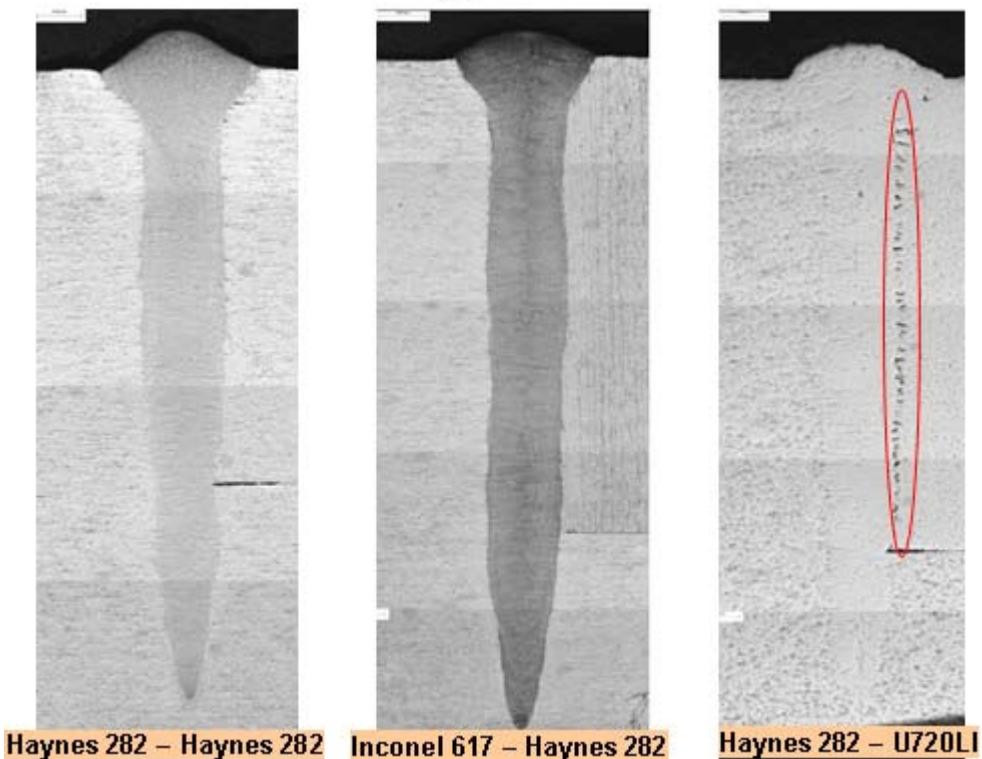
**Figure 6.** Metallographic examination in Trial 1 confirming ultrasonic examination findings including defects in the Haynes 282 to Udiment 720Li joint.

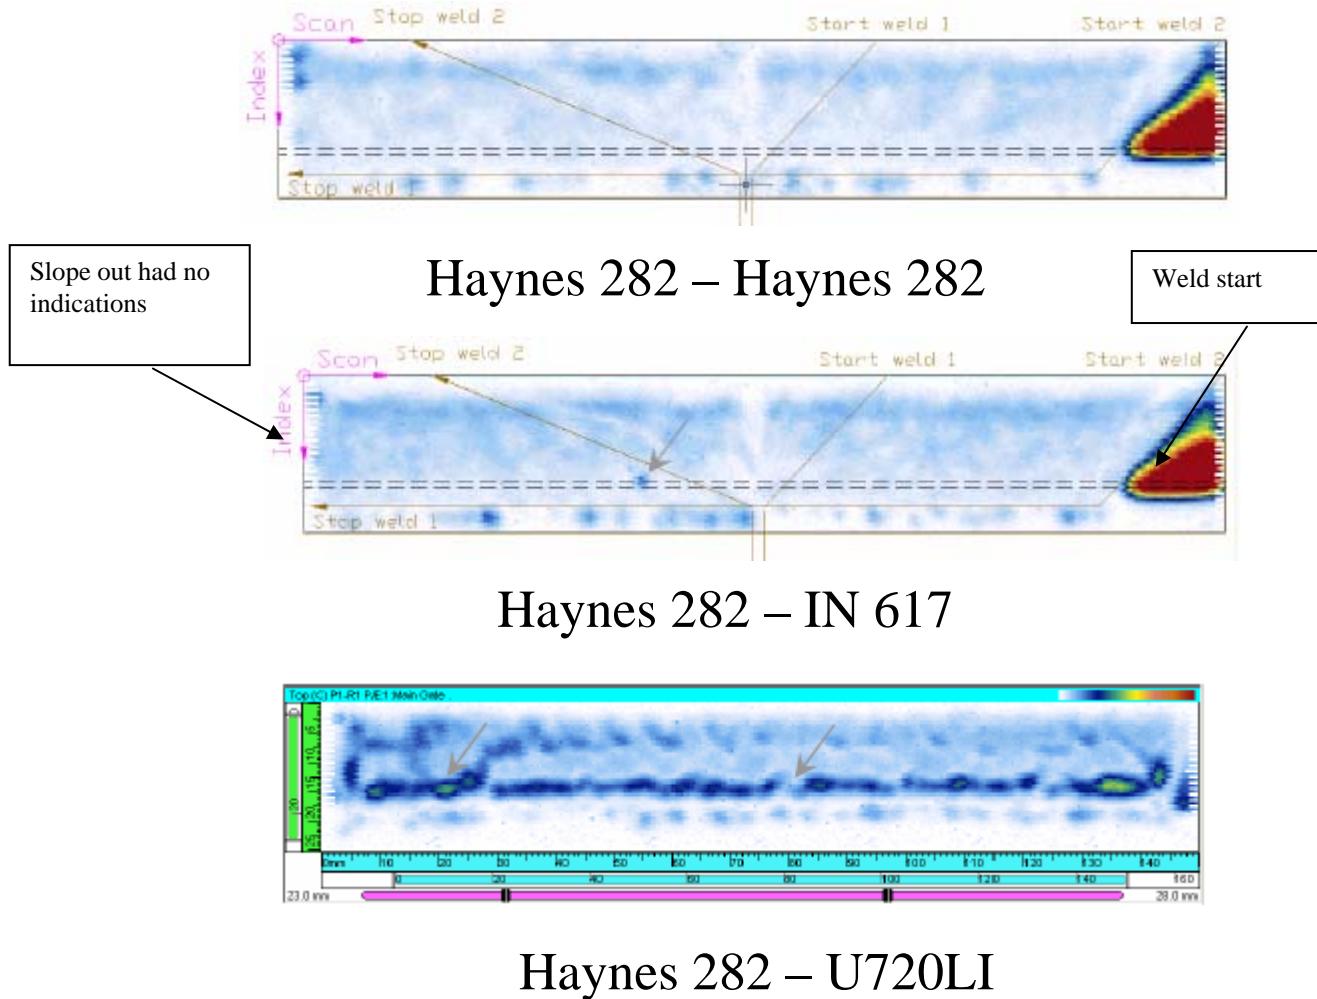
**Figure 8. Ultrasonic immersions results for trial 2.**

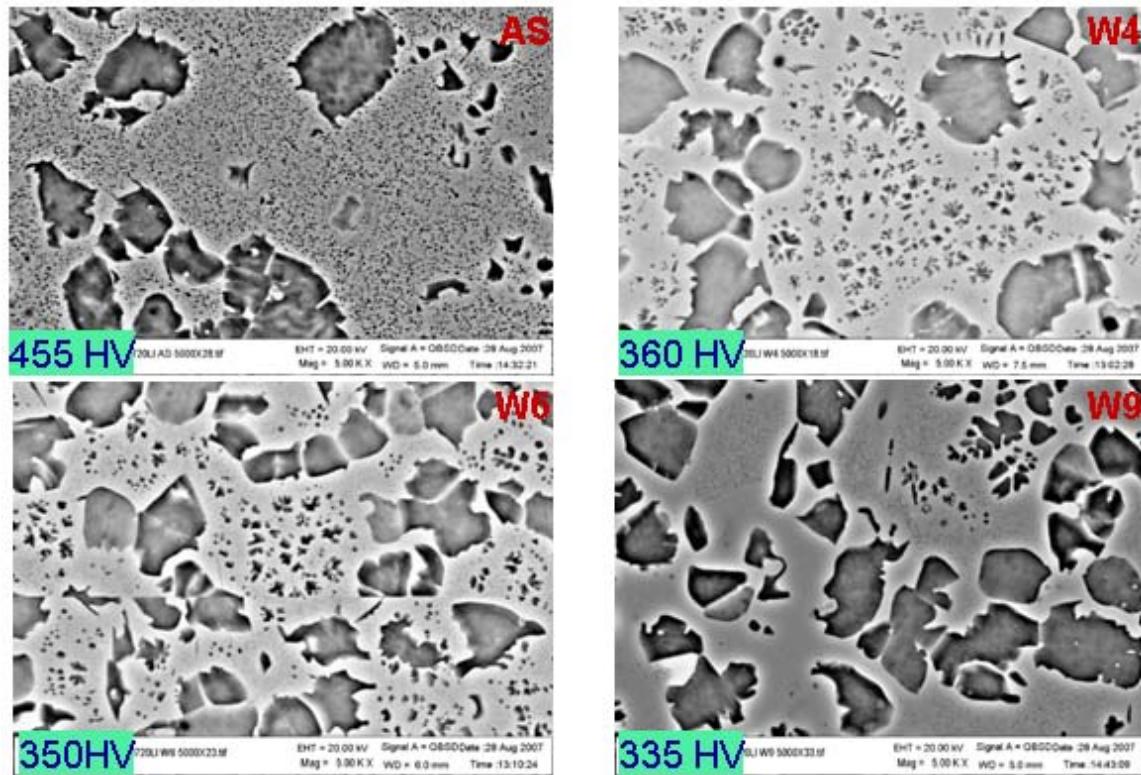
**Figure 10 Microstructures of the as-received, W-4, W-6 and W-9 heat treatments as well their corresponding average Vickers hardness values.**

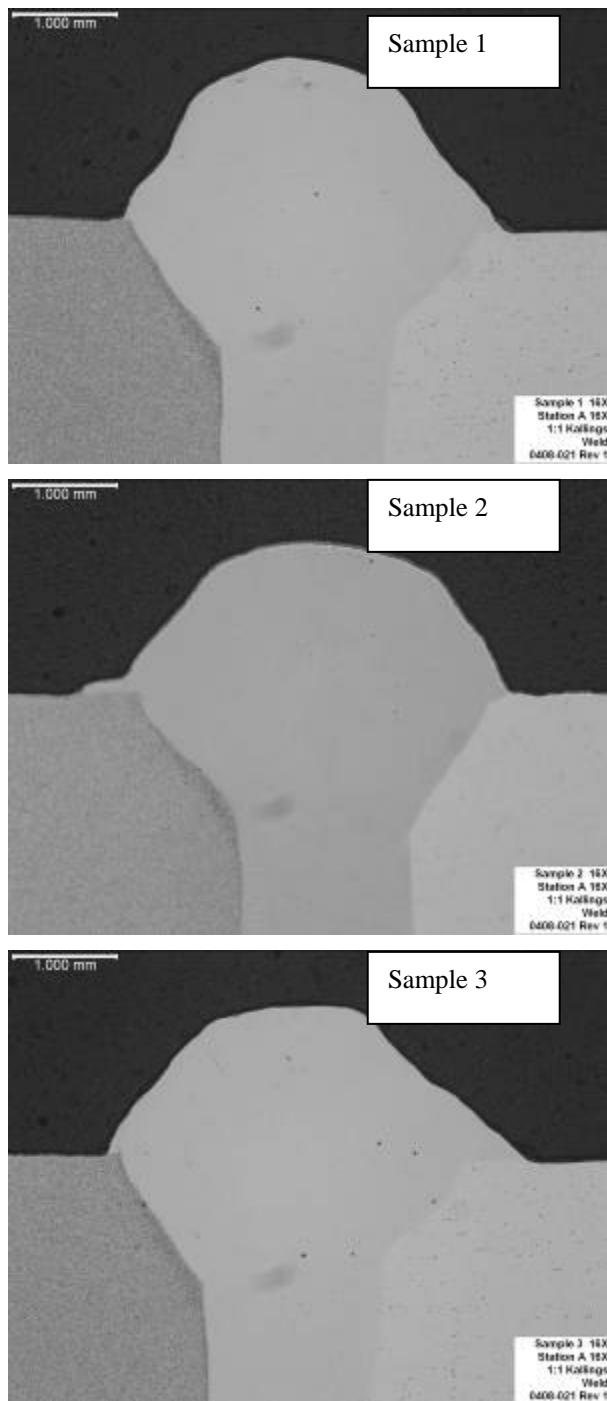
**Figure 13. Metallographic results of post-weld heat treatments 1-3 on U720Li to Haynes 282 for Trial 3.**

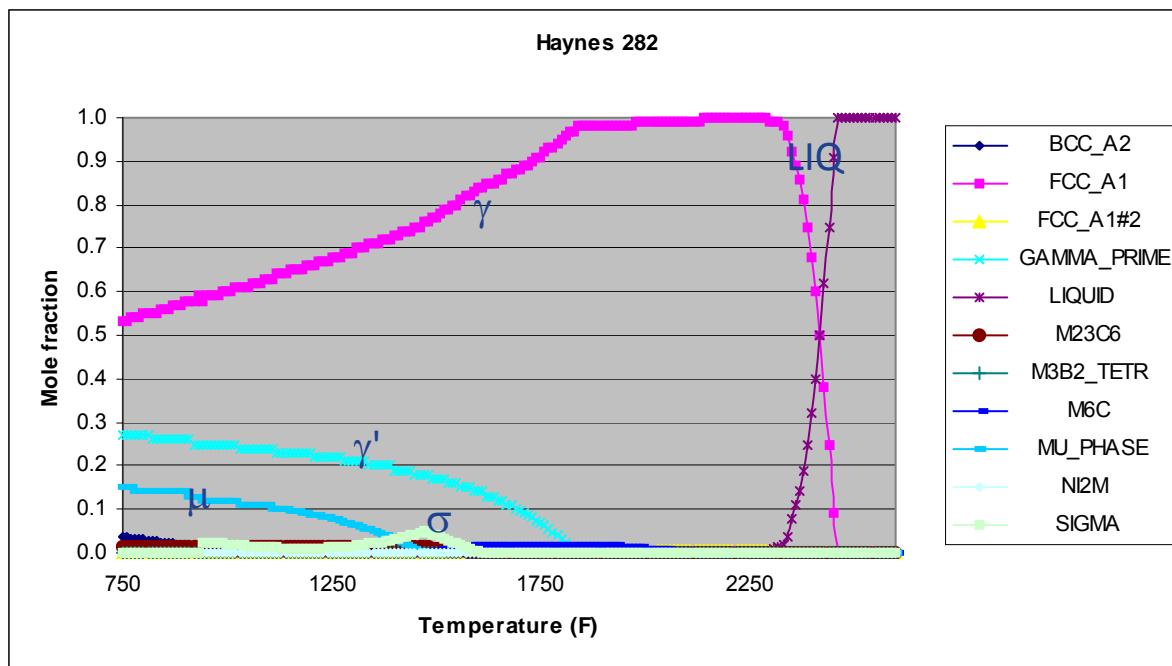
Figure 4: ThermoCalc phase diagram for Haynes 282 showing ideal mole fractions of  $\gamma$ ,  $\gamma'$ ,  $\mu$  and  $\sigma$ .

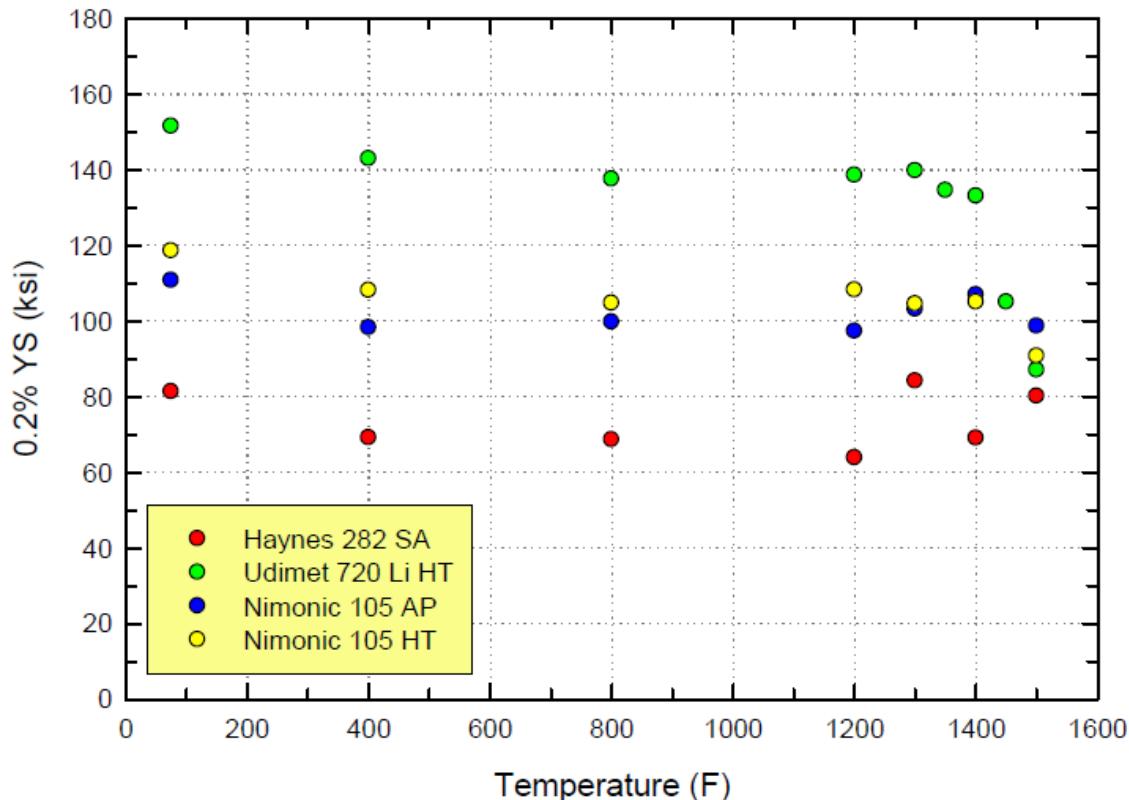
**Figure 10: 0.2% YS as a function of temperature for Haynes 282 SA, Udimet 720Li HT, Nimonic 105 AP, and Nimonic 105 HT.**
