# **Report Title: Steam Turbine Materials for Ultrasupercritical Coal Power Plants**

**Type of Report:** Final Technical Report

DOE Award Number DE-FC26-05NT42442

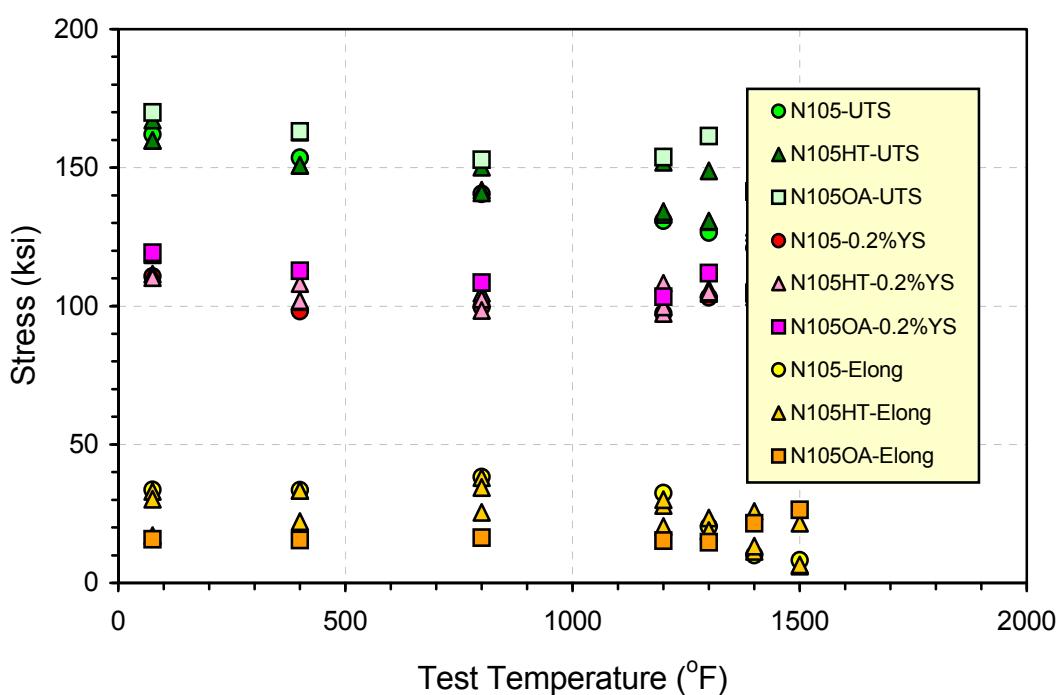
**Figure 11: Mechanical behavior as a function of temperature for Nimonic 105, all processing and heat treatment conditions.**

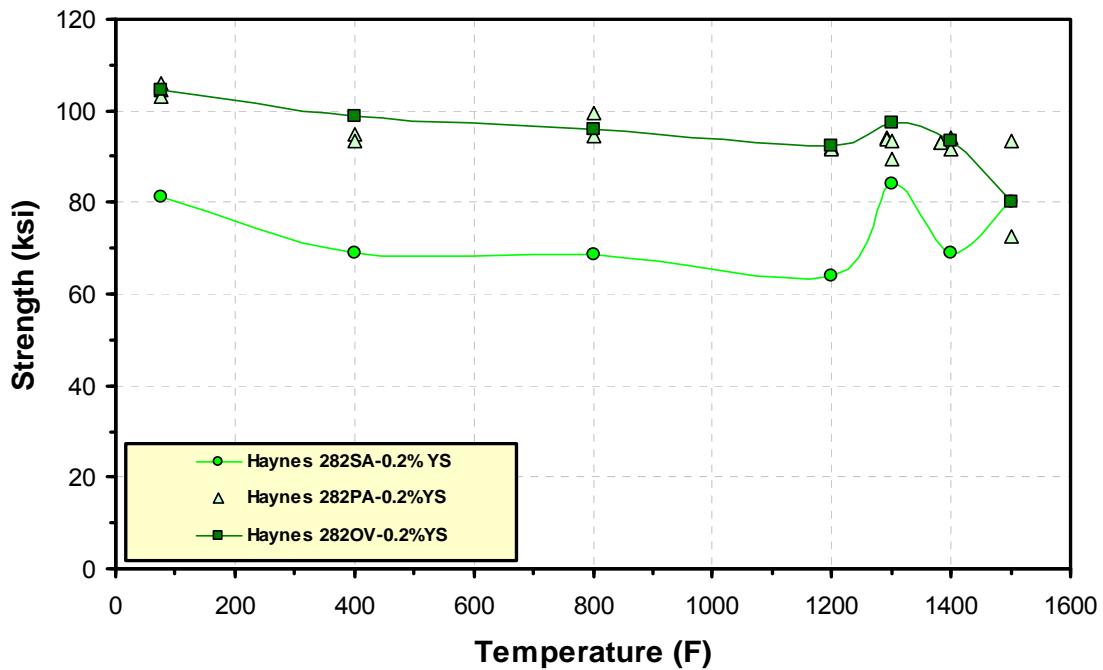
Figure 34: Yield strength (ksi) versus temperature for Haynes 282 alloy in solution annealed, peak aged and overaged conditions.

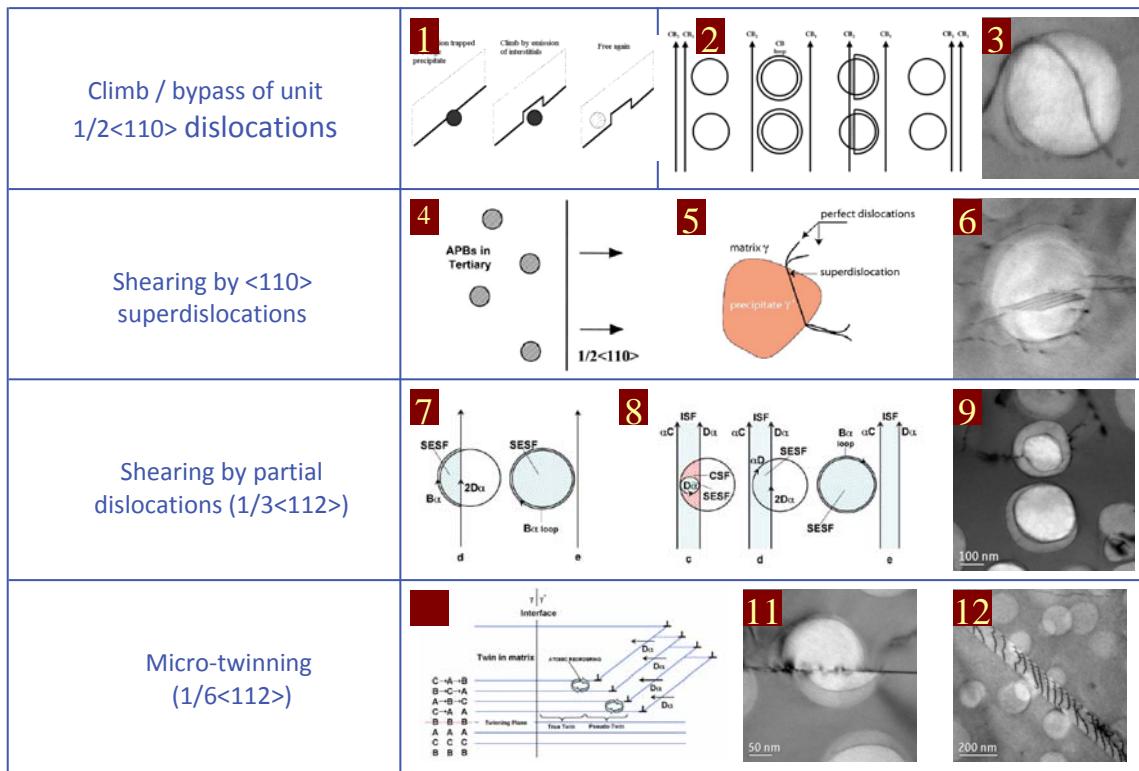
**Figure 35: Potential deformation mechanisms that operate in nickel-base alloys. From the top there is dislocation climb, particle shearing and micro-twinning.**

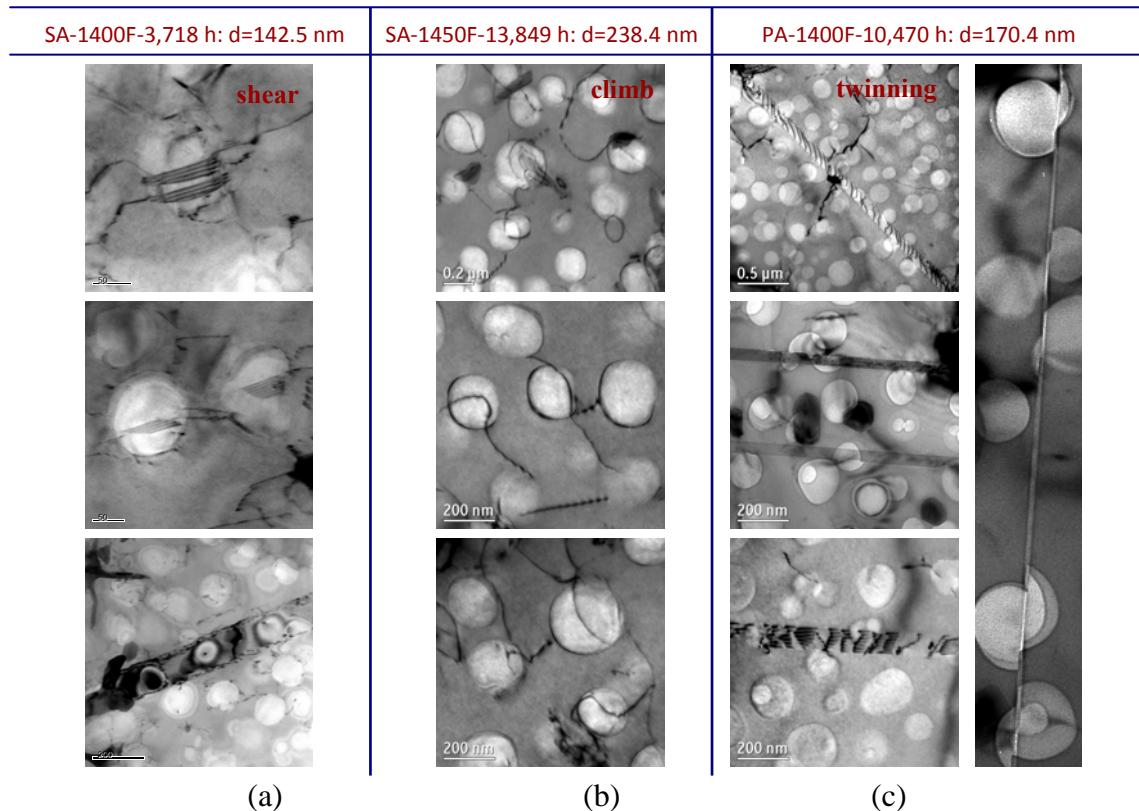
**Figure 35: Observed deformation mechanisms in Haynes 282. From the left ther is (a) shear of  $\gamma'$  precipitates as a consequence of high stress creep conditions, (b) particle climb (and Orowan looping) as a consequence of higher temperature conditions (1450°F compared to 1400°F) and (c) micro-twinning at low temperature and low stress.**

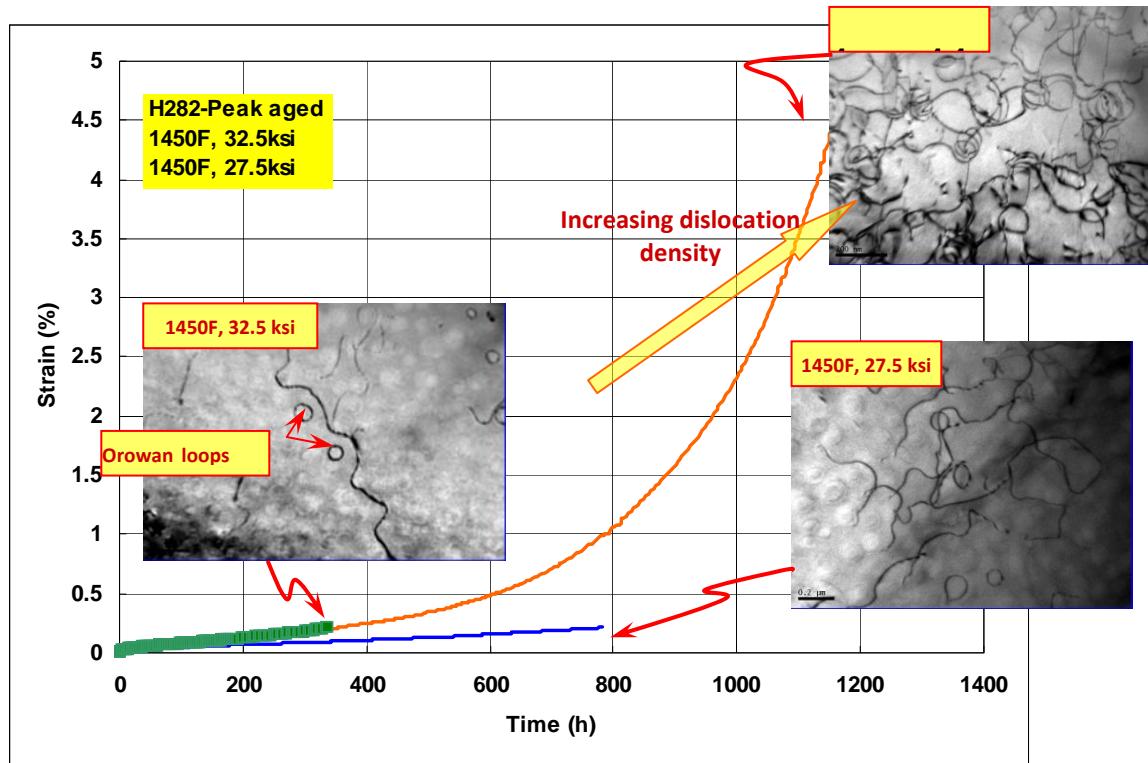
Figure 36: Composite representation that shows the dislocation interaction within the  $\gamma$  matrix for various temperature-stress conditions.

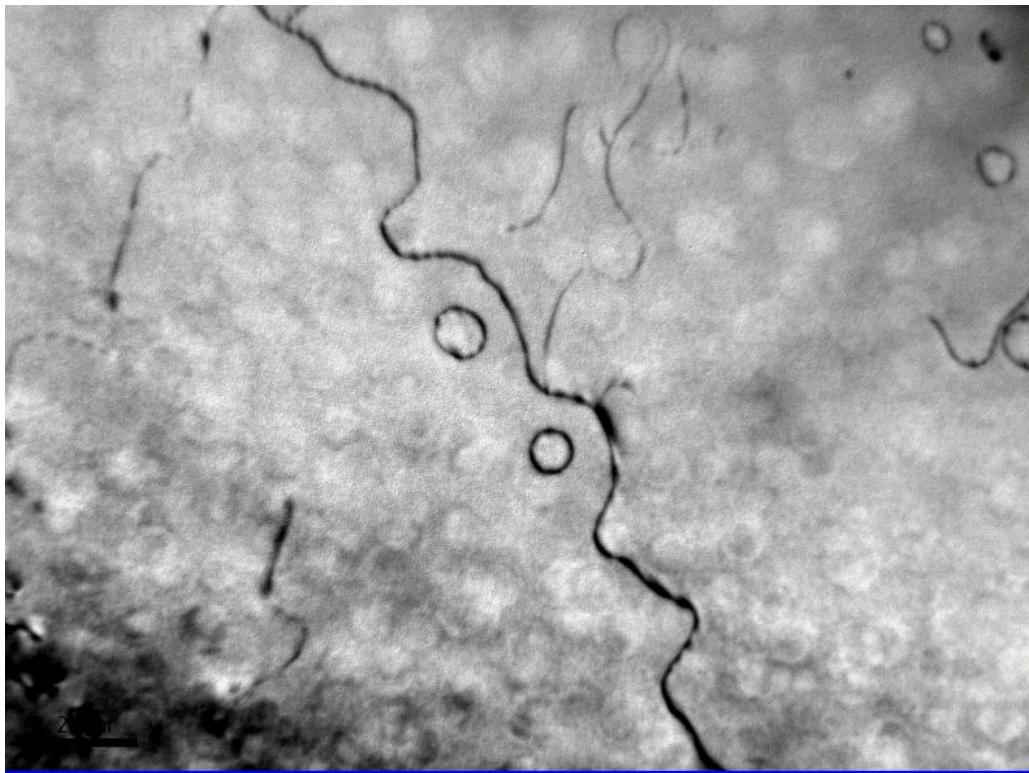
**Figure 38: High magnification of image of Orowan left behind after dislocation moved through the matrix. High magnification view of dislocation line and Orowan loops from Figure 37(a). Sample tested at 1450°F and 32.5 ksi. Crept to 0.2% strain.**

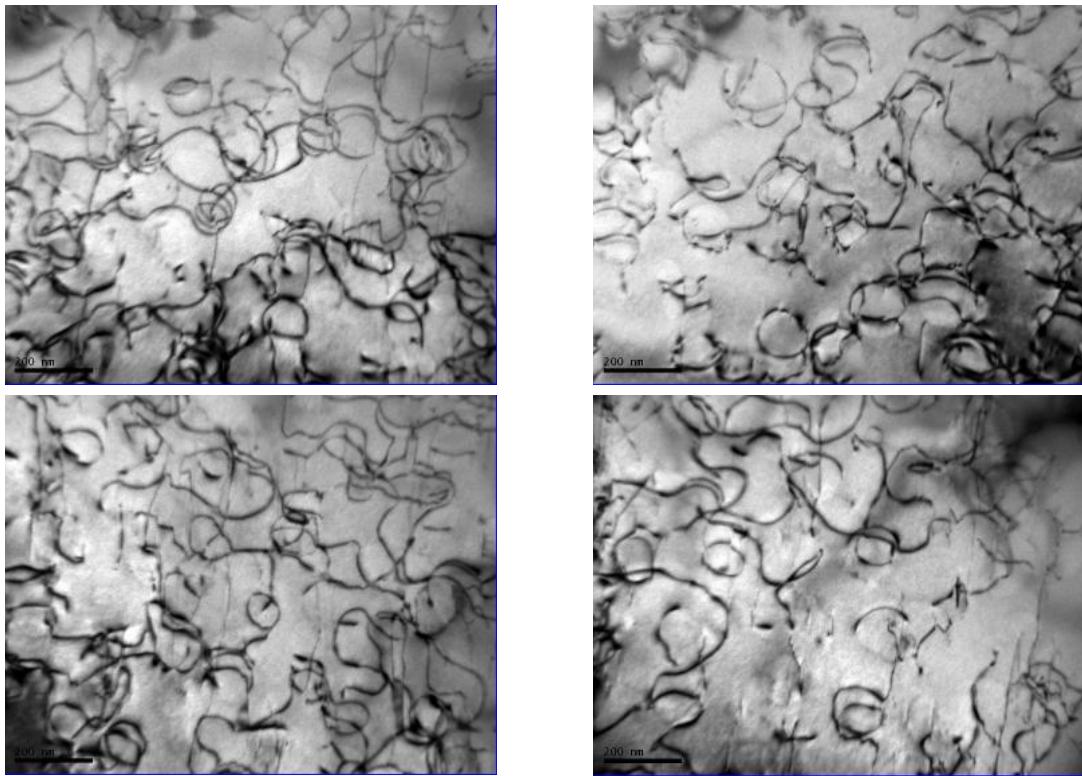
**Figure 39:** Various views of the  $\gamma$  matrix showing Orowan loops, particle-dislocation interactions and cross-slip. Sample tested at 1450°F and 32.5 ksi. Crept to 4.0% strain.

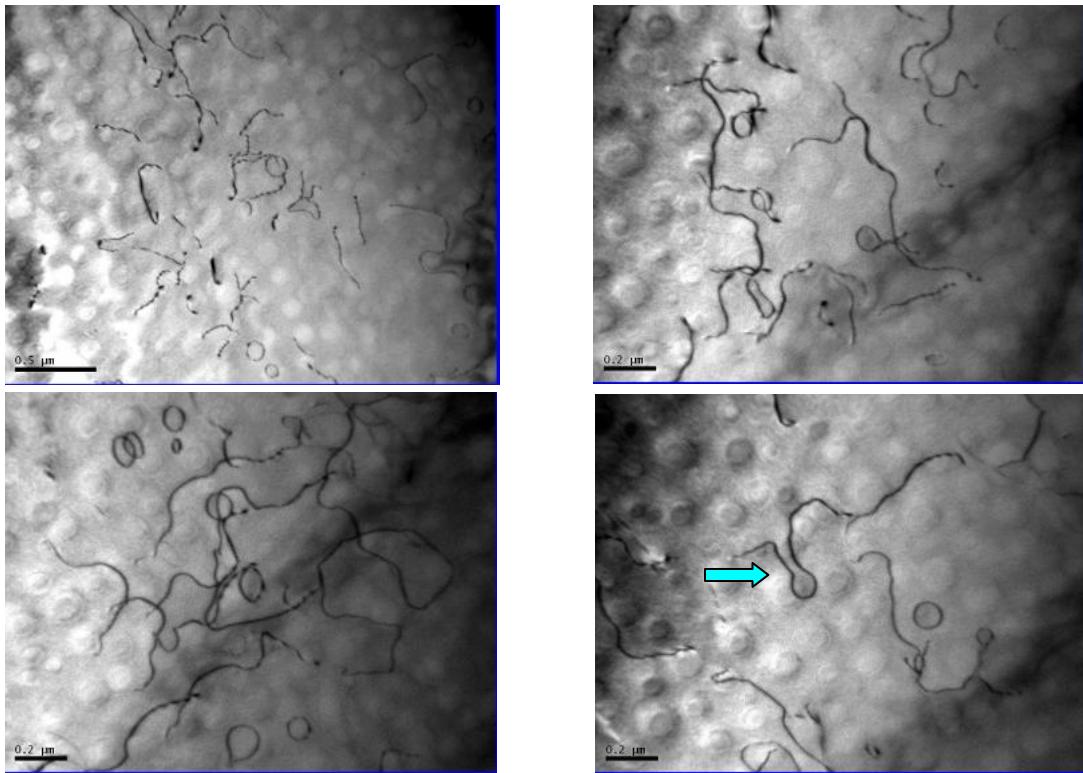
**Figure 40: Various views of the  $\gamma$  matrix showing Orowan loops, particle-dislocation interactions and cross-slip. Sample tested at 1450°F and 27.5 ksi. Crept to 0.2% strain.**

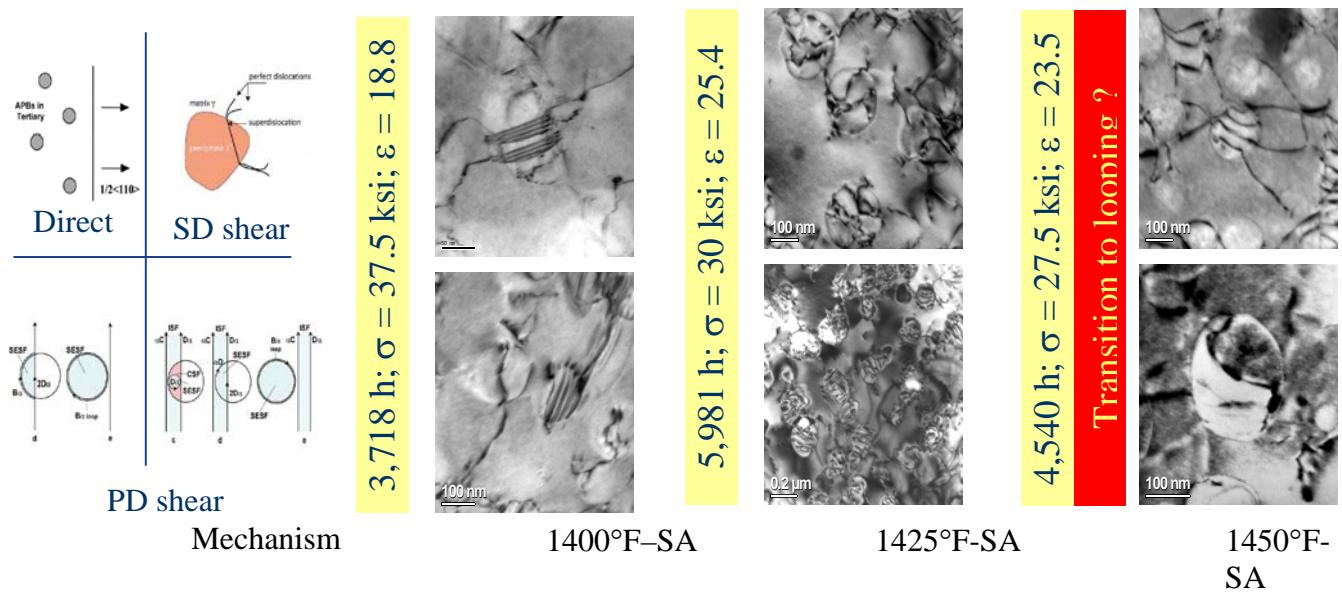
The short-term specimens were tested to rupture and exhibit clearly a cutting/shearing mechanism. The elongations-to-failure for these three samples was between about 19% and 25%. Clearly, this is a high-stress phenomenon and does not affect the overall creep ductility of the alloy.

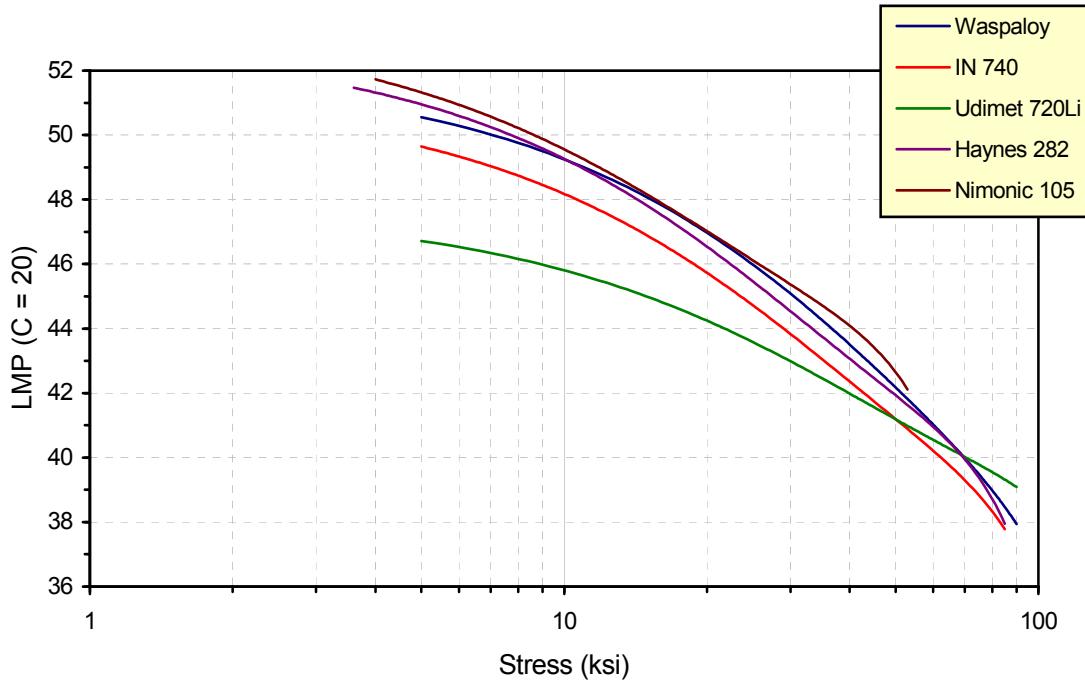
Figure 45: LMP versus stress for 1400°F candidate alloys for steam turbine rotor.

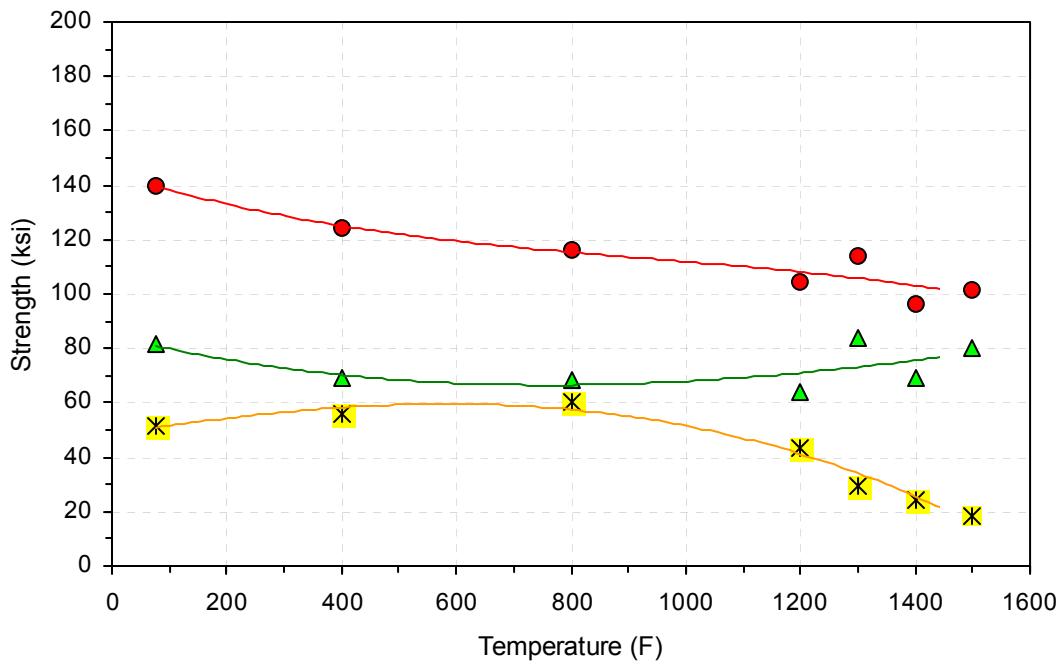
**Figure 3.1:** Graph showing the 0.25%YS, UTS and elongation for Haynes 282 from room temperature to 1500°F in the solution annealed condition.

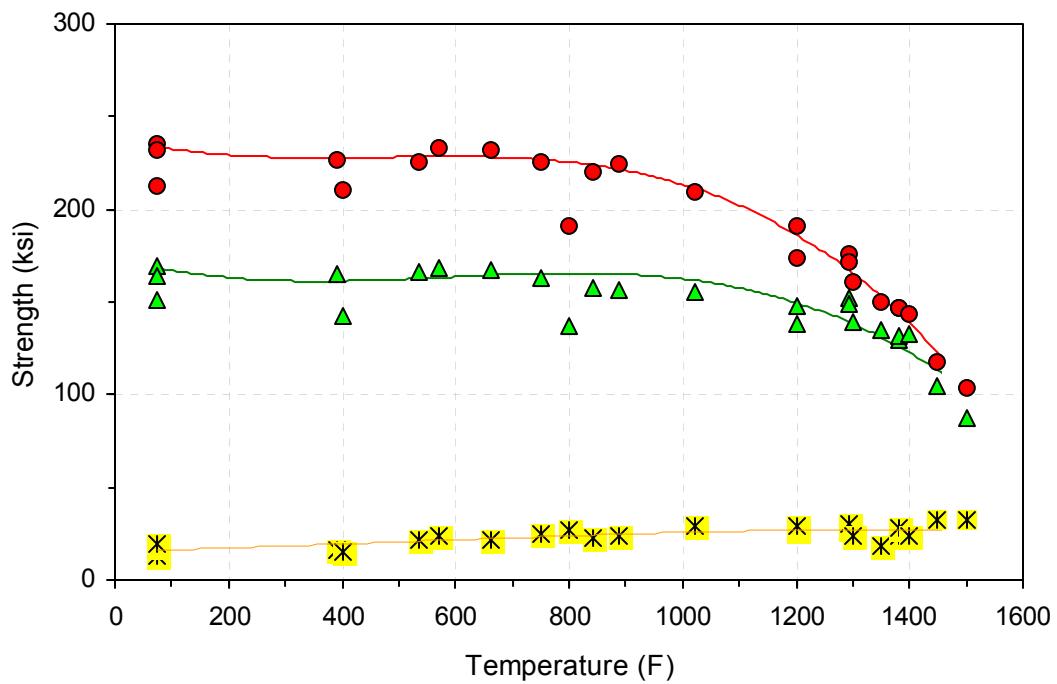
**Figure 3.5: Graph showing the 0.25% YS, UTS and elongated for Udimet 720 from room temperature to 1500°F in the peak aged condition.**

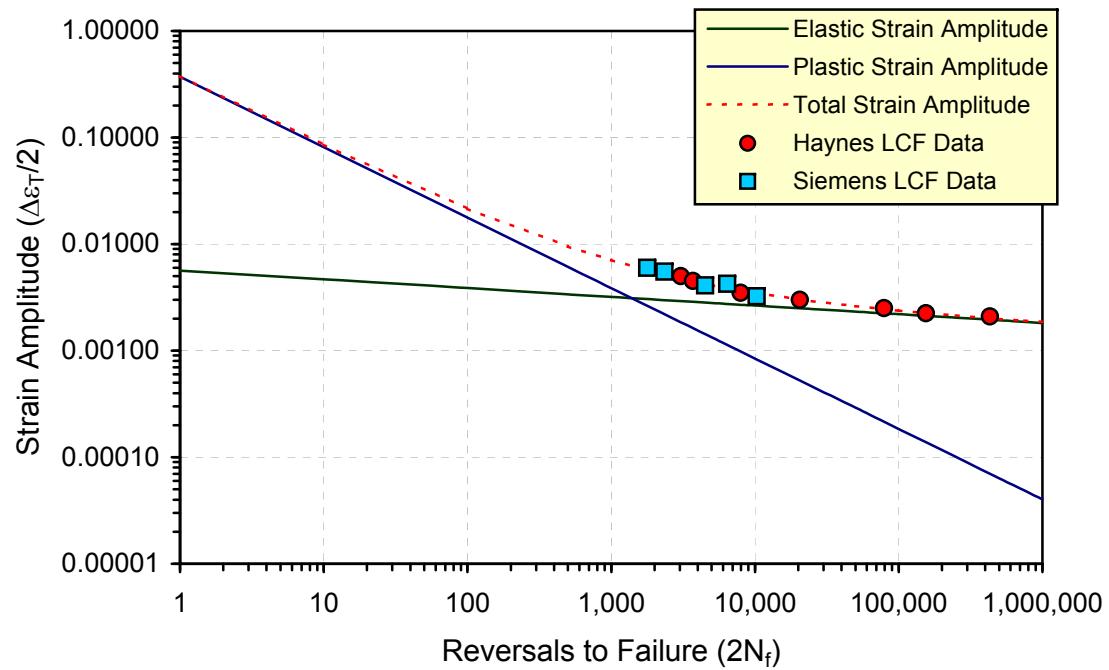
Figure 4.2: Strain amplitude versus reversals to failure for Haynes 282 at 1400°F and  $R = -1$

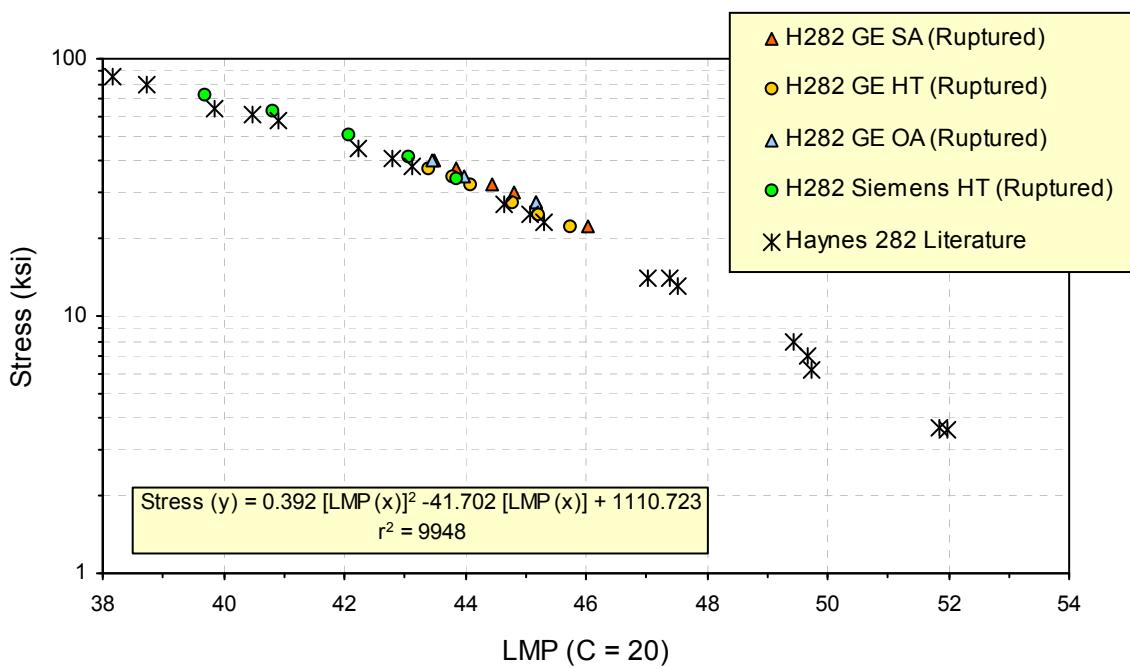
Figure 5.1: Stress (ksi) versus LMP (C = 20) for Haynes 282 in three alloy conditions: solution annealed (SA), heat treated to peak age (HT), and overaged (OA).

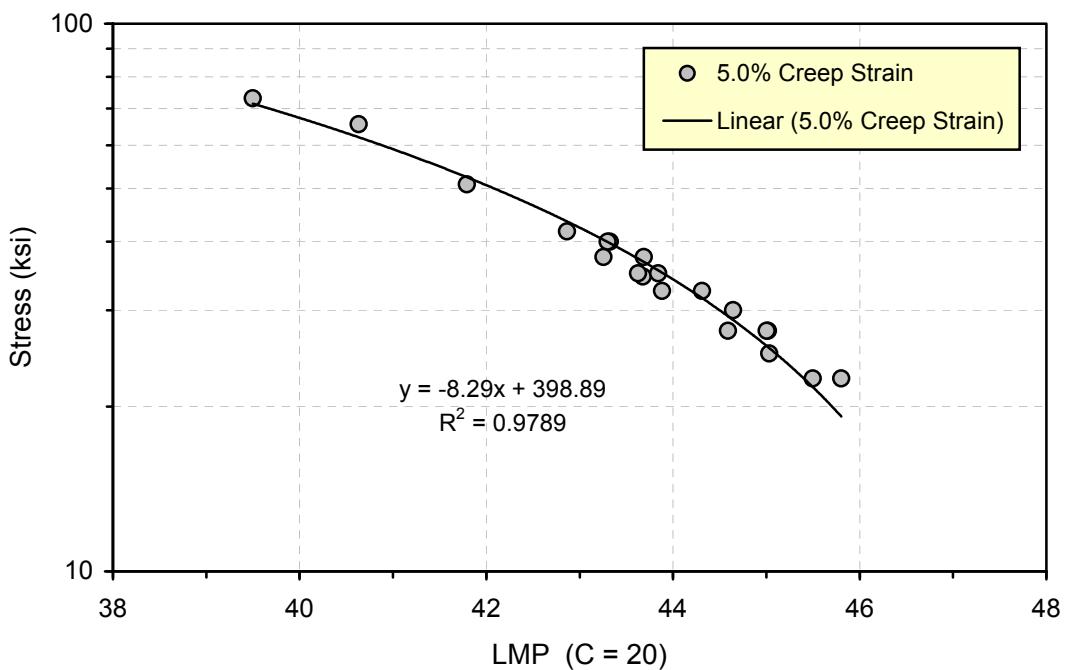
Figure 5.8: Stress (ksi) versus LMP (C = 20) at 5.0 creep strain for Haynes 282.

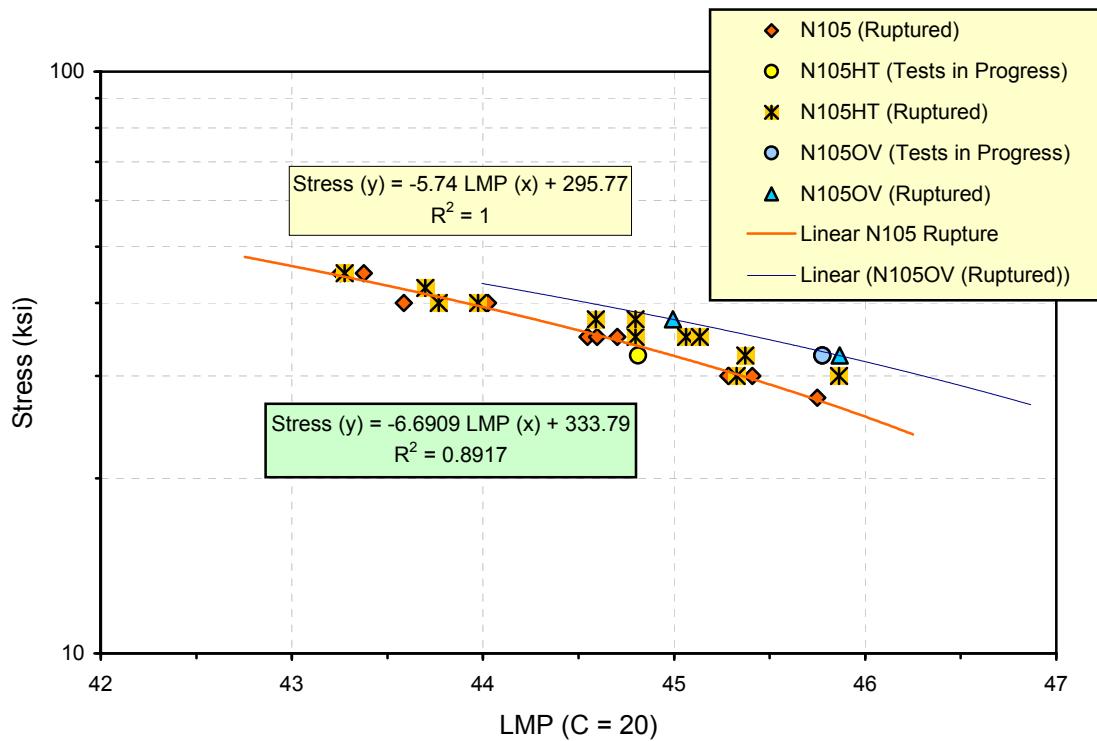
Figure 5.9: Stress (ksi) versus LMP (C = 20) for Nimonic 105 in three alloy conditions as-processed (AP), heat treated to peak age (HT), and overaged (AG), or heat conditions, state (OV).

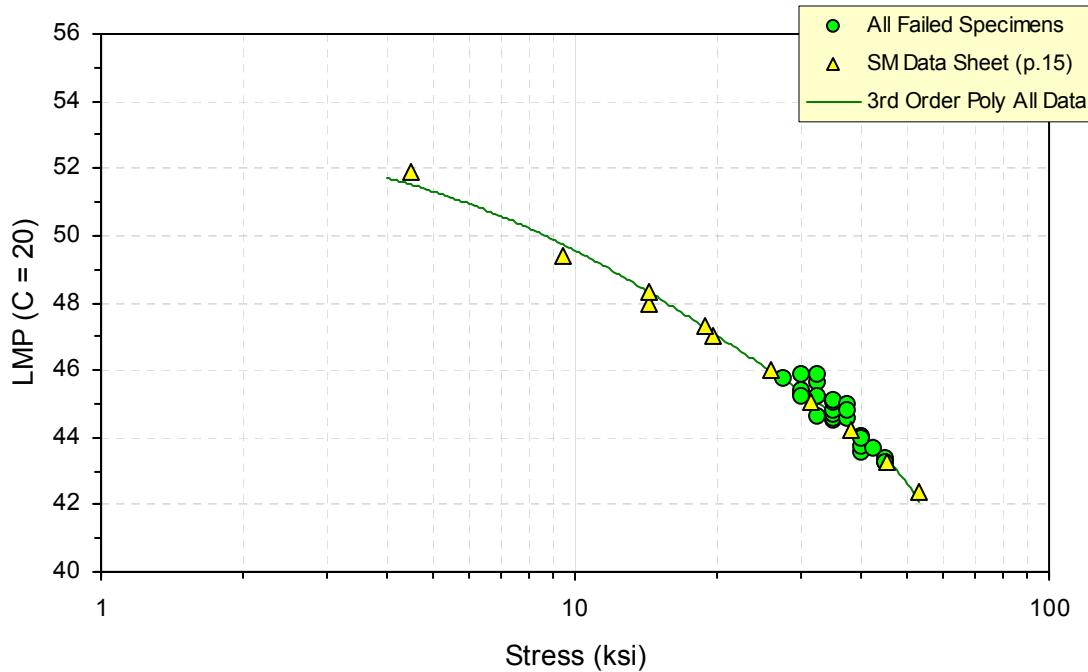
Figure 5.10: Stress (ksi) versus LMP (C = 20) for combined Nimonic 105 rupture data.

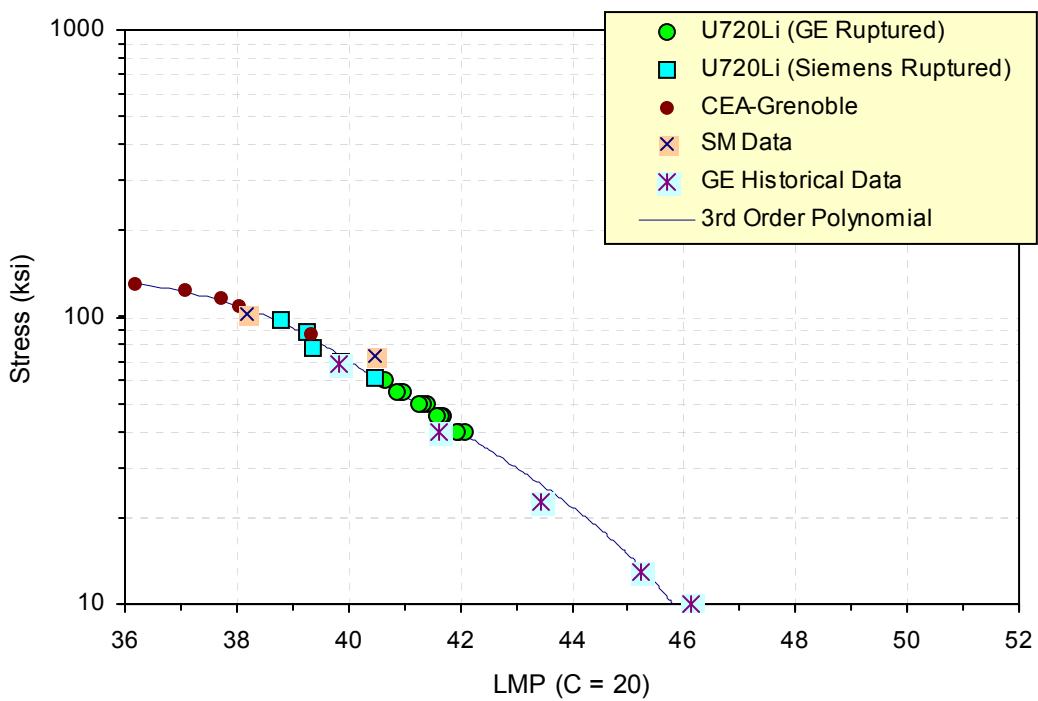
**Figure 5.16: Stress (ksi) versus LMP ( $C = 20$ ) for combined Udimet 720 rupture data (peak aged condition).**

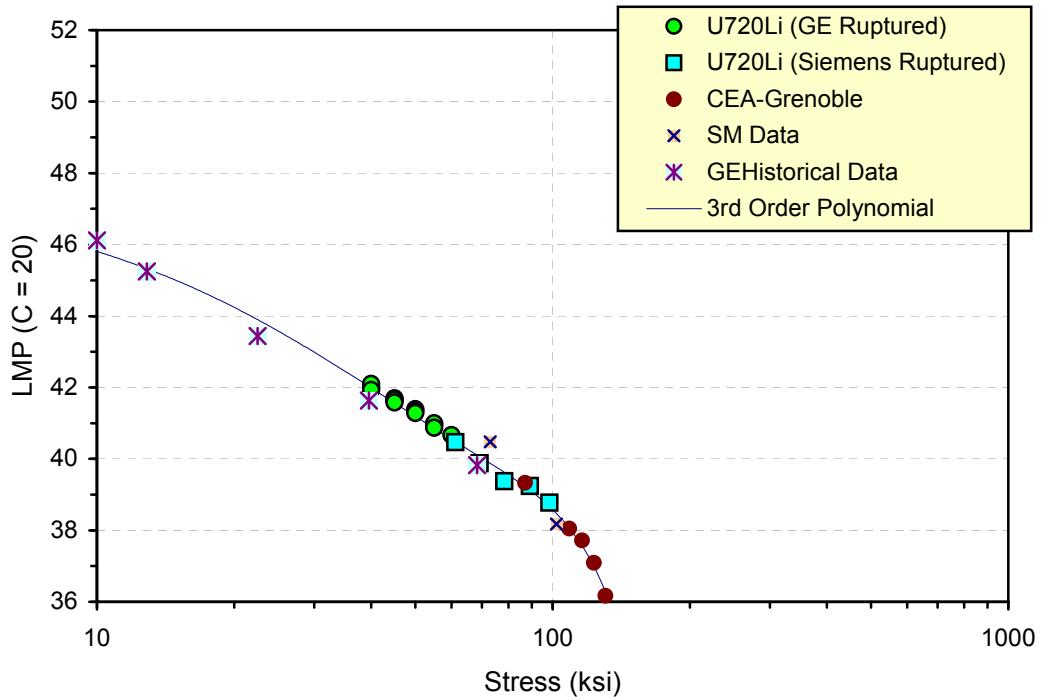
**Figure 5.18: LMP ( $C = 20$ ) versus Stress (ksi) for combined Udimet 720 rupture data (peak aged condition).**

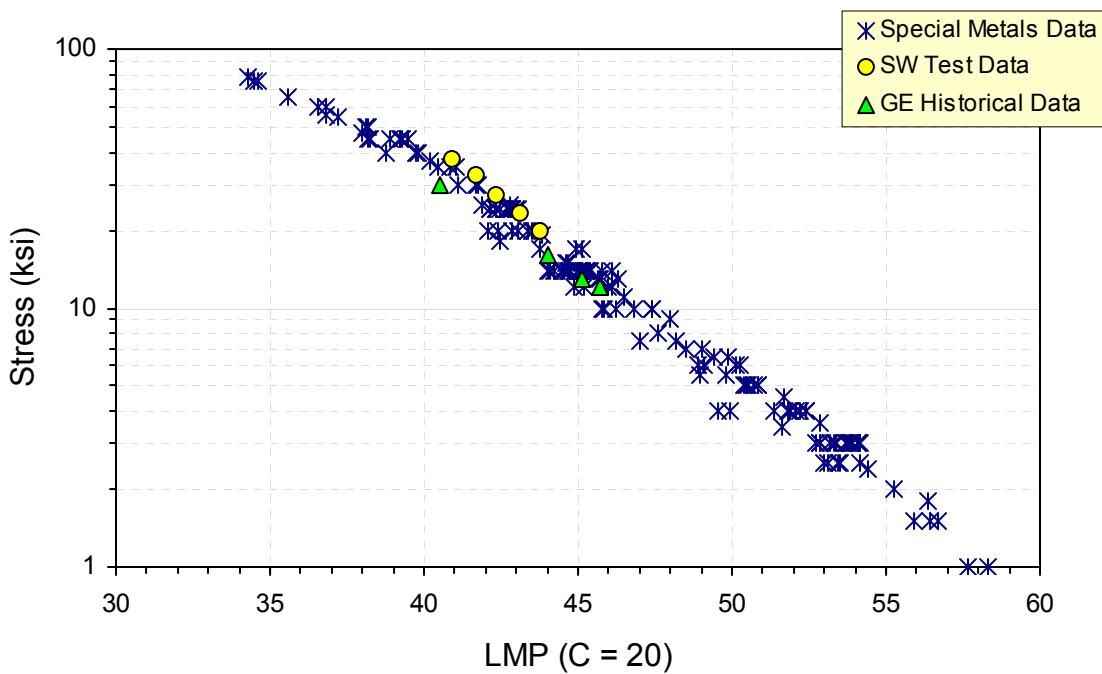
**Figure 5.25: Stress (ksi) versus LMP (C = 20) for Inconel 617 in the solution annealed condition.**  
**Note: SM data not included in Appendix tables.**

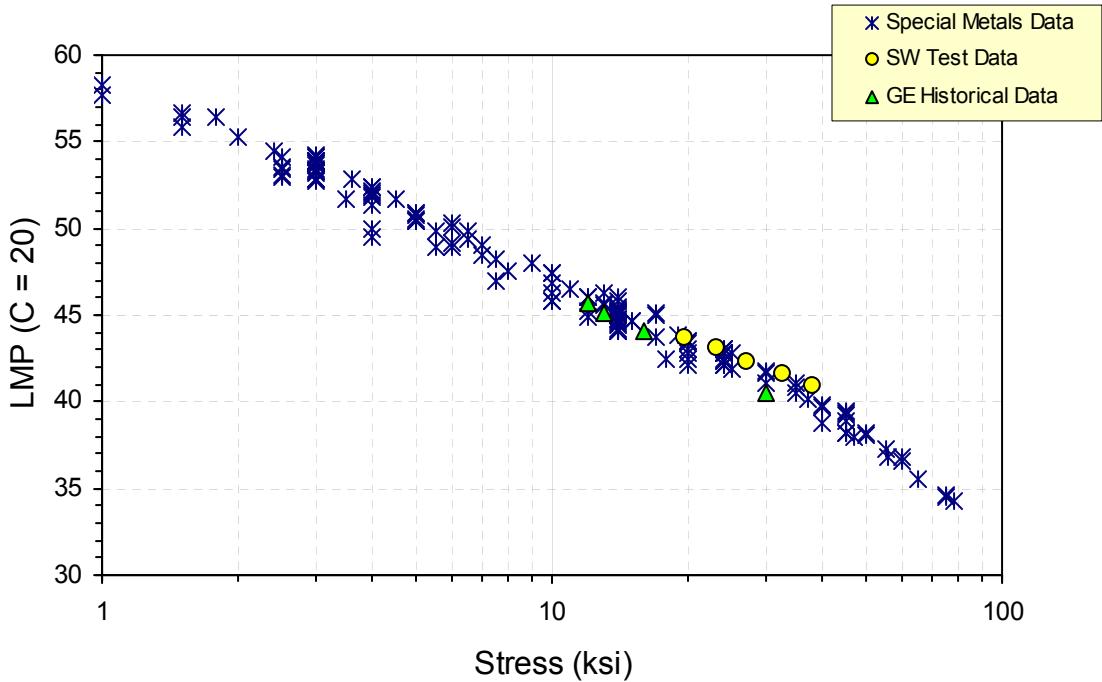
**Figure 5.26: LMP (C = 20) versus Stress (ksi) for Inconel 617 in the solution annealed condition.**  
**Note: SM data not included in Appendix Tables.**

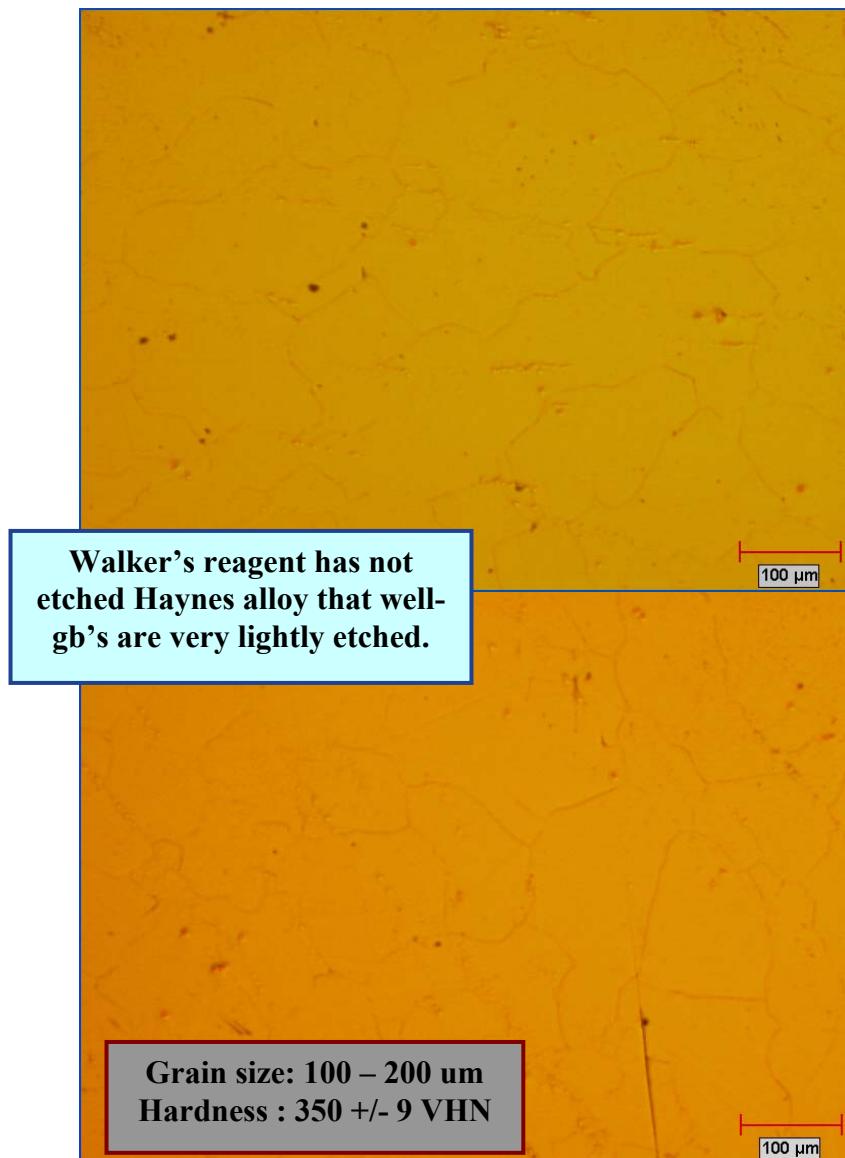
Figure 6.1: Optical micrograph of etched Haynes 282 in the solution annealed condition.

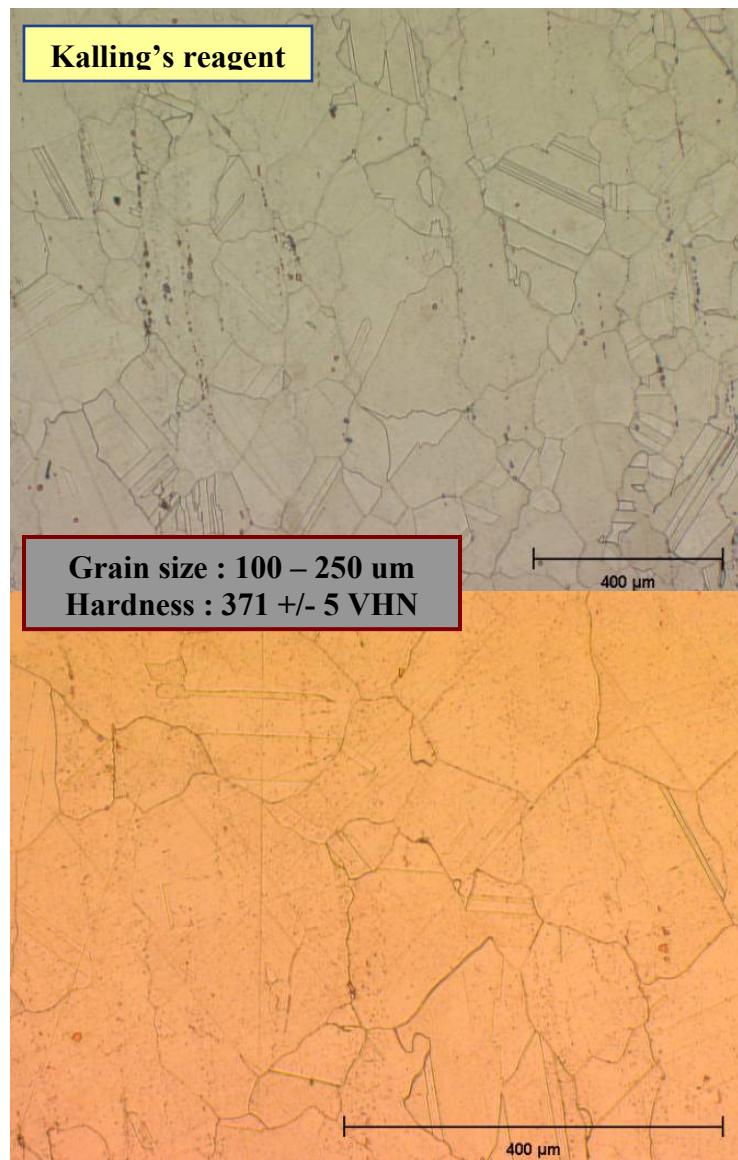
Figure 6.2: Optical micrograph of etched Haynes 282 in the peak aged condition.

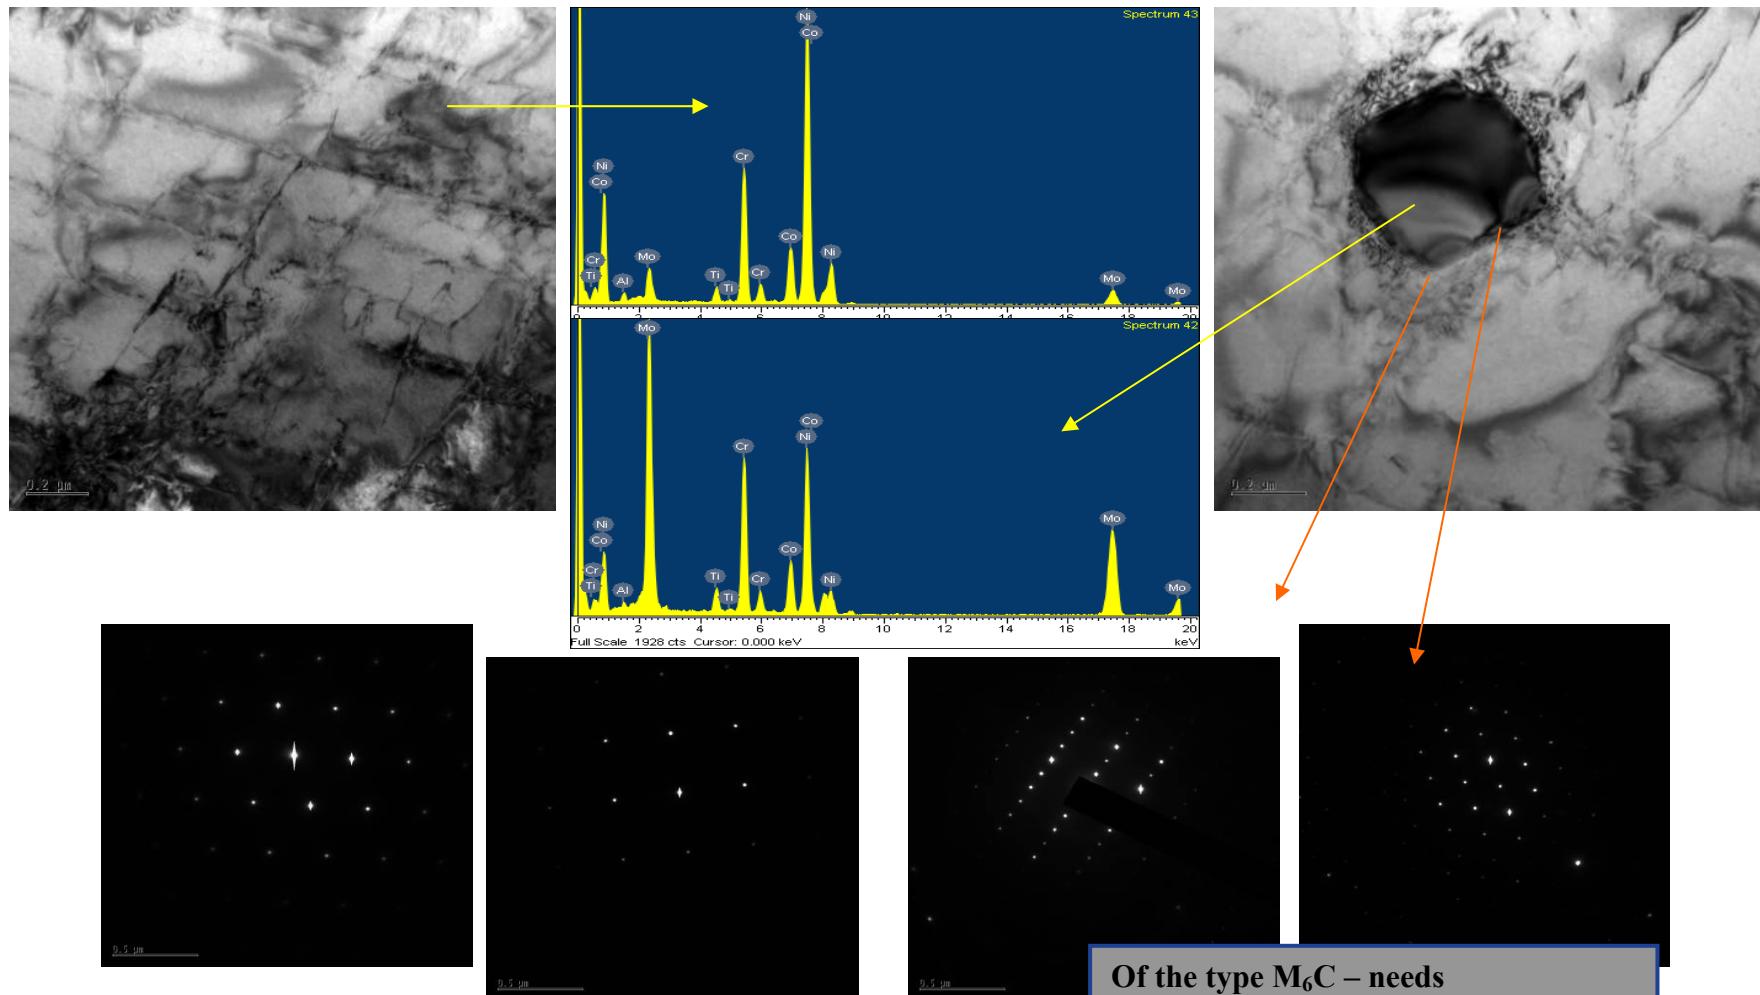
Figure 6.4: TEM micrographs and SAD patterns of Haynes 2828 microstructure in SA condition showing general matrix area (left upper micrograph),  $M_6C$  carbide (upper right) and SAD patterns (lower figures) with EDS (center).

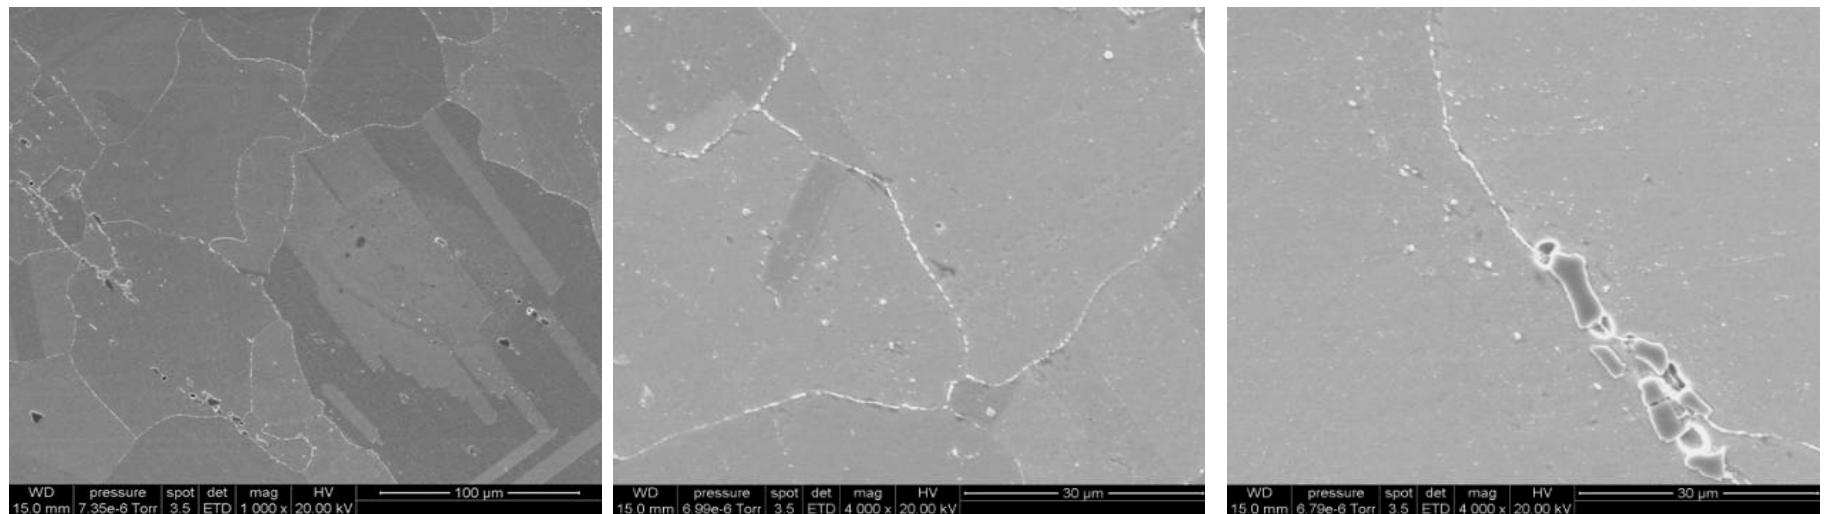
Grain boundaries decorated by fine carbides.
