# **Report Title: Steam Turbine Materials for Ultrasupercritical Coal Power Plants**

**Type of Report:** Final Technical Report

DOE Award Number DE-FC26-05NT42442

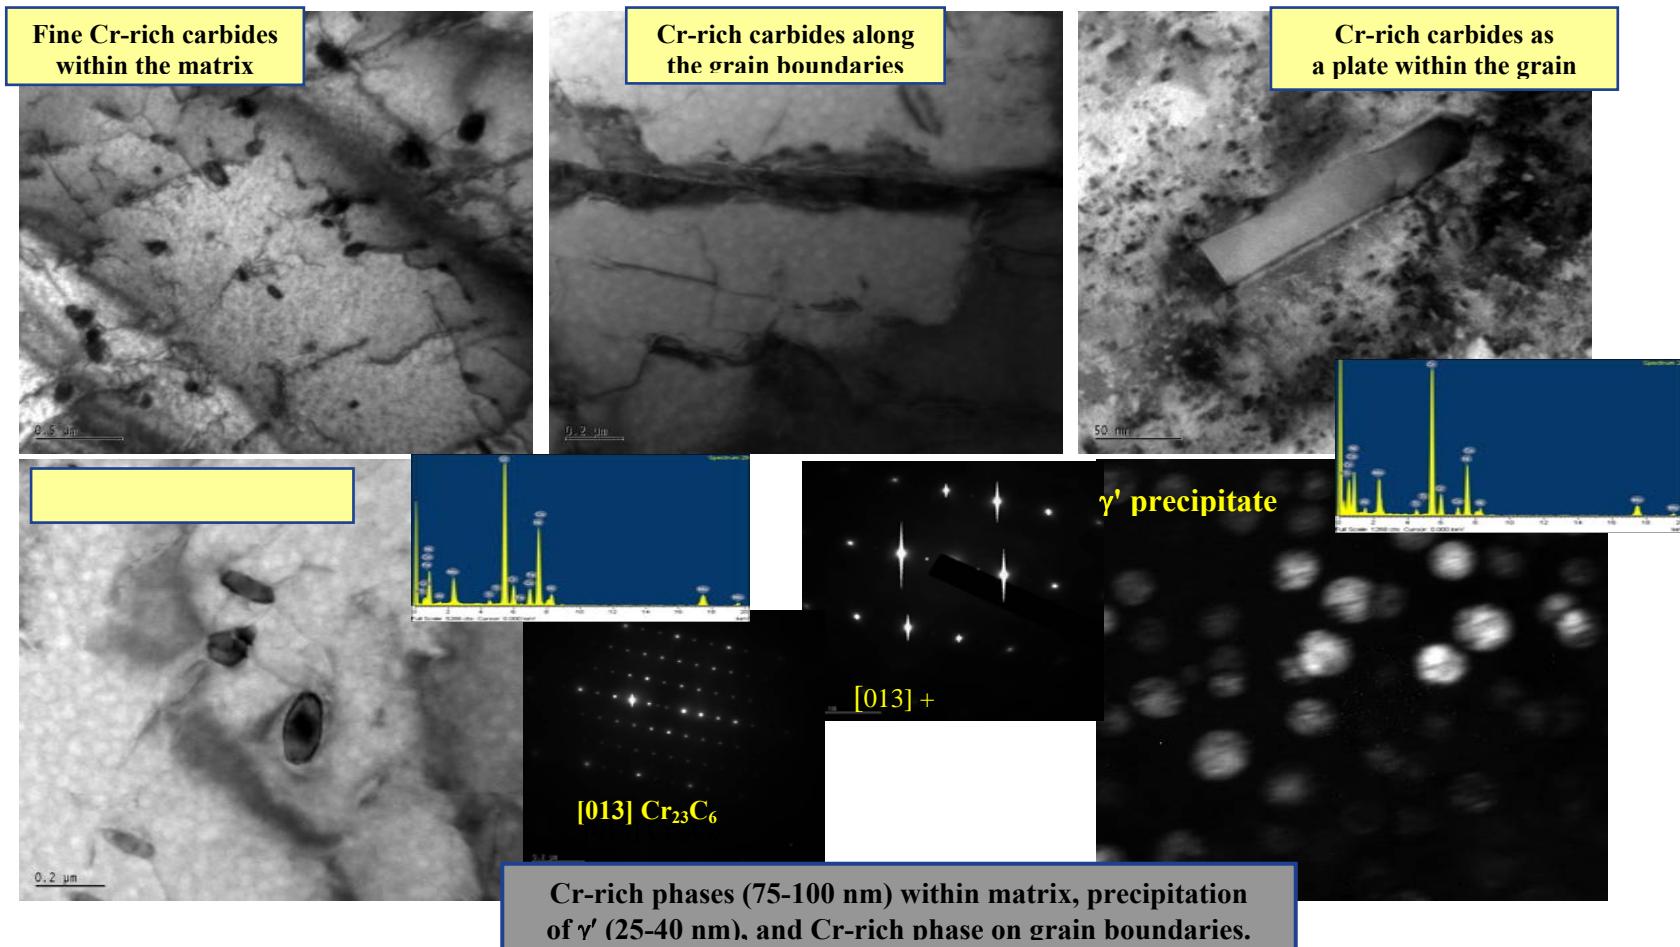
Figure 6.6: TEM micrographs and SAD patterns of Haynes 282 microstructure in PA condition showing general matrix area with various carbides (upper row and lower left), SAD patterns with EDS (lower center left) and  $\gamma'$  precipitates in the matrix (lower right) with associated SAD pattern with EDS of the matrix (upper center right and right center edge)

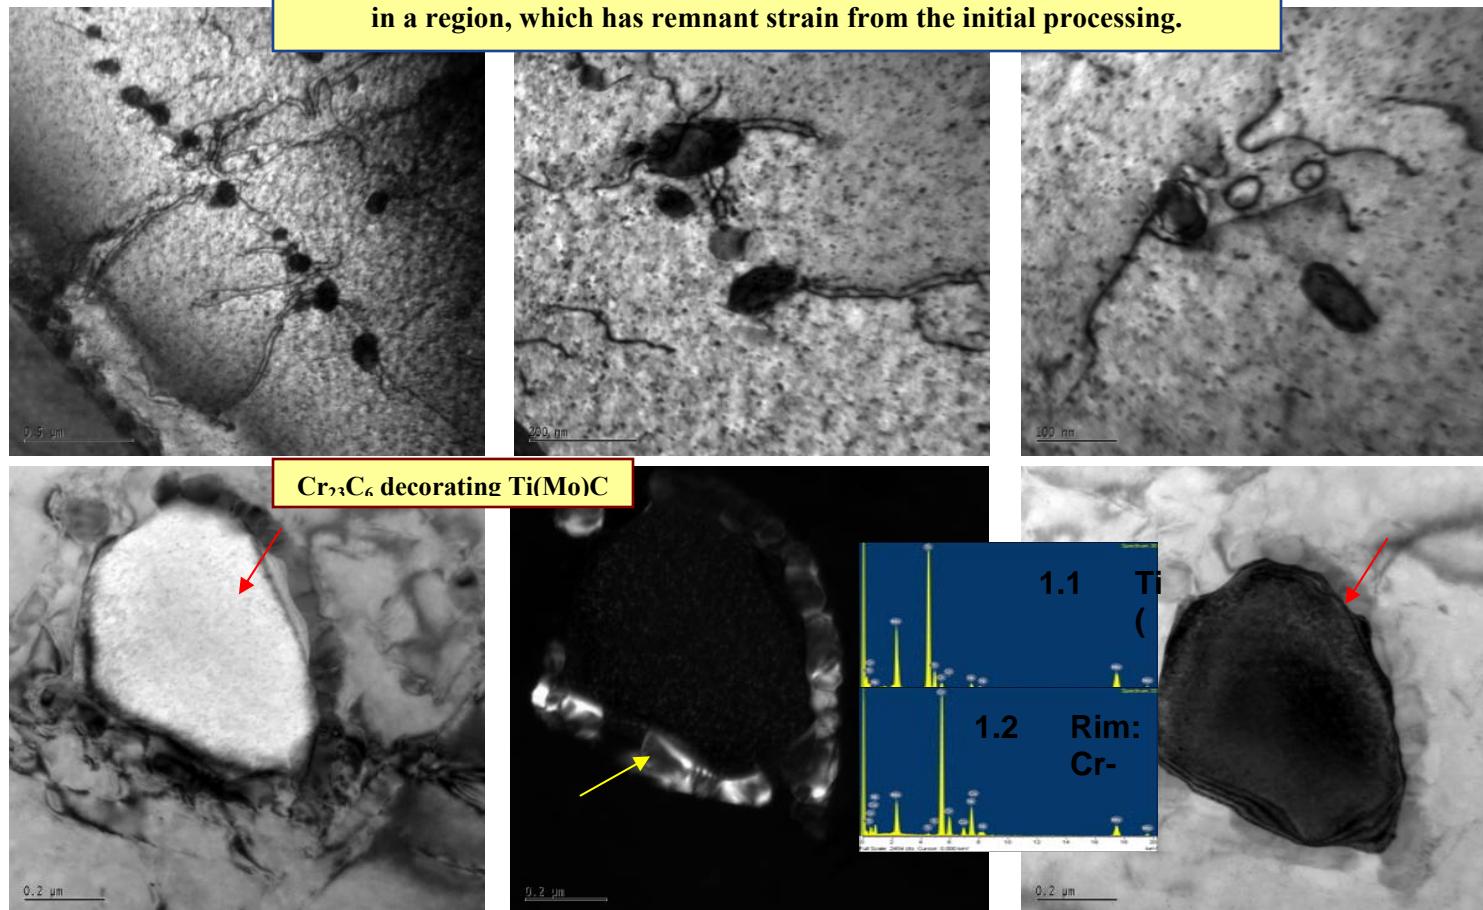
Figure 6.7: TEM micrographs of Haynes 282 microstructure in PA condition showing carbide arrangement that pin dislocations in a low energy boundary structure (upper row). In the bottom row of micrographs, note the ring of  $\text{Cr}_{23}\text{C}_6$  carbides decorating a larger  $\text{Ti}(\text{Mo})\text{C}$ -type carbide (EDS shows differences in carbide chemistry).

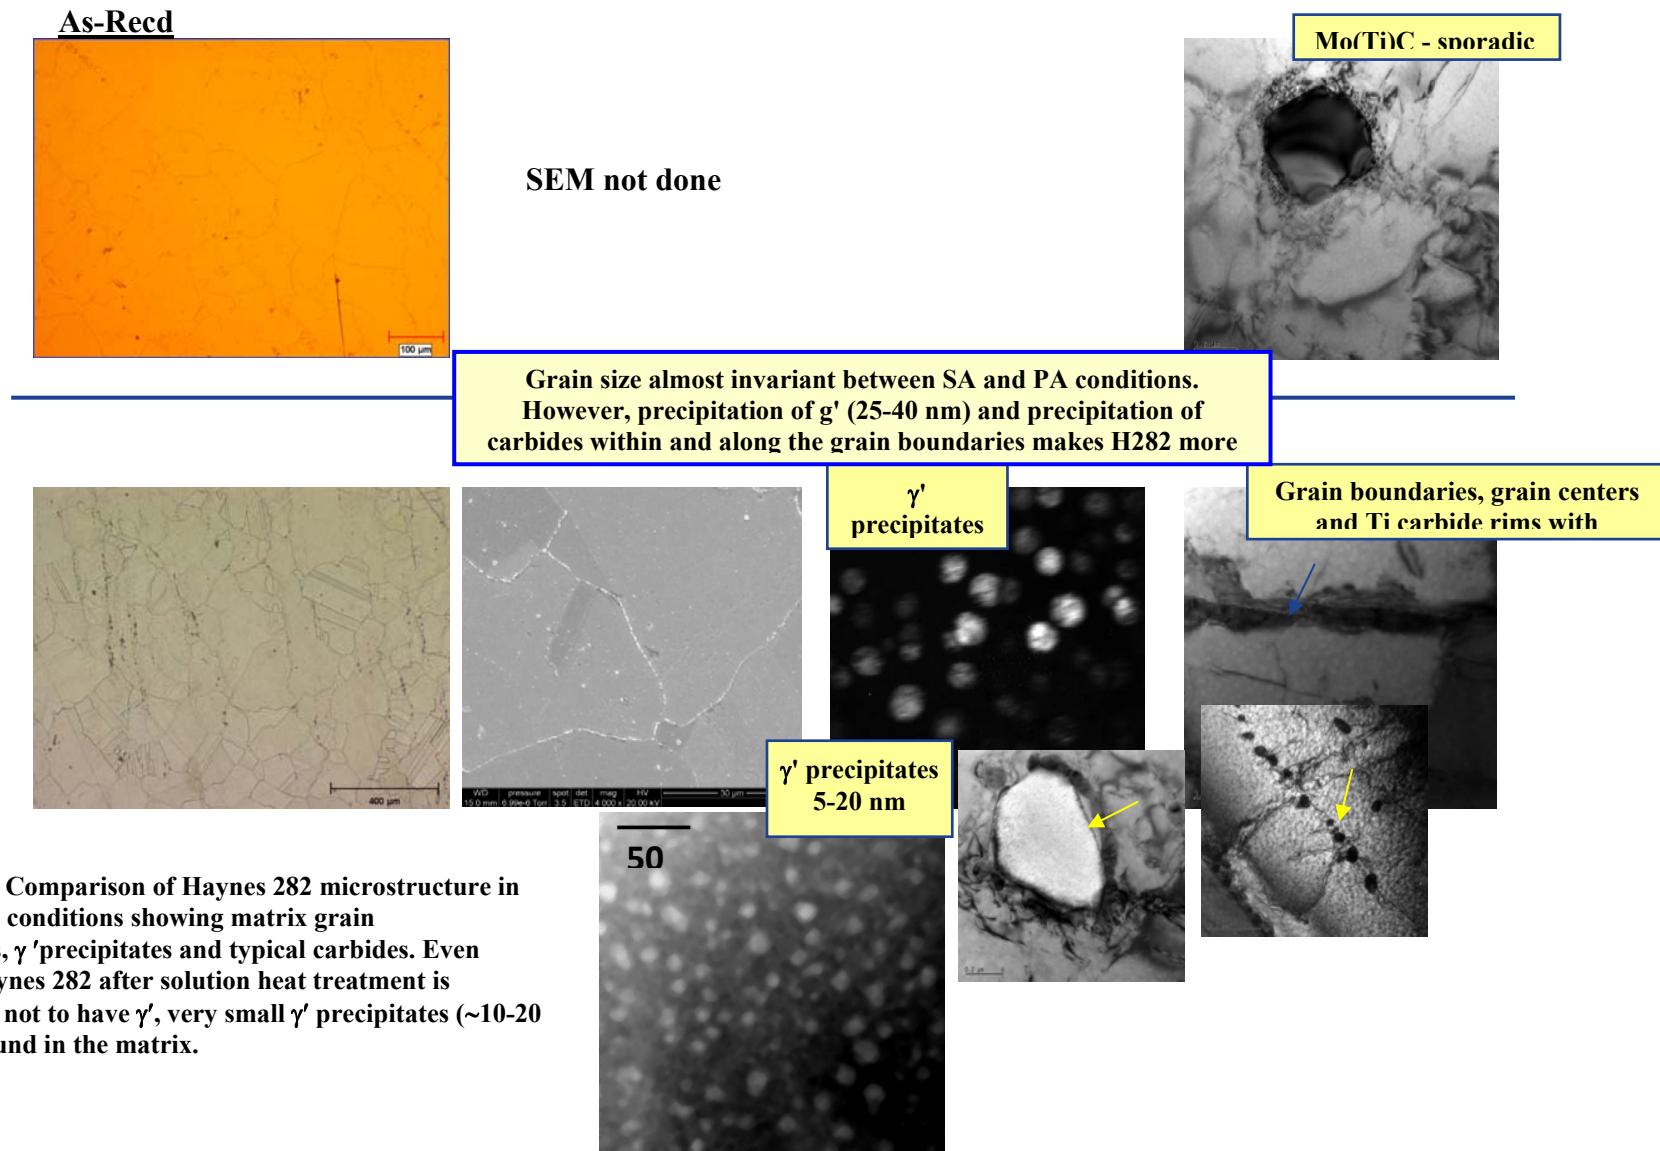
**Figure 6.8: Comparison of Haynes 282 microstructure in SA and PA conditions showing matrix grain boundaries,  $\gamma'$  precipitates and typical carbides. Even though Haynes 282 after solution heat treatment is considered not to have  $\gamma'$ , very small  $\gamma'$  precipitates (~10-20 nm) are found in the matrix.**

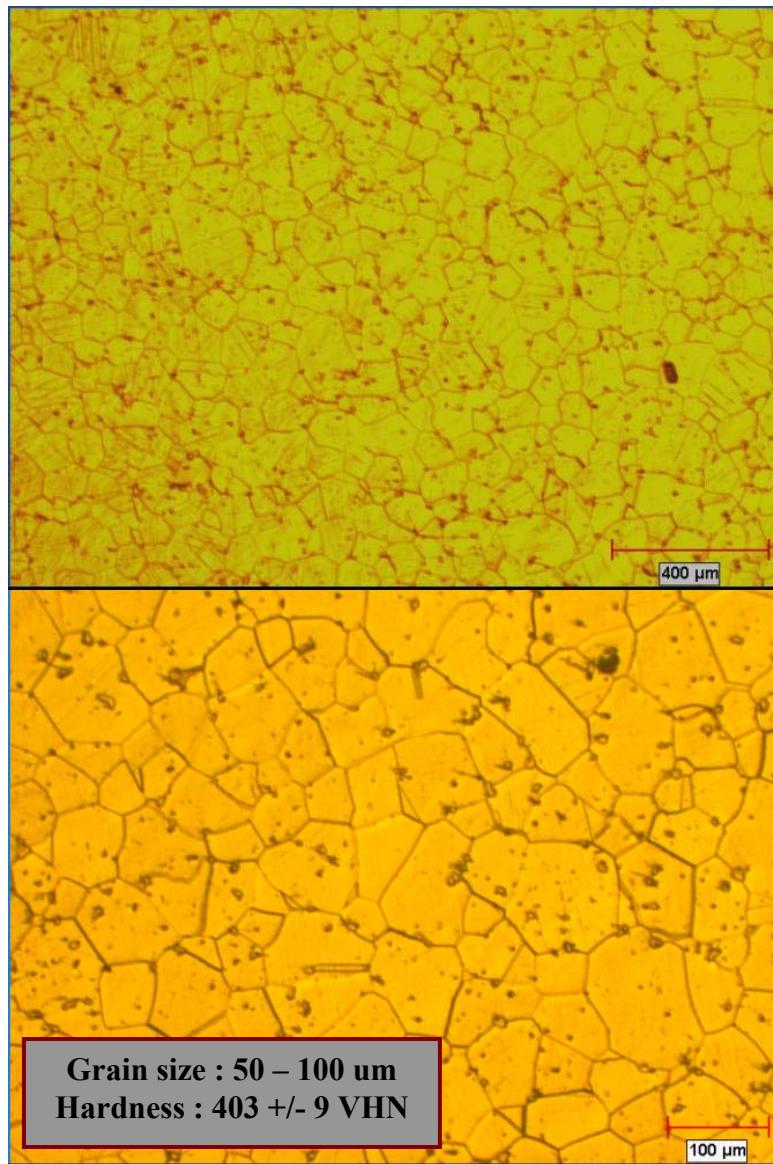
Figure 6.9: Optical micrograph of etched Nimonic 105 in the as-processed condition.

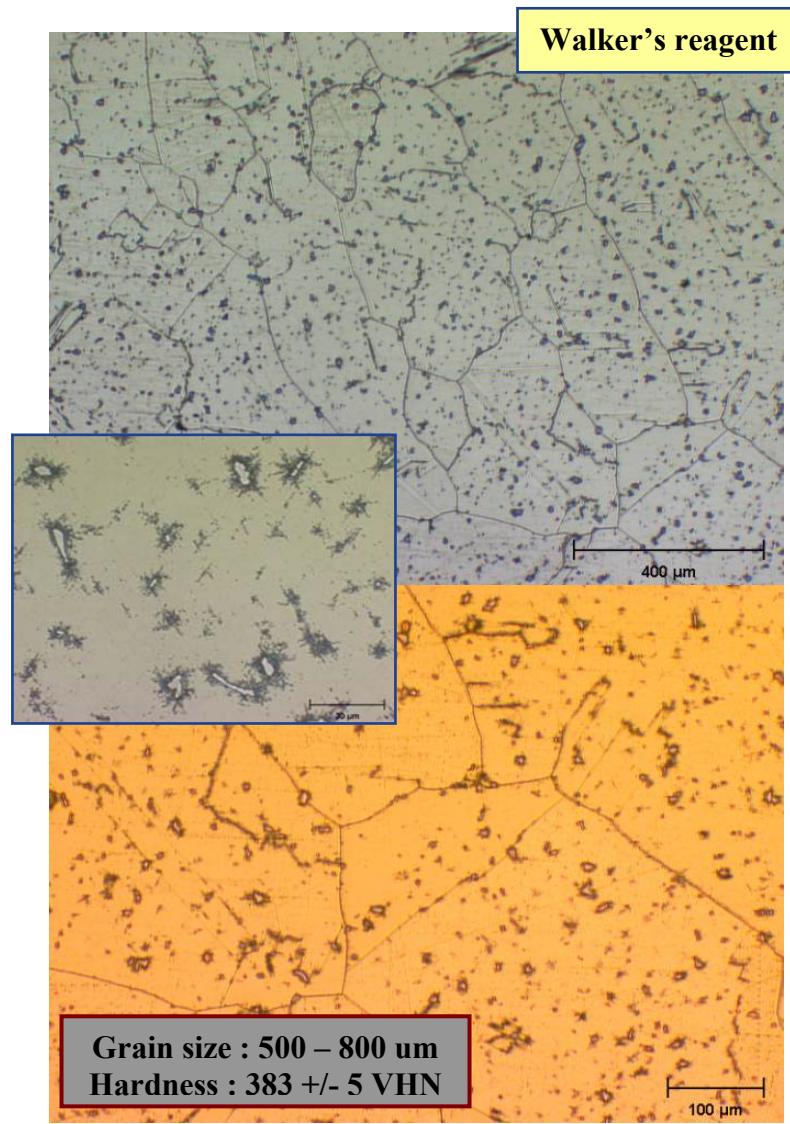
Figure 6.10: Optical micrograph of etched Nimonic 105 in the peak aged condition.

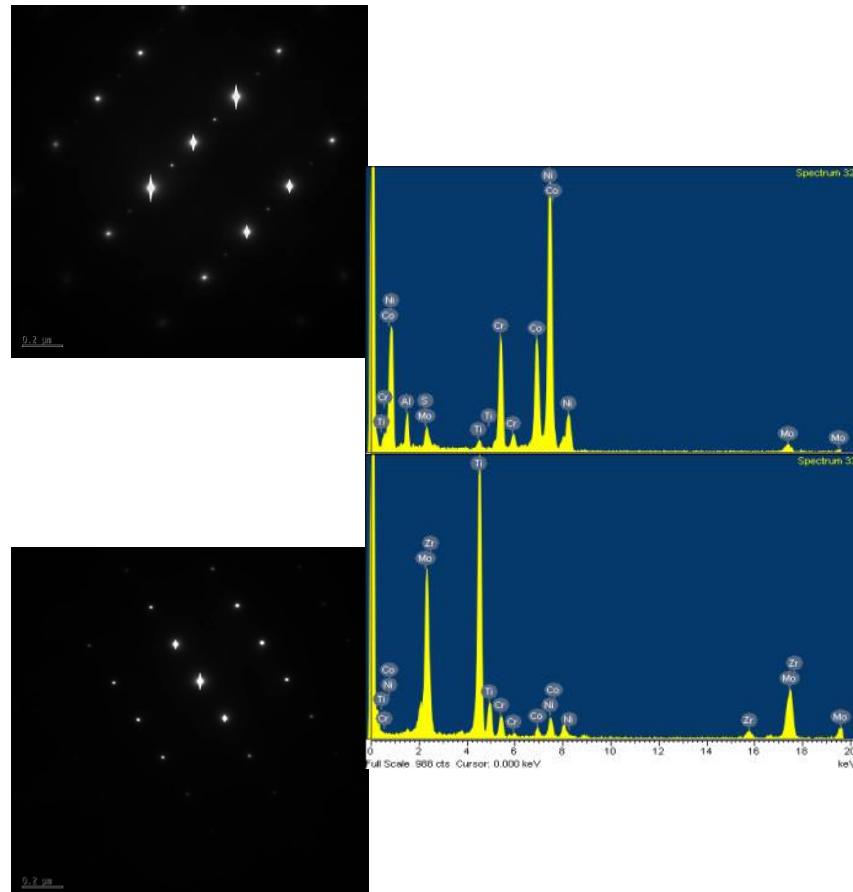
Figure 6.11: TEM micrographs and SAD patterns of Nimonic 105 microstructure in AP condition showing general matrix area (left upper micrograph), Ti-Mo-Zr phase (lower left) with associated SAD patterns (center) and EDS (right).

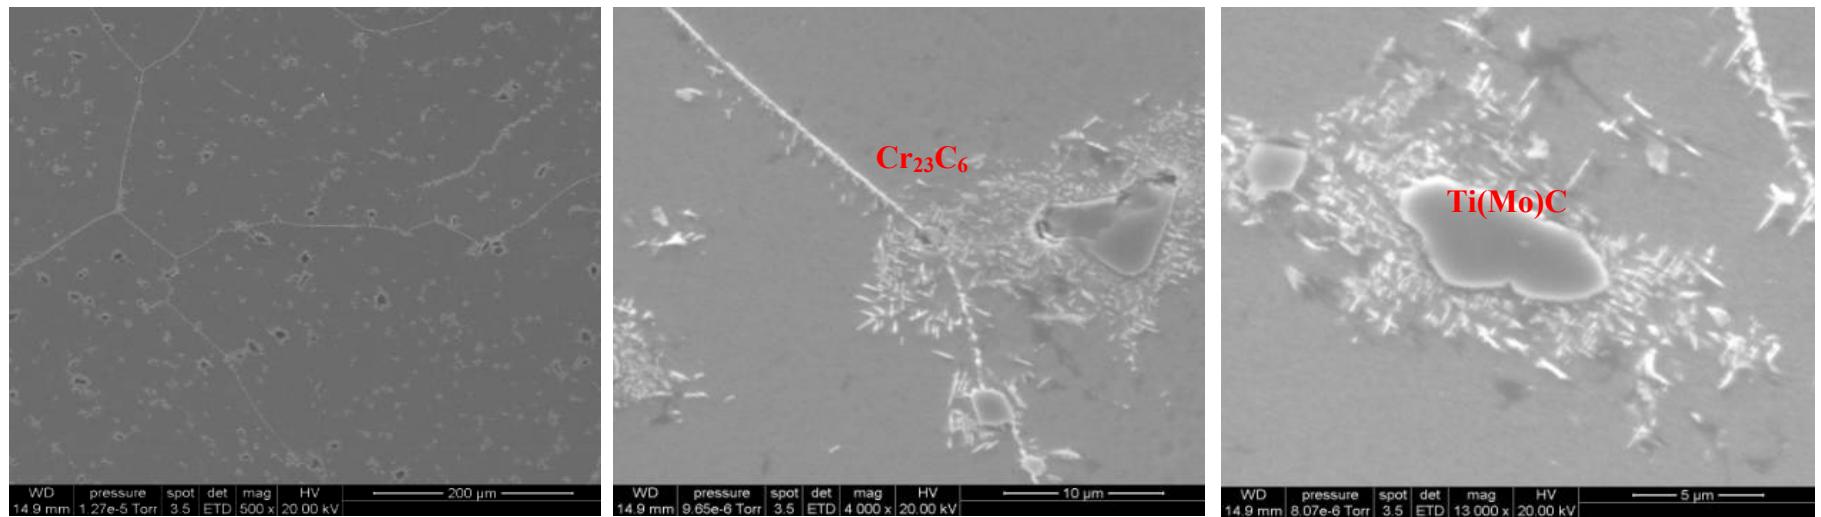
**Large fraction of carbides after HT, especially Cr-rich ones decorating the grain boundaries.**

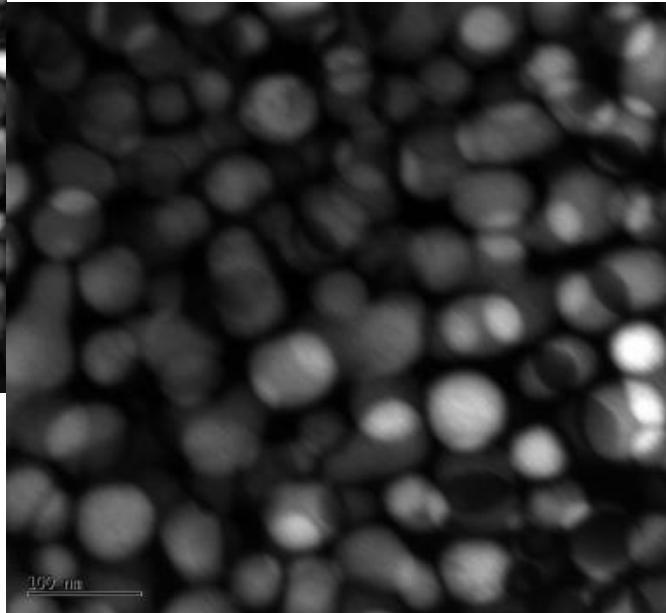
Unimodal distribution of secondary  $\gamma'$  ppte.  
(50-60 nm). Coarsening of tertiary fine  $\gamma'$  ppte.  
from the as-processed state.

Figure 6-14: : TEM micrographs of Nimonic 105 that show the unimodal distribution of  $\gamma'$  in the peak aged condition, where coarsening of the tertiary fine  $\gamma'$  precipitates has proceeded from the as-processed state.

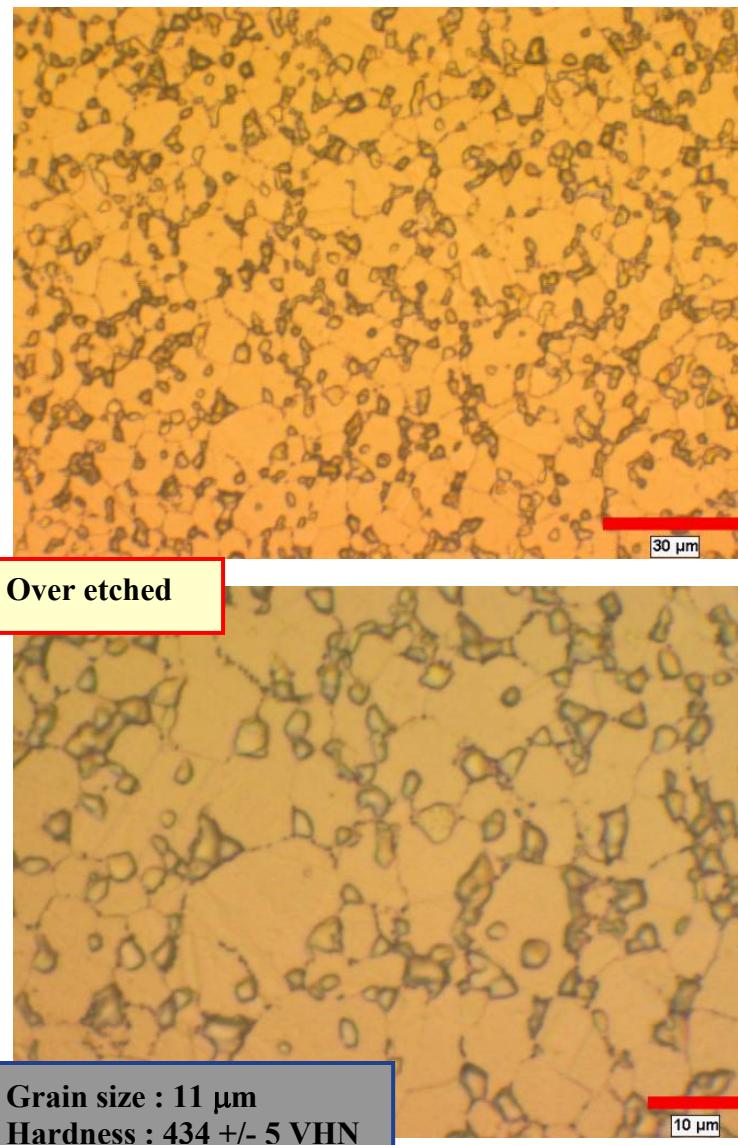
Figure 6.16: Optical micrograph of etched Udimet 720Li in the peak aged condition.

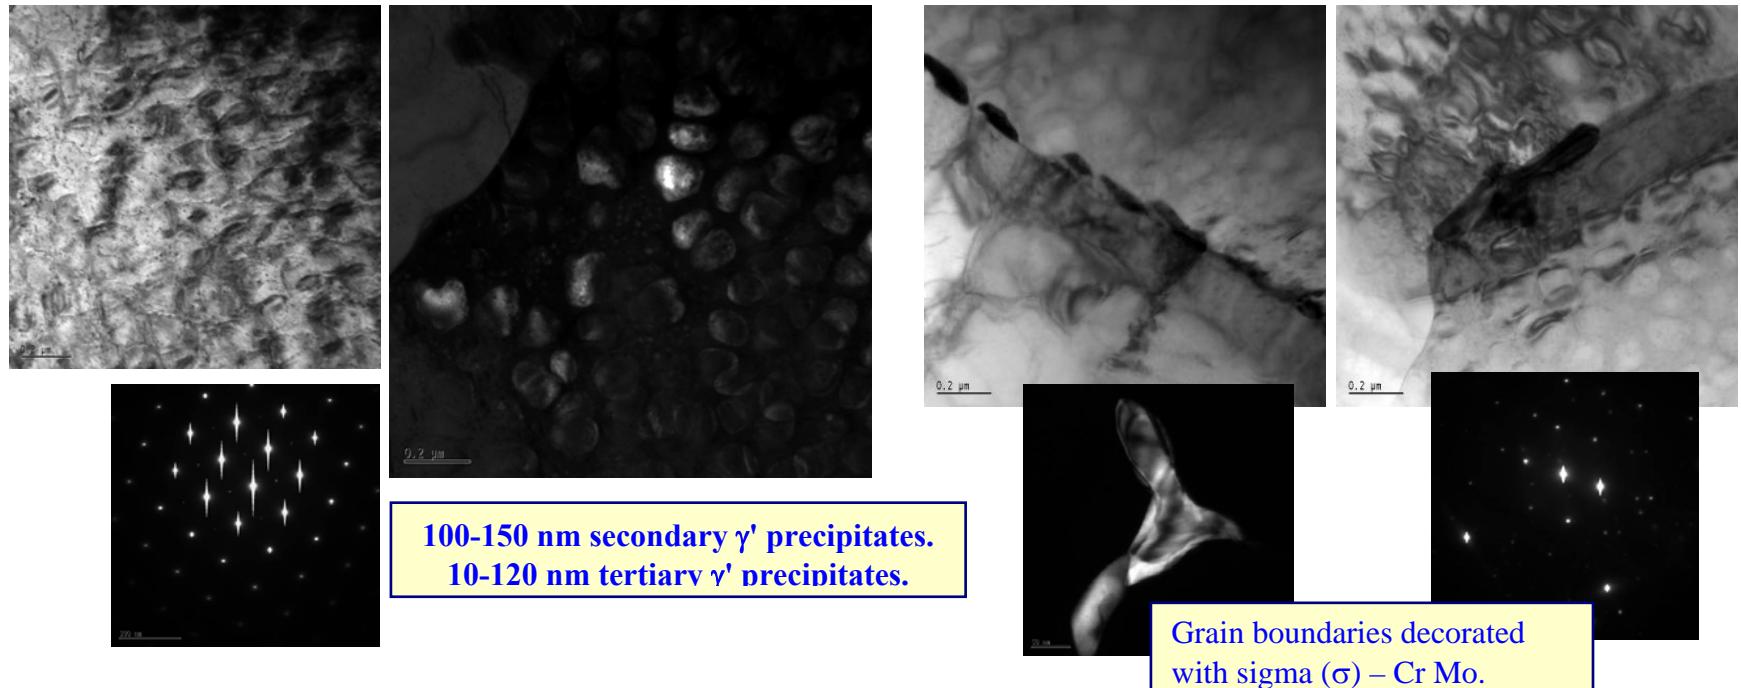
Figure 6.17: TEM micrographs showing the general features of the matrix including  $\gamma'$  precipitation (left figures) with associated SAD pattern and Cr-o (sigma) precipitates along the grain boundaries (right) with associated SAD pattern.

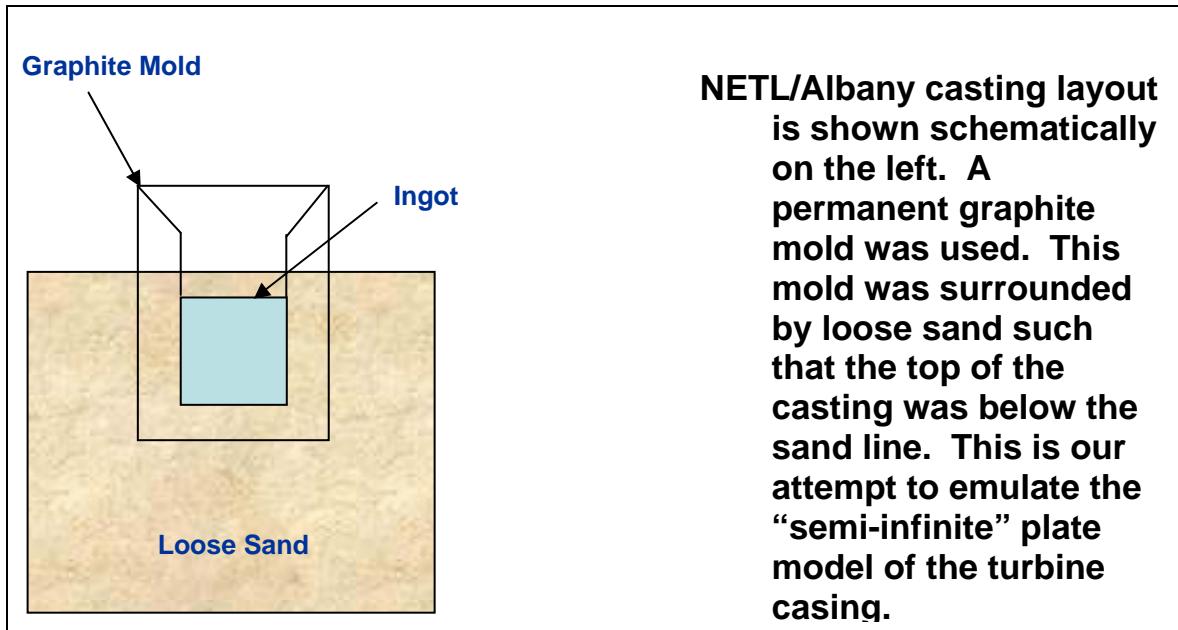
Figure 1 – Schematic of cast ingot geometry and combination of graphite mold insulated by loose sand, used to obtain lower cooling rates typical of larger section castings.

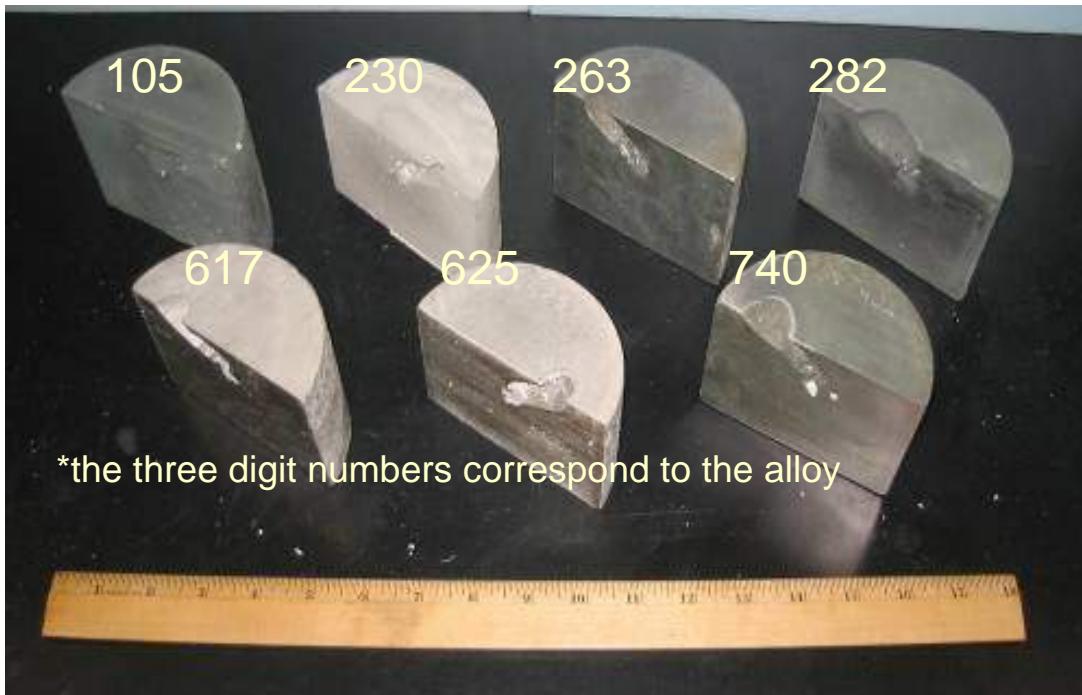
Figure 2 – Photo of the ingots of the various alloys after they were cut in half. Alloys were homogenized and heat-treated. NETL/Albany and ORNL each received one-half of each alloy for characterization and testing.

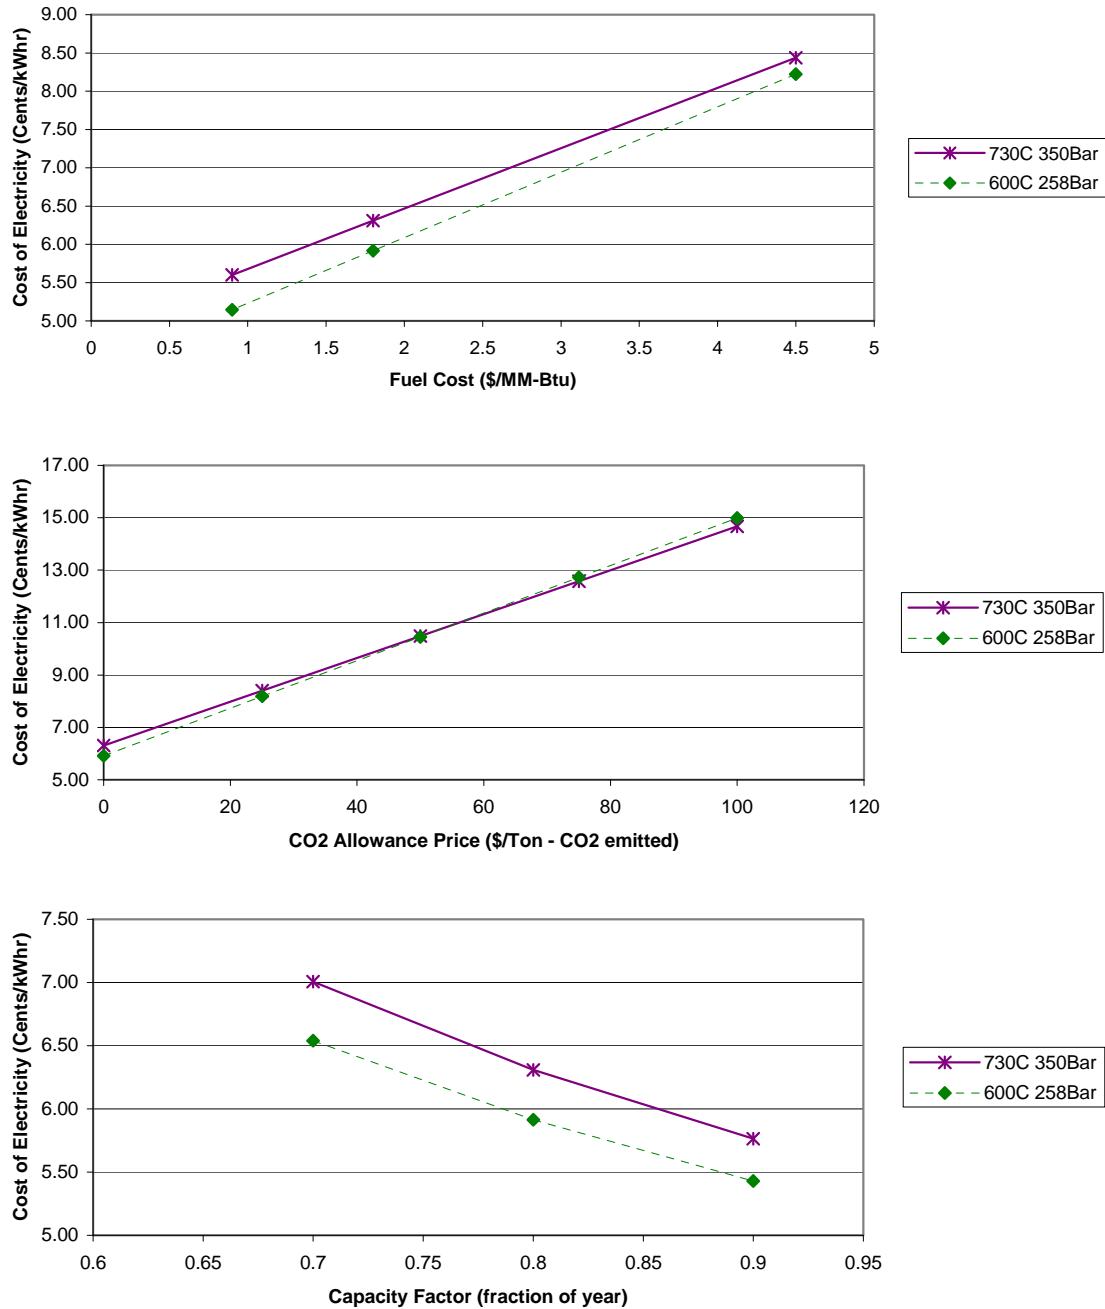
Figure 5-5: Economic Sensitivity Study with “Low” Ni Alloy Cost  
 (Coal Cost, CO<sub>2</sub> Allowance Price, Capacity Factor)
