Lightweight Radioisotope Heater Unit (LWRHU)
Production Qualification Impact Test

LIGHTWEIGHT RADIOISOTOPE HEATER UNIT (LWRHU) PRODUCTION QUALIFICATION IMPACT TEST

M. A. H. Reimus and G. H. Rinehart

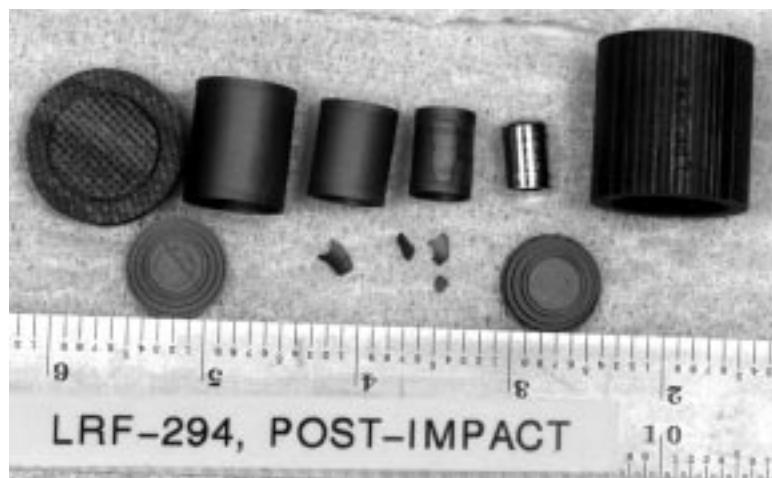
Figure 6. Disassembled LRF-294.

located at each end of the nested cylinders. Figure 6 shows the disassembled aeroshell, including the fueled capsule. When the aeroshell was opened, the open end insulator tube plug was found to be partially glued to the FWPF end cap. The interior surface of the pyrolytic end cap showed no visible damage, and the blind end insulator tube plug sustained no damage. Photographs of both insulator tube plugs appear in Figure 7.

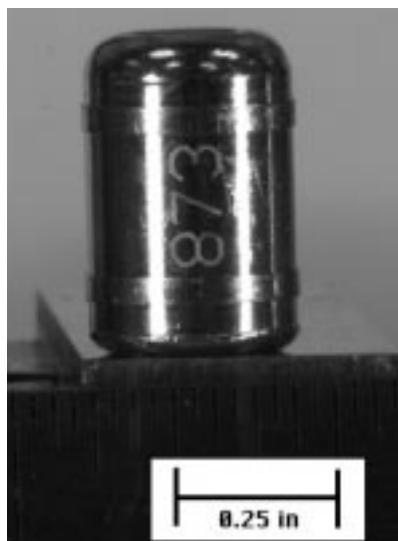
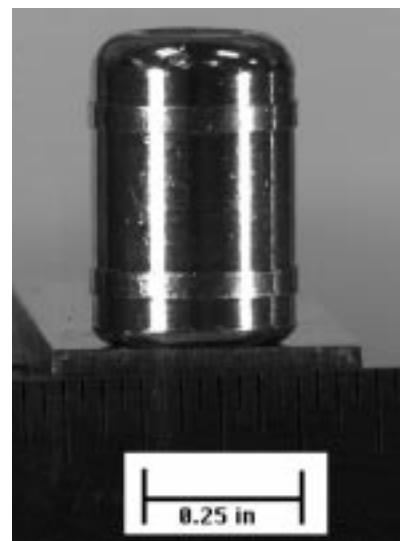
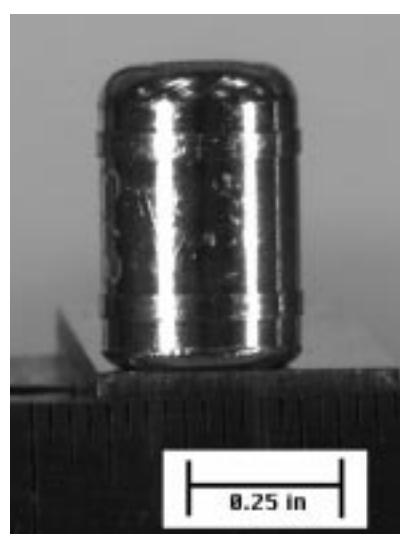
Figure 12. Fueled capsule CB873: (a) profile, 0 deg.; (b) 90 deg.; (c) 180 deg.; (d) 270 deg.

No visible damage to the fueled capsule was discovered. Profiles of the recovered capsule are pictured in Figure 12. The dimensions of the clad remained within the product specifications. The measured dimensions and comparison with the product specifications are listed in Table III.
