DOE/NV--1504

**Closure Report for
Corrective Action Unit 104:
Area 7 Yucca Flat Atmospheric
Test Sites,
Nevada National Security Site,
Nevada**

June 2013

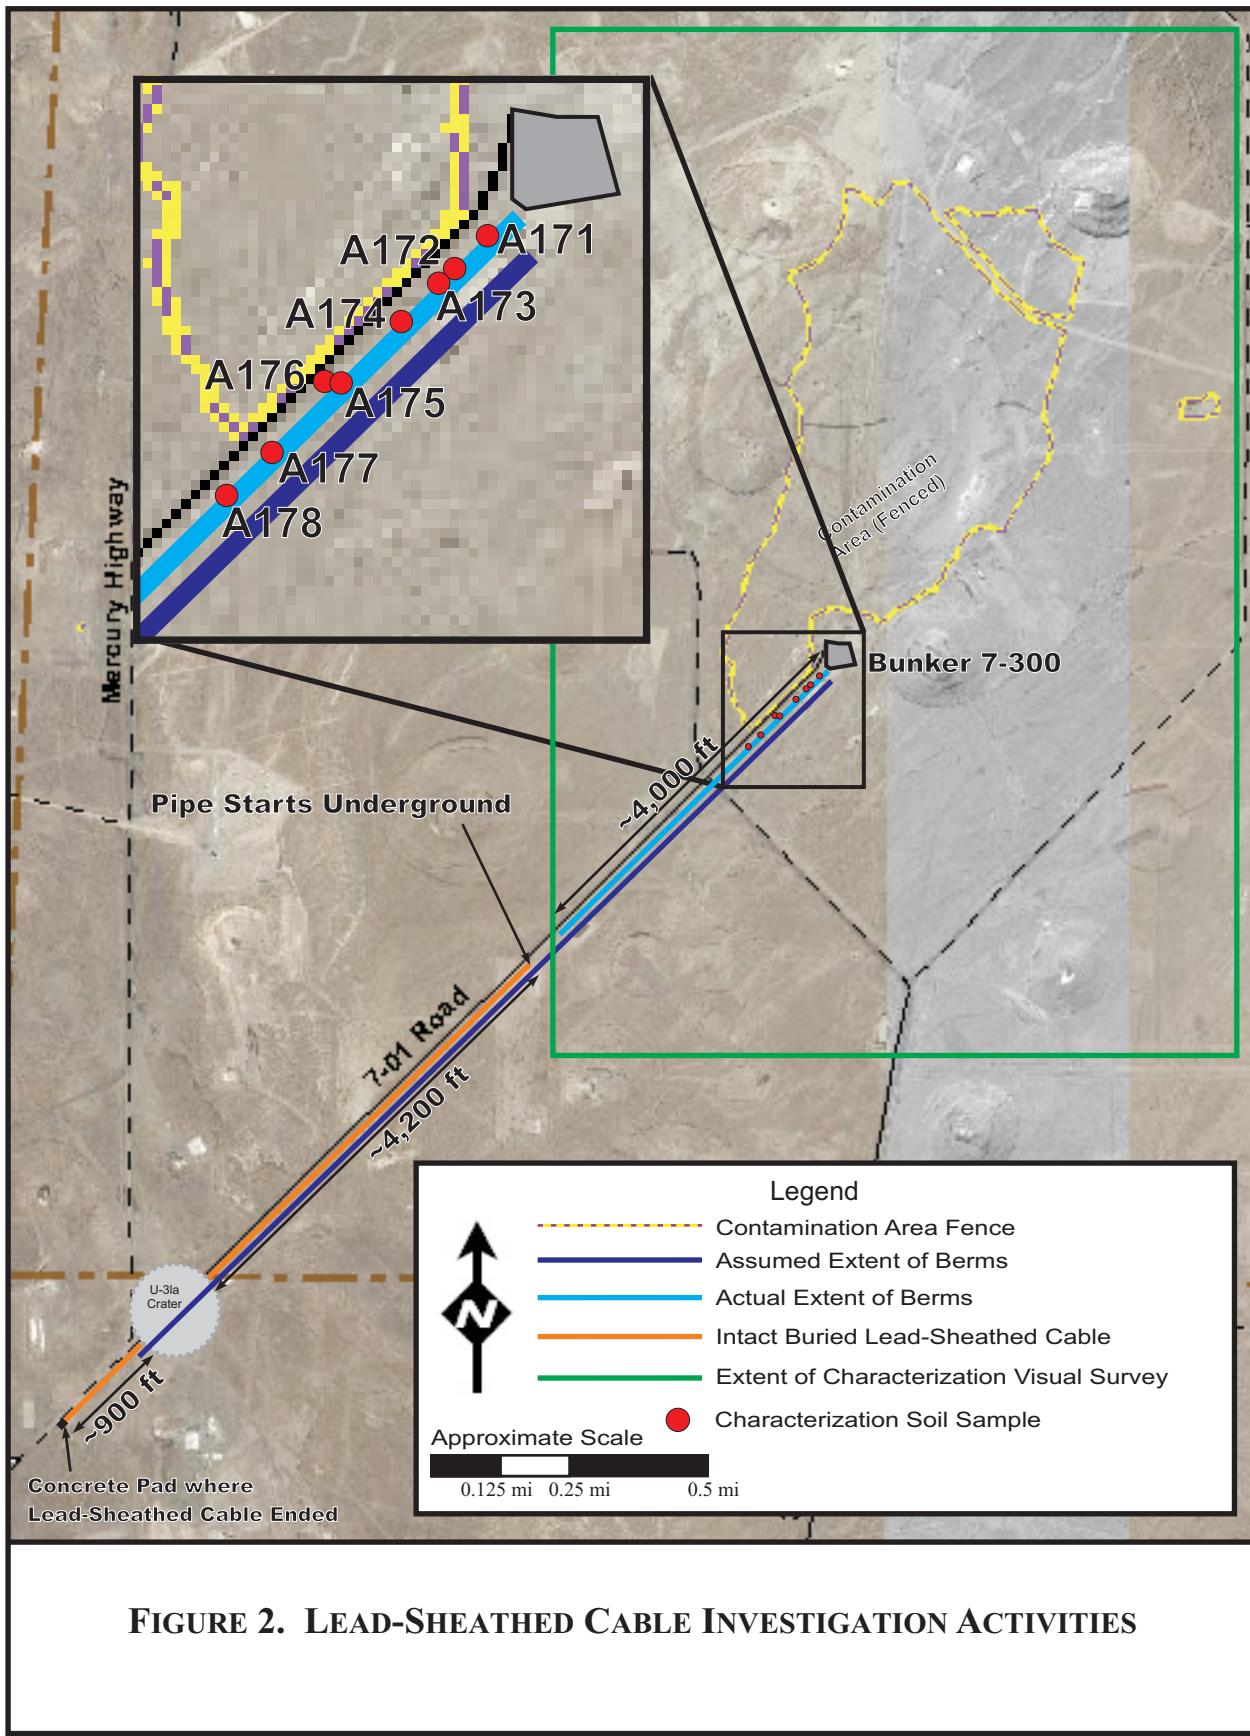
Eight soil samples were collected from beneath the lead-sheathed cable debris. The sample locations are shown in Figure 2. Lead concentrations in these soil samples did not exceed the FAL of 8,356 milligrams per kilogram (mg/kg). The highest lead result for a sample collected from the soil beneath the lead-sheathed cable debris was 810 mg/kg. The CAIP requirements were shown to have been met at this CAU for other chemical releases (NNSA/NSO, 2012).

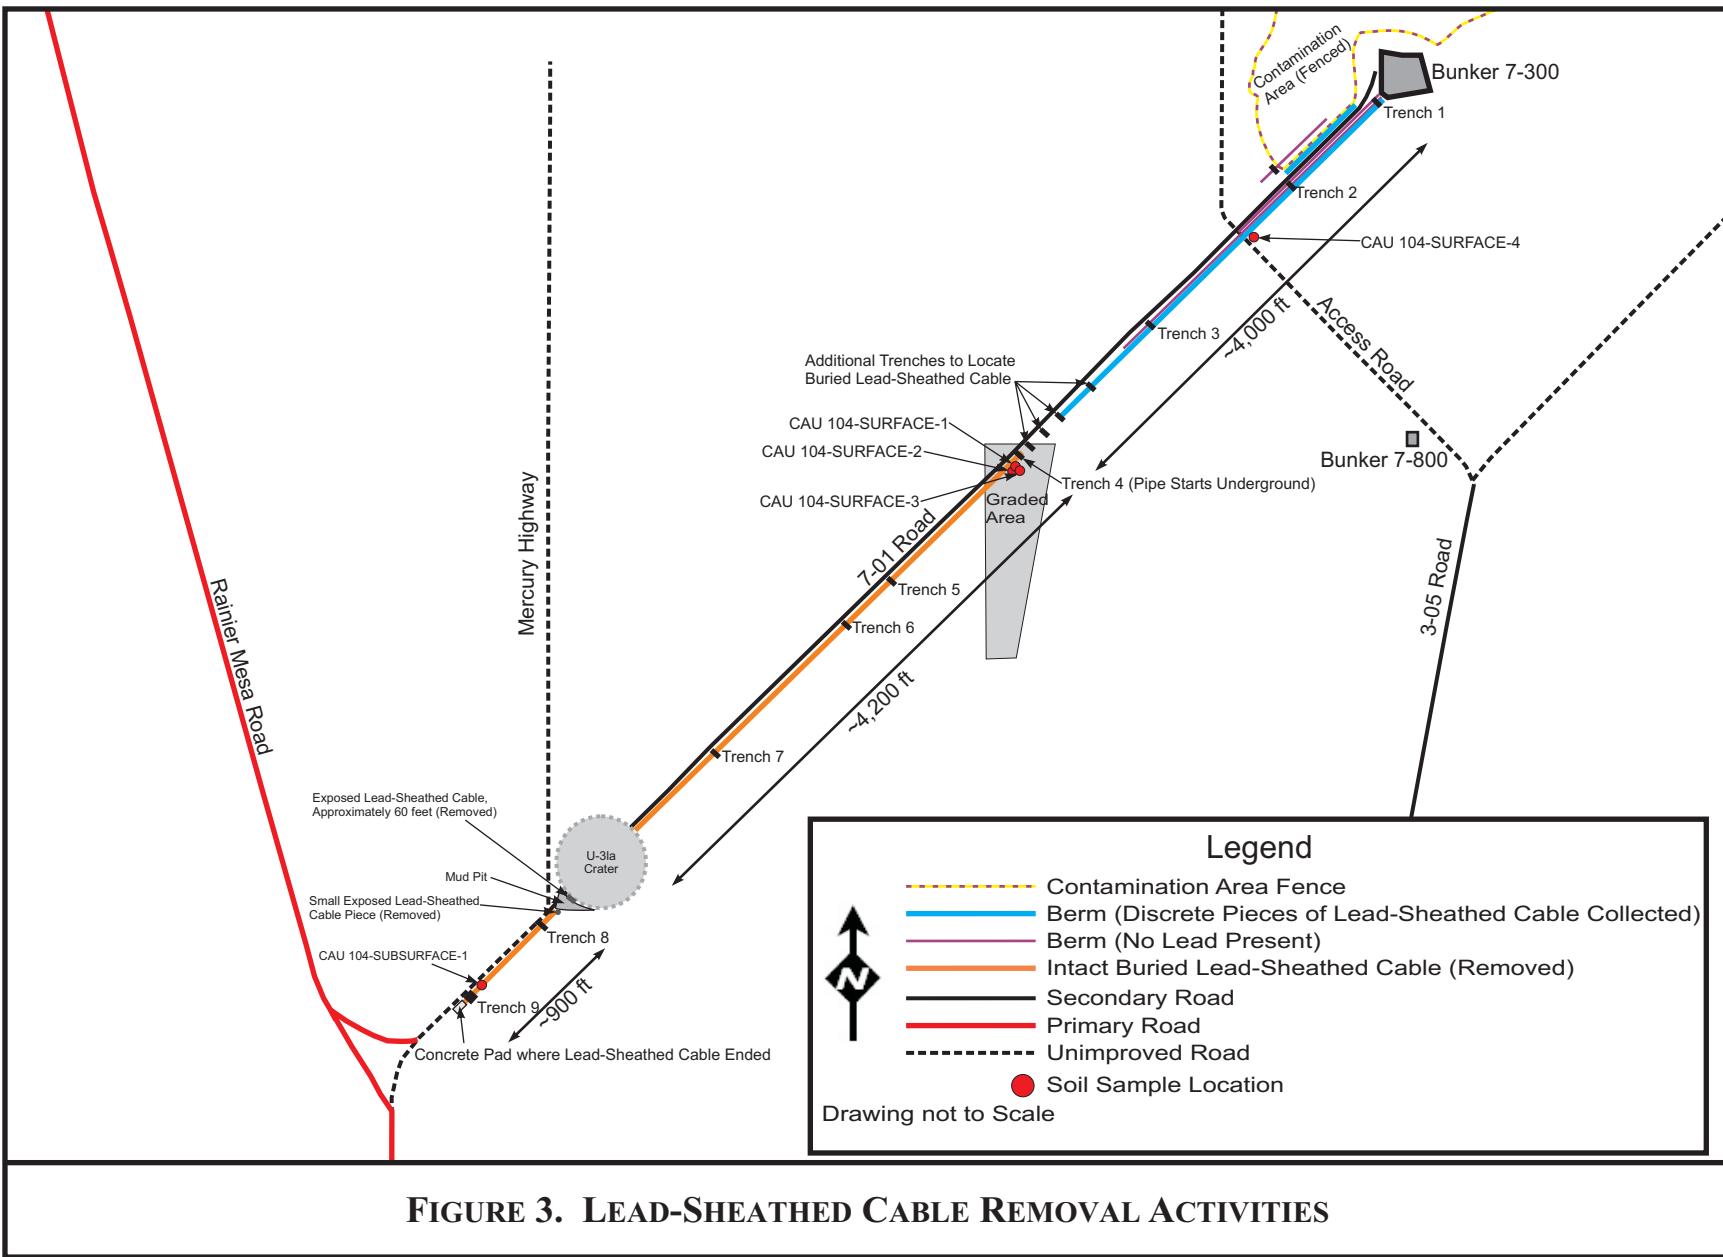
CAS 07-23-16, Atmospheric Test Site B7-b, was clean closed due to the presence of PSM in the form of lead-sheathed cables. Lead-sheathed cables were removed for disposal or recycling. Berms ran to the southwest from Bunker 7-300 along the 7-01 Road for approximately 4,000 ft. Discrete pieces of heavily damaged lead-sheathed cable were found in one of the berms on the south side of the 7-01 Road. Similar pieces were also found on the north side of the 7-01 Road in a few locations outside the CA fence. The berms where lead pieces were found are shown as blue lines in Figure 3. Several other berms were present that did not have pieces of lead. These are shown as purple lines in Figure 3.

Visible pieces of lead-sheathed cable were removed from two locations on the southwest side of crater U-3la. The approximate locations are labeled in Figure 3. The buried lead-sheathed cable was located on the southwest side of crater U-3la and continued for an additional distance of approximately 1,000 ft, where it ended at the concrete pad of a former substation. Approximately 900 ft of intact lead-sheathed cable were removed on the southwest side of crater U-3la.

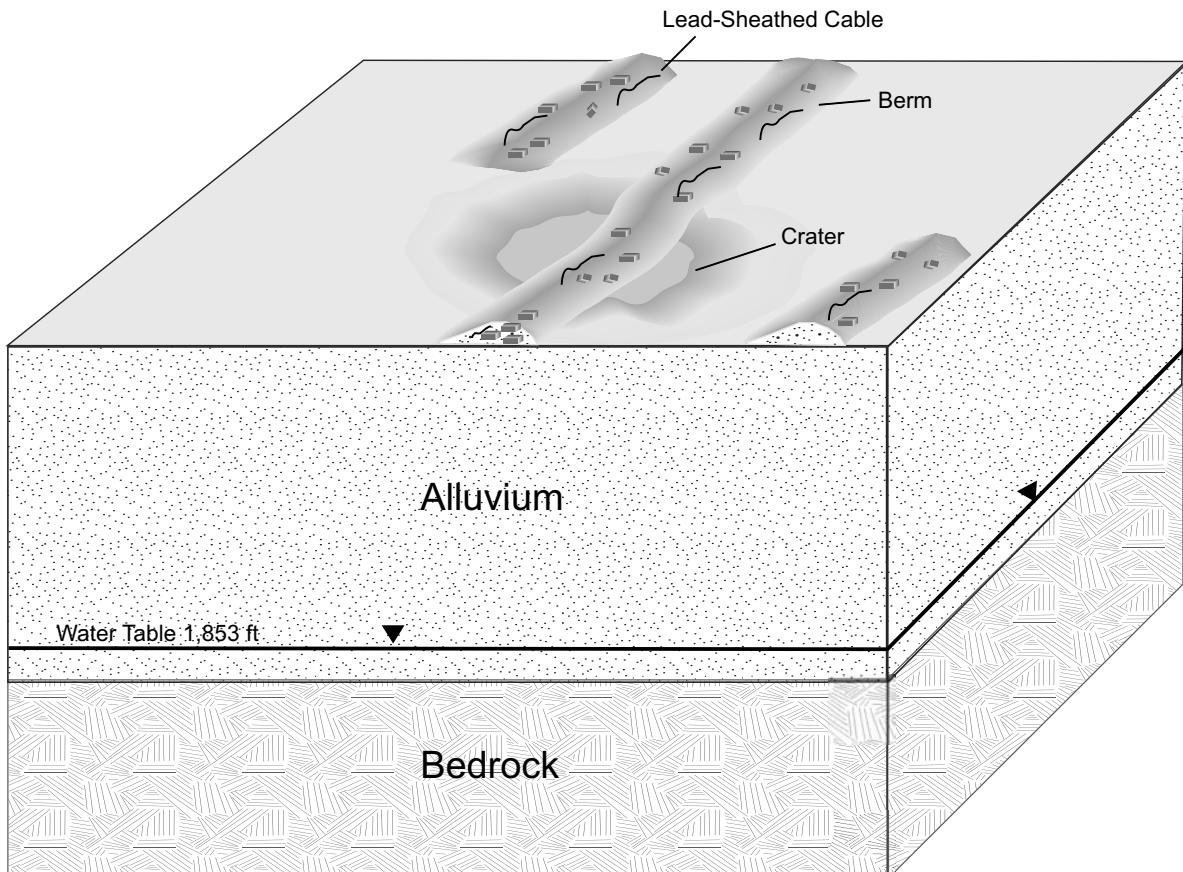
Figure F.1-1
CAU 104 CSM

The release-specific COPCs are defined as the contaminants reasonably expected at the site that could contribute to a dose or risk exceeding FALs. Based on the nature of the releases identified in [Section 2.2.1](#), lead is not present in adjacent soil at levels exceeding FALs. Therefore, the environmental problem is limited to metallic lead in sufficient amounts that future degradation into soil would cause an unacceptable risk to a site receptor.

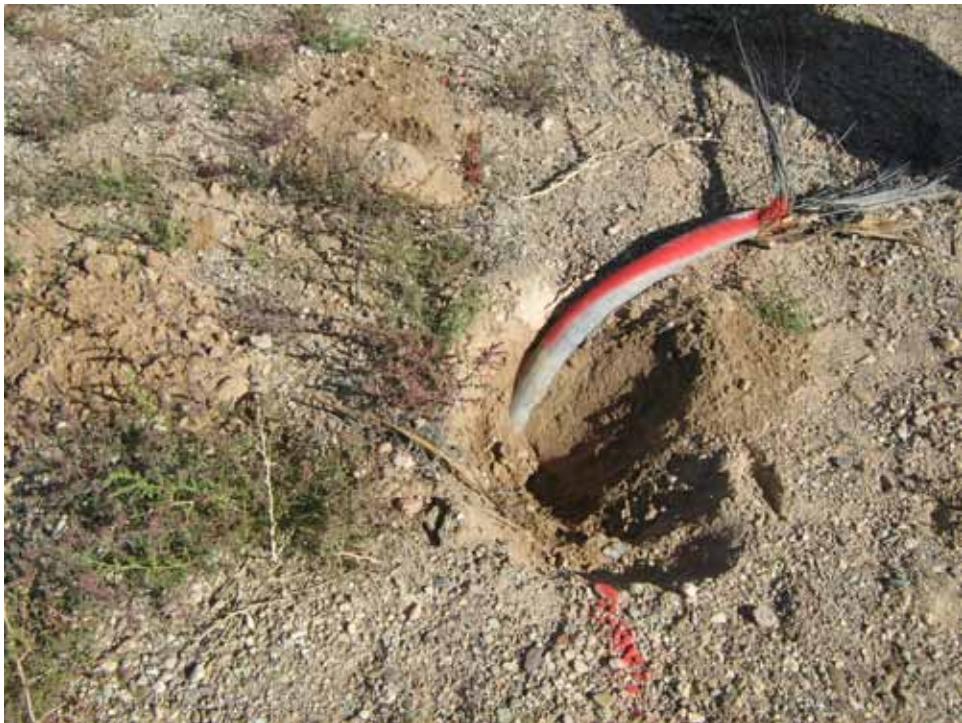
Photograph 1: Section of Lead-Sheathed Cable at Trench 4 Leading Underground, 10/23/2012

At a location near the southwest end of the berms, at Trench 4, a section of lead-sheathed cable approximately 3 ft long was found to be protruding up from the ground surface. When removal of this section of cable began, the cable was found to be buried. The lead-sheathed cable was found to generally be intact at varying depths from approximately 2 to 7 ft below grade parallel to the road from Trench 4 to the northeast edge of crater U-3la. Approximately 4,200 ft of mainly intact lead-sheathed cable were removed from the location of Trench 4 to the northeast edge of crater U-3la. The lead-sheathed cable was observed to continue into the crater; however, due to safety concerns, the crater was not entered to continue removal of the cable.

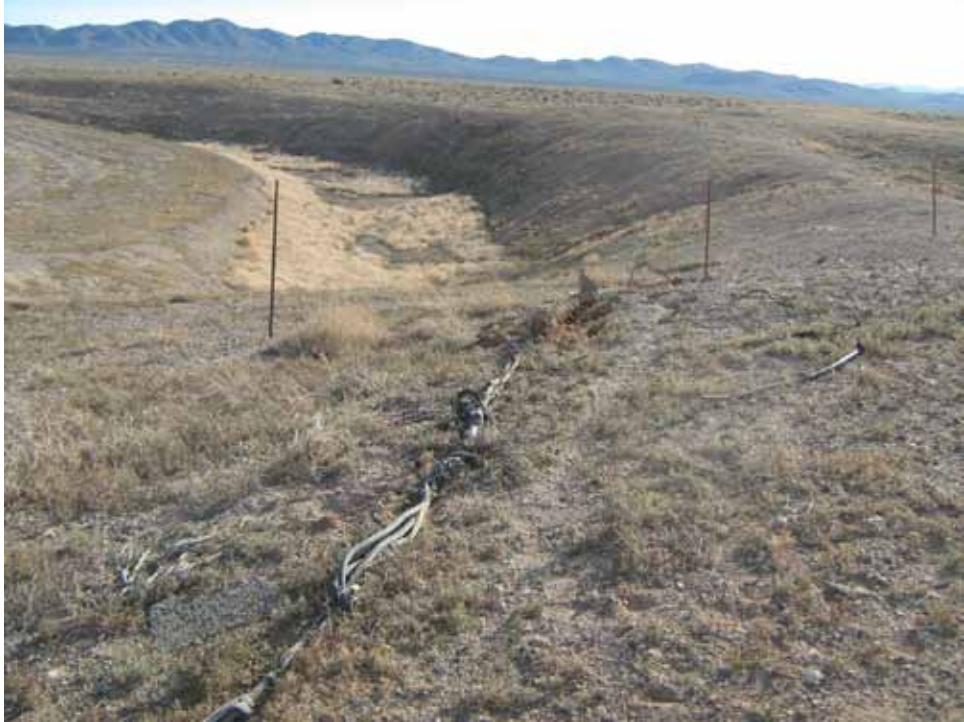
Photograph 14: Section of Lead-Sheathed Cable on the Southwest Side of Crater U-31a, 11/28/2012

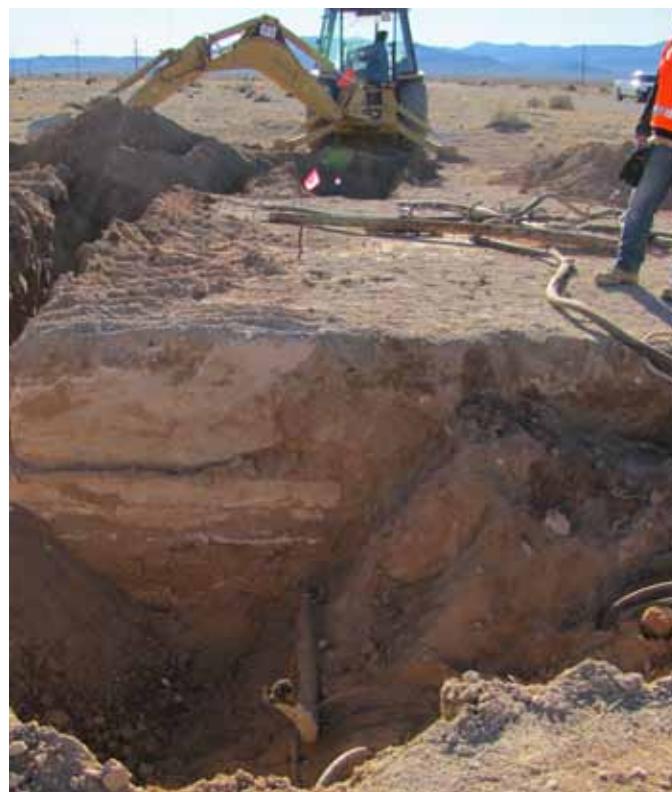
Photograph 16: Concrete Pad Where the Lead-Sheathed Cable Ended, 01/30/2013

The lead-sheathed cable entered a horizontal steel conduit in the soil beneath the northeast side of the footing of the concrete pad of a former substation. The conduit turned 90 degrees under the pad and ran up through the concrete pad to the surface, where the lead-sheathed cable ended. A trench was excavated around the perimeter of the concrete pad, and the lead-sheathed cable was not found exiting the pad at any other point. The concrete pad was demolished to remove the remaining section of lead-sheathed cable, and this section was packaged in one of the macroencapsulation boxes with the small pieces of lead.

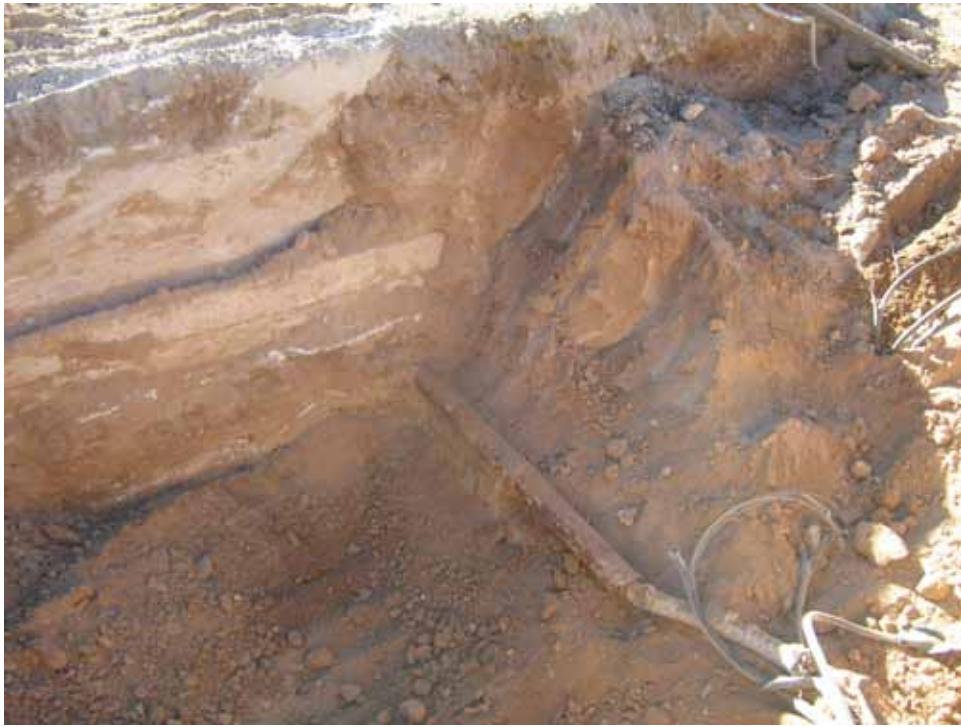
Photograph 17: Lead-Sheathed Cable and Steel Conduit under the Concrete Pad, 01/30/2013

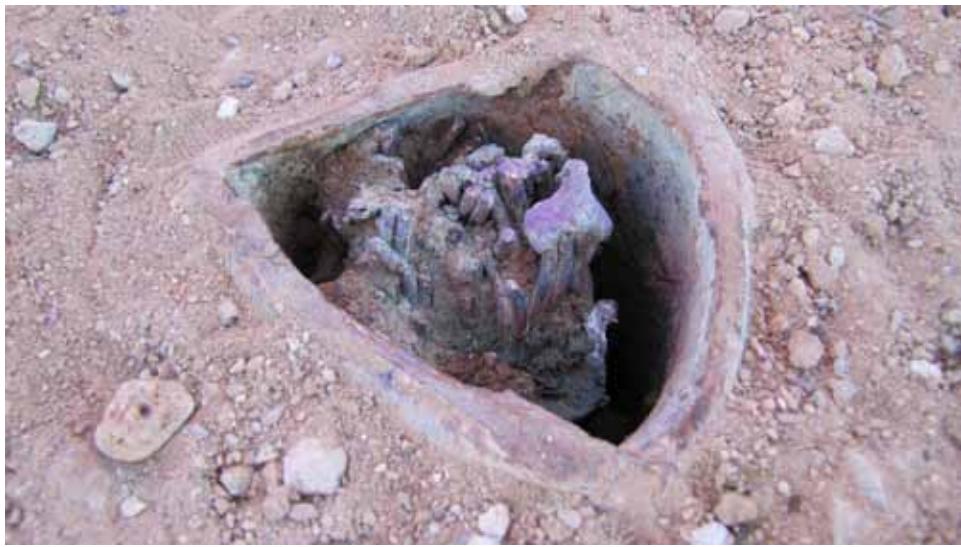
Photograph 18: Lead-Sheathed Cable and Steel Conduit at the Surface of the Concrete Pad, 01/30/2013

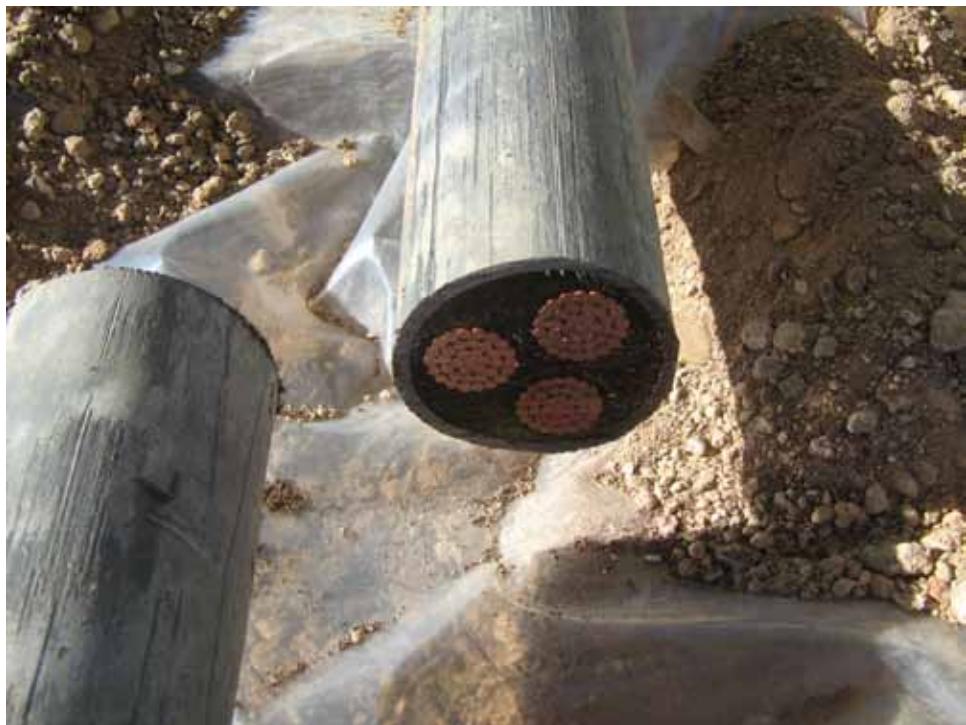
Photograph 22: Cross Section of Lead-Sheathed Cable, 02/06/2013

The presence of an outer sheath of lead seemed unusual, but further investigation indicates that this is not at all unusual for “hardened” direct-buried cables, especially for the time period in question. Research has revealed that cables intended for underground use or direct burial in earth will have heavy plastic or metal, most often lead sheaths, or may require special direct-buried construction. Also, a conductive sheath / shield, typically of copper tape or sometimes lead alloy, is used as a shield to keep electromagnetic radiation in, and also provide a path for fault and leakage currents (sheaths are earthed at one cable end). Lead sheaths are heavier and potentially more difficult to terminate than copper tape, but generally provide better earth fault capacity.

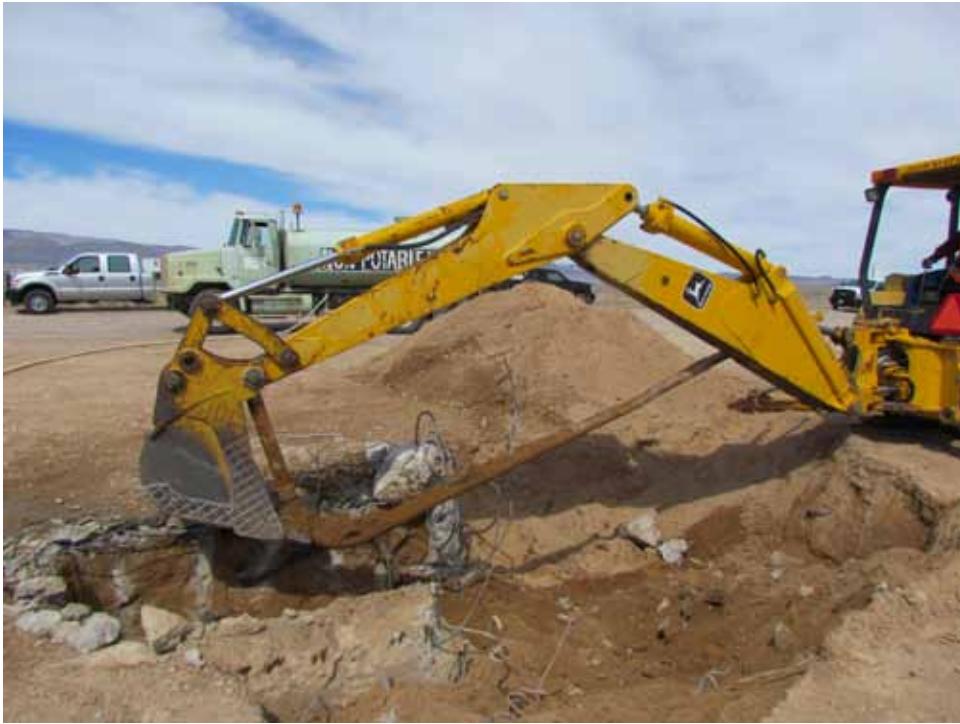
Photograph 27: Removal of the Steel Conduit and Lead-Sheathed Cable from the Concrete Pad, 03/14/2013

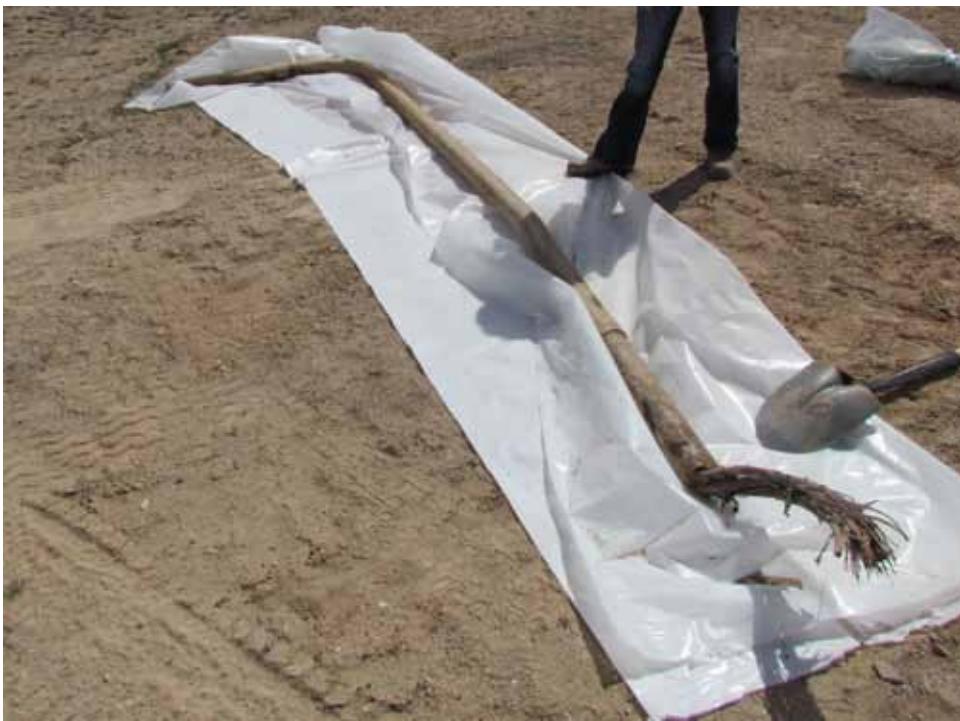
Photograph 28: Steel Conduit and Lead-Sheathed Cable, 03/14/2013

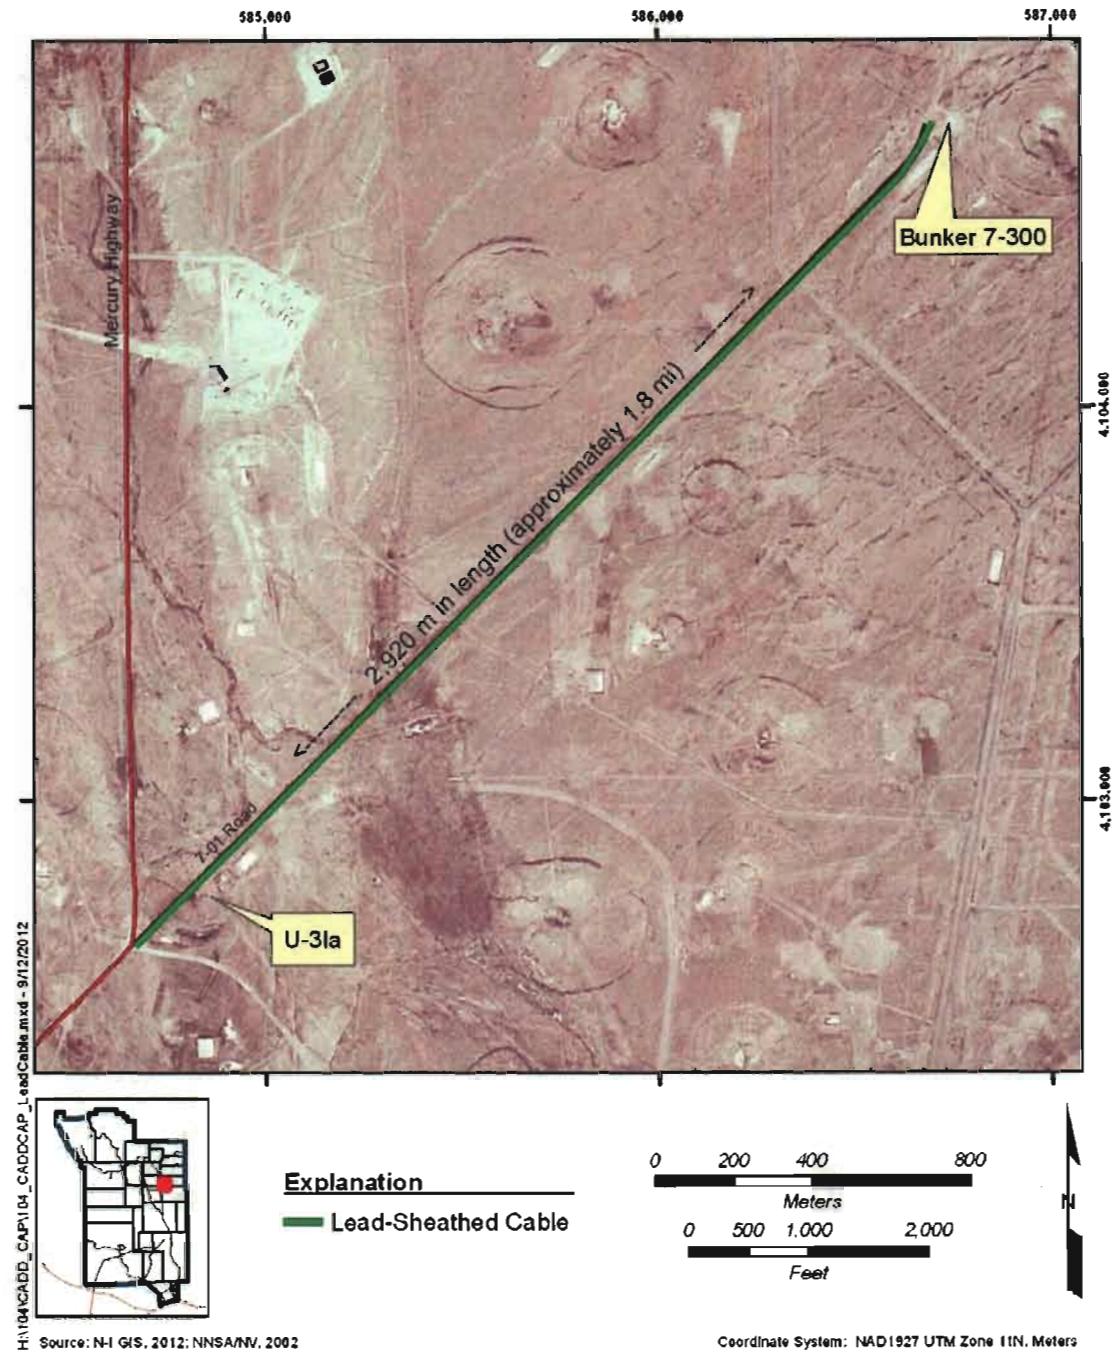
Figure 1 – Location of Lead-Sheathed Cable Removal

During excavation of the cable, it was noted that the cable was found at various depths below the ground surface. This seems unusual, since standard trenching techniques would result in a trench at a fixed depth. It seems that the cable was laid such that it formed a perfectly straight and flat line in space, regardless of topography. This might serve as a clue to its intended function. In addition, one section of cable was accompanied by a series of three-inch diameter galvanized pipes that were driven into the ground. The pipe interiors were empty, the pipe tops were capped, and the tops generally protruded a few inches above the ground surface. The pipes formed a picket that paralleled the cable. These might also serve as a clue to function.
