## Final Report

**Project Title:** Innovative Application of Maintenance-Free Phase-Change Thermal Energy Storage for Dish-Engine Solar Power Generation

**Recipient:** Infinia Corporation

**Award Number:** DE-FC36-08GO18157

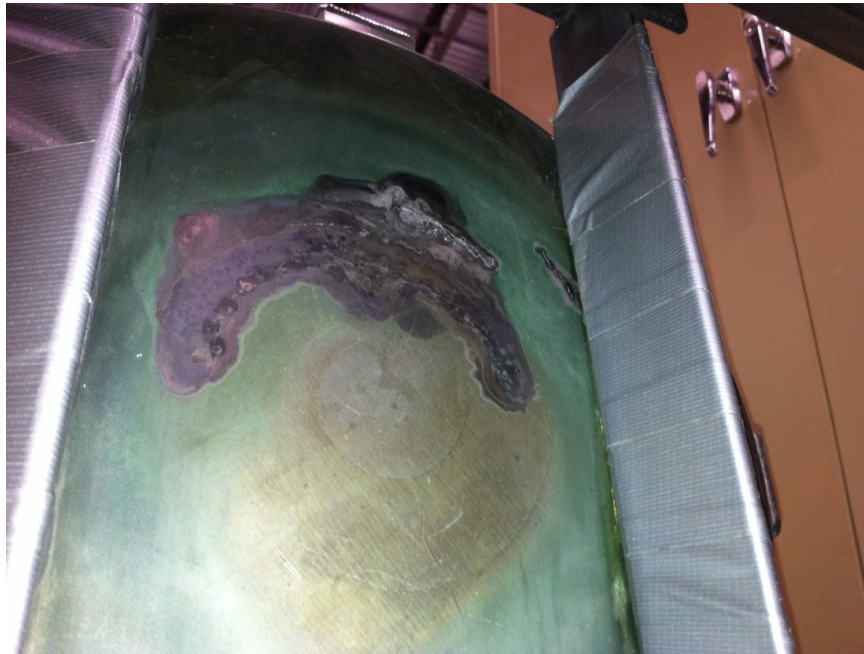
**Figure 12, Test #1 Receiver Damage**

The TES module was removed from the test stand and examined. The receiver plate sustained some discoloration and minor surface damage, a photograph of which is shown in Figure 12. The damage to the receiver was judged to be superficial, and ready for further testing.

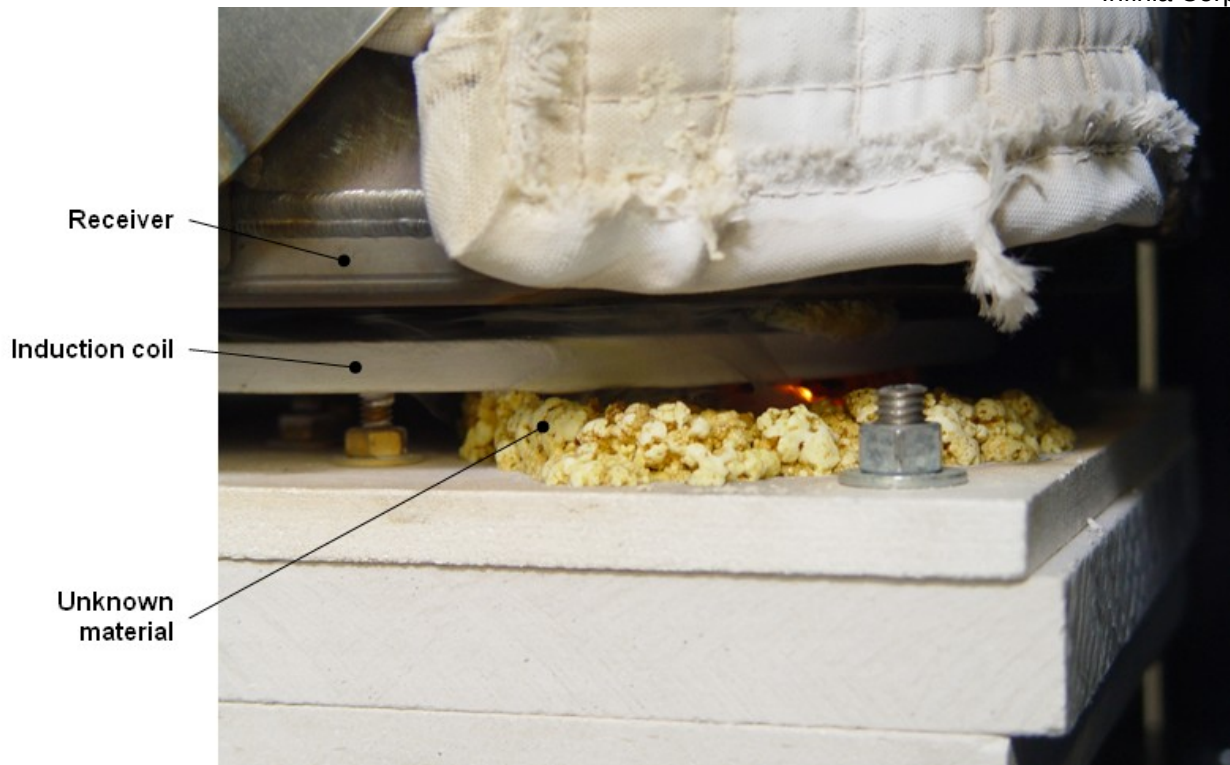
**Figure 14, Unknown Material, Post-Failure**

After a short cool-down period, the safety enclosure was opened. Upon investigation, it was determined that a small quantity of an unknown substance located between the receiver and inductor coil was burning. The substance was dry, fluffy, and resembled popcorn. A photo of the findings is shown in Figure 14.

The TES module and engine housing assembly was removed from the test stand. Some metallic-appearing material was collected from the coil and was combined with water outdoors. The sample reacted violently, confirming the suspicion that the receiver had breached and leaked sodium.

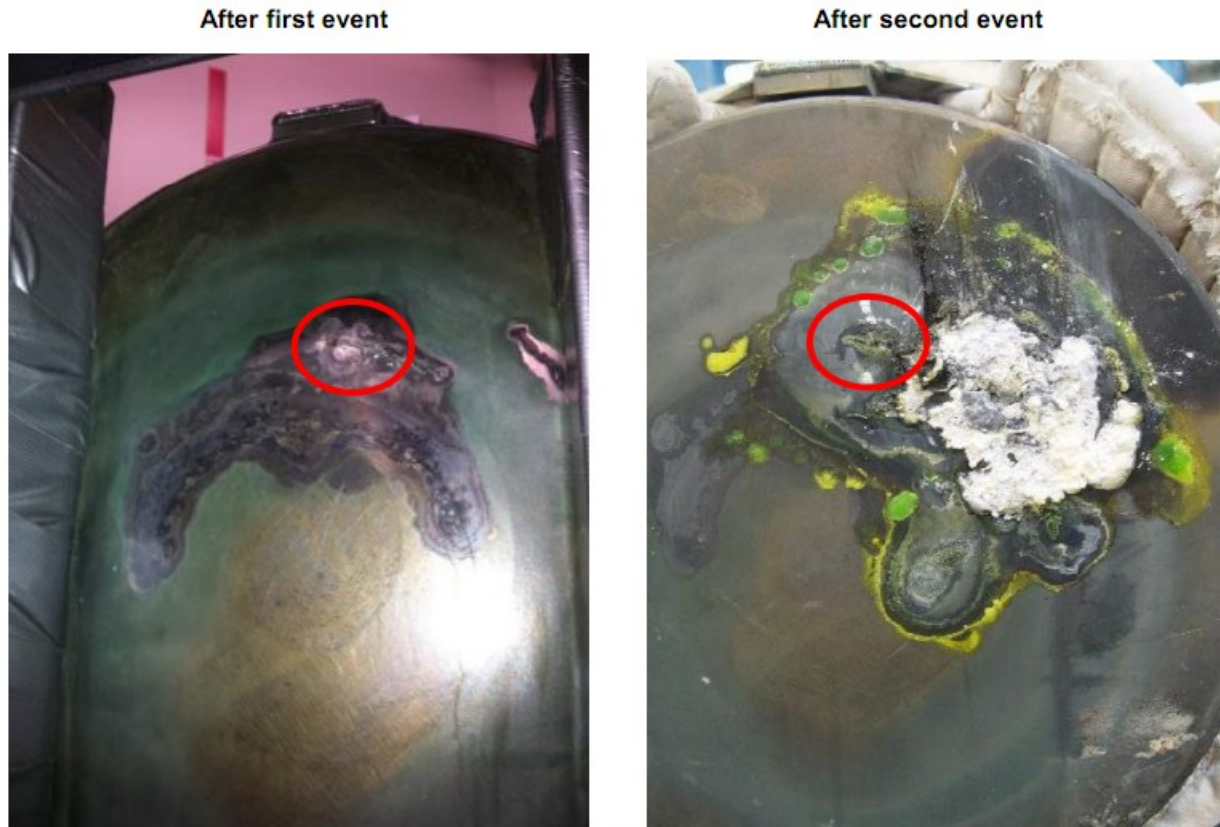
**Figure 17, Previous Damage at the Breach Site**

As the accompanying photo in Figure 17 shows, there is a strong indication that surface damage documented after the first event corresponds to the same location of the breach. Thus, the prior incident likely precipitated the ultimate failure.
