THE EFFECT OF STRUCTURAL DEFECTS IN SiC PARTICLES ON THE STATIC & DYNAMIC MECHANICAL RESPONSE OF A 15 VOLUME PERCENT SiC/6061-Al MATRIX COMPOSITE

R. U. Vaidya, S. G. Song, A. K. Zurek, and G. T. Gray III

Materials Science & Technology, Los Alamos National Laboratory, Los Alamos, New Mexico 87544

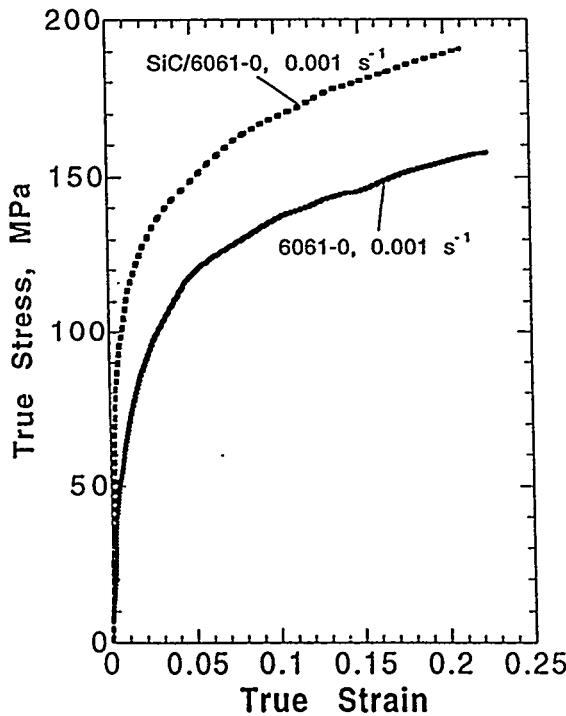
FIGURE 1. Compression responses for the unreinforced 6061 alloy and SiC/6061 composite samples at 10^{-3} s^{-1} .

Results of the compression and tension tests are shown in Figures 1, 2 and 3. Although the elastic

modulus of the composite samples was significantly enhanced over the unreinforced alloy samples, the composite samples fractured at significantly smaller strains in tension as compared to the unreinforced alloy. Furthermore, the compression strain hardening for the composite samples was not significantly enhanced as compared to the unreinforced alloy samples.

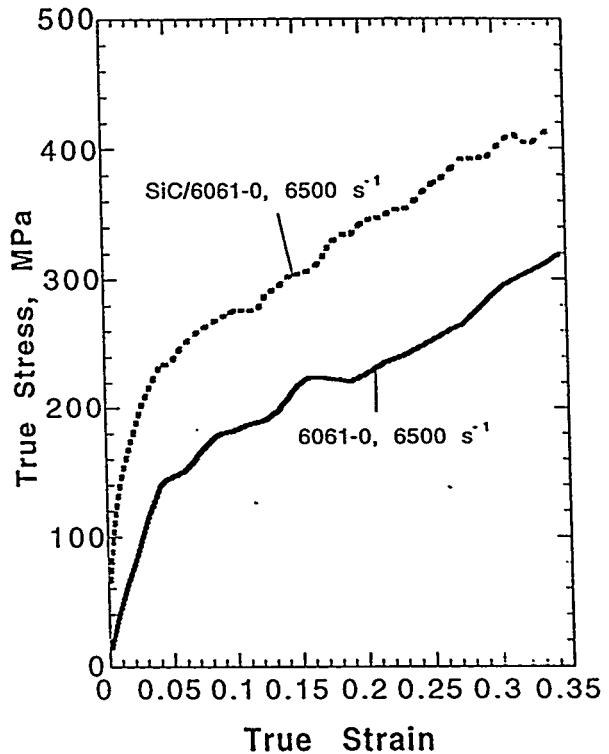
FIGURE 2. Compression responses for the unreinforced 6061 alloy and SiC/6061 composite samples at 6500 s^{-1} .

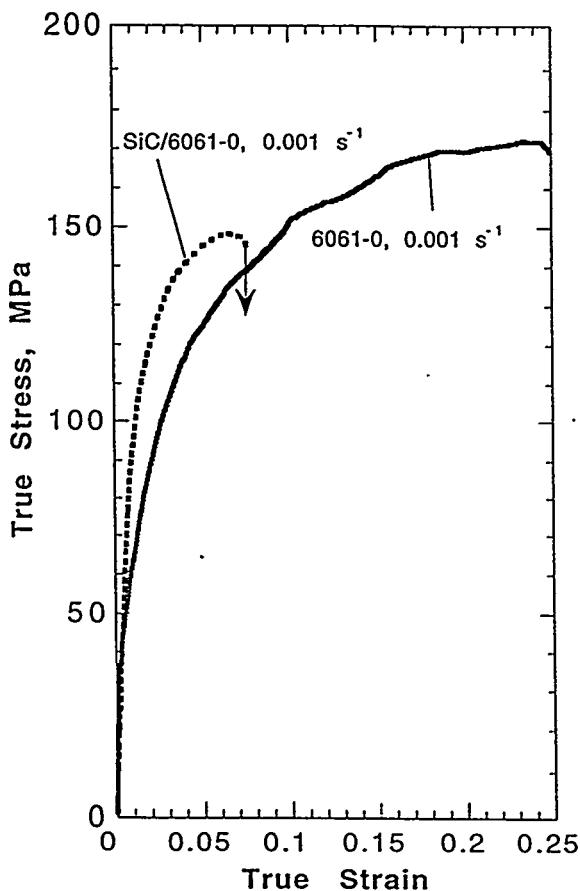
FIGURE 3. Low strain rate tension responses for the unreinforced 6061 alloy and SiC/6061 composite samples.
