Final Report- Testing of Optimized Bubbler Configuration for HLW Melter VSL-13R2950-1, Rev. 0, dated 6/12/2013

Testing of Optimized Bubbler Configuration for HLW Melter

**Vitreous State Laboratory
The Catholic University of America
Washington, DC 20064**

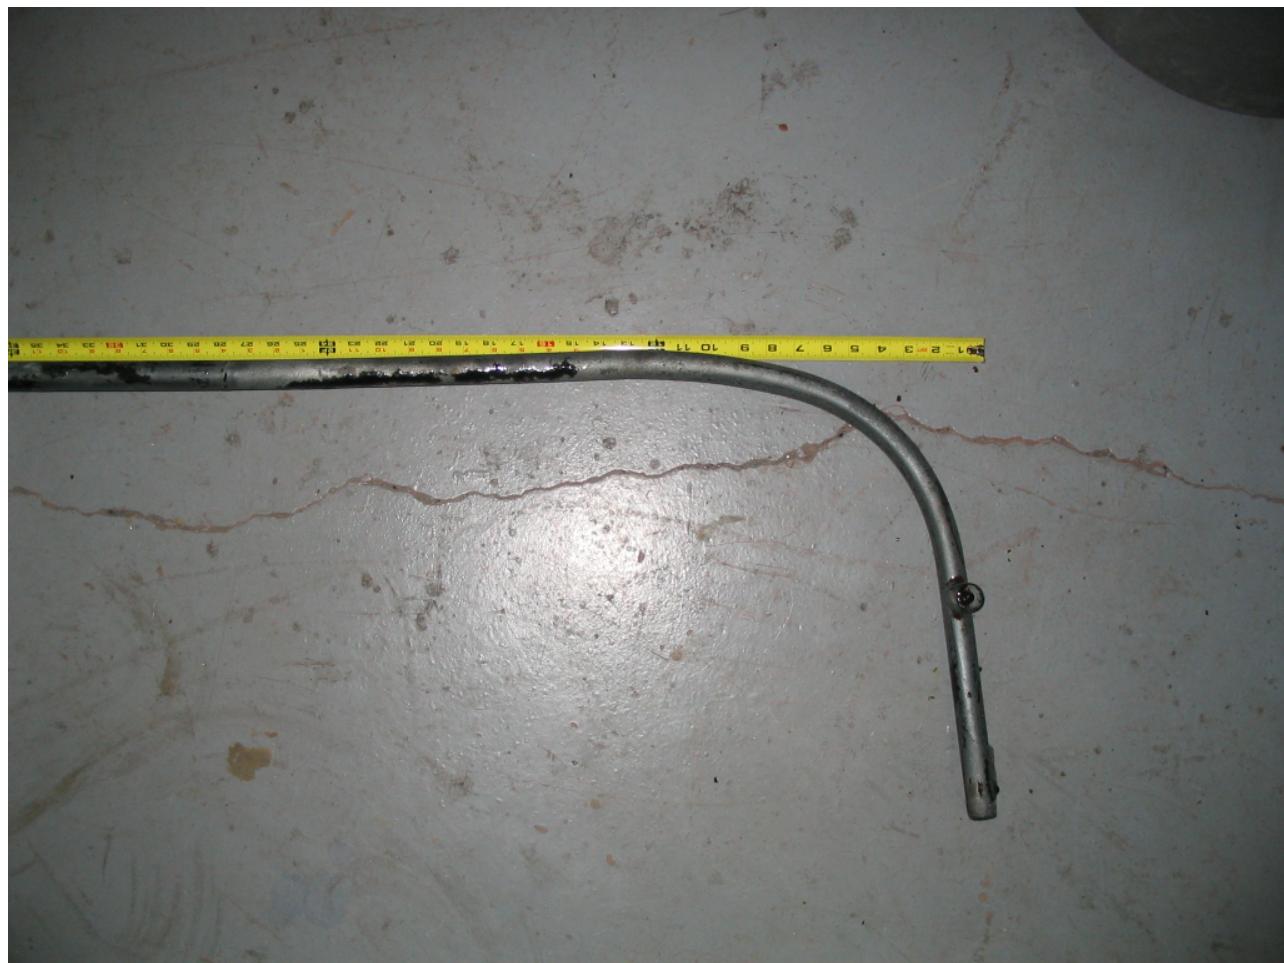
Figure 1.5. Double-Outlet “J” Bubbler.

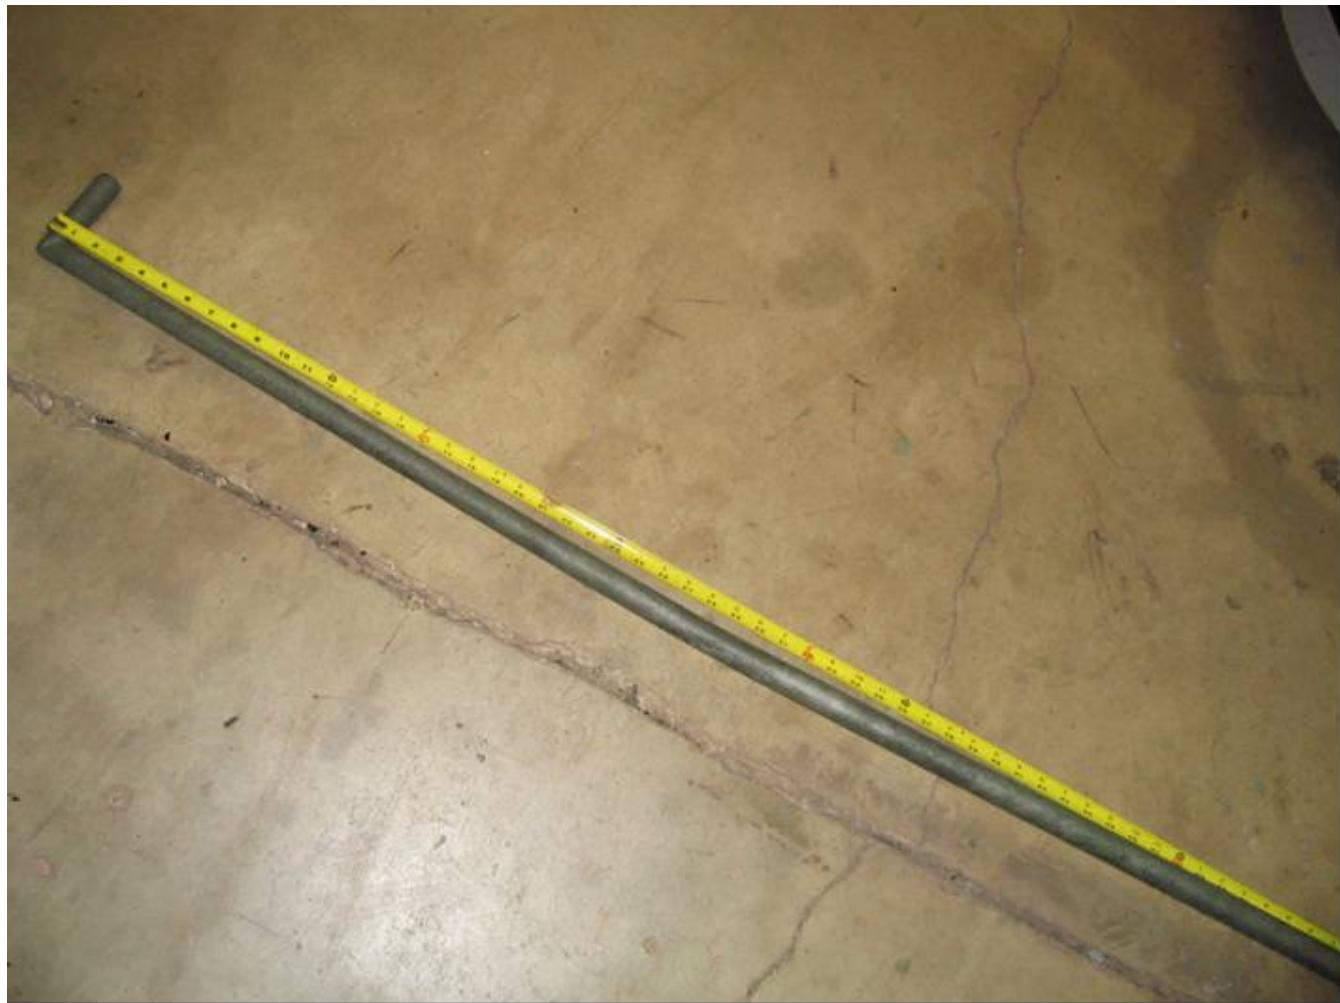
Figure 1.7. Single-Outlet “L” Bubbler.
