Impact of Atmospherically Deposited Solid Contaminants on Materials of Interest for the Interim and Long Term Storage of High Level Nuclear Waste

D.G. Enos, W.R. Olson, K.R. Norman
Sandia National Laboratories
P.O. Box 5800
Albuquerque, NM 87185
USA

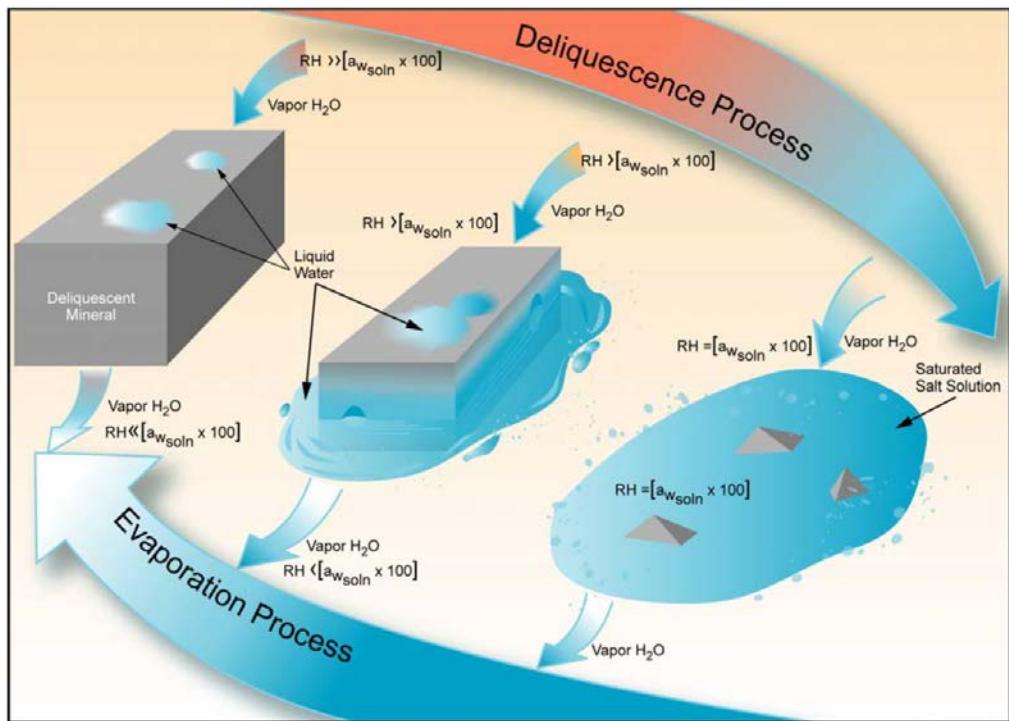
Figure 1: Schematic representation of the deliquescence process.³

Any waste package which is exposed to the atmosphere will have particulates (i.e., dust) carried by the atmosphere deposited on its surface. A portion of most atmospheric dusts consists of various soluble salts. Given the correct combination of temperature and atmospheric moisture content, these salts may deliquesce. Deliquescence, illustrated schematically in Figure 1, is essentially the transformation of the solid salt to a saturated salt solution, or brine. It has been suggested by several researchers that the salts which are deposited on waste package or container surfaces may combine to form deliquescent brines on the surface of a waste package at temperatures well above the boiling point of water, and further, that these brines might be corrosive depending on the material used to construct the package.¹ Other researchers have suggested that for highly corrosion resistant/passive materials, several factors will prevent extensive localized corrosion due to deliquescence, including electrochemical limitations (e.g., insufficient cathode reaction area) and physical (e.g., limited concentration of brine coupled with consumption or sequestration of aggressive species in the corrosion product).²

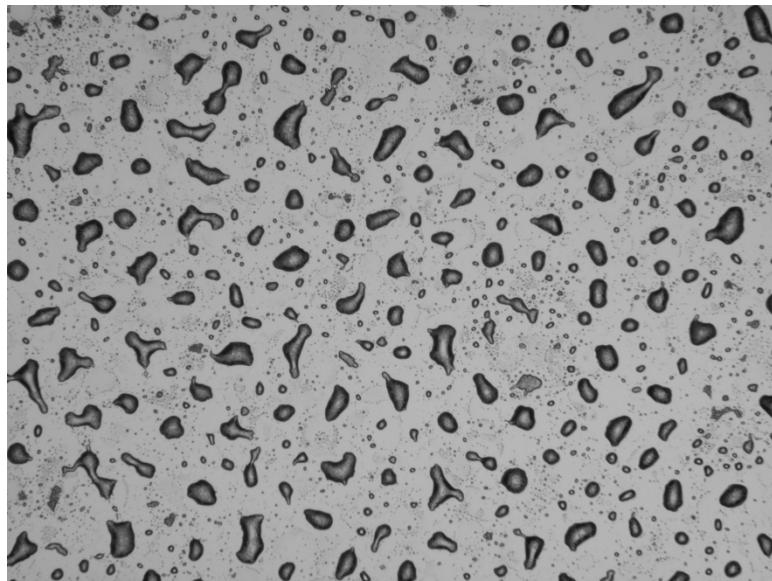
Figure 2: Small droplets typical of the airbrushed salt deposits. Note that the field of view presented in the image is approximately 1.15mm (typical droplet is approximately 25 microns in size or smaller.)

Deposition of each salt assemblage was accomplished by first creating a dilute solution (approximately 0.1M) of the salt in a methanol carrier. The salt was then deposited via an air brush using a dry nitrogen carrier gas onto the metal surface. For the deposition, the air-brush was held rigidly in place while the sample was moved through the salt deposition cone at a fixed rate. A quartz crystal microbalance was mounted adjacent to each coupon and was used to monitor the total quantity of salt deposited on the sample surface (once the methanol carrier had evaporated.). The resulting deposit was extremely uniform, as illustrated in Figure 2 for the four salt assemblage (note that this assemblage forms a liquid brine at ambient temperature, hence the appearance of small droplets on the sample surface)

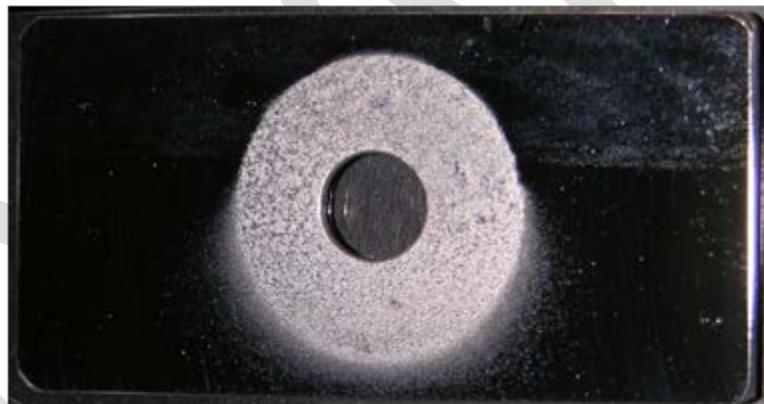
Figure 3: Typical salt deposition region. Note that the coupon is approximately 2 in. x 1 in.

Salt was deposited only in the region where corrosion testing was to be performed (i.e., it was present in the area where the multiple crevice former assembly would be present, but only extended a few mm past that diameter) as illustrated in Figure 3 below.

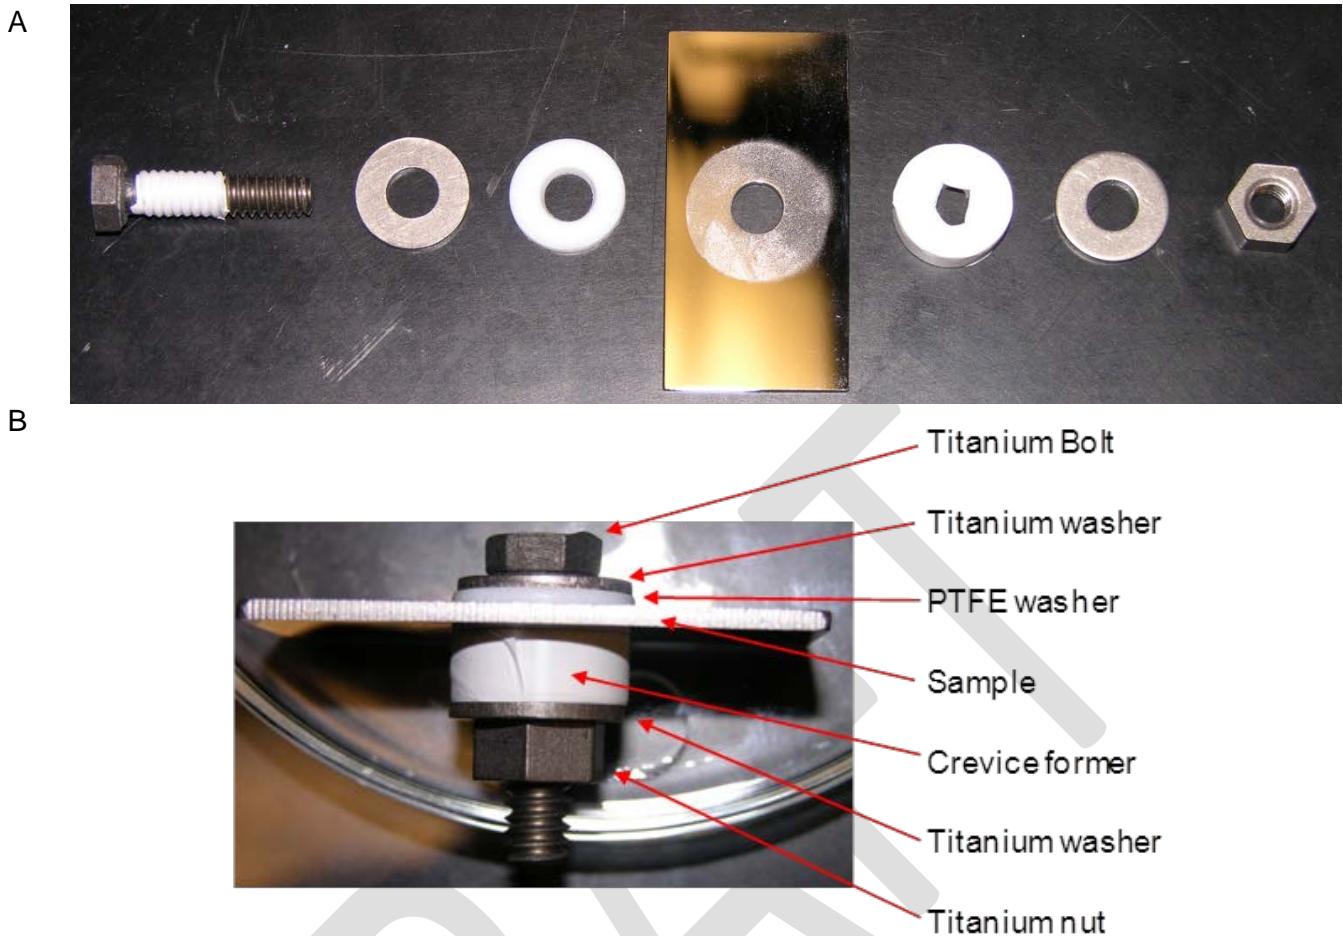
Figure 4: Crevice corrosion testing sample configuration. Titanium hardware was used to secure the MCA to the surface of the corrosion test coupon. Care was taken to electrically isolate the titanium hardware from the coupons itself. The MCA was made from zirconia and was wrapped in PTFE tape prior to being secured to the coupon surface at a torque of 70 in-lbs.

Once each coupon was cleaned and the appropriate quantity of salt deposited as discussed above, a multiple crevice former assembly (MCA) was attached to the surface. The ceramic MCA assembly was wrapped with PTFE tape prior to being torque down onto the metal surface. Titanium hardware, along with PTFE washers and the MCA were assembled as illustrated in Figure 4. The combination of coupon surface finish, PTFE wrapped MCA, and applied torque were based upon work performed by Shan and Payer (Shan, 2007) where they demonstrated that this was the most aggressive manner in which to evaluate the potential for crevice corrosion initiation.

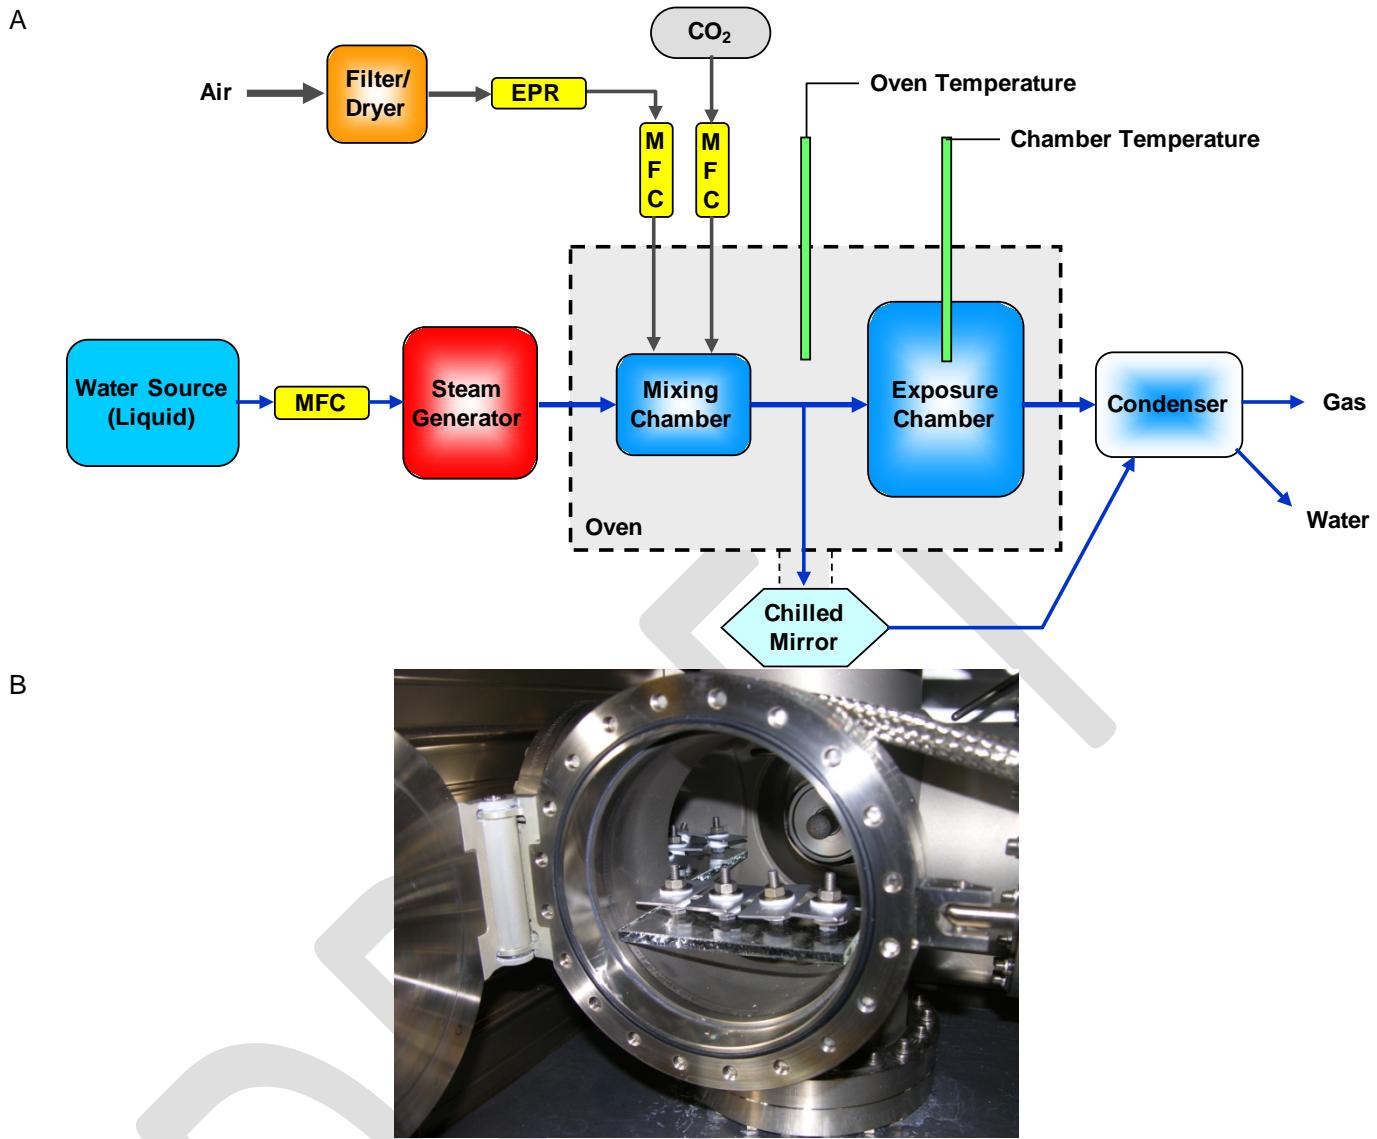
Figure 5: Schematic representation of the high temperature exposure system used for the elevated temperature experiments, along with a view of the loading port on the test chamber to illustrate the placement of coupons which was used)

Once assembled, the coupons were placed within a high-temperature, controlled dewpoint test chamber at a prescribed temperature and moisture level. The system is illustrated schematically in Figure 5. The gas stream, which is predominantly water, is provided by utilizing a mass flow controller to feed liquid water to a steam generator. A second mass flow controller is then used to add however much air is required to meet the desired dewpoint. The reaction chamber itself is housed within an oven. Throughout each experiment, the conditions within the chamber are monitored via a series of thermocouples along with a chilled mirror.

Specimens were placed on a glass surface and were not in contact with either the chamber walls or with other specimens within the chamber, as illustrated in Figure 5. The gas flow rate through the chamber provided multiple environment exchanges per hour. Both the temperature and dewpoint were monitored continuously throughout the course of each experiment. In addition, a dish containing the salt assemblage under investigation was also placed within the chamber. Periodic observation of the bulk sample enabled verification that a liquid brine was stable and that little or no second phase precipitation was taking place (which would in turn alter the composition of the brine).

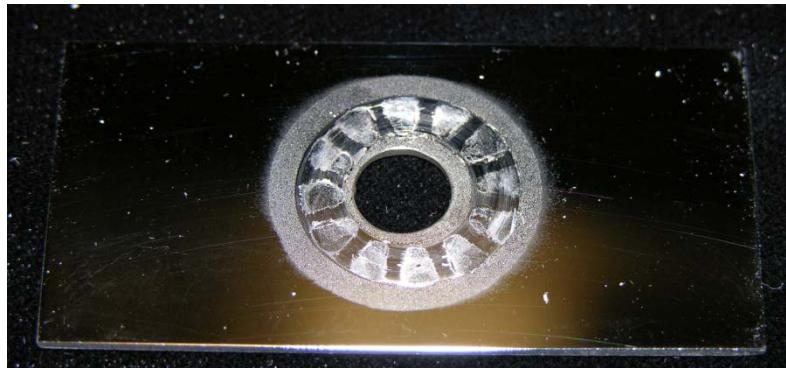
Figure 6: Hastelloy C-22 sample following long term exposure and removal of the MCA from the surface. Note the residual salt remaining on the surface, along with deposits from the PTFE tape which the MCA was wrapped with.

Upon completion of the each test, the MCA/coupon assembly was disassembled. As can be seen in Figure 6, most samples had a deposit remaining on the surface consisting of the initially deposited salt, as well as a film of PTFE tape from the crevice former. Each coupon was photodocumented in the as-removed condition, and then cleaned ultrasonically in deionized water, followed by immersion in a 15 vol% HCl solution to remove the surface contamination left behind by the test.

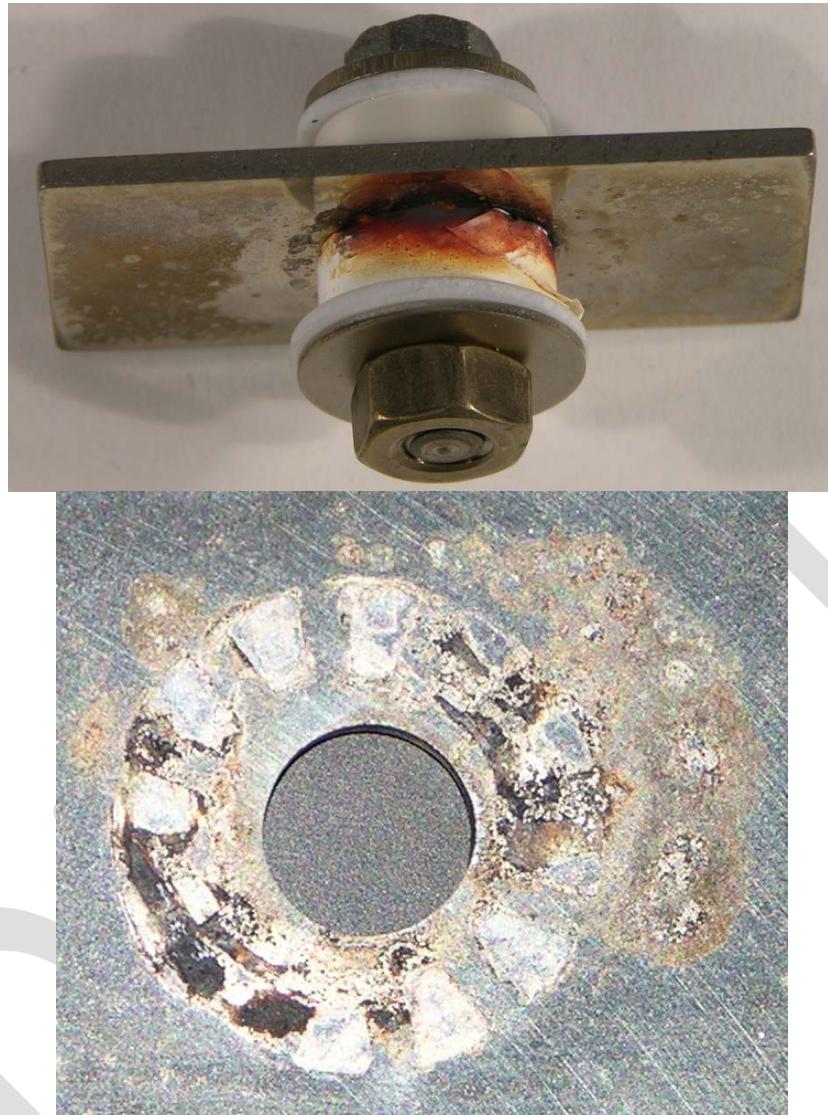
Figure 7: Crevice attack observed on 303SS samples after 100 days of exposure at a dewpoint of 94.5C and an ambient temperature of 101°C.

corrosion for a sufficiently susceptible material. The test was run for a total of 100 days, and for the nickel based alloys, no discernable crevice corrosion was observed. The 303SS, however, did initiate localized corrosion for many of the MCA teeth, as illustrated in Figure 7.

demonstrated here for SS303 in the presence of a chloride rich brine. As the material becomes more electrochemically active, the cathodic reaction rate on the exterior surface becomes larger, reducing the cathode area required to support the active region beneath the crevice. In addition, the anodic reaction rate increases, facilitating maintenance of the critical crevice solution within the occluded geometry, an preventing stifling of the propagating crevice. Related to this effect, the critical crevice solution required by the less corrosion resistant material is less concentrated, further increasing the resistance of the advancing localized corrosion site to mass transport of metal ions out of the solution beneath the crevice.
