# Interface adhesion and coating integrity effect on the performance of the $\text{Bi}_2\text{Te}_3$ -based thermoelectric module

Nancy Yang, D. E. Wesoloski, S. Whalen, C.R. Koripella and , A. Wu

Sandia National Laboratories

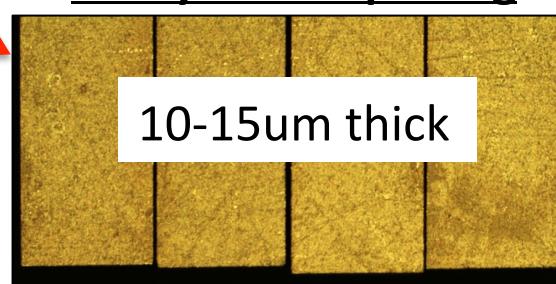
### Au by electroplating

Well adhered Au film

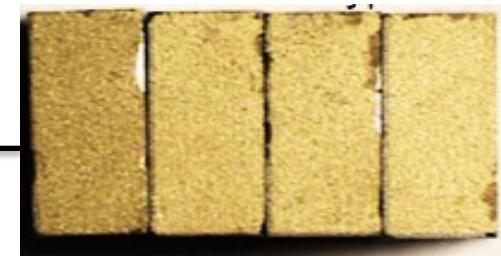
PVD (300-400nm)

# Microstructure and interface adhesion of Au film are process dependent

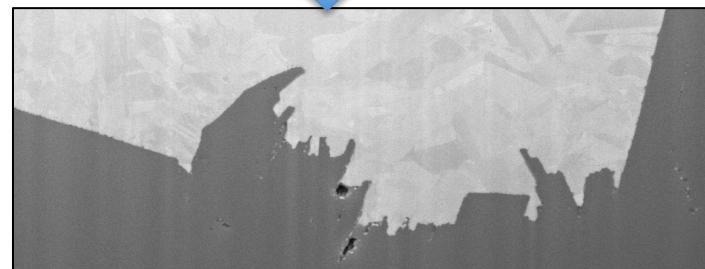
By PVD

**3-D images suggest the thru-thickness pinholes & large interface pores are responsible for the poor adhesion of the 10-15um PVD Au film**

The PVD Au is unable to fill the surface defect to provide mechanical locking.
