Evaluate Thermal Spray Coatings as a Pressure Seal

June 09, 2011

Joseph Henfling
Sandia National Laboratories

Specialized Materials & Geopolymer Sealing Materials

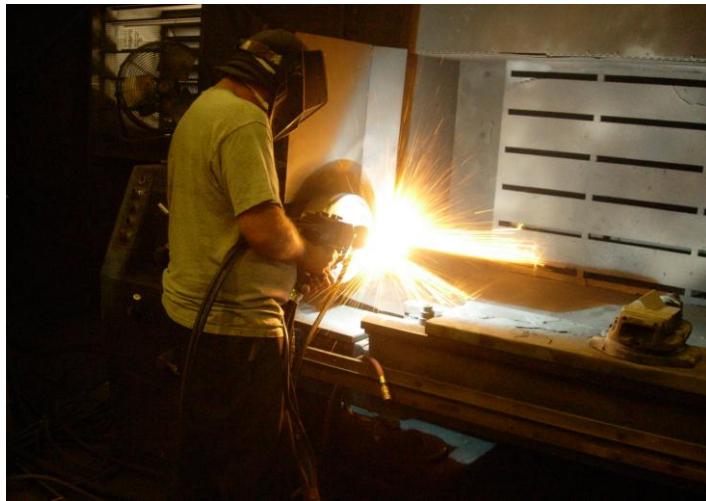
Twin Wire Arc System

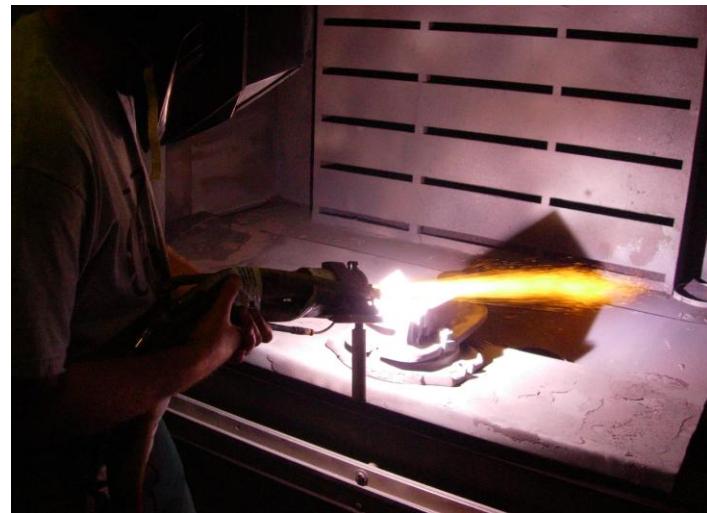
Atmospheric Plasma Spray System

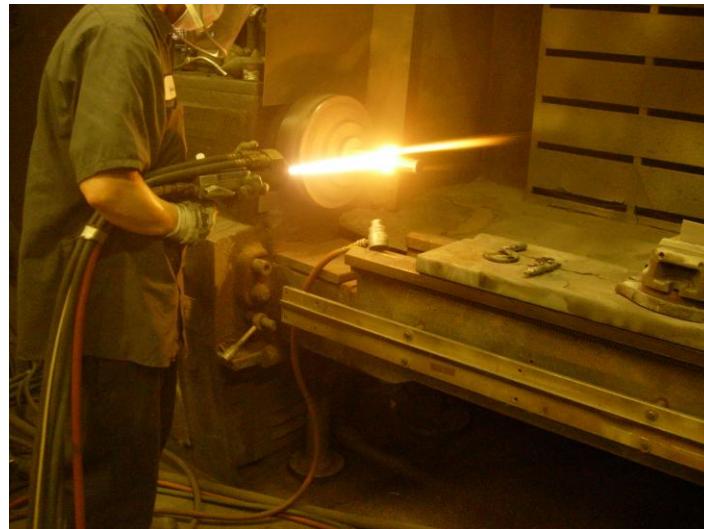
HVOF Spray System; Inconel 625

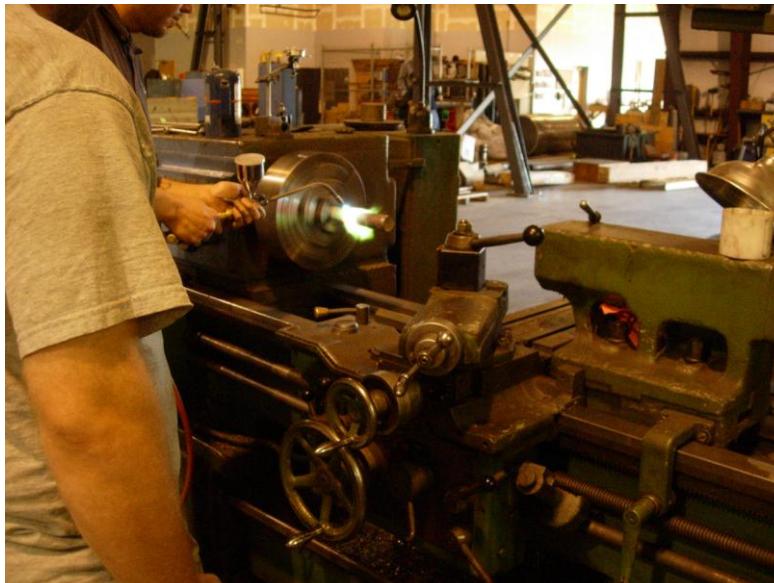
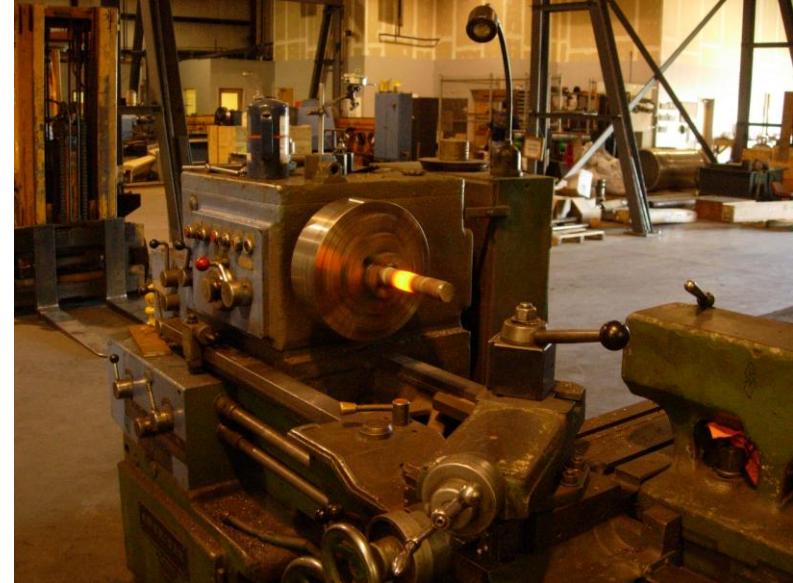
Flame Spray system – Fusible coating

- Fusible coating is very dense and is a cost effective process
 - Unfortunately it requires extreme heat to fuse (1800°F)
 - As such, not ideal for tool seals

Application of fusible coating process at Thermal Spray Solutions facility
