**CRADA Final Report
for
CRADA Number ORNL92-0149**

**FRICION AND WEAR BEHAVIOR OF IN-SITU
REINFORCED SILICON NITRIDE**

FINAL REPORT
FOR CRADA
ORNL 92-0149

FRICITION AND WEAR BEHAVIOR OF
IN-SITU REINFORCED SILICON NITRIDE

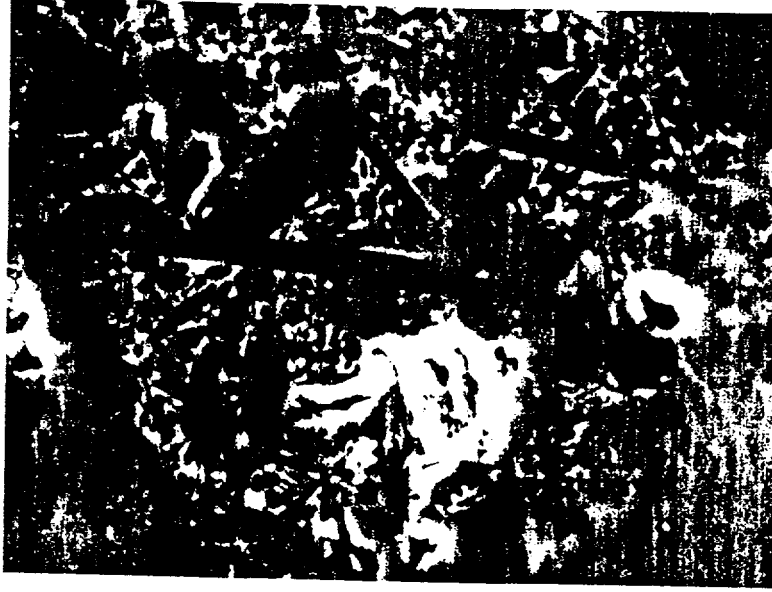
Fig. 4. Scanning electron micrograph of the wear track condition on a hot-pressed specimen after 300,000 cycles at 2.5 GPa contact pressure (test CP-369). As seen in (a), the debris layer contains micrometer-scale openings. At higher magnification, (b), the underlying microstructure is imaged through thin portions of the debris layer.

A hot pressed specimen sliding at a contact pressure of 2.5 GPa for a 300,000-cycle test duration (test CP-369) did not exhibit any measurable wear, but the position of the track on the specimen surface was made evident by the accumulation of wear debris from the counterface ball tip. An example of the debris layer formed on the wear path is shown in Fig. 4(a). The debris layer is not completely continuous, containing a distribution of pore-like openings. Additionally, the layer thickness is apparently not uniform, some portions of the layer being lighter in appearance than others. At higher magnification, Fig. 4(b), it is more evident that the layer has varying thickness, the lighter portions being the thicker regions, and the thinner portions transmitting an image of the underlying microstructure. The transmitted underlying image, formed by differential secondary electron emission from grain and boundary phases, indicates the accumulation of debris in the originally empty intergranular spaces of the polished surface (see Fig. 1 (a)). Large pits are not evident on any of the hot-pressed specimen mild wear tracks.

Fig. 4. Scanning electron micrograph of the wear track condition on a hot-pressed specimen after 300,000 cycles at 2.5 GPa contact pressure (test CP-369). As seen in (a), the debris layer contains micrometer-scale openings. At higher magnification, (b), the underlying microstructure is imaged through thin portions of the debris layer.

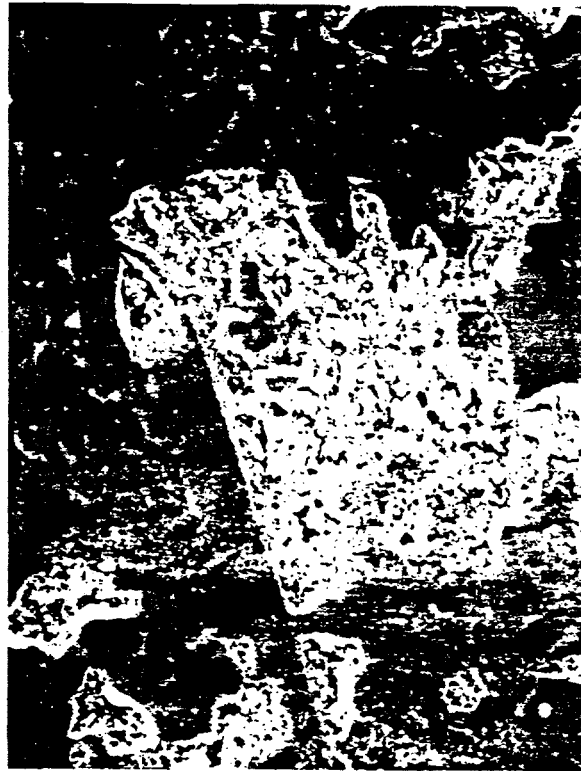
Fig. 6. A pit formed in the wear track of a sintered specimen. Fracture started over an area about 7 micrometers in diameter. Extension of the fracture seems to be limited by the needle-like grains.

On other sintered specimens tested at the same conditions, 2.5 GPa and 300,000 cycles, some pit formation on the wear path was observed by optical microscopy. An SEM view of one such pit showed an area of fracture about 7 microns in diameter, Fig. 6, limited by needle-like grains. The size of the pit was much greater than any residual surface pits on the as-prepared specimen surface, indicating the formation and/or growth of the pit during the wear experiment. The ball tip in this experiment also showed some degree of wear.

Fig. 6. A pit formed in the wear track of a sintered specimen.

Fracture started over an area about 7 micrometers in diameter. Extension of the fracture seems to be limited by the needle-like grains.
