In-situ Observation and Multiscale Three-dimensional Characterization Ta Tensile Samples

SAND2013-8942C

Sandia National Laboratories

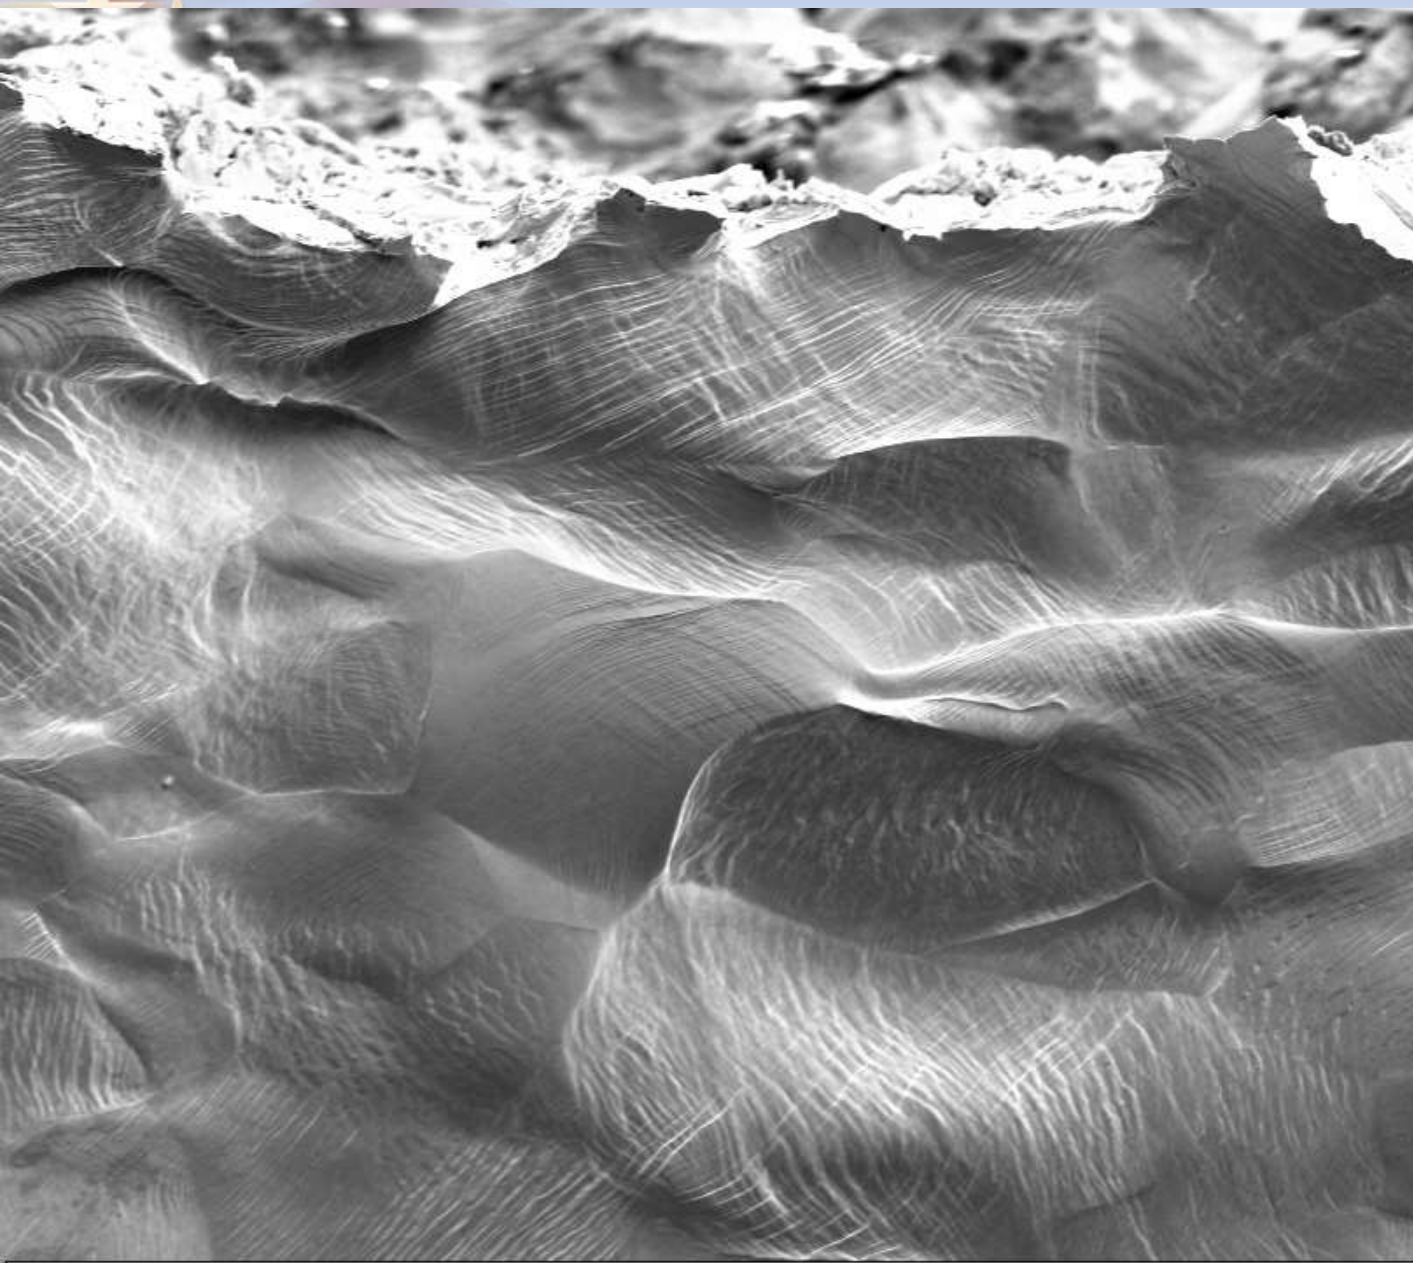
File Name = Ta-N1_d1850mV_14.tif

20 μ m

EHT = 10.00 kV

WD = 21.1 mm

Signal A = SE2

Observing Deformation in Tantalum

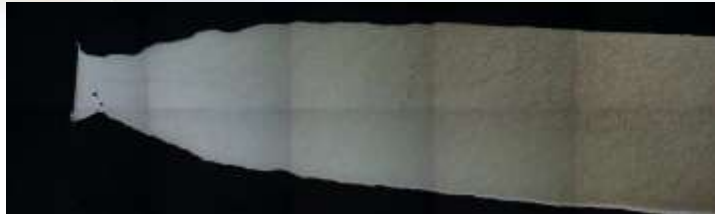
3D RoboMet Polishing Provides Significant Insight

montage: 5 x 2
magnification :
20X

Tantalum tensile void sample

- Completed 135 serial sections at ~ 2.5 microns per slice (total sectioning depth of ~ 340 microns)
- Sample reveals voids at initial cross-section which quickly link to a full crack across the gauge cross-section
 - Crack appears to close at further distances into the gauge section (see end of animation)
- Developed an image segmentation process to binarize the image set for reconstruction and keep fidelity of voids and cracks in gauge section
 - Should have full 3d reconstruction by week's end
