Probability of Detection Studies to Quantify Flaw Detection in Composite Laminate Structures

SAND2013-7868C

Dennis Roach & Tom Rice
Sandia National Labs
FAA Airworthiness Assurance Center

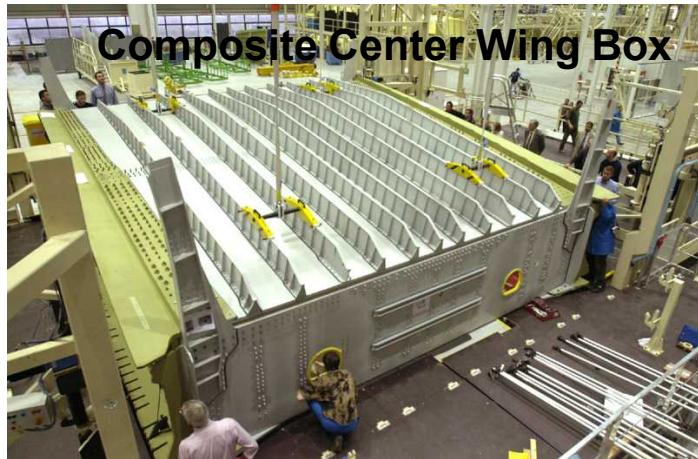
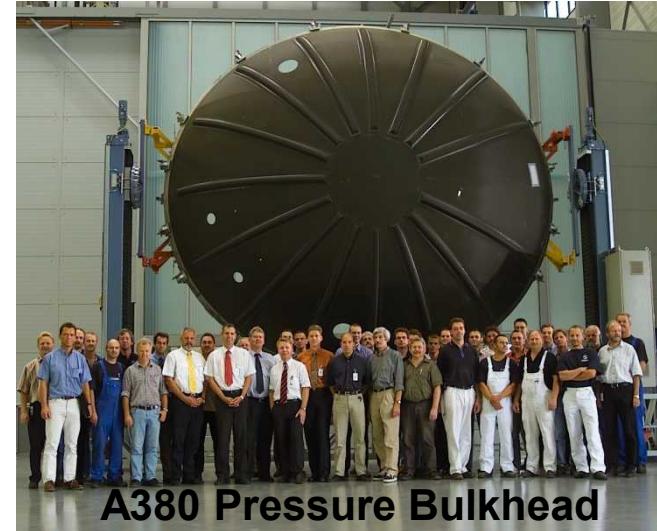
Composite Structures on Boeing 787 Aircraft

- █ Carbon laminate
- █ Carbon sandwich
- █ Fiberglass
- █ Aluminum
- █ Aluminum/steel/titanium pylon

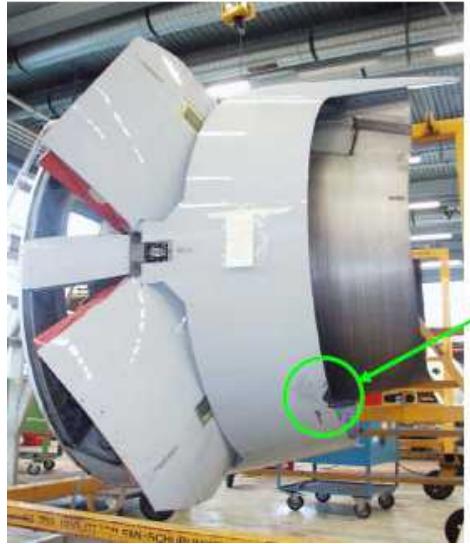
**Lightning
Strike on
Thrust
Reverser**

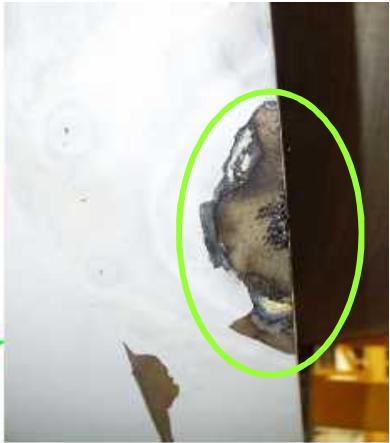
Bird Strike

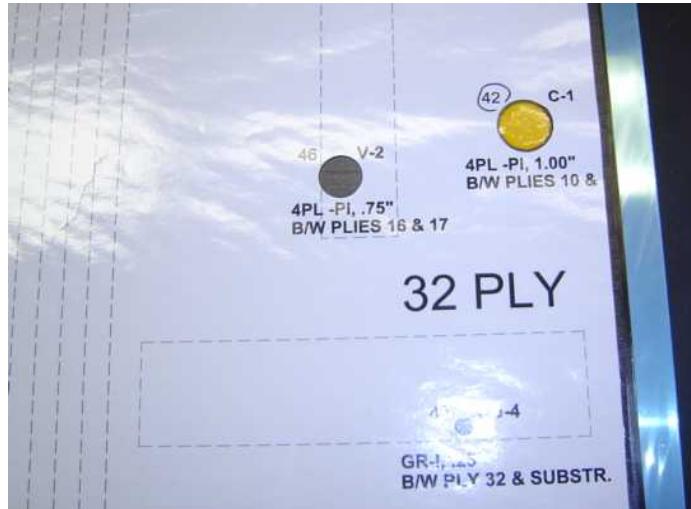
Flaw templates - ensure proper location of flaws

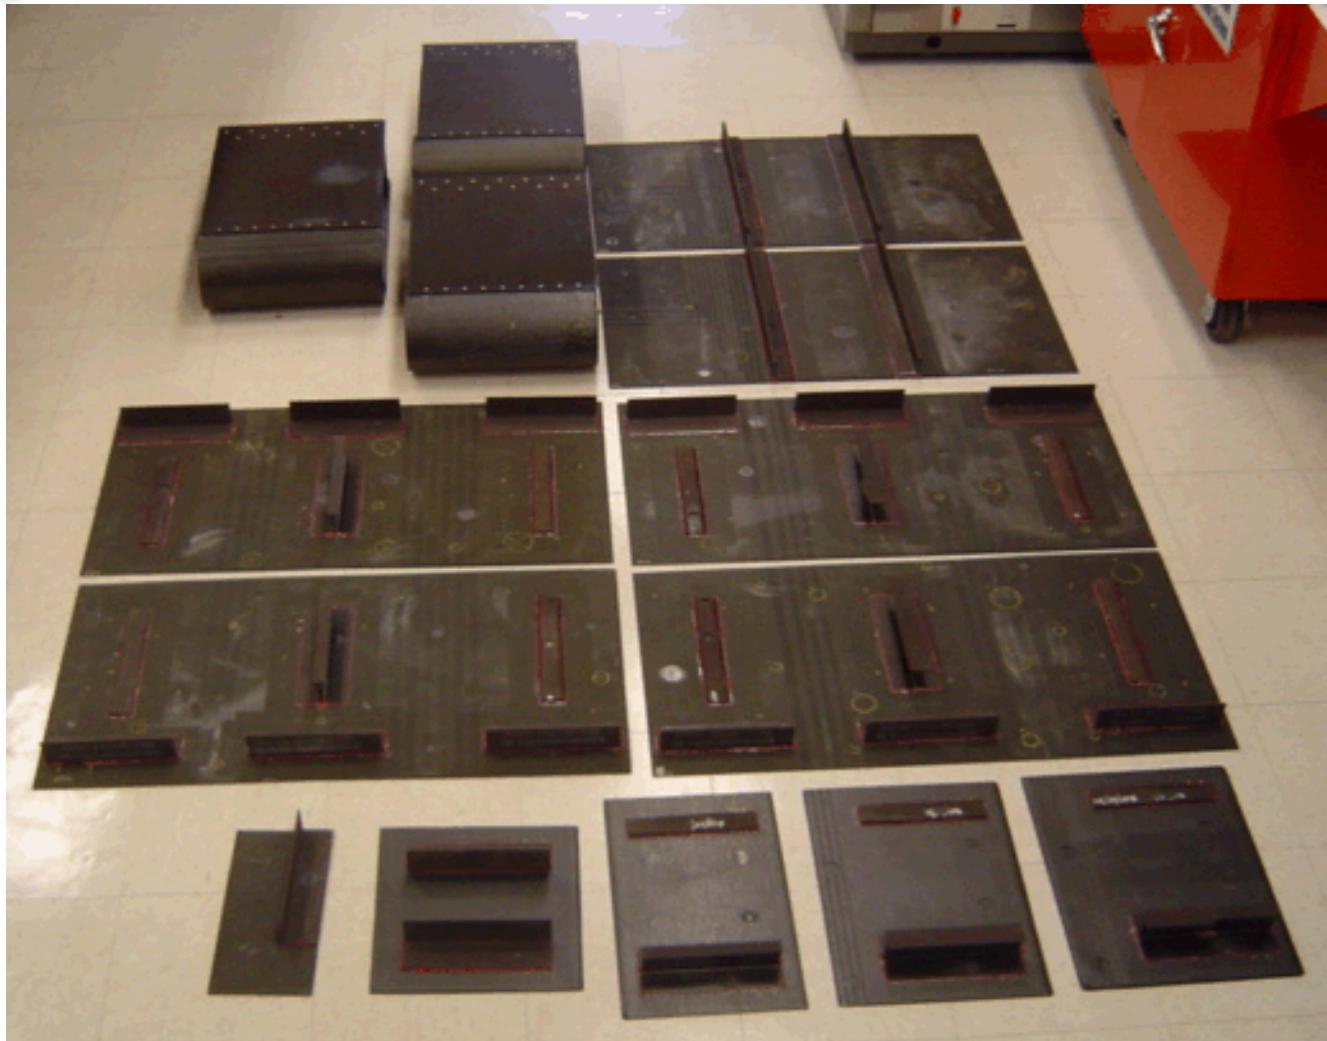
Specimen Set - Flaw Detection in Solid Laminate Composites

Thickness Range:
12 – 64 plies

Inspection Area:
46 ft.²

Number of Flaws:
202

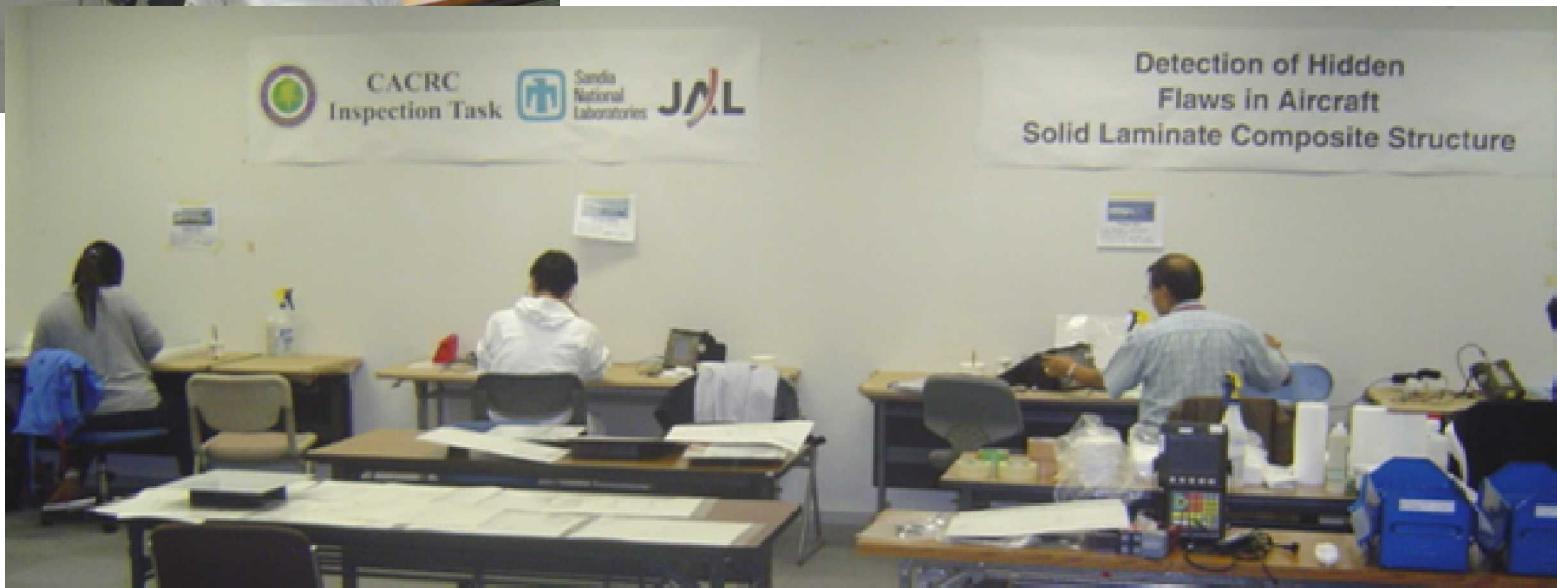
PODs calculated for overall laminate, by thickness family, by substructure effects, by complex geometry effects, by flaw types, etc. → 57 inspectors

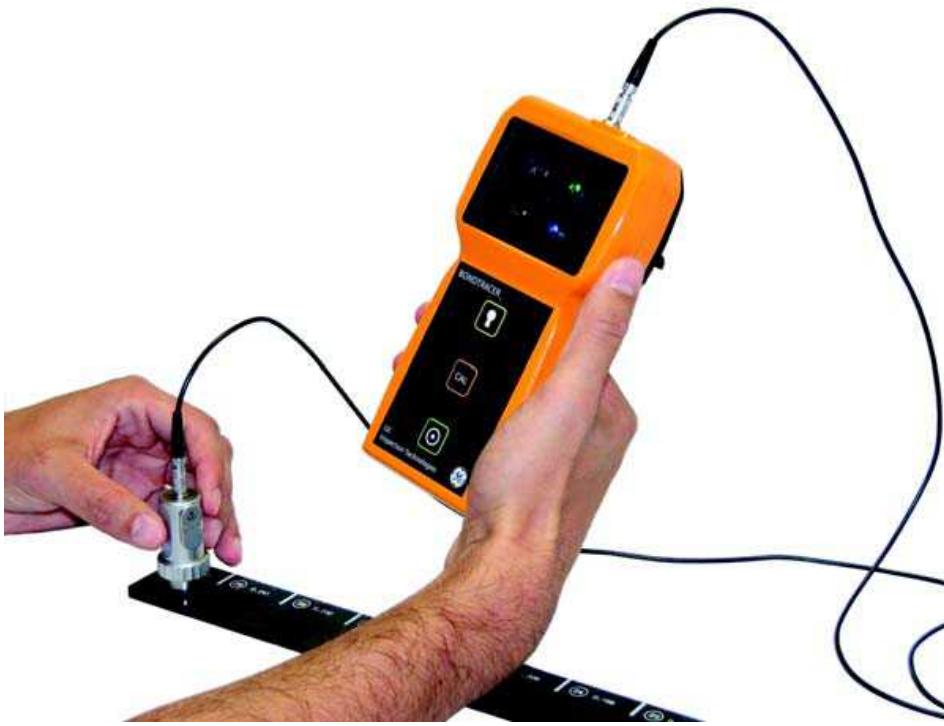
**General Electric –
“Bondtracer”**

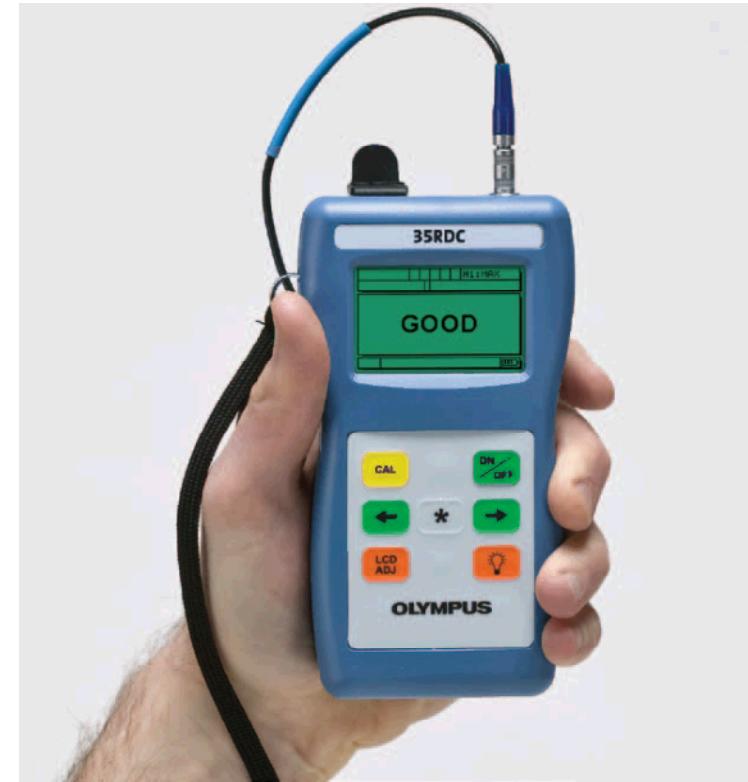
**Olympus –
“Ramp Damage Checker”**

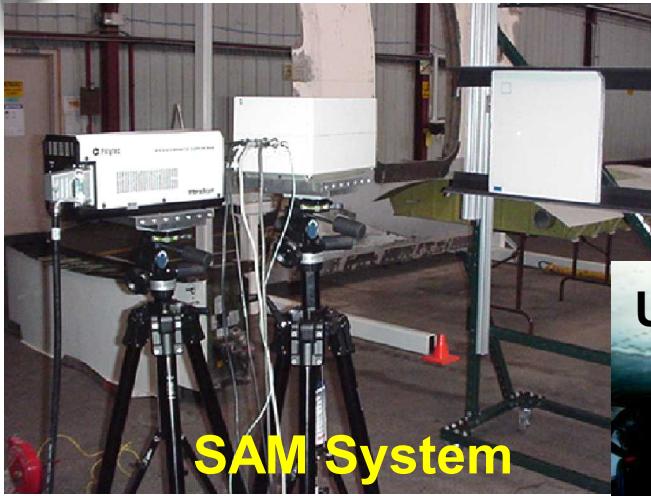
SAM System

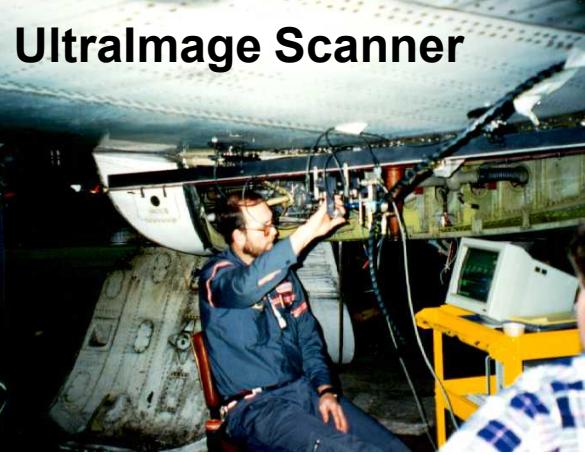
Ultralimage Scanner

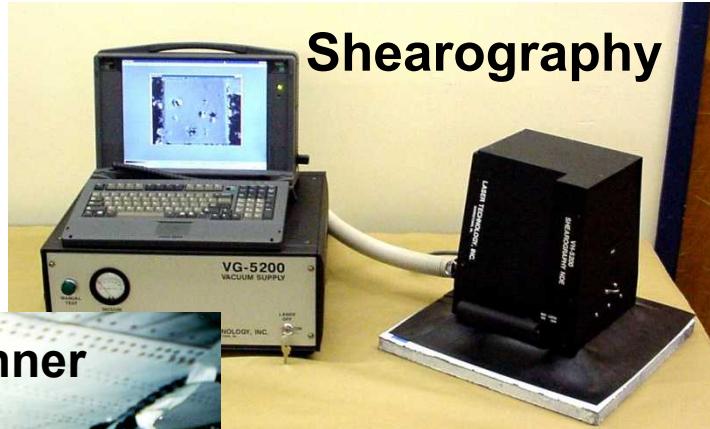
Shearography

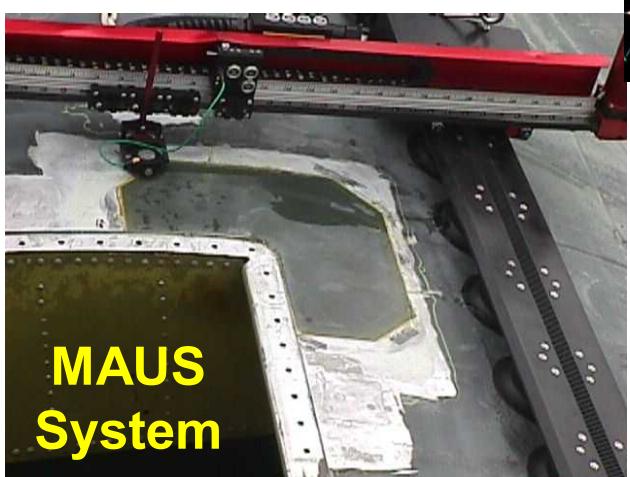
MAUS System

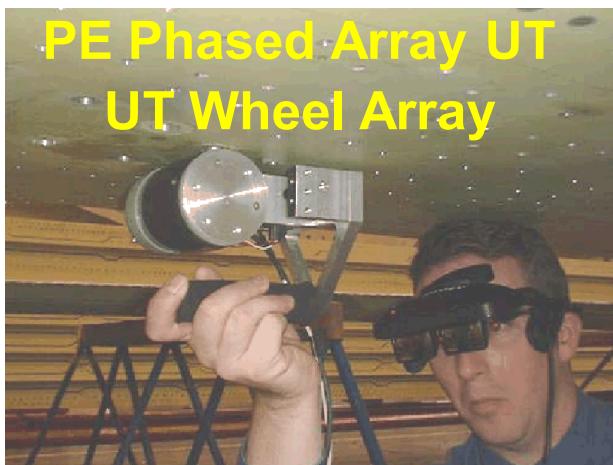
**PE Phased Array UT
UT Wheel Array**
