# Improving In-Service Inspection of Composite Structures

## CACRC Inspection Task Group Update

**CACRC Inspection Task Group**  
Status – June 6, 2013 – Lisbon, Portugal

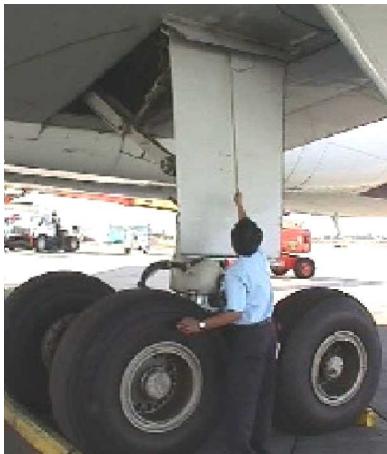
Experiment to  
Assess Flaw  
Detection  
Performance

## Composite Flaw Detection Experiment

Industry-wide performance curves generated to quantify:

- how well current inspection techniques are able to **reliably** find flaws in composite honeycomb structure
- the degree of improvements possible through integrating more advanced NDI techniques and procedures.

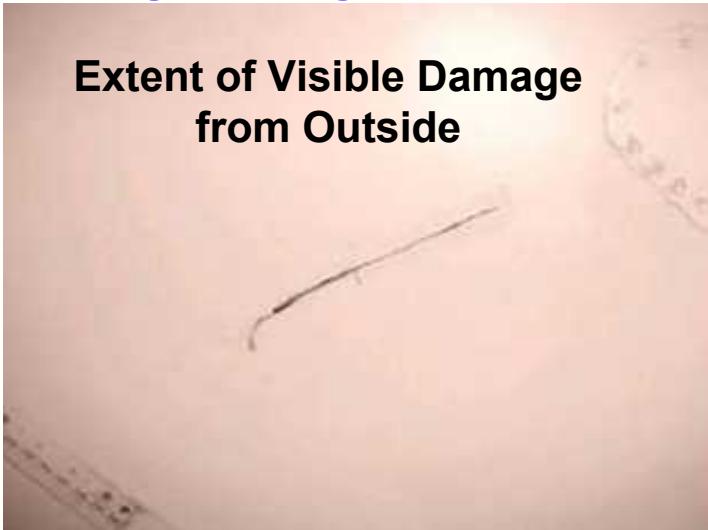
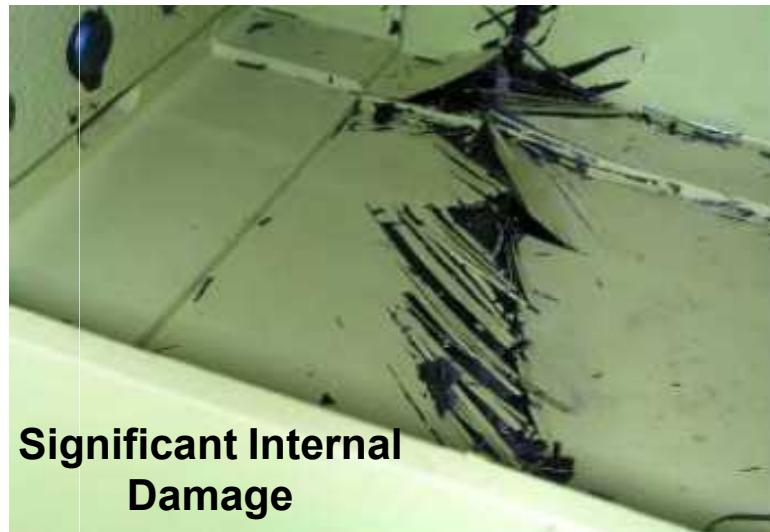
## Visible Impact Damage – external skin fracture

## Backside Damage – internal skin fracture & core crush

## Damage from ground vehicle

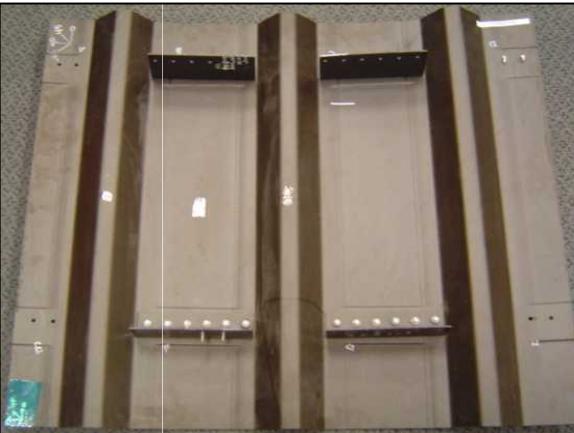
## Stringer Fracture

Note: subsurface damage & comparison to visual inspection

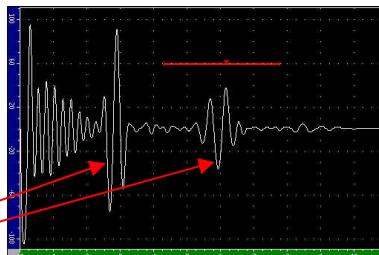
A-scan Flaw

Notice loss of backwall signal  
and new intermediate signal
