# **OECD WGIAGE Expert Meeting on**

## **Post-tensioning Methodologies for Containment Building: Analytical Methods for Evaluating Corrosion in Grouted and Ungrounded Systems**

**November 26-27, 2012  
Villeurbanne, France**

# Long-Term Corrosion Protection Methods for Grouted and Ungrouted Systems

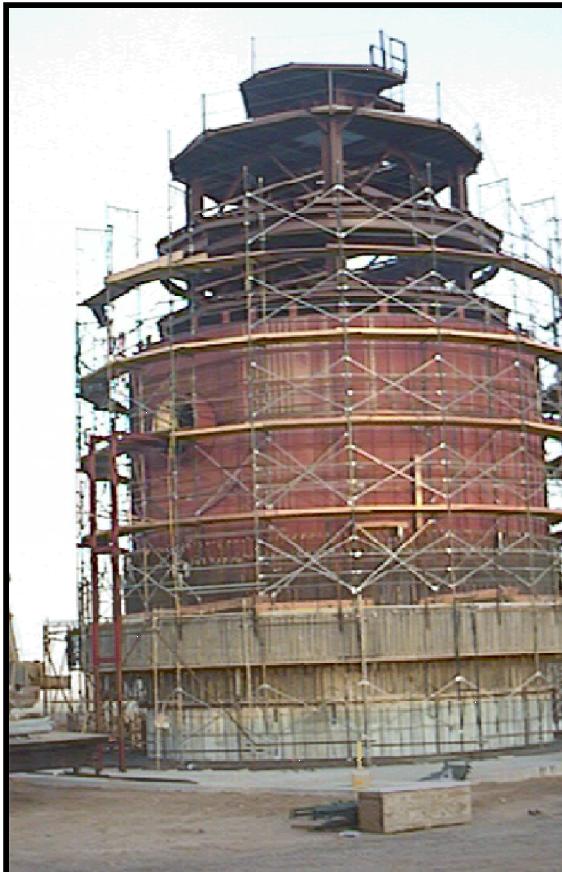
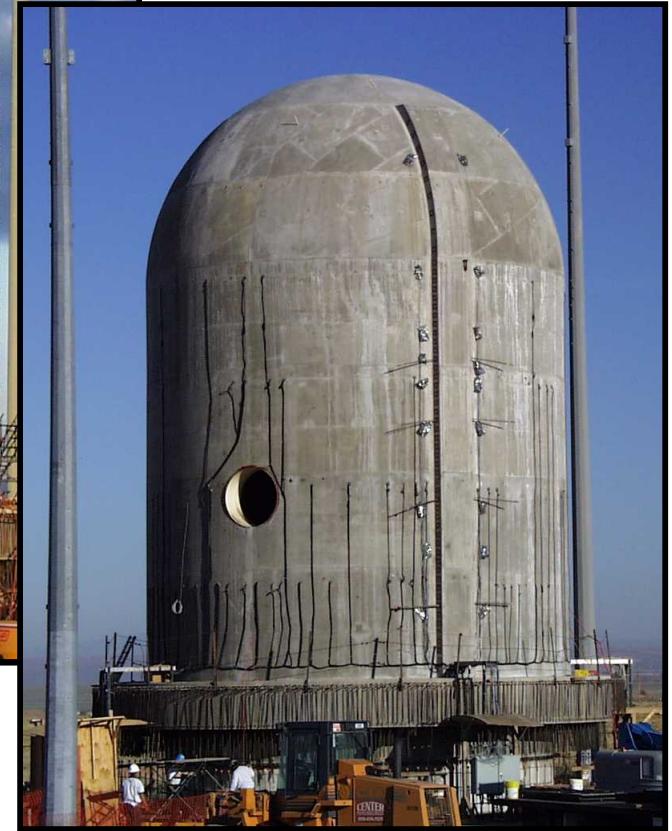
# FEA Studies Continuing to Utilize NUPEC/NRC/Sandia 1:4 Scale PCCV Model
