# Used Fuel Disposition Campaign

## Interim Storage Container Corrosion Testing at SNL

**David Enos, Charles Bryan  
Sandia National Laboratories**

**EPRI/ESCP International Subcommittee Meeting  
November 30<sup>th</sup>, 2012**

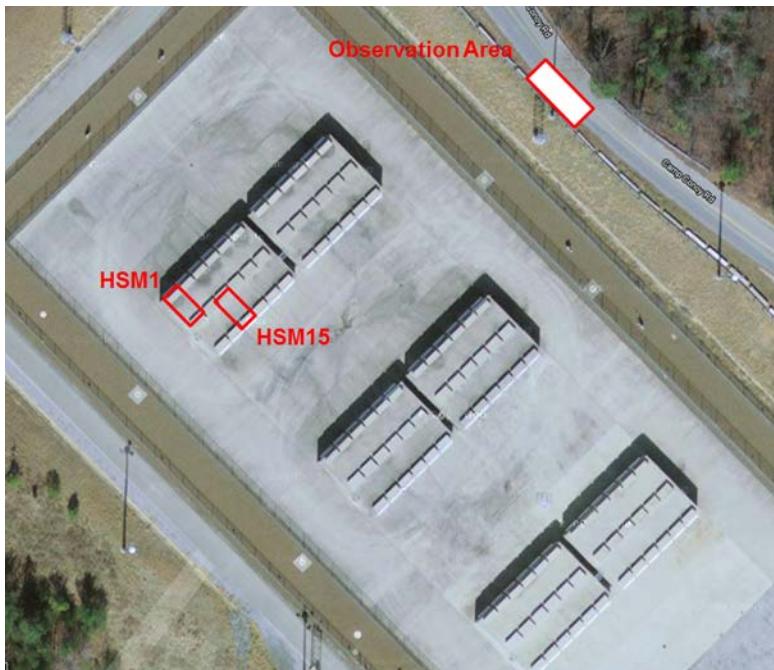
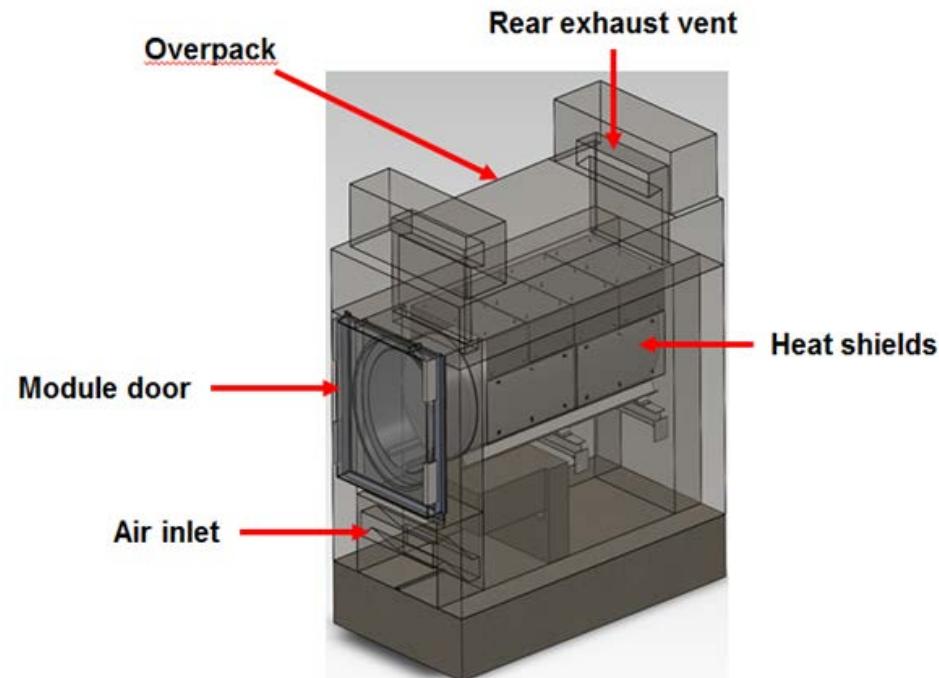
- NRC inspection of the Calvert Cliffs ISFSI performed in June, 2012
- Imaging of two containers, coupled with temperature measurement and surface deposit sampling

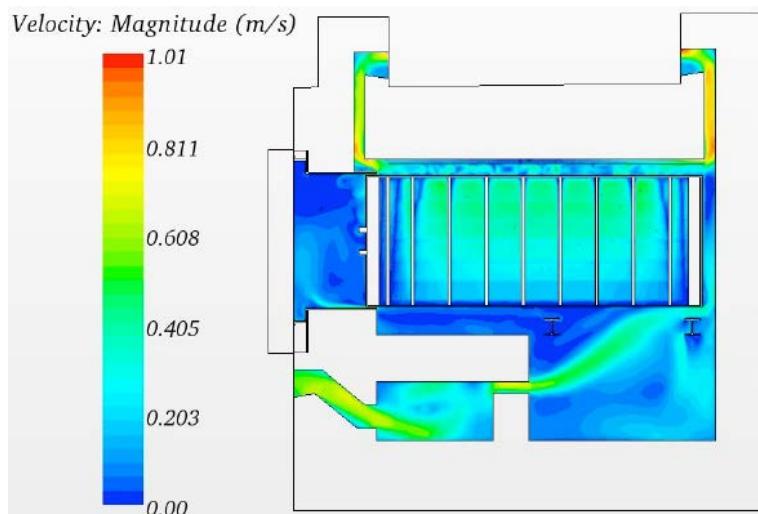
FCRD-UFD-2012-000344  
Figure 7.1

- Calvert Cliffs NUHOMS HSM-15 canister and storage module
- Temperature map of full canister surface, internals (huge temperature range on the surface, corresponding to a huge range in relative humidity)
- Provides ventilation velocities (useful for determining potential salt load)
- Seasonal temperature fluctuations evaluated (correspond to similar-magnitude temperature fluctuations on the container surface)

- *However:*
  - Provides snapshots, but does not model full temperature evolution through time.
  - Currently, for only one waste profile (thermal load)

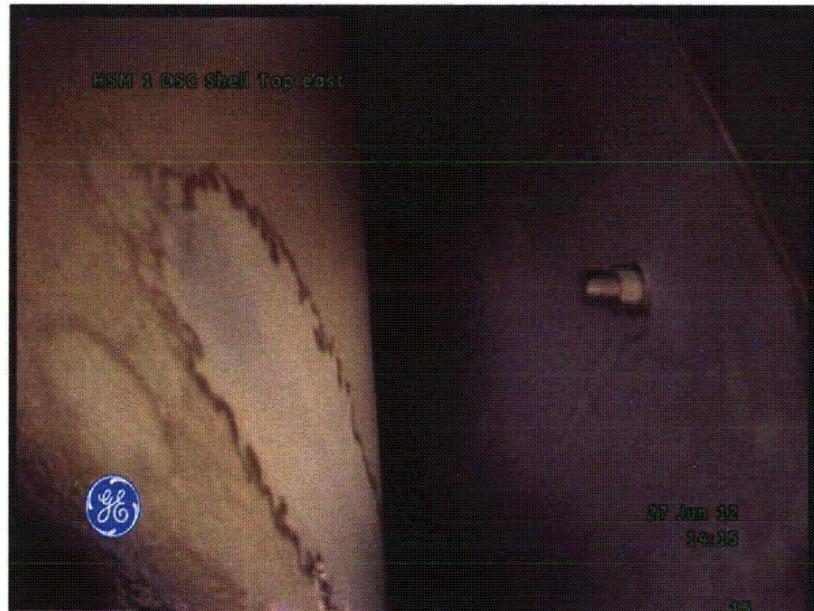
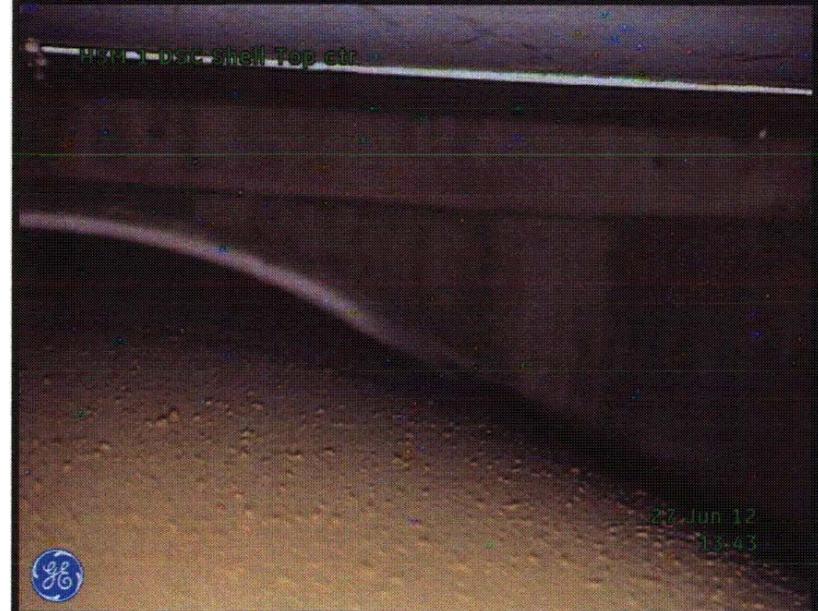
- SaltSmart device used to acquire surface chloride levels
- Single measurement made at the 0900 location
- 543 mg/m<sup>2</sup> (54.3 µg/cm<sup>2</sup>) for container which was in service for 19 years
- Significant particulate visible on the surface of the container

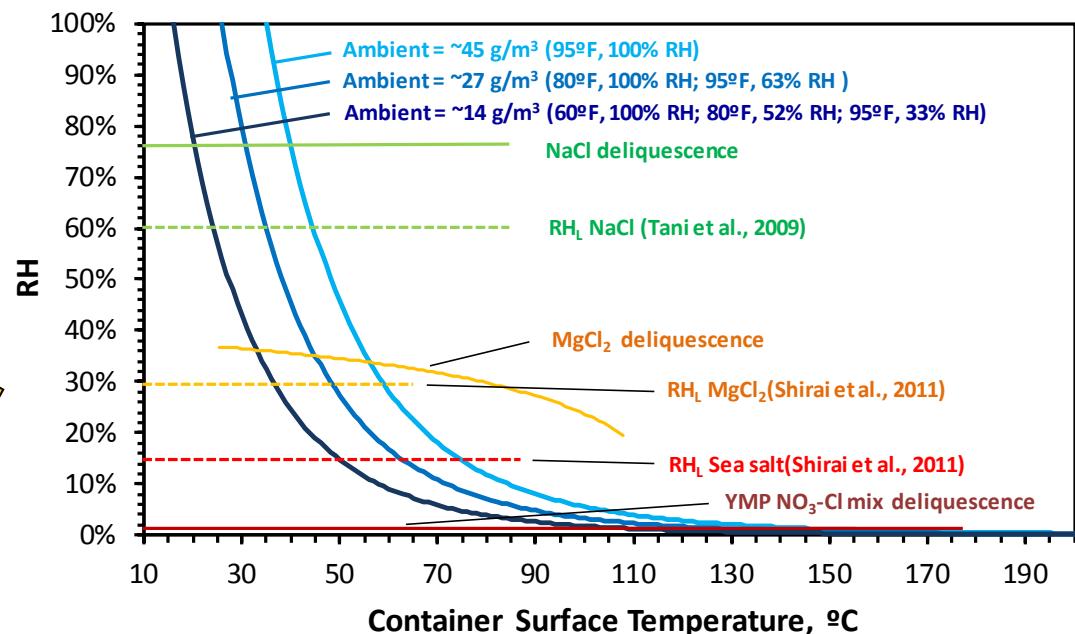
- Can be calculated from the ambient RH and air temperature (monitored) and the container surface temperature at a specific location. Will vary with daily/seasonal variations air RH/T and waste package T.

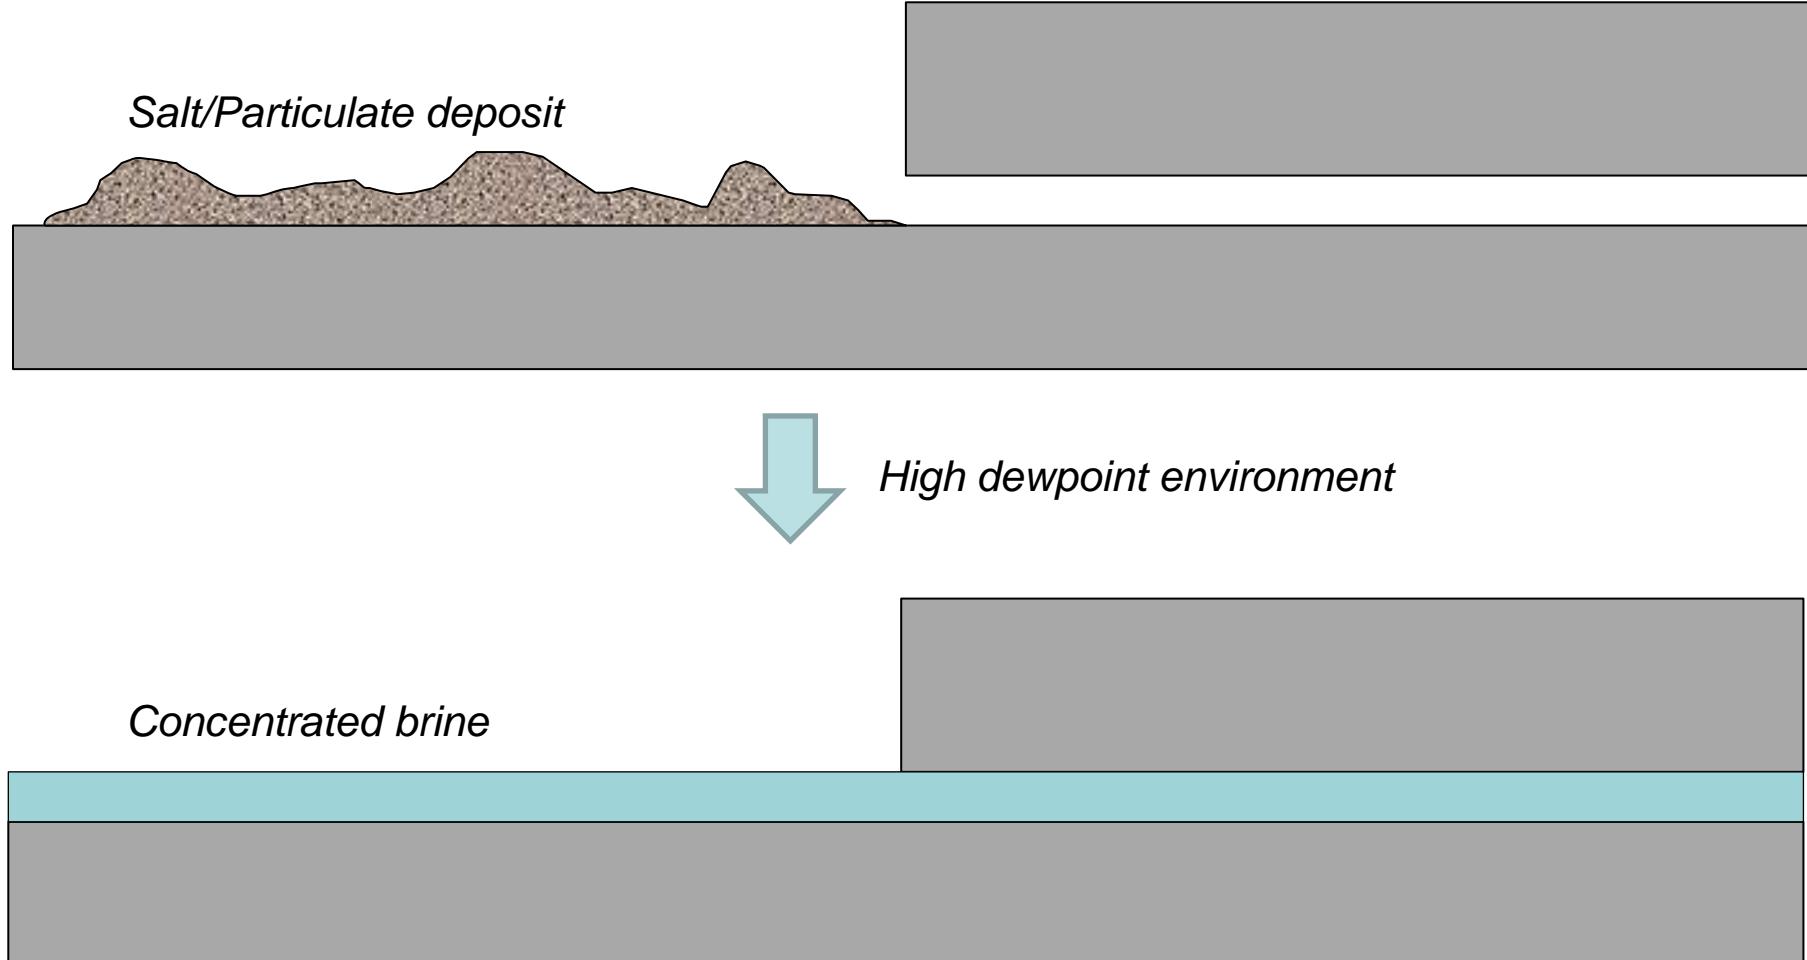
## Schematic of a Crevice

- A series of relevant materials has been evaluated
  - Stainless steels used in interim storage applications
  - Alloy 22
  - Inconel 625
  - Hastelloy C276
  - 80:20 Ni:Cr
- Thin film of salt (with known mass loading) deposited on surface, followed by the use of a traditional PTFE coated ceramic crevice former

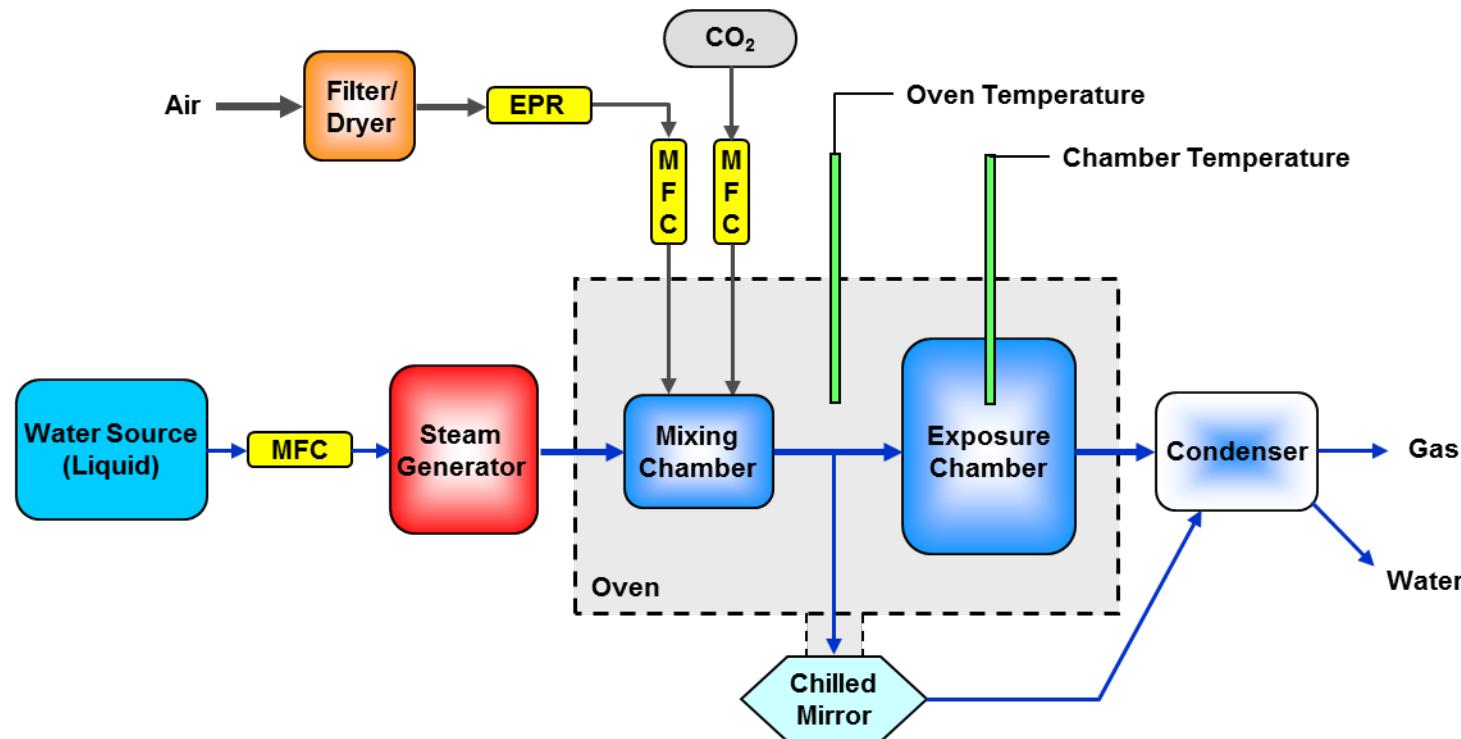
# Schematic of High Temperature System

EPR = Electronic Pressure Regulator and MFC = Mass flow controller

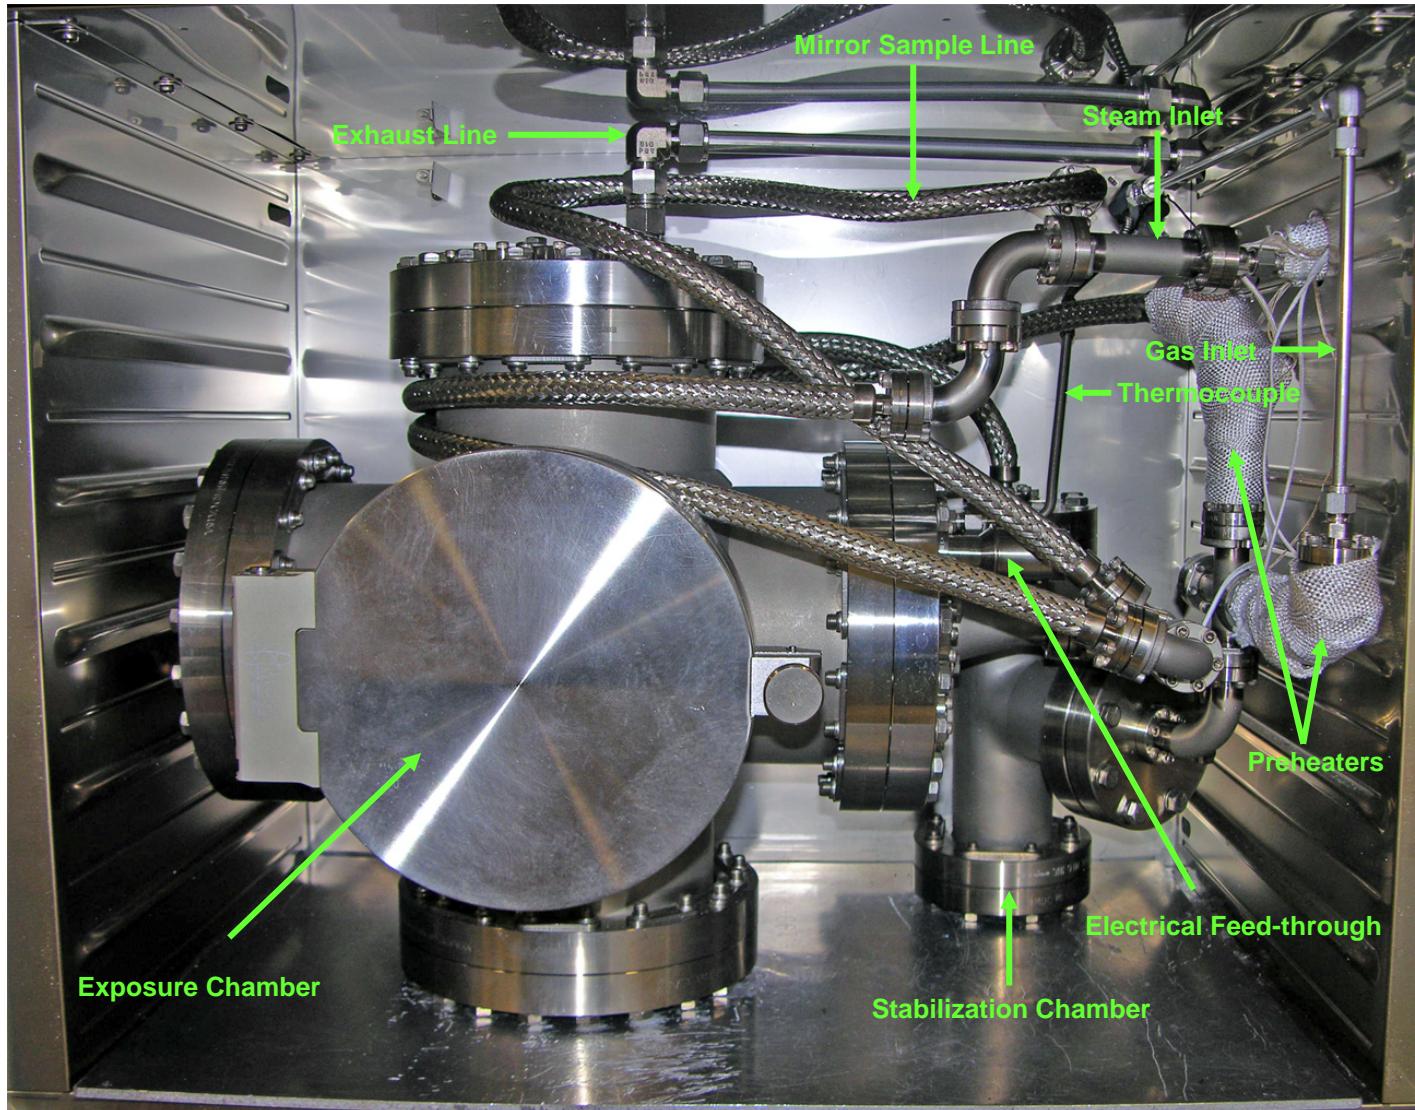
# High Temperature, Controlled Dewpoint System

- Alloy 22, Inconel 625, Hastelloy C276, 80:20 Ni:Cr, 304SS, and 303SS evaluated
- PTFE coated ceramic crevice former torqued to 70 in-lbs, Mirror finish on coupon surface
- Range of salt loadings from 50 to 250  $\mu\text{g}/\text{cm}^2$  of a NaCl-KCl mixture (approx. 1  $\mu\text{m}$  thick)
- $T=105^\circ\text{C}$ ,  $T_d=\sim 94.5^\circ\text{C}$  (pure steam) for test intervals of 100 days

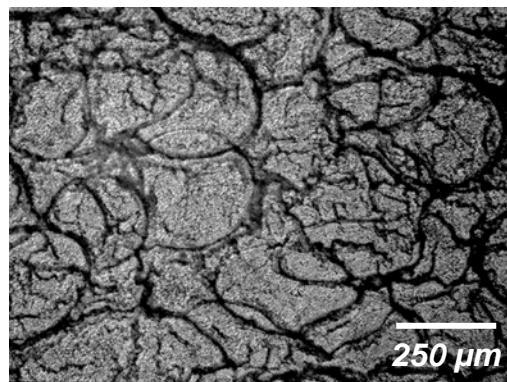
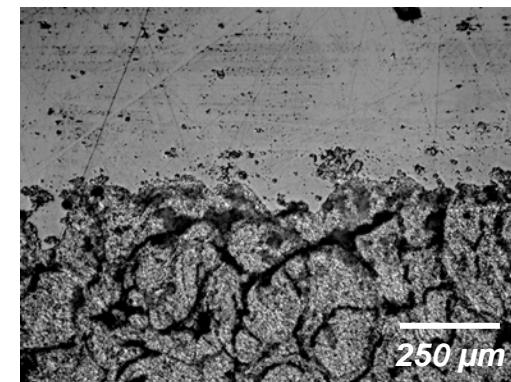
120  $\mu\text{g}/\text{cm}^2$

Wiped region

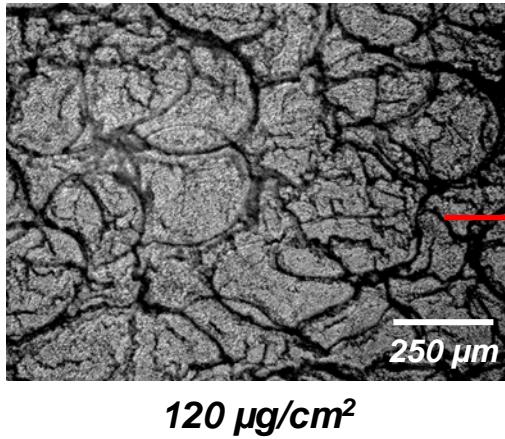
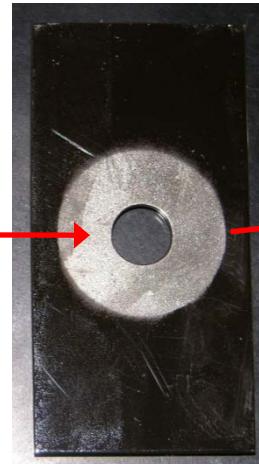
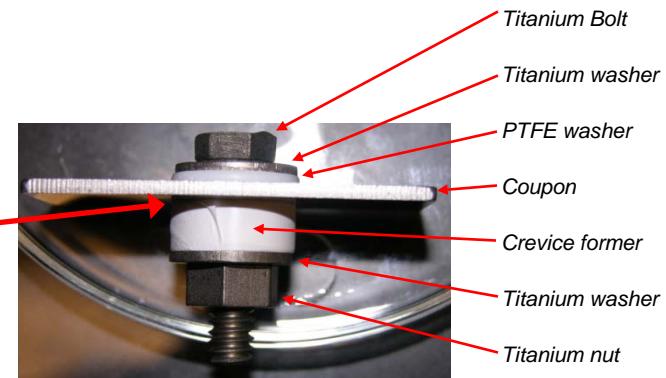
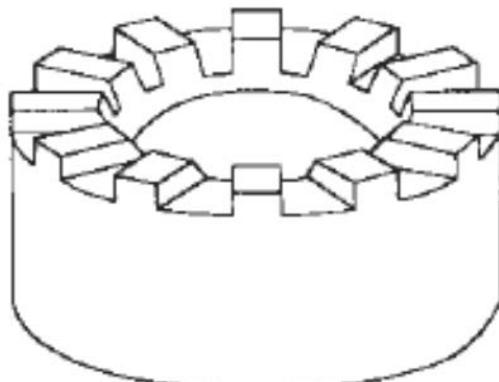
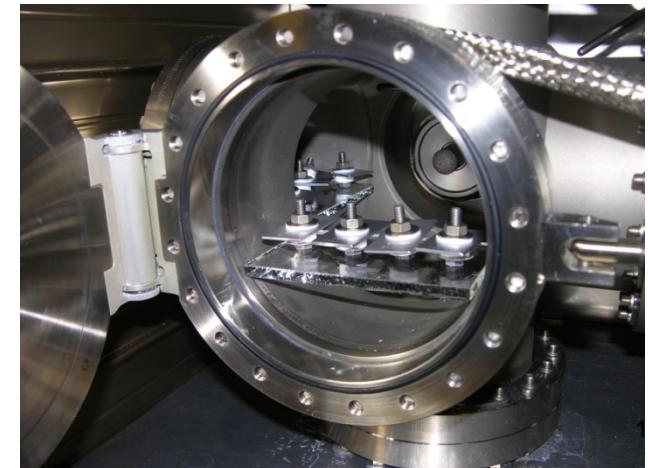
# Dust Deliquescence Testing: Initiation Studies

- Crevice former and salt on one side of coupon which was polished to a mirror finish

(All titanium hardware electrically isolated from the sample)

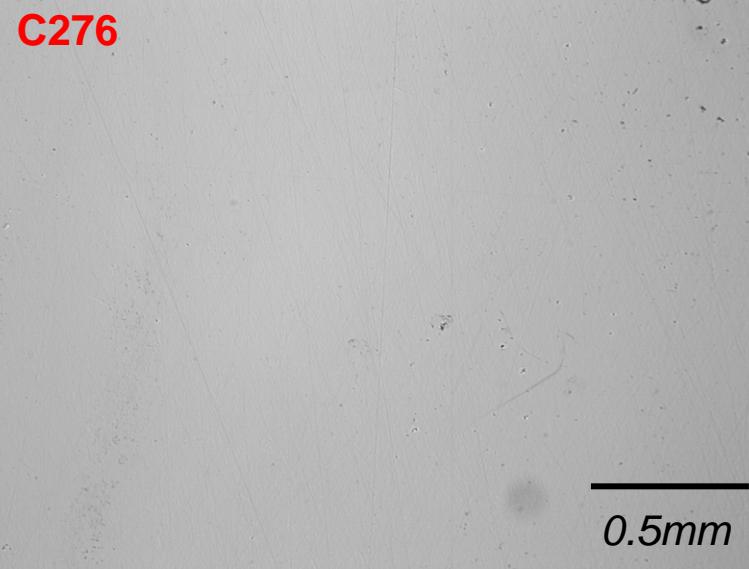
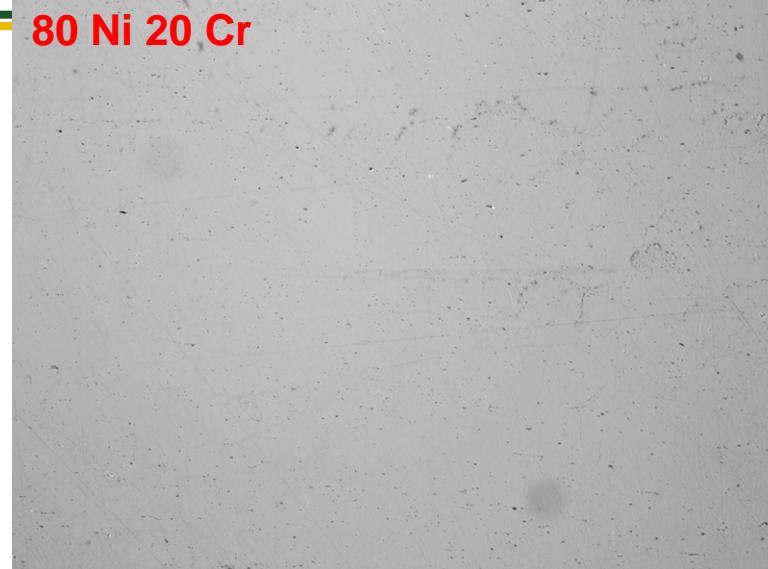
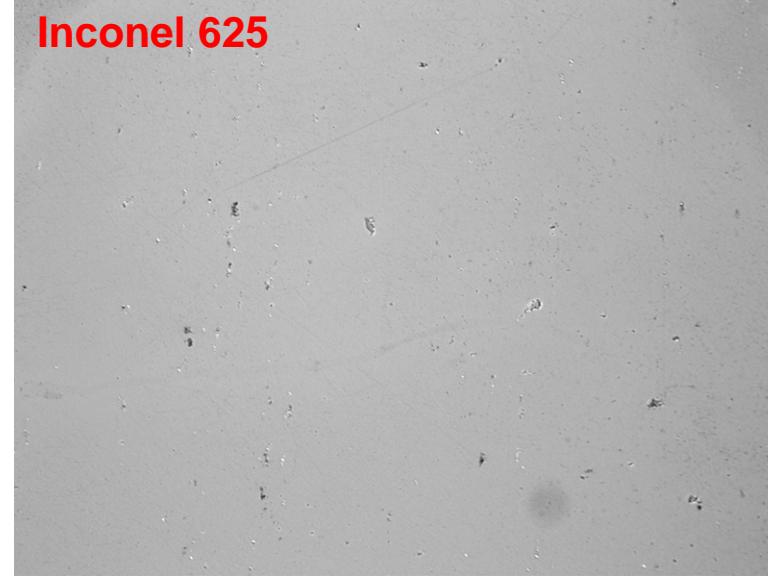
# Nickel Alloys in Chloride Brines

*No crevice  
corrosion  
initiation*

- Ni-Cr-X alloys are resistant to crevice corrosion initiation where limited reactant and a thin electrolyte layer is present, consistent with assertions in the literature
- 304 and 303 SS were susceptible to crevice corrosion initiation
- The extent of damage on 304SS roughly correlated with the quantity of reactant present
  - Number of sites seemed to be stable after a short time period
  - Surface area roughly correlated with mass loading
  - Need more data...
- Results suggest that crevice corrosion will stifle under conditions where limited reactant is present, presumably due to cathodic limitations or consumption of the reactant

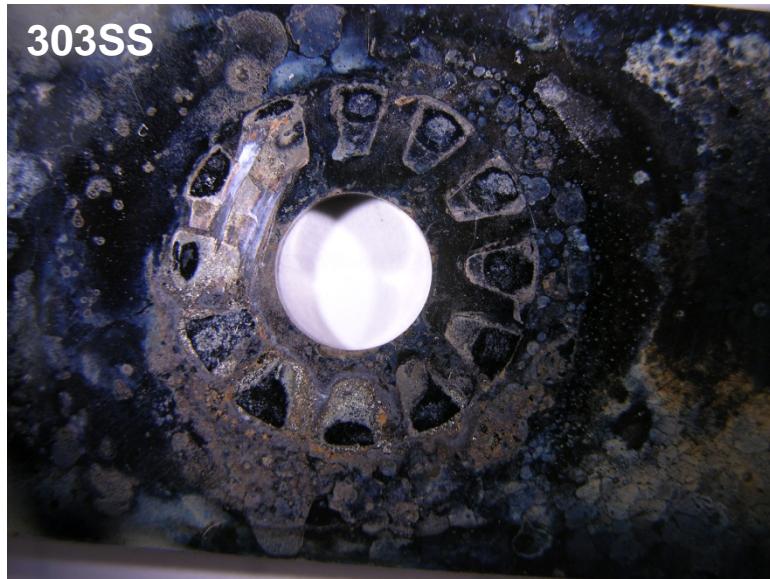
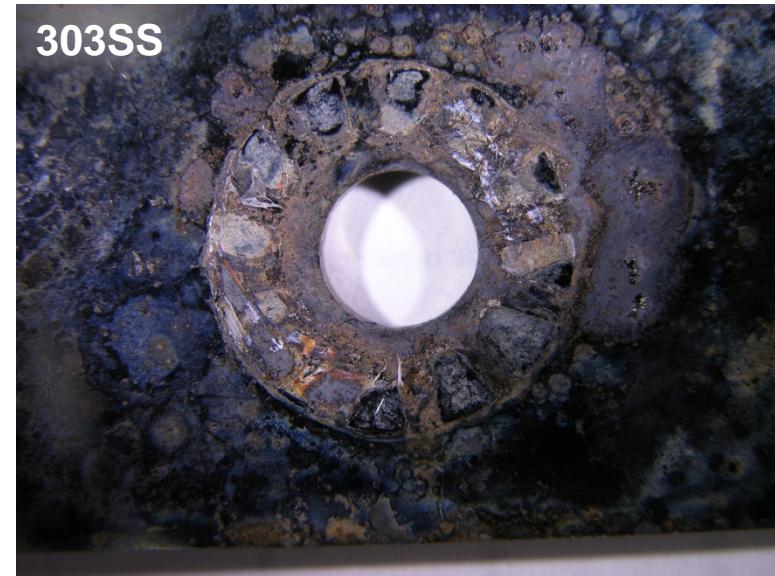
*To alleviate concern that technique was not capable of supporting crevice corrosion even on highly susceptible materials, 303SS was introduced into the test matrix*

- 303SS too susceptible – significant attack wherever salt mixture was present
- Three different mass loadings evaluated (50, 100, and 200  $\mu\text{g}/\text{cm}^2$ )
- Initial experiments performed for a period of 100 days
  - Initiation observed at all mass loadings
  - Extent of attack correlated with mass loading
- Samples exhibited SCC in a number of cases, but did not correlate with mass loading

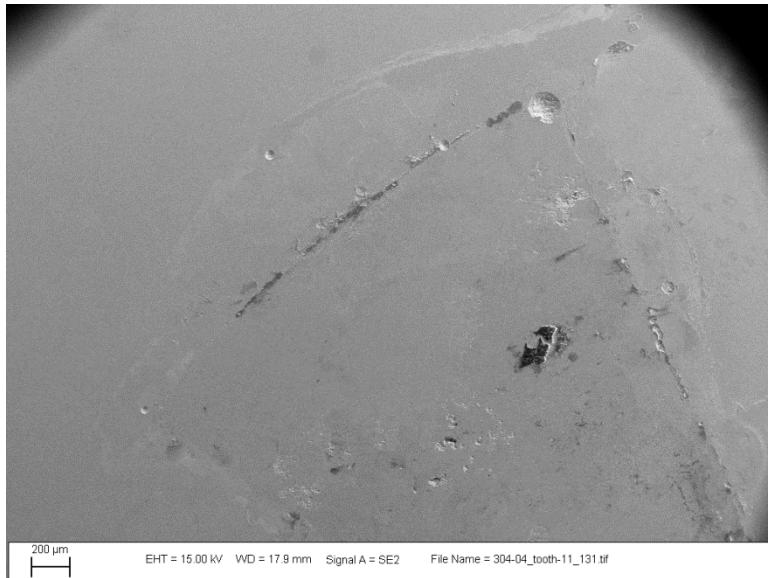
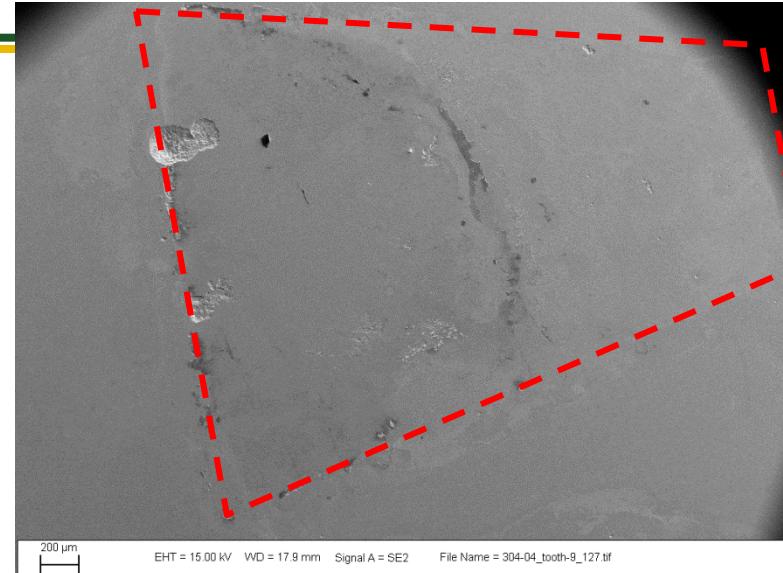
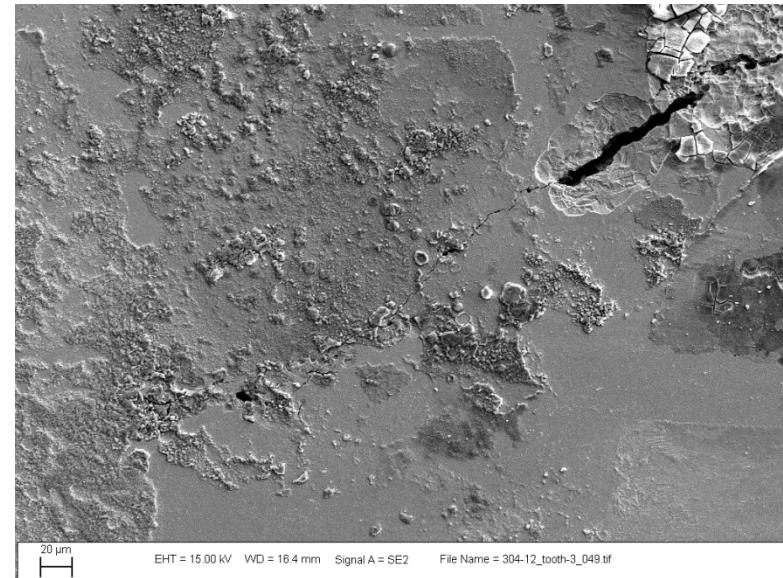
# Impact of Salt Loading on 304SS 50 $\mu\text{g}/\text{cm}^2$

- At least small sites on most teeth
- Cracking observed on some teeth
- Propagation limited in extent

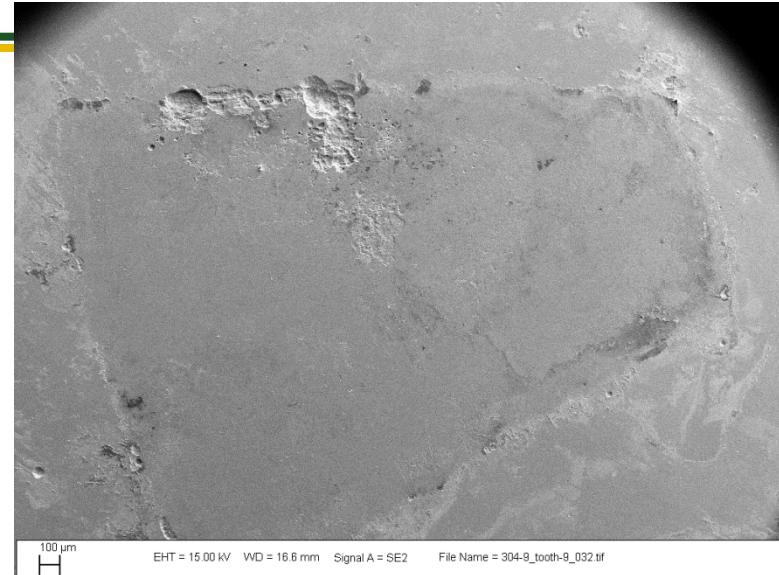
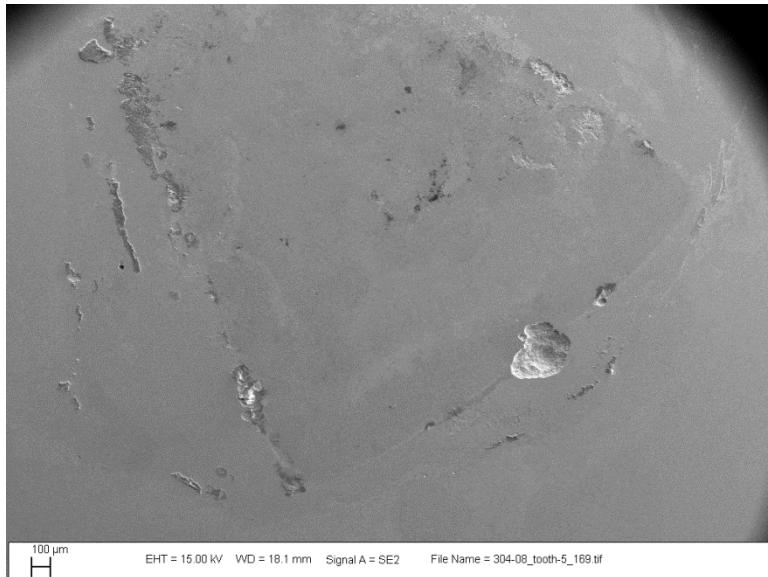
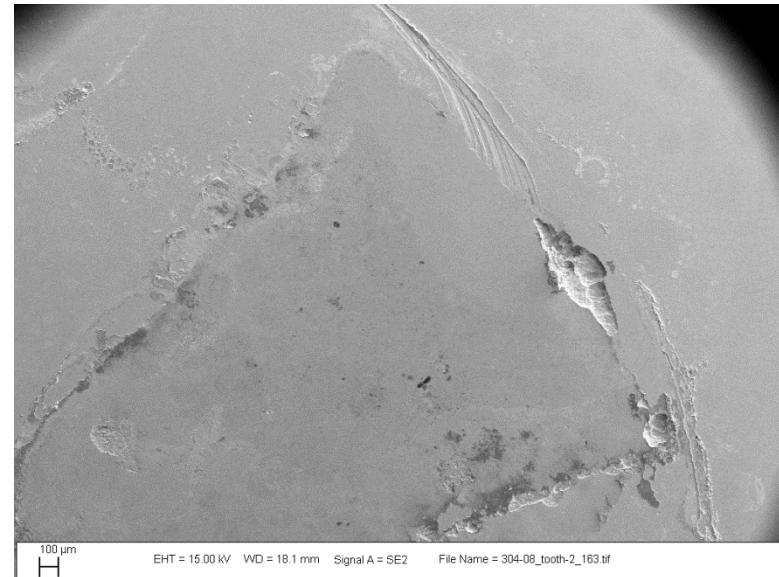
# Impact of Salt Loading on 304SS 100 $\mu\text{g}/\text{cm}^2$

- *More teeth where crevice corrosion initiated*
- *Typically multiple sites on teeth where crevice corrosion initiated*
- *Propagation more extensive (further/deeper)*

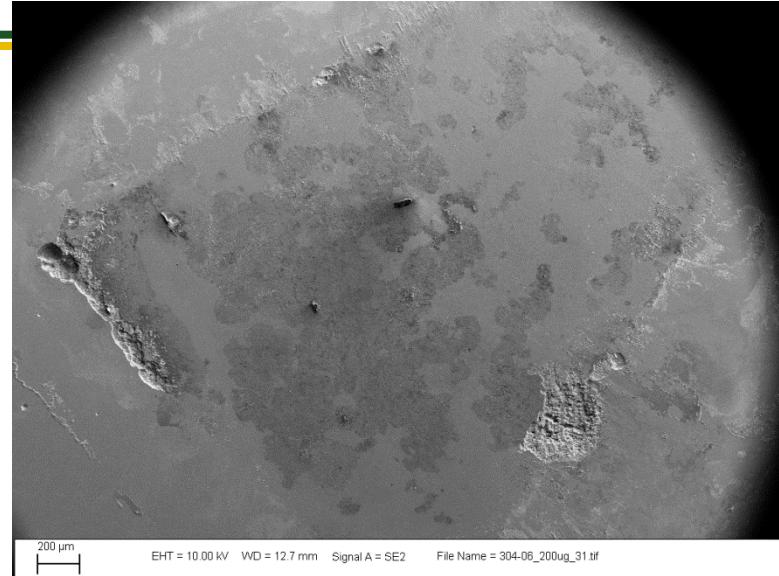
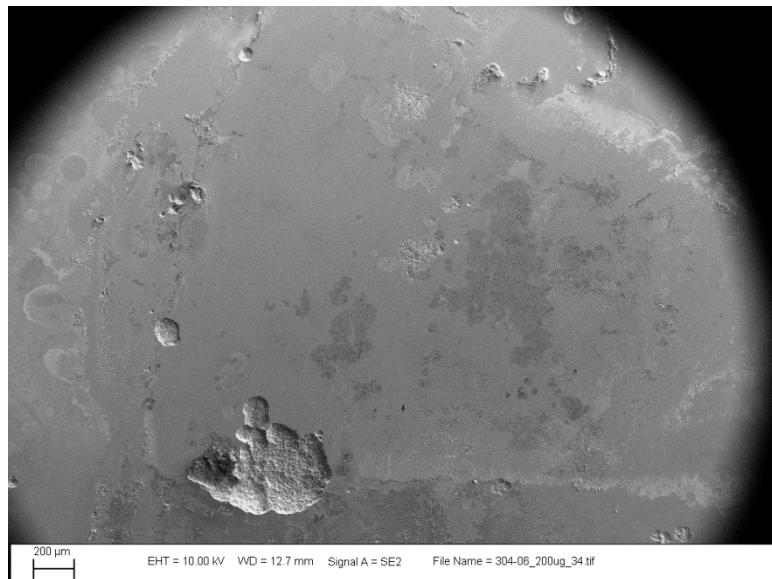
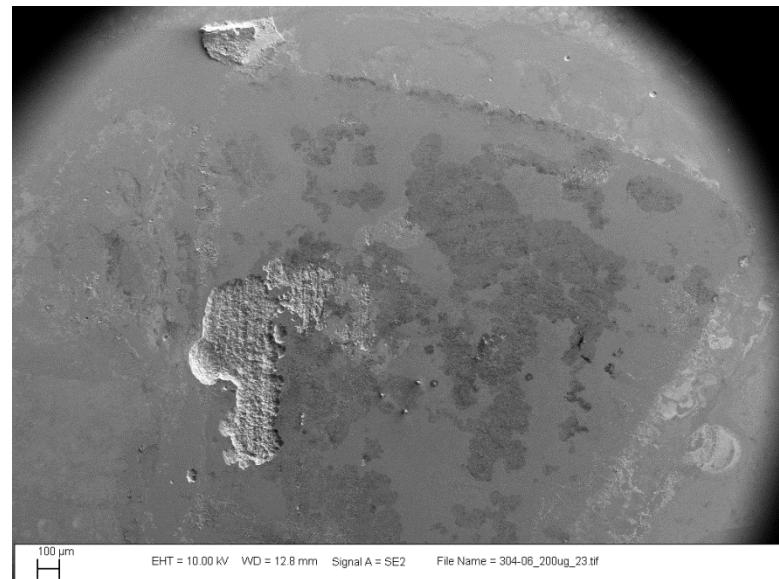
# Impact of Salt Loading on 304SS 200 $\mu\text{g}/\text{cm}^2$

- *Crevice corrosion initiated on most teeth*
- *Typically multiple sites on teeth where crevice corrosion initiated*
- *Propagation more extensive (sites tended to be larger/deeper)*

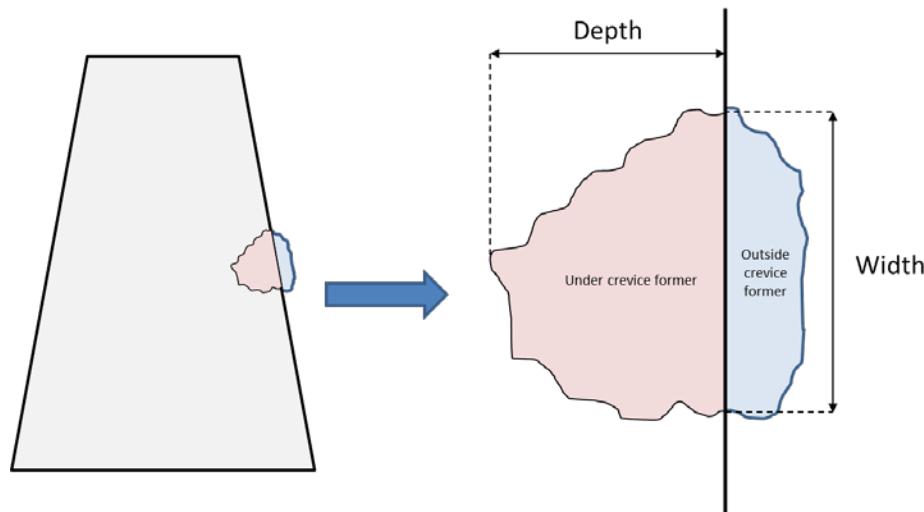
## Optical Characterization of Sites

- Quantify the number, size, and shape of all crevice sites initiated on 4 representative teeth from each sample

*Quantitative measurement of the width and depth beneath crevice former for each site*

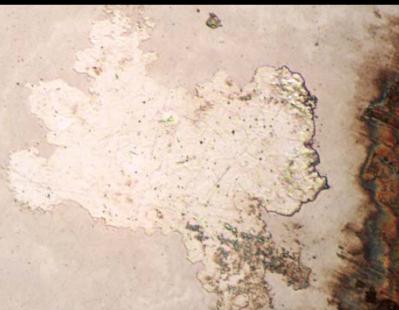
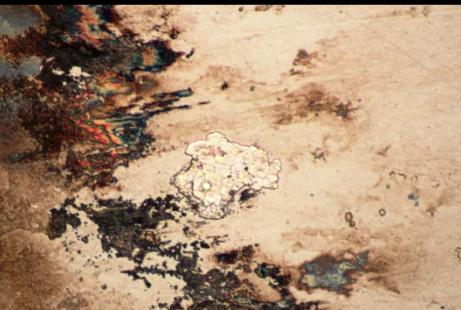
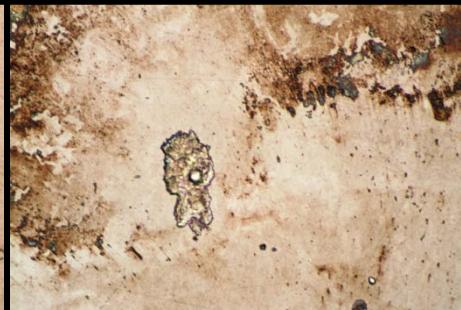
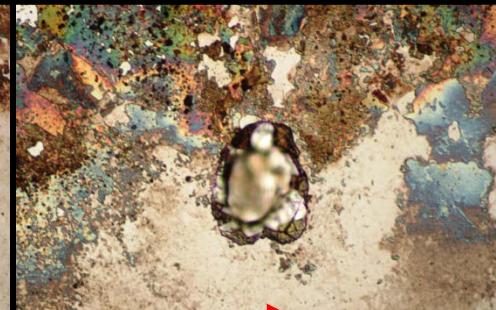
*Qualitative assessment of the degree of penetration into the sample surface for each site*

Shallow

Very Deep

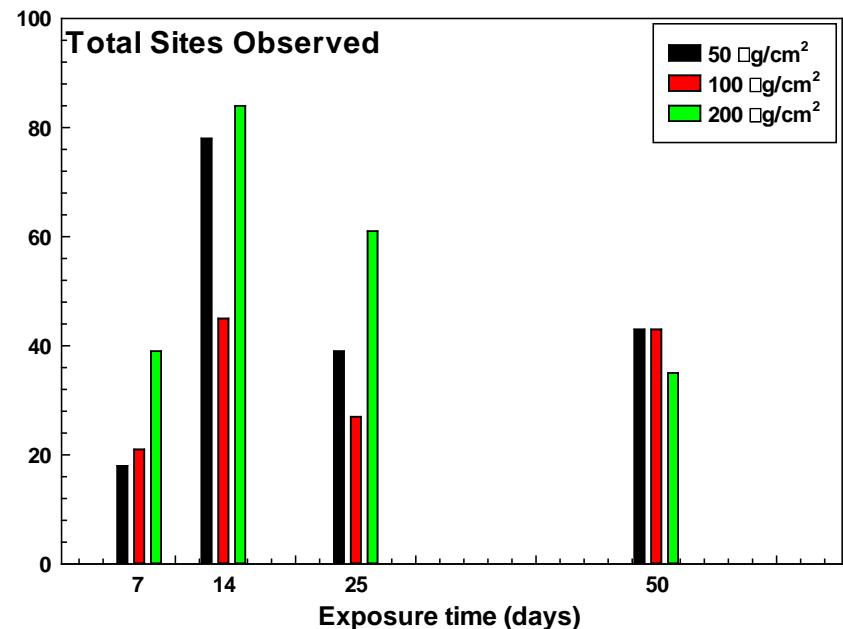
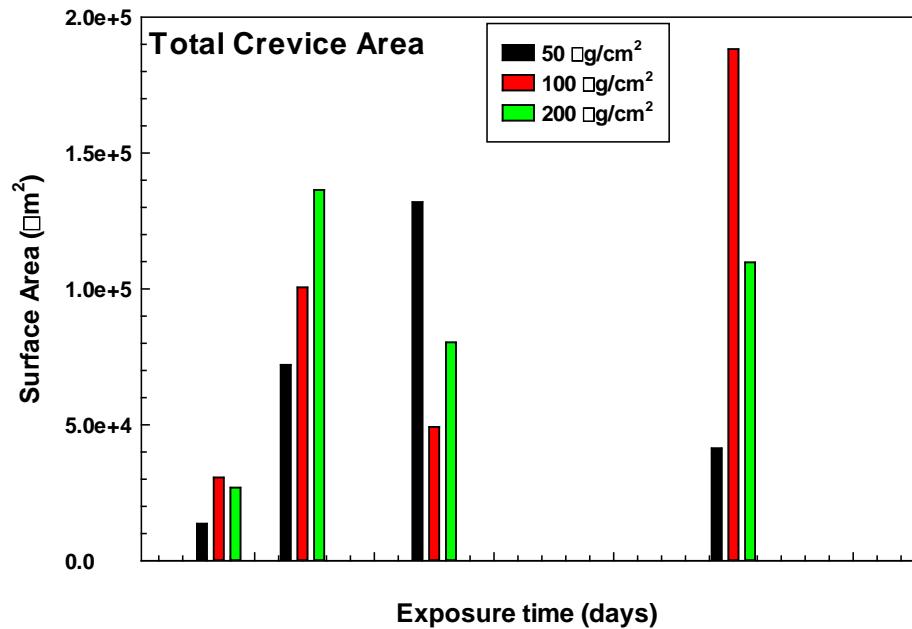
# Total Number and Surface Area of Sites (Summed Over 4 Crevice Teeth)

- Number density and overall surface area of sites appears to increase and stabilize after 14-25 days (but data is too sparse to be conclusive)
