Neutron Diffraction and Imaging of a Full-Scale Sodium Alanate Hydrogen Storage System

Sandia National Laboratories

General Motors R&D

Oak Ridge National Laboratory

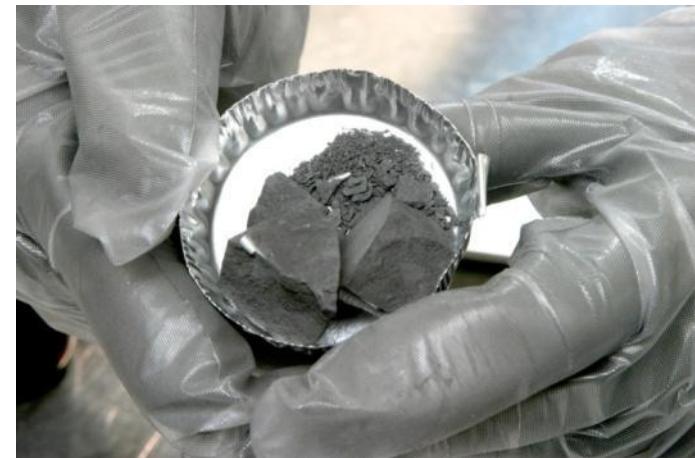
Our specific recipe:

- NaH, Al, and TiCl_3 powders ball-milled
- 3 mol% TiCl_3
- Enhanced thermal conductivity
 - Extra Al, Graphite (ENG) mixed in
- 1 g/cc packing density
- Sintered porous solid upon cycling

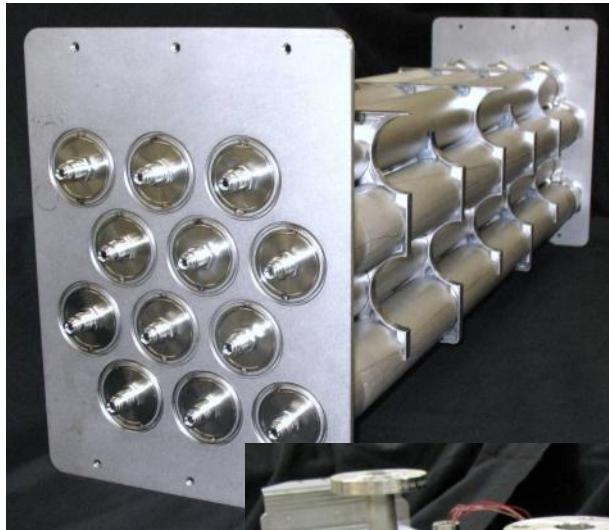
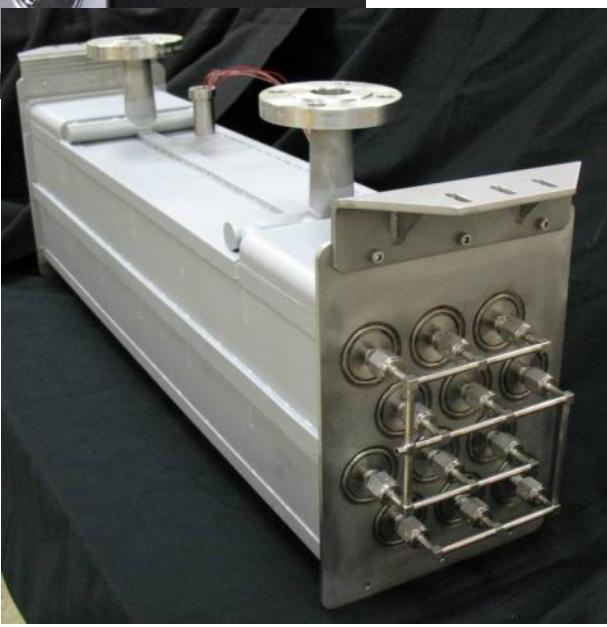
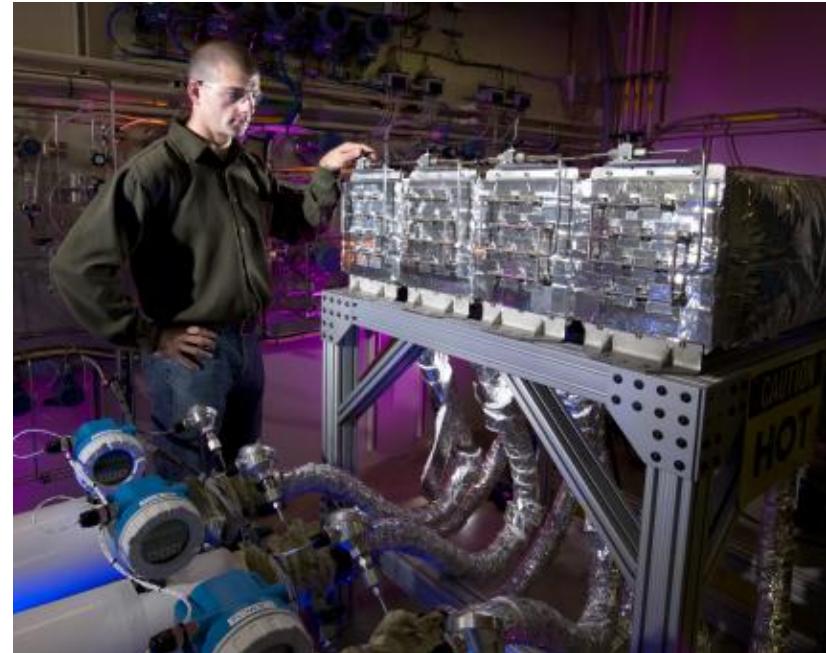
3 kg H₂ system designed for mass and volume efficiency as well as simplicity and low cost

- Pressure, mass flow
- 18 total external shell thermocouples
- 48 thermocouples installed into end caps
- 26 RTDs on tube surfaces

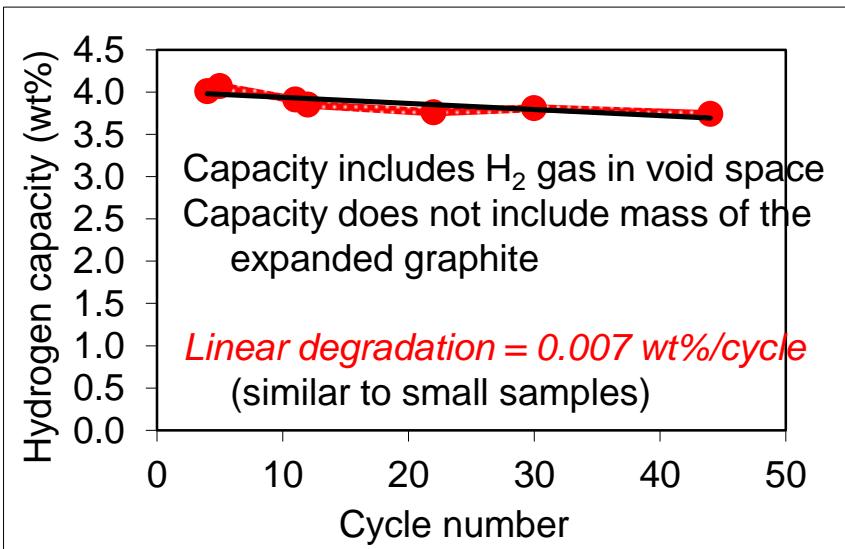
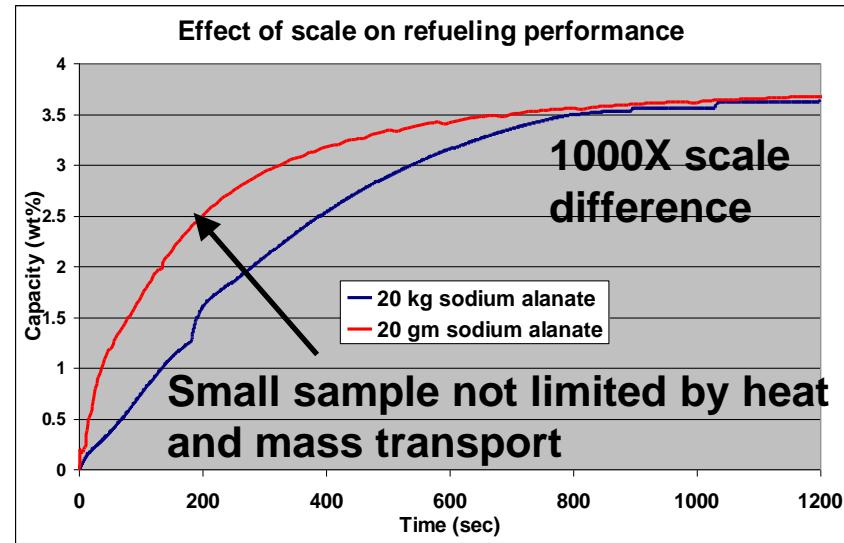
Cycling showed capacity loss and effects of heat and mass transport limitations

- Capacity loss similar to small samples
- Large-scale system heat and mass transport limited by design
- But, detailed explanation of capacity loss unknown and some transport mechanisms not well understood

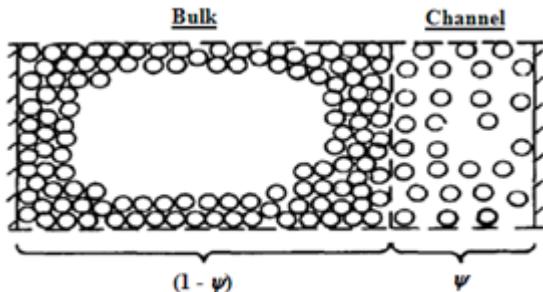
Wall channeling added to hydrogen transport model required to explain experimental results

Wall channeling is a region of low density and high permeability near the vessel wall

Wall channeling model validated by tube sectioning; confirmed by neutron radiography

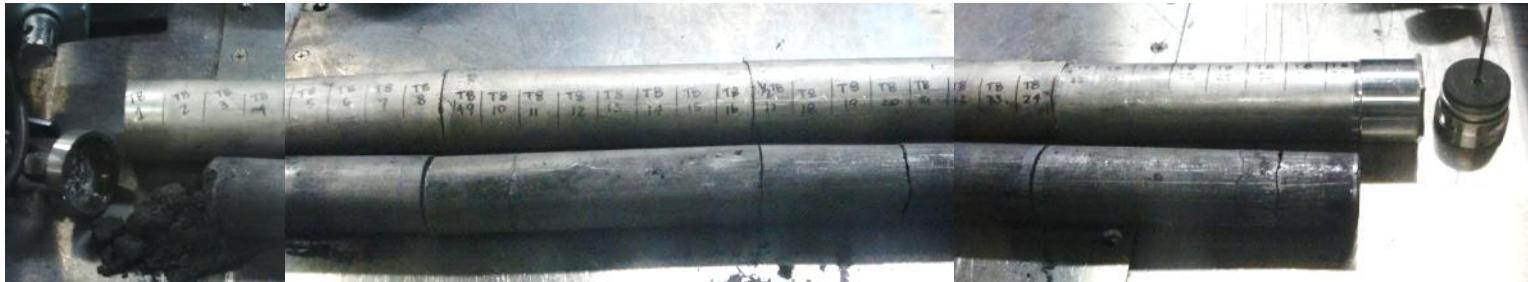
Tube sectioning confirms wall channel; reveals cracks, wormholes, and density differences

A close-up photograph of the interior of a metal container, likely a can or jar. The interior is dark and textured. A small, dark hole is visible on the left side. A yellow arrow points to the right edge of the hole, highlighting it. The container's edges are visible in the background.

Axial and Transverse Cracks

Both methods revealed other large-scale structures such as cracks, wormholes, and density variations that could affect H₂ transport

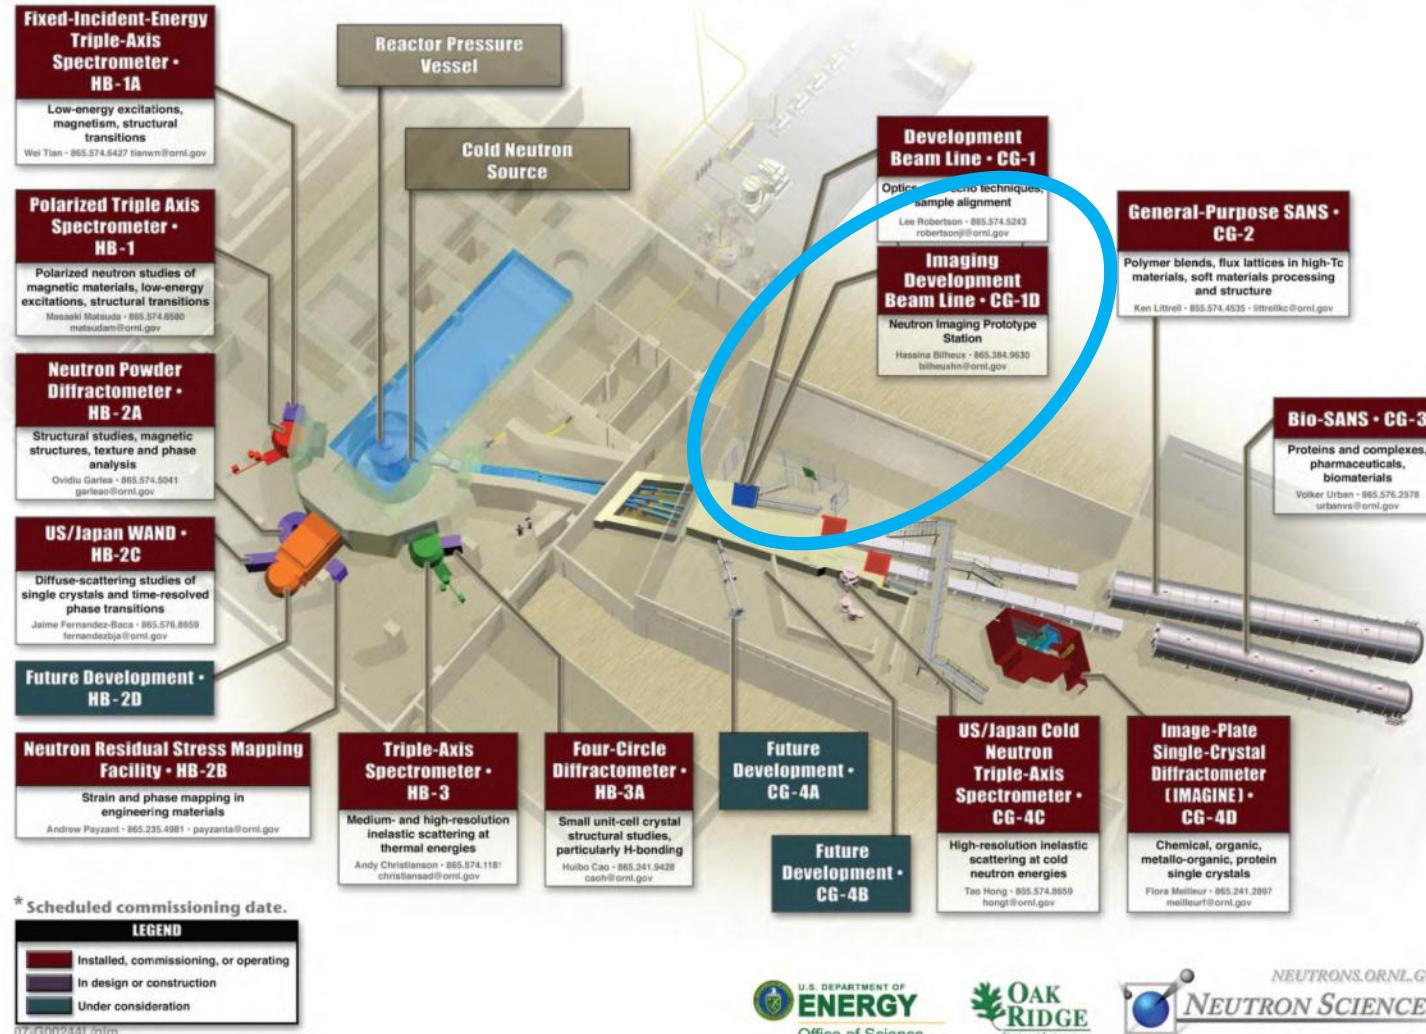
NDE: Neutron imaging was performed at ORNL's HFIR facility

High Flux Isotope Reactor at Oak Ridge National Laboratory

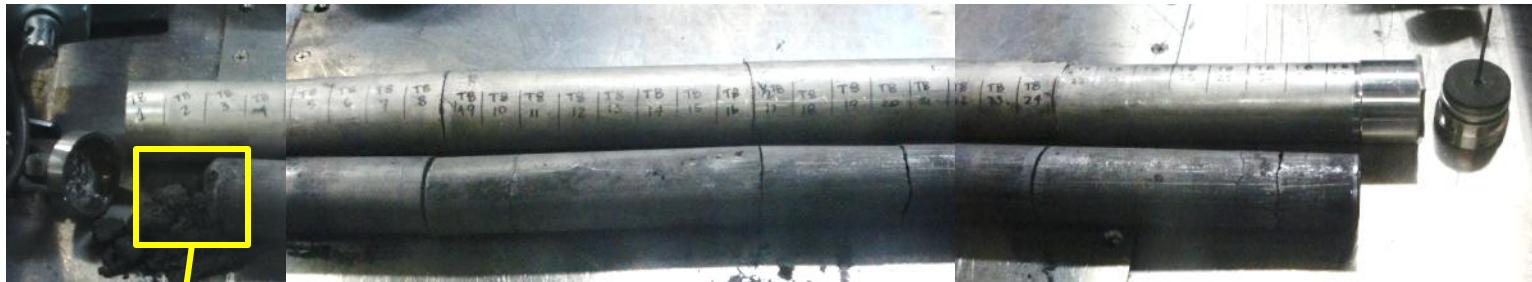
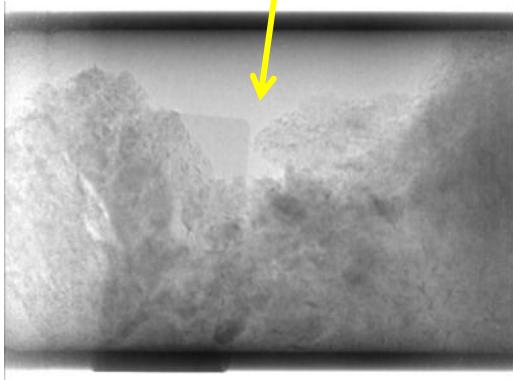
Radiography confirmed sectioning results

Voids and low density material found near inlet

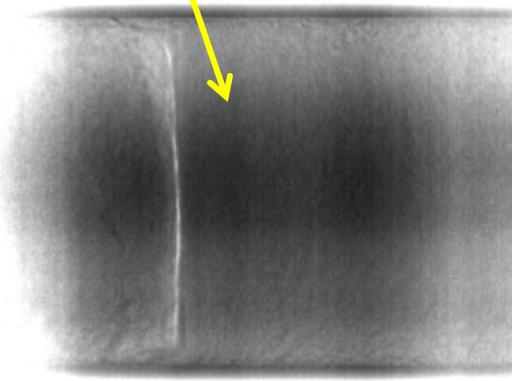
Large transverse crack near middle

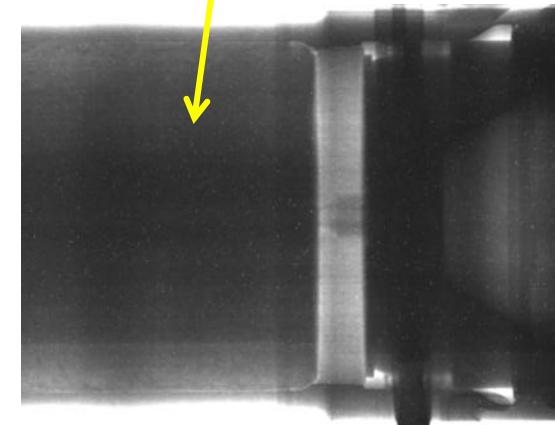
Evidence of wall channel

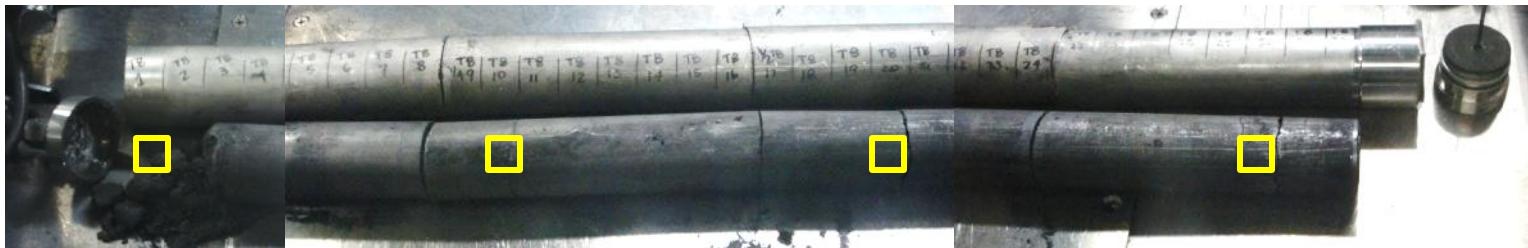
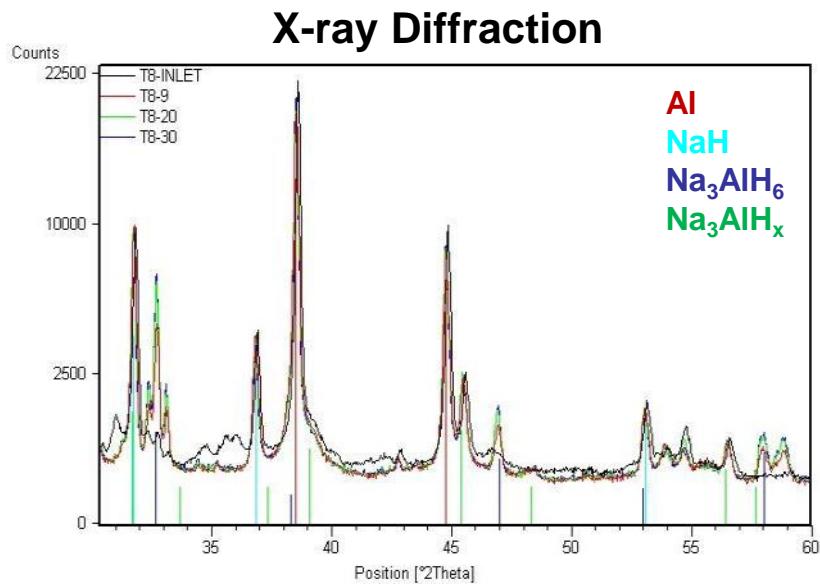
Analysis of cycled material showed “stranded” hydrogen increasingly toward far end of vessel

Samples taken from four locations at distances of 0, 10, 20, and 30 inches from the reactor inlet

Hexahydride present in regions away from the inlet/outlet of the bed

Results indicate that residual uncatalyzed Na_3AlH_6 exists in regions away from the inlet/outlet of the bed

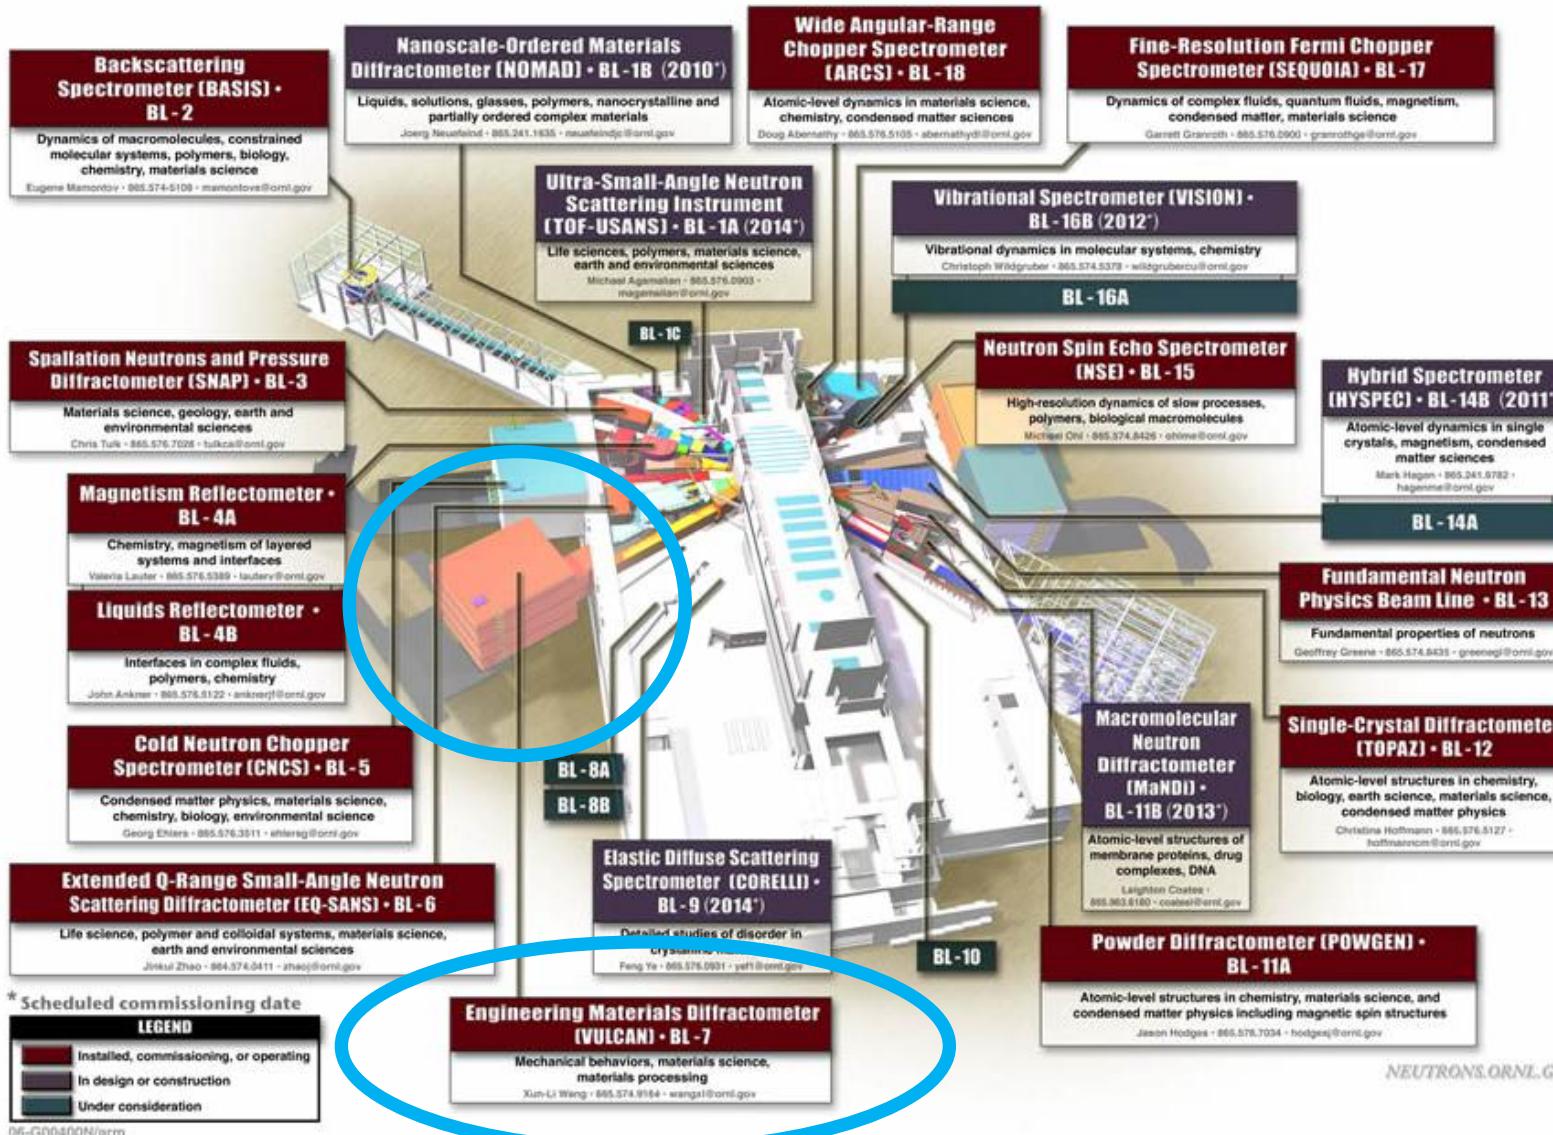
NDE: Neutron diffraction was performed at VULCAN beamline at ORNL's SNS facility

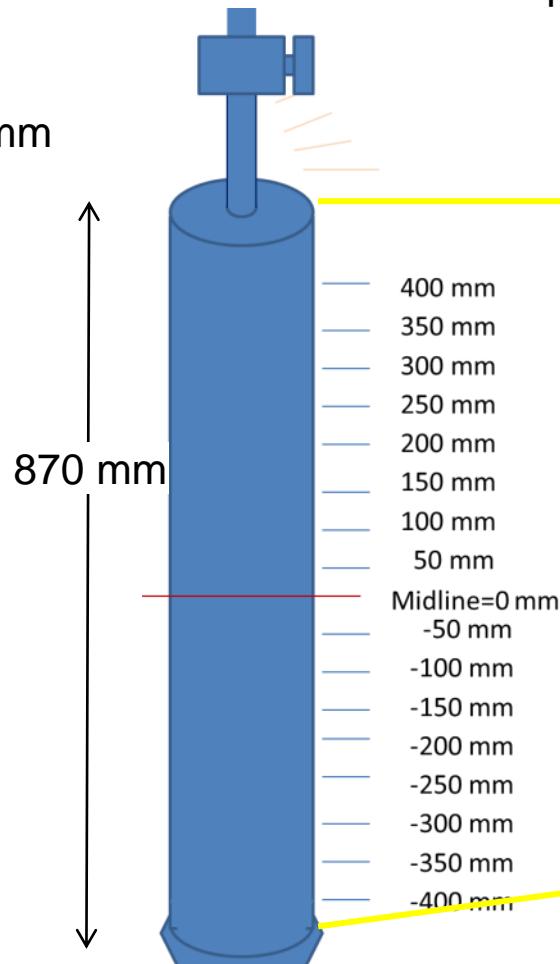
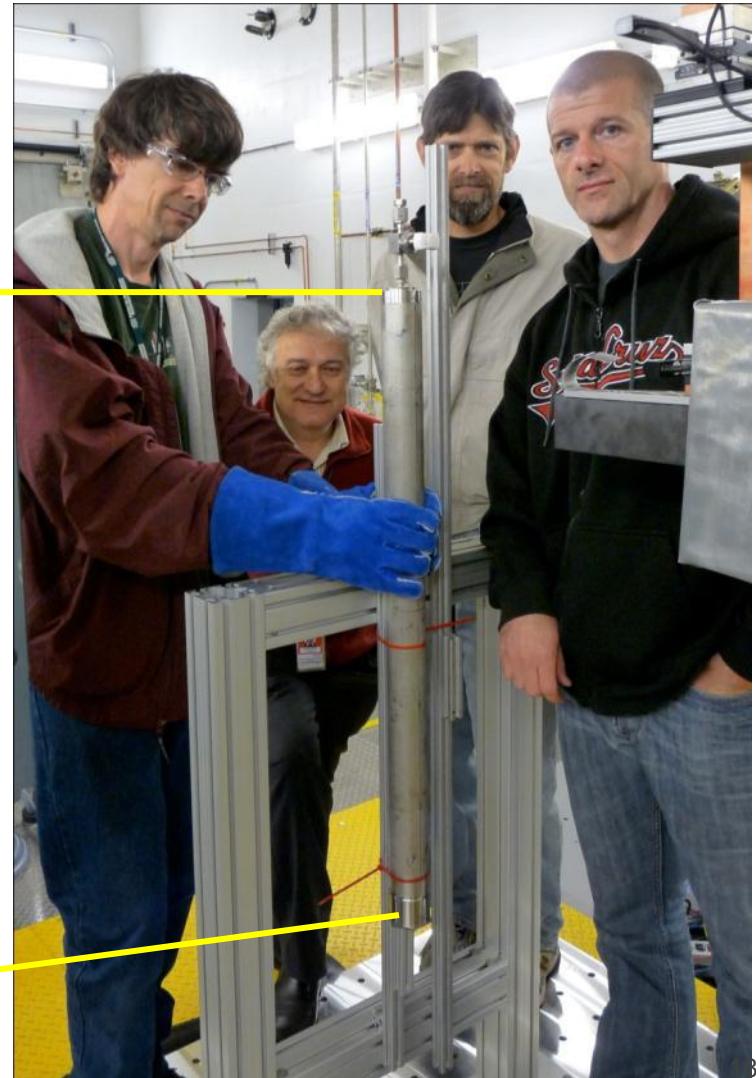
Hydride interrogated along the vessel axis in 50 mm steps

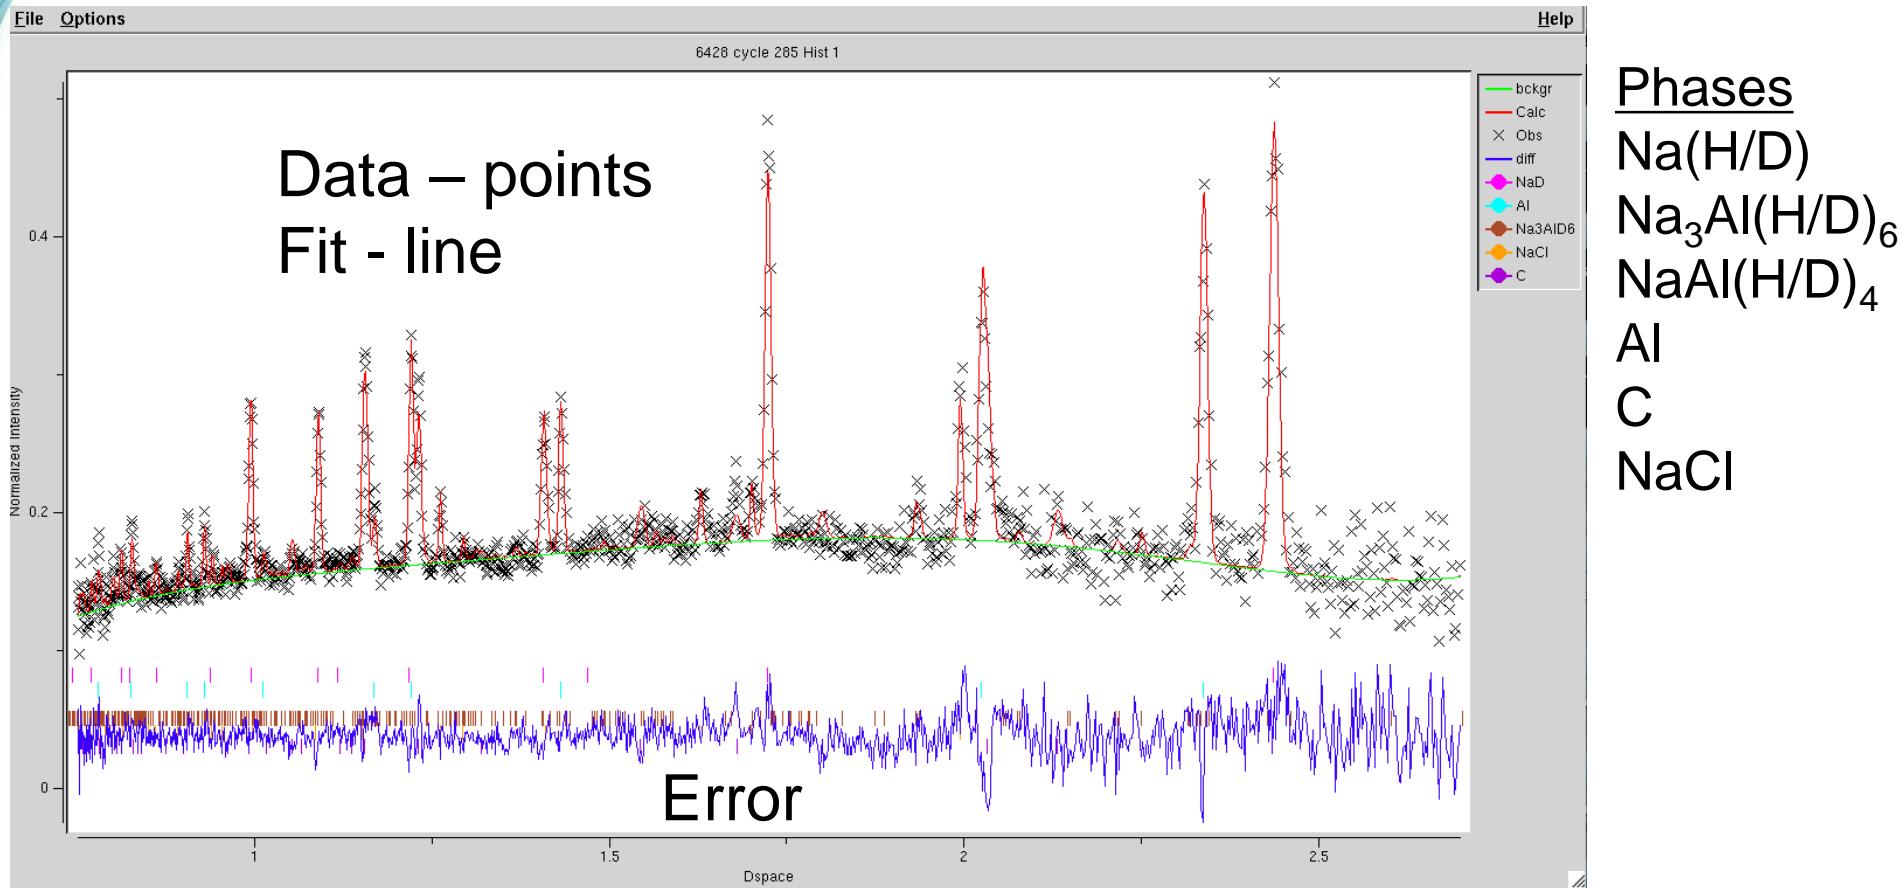
With 6 possible phases, refinement of the diffraction data was a challenge

Plus the usual problems of finding correct reference spectra

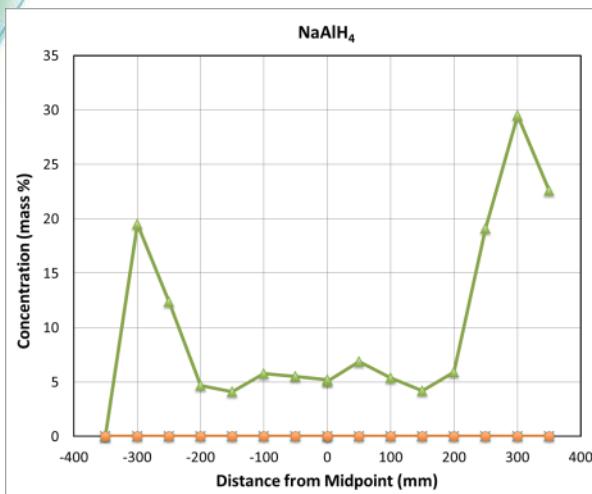
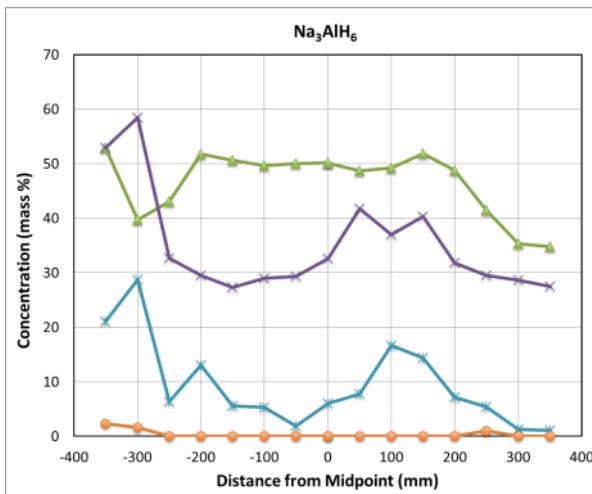
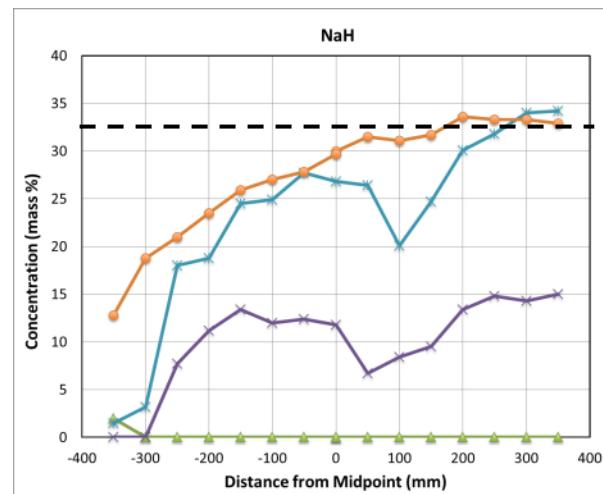
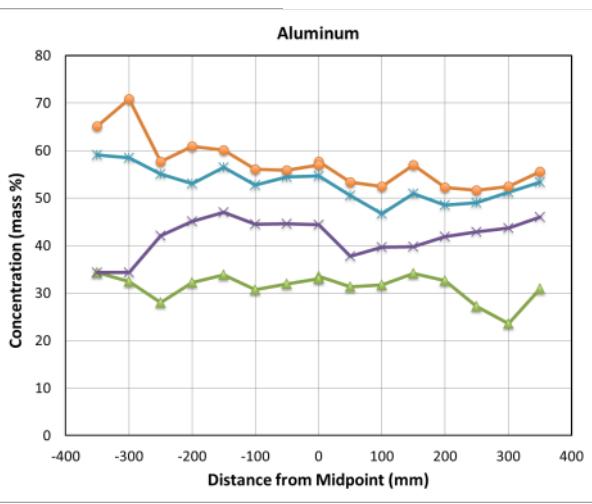
Refinement results show expected changes in species concentration with fill level; some unexpected results revealed

- Only tet and hex seen at 50% full
- Tet distribution unexpected
- Tet not seen on subsequent desorptions
- Peaks and valleys of Na species correspond, also aluminum
- Hex and NaH progression reasonable
- Non-uniform hex desorption likely due to temperature gradients

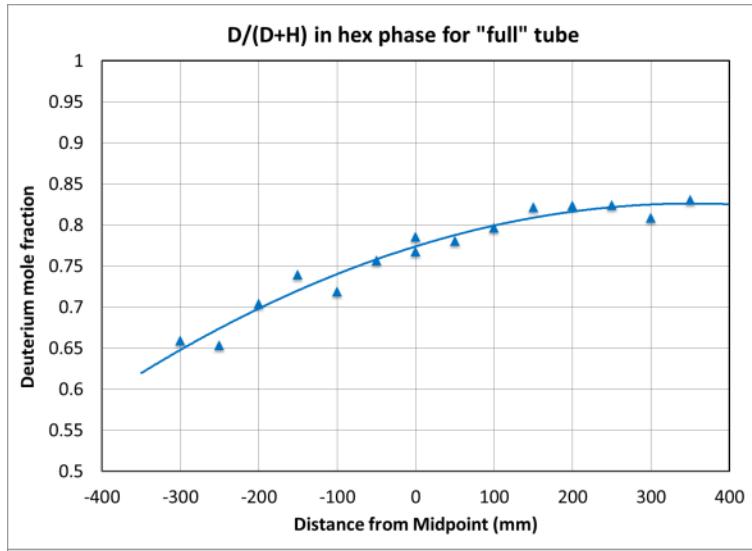
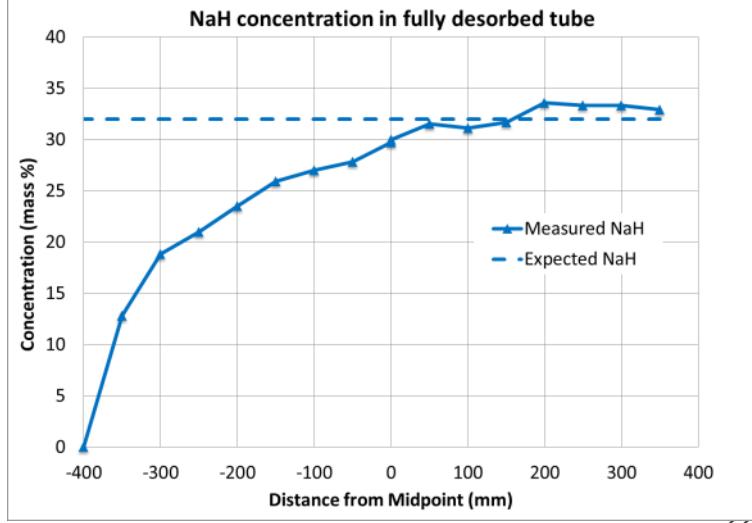
“Stranded” hydrogen theory supported by neutron diffraction results for NaH and D/H ratio

- D/H ration from diffraction refinement shows increased H concentration at closed end
- NaH profile for empty state supports “stranded” hex phase
- Amount of inactive hex phase corresponds to capacity loss over 79 cycles of 0.55 wt%

- Contamination: Catalyst poisoning or reaction with Na phase
- Morphology change due to temperature or repeated cycling: catalyst segregation or particle growth/sintering

Analysis points to stranded H₂ in inactive hex phase
