Quantitative Assessment of Crack Detection in Aerospace Engine Disks using Acoustic Thermography Inspection

38th Conference on Quantitative Nondestructive Evaluation

Michel D Bode¹ & Forrest R. Ruhge²

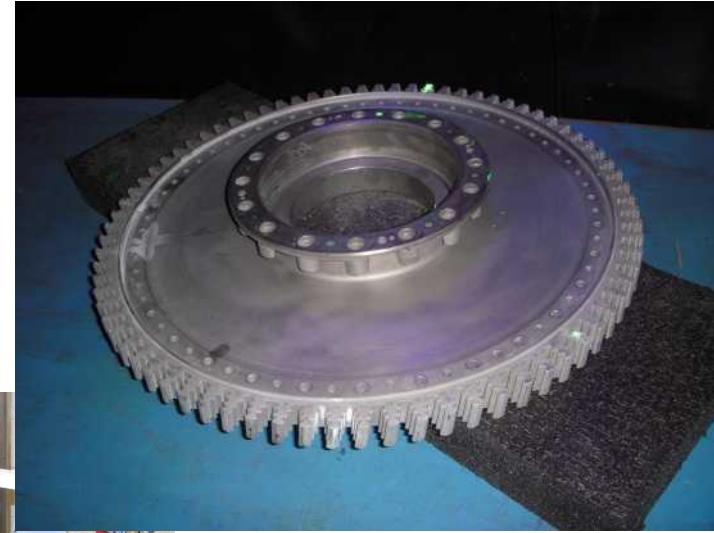
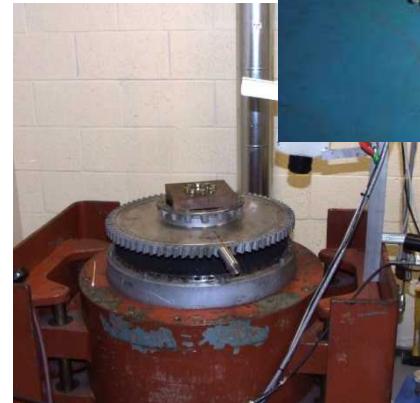
Pratt & Whitney JT8D Stage 2 Turbine Disks

- Retired at end of service life with no inspection at Delta.
- Characterized by fluorescent penetrant and eddy current inspection
 - FPI Method D, Level 4
 - ET High Frequency (1-2 MHz) Small Diameter Probe
- One disk had cracks installed in 19 fir tree slots.
- Two other disks had one each naturally occurring cracks.

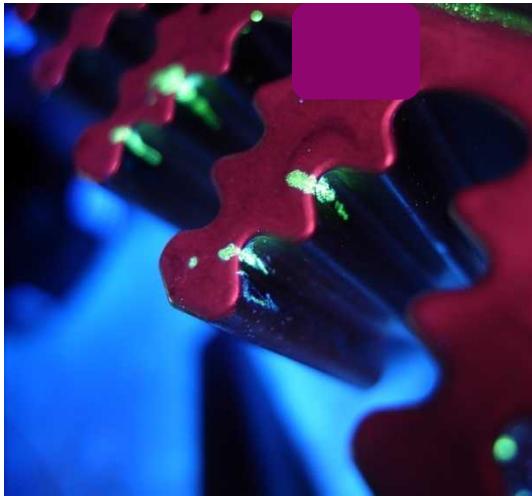
Pratt & Whitney JT8D Stage 2 Turbine Disks Defect Distribution

Disk SN	FPI Top (in)	FPI Leadin g (in)	FPI Trailing (in)	Note
1		0.100		Natural
2		0.070		Natural
3	0.160	0.160	0.270	Fabricated
3	0.118	0.305		
3	0.141		0.202	
3	0.085		0.194	
3	0.080		0.136	
3	0.103		0.154	
3	0.154	0.446	0.267	
3	0.155		0.111	
3	0.051		0.148	
3	0.137		0.197	
3	0.044		0.052	
3	0.067	0.104		
3	0.082	0.151		
3	0.102	0.147		
3	0.020	0.062		
3	0.217	0.308		
3	0.190	0.020	0.342	
3	0.160	0.244	0.438	
3	0.139	0.108

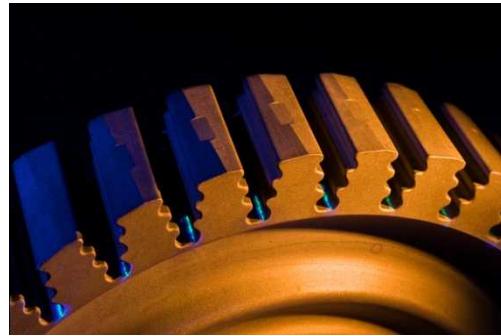
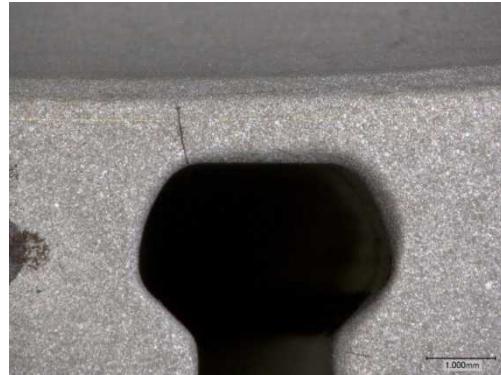
Honeywell APU 2nd Stage Turbine Disks

- Retired at end of service life with no inspection at Delta.
- Characterized by fluorescent penetrant inspection
 - FPI Method B, Level 4
- Post-inspection etch and 50X optical microscope crack length measurement by Sandia Metallography Laboratory provided destructive defect characterization.
- All six disks had naturally occurring cracks in fir tree slots.
