Does Aging Degrade Performance of the Pull Out Switch Contact Assembly?

Using Contact Resistance Measurements to Determine Aging Effects on Pull Out Switch Assembly Contacts

Sandia National Laboratories

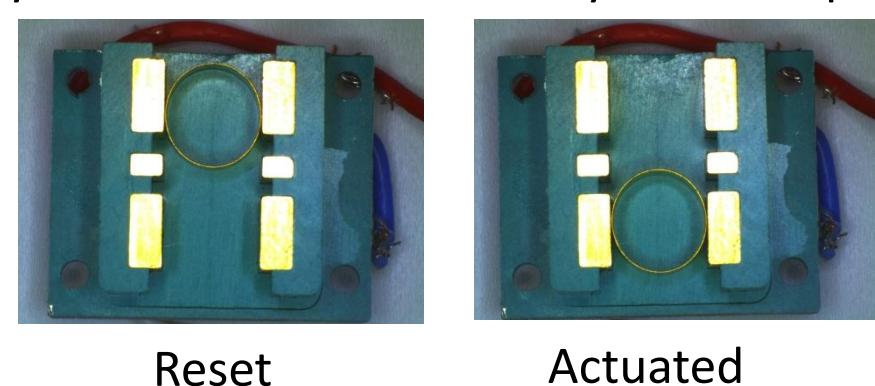
Reset Actuated

The pull out switch assembly is responsible for firing all the electronics in a bomb as it is released for deployment. The movement of the “wedding band” contact from position 1 to position 2, as seen in the diagram below, initiates all the electronics. As these switches age corrosion at plating defects results in increased contact resistance (see background section). To assess the degradation in contact resistance, measurements were taken across the contact surface. Some of the measurements exhibit extremely high resistance. To verify that the high values are the result of atmospheric corrosion, samples were abraded slightly with 4000 grit silicon carbide paper, resulting in a significant decrease in contact resistance. Additional experiments are needed to determine the fraction of the population affected by this process, and to assess the extent of degradation. These measurements must then be analyzed to determine the likely effect on performance.

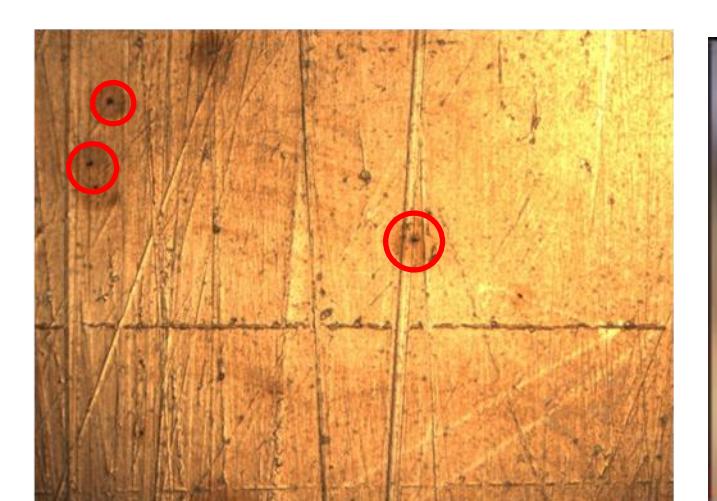
Copper rings, “wedding bands”, are plated with 50 micro in. of Ni, then 50-150 micro in. Au

Defects in the plating layer are susceptible to atmospheric corrosion resulting in corrosion product build-up on the surface.

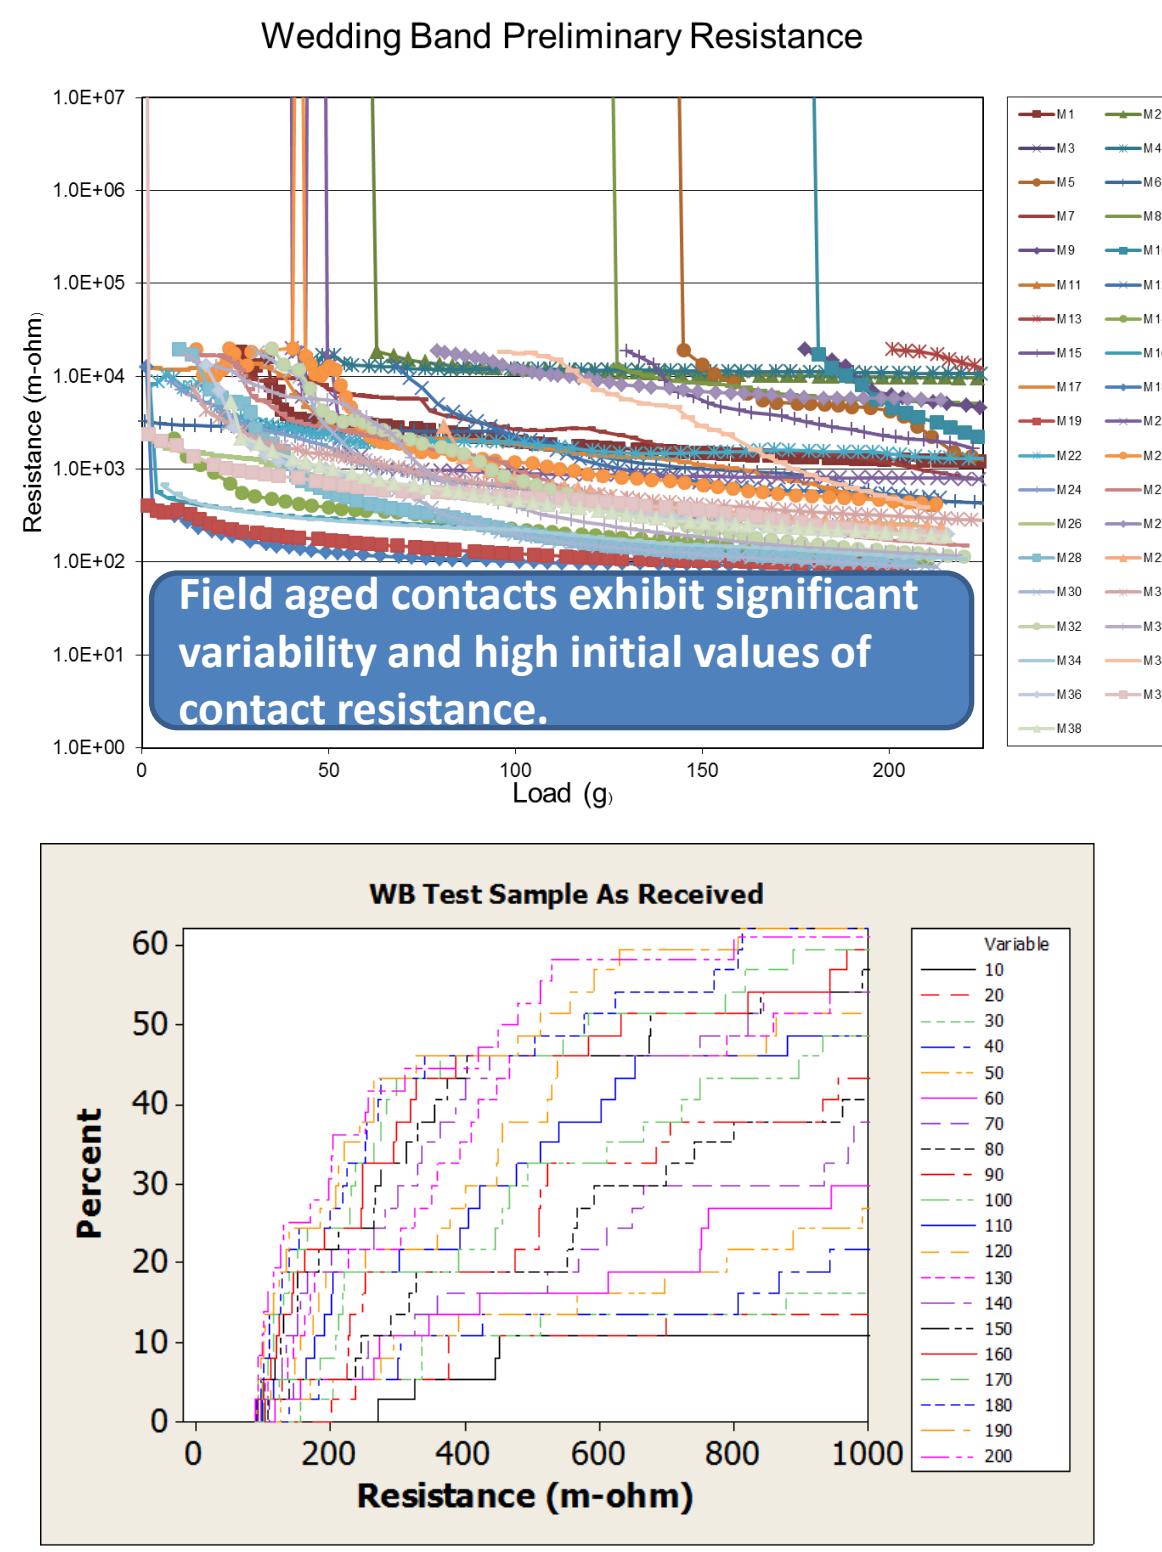
As-Received

- Contacts exhibit high resistance
 - Variable between contacts
 - Variable across surface for single contact
- Abrasion of the surface lowered the contact resistance
- Variability likely due to:
 - Storage environment
 - Defect density

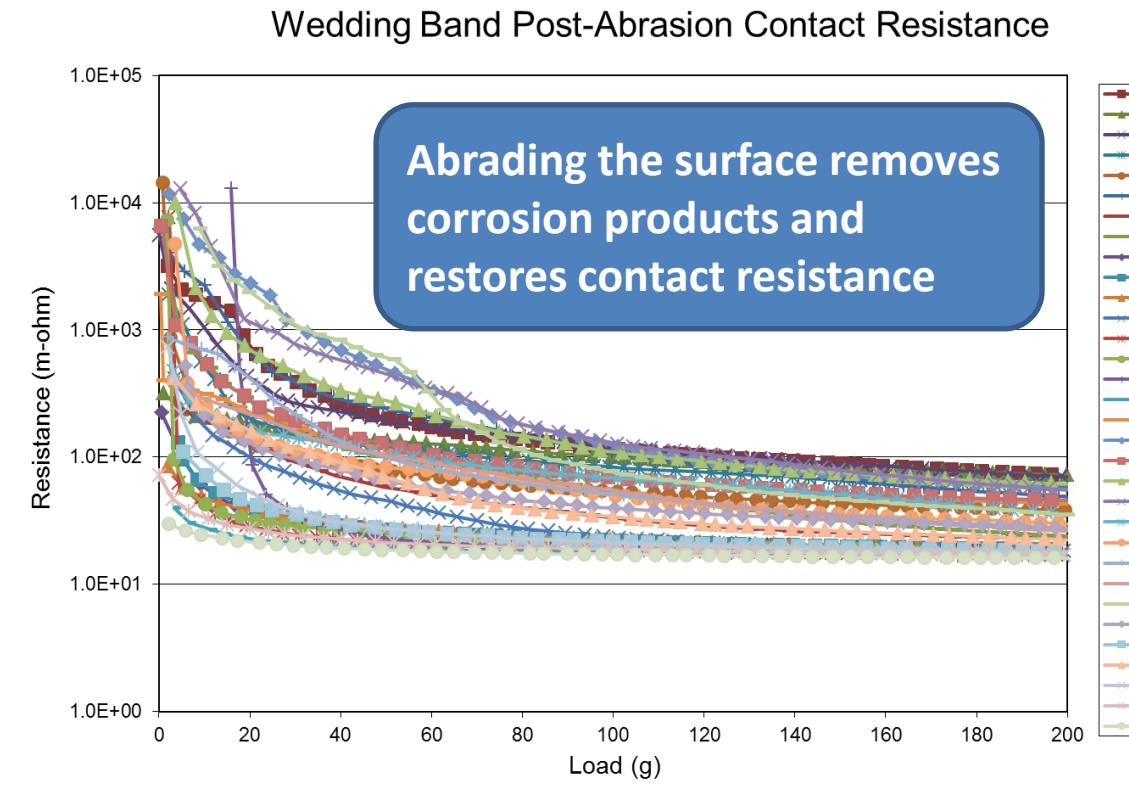
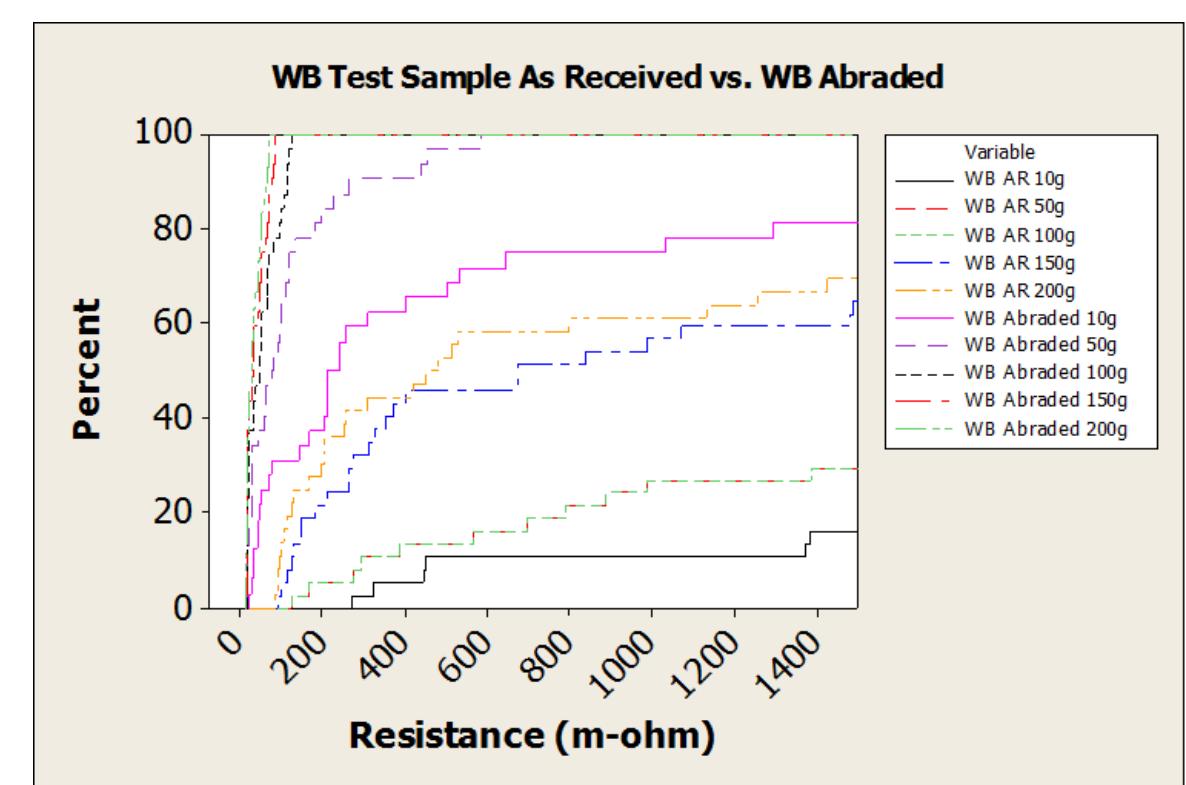
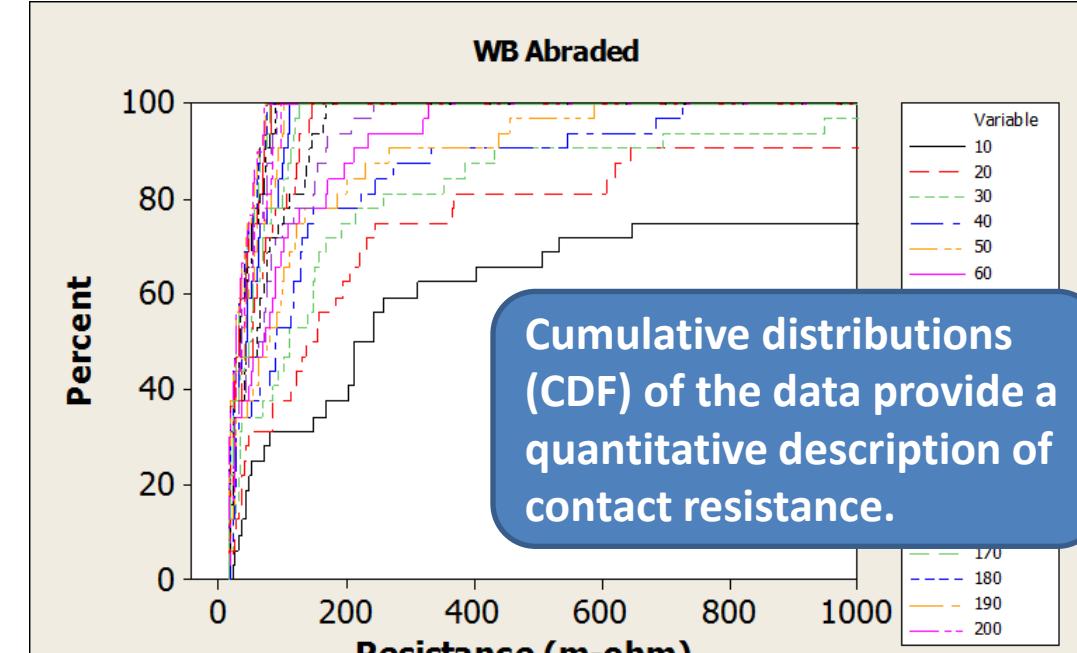
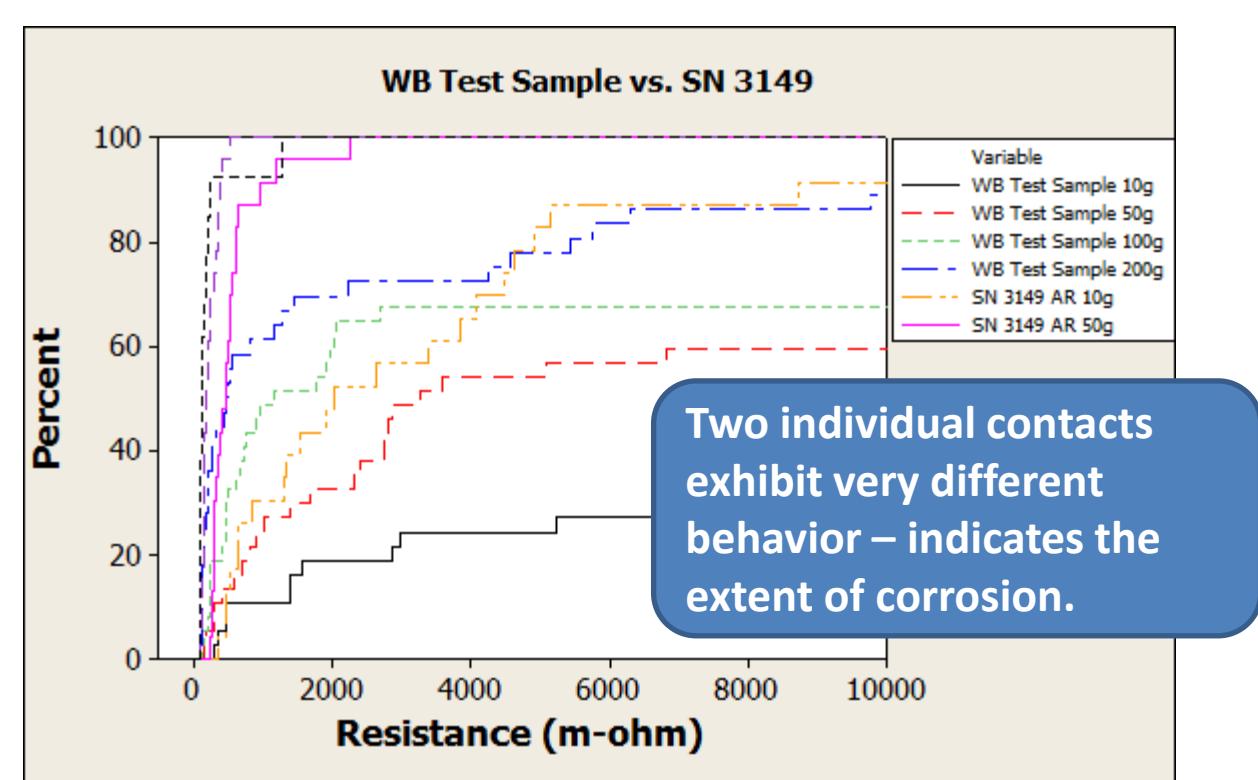
Abraded 2400 grit

To assure that the process would work, we made measurements on the “wedding band” contact of a test pull out switch assembly. After initial measurements, the ring was abraded with p1400 sand paper in an attempt to remove any corrosion buildup on the surface. As evidenced by the data, the resistance was quite a bit higher on the “wedding band” before abrasion. A similar comparison was completed with a “wedding band” that was in a weapon, SN 3149, and the WB test sample pre-abrasion. Nothing had been done to SN 3149 and the data after from tested as received was more comparable to the contact resistance of the abraded test sample, not the un-abraded test sample.
