# 4. Case Study

# The Fukushima Dai-ichi Nuclear Power Station Accident Chronology

# Outline of Presentation

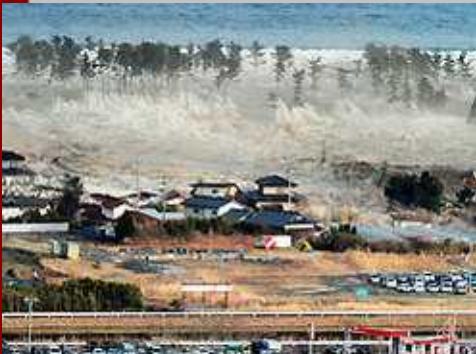
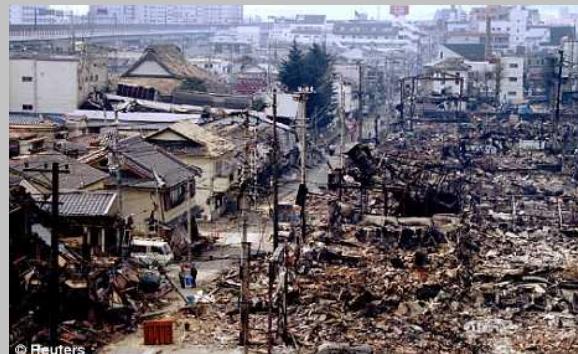
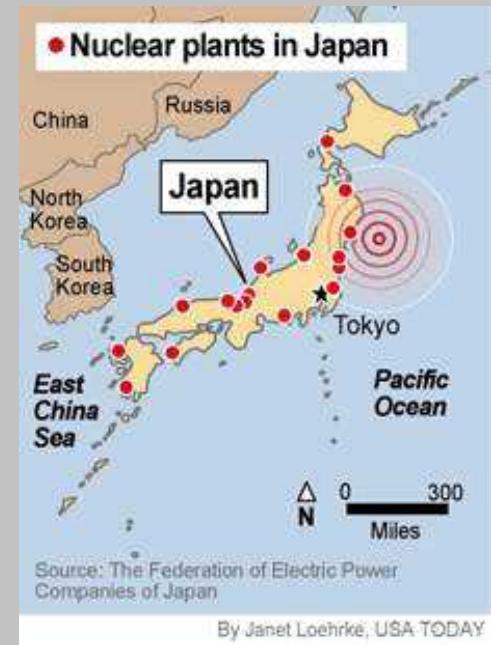
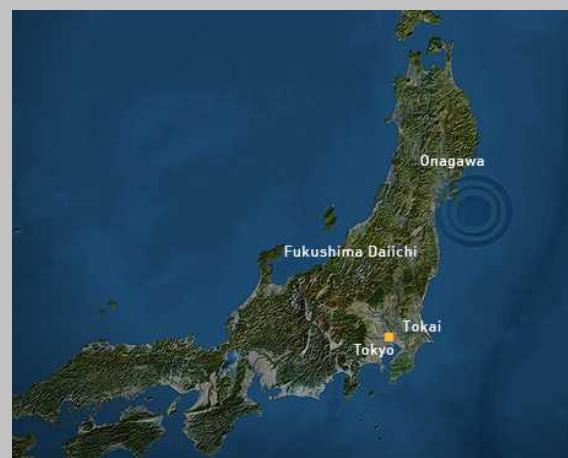
- A magnitude 9.0 earthquake occurred on March 11 (Japan time), centered offshore of the Sendai region, which contains the capital Tokyo with peak ground horizontal acceleration of 0.561 g
  - Plant design basis was a magnitude 8.2 earthquake and a peak ground horizontal acceleration of (0.447 g)
- Serious secondary effects followed – a significant tsunami and aftershocks.
- Estimated frequency of this earthquake 1E-6 to 1E-4 per reactor year (Japanese government)

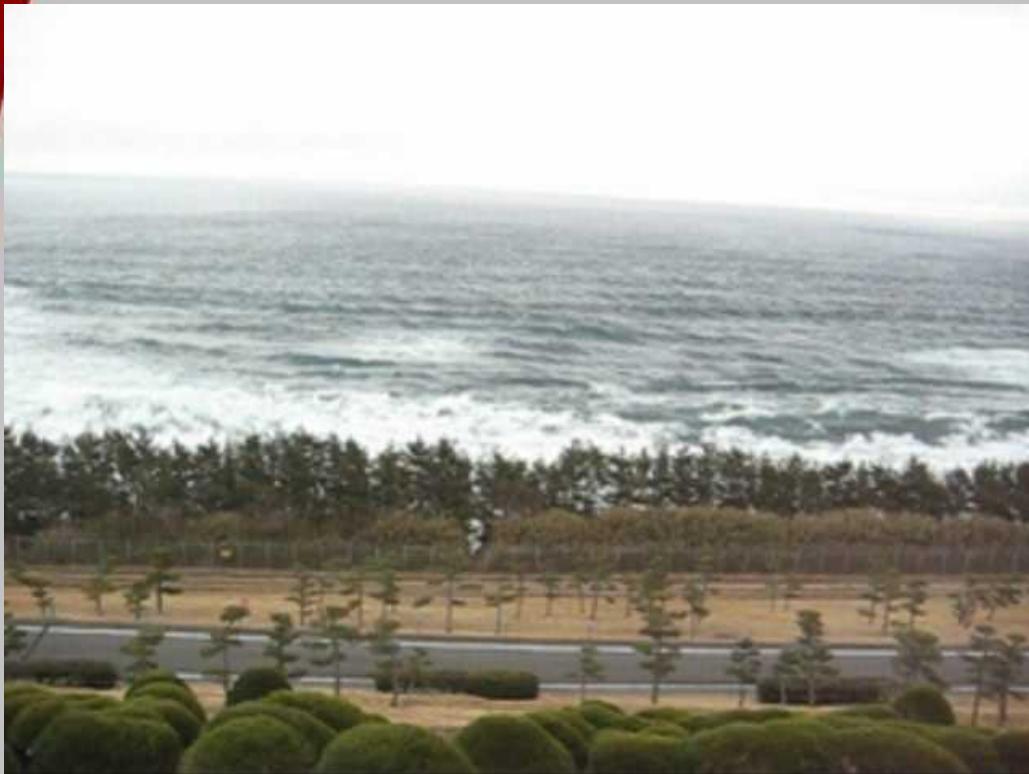
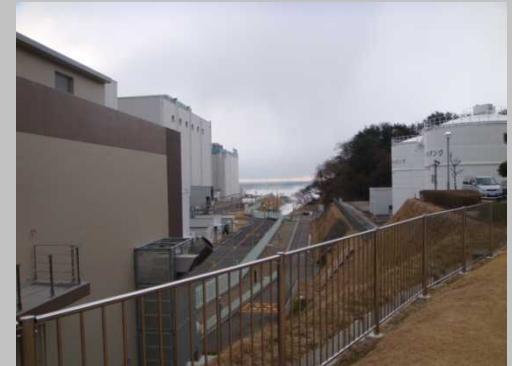
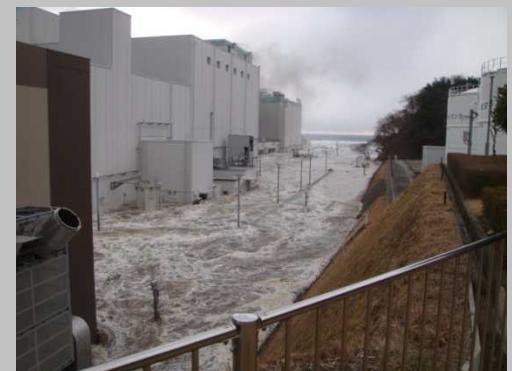
# The Tsunamis at Dai-ichi

- Seven tsunamis hit the plant
- Maximum height was 14 to 15 m
- Exceeded design basis of 5.7 m (original design basis was 3 m)
- Site grade is 10 m (Units 1-4) and 14 m (Units 5-6)

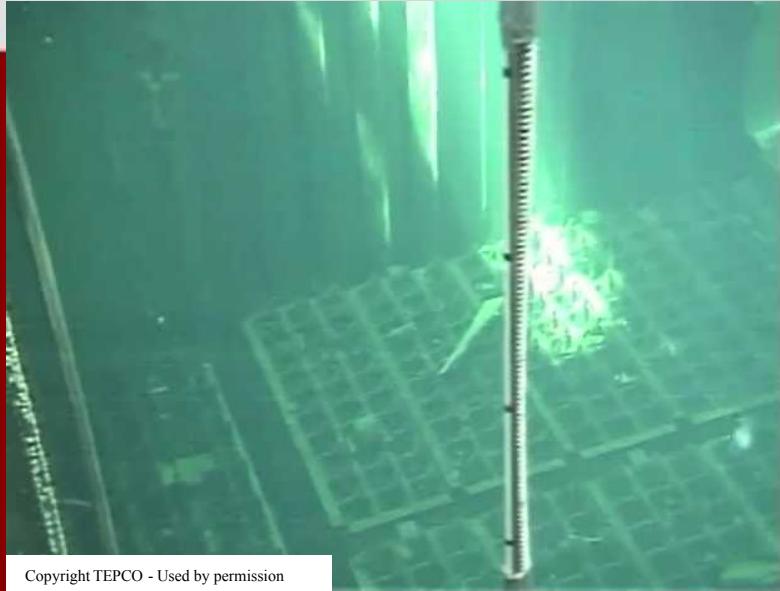
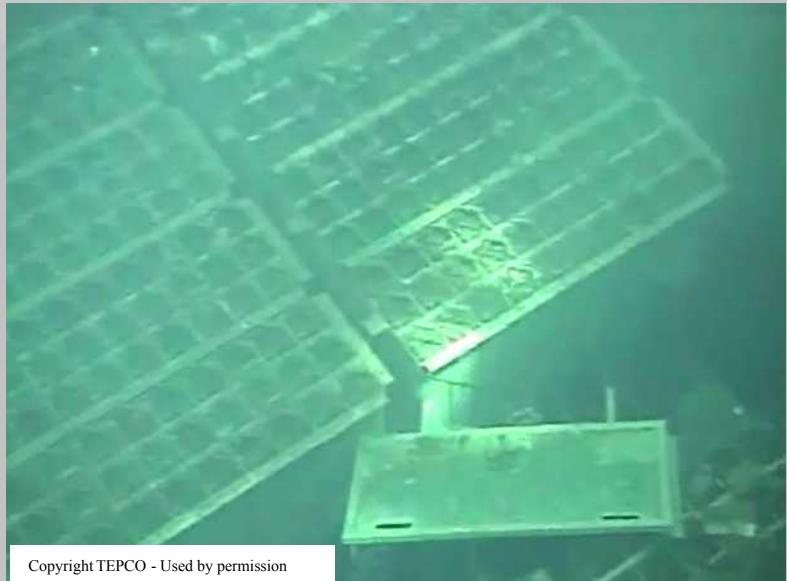
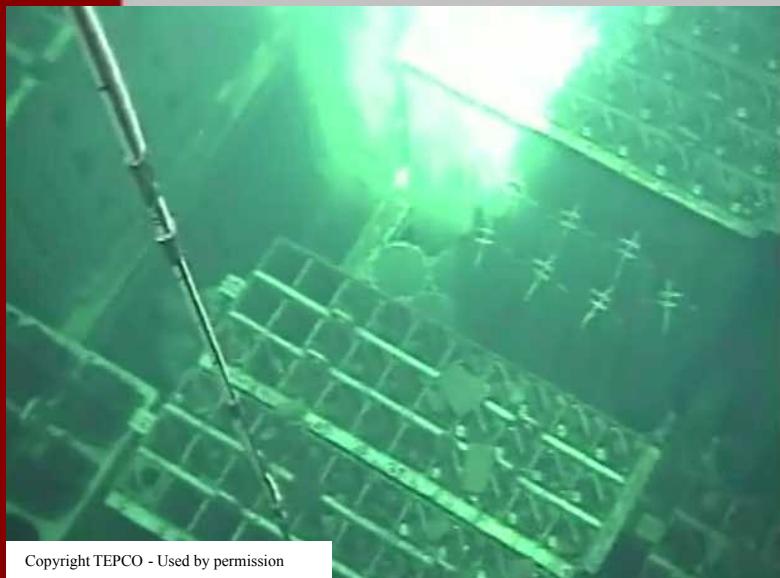
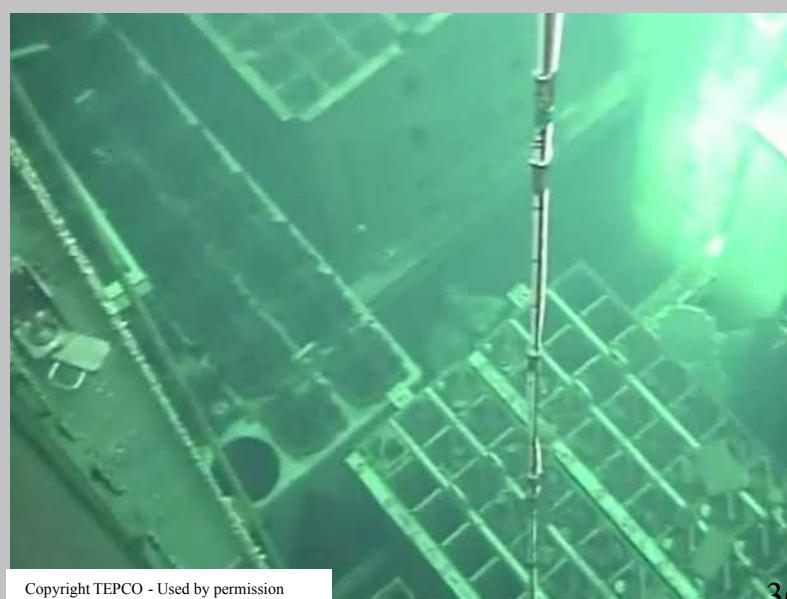
# Video from Unit 4 Spent Fuel Pool

- Reactor in Unit 4 was completely de-fueled for maintenance
- All fuel offloaded to spent fuel pool
  - Youngest (hottest fuel was 105 days)
  - Decay heat level was ~2 to 2.5 MW
- Reactor building was devastated by violent explosion on Tuesday March 15 at ~6:10 am after Unit 2 reports loud noise from torus room (events assumed unrelated)
  - Unlike Units 1 and 3, there is no actual video of Unit 4 explosion
  - Explosion was 3.5 days after earthquake

- It was feared that the pool had boiled dry and Zr-steam reaction produced H<sub>2</sub> that subsequently exploded
- Such conditions seemed difficult to imagine without significant water loss
- MELCOR analyses employed to evaluate draindown scenario
- Release of large amount of Cs-137 (little I-131) would have occurred

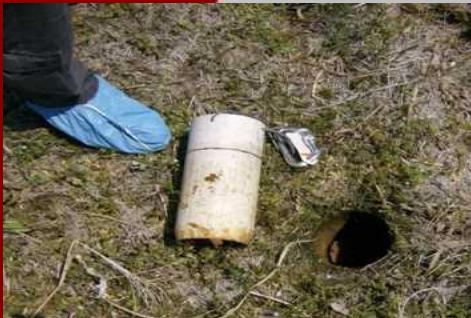
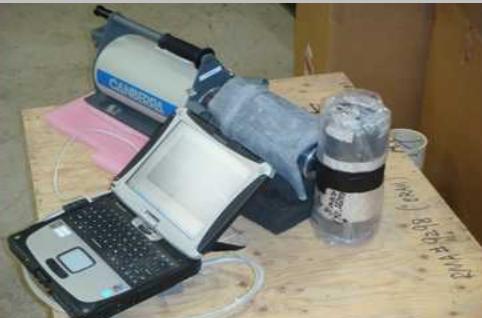
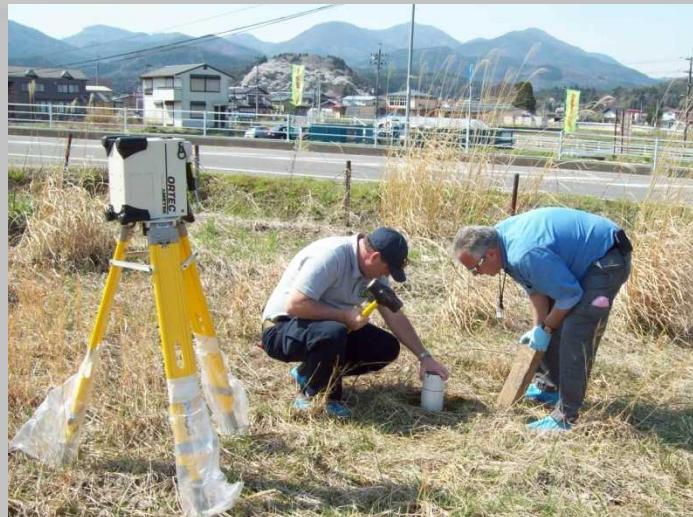
# Field Monitoring Activities

- Mobile monitoring
- In-situ measurements
- Exposure/dose rate measurements
- Air sampling
- Soil samples
- Swipe samples

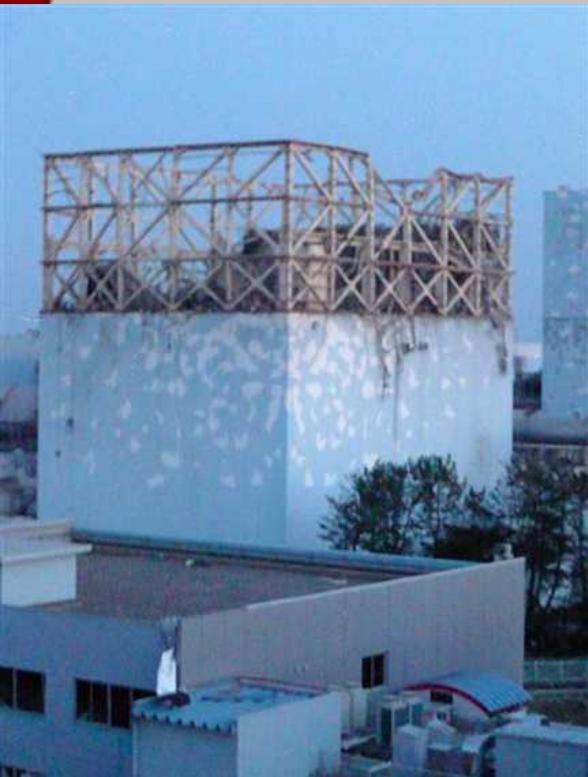
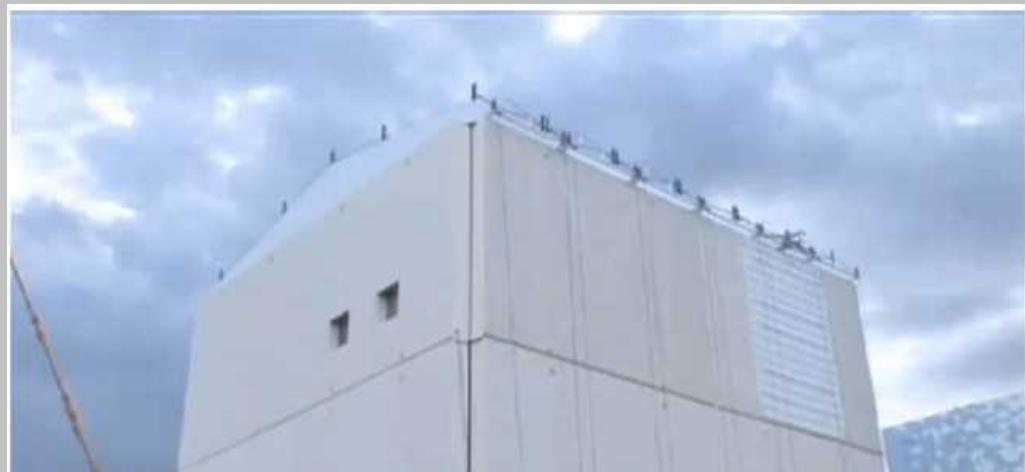
# Recovery at Unit-1

After hydrogen burn

Now
