**Post-Closure Report for Closed  
*Resource Conservation and*  
*Recovery Act Corrective Action*  
Units, Nevada National Security  
Site, Nevada**

**For Fiscal Year 2013  
(October 2012–September 2013)**

January 2014

**U.S. Department of Energy,  
National Nuclear Security Administration  
Nevada Field Office  
Las Vegas, Nevada**

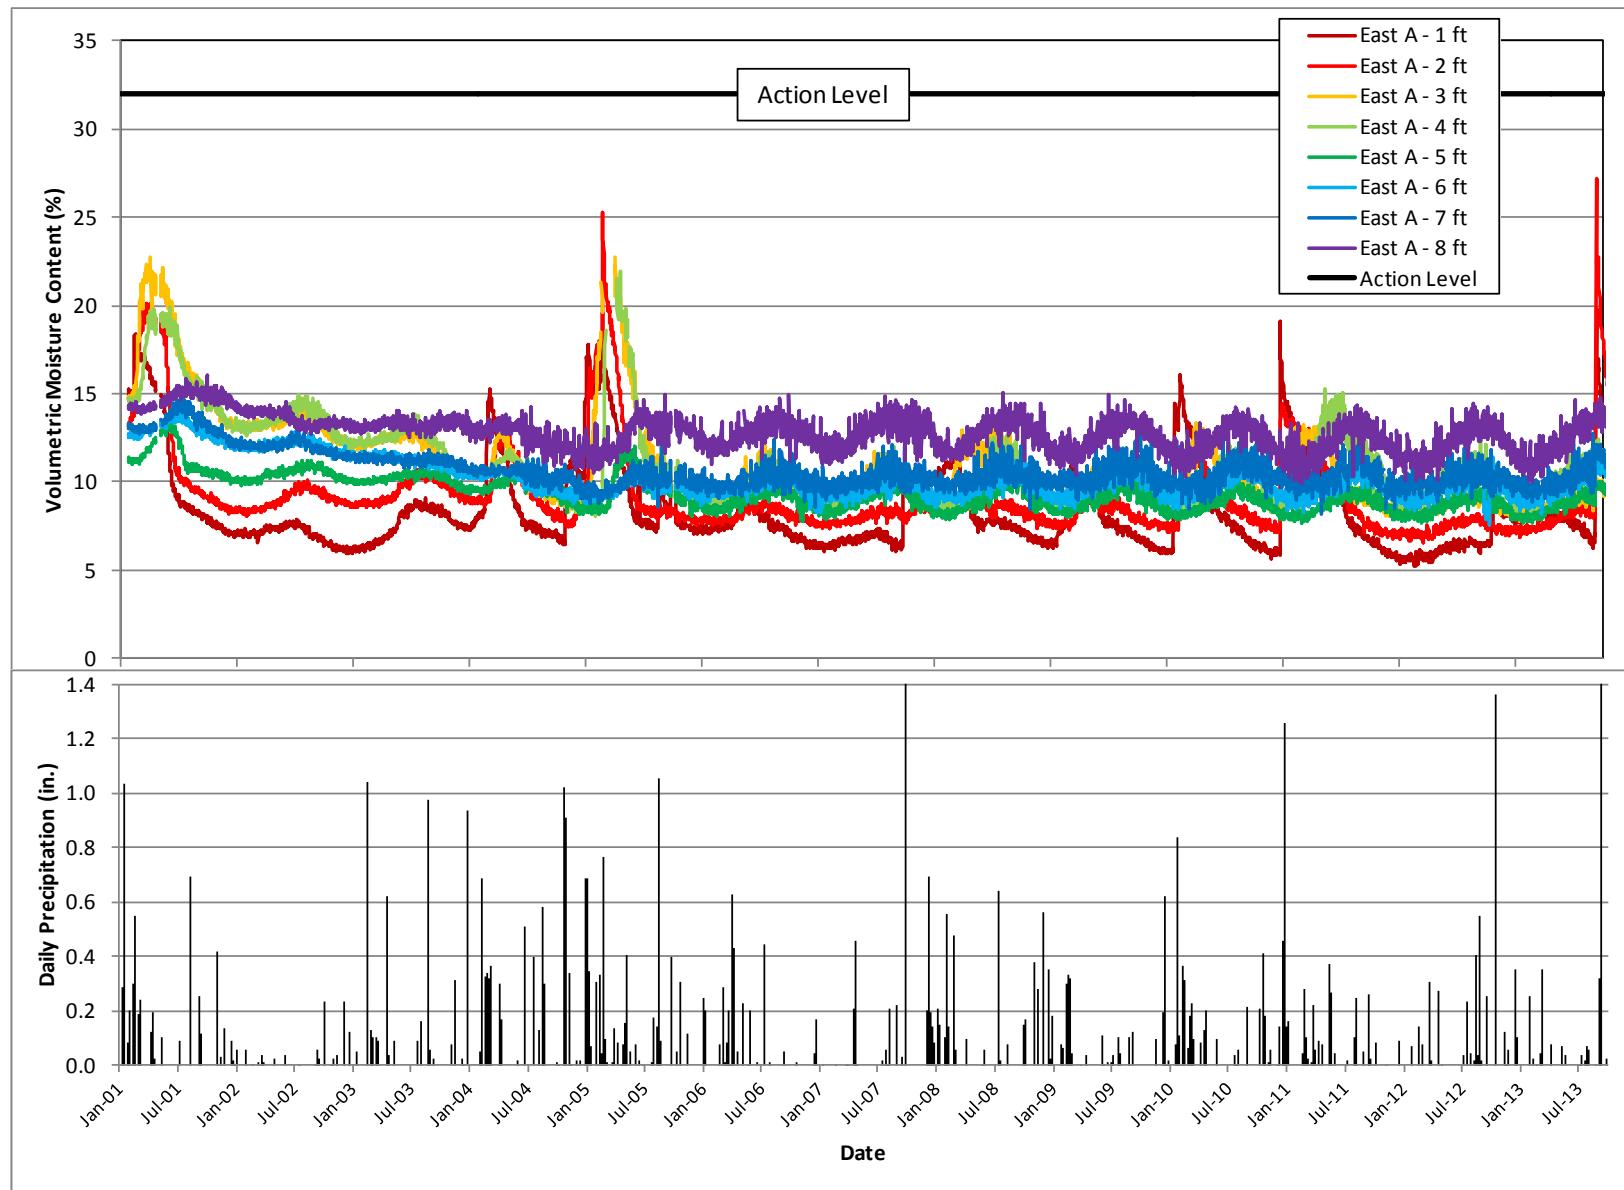
FIGURE 3. EAST TDR NEST A SOIL MOISTURE CONTENT PROFILE

The action level is illustrated in Figures 3 through 6. The action level was not exceeded.
