SAND2011-7575 C

In Situ Transmission Electron Microscopy Investigation of Microstructural Evolution in Complex F-M Steels under Ion Irradiation

THE SECOND WORKSHOP ON THE USE OF IN SITU TEM / ION ACCELERATOR TECHNIQUES IN THE STUDY OF RADIATION DAMAGE IN SOLIDS

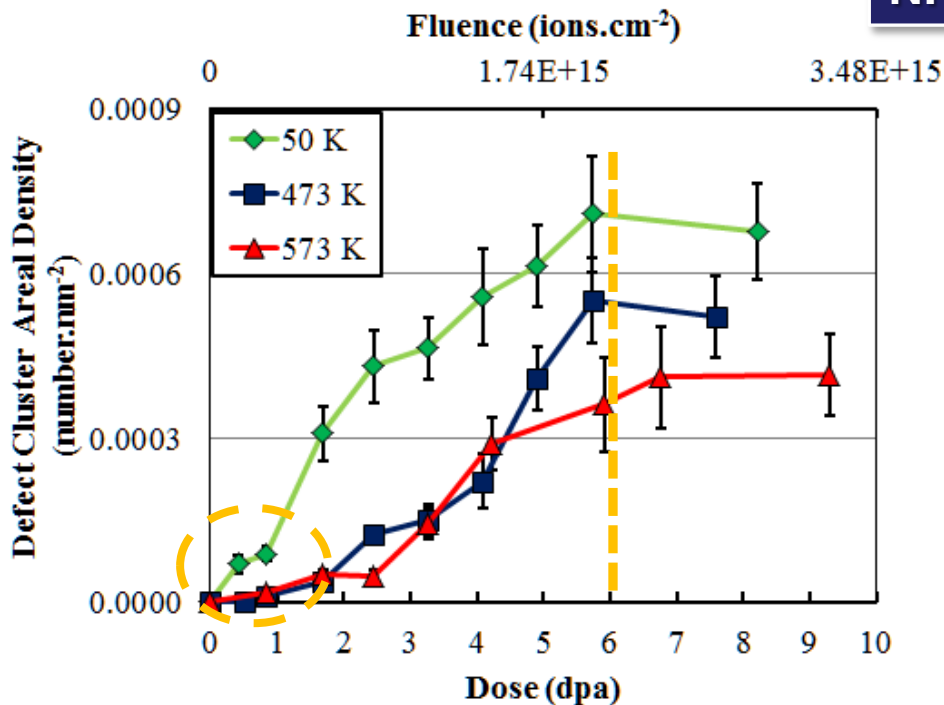
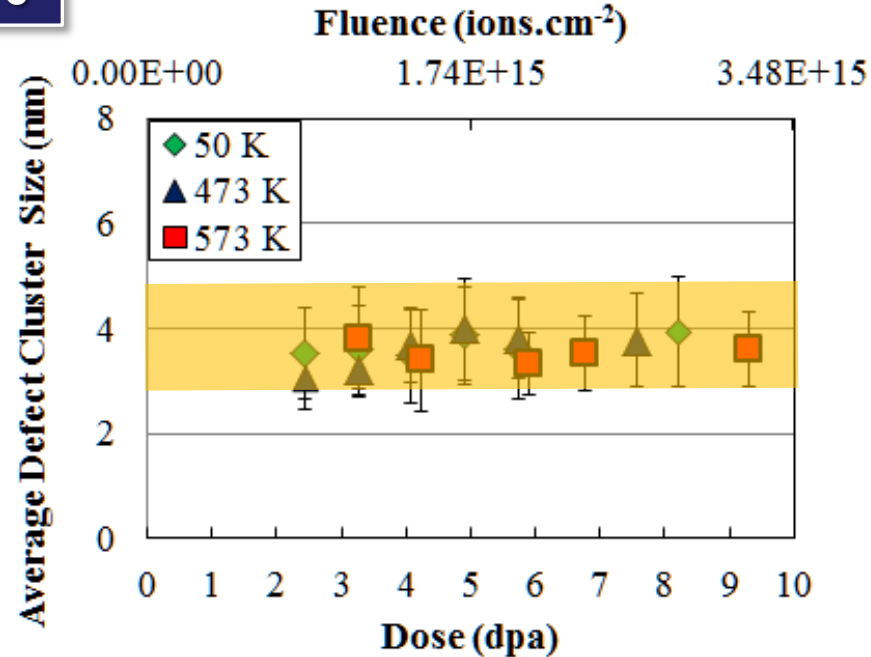
NF616

Defect Cluster Density and Average Cluster Size Vs. Dose and Temperature

- Defect cluster density increases and tends to saturate at ~ 6dpa
- Saturation level of defect density decreases as temperature increases
- Defect accumulation starts at lower doses at 50K

- Average size between 3 and 4 nm
- Average defect size does not depend on temperature and dose below 573K.

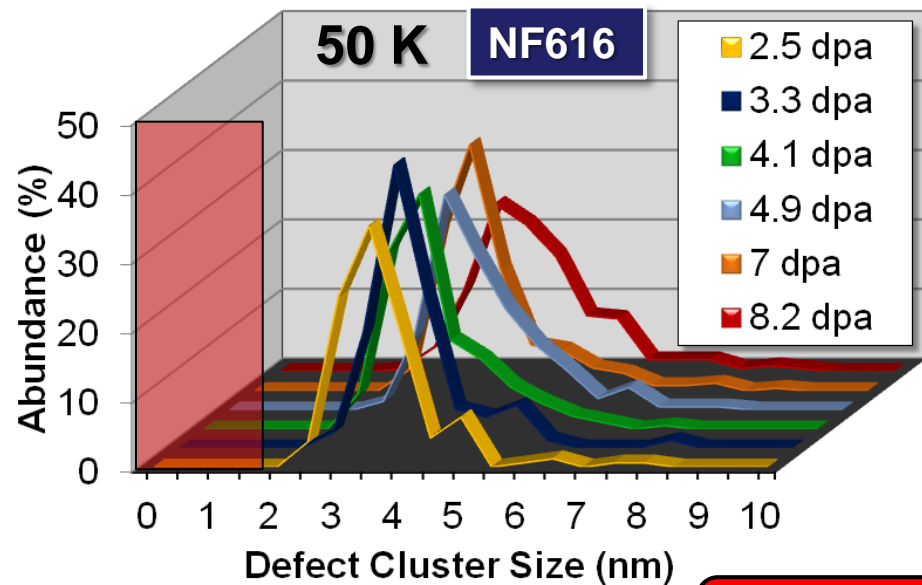
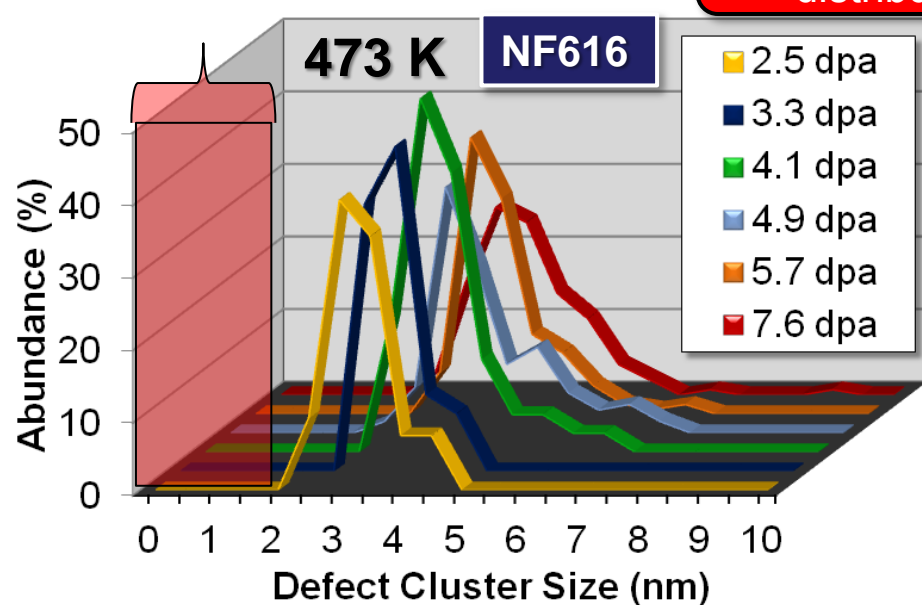
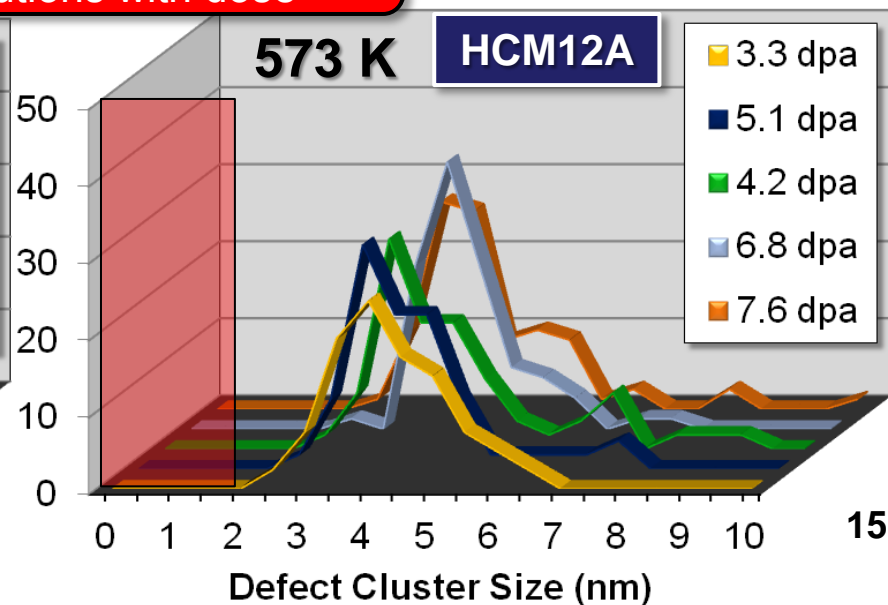
Defect Cluster Size Distributions

<resolution limit of TEM

➤ No significant shift in size distributions with dose
