Stainless Steel Canister Surface Analysis: Process and Results

Charles Bryan and David Enos, Sandia National Laboratories
EPRI ESCP meeting, 3-5 December 2013, Charlotte

Analysis of Calvert Cliffs Samples

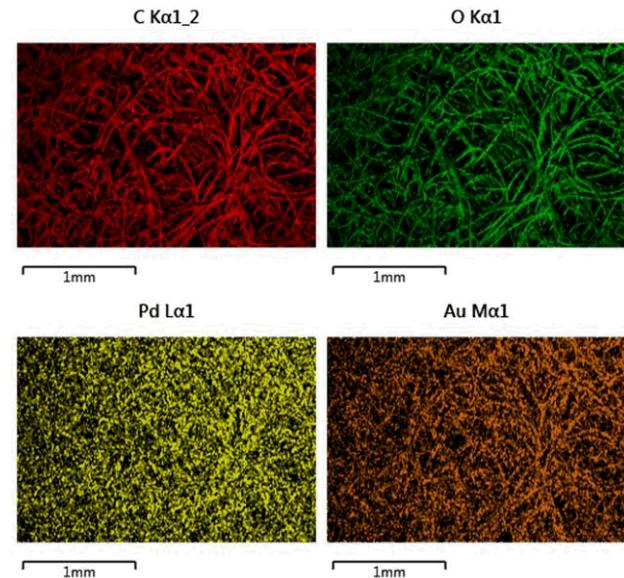
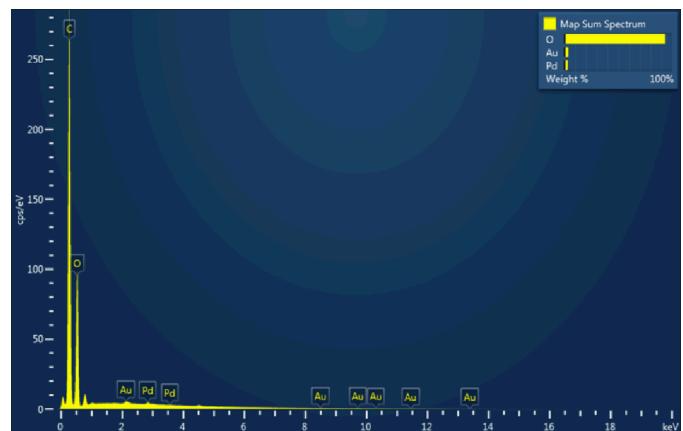
EPRI filter blank

- Filter clean—sparse particulate contaminants
- Carbon, oxygen only significant components

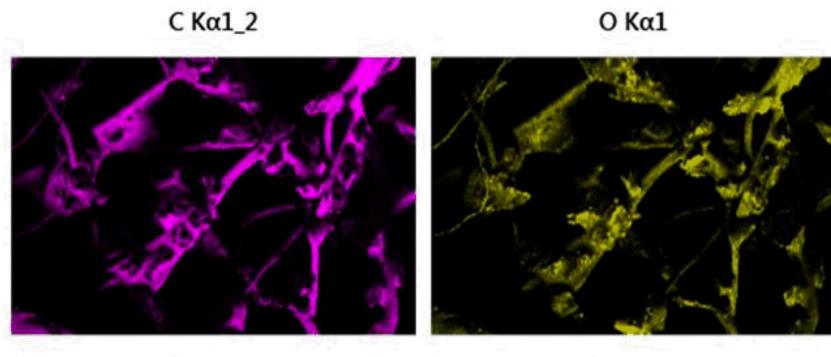
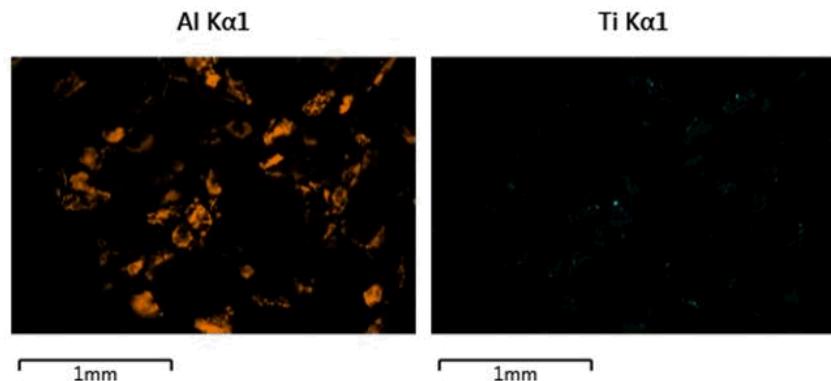
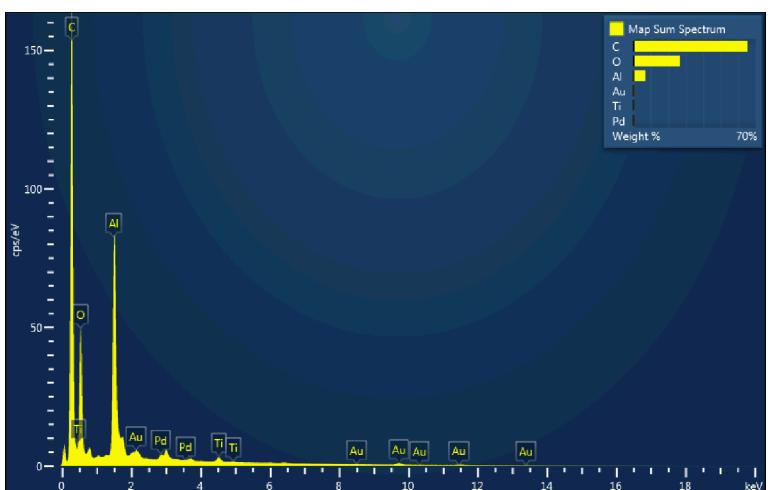
EPRI Scotchbrite pad blank

- Alumina grains and nylon fibers embedded in resin
- Trace titanium oxide particles
- Few contaminant particulates

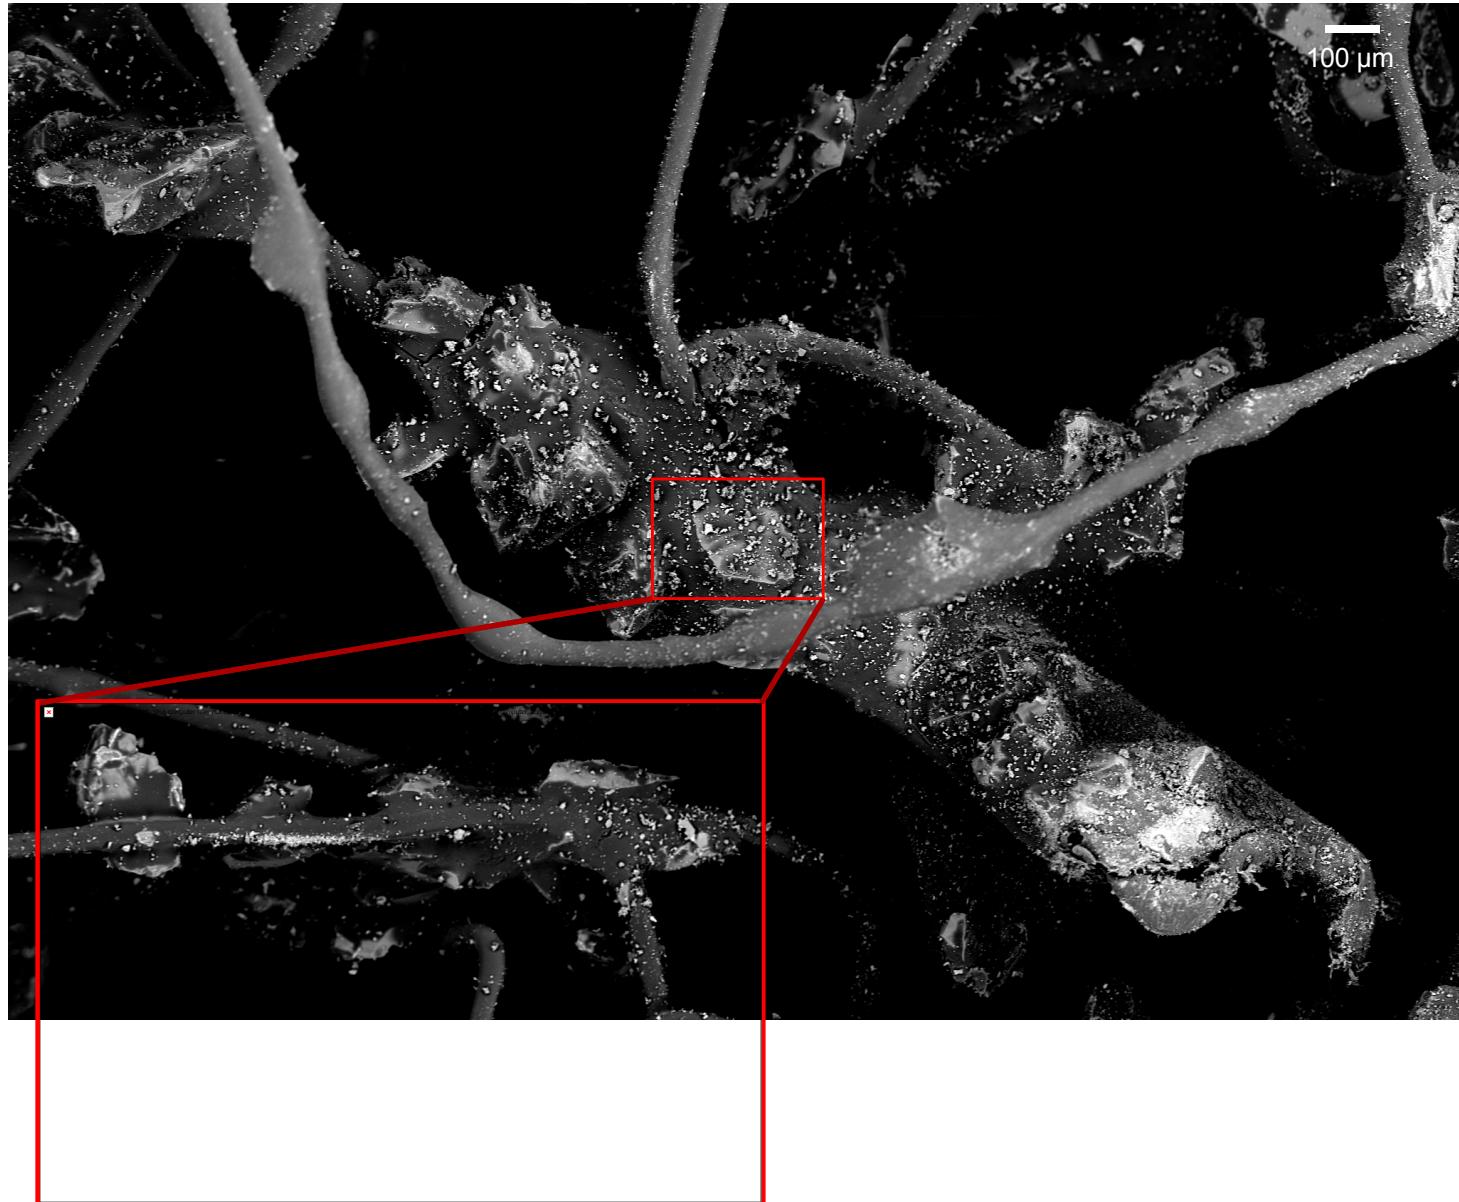
EPRI #4 Scotchbrite

Heavily loaded
with dust
particulates

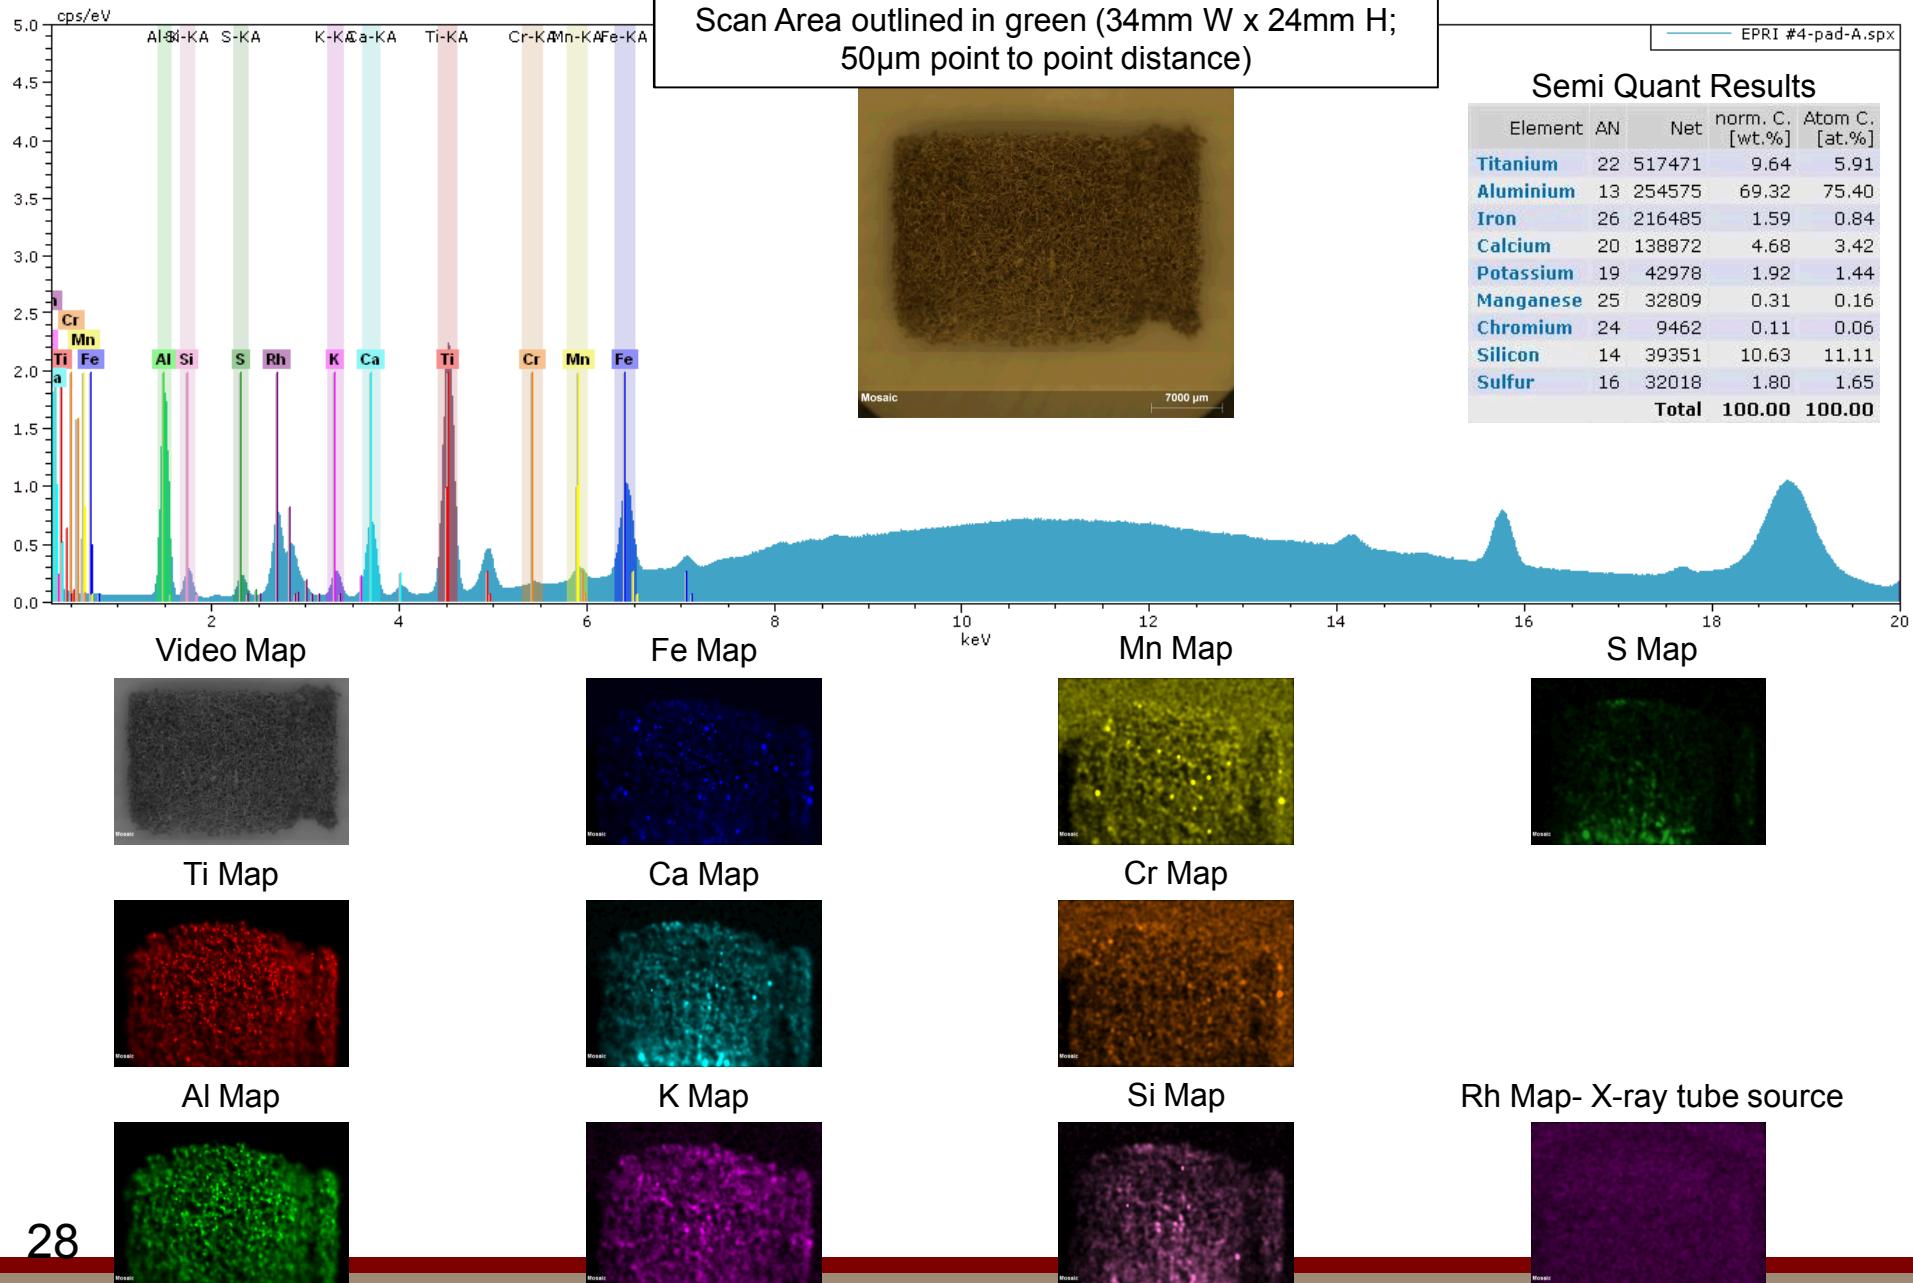
XRF analysis: EPRI #4-pad

Scan Area outlined in green (34mm W x 24mm H;
50 μ m point to point distance)

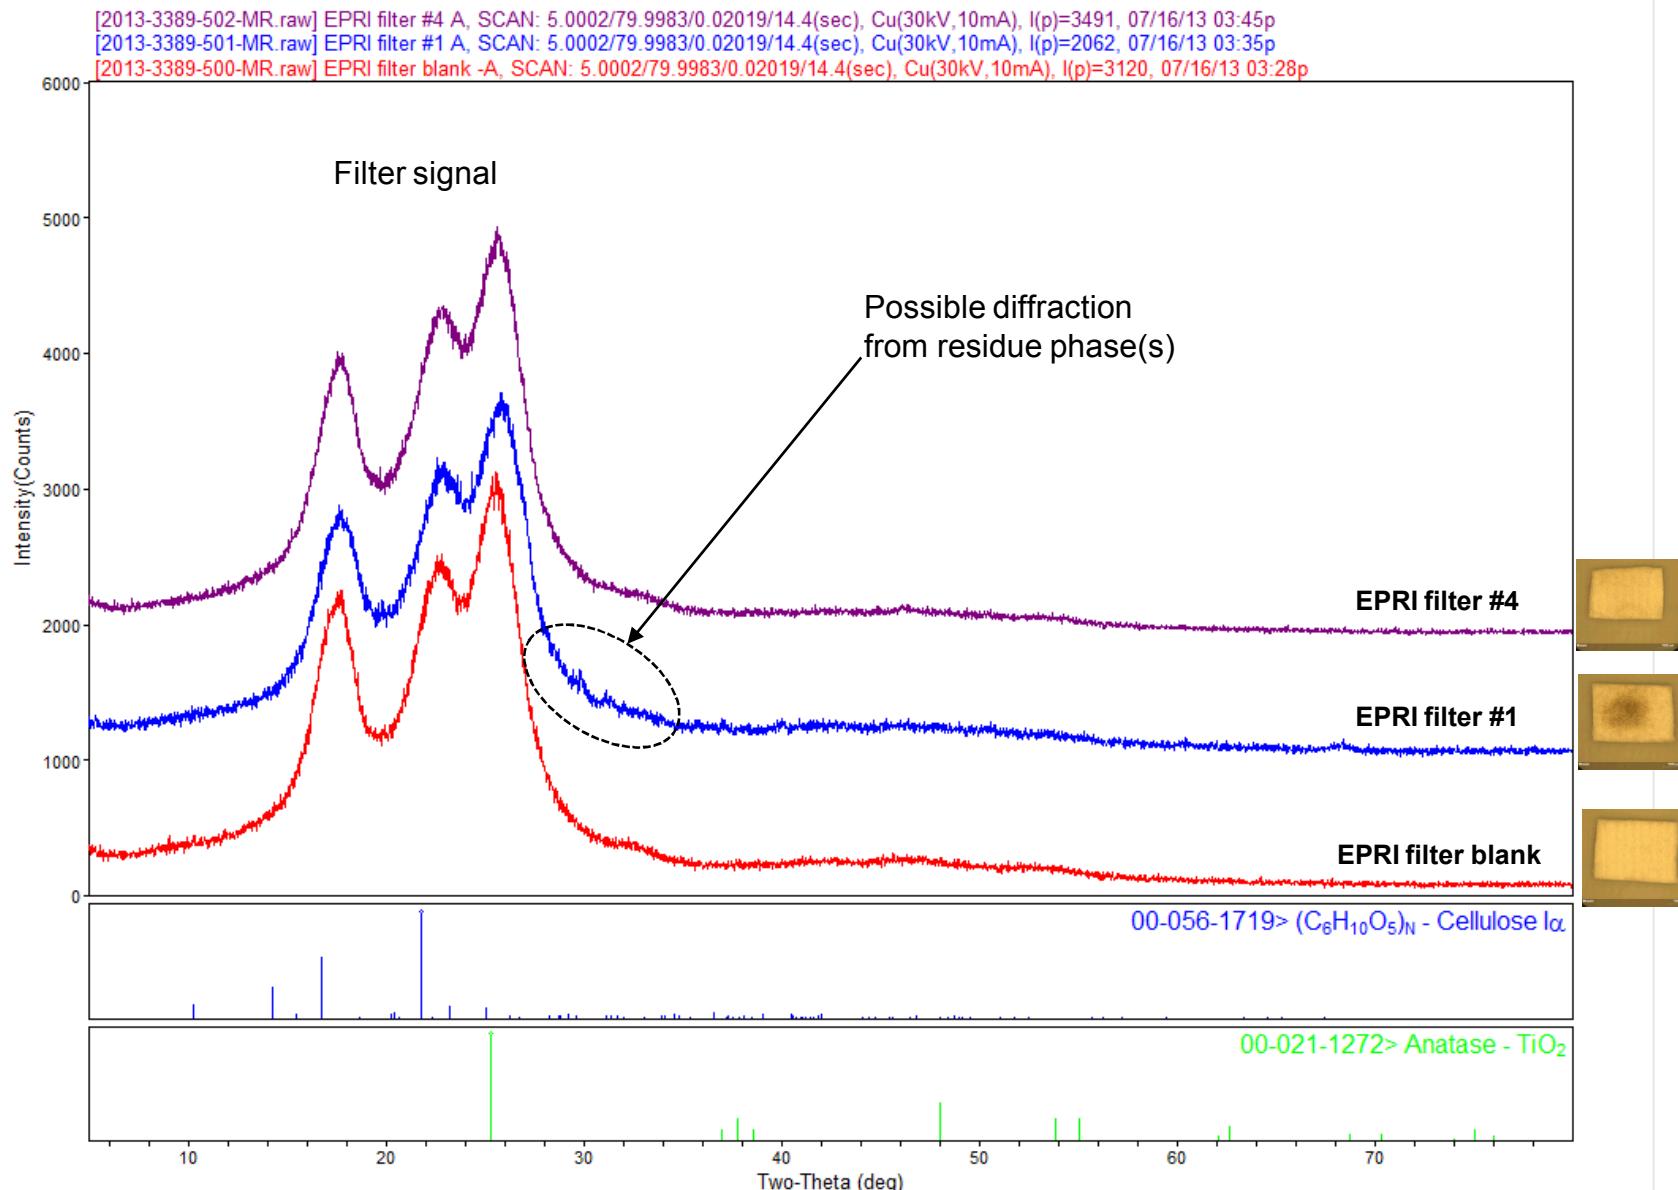
XRD Analysis: EPRI filter samples

All the patterns are similar with little evidence of additional crystalline phases. There is a faint signal in the #1 pattern that could be indicative of an additional phase(s).

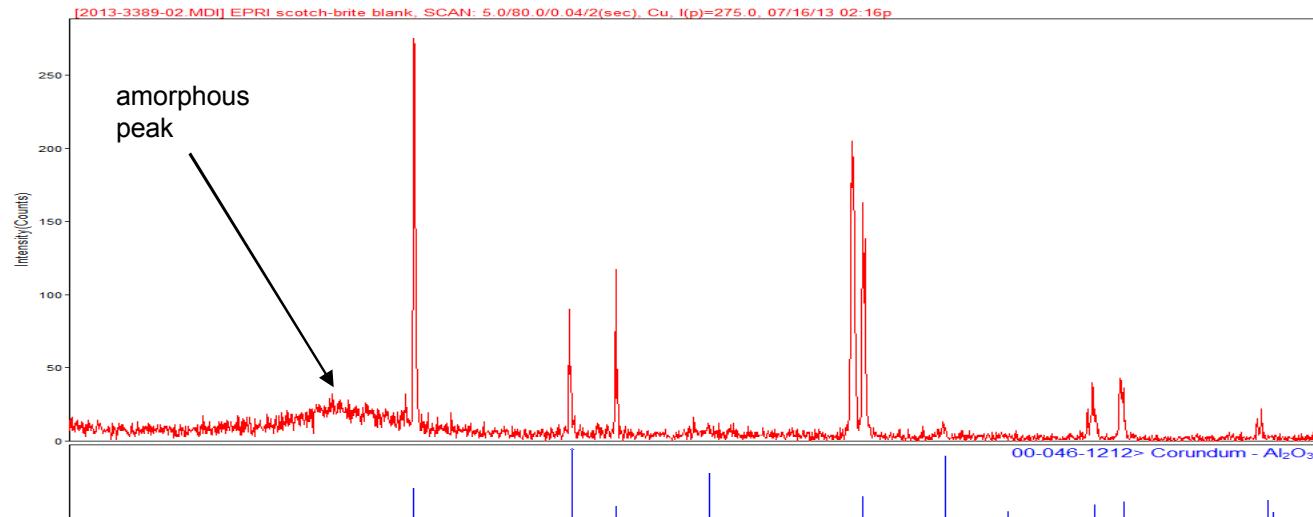
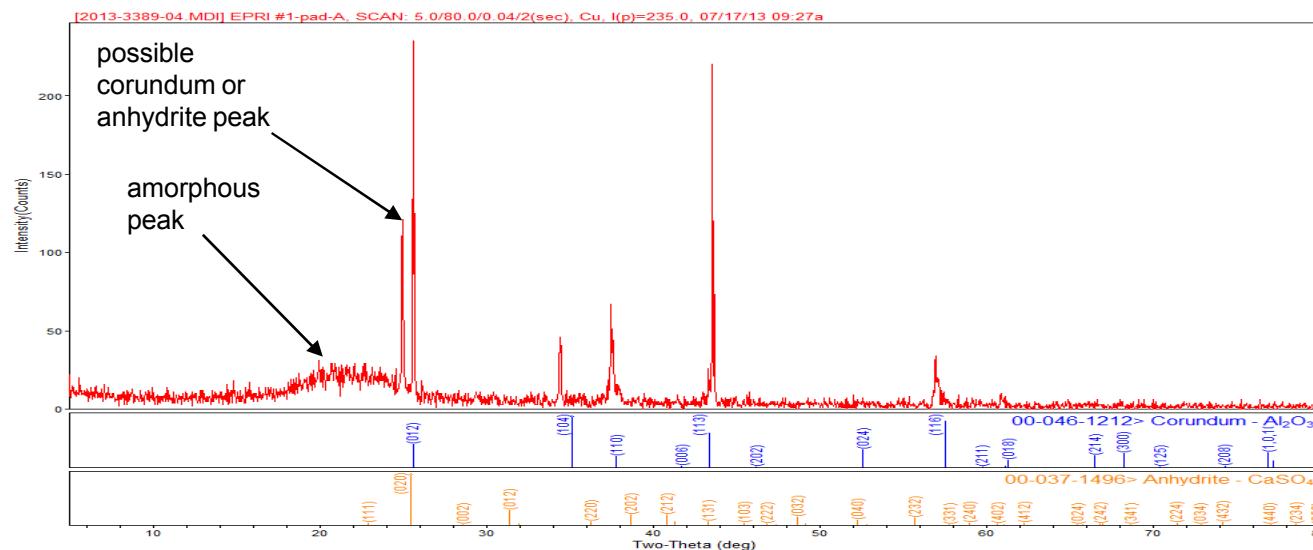
XRD Analysis: EPRI pads

The XRD pattern for the **EPRI Scotch-brite blank** shows a broad amorphous peak at $\sim 21^\circ$ 2 θ as well as sharp peaks for Corundum (Al_2O_3). The “splitting” and shifting of observed peaks is due to the dispersal of the phase at differing heights in the sample.

XRD results for the **EPRI #1-pad-A** again show a broad amorphous peak along with sharp diffraction peaks consistent with well crystallized corundum (Al_2O_3). Anhydrite (CaSO_4) is a possible match for some peaks, but the overlap between the peaks of Corundum and Anhydrite complicate the identification.

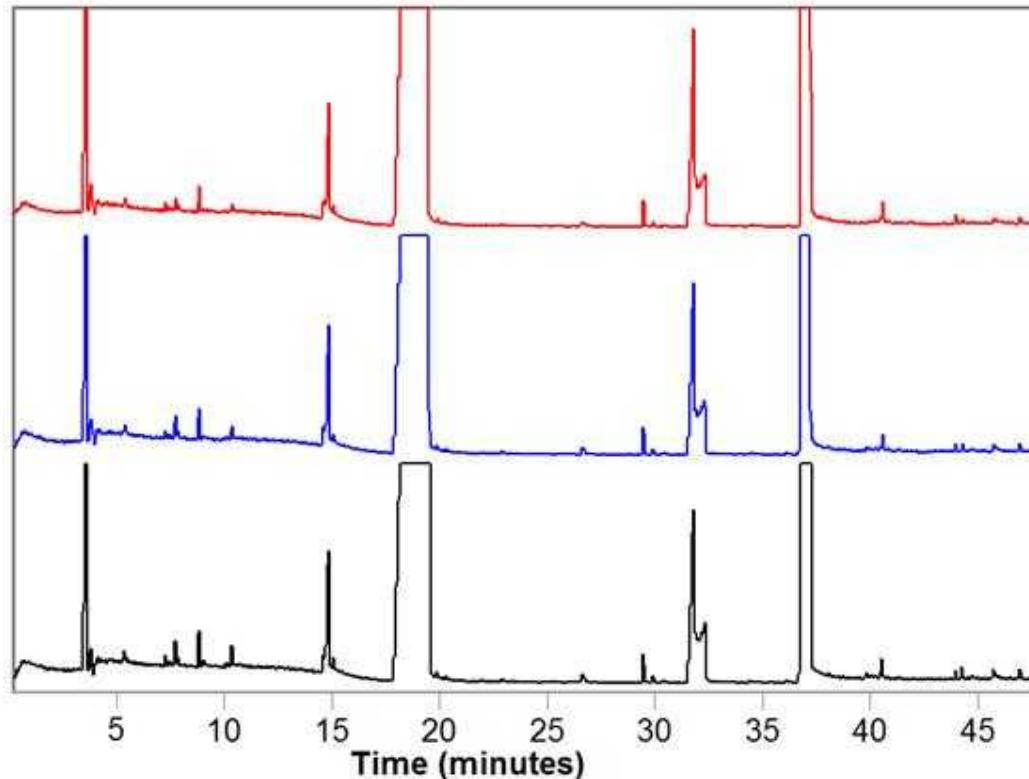
GC-MS Analysis

- Temperatures ramped to 100°C, 200°C and then 250°C. No difference was observed in decomposition patterns of the blanks versus the samples with time.

Total ion signal versus retention time for the Scotch-Brite® samples, blank, #1-D, #4-D (top to bottom). The y-axis is greatly expanded for viewing clarity of the minor peaks.

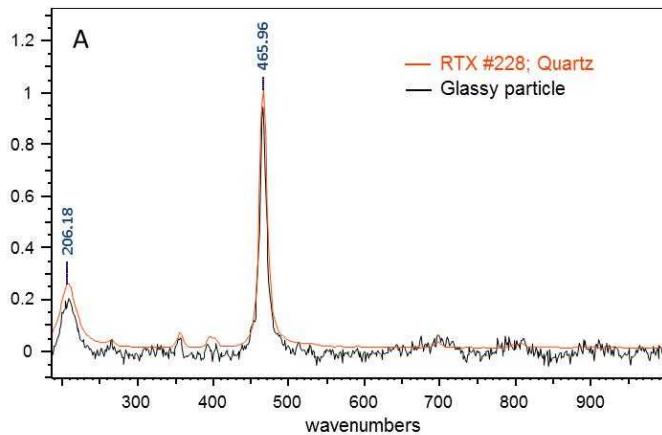
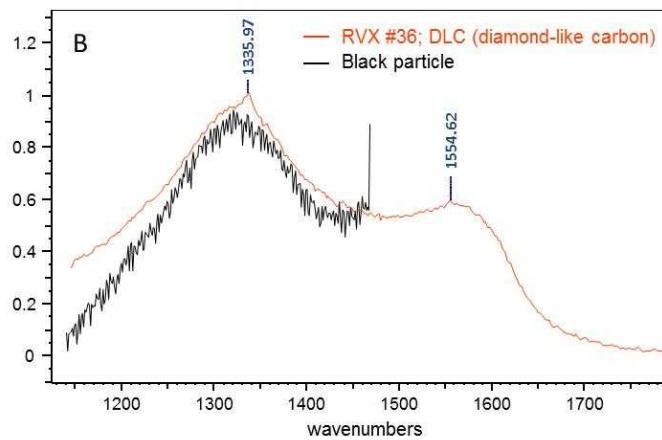
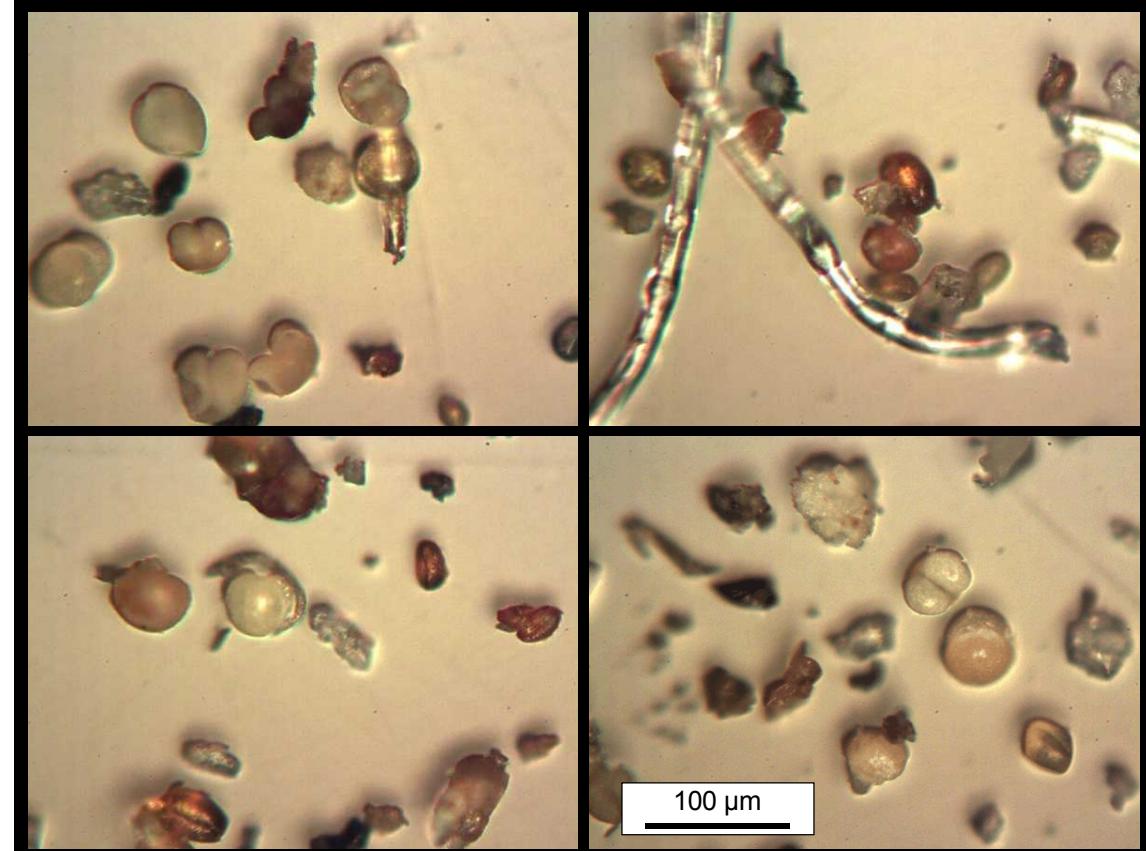
Micro-Raman Analysis

Photos taken during micro-Raman analysis show that dust coarse fraction is mostly pollen

Other phases identified:

- Quartz
- Soot

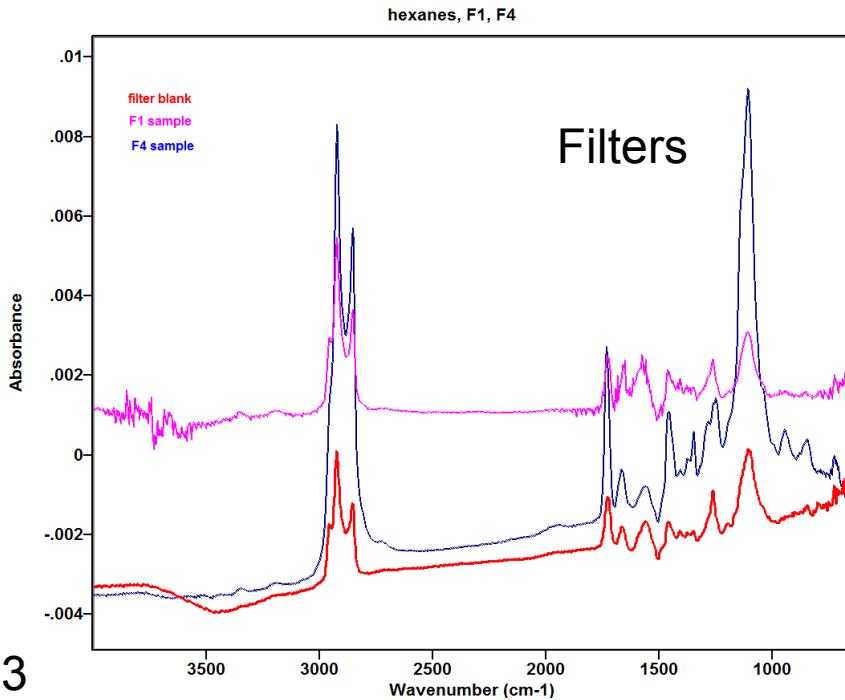
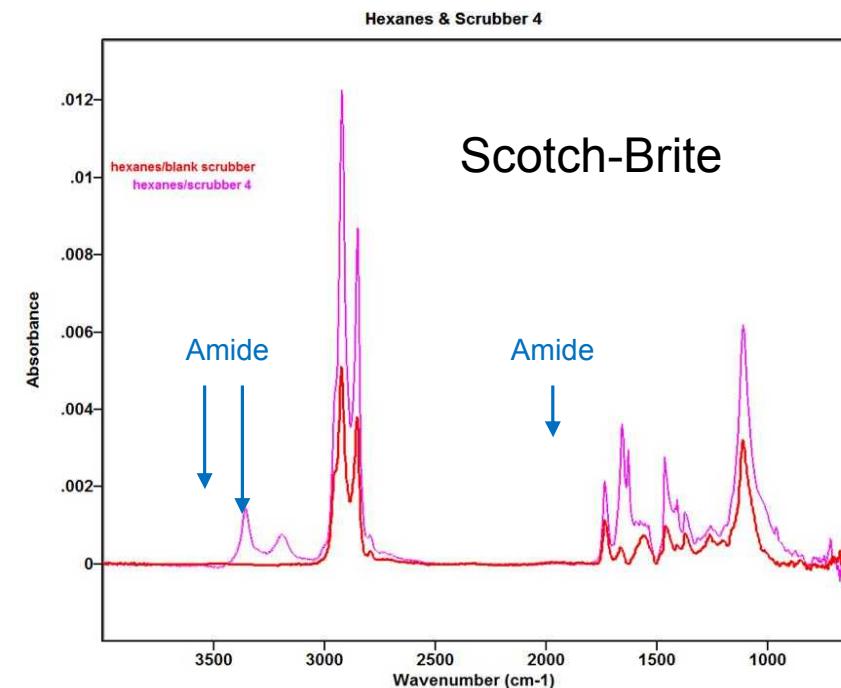
FTIR Spectroscopy

Samples leached with isopropanol and hexane

- Isopropanol will leach polar organic molecules
- Hexane will leach non-polar organics (hydrocarbons)
- Filter samples did not vary significantly from blank
- Pad samples varied from blank: compound tentatively identified as a primary amide
 - Probable source: breakdown products of the scrubber, exposed by the abrasive action, allowing it to be extracted and not show up in the blank (e.g., the cured resin that is holding the abrasive to the nylon fiber; a slip agent on the nylon covered by the resin). Note that nylon itself is an amide.
 - Less likely: a protein or a degraded protein material in the dust

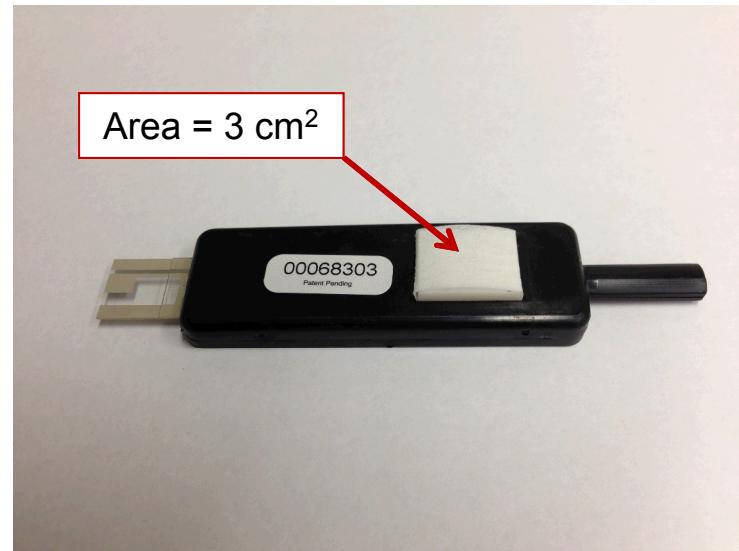
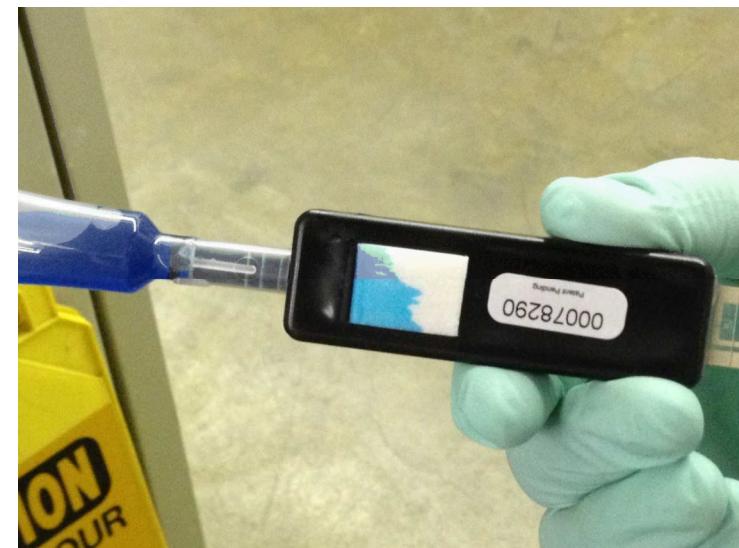
Salt-Smart Analyses

- Salt-smart® sensors developed to measure sea salt deposition on metal surfaces in shipyards, prior to painting the cleaned surface.
- Sample salts over a known surface area, providing salt amounts present per unit area.
- Fluid (DI water) is drawn by capillary action through a wick contacting the surface, and into an internal pad
- In ordinary usage, the conductivity of the wet pad is measured is measured, and chloride concentration is provided, assuming conductive salts are sea salt in composition.

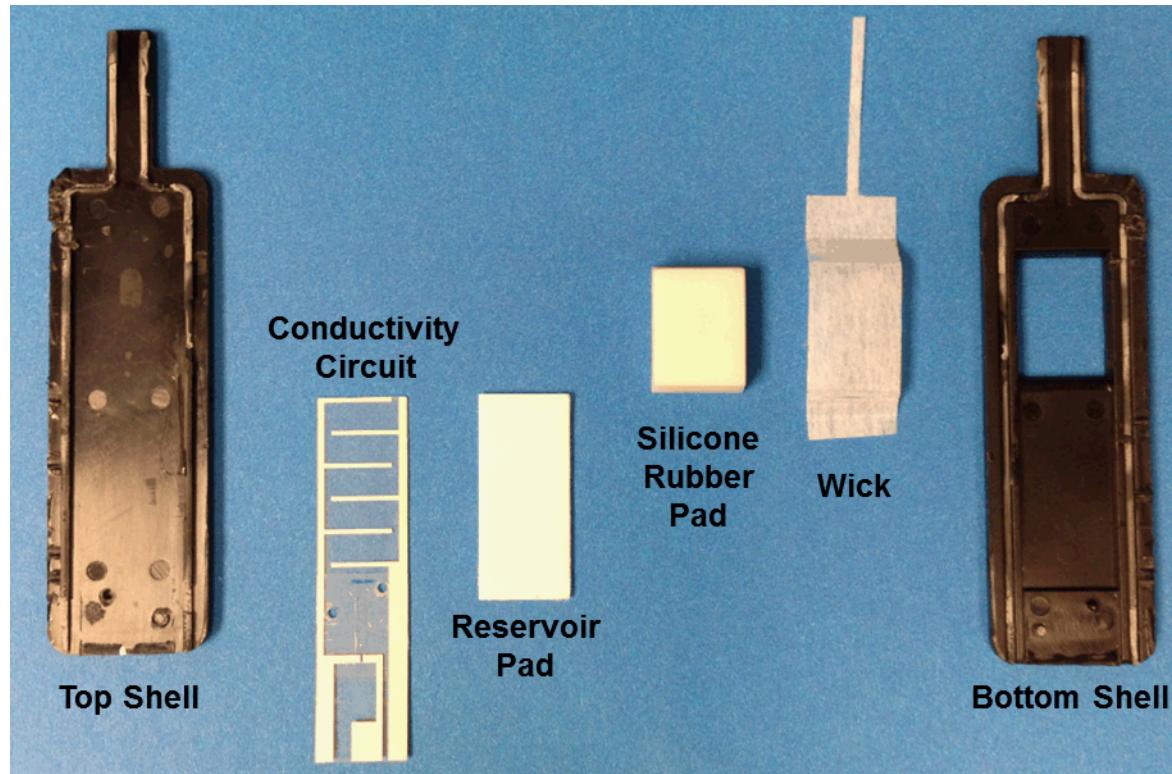
Salt-Smart Analyses

- To accurately measure salt composition, we will disassemble the Salt-smart sensor, rinse the internal surfaces, and soak the wick and reservoir pad in DI water to extract salts. Extracted fluid is measured by IC (anions) and ICP (cations)
