Structural integrity and thermal stability of low emissivity electroplated Au on 304L Stainless steel

Nancy Yang,
Sandia National Laboratories (SNL), CA

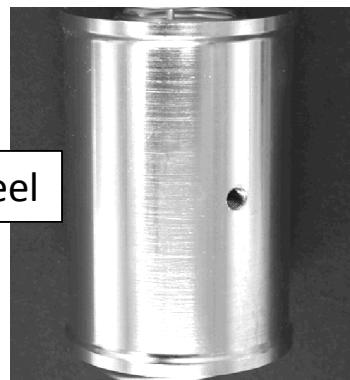
304L stainless steel

Design a low emissivity device for thermal management

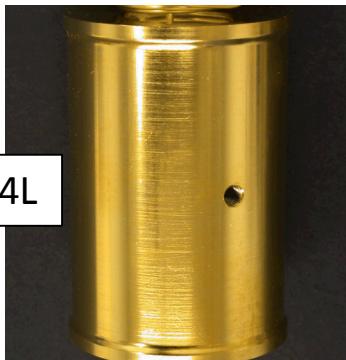
Au-plated 304L

Lower thermal emissivity by applying metal coating

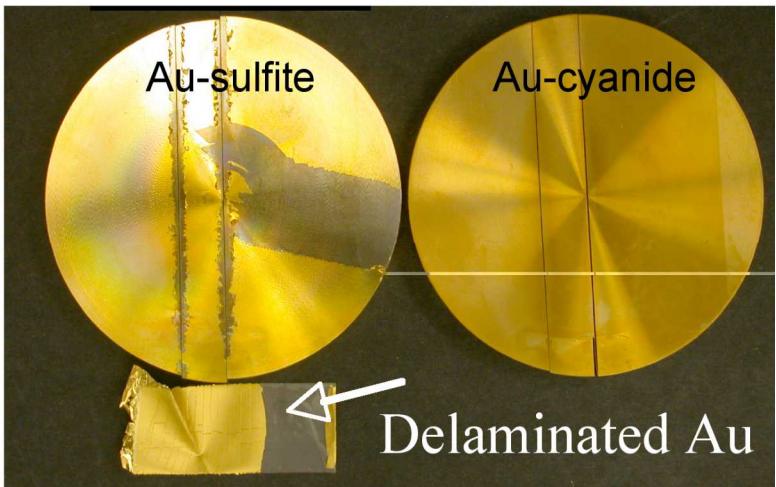
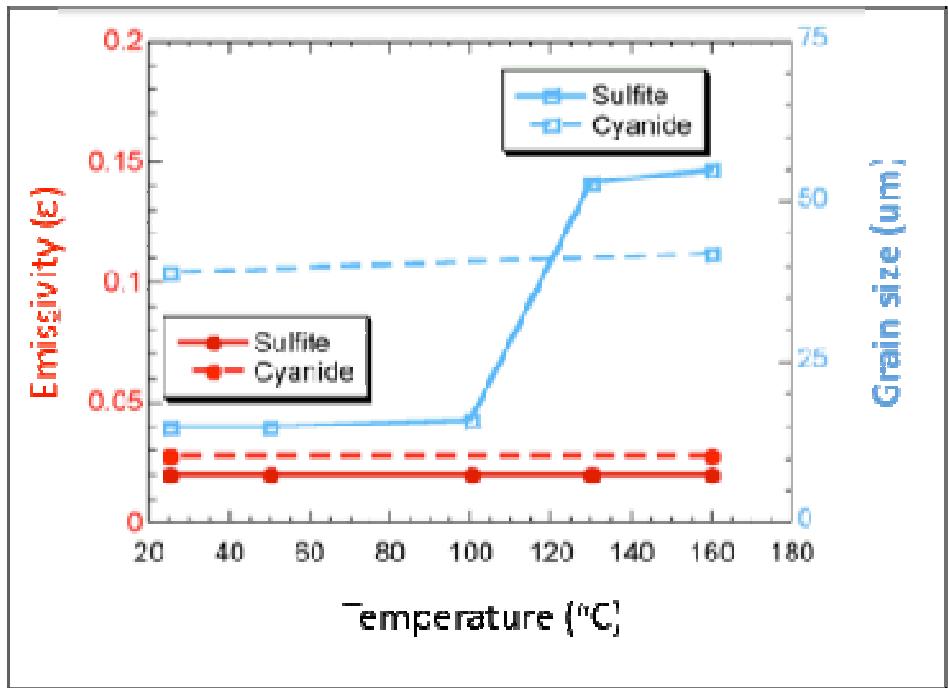
Developed an electroplating process for a Au coating on 304L with strong adhesion and stable microstructure

Au-sulfite exhibits weak adhesion and unstable microstructure at $\geq 100^{\circ}\text{C}$, not suitable for elevated temperature applications.

Down selected Au-cyanide process based on its good adhesion and thermally stable microstructure

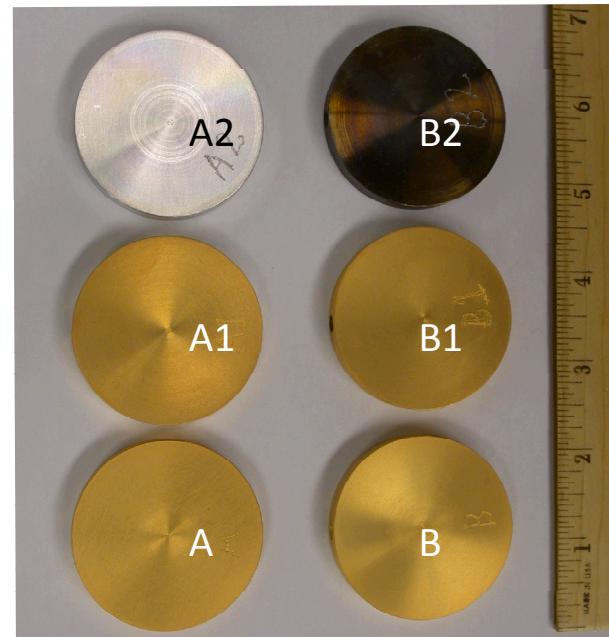
Sample geometry and dimension

The annealing temperature and annealing duration are ambient to 250°C and 7days to two months, respectively

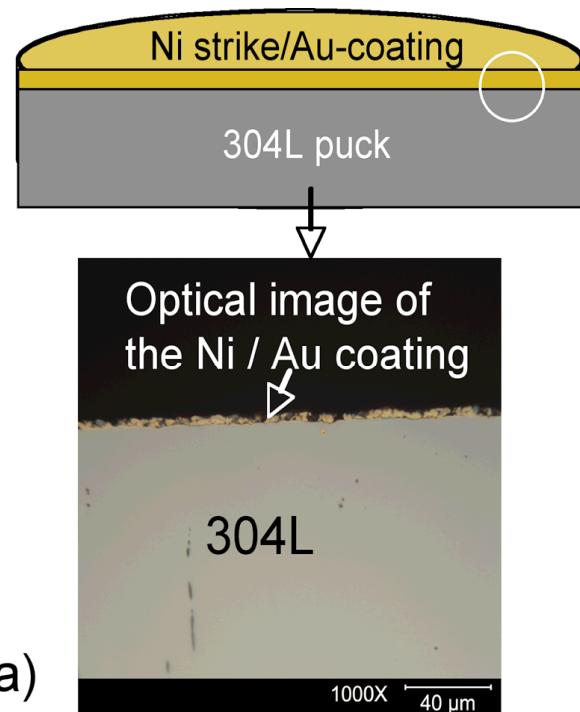
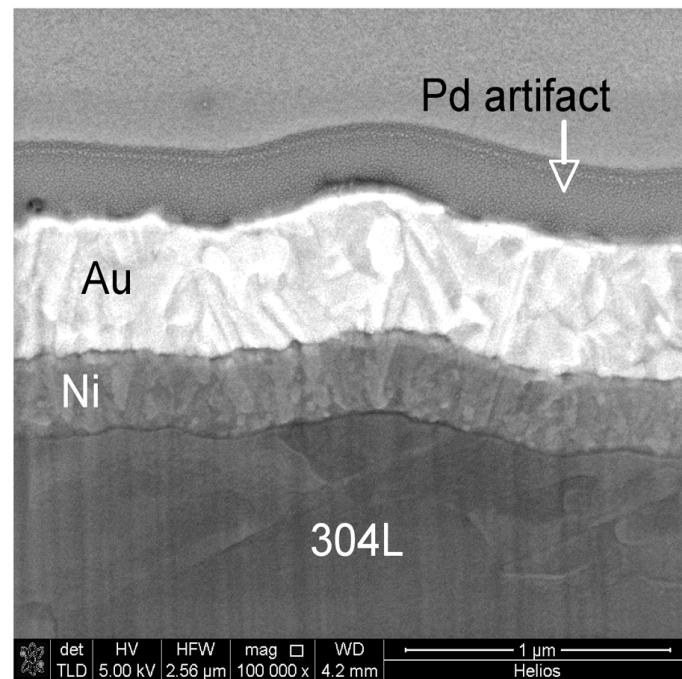
SEM image of the FIB cross section

The electroplated Au and Woods Ni on 304L substrate system, fabricated at SNL-CA, meets the technical requirements

- The system consists of thin electroplated Au (500nm) and Ni (300nm) on a 304L stainless steel substrate.
- Adhesion along the Au-Ni and Ni-304L interfaces appeared to be continuous

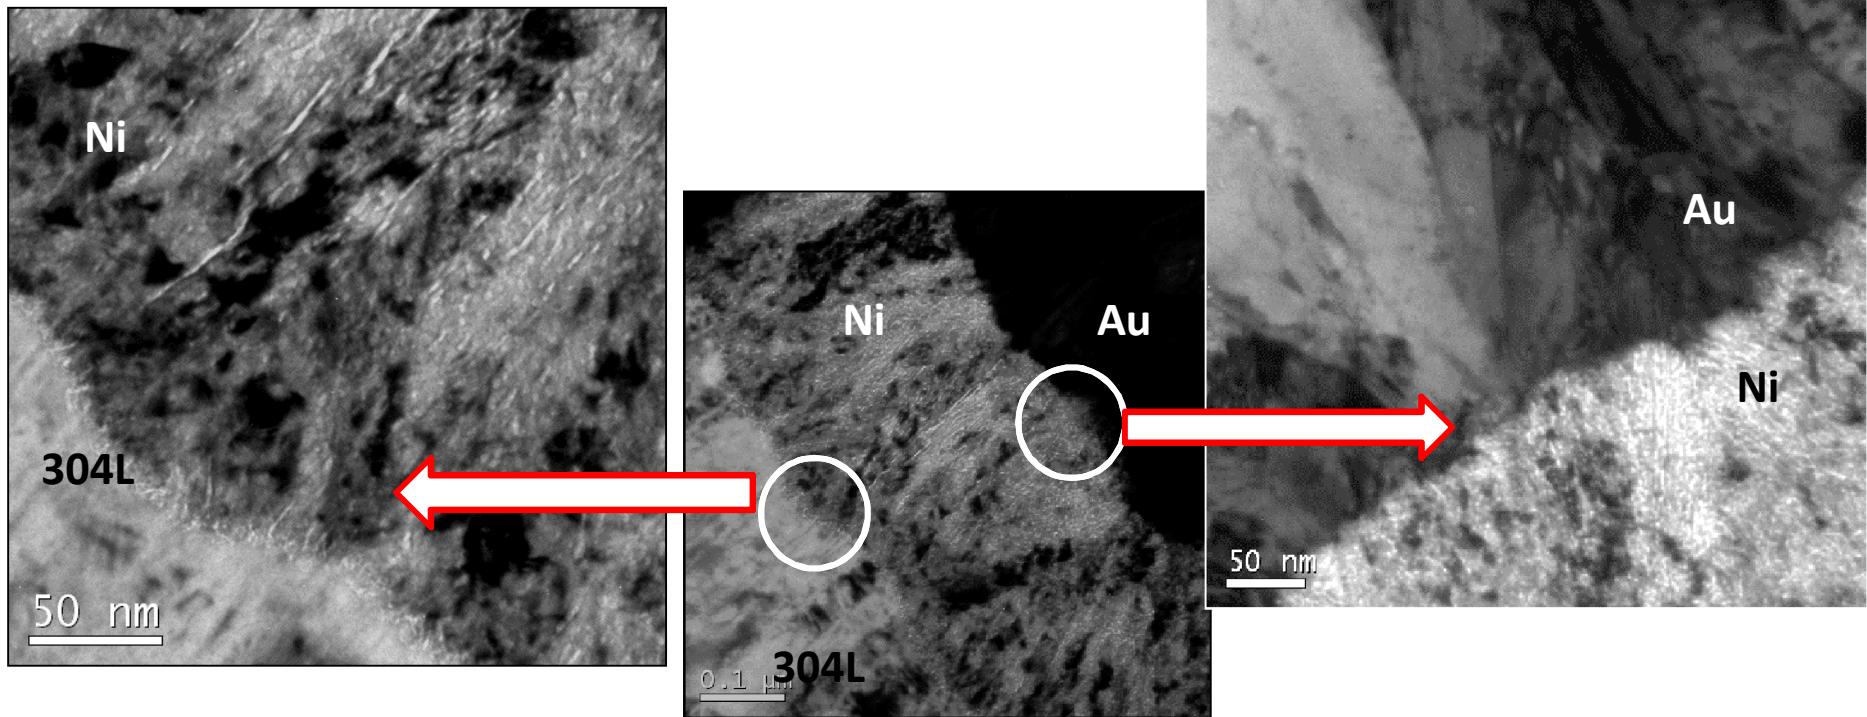
Good adhesion at the as-plated Au-Ni and Ni-304L interfaces was confirmed using TEM images

Good adhesion derived from the intertwined Au, Ni and 304L at the interfaces

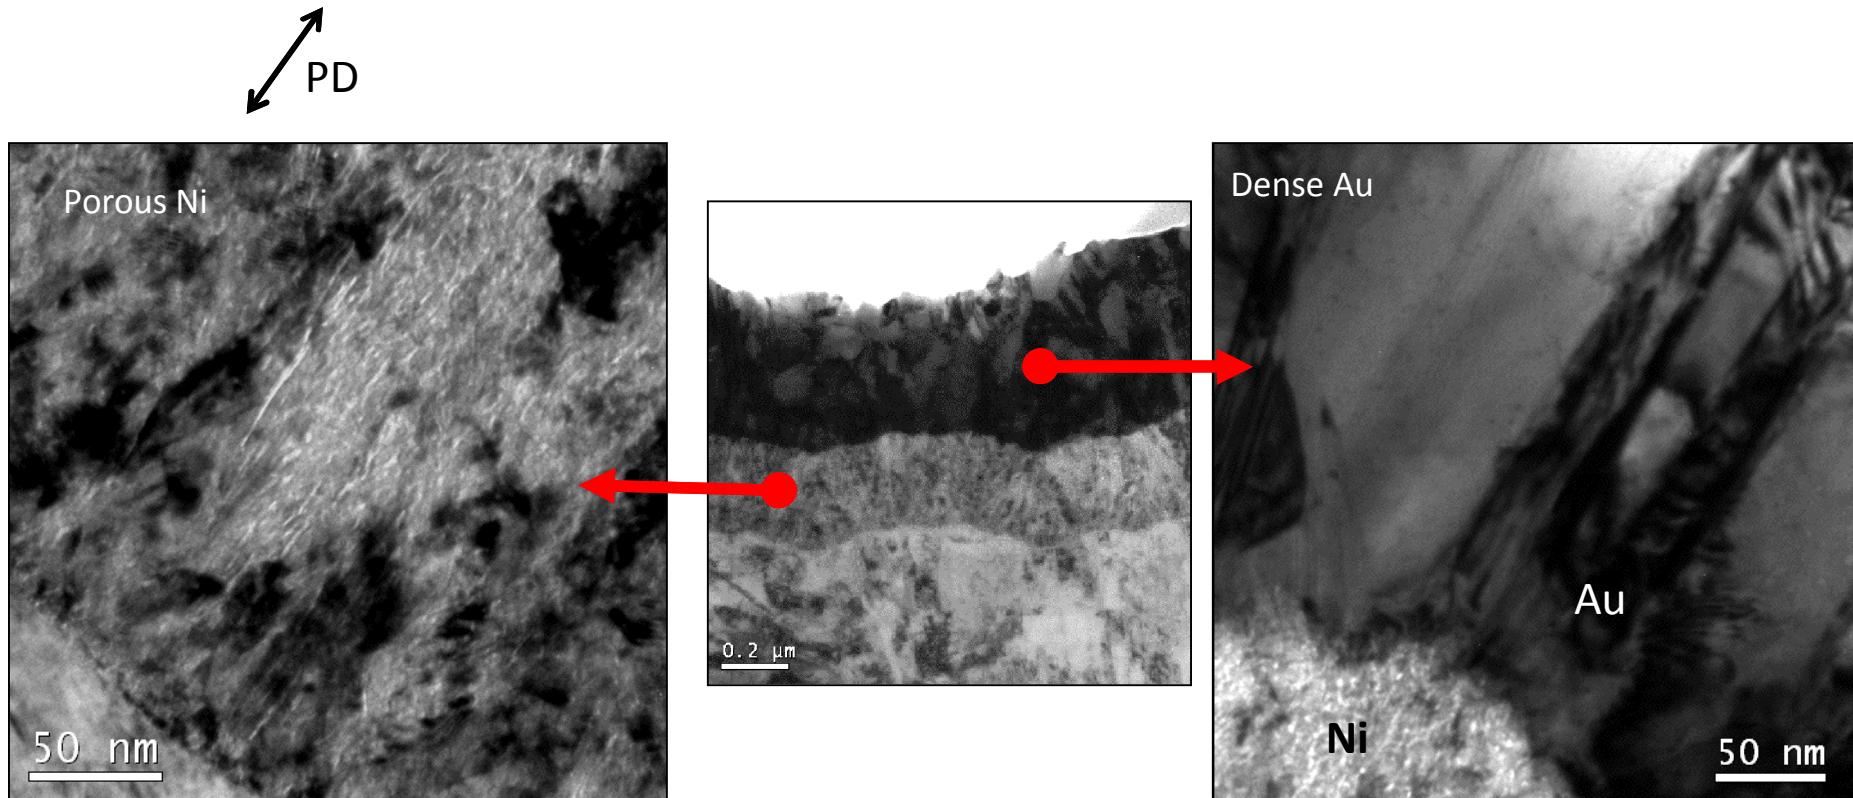
The Woods Ni-strike contains high density of nanopore stringers while the Au coating is fully dense

The long axis of nanopore stringers appears to follow the plating direction, along the columnar grain boundaries.

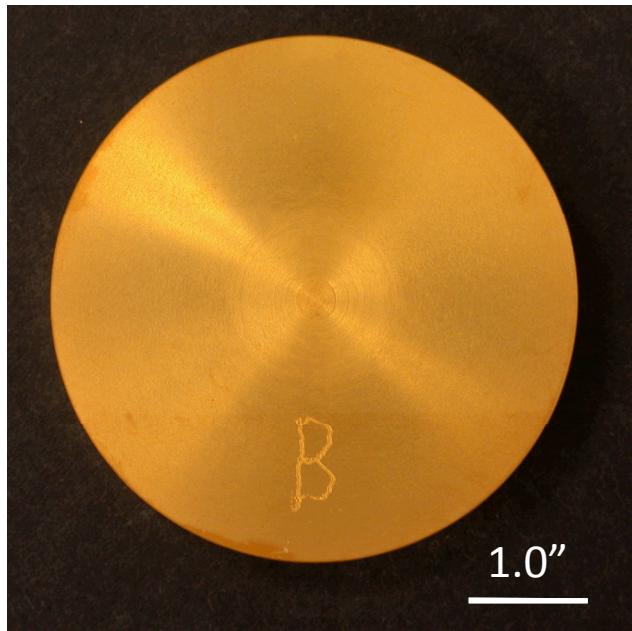
Before tape test

Qualitative Scotch tape test show good adhesion of the thermally annealed electroplated Au on Ni/304L

The Scotch tape test shows the Au coating remains intact on Sample B, subjected to a 100°C/7days annealing

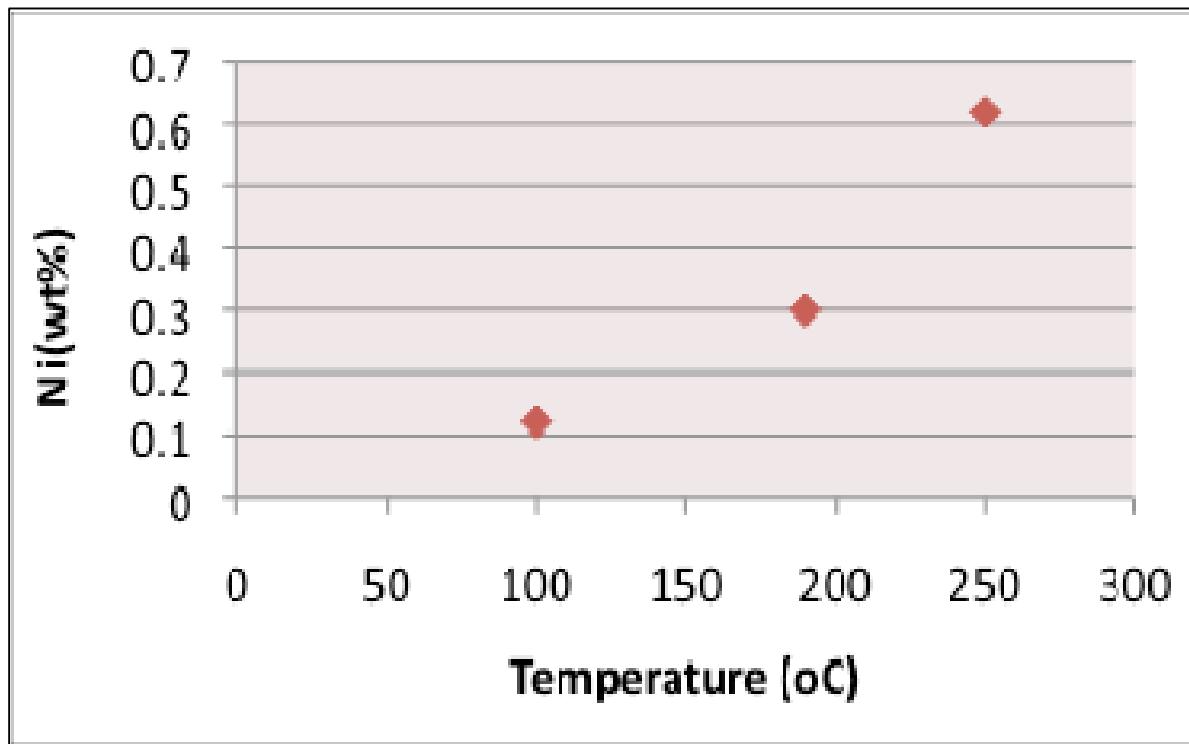
Ni diffusion to the electroplated Au coating is evident at $\geq 190^{\circ}\text{C}$

Ni concentration in Au increases with annealing temperature

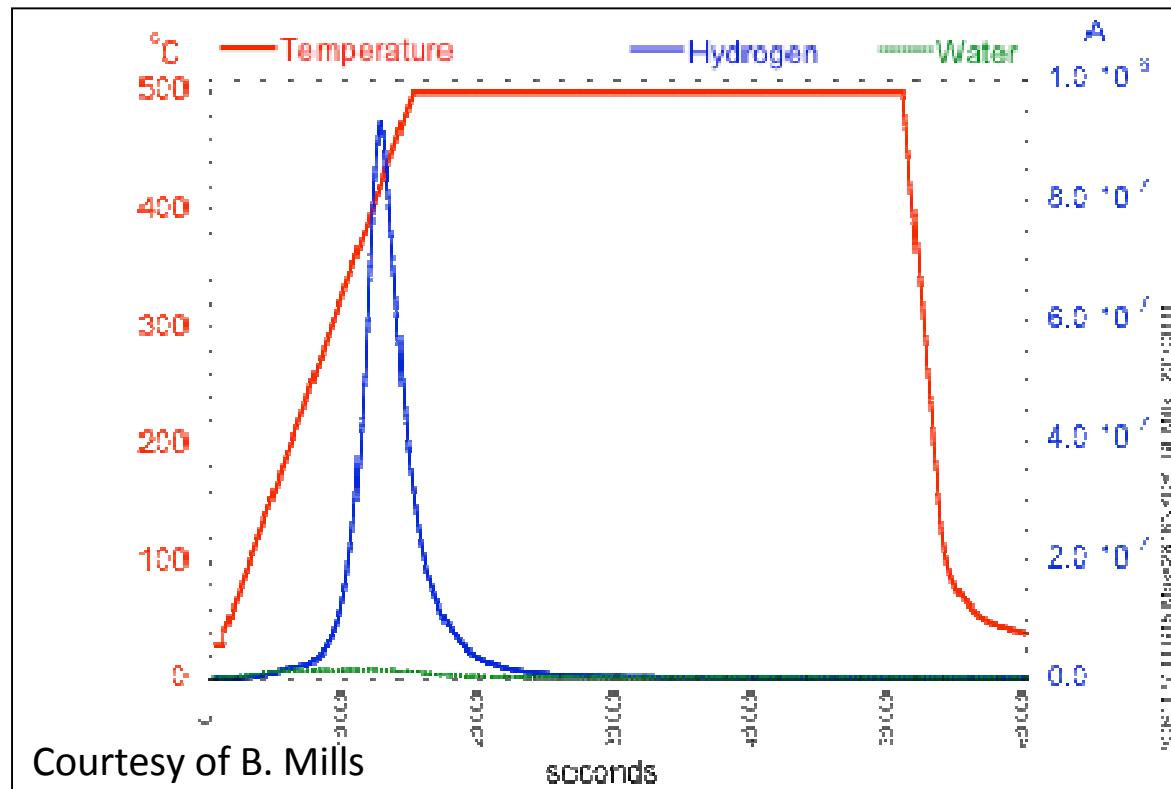
Mass spectrum shows the presence of hydrogen and water in the current Au/Ni/304L system

Water and hydrogen, entrapped during the electroplating process, outgas upon heating.

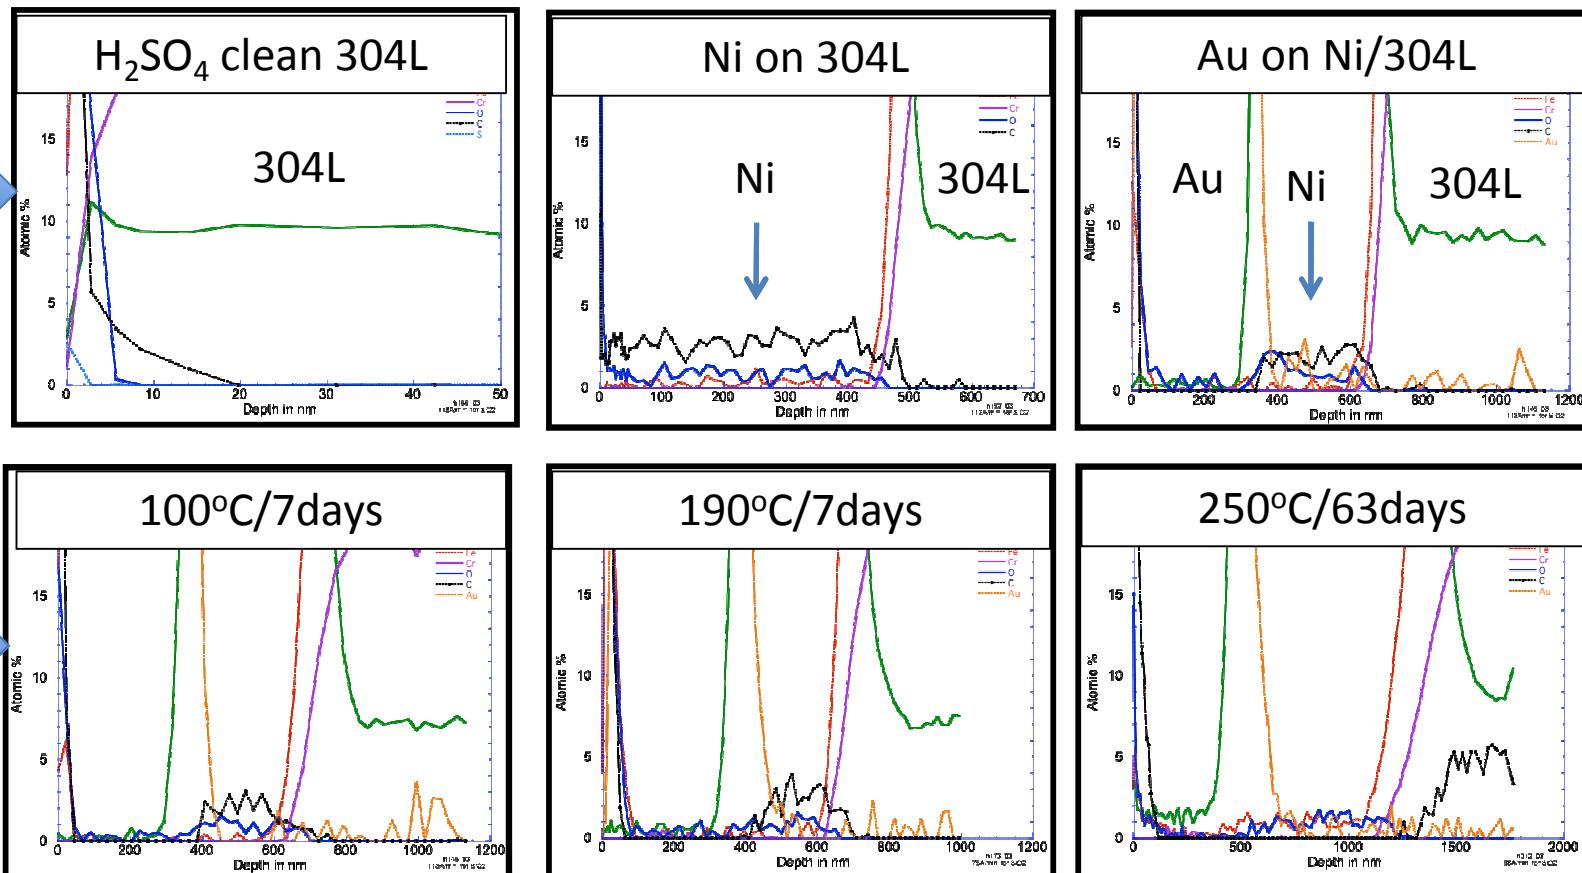
Auger depth profiles show elevation of C (black) and O (blue) in all the Ni layers except for the sample 250°C/63days

- Oxygen elevation observed in all samples.
- Carbon diffused back to 304L substrate at 250°C/63 days.
- H presence is unable to be verified by Auger technique

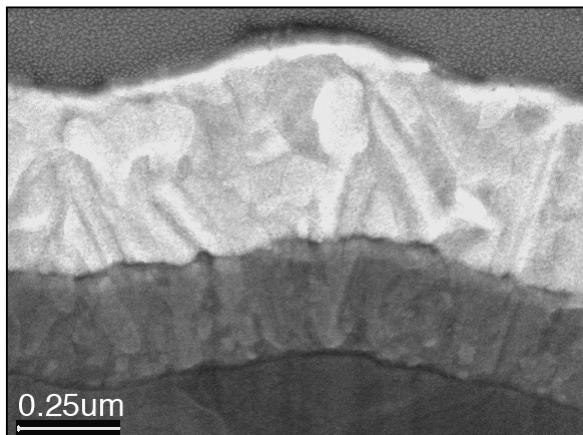
As-plated

FIB images show the size of the pores in the Woods Ni increases with annealing temperature

- The size of the large pores approaches one half of the Ni thickness at 250°C/63 days
- The population of the visible pores decrease with annealing temperature suggesting Oswald Ripening.

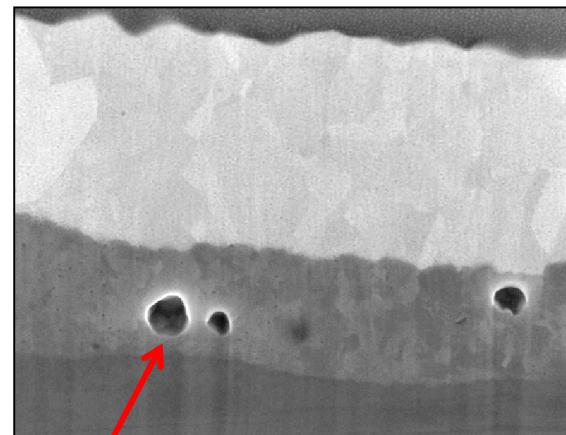
250°C/63 days

Coalesced large pores

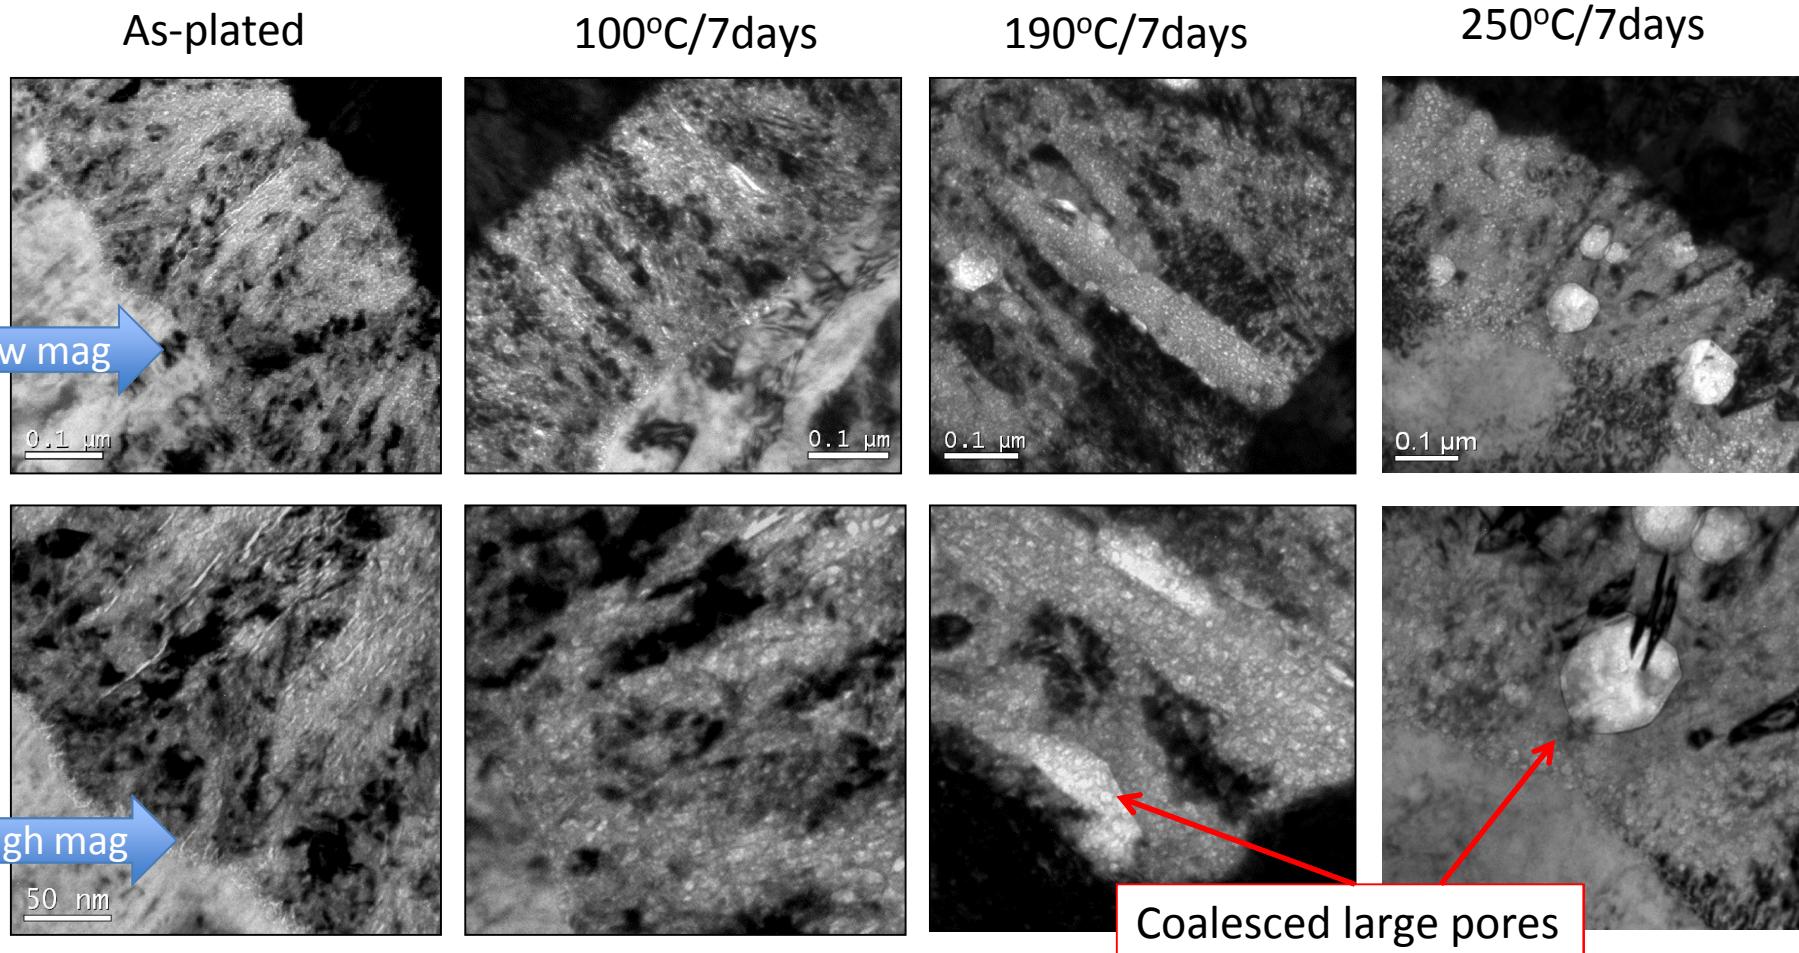
Thermal evolution of pore structure, size and morphology, are also evident in the TEM images.

- Upon thermal annealing, the nanopore stringers spherodized and coalesced.
- Pore coalesces preferentially along the grain boundaries.

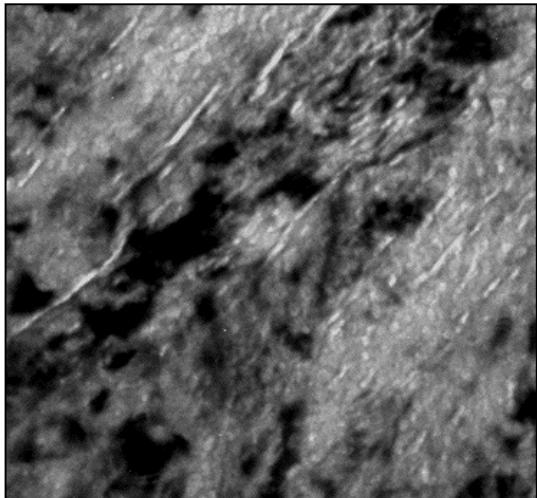
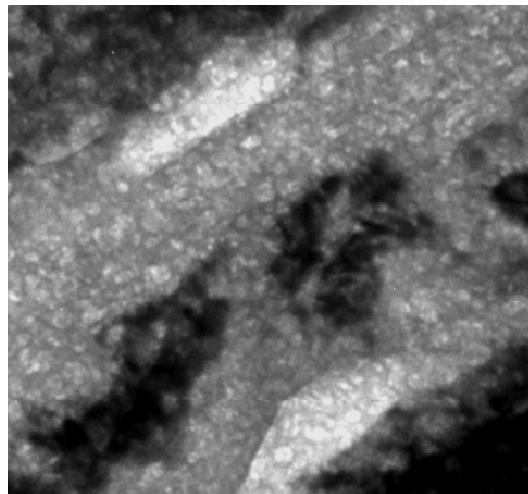
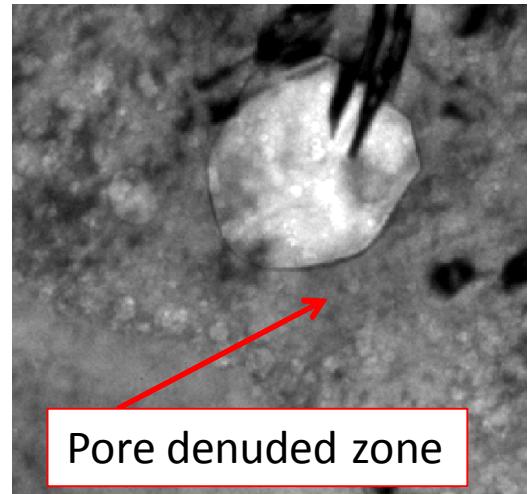
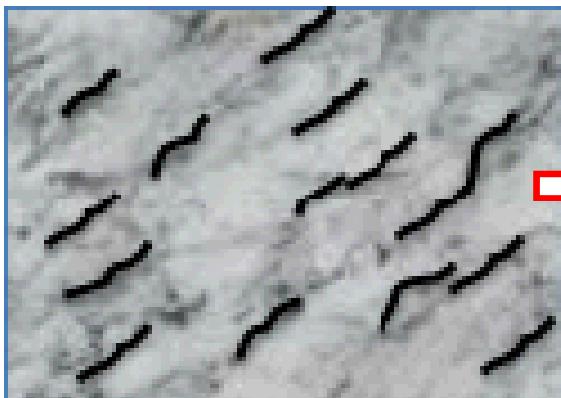
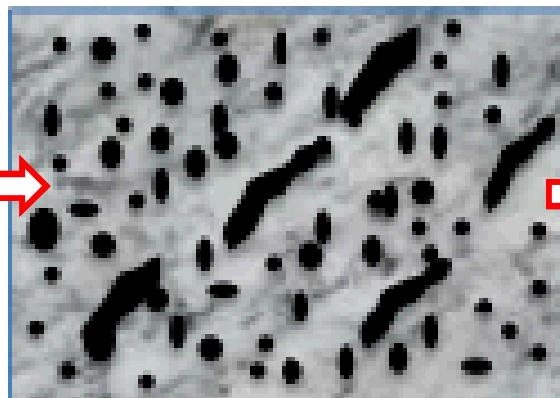
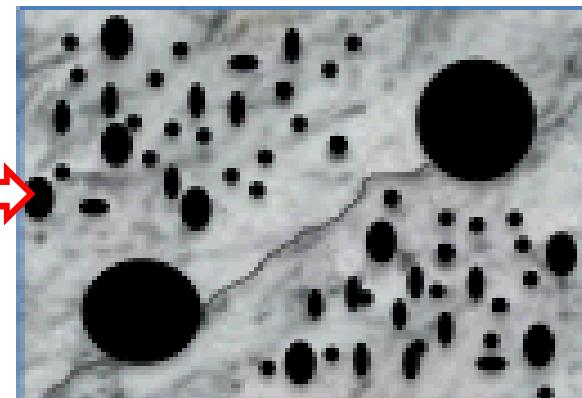
Schematic for thermal evolution of nanopore stringers

Nanopore stringers

Pores spherodize & coalesce

Large pore w/ denuded zone
