Cone Penetrometer Load Cell Temperature and Radiation Testing Results

Key Words: Cone Penetrometer, Icone, Load Cell, BDGRE, DSGRE, Shear Strength, 241-AN-101, 241-AN-106

Abstract: This report summarizes testing activities performed at the Pacific Northwest National Laboratory to verify the cone penetrometer load cell can withstand the tank conditions present in 241-AN-101 and 241-AN-106. The tests demonstrated the load cell device will operate under the elevated temperature and radiation levels expected to be encountered during tank farm deployment of the device.

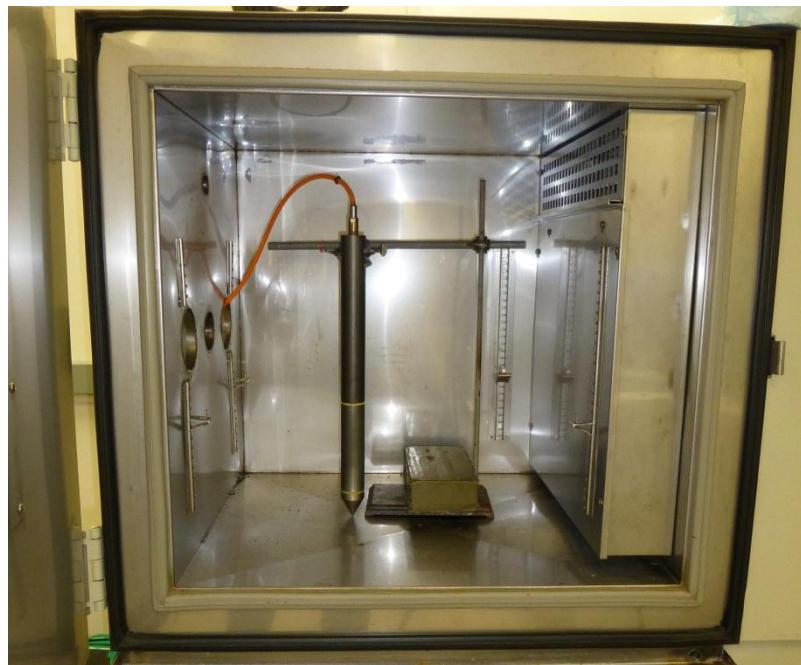
Figure 1. Icone Loaded in the Environmental Chamber

Temperature testing took place July 23, 2013 at the PNNL 318 Building, Room 127. The Icone was loaded into an environmental chamber, shown in Figure 1, and supported in the vertical position by a ring stand. A conical tip was used in place of the ball attachment for this test because of vertical space constraints. The conical tip is more sensitive to fluctuations in force measurements, but is expected to have minimal impact on the test.

The pre-exposure control test consisted of three test runs. These test runs were performed in the environmental chamber at ambient conditions (74 °F). The door to the chamber was left open, as in Figure 1. Each test run was a total of ten minutes in length and measurements of tip resistance and inclination were recorded in one minute intervals. As described previously, the Icone was lifted off the surface prior to starting the test and zeroing the parameters in the *GOonsite!* program. The Icone tip was then lowered back onto the surface and was secured upright with a ring stand. Once in place, the time was started and the first measurement was recorded.

The post-exposure control test consisted of three test runs. These test runs were performed in the environmental chamber at ambient conditions. The door to the chamber was left open, as in Figure 1. Each test run was a total of ten minutes in length and measurements of tip resistance and inclination were recorded in one minute intervals. As described previously, the Icone was lifted off the surface prior to starting the test and zeroing the parameters in the *GOOnsite!* program. The Icone tip was then lowered back onto the surface and was secured upright with a ring stand. Once in place, the time was started and the first measurement was recorded.

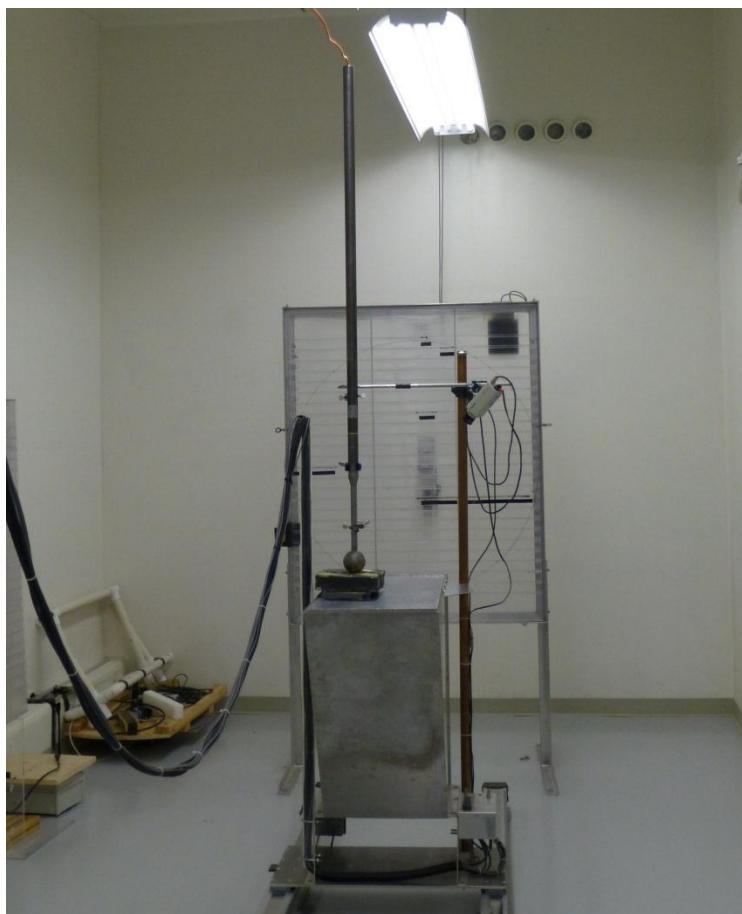
Figure 2. Icone Setup in the HEF

Radiation testing took place July 25-26, 2013 at the PNNL 318 Building, Room 8, in the High Exposure Facility (HEF). The Icone was set up on the exposure table in the HEF, as shown in Figure 2, and supported in the vertical position by a ring stand. To provide additional height ensuring the source was level with the load cell, the ball end attachment was used in place of the cone tip used in temperature testing. A one meter extending rod was also included for the 24 hour exposure test to raise the data cable above the source as much as possible. Environmental conditions were not controlled, but were monitored with a Fisher Scientific weather station (Appendix A). A Cobalt-60 source was used to provide radiation dose. Calibration of the source is shown in Appendix A.

Testing data sheets for all radiation test runs are provided in Appendix C. The pre-exposure control test data prior to the elevated temperature test are shown in Figure 8. The data show some natural variation in tip resistance and inclination measurements at ambient conditions, as anticipated. Tip resistance fluctuations of about 3 N (0.003 kN) and inclination fluctuations of 0.2 degrees were observed during control test runs. These values are slightly larger than those observed in the temperature control tests, but larger fluctuations are anticipated with the setup in the HEF facility because the Icone had an additional extending rod attached above the load cell, which provides greater self-weight and is more prone to slight fluctuations given the stabilizing point on the ring stand, shown in Figure 2.

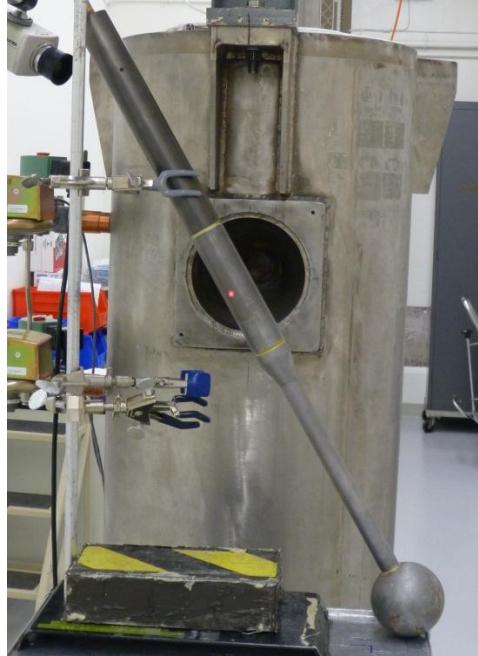
Figure 3. High Radiation Exposure Test Setup

These control tests served two purposes. First, the test runs provided a baseline for natural variation in the measured values to ensure the Icone was not damaged by the radiation test. Second, the testing provided a baseline for natural variation in measured values for the Icone placed at an angle without the extending rod attached. The Icone had to be positioned closer to the source in order to achieve 34,998 R/hr, which required placement at an angle.

dose rate and to observe what indications would be present if sensor failure were to occur. The test consisted of a single one hour test run with measurements taken at varying intervals (typically one minute). The Icone was positioned as shown in Figure 3 in order to ensure the portion of the Icone containing the sensors received a direct dose. The Icone was lifted off the surface prior to starting the test and the parameters were zeroed in the *GOnsite!* program. The Icone was then lowered back onto the surface and was secured at an angle with a ring stand. Once in place, the Cobalt-60 source was raised and the test was initiated. In order to achieve the highest dose rate available, 34,998 R/hr, the Icone was placed about 0.4 meters from the source. Calibration information for the Cobalt-60 source is available in Appendix A.

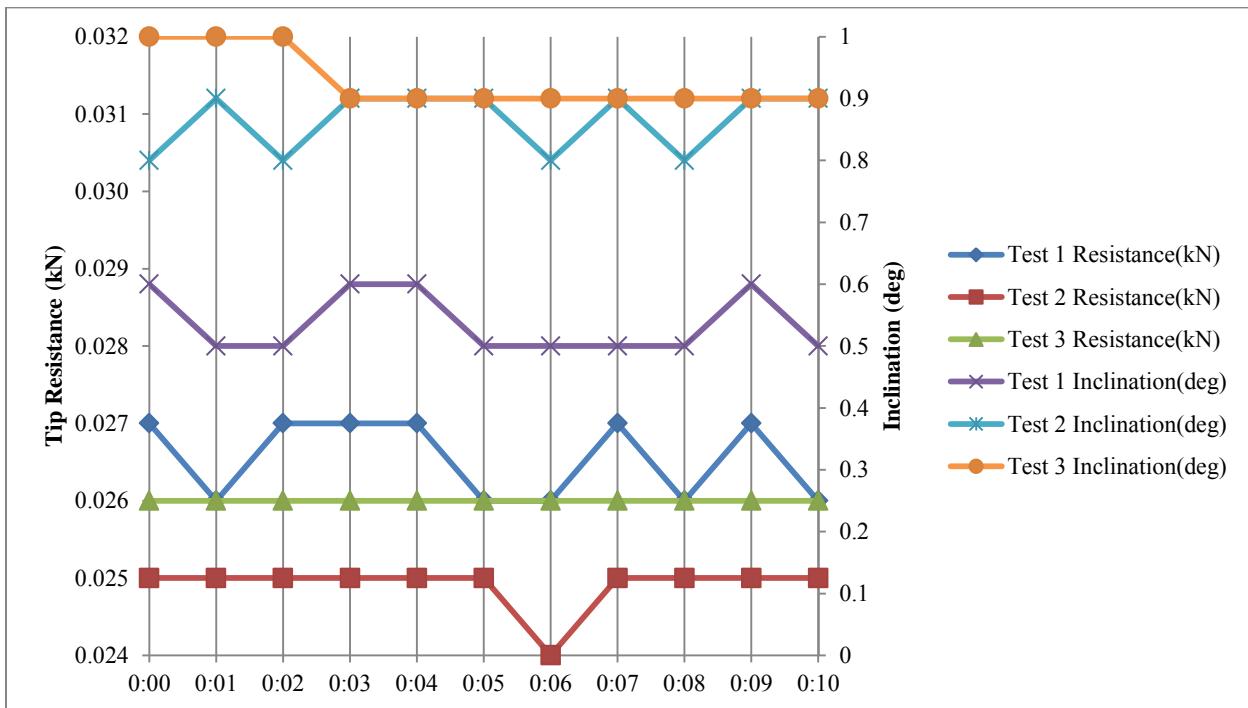
Figure 4. Pre-Temperature Exposure Control Test Results

Testing data sheets for all temperature test runs are provided in Appendix B. The pre-exposure control test data prior to the elevated temperature test are shown in Figure 4. The data show some natural variation in tip resistance and inclination measurements at ambient conditions, as anticipated. Tip resistance fluctuations of about 1 N (0.001 kN) and inclination fluctuations of 0.1 degrees were observed during control test runs.

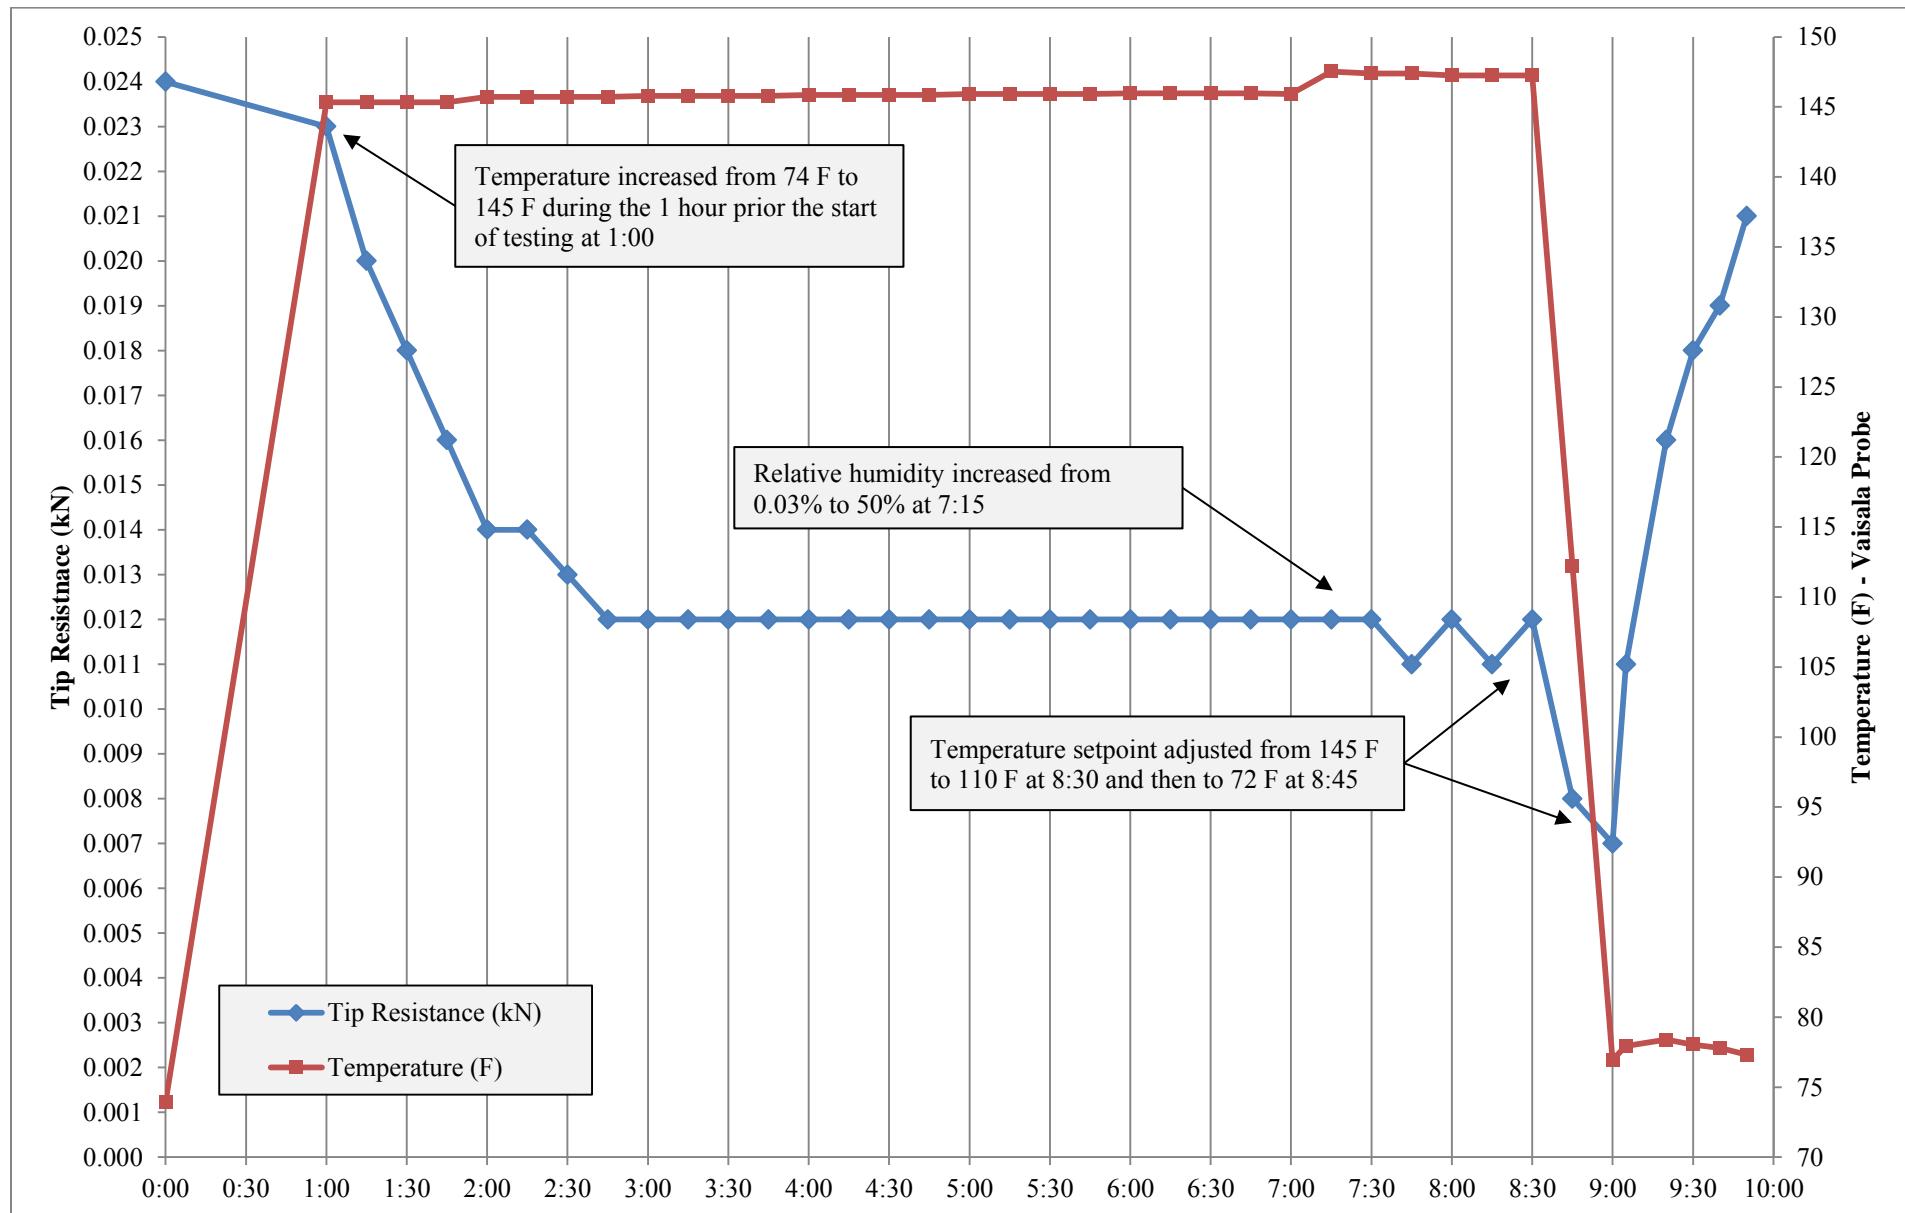
Figure 5. High Temperature Test Results (Tip Resistance versus Temperature)

Test results for the eight hour exposure run are shown in Figure 5 and Figure 6. Figure 5 shows the tip resistance measurements over time versus the chamber temperature changes, while Figure 6 shows the inclination measurements over time versus chamber temperature changes. In order to properly display all the data, including the measurements taken prior to the chamber temperature increase, the actual start time for the eight hour test is shown as 1:00. Therefore, Icone equilibration is shown taking place between the 0:00 and 1:00 marks, and the chamber door was opened to atmospheric conditions at the 9:00 mark.

As anticipated, temperature changes had an effect on tip resistance measurements, as indicated by the trend shown in Figure 5. After the chamber temperature reached 145 °F, tip resistance measurements shifted downward to a point, then leveled off. Based on the test run results, the Icone took more than an hour to reach an equilibrium temperature when increasing from ambient conditions at 74 °F to 145 °F. The tip resistance stopped decreasing and settled on a constant value, seeming to indicate the Icone reached an equilibrium temperature, after about 2-2.5 hours. The resistance measurements then remained constant until chamber conditions were adjusted.

Relative humidity was increased from 0.03% to 50% at the 7:15 mark. The increased humidity does not appear to have a significant effect on tip resistance, although slight fluctuations of 1 N (0.001 kN) were recorded. Natural fluctuations in resistance measurements are expected based on the pre-exposure control tests.

To determine whether the measurement shift was a permanent or temporary effect, the temperature of the chamber was decreased back to ambient conditions over a thirty minute period. As the temperature of the chamber decreased to about 76 °F, the resistance measurements increased, approaching the starting test conditions, as anticipated. This appears to indicate the shift in resistance measurements is a direct result of the temperature change. Damage to the Icone also does not appear likely based on the rise of resistance measurements back toward the original starting values.

As anticipated, temperature changes appear to affect tip resistance measurements. Increasing the testing chamber from 74 °F to 145 °F resulted in a shift in resistance measurements that took approximately 2-2.5 hours to stabilize. Based on the test run results, the Icone took more than the anticipated hour to reach an equilibrium temperature when increasing from ambient conditions to a sludge waste temperature of 145 °F. The tip resistance leveled out at a constant value during the high temperature test indicating the Icone reached equilibrium temperature. Failure of the tip resistance sensor was not observed, based on the resistance measurements returning to pre-test conditions as the temperature was decreased.

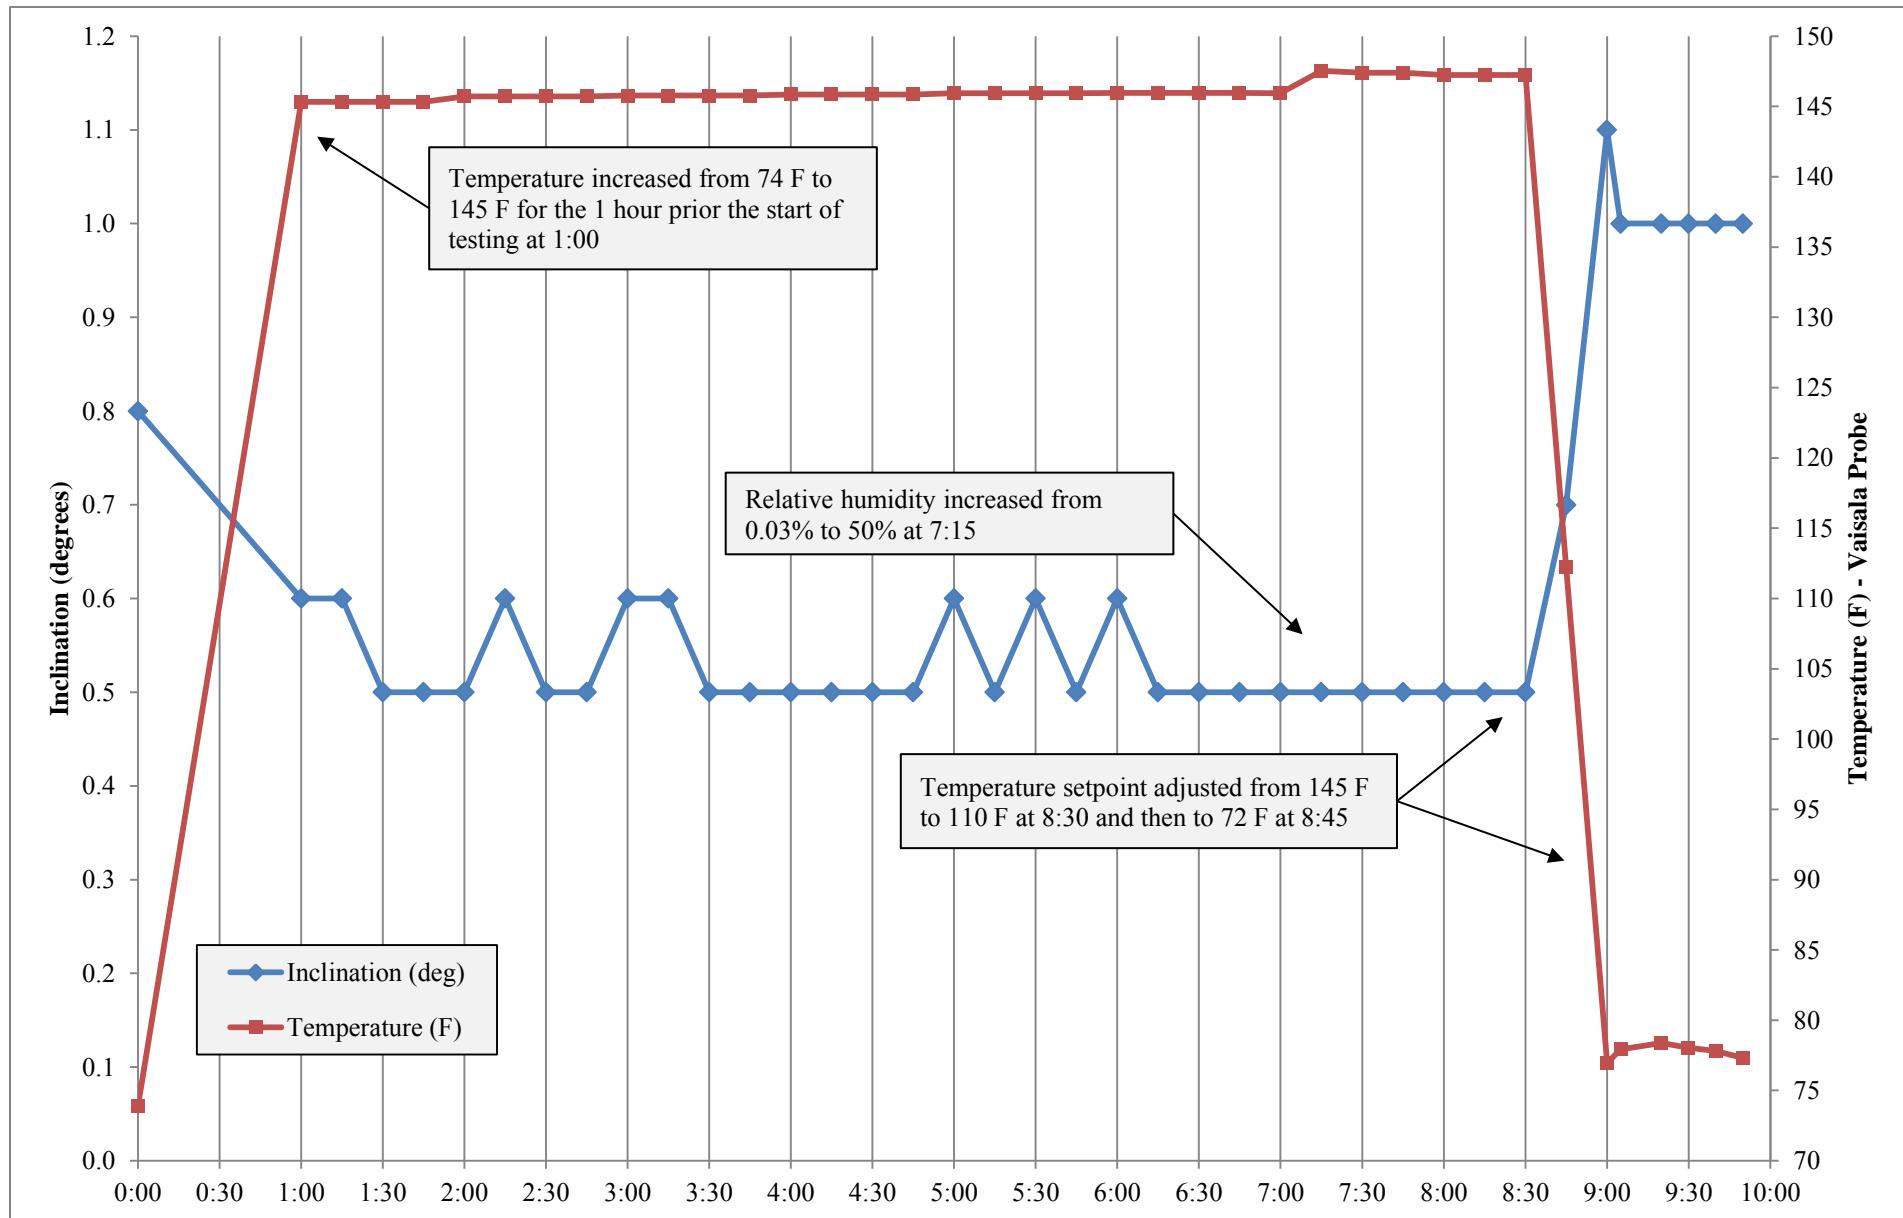
Figure 6. High Temperature Test Results (Inclination versus Temperature)

Inclination measurements, shown in Figure 6, appear to be less affected by temperature change. The inclination appeared to decrease as the temperature rose, then leveled off for the duration of the test until the temperature was decreased, at which time the inclination rose. It was noted in the data sheets that the temperature probes placed in the chamber were observed swinging slightly at times during the test run. The natural airflow in the chamber from changing temperature conditions may have played a role in the slight change in measurements over the course of the test. The inclination sensor provides resolution of 0.1 degrees, which means slight variations in the environmental conditions could cause a shift in measurements. Both the temperature and the airflow may have played a role in the variability of the measurements.

Temperature did not appear to significantly affect the inclination measurements. The inclination appeared to decrease as the temperature rose, then leveled off for the duration of the test until the temperature was decreased, at which time the inclination rose. It was noted in the data sheets that the temperature probes placed in the chamber were observed swinging slightly at times during the test run. The natural airflow in the chamber from changing temperature conditions may have played a role in the slight change in measurements over the course of the test, in addition to the air temperature change. Failure of the inclination sensor was not observed.

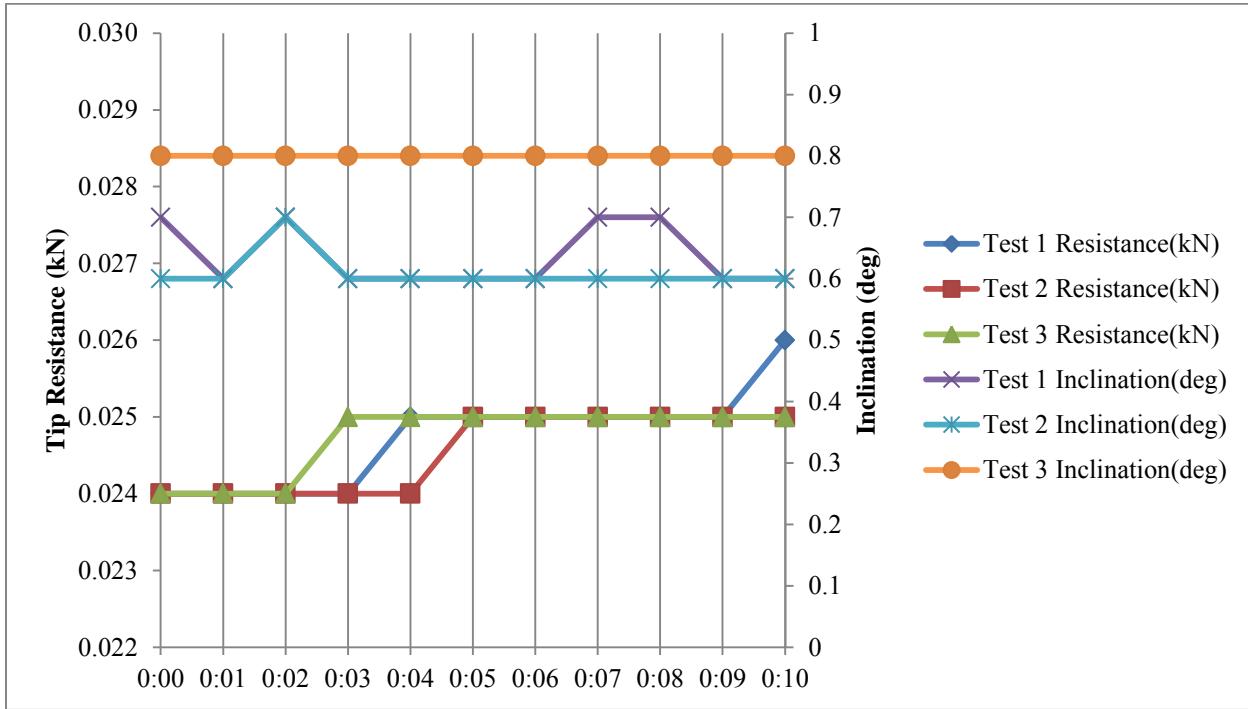
Figure 7. Post-Temperature Exposure Control Test Results

Due to a slow cool down time for the chamber, the temperatures for the three runs were slightly different, as shown on the data sheets (Appendix B). The control runs took place immediately following the high temperature test and based on the trend in Figure 5, the Icone was likely still equilibrating to the decreased chamber temperature. The slight increase in tip resistance is consistent with the Icone returning to ambient temperature. It was also noted on the data sheets that the Icone was warm when the first post-test control run started, compared to the condition prior to testing. Given that the measurement is zeroed before each control run, the total shift in tip resistance over the three runs was 0.004 kN. Based on the end point resistance for the high temperature test of 0.021 kN, adding 0.004 kN would result in a tip resistance of 0.025 kN,

which matches the starting point prior to increasing the temperature. Tip resistance appeared to level off and stabilize during the third control run, indicating the Icone reached ambient conditions about two hours after the chamber temperature was decreased from 145 °F, which is also consistent with the time it took to reach equilibrium when the temperature was increased during testing.

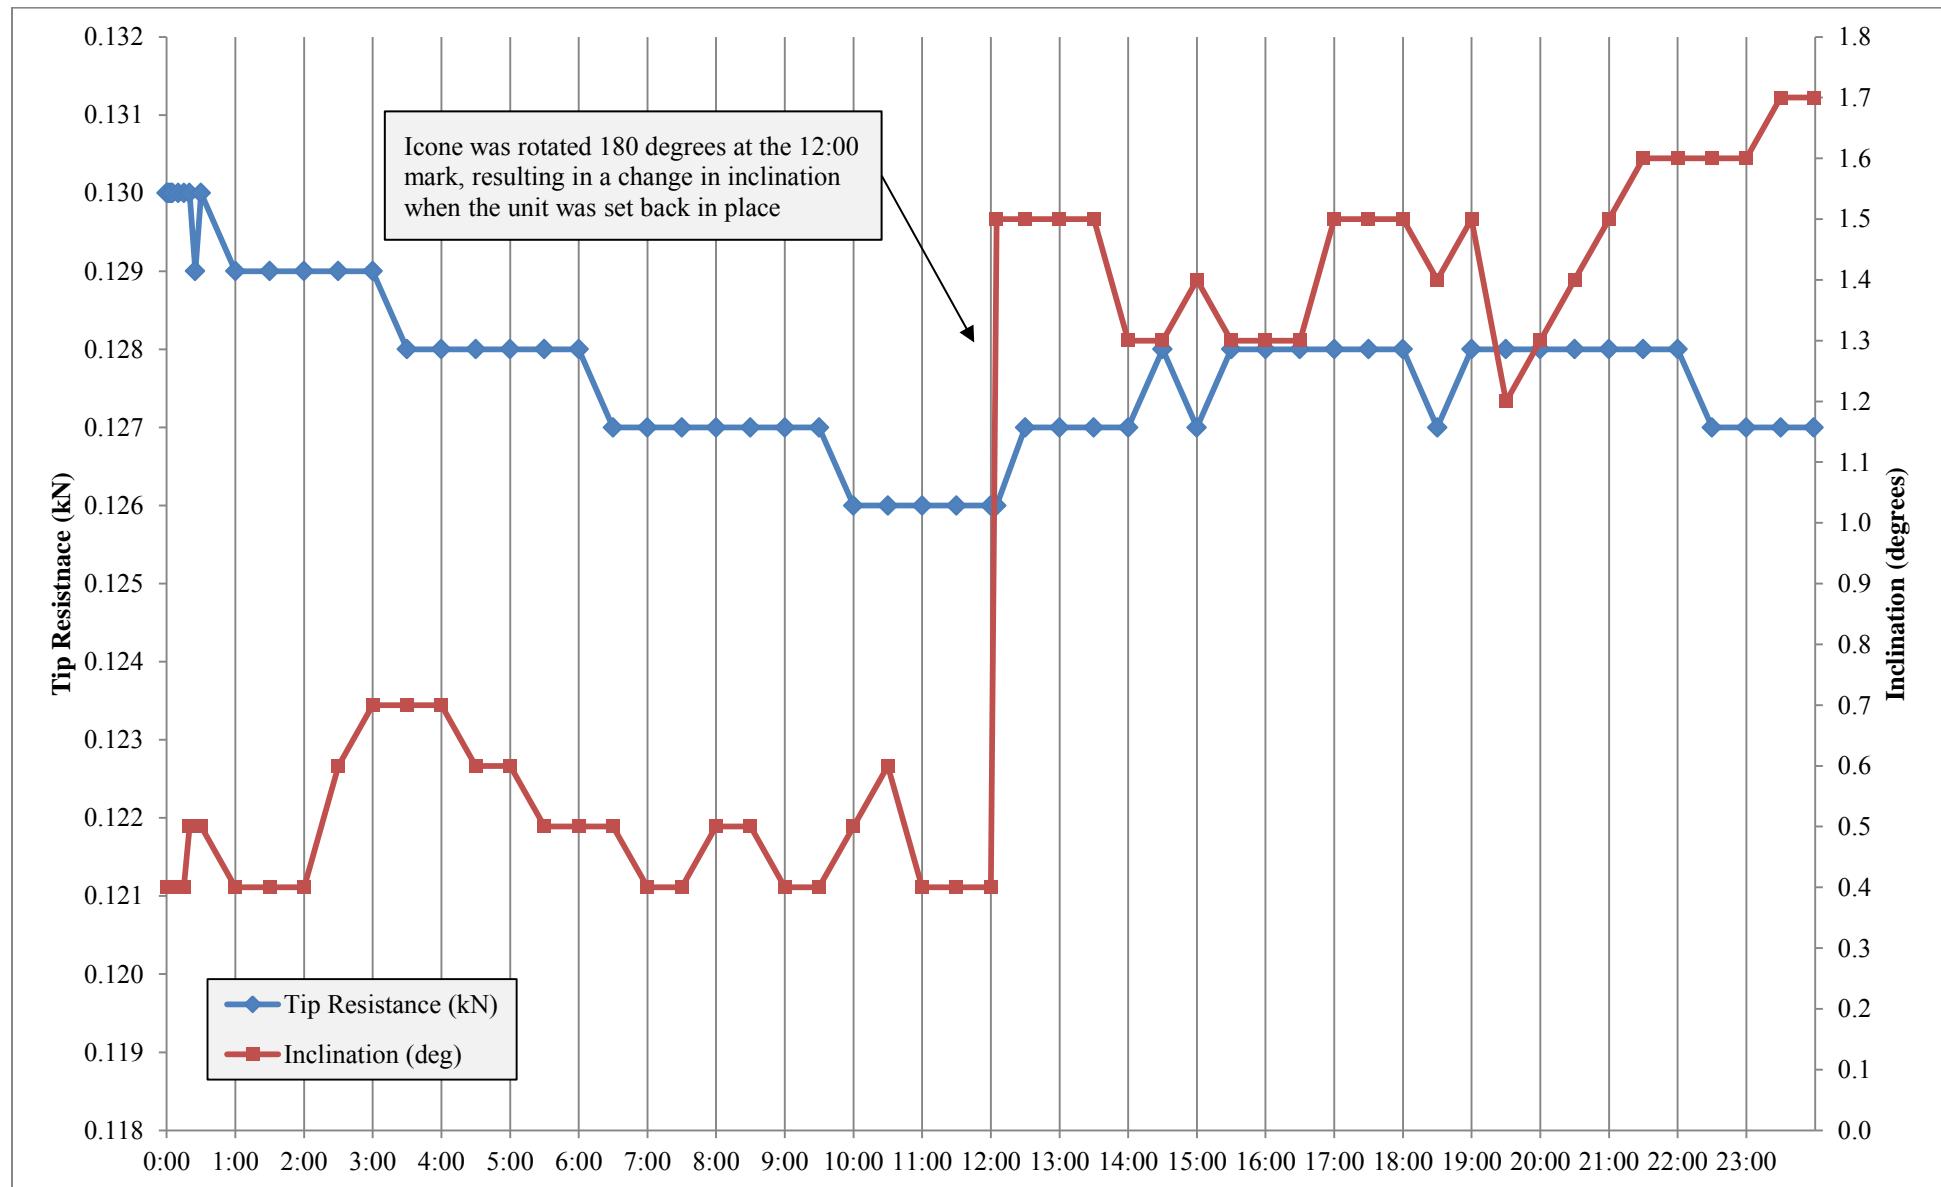
Figure 9. Radiation Exposure Test Results (250 R/hr)

Test data for the twenty-four hour exposure run are shown in Figure 9. Tip resistance and inclination measurements are shown over time. In total, the Icone received a dose of 6,000 R. The test data remained stable for the duration of the test, except for the mid-test rotation. The Icone was rotated 180 degrees at the 12:00 mark and was not secured in the exact same position on the ring stand, resulting in a shift in inclination values. Tip resistance measurements showed total fluctuations of about 4 N (0.004 kN), which is consistent with the natural variation determined in pre-exposure control tests. Inclination measurements varied by about 0.3 degrees prior to rotation and about 0.5 degrees after rotation. This test appears to show the dose rate did not have a significant effect on the tip resistance or inclination measurements.

Radiation exposure at a dose rate of 250 R/hr for twenty-four hours did not appear to affect tip resistance or inclination measurements. Test data remained stable for the duration of the test, compared to pre-test control runs. Signal drift was not observed for either measurement indicating failure of the sensors was not observed.

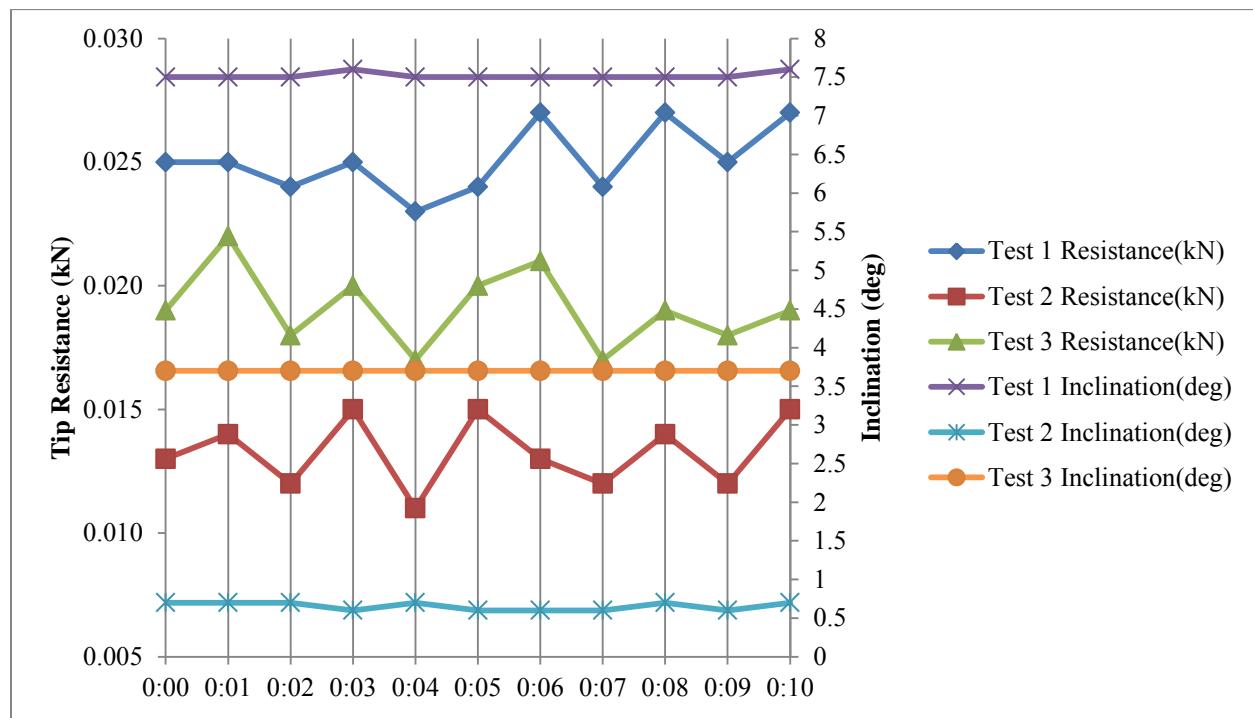
Figure 10. Post-Radiation Exposure Control Test Results

Control tests were then performed after the twenty-four hour exposure test, shown in Figure 10. These test runs were performed in the HEF with no source present. The Icone assembly was supported at an angle by a ring stand to prepare for high exposure testing, as shown in Figure 3. These tests were designed to provide a baseline for natural variation in the measured values to ensure the Icone was not damaged by the radiation test and to provide a baseline for natural variation in measured values for the Icone placed at an angle without the extending rod attached.

The data show some natural variation in tip resistance and inclination measurements at ambient conditions, as anticipated. Tip resistance fluctuations of about 4-5 N (0.004-0.005 kN) and inclination fluctuations of 0.1 degrees were observed during control test runs. The inclination measurements varied greatly from run to run due to difficulty zeroing the Icone at the same angle as it was held by the ring stand. However, absolute values are not important between runs; only fluctuations are observed for determining measurement drift.

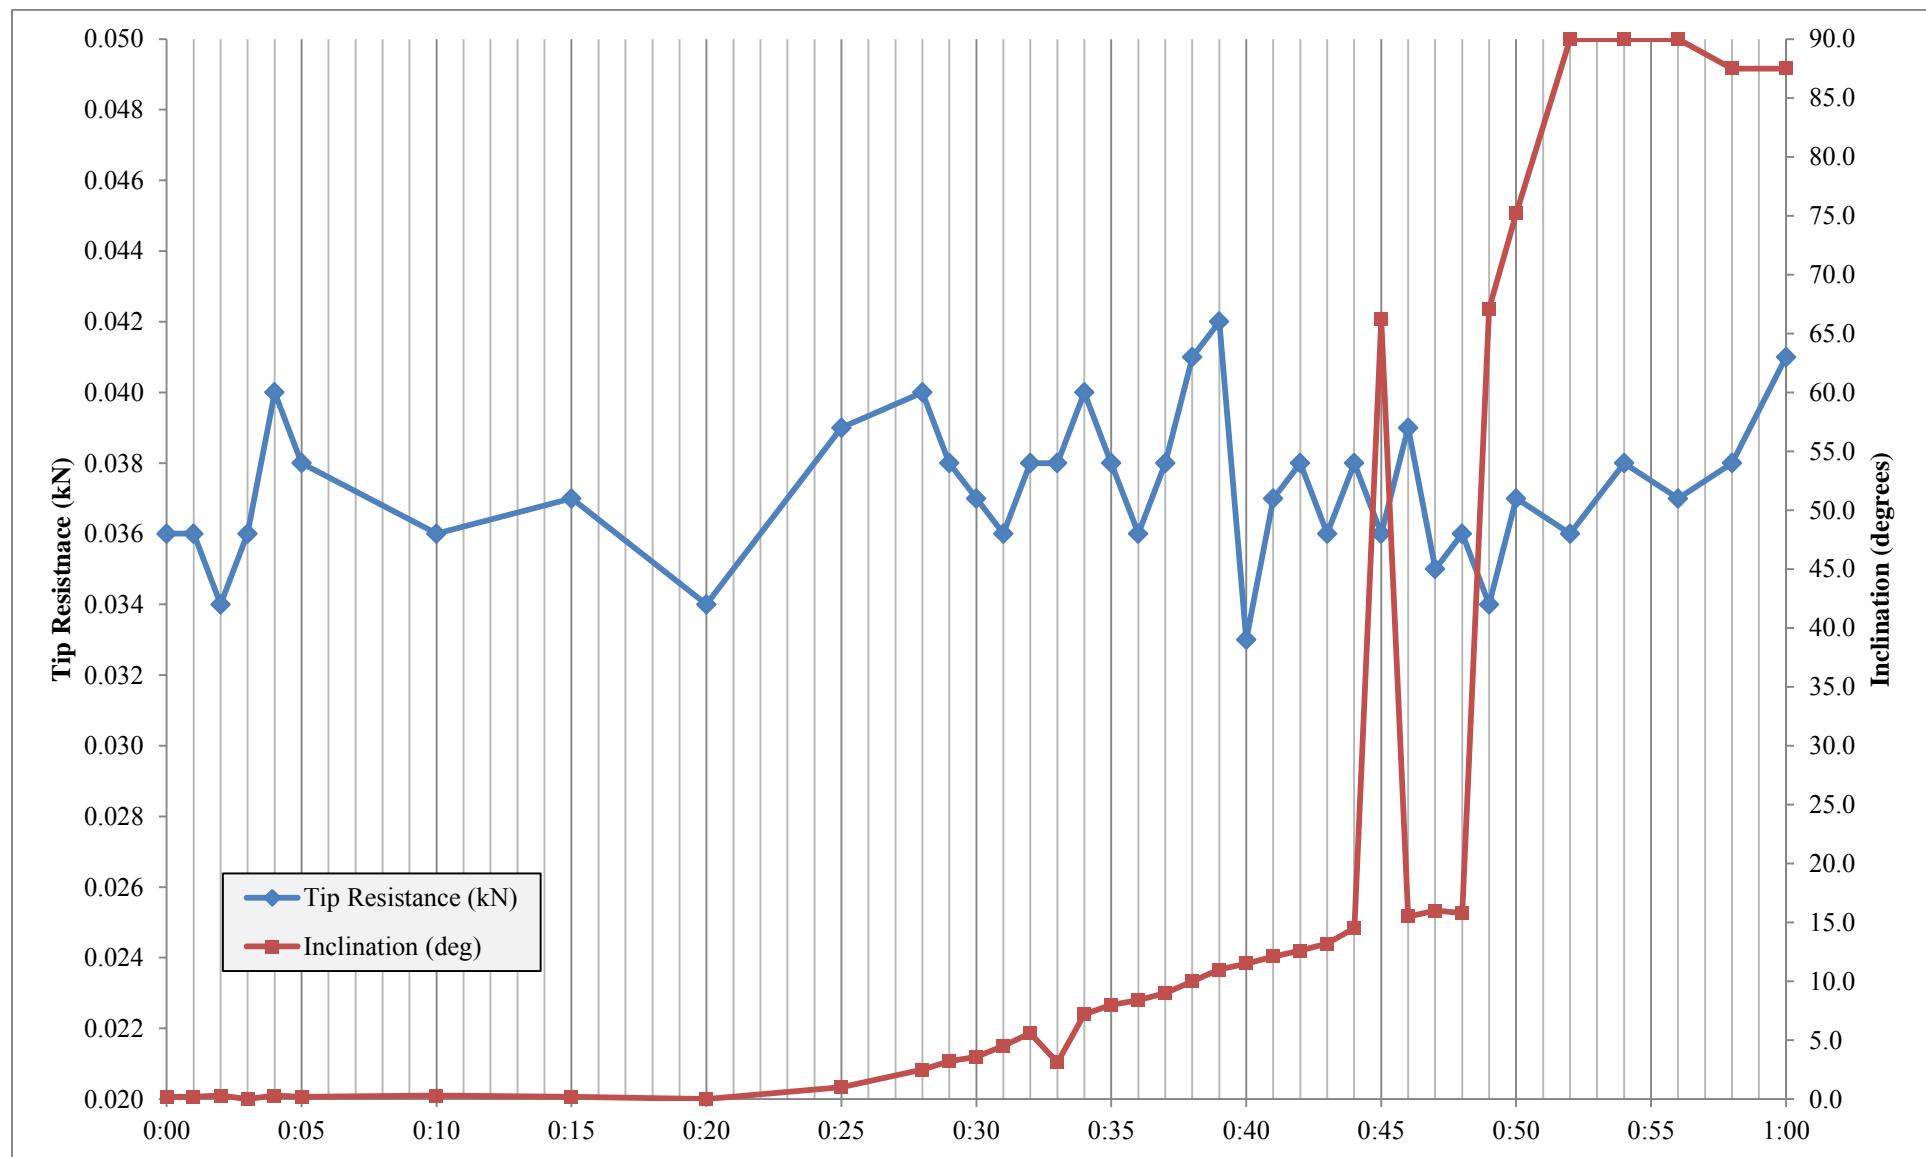
Figure 11. Radiation Exposure Test Results (34,998 R/hr)

The Icone was then exposed to the Cobalt-60 source at a distance of 0.4 meters, resulting in a dose rate of 34,998 R/hr. Test results are shown in Figure 11. Tip resistance measurements were observed fluctuating up to 8 N (0.008 kN) prior to raising the source to initiate the test, as noted in the data sheets in Appendix C, indicating placement of the Icone may not have been exactly the same as the control tests run previously. Tip resistance throughout the test primarily fluctuated about 5 N (0.005 kN), with a few isolated measurements separated by 9 N. Given the fluctuations prior to commencing the test, the variation during testing is not deemed to be a result of the radiation. Despite fluctuations, the tip resistance data show a consistent measurement throughout the test. However, the inclination sensor appears to have failed about twenty-five minutes into the test, as shown by the steady increase in inclination.

During high exposure of 34,998 R/hr, the inclination measurement began steadily increasing by about one degree per minute at the 25:00 mark of the test. At the 45:00 mark, the inclination began providing erratic measurements and ultimately spiked to 90 degrees at the 52:00 mark. Live camera footage of the Icone setup in the HEF confirmed the assembly was not in motion, indicating a failed sensor.

To confirm the results, a second high exposure test run was performed without resetting the Icone. A test run was initiated in *GOnsite!*, which zeroed the tip resistance and inclination in place (i.e., both parameters started at zero for the test, rather than lifting the assembly prior to zeroing). The test was again run at 34,998 R/hr for five minutes and the results are shown in Appendix C. The tip resistance maintained fluctuation of about 6 N (0.006 kN) during the test, but the inclination began to rise immediately, ending at 8.2 degrees after only five minutes, confirming the inclination sensor had failed.

Radiation exposure at a dose rate of 34,998 R/hr for one hour did not appear to affect tip resistance, but did appear to produce failure of the inclination sensor. Tip resistance, which is the primary data of interest as the input to determine in situ waste shear strength, maintained steady variability with or without the source present, indicating no significant effect. The inclination data began increasing slowly after twenty-five minutes of exposure and reached a 90 degree value after fifty-two minutes, indicating sensor failure. Further testing appeared to confirm the inclination sensor in the Icone had failed. The high dose rate used in testing is orders of magnitude greater than the anticipated dose rate in AN-101 or AN-106 sludge, but provided a bounding test case and allowed for observation of how sensor failure is indicated.

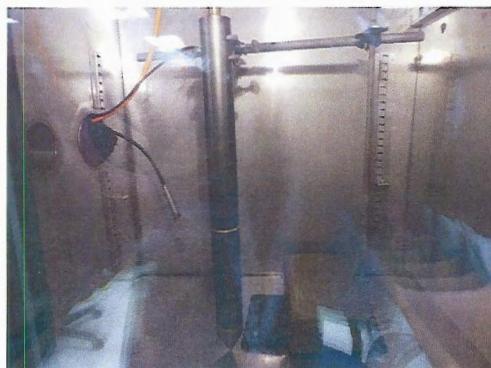
Figure 1. Cone Penetrometer Load Cell in Environmental Chamber.

Temperature testing for the Cone Penetrometer Load Cell began July 23, 2013 at 0700 at the 318 building room 127. Over the next hour, measurement and test equipment (M&TE) consisting of a Vaisala temperature/relative humidity probe (attachment 1), a Fluke 80T-150 (attachment 2 and 3) temperature probe were placed in the environmental chamber at the approximate position of Cone Penetrometer Load Cell (see figure 1).

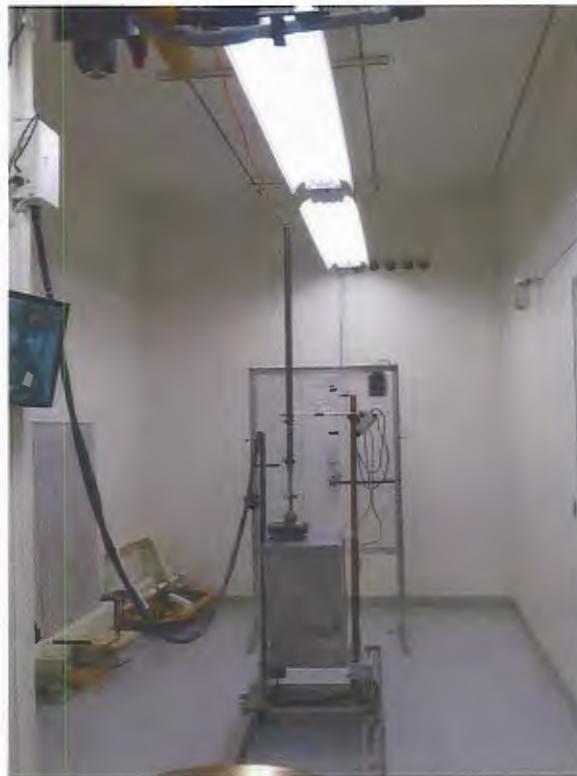
Figure 2. Preparation for Long Duration Radiation Hardness testing

Radiation hardness testing for the Cone Penetrometer Load Cell began July 25, 2013 at 0700 at the 318 building room 8, the High Exposure Facility (HEF). The HEF is capable of exposure rates exceeding 60 kR/h. For the first radiation hardness test; a long duration test (24 h) which included a 180 ° rotation at the 12 hour mark, a lower exposure rate of 250 R/h was used. Environmental conditions were monitored by a Fisher Scientific weather station (attachment 4); the room temperature was 73 °F with a relative humidity of ~ 30%. The Load Cell was placed approximately 5 m from the radioactive source (5,655 Ci ^{60}Co – ID# 318-528, RMT 12155), equipment cabling was suspended above and out of the radiation field (see Figure 2), and 3 separate control tests, each 10 minutes in duration, were performed by WRPS staff. Calibration of the HEF Source #8 (318-528) is found in attachment 5.

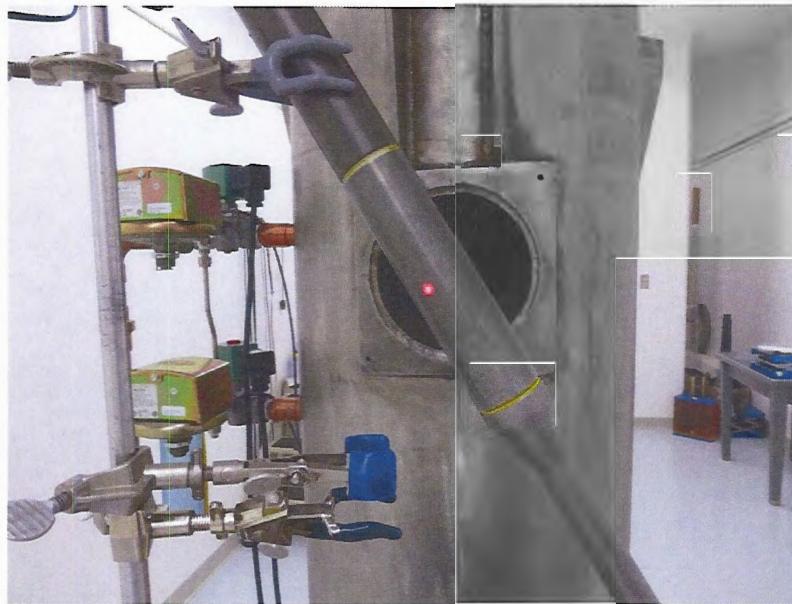
Figure 4. Load Cell position for short duration test.

A one hour test run was then performed at 35 kR/h (34,998 R/h) with the same ^{60}Co source at a much shorter distance, approximately 0.4 m, on July 26, 2013.

It should be noted that the source is positioned in the center of the irradiator column, thus the distance (0.4 m) is measured from the source position, not the irradiator column. At approximately 10:30 am, the short duration test began, after approximately 25 minutes; the WRPS staff member reported that the inclination measurement began increasing. By visual observation of the Load Cell, WRPS and PNNL staff determined that the Load Cell was not moving and that the radiation was suspected to be causing the incorrect inclination measurement. The inclination measurement kept increasing until the 45 minute mark, at which time the readings became increasingly erratic and reached 90 degrees; please refer to WRPS documentation for a detailed discussion of the effects noted during this testing. A five minute control test was then performed. Effects noted by the WRPS representatives during this test indicated that the inclination readings did not return to pretest levels; the levels began to increase until the test ended, indicating a failed sensor; this 5 minute test occurred within the approximately 35 kR/h (34,998 R/h) ^{60}Co source field. All equipment was then removed from the HEF and WRPS staff departed the 318 building.
