Title: Surveillance and Monitoring Program Review March 25 & 26, 2014

Intended for: 3013 Surveillance and Monitoring Annual Program Review March 25, 26,
2014, 2014-03-25/2014-03-26 (Aiken, South Carolina, United States)

Surveillance and Monitoring Program Review

Meeting Agenda & List of Attendees	Laura Worf	3
Small-Scale Update	Kirk Veirs	6
Review of Corrosion Conditions, Pitting, SCC, and Ties to 3013 Inventory	Kirk Veirs	32
Review of Corrosion Conditions, Pitting, SCC, and Ties to 3013 Inventory	John Berg	50
Overview Presentation: Test Plan for Assessing Potential for Stress Corrosion Cracking in the 3013 Inner Container Closure Weld Region	John Berg	65
Status of Large-Scale Corrosion Containers	Joshua Narlesky	97
Status on LANL Studies with Respect to RH, Temp, and Droplet Size	Juan Duque	149
Selection of 3013 Containers from K-Area for DE and for Disposition	Elizabeth Kelly	172
Prompt Gamma Update	Joshua Narlesky	181
Low-temperature Stabilization of Direct Metal Oxidation (DMO) Product: 3013 Equivalency Tests and Recommendations	John Berg	194
Independent Review of LANL DMO Equivalency	Ted Venetz	204
Oxide Production Update Status and Path Forward	Steve McKee	210

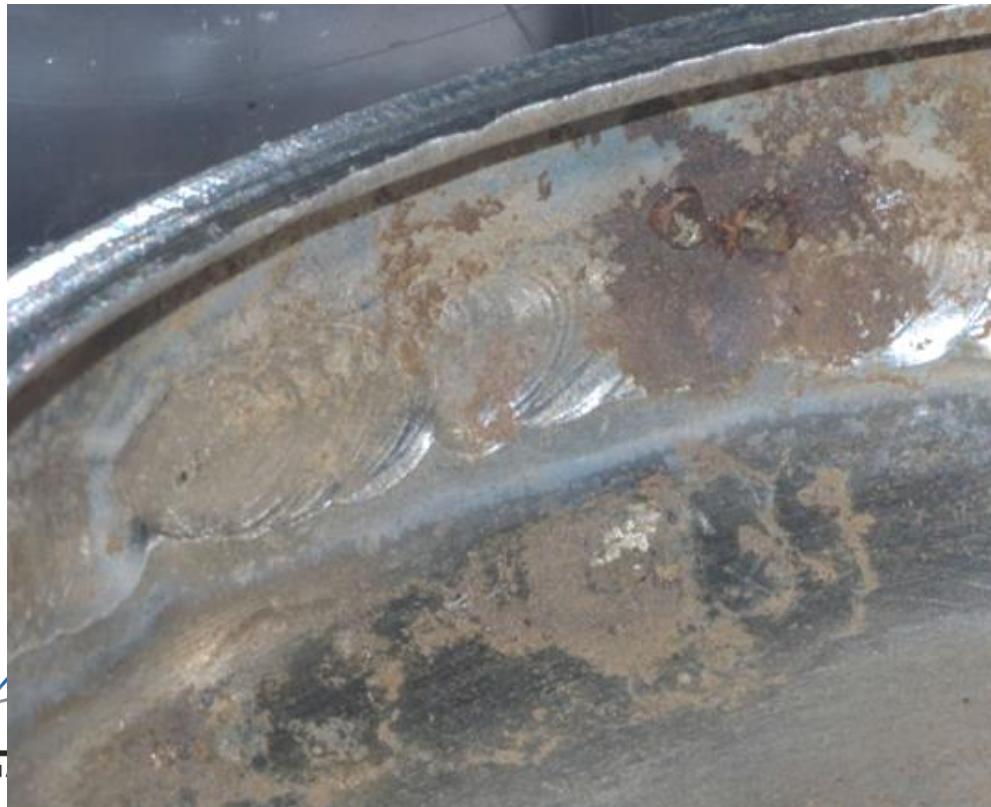
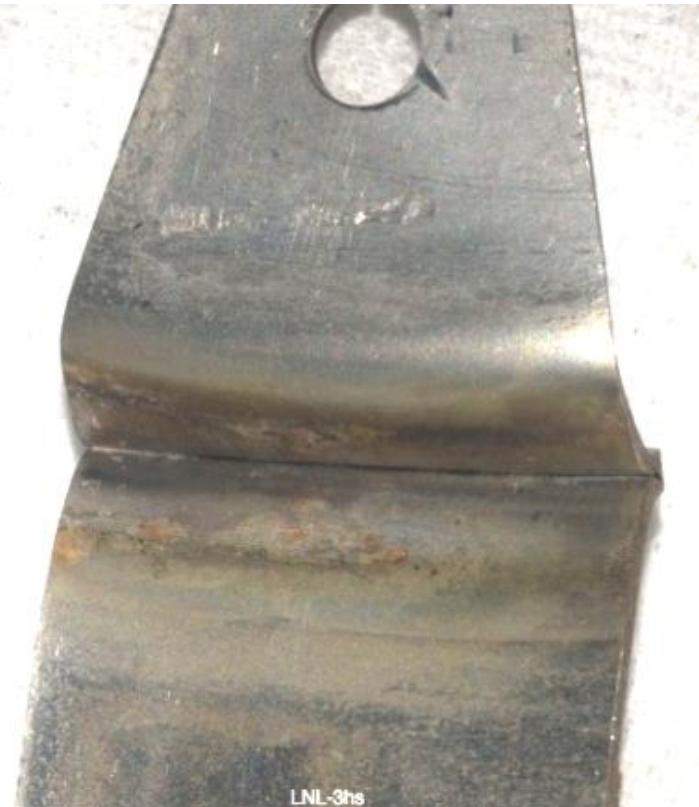
Shelf-life studies – LANL Large-Scale PMAXBS

- Lid of Large-Scale container. 316L for 100 days. HAZ show extensive patches of corrosion.
- Walls of container in contact with material are shiny.
- LLNL lid sample in headspace.
- Corrosion seen in crevice (sample opened for illustration).
- Similar sample in contact region shows no corrosion in crevice.

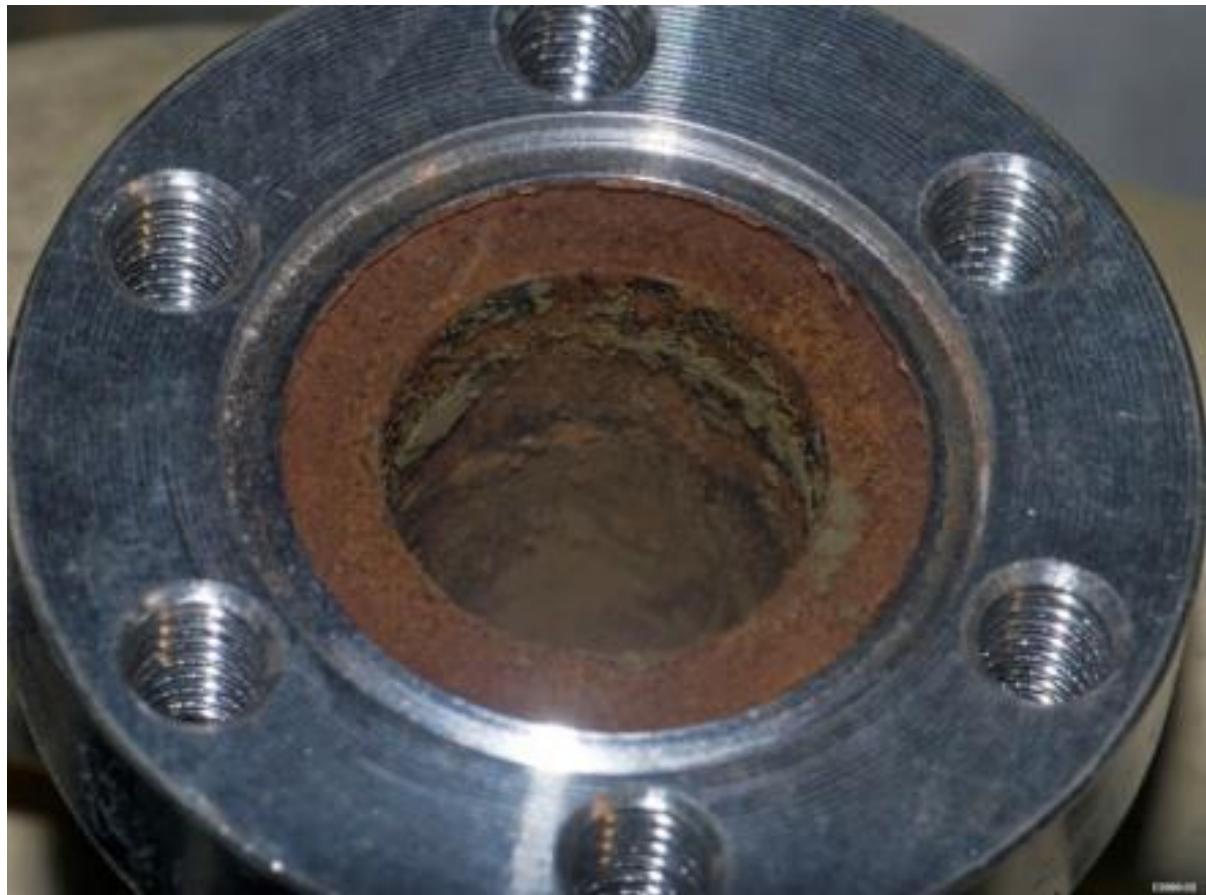
Shelf-life studies – LANL Small-Scale

- Body constructed of 316L SS.
- Material in inner bucket – material never directly in contact with body.
- High-purity oxide (PEOF1) with 5wt% CaCl_2 .
- Body used multiple times – corrosion observed to start with 3.1 waters of hydration.
- Small-Scale Studies: Oxygen Generation and Corrosion, presented by Ed Garcia, Surveillance & Monitoring Annual Meeting, Jan. 2007.

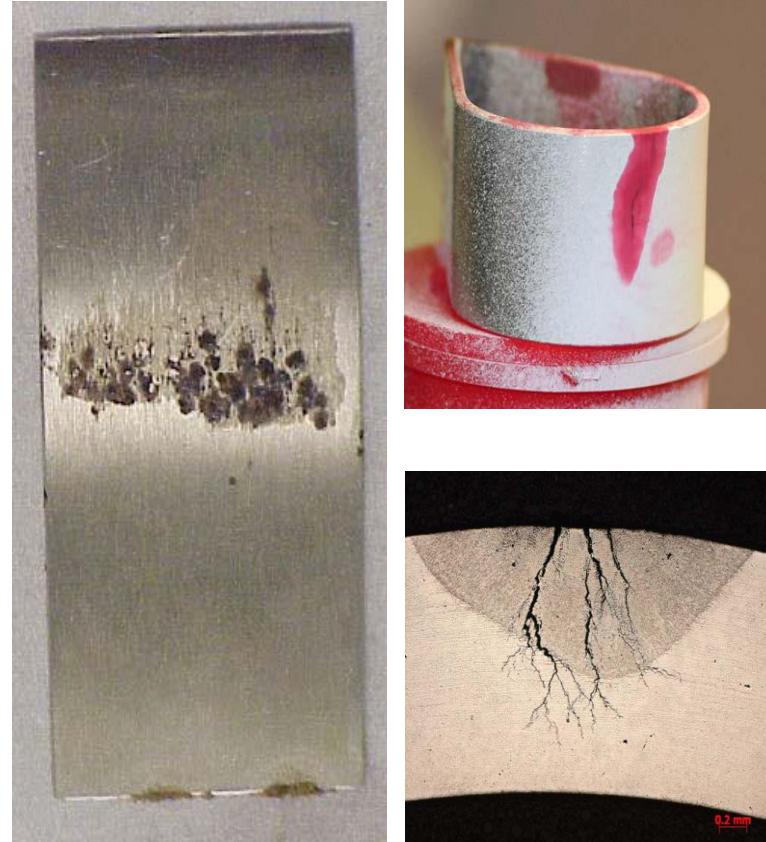
- SCC observed after 5.5 and 11 months at RT in 2 welded, stressed 304L SS teardrop (TD) coupons in contact with
 - 98% PuO_2 /2% salt with 0.2% CaCl_2 (4a)
 - Loaded with ~0.6% H_2O at ~ 75% RH
- SCC not observed in equivalently exposed 316L SS TD coupons

SCC not observed in 304L TD coupons in solid contact with 98% PuO_2 /2% salt with 0.9% CaCl_2 (4b)

- SCC not observed in any coupons exposed to headspace atmosphere
- Pitting corrosion observed mainly in flat coupons exposed to mixtures with 2% total salt containing CaCl_2

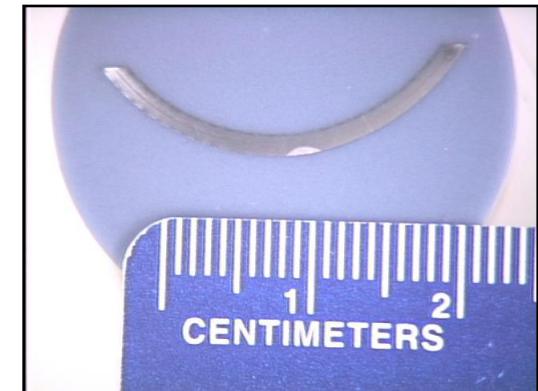
▪ 85-Day
Exposur
e

Test Series 1 – Cross Sectional Metallography

- Teardrop exposed to salt for 85 days at 54%

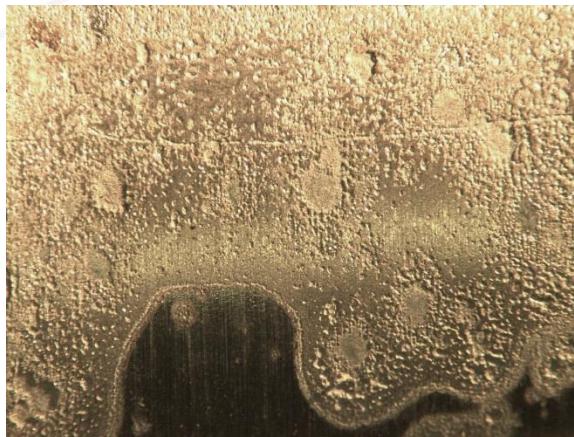
DE of High Ca Container

TD21
Pitting

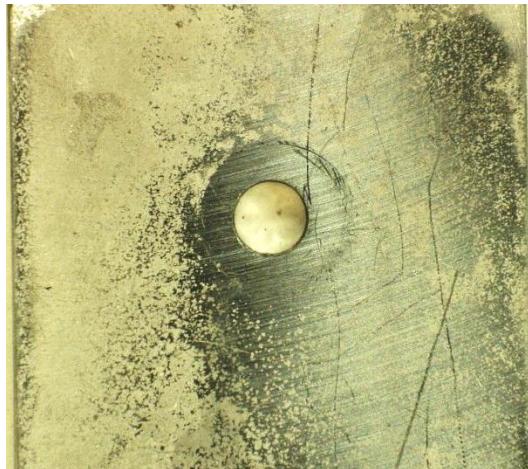
DE of High Ca Container

Pitting on outside of crevice specimen

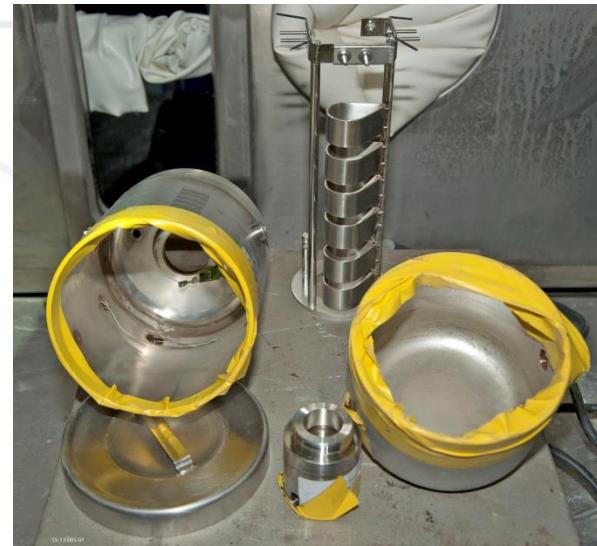
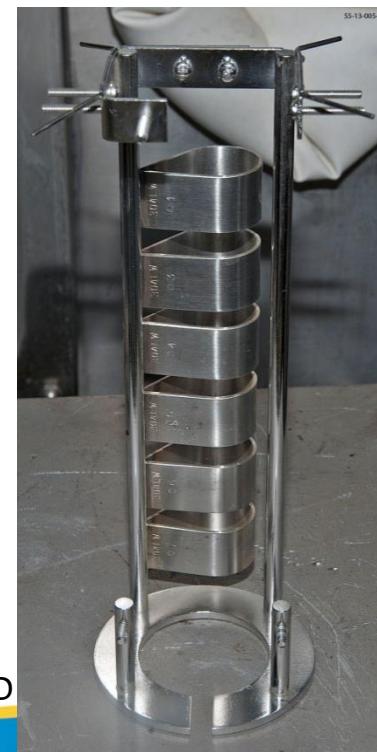
- Container condition: clean/shiny
- Burst disk condition: clean/shiny
- DCBs: None present
- Tear drops: shiny clean, slight discoloration on 05 and 07 in material phase—not removed with cleaning
- Lid section specimens: None present
- Crevice specimens: None present
- 200°C moisture loss: 0.0085 wt%

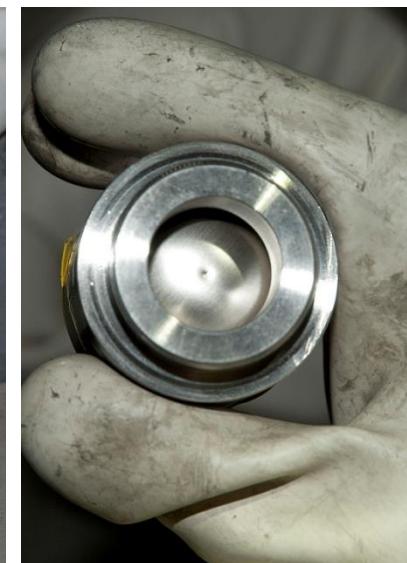
Base Material DE

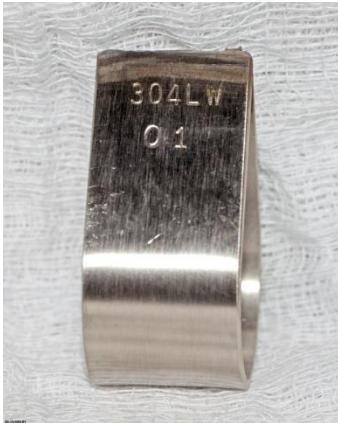
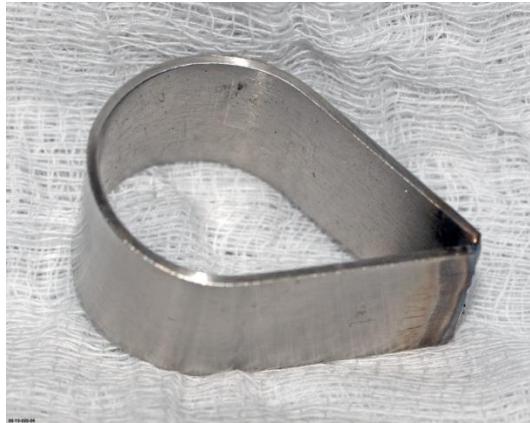
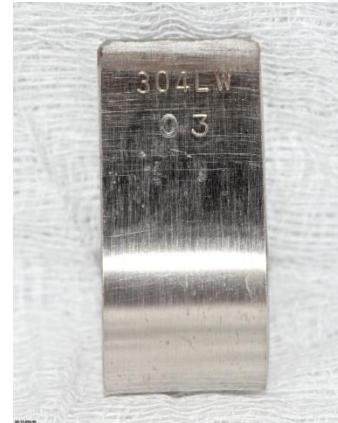
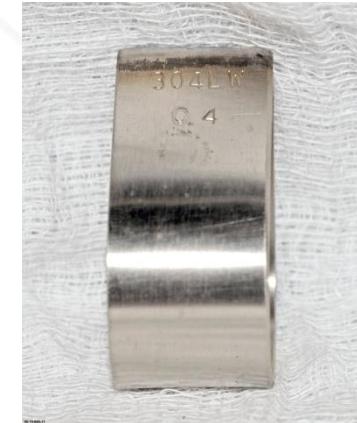
Headspace

Base Material DE

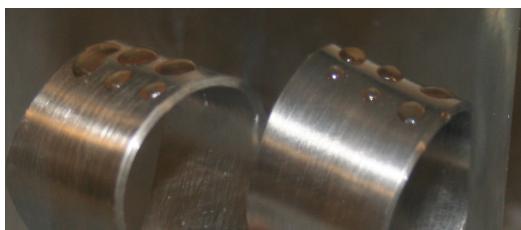
Experimental Parameters:

- Saturated solutions of CaCl₂
- Droplets of 0.5, 1, 5, and 10 μL at the surface of teardrops, near the heat-affected zone of the transverse autogenous weld
- Teardrops were placed inside a vial
- RH was held constant using saturated salts
- Vials were placed inside oven at 30 or 50 °C
- Samples were left inside oven for 55 days

RH measured inside the glass vials using a sensirion

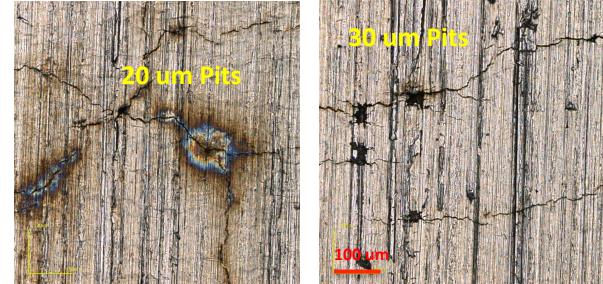
22%

- Significant number of cracks
- Very small pits with $\sim 20-30 \mu\text{m}$ in diameter
- Cracks stopped at the droplet interface
- Cracks are interconnected
- Small amount of corrosion accumulation/stain

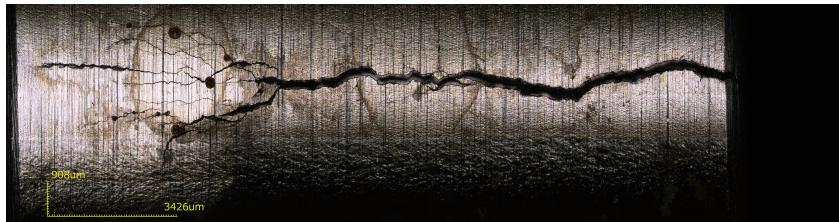
Most aggressive SCC close to the deliquescence od CaCl₂ (22% RH) and 50C

Unable to determine origin of crack

At 30 C the number and length/surface area of cracks/Pits decreases with increasing RH

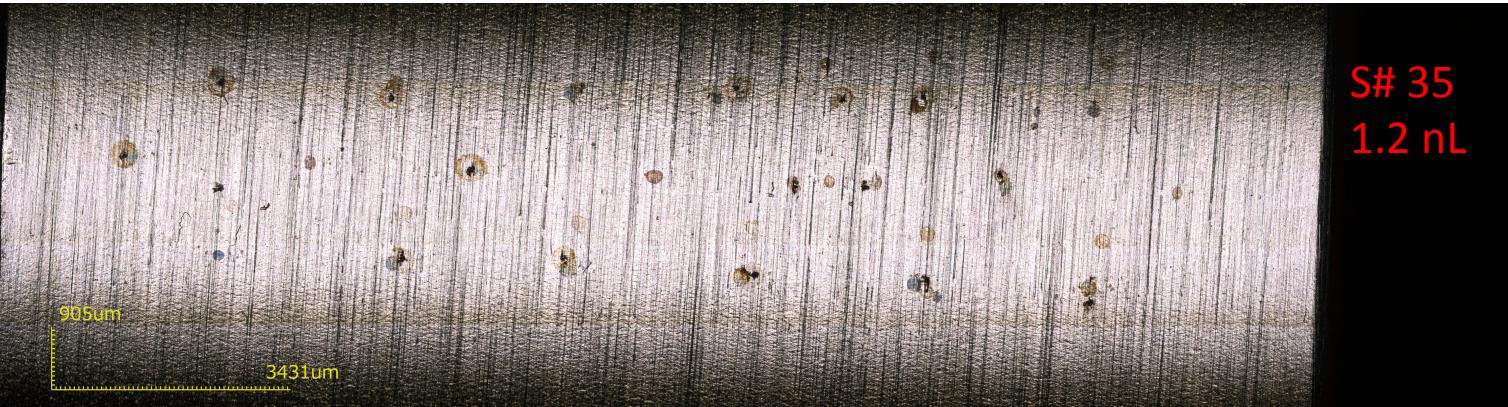
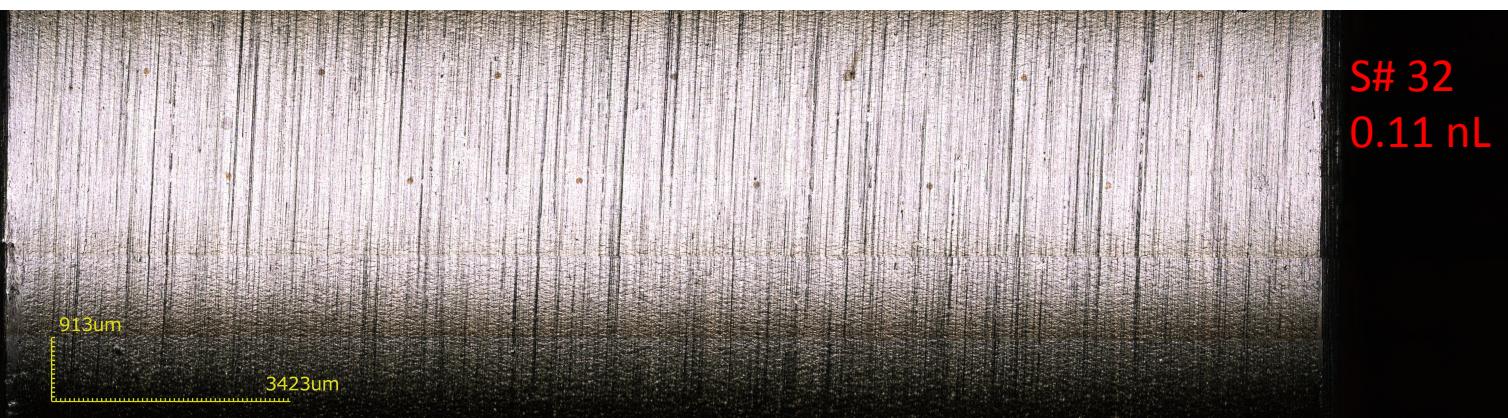
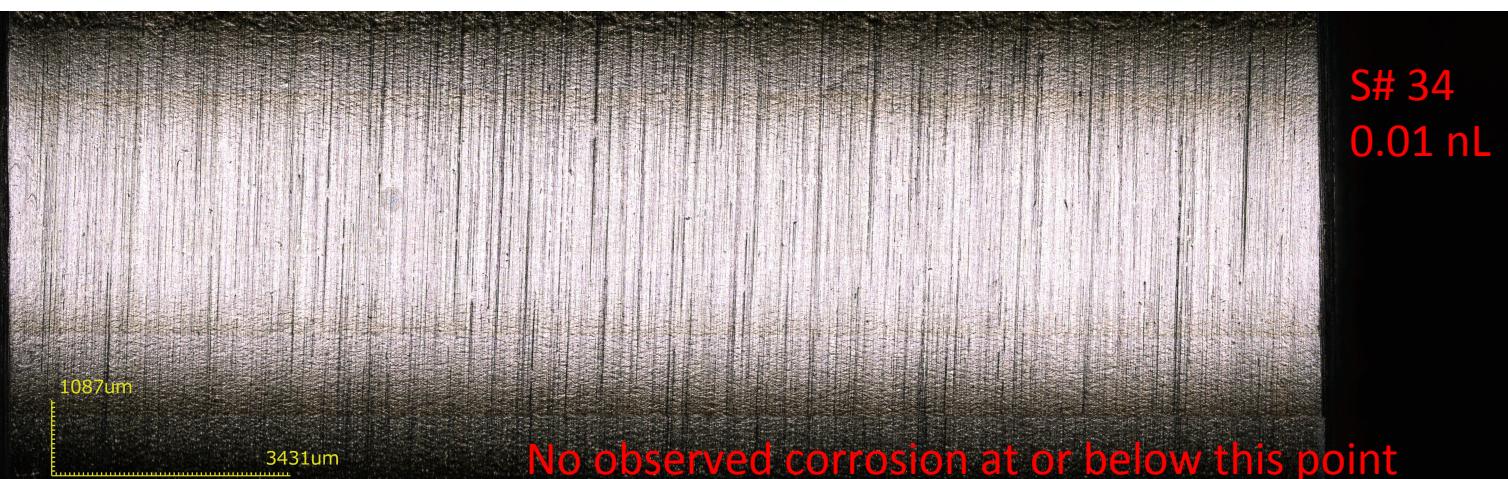
More uniform droplets as droplet size decreased

No observed corrosion at or below this point

Corrosion Pit Cut Off

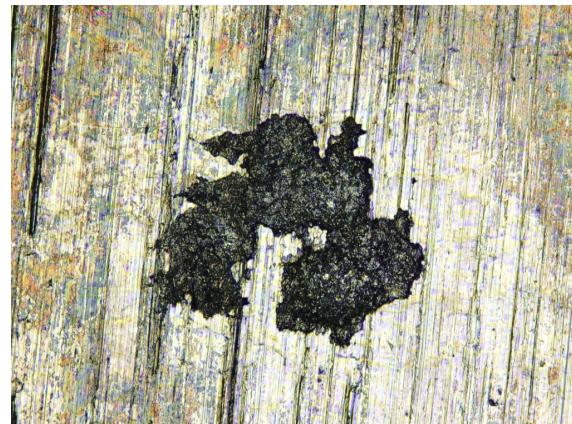
Pits much smaller than droplet

Types of Pits

Irregulars in shape, diameter, depth

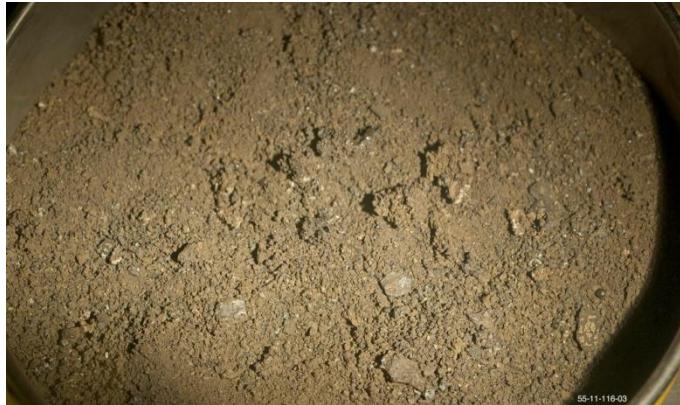
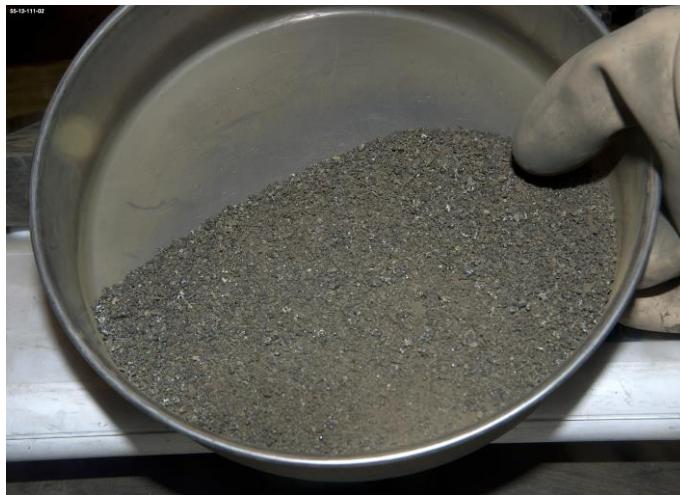
DMO Product Oxide vs. Test Material

- unmilled DMO product
 - 30-80% greater than 200 μm
 - Typical surface area $< 0.4 \text{ m}^2/\text{g}$
- TGA-MS of blend lots
 - Typical moisture = 0.01 wt%
 - Total volatiles $< 0.05 \text{ wt\%}$
- uncalcined DMO product
 - 25 % greater than 200 μm
 - surface area $0.38 \text{ m}^2/\text{gram}$
 - moisture = 0.007 wt% (by TGA-MS)
 - Total volatiles $\approx 0.05 \text{ wt \%}$ by TGA

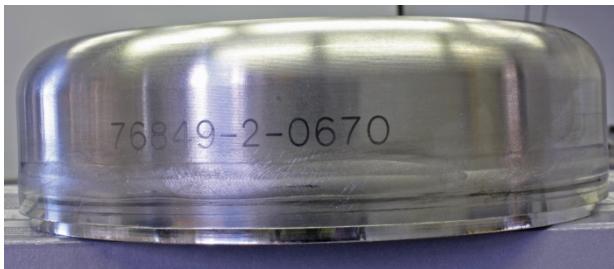
weld face
courtesy Scott Breshers

- Replacement of the manual inner- and outer-can welding stations.
 - Systems approaching their service lifetime.
 - Inner can has been in operation since 1998.
 - Outer can has been in operation since 2003.
- The procedure qualification record and the welding procedure specification for these welds will not be altered.
 - Verification weld (dummy can) for the outer can will be performed and subjected to full volumetric radiographic examination and metallographic examination in accordance to section 1.d of G-ESR-G-00035.
 - If there are other requirements that we must meet prior to the use of these welders for production welds, please let us know.
