Final Report on TREAT Tests R4 and R5;
Seven-pin, Loss-of-flow Tests with Full-length,
Unirradiated FFTF-type Fuel Pins

Reactor Analysis and Safety Division
ARGONNE NATIONAL LABORATORY
9700 S. Cass Avenue
Argonne, Illinois 60439

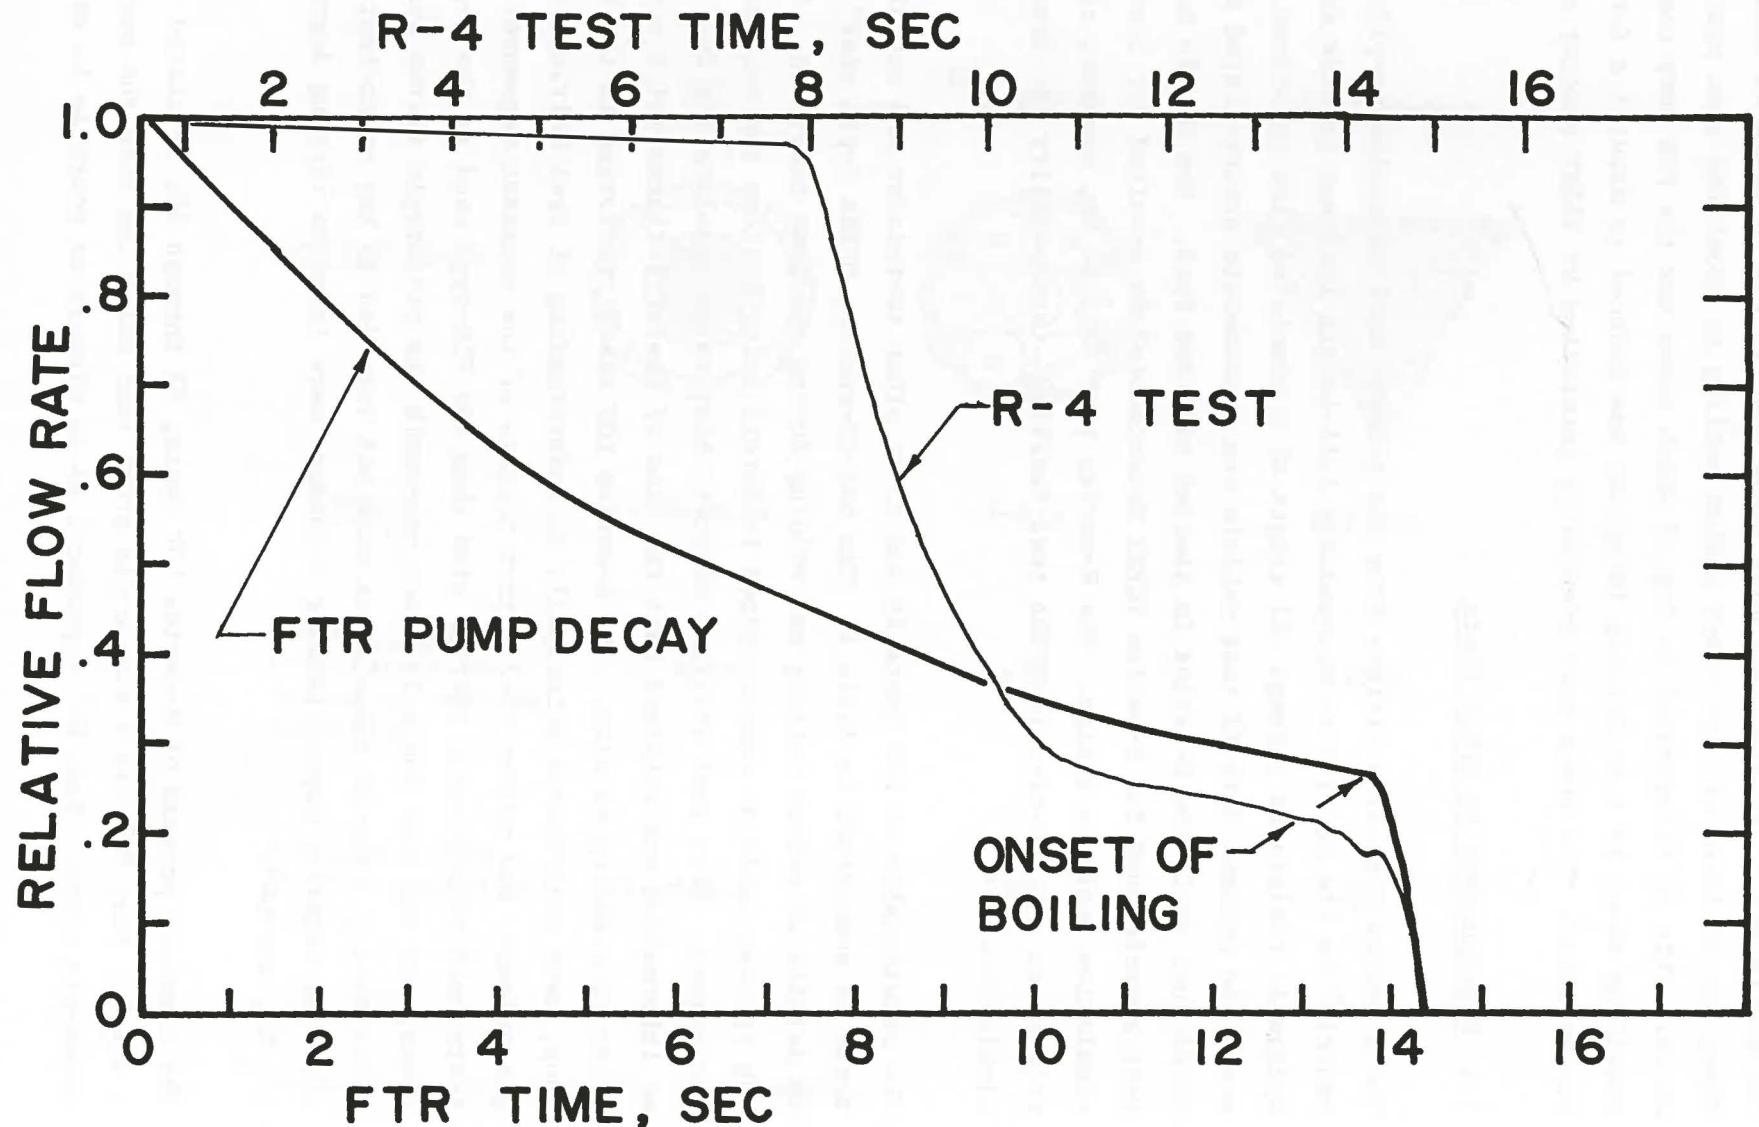
Fig. 2 Illustration of Experimental Approach to Simulate FTR Pump Coastdown Accident.

was programmed to be initially more rapid than in FTR to conserve TREAT run time, but to level off and enter sodium boiling at about the same rate of flow decay. This is illustrated in Fig. 2 which shows how the FTR pump coastdown requiring about 14 s to boiling inception was reduced to about 6 s for the R-series tests. The tests were eventually terminated by TREAT reactor scram.

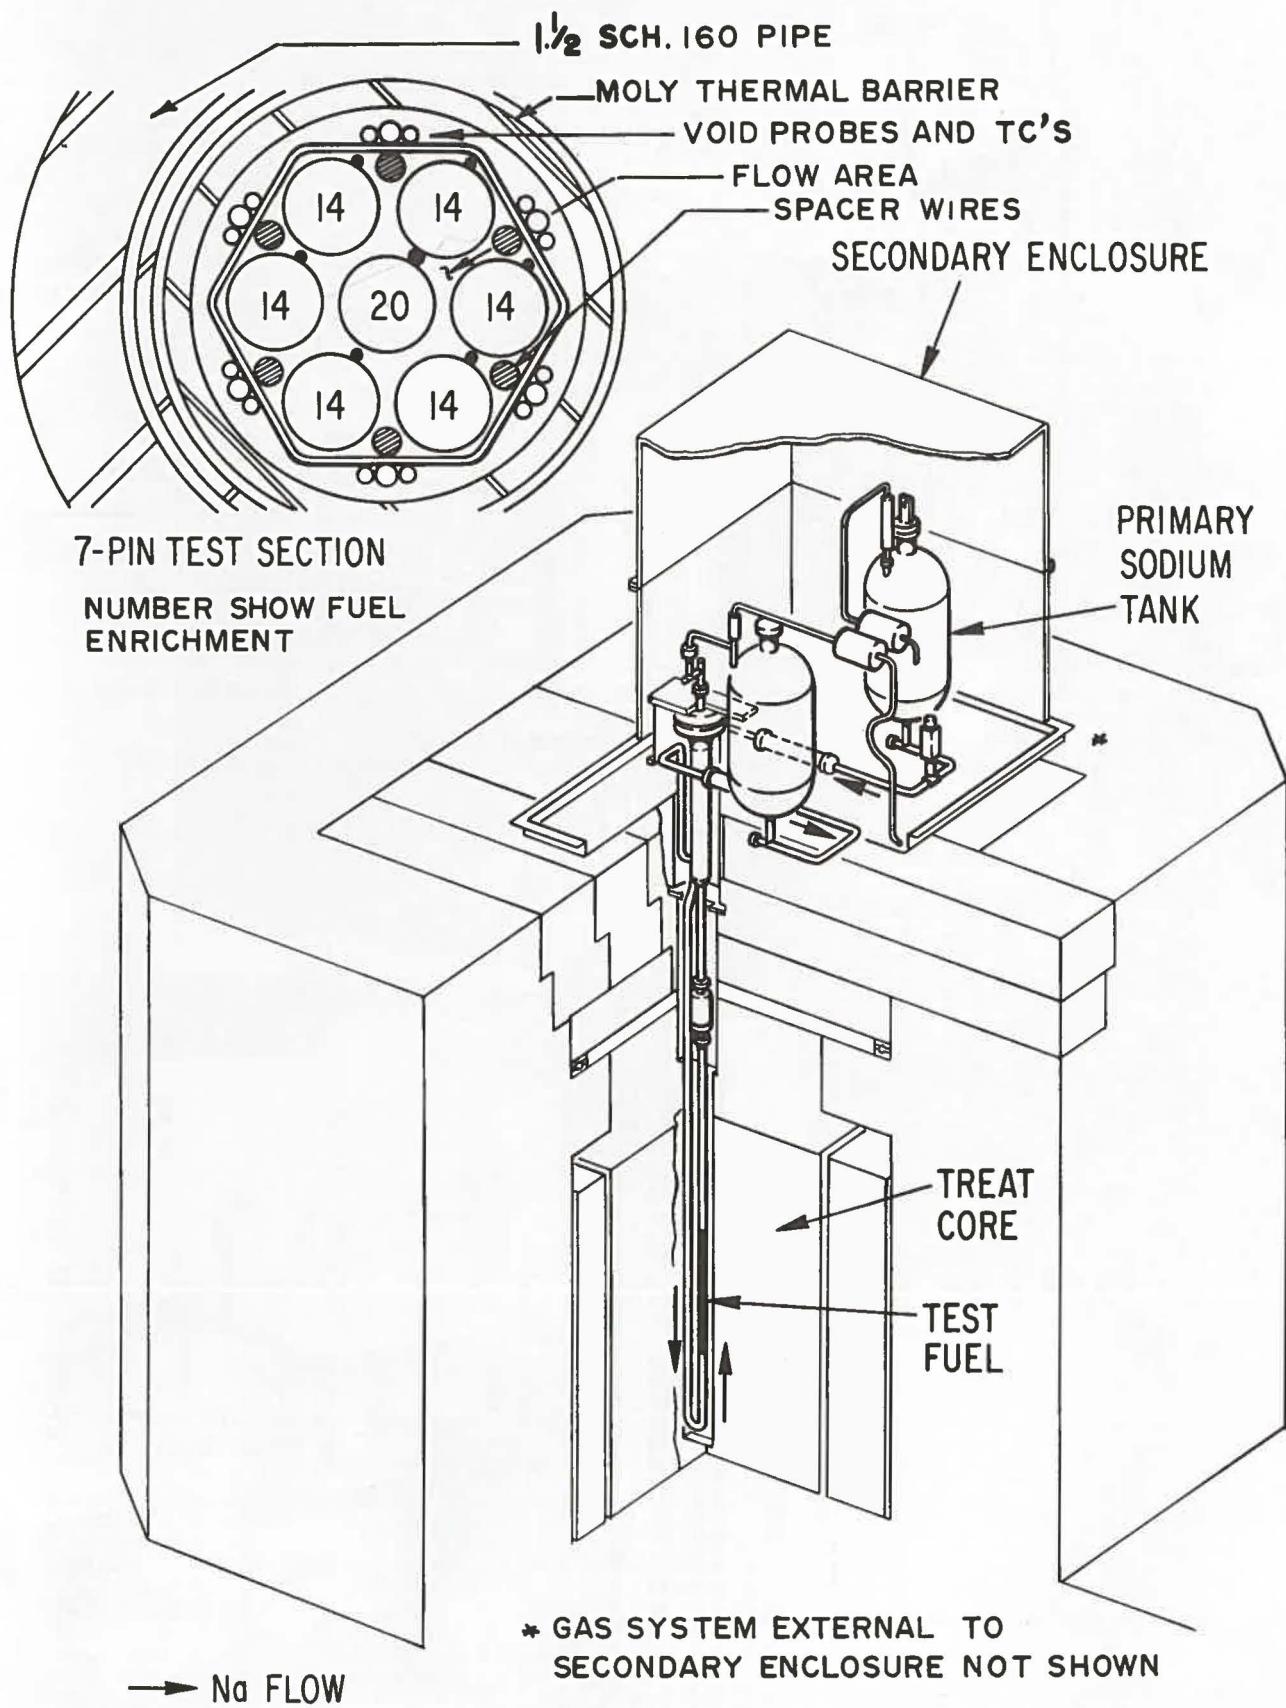
Fig. 3 The R-Series Test Apparatus.

The R-series test apparatus, Figs. 3 through 7, was designed for use in TREAT to provide a flowing-sodium system capable of providing prototypic thermal and hydraulic conditions for performing tests of hypothetical LMFBR whole-core accidents¹⁰. It contains the essential features of the current design LMFBR core including high pressure inlet plenum, inlet flow orificing, fuel bundle comprised of full-length FTR fuel pins, and an upper plenum having a sodium free surface and inert cover gas. The interconnecting piping routes through the TREAT core in a U-bend such that the active fuel region of the test fuel pins is approximately centered in the TREAT core with upward-directed sodium flow. Sodium flow was driven through the apparatus by differential gas pressure. This provides prototypic sodium velocity through the 7-pin test section while effectively simulating an infinite bypass flow. The apparatus inlet and outlet inertial lengths closely matched the corresponding subassembly parameters, as was the case for the axial pressure distribution. Hence, the combination of matched sodium velocity, infinite bypass ratio, matched inertial lengths, and matched system pressures provided simulation of dynamic as well as static system hydraulic behavior.

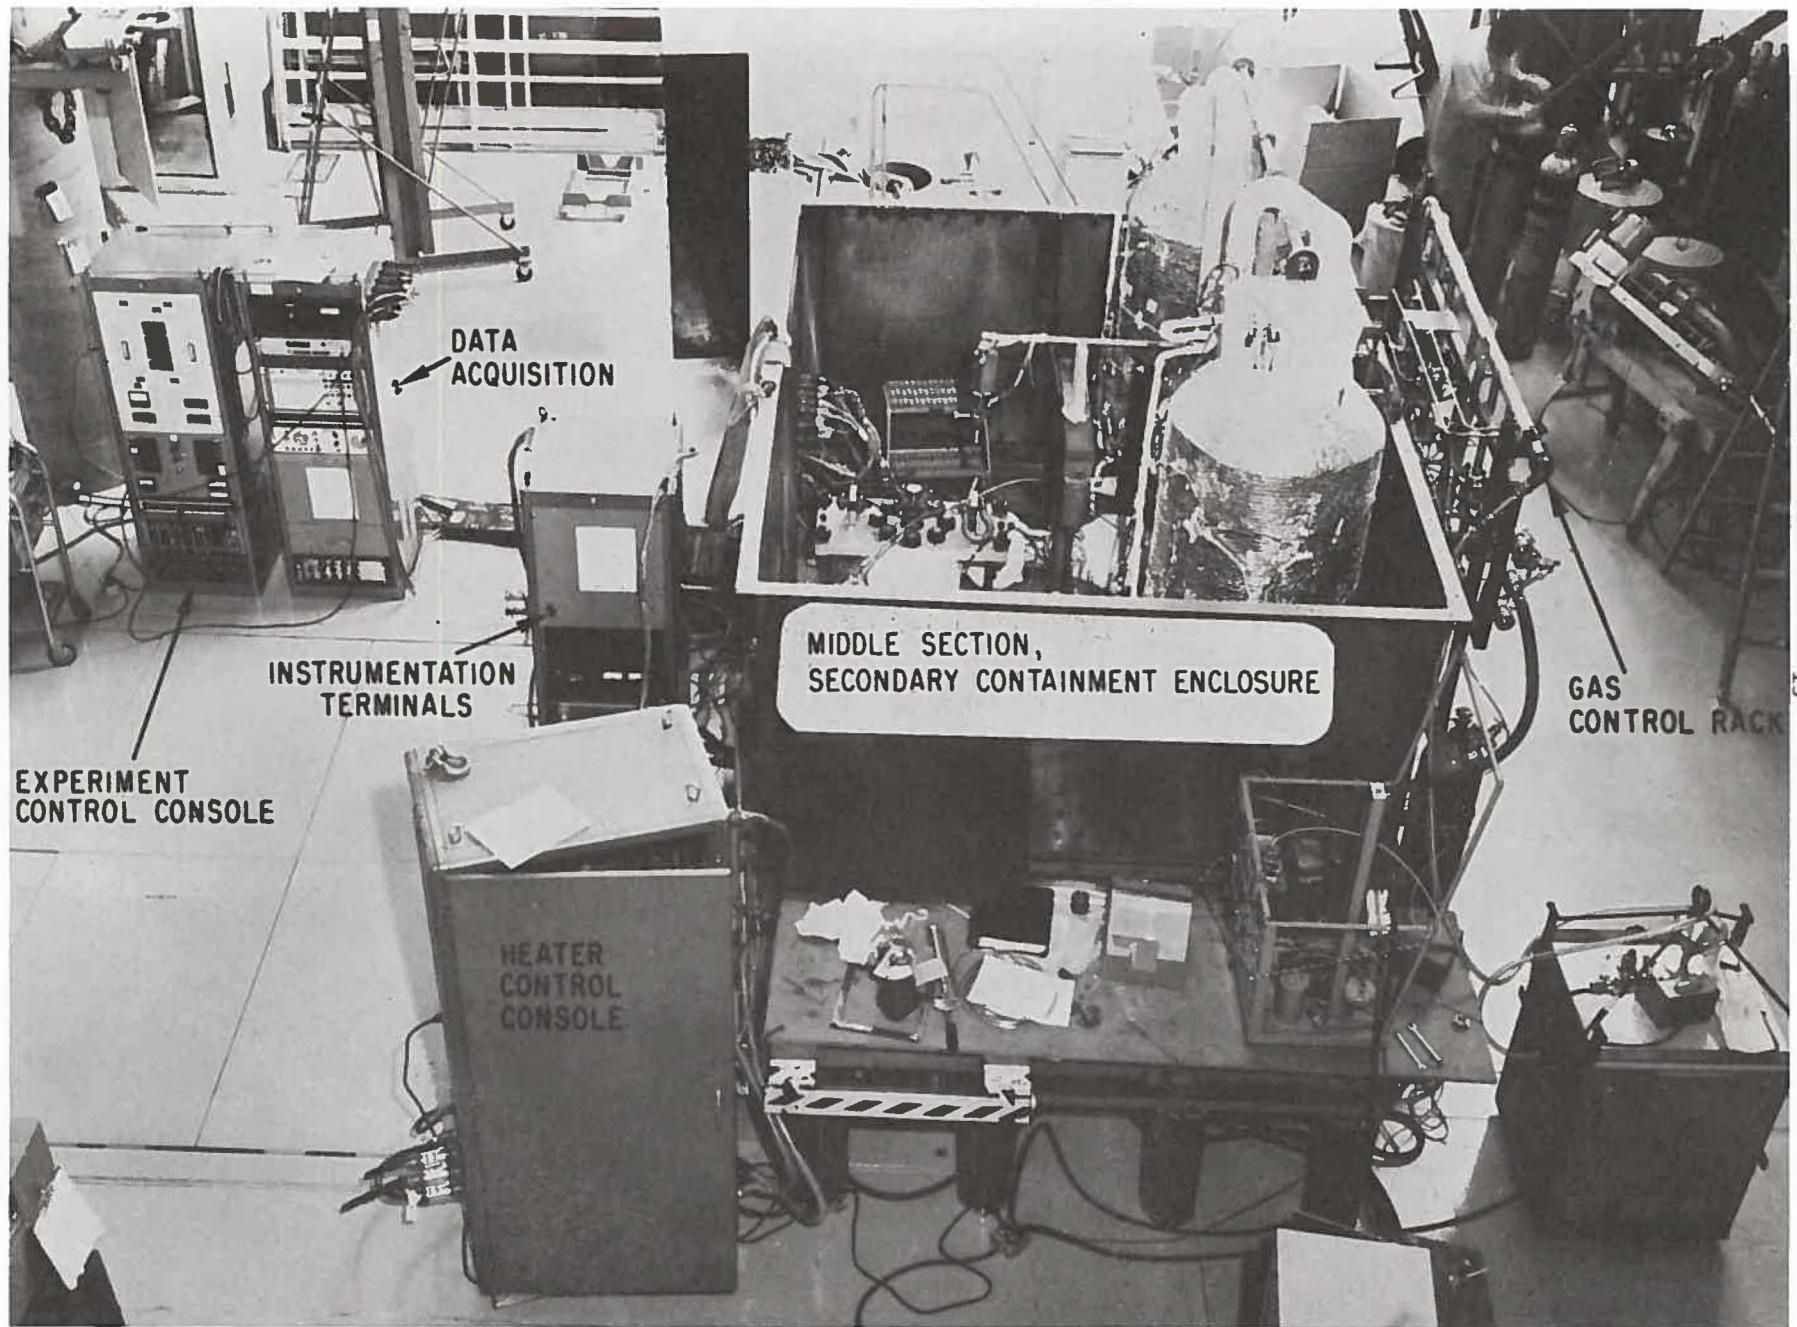
Fig. 5 Photo of R-Series Equipment During Floor Checkout at TREAT.

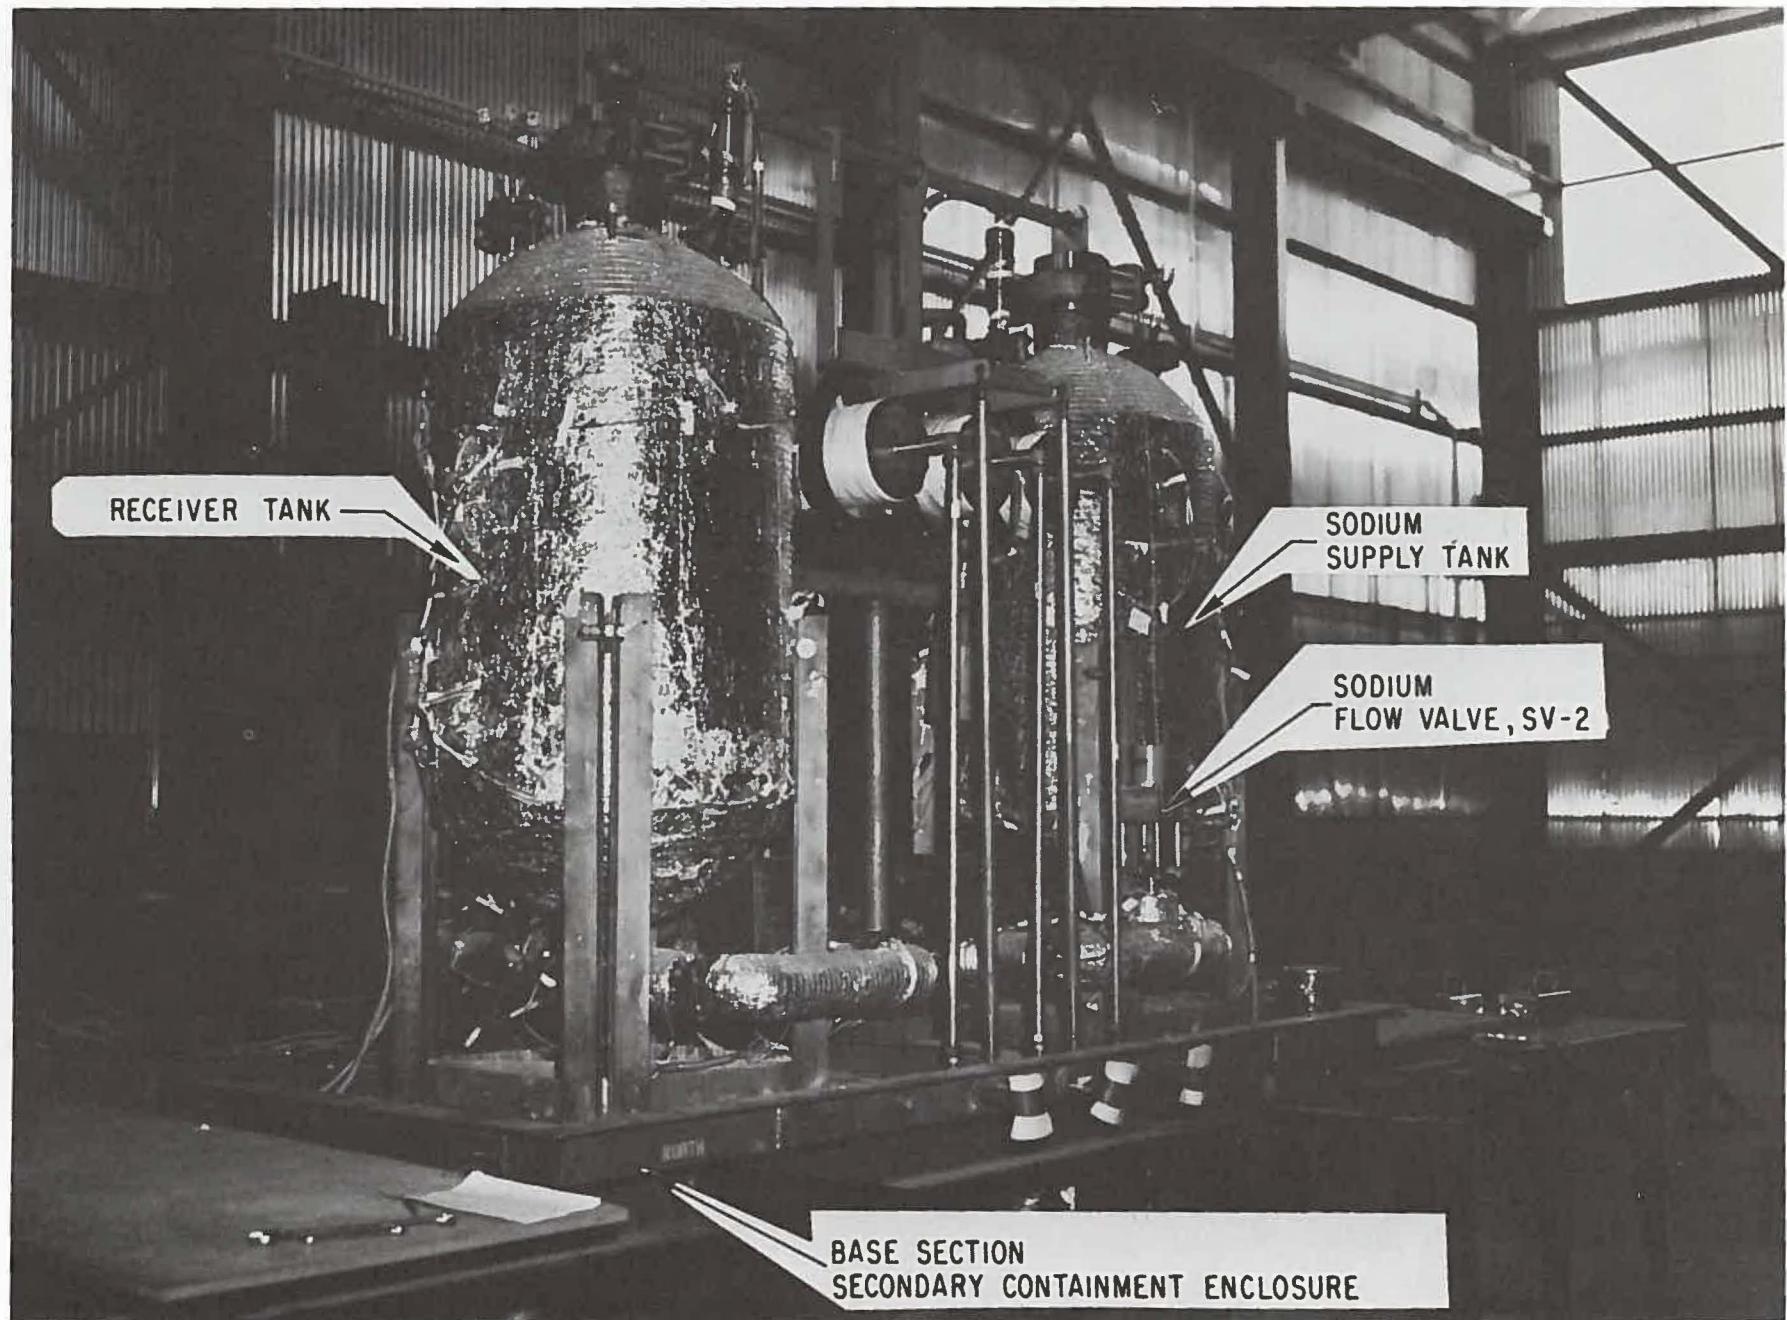
Fig. 6 R-Series Sodium Tanks.

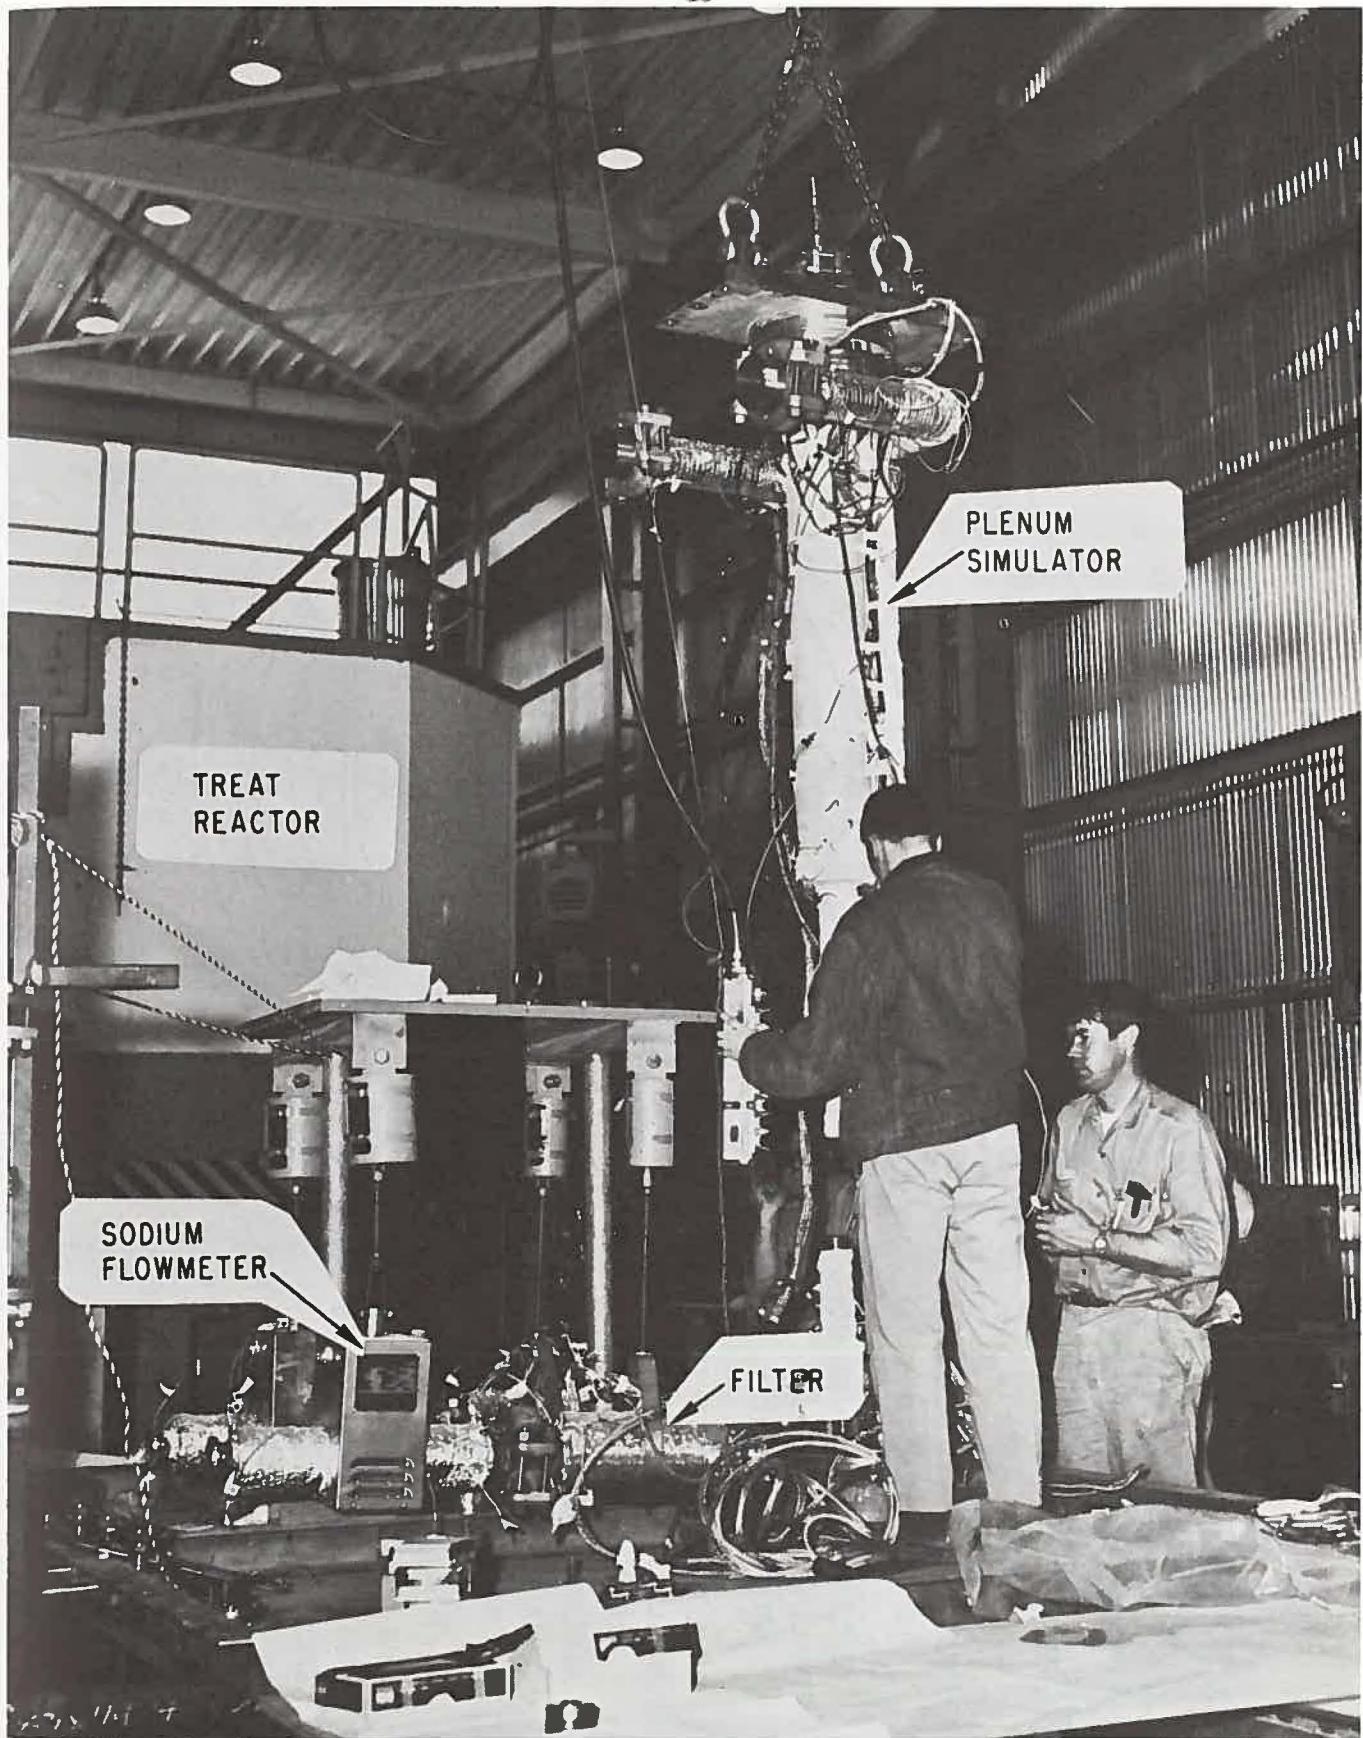
Fig. 7 Components of R-Series Apparatus During Assembly.

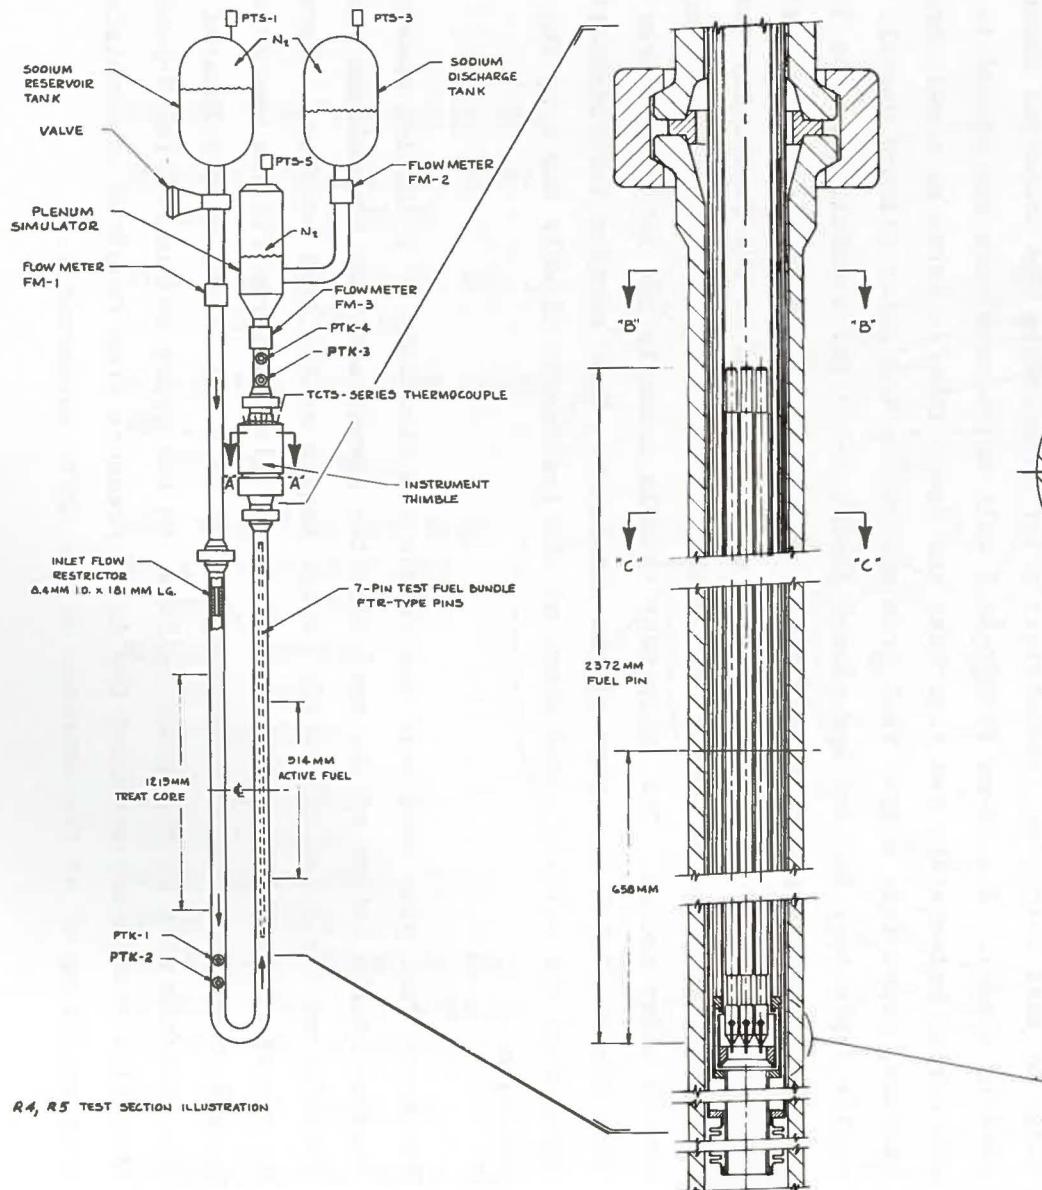
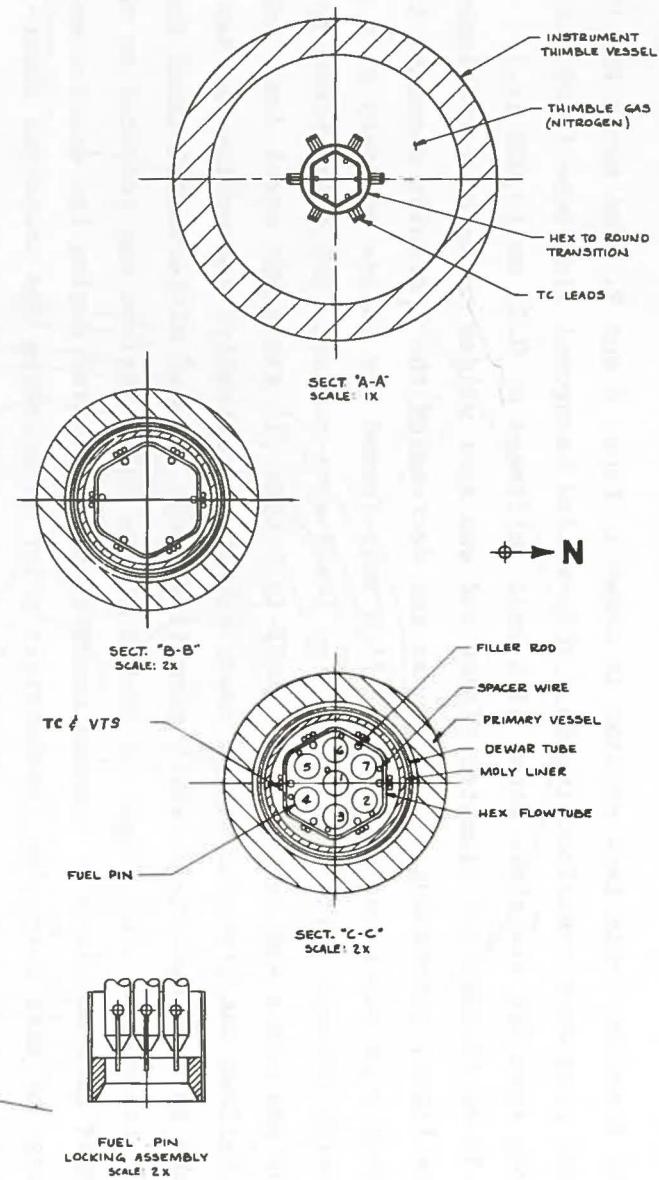
Fig. 9 Illustration of R-Series 7-pin Test Train.

The R-series 7-pin test section is shown in Figs. 8 and 9. The seven FTR-type fuel pins were contained inside a thin-walled hexagonal flow tube fabricated from type 316 stainless steel with wall thickness of 0.51 mm (0.020 in.). A 1.57-mm (0.062-in.) diameter filler rod was spot welded to each of the inner hex flats, decreasing the flow area and decreasing the hydraulic diameter in these edge subchannels. The hex flow tube formed the inside boundary of a gas cavity through which instrumentation leads were routed. The outer boundary of the gas space was the 0.81-mm (0.032-in.) type 316 stainless steel dewar tube. A bellows was provided at the lower end of the assembly, connecting the hex tube to the dewar tube, which permitted about 3 cm of differential axial thermal expansion. The elevation of the active fuel midplane was centered on the TREAT core midplane at thermal conditions encountered during the quasi-steady stage of test operation (immediately prior to entering the transient undercooling stage). A 1.52-mm (0.060-in.) wall molybdenum tube was placed in the gas cavity between the hex flow tube and dewar tube to serve as a meltthrough barrier, preventing molten fuel from contacting the outer primary vessel. The entire 7-pin test section was placed inside 1-1/2 in. schedule 160 type 316 stainless steel pipe which served as the primary system containment vessel. The primary vessel and the dewar tube were connected at the instrument thimble; the gap between the two was filled with sodium as a consequence of filling the system under vacuum. The instrument thimble connects the top of the test section assembly with the upper plenum simulator. Test section instrumentation penetrated the primary containment at the instrument thimble and atop the plenum simulator.

The seven fuel pins were held inside the hex flow tube by a locking assembly located at the bottom of the hex, directly downstream from the bellows assembly. This formed the inlet to the pin bundle region of the test section. There was no restraint at the top ends of the pins. Inlet flow restriction was provided by a 8.38-mm (0.33-in.) diameter by 181-mm (7.12-in.) long nozzle located on the upstream side of the inlet bellows, on the opposite side of the U-bend. This flow restrictor provided the inlet pressure drop required to simulate the zone orificing ΔP at the entrance to the LMFBR subassembly.

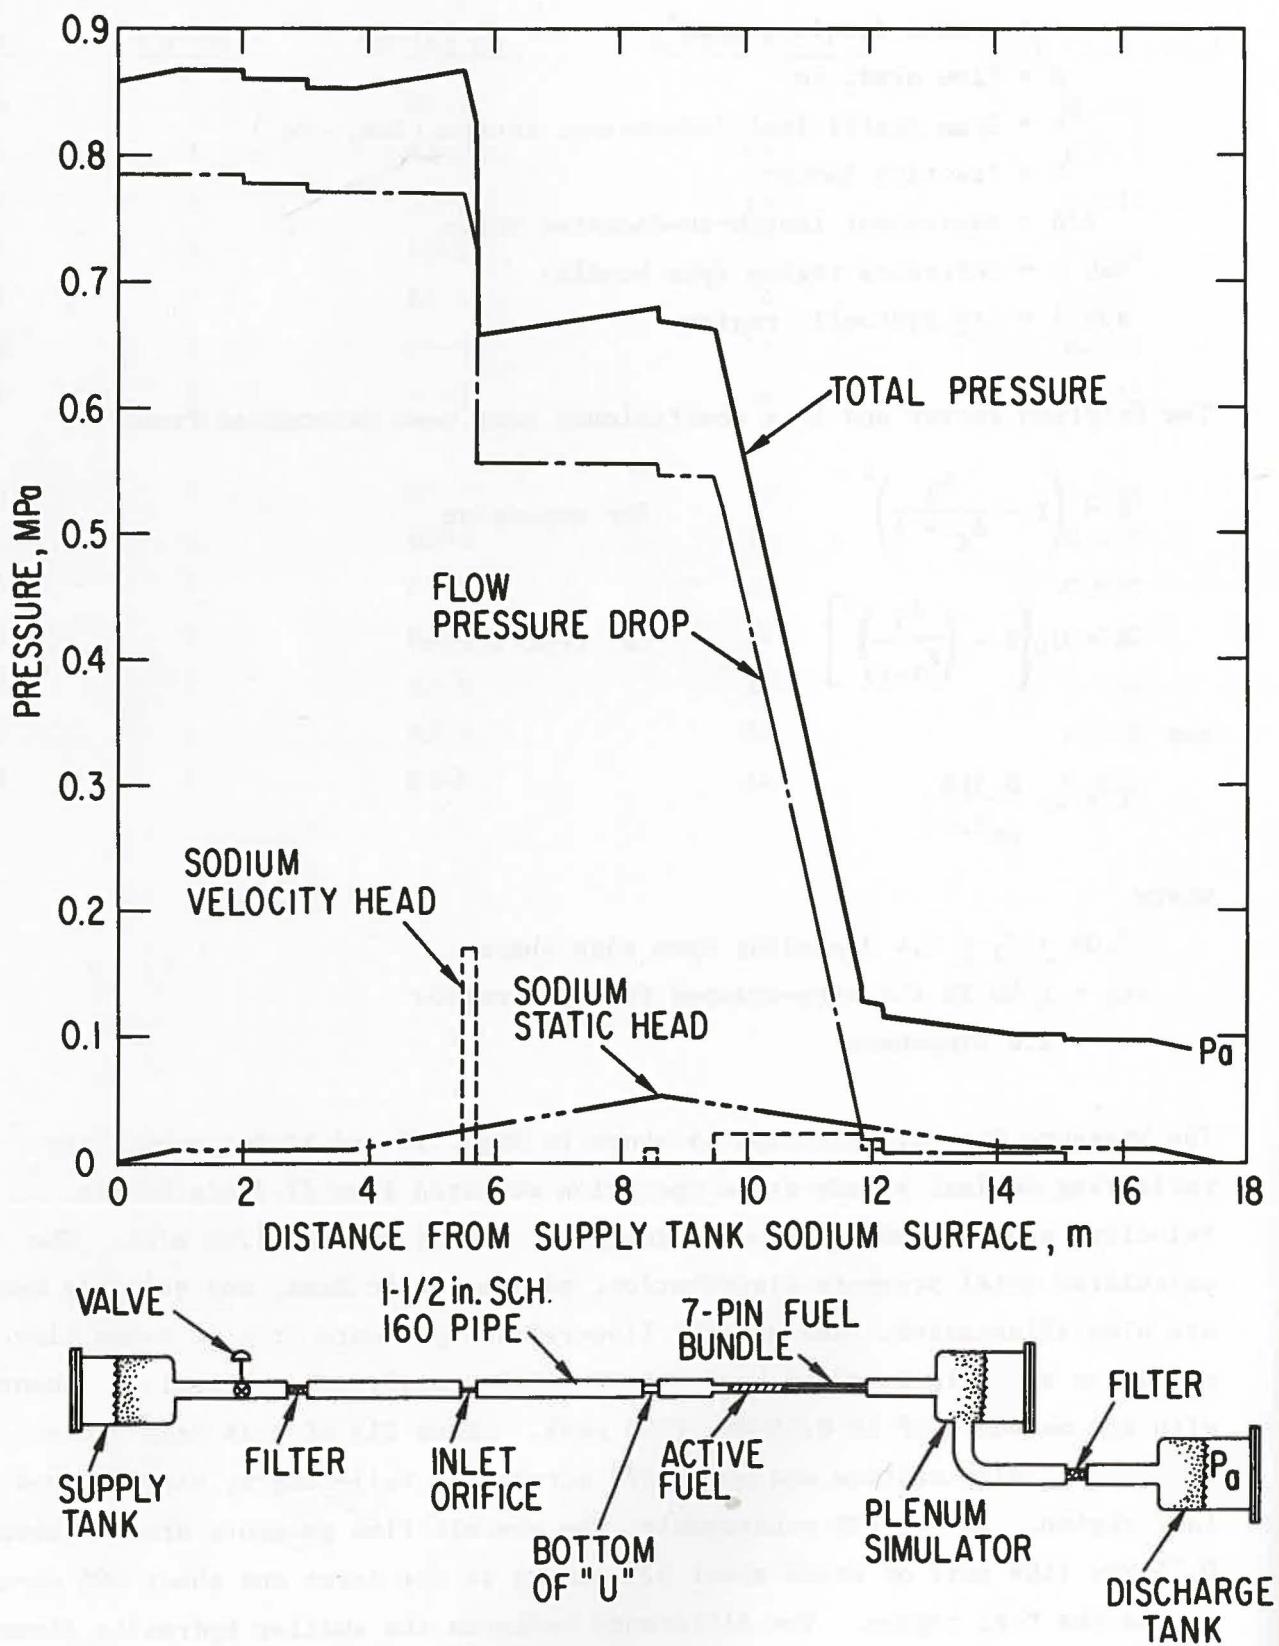
Fig. 12 System Pressure Drop Distribution at Nominal Steady-State Operating Condition; $T = 316^\circ\text{C}$.

The pressure drop distribution is shown in Figs. 12 and 13 for conditions reflecting nominal steady-state operation at rated flow (7.3 m/s bundle velocity) and for reduced flow at incipient sodium voiding (2.0 m/s). The calculated total pressure distribution, sodium static head, and velocity head are also illustrated. The overall flow-related pressure drop at rated flow condition was calculated to be 0.785 MPa (113.8 psi), in excellent agreement with the measured ΔP of 0.79 MPa (115 psi). About 31% of this drop occurs across the inlet orifice and about 66% across the full-length, wire-wrapped fuel region. In the FTR subassembly, the overall flow pressure drop is about 0.75 MPa (109 psi) of which about 52% occurs at the inlet and about 40% occurs across the fuel region. The difference reflects the smaller hydraulic diameter

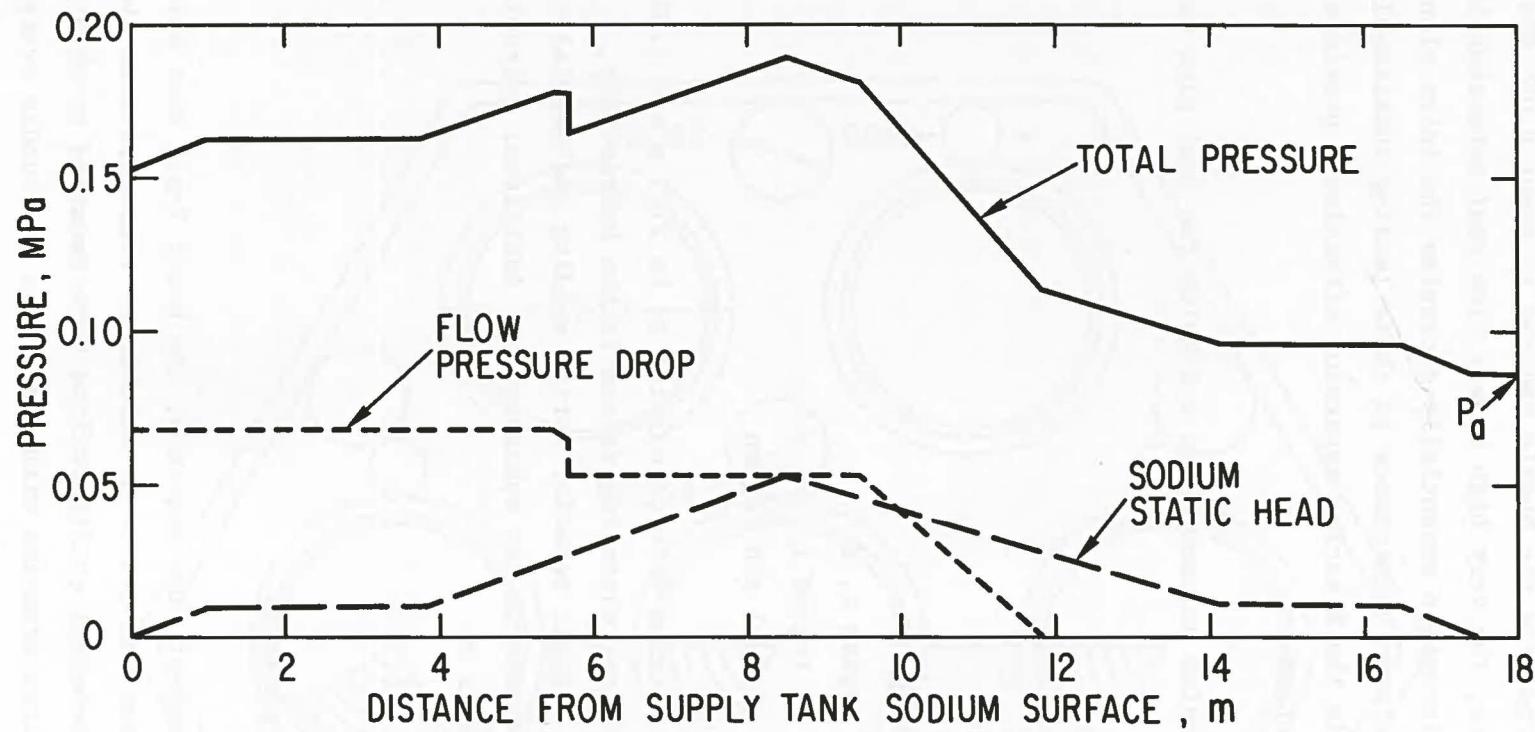
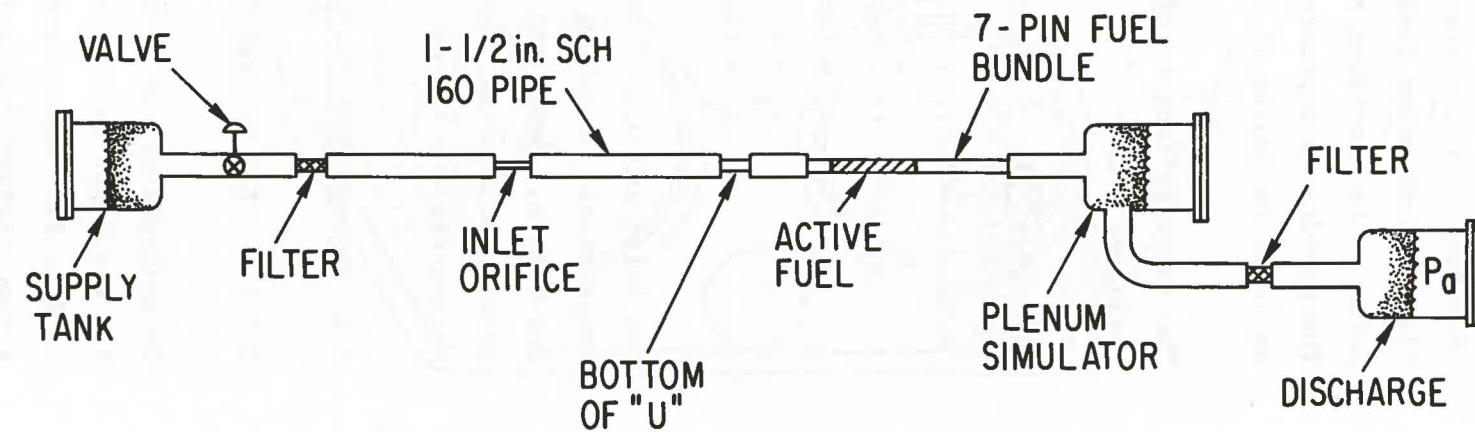
Fig. 13 System Pressure Drop Distribution at Incipient Boiling;
 $T = 316^{\circ}\text{C}$.

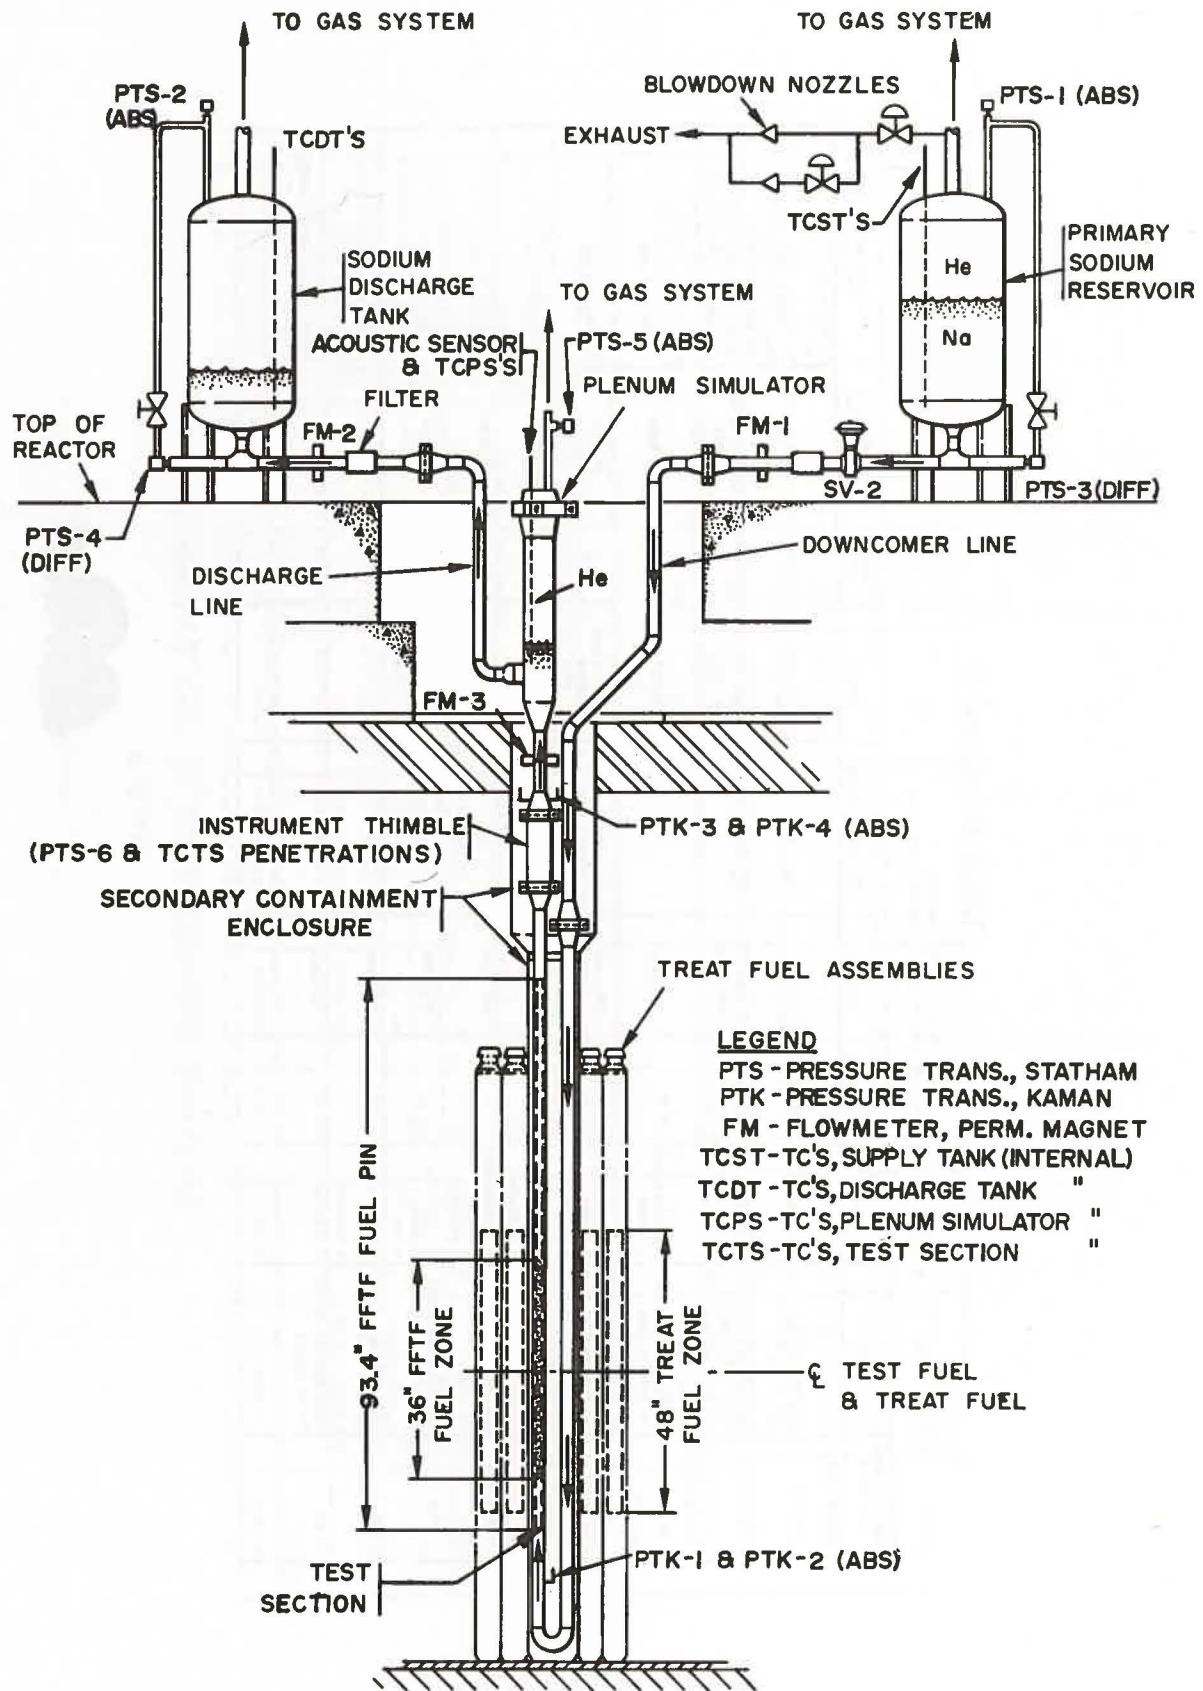
Fig. 20 Locations of Instrumentation in R-Series Test Apparatus.

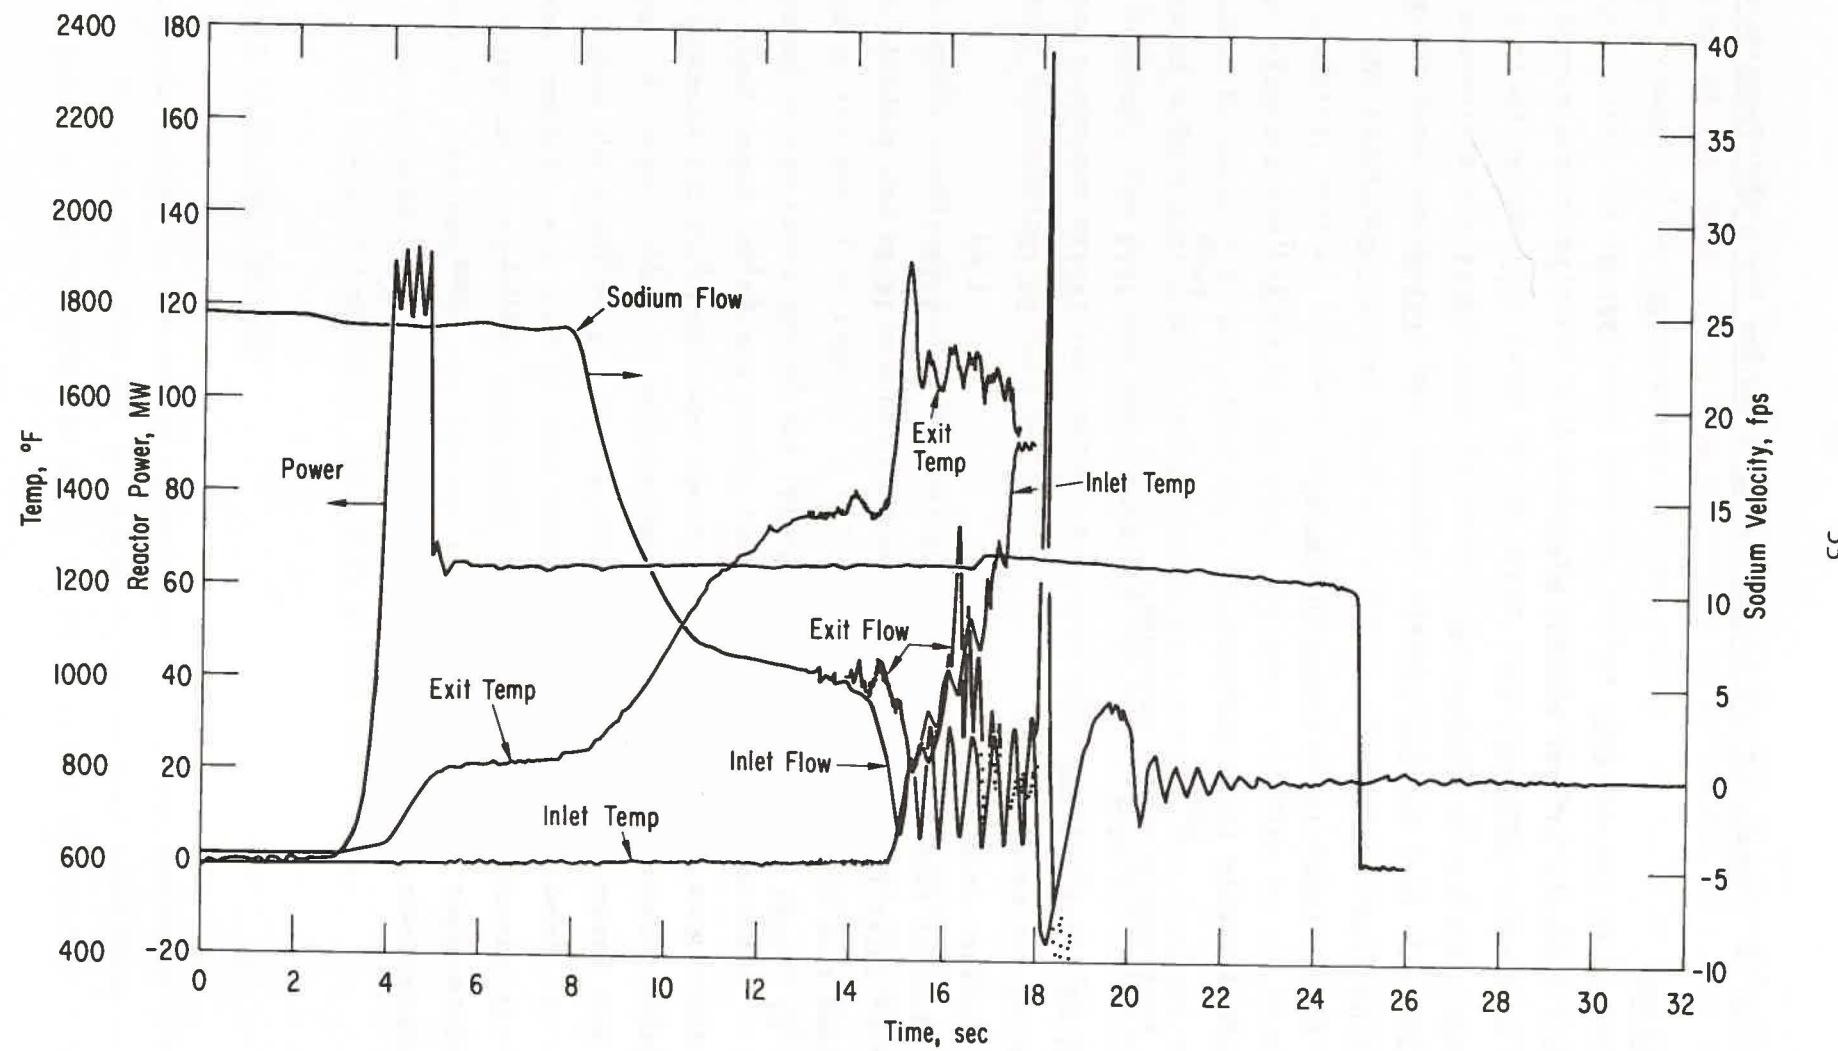
Fig. 26 Test Sequence for R-Series 7-pin Loss-of-flow Test R4, showing power, flow, and temperature history.

A summary of the timing of key test events is given in Table 10. The coolant flow coastdown was initiated at 7.90 sec, at which time the sodium inlet temperature was 327°C and the coolant velocity through the pin bundle was 7.15 m/s. Local sodium boiling was first detected at 13.15 s. A vapor bubble formed and collapsed from 13.8 to 14.1 s. Sustained channel voiding began at 14.15 s; at that time the coolant velocity was down to 1.83 m/s, 26% of the initial flow-rate, and the rate of flow decay was 12%/sec. Inlet flow reversal (FR) followed 0.72 sec later at 14.87 sec. The first of the cladding failures was detected 1.13 sec after FR. The helium fill gas contained in the fuel pin fission gas
