Final Report on TREAT Tests R4 and R5;
Seven-pin, Loss-of-flow Tests with Full-length,
Unirradiated FFTF-type Fuel Pins

Reactor Analysis and Safety Division
ARGONNE NATIONAL LABORATORY
9700 S. Cass Avenue
Argonne, Illinois 60439

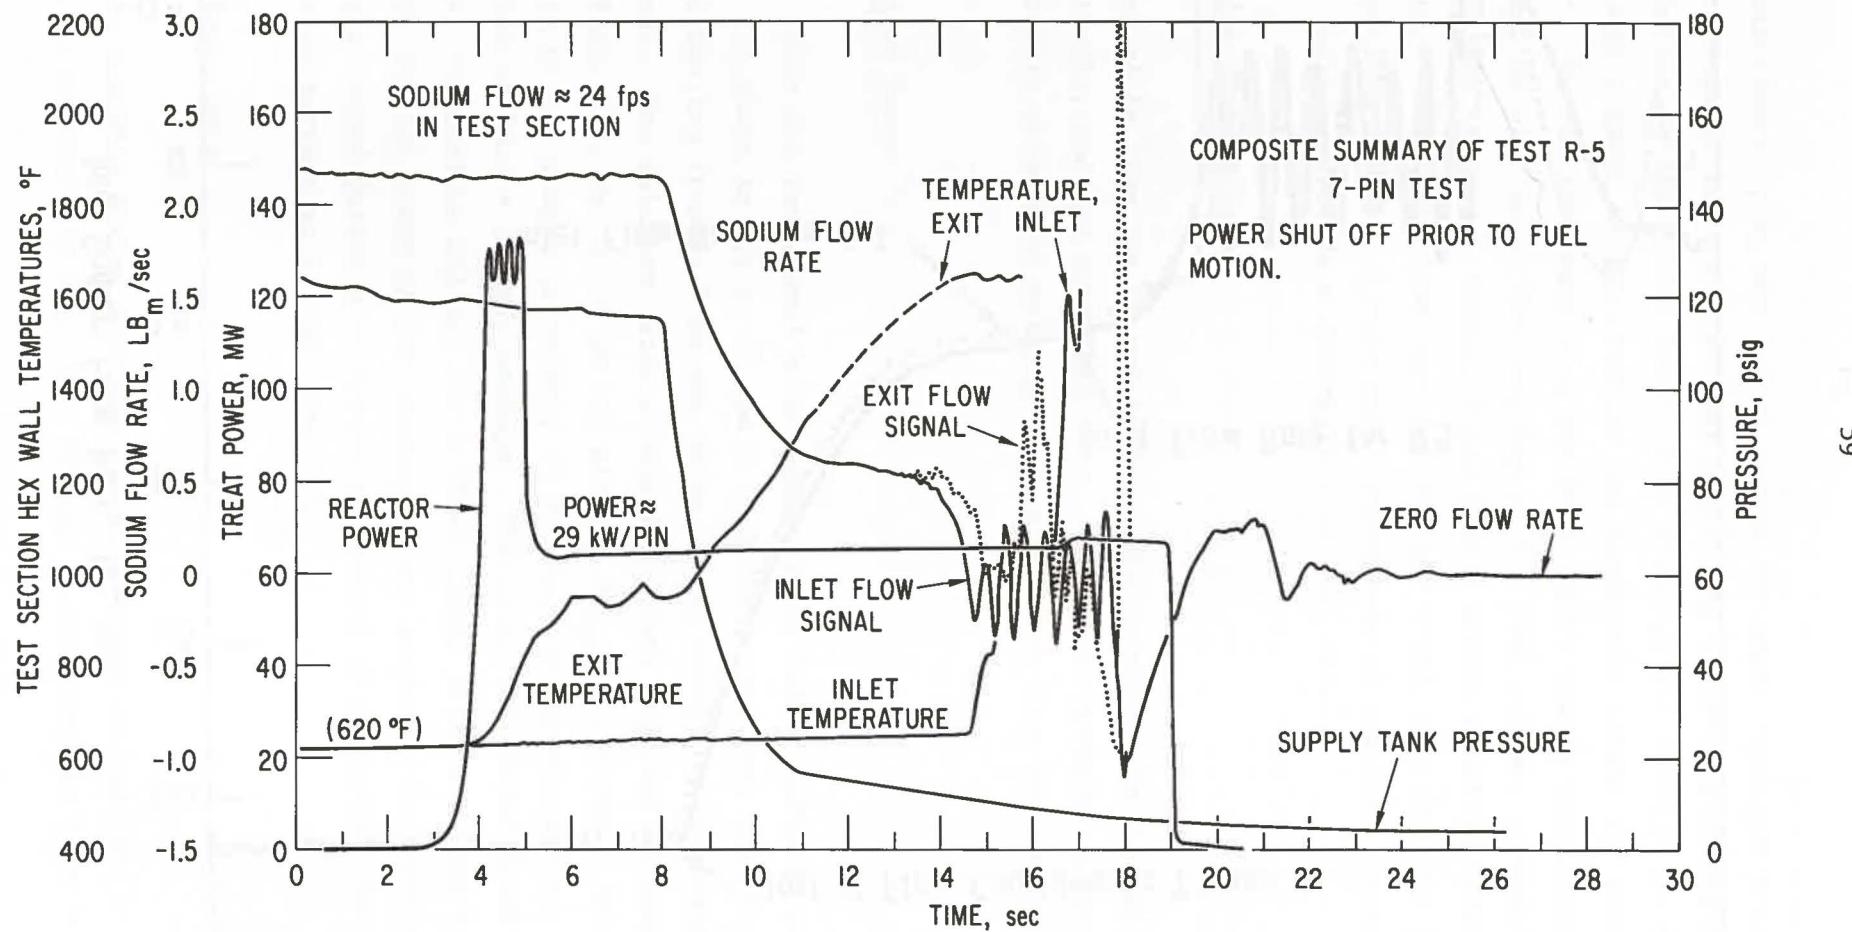
Fig. 27 Operating Sequence for R-Series Loss-of-flow Test R5 illustrating flow, power, temperature, and supply tank pressure variation during experiment sequence.

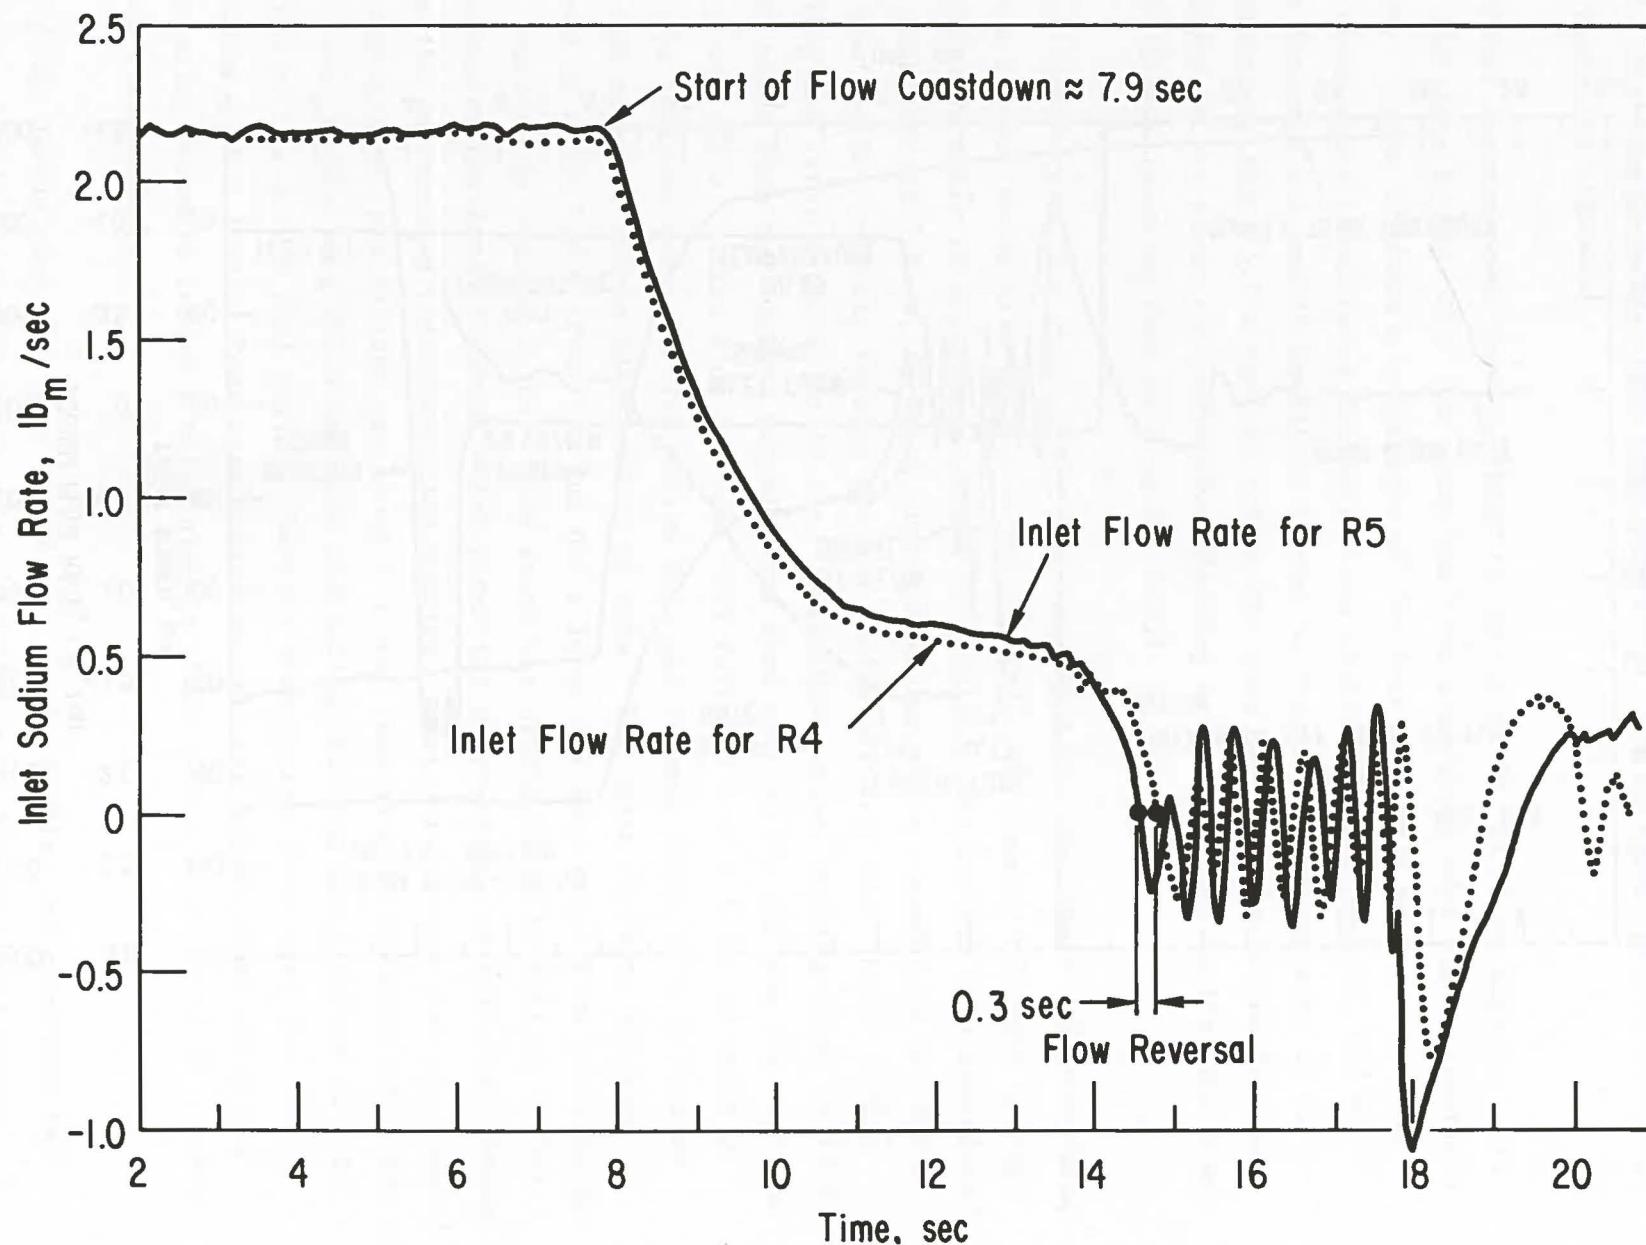
Fig. 28 Comparison of Inlet Flowrates for R4 and R5.

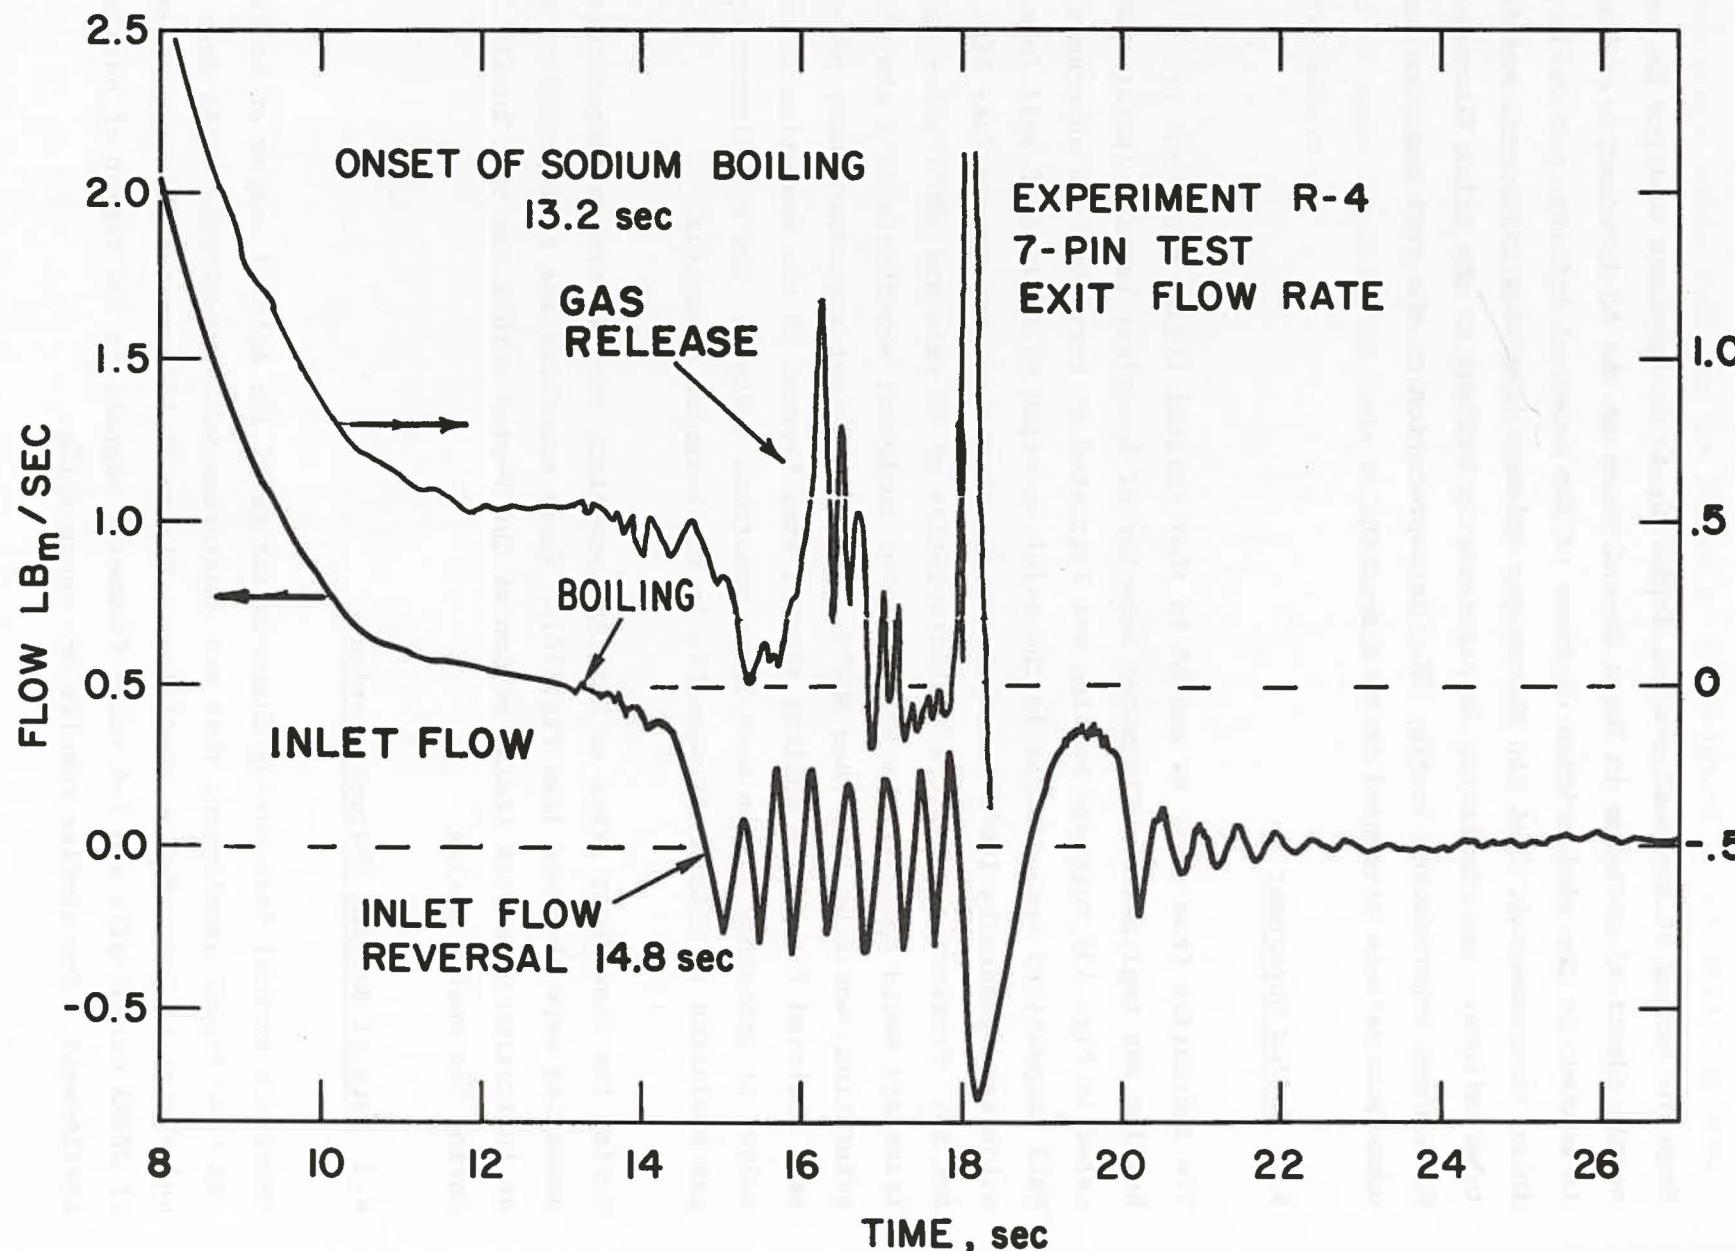
Fig. 35 Measured Inlet and Outlet Flowrate Behavior During Test R4.

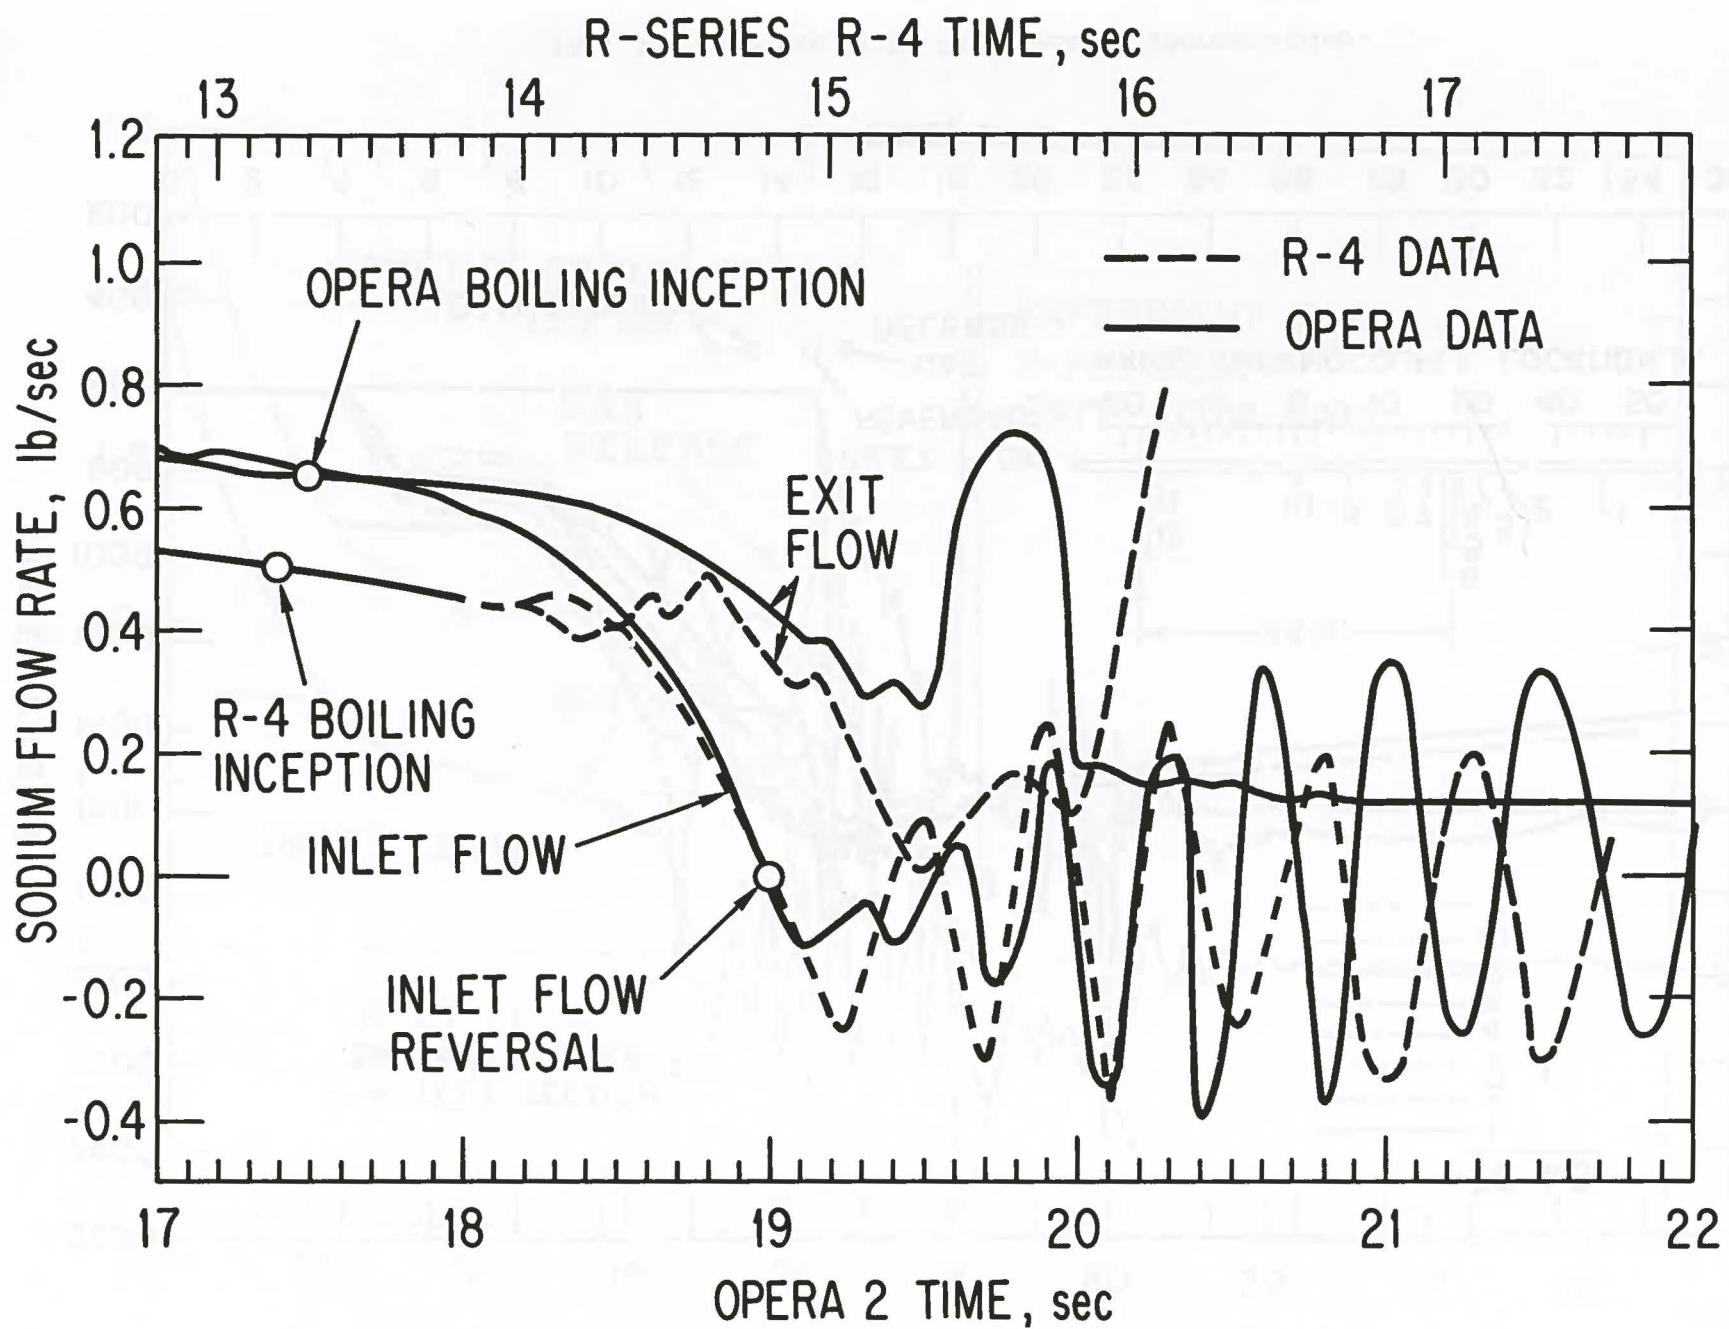
Fig. 37 Comparison of In-pile R4 and Out-of-pile OPERA Flow Rate Response at Boiling for Seven-pin Test Sections under Similar Loss-of-flow Conditions.

There are several interesting characteristics of the initial stages of boiling and flow regime development that are consistent with out-of-pile OPERA data under similar loss-of-flow conditions. Figure 37 illustrates the comparison of OPERA out-of-pile and R-4 inlet flowmeter signals in the region of boiling development. The similar results are encouraging.

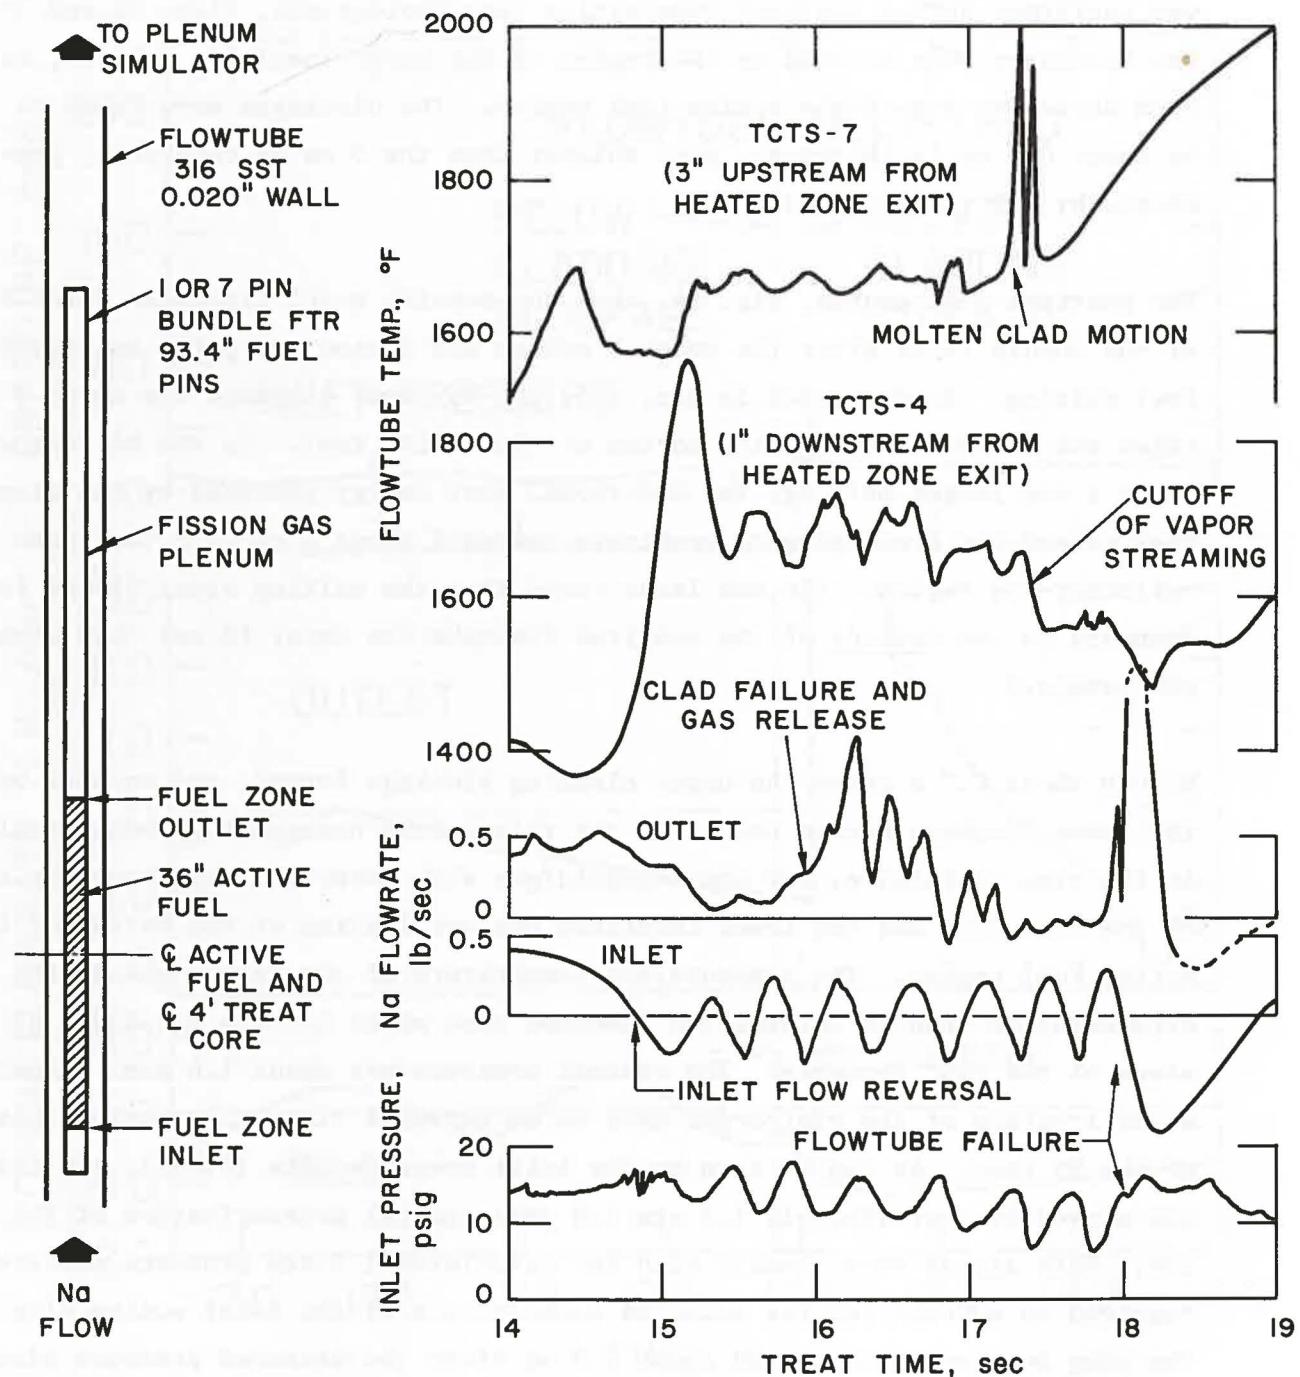
Fig. 39 Composite of R4 Test Data During Time Interval of Cladding Melting and Motion.

Figure 39 illustrates test data from R4 during the time interval of cladding melting and motion.²³ Two aspects of the thermocouple data are of special interest insofar as their implications about bundle events. First, with the onset of sodium voiding at about 14.4 sec, sodium vapor streaming becomes an important phenomenon within the bundle. Sodium vapor, produced in the lower region of the bundle, streams upward toward condensation sites in the pin plenum region. The estimated vapor velocity of up to 300 fps exceeds the flooding threshold for liquid sodium (wall film) or for molten stainless steel (cladding) by an appreciable margin. The vapor flow is oscillatory in nature due to the chugging behavior exhibited by the lower sodium slug (Fig. 39). As a consequence of the cyclic nature of the associated film motion and vapor condensation, the vapor streaming phenomenon is detectable by the wall thermocouples as a characteristic temperature oscillation. Hence, the occurrence of sodium vapor streaming is an event which is qualitatively detectable from the fast-response wall thermocouple. Secondly, at a time in the test sequence when SAS calculates the onset of cladding motion (about 1 sec after the cladding solidus temperature is reached), thermocouple TCTS-7, located 3 inches below the top of the fuel column, indicates a rapid transient heating event. This is interpreted as being caused by the motion of molten cladding material which accumulates and bridges to the flowtube wall. Additionally, thermocouple TCTS-5, at the top plane of the fuel column (not shown in Fig. 39), shows a similar heating event about 0.1 sec after the lower TC, suggesting a net upward motion of the molten material. However, thermocouple TCTS-4, located one inch above the heated zone in the colder insulator pellet region (Fig. 39), does not show such an event, suggesting that the molten material stopped its upward motion between these two measurement locations. This upper thermocouple indicates that at about this same time in the test sequence the cyclic wall temperature behavior is interrupted, suggesting that a cutoff of the vapor streaming has taken place. Hence, the thermocouple data provided indications of a) the time of molten cladding motion (first indication at 17.3 sec for R4 data), b) the initial progression of motion under the influence of sodium vapor

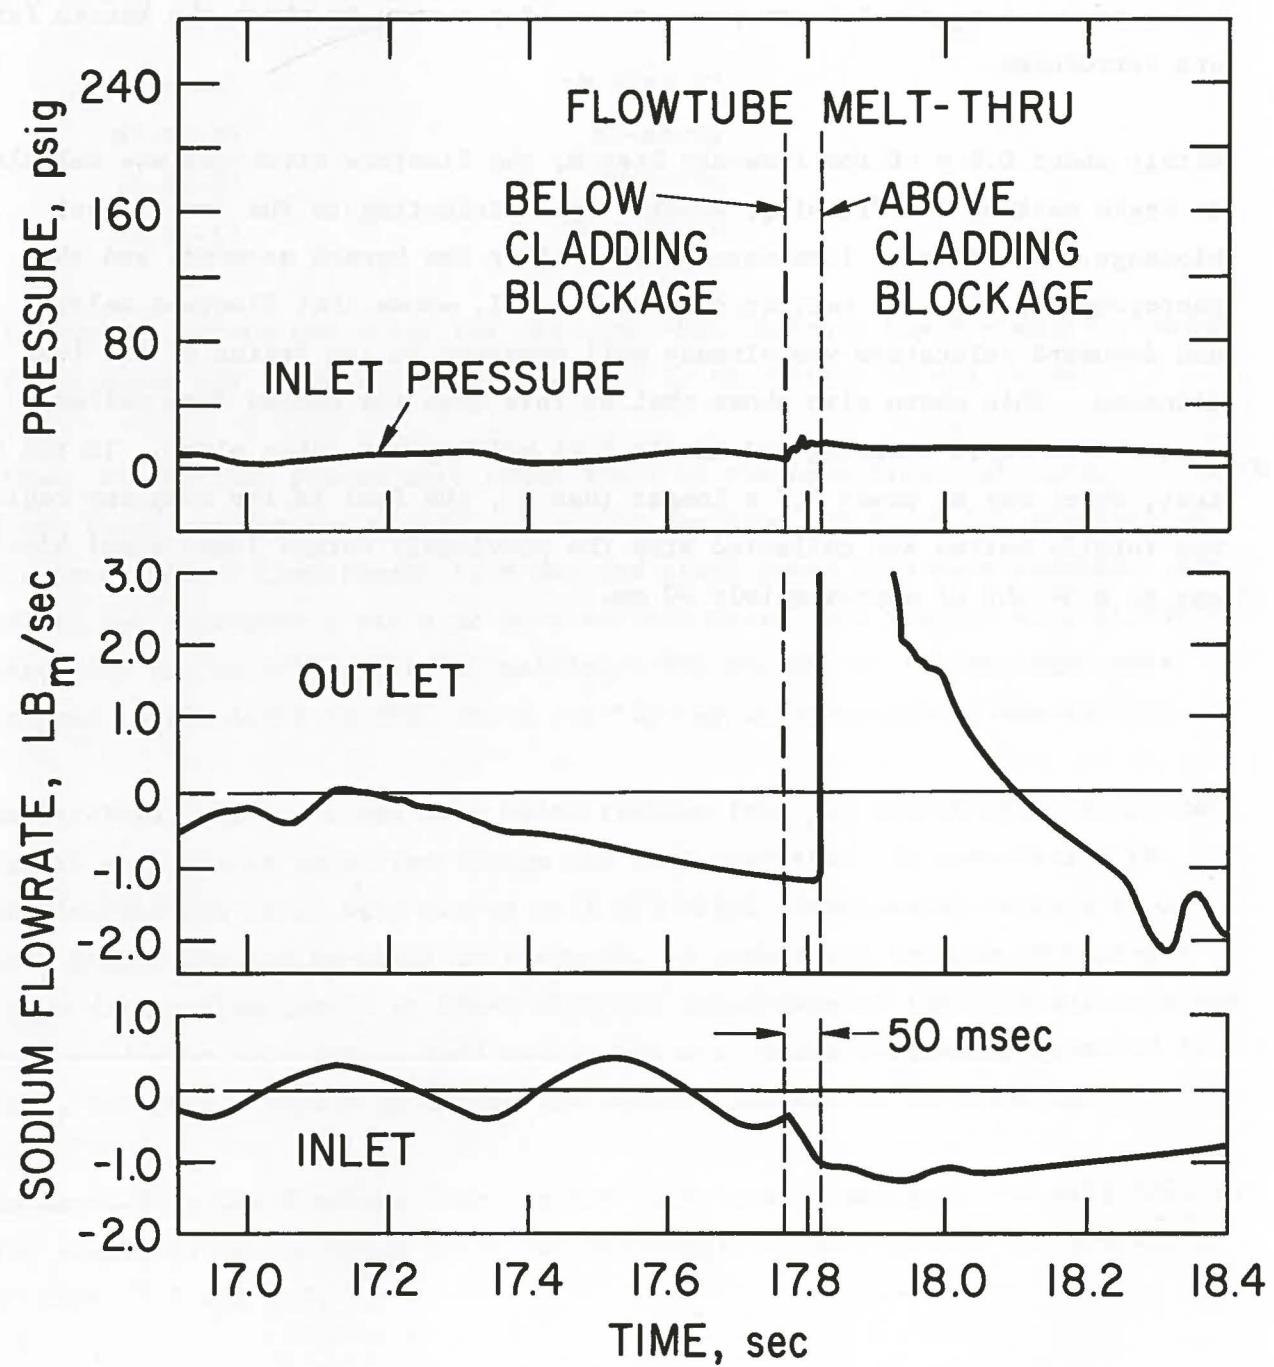
Fig. 40 Expanded View of R5 Visicorder Data Showing Flowrate and Pressure Behavior During Flowtube Failure.

Within about 0.7 s after the upper cladding blockage formed, and seconds before the lower blockage became complete, the thin-walled hexagonal flowtube failed. At the time of failure, the upper liquid/gas slug interface was above the tops of the fuel pins and the lower interface was oscillating at the bottom of the active fuel region. The pressure and temperature of the helium gas in the instrumentation annulus outside the flowtube were about 2.4 atm and 430°C at this stage of the test sequence. The channel pressure was about 1.4 atm. Figure 40 shows tracings of the visicorder data on an expanded time scale during this stage of the R5 test. As can be seen by the inlet pressure data (PTK-1), the failure was marked by approximately 1.3 atm (18 psi) channel pressurization at the inlet. This agrees very closely with the calculated 1.2 atm pressure difference required to account for the measured deceleration of the inlet sodium slug. The slug deceleration started about 2.5 ms after the measured pressure rise, which is approximately the acoustic-wave transit time from PTK-1 to the inlet flowmeter. Note in the figure that the measured acceleration of the upper sodium slug was delayed by 50 ms from the pressure rise. This delay is too long to be

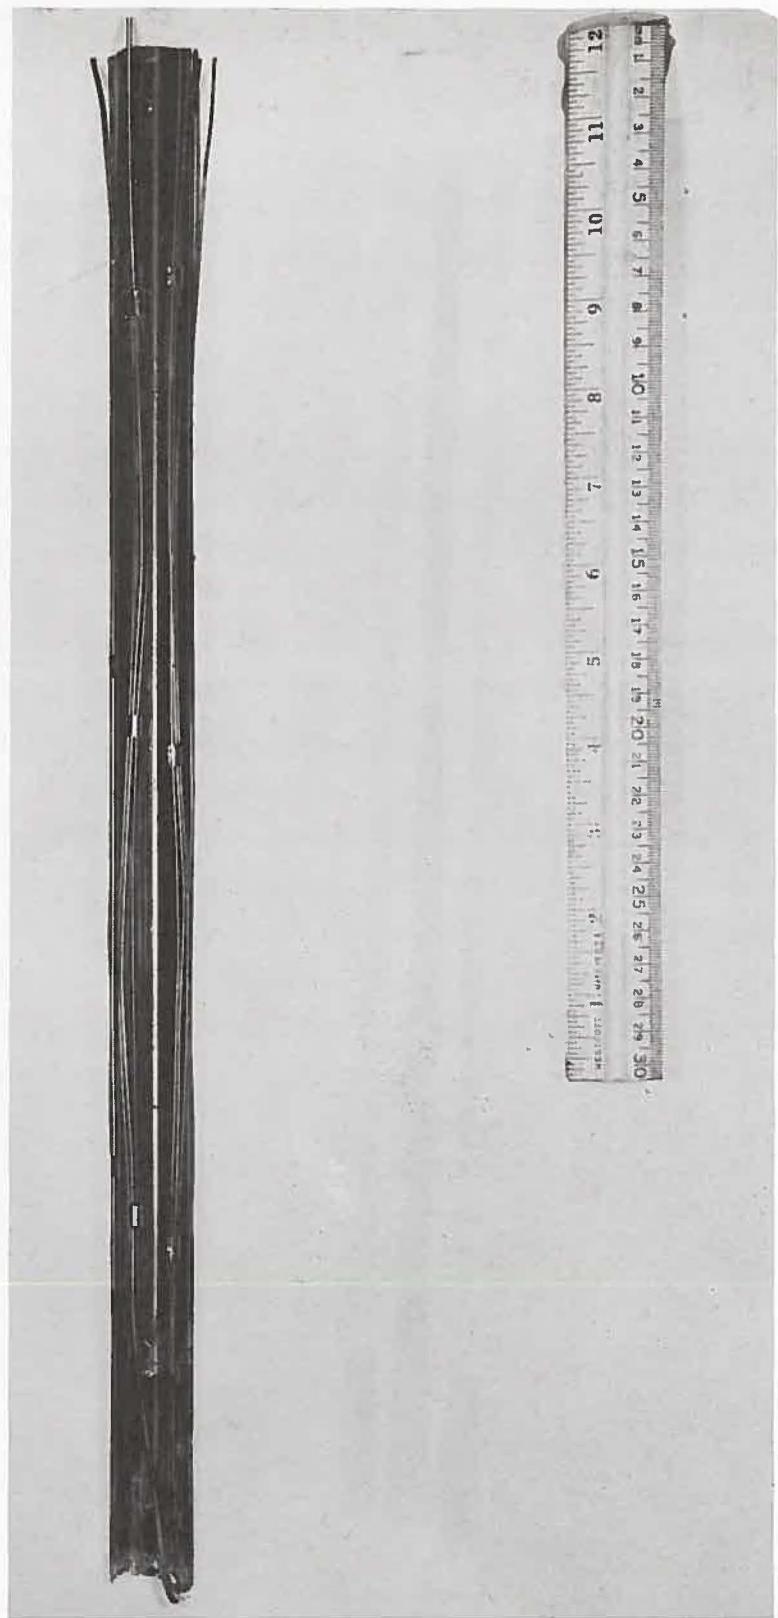
Fig. 43. The Hexagonal Flow Tube from Section 70-R4-40 with Lower End Melted off. Neg. No. MSD-183792.

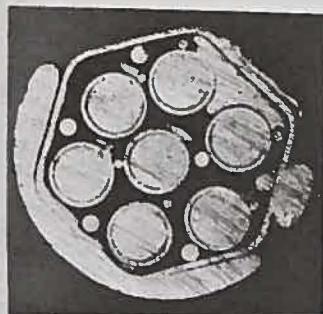
SECTION A. 4.8 CM BELOW
BOTTOM OF FUEL COLUMN.
REFLECTOR RODS IN ELEMENTS,
SOME MELTED STEEL.

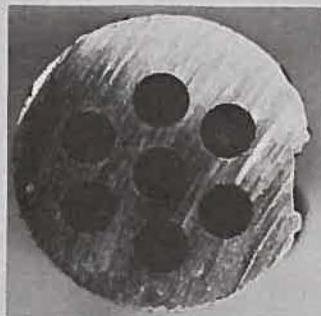
SECTION B. 0.6 CM ABOVE
BOTTOM OF FUEL COLUMN.
UNMELTED FUEL PELLETS IN
MATRIX OF STAINLESS STEEL.

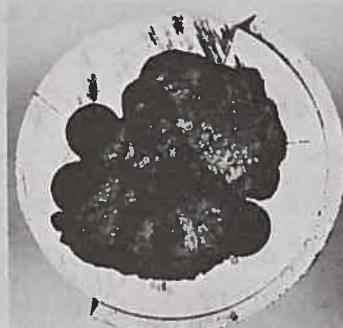
SECTION E. 18.1 CM ABOVE
BOTTOM OF FUEL COLUMN.
MELTED FUEL, PARTS OF
PELLETS IN STEEL MATRIX.

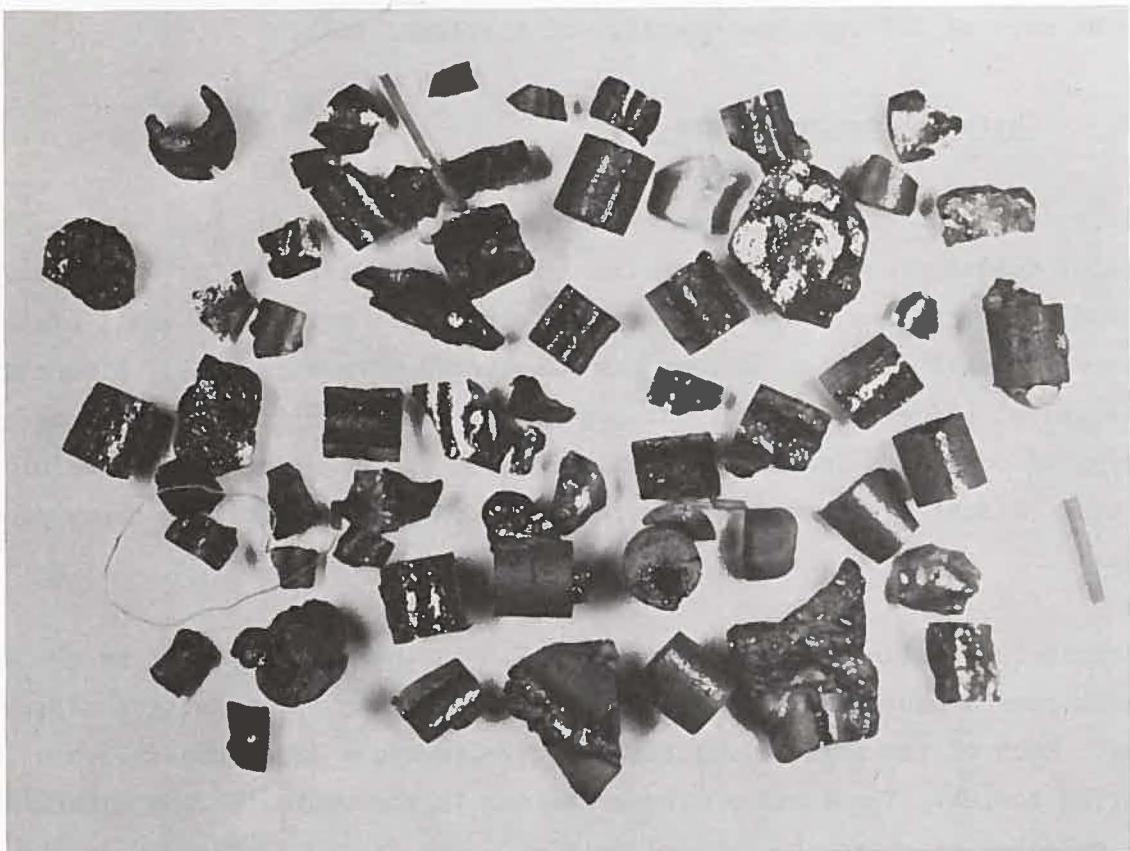
Fig. 46 Pellets and Pellet Fragments from Section 70-R4-40. Neg. No. MSD-183616.

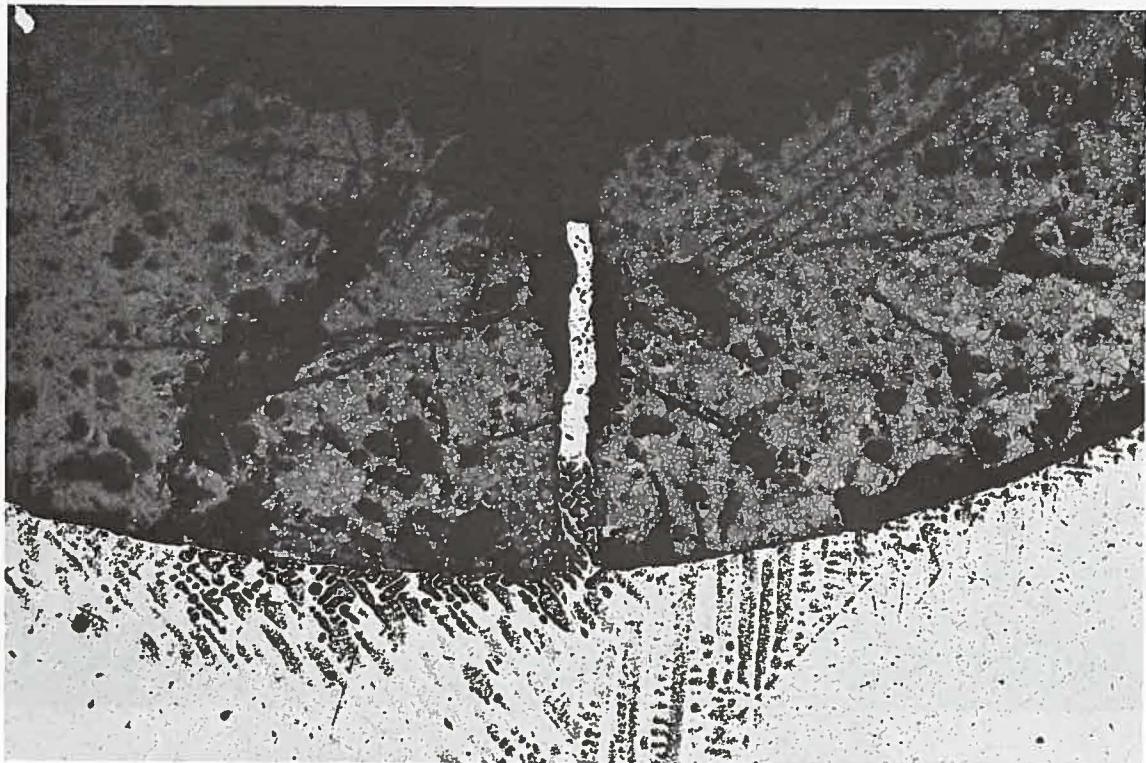
Fig. 57 Stringer of Steel Extending from Pool of Steel into
Unmelted Fuel. Neg. No. MSD-185647. 75X.

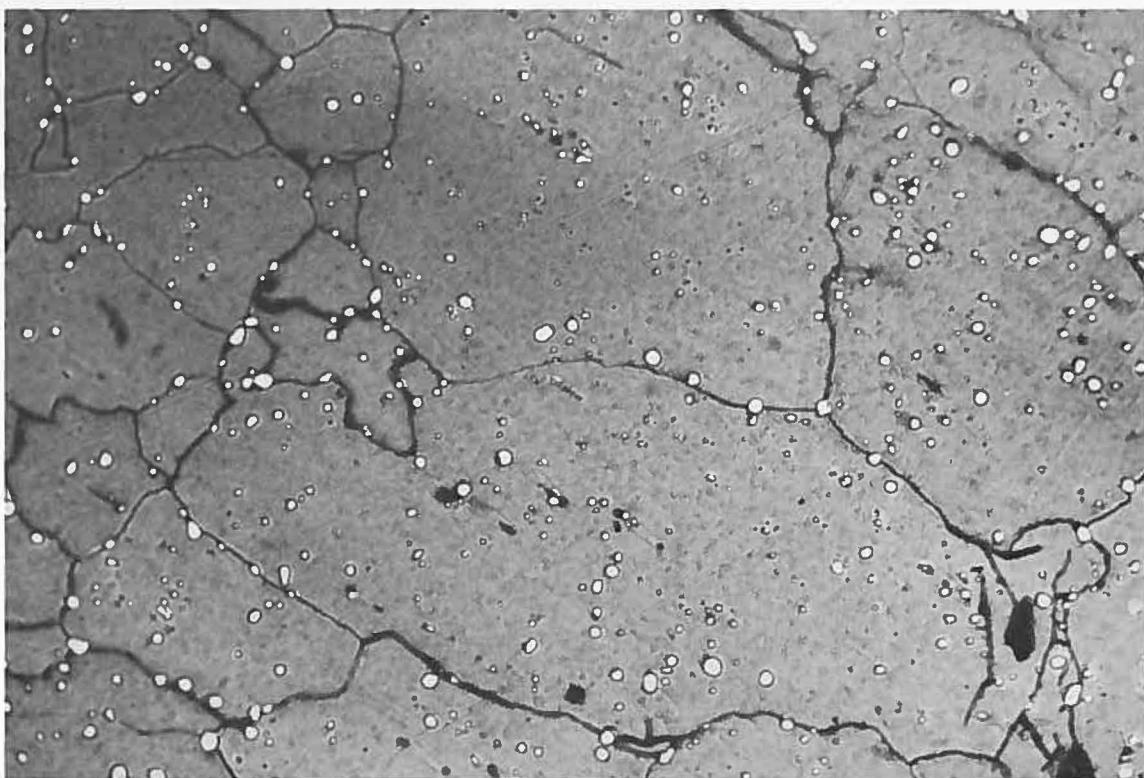
Fig. 63 Melted Fuel with Globules of Stainless Steel Dispersed Throughout. Neg. No. MSD-185244. 250X Etched.

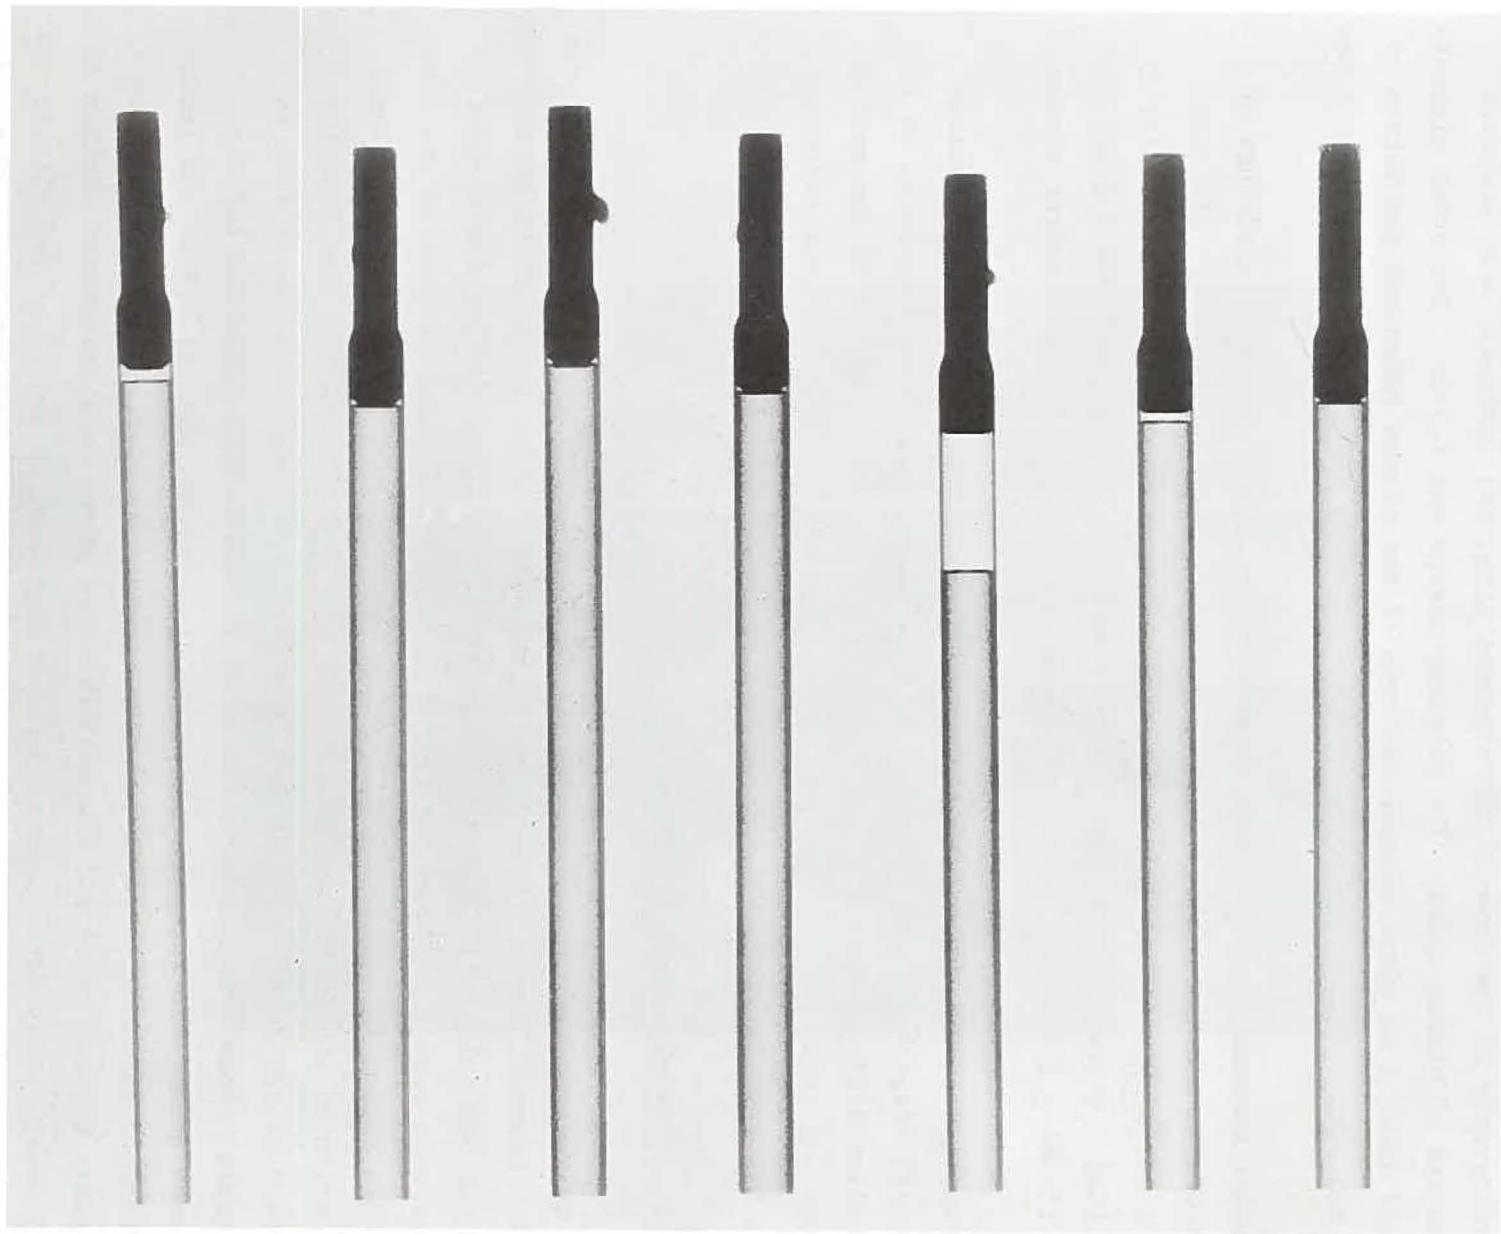
Fig. 64 X-radiographs Showing Location of Spacer Tubes and Relative Positions of the Tops of the Elements. Neg. No. MSD-185671. $\sim 1\frac{1}{4}$ X.

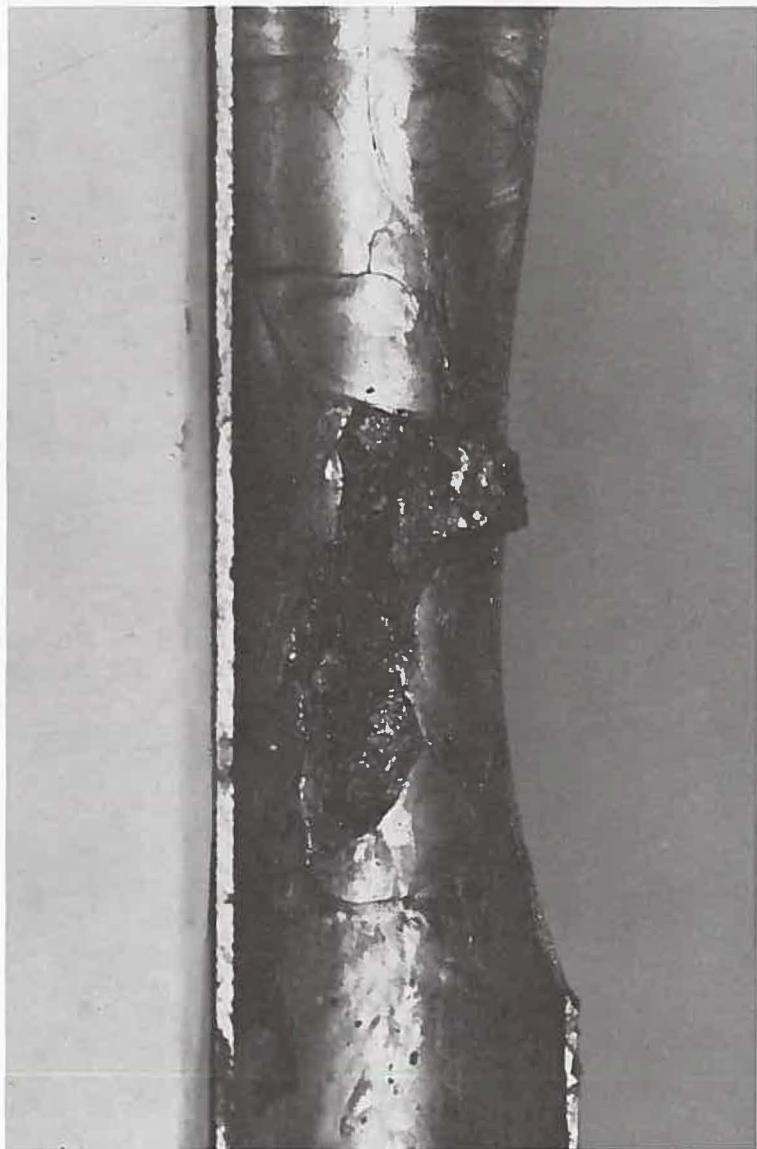
Fig. 65 Inner Surface of Molybdenum Tube from Section 40-R4-17
Showing Fuel and Steel. Neg. No. MSD-183806. $1\frac{1}{2}$ X.

The molybdenum heat shield tube appeared to be intact at the conclusion of the test. However, during disassembly the molybdenum tube proved to be quite brittle and relatively easy to break toward the top of the Section 40-R4-17. There were some visual indications of cracks on the outer surface of the tube in this region (upward from about 10 cm above the bottom of the fuel column). A section of the broken molybdenum tube is shown in Fig. 65. The interior surface of the tube has reacted with molten steel and a section of fuel is attached. Some thinning of the wall of the tube (~10%) occurred locally. In some areas thin irregular platelets of metal had spalled off of the inside surface of the tube where it had been attacked by steel. The nature of the boundary between steel and the molybdenum is shown in a transverse section in Fig. 66(a). Molybdenum appears to have dissolved in the steel and altered the character of the steel. The molybdenum itself has completely recrystallized to equiaxed grains as can be seen in the right side of the figure. For comparison a transverse section of the molybdenum tube from the top of section 92-R4-70 is shown in Fig. 66(b). The grain structure at this location does not

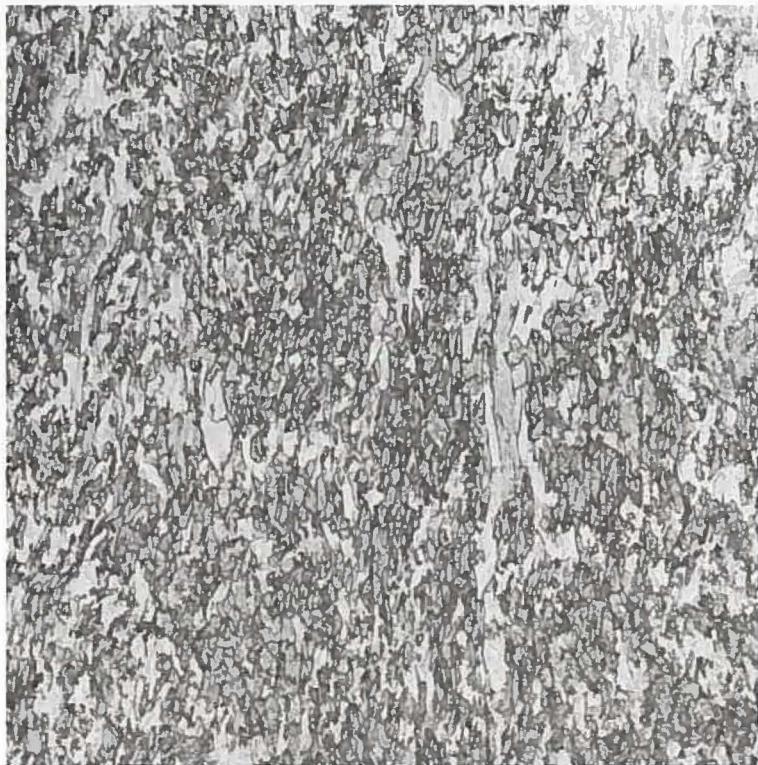
Fig. 66(b). Microstructure of Molybdenum Tube from Top of Section 92-R4-70. Neg. No. MSD-184778. 150X Etched.
