Final Report on TREAT Tests R4 and R5;
Seven-pin, Loss-of-flow Tests with Full-length,
Unirradiated FFTF-type Fuel Pins

Reactor Analysis and Safety Division
ARGONNE NATIONAL LABORATORY
9700 S. Cass Avenue
Argonne, Illinois 60439

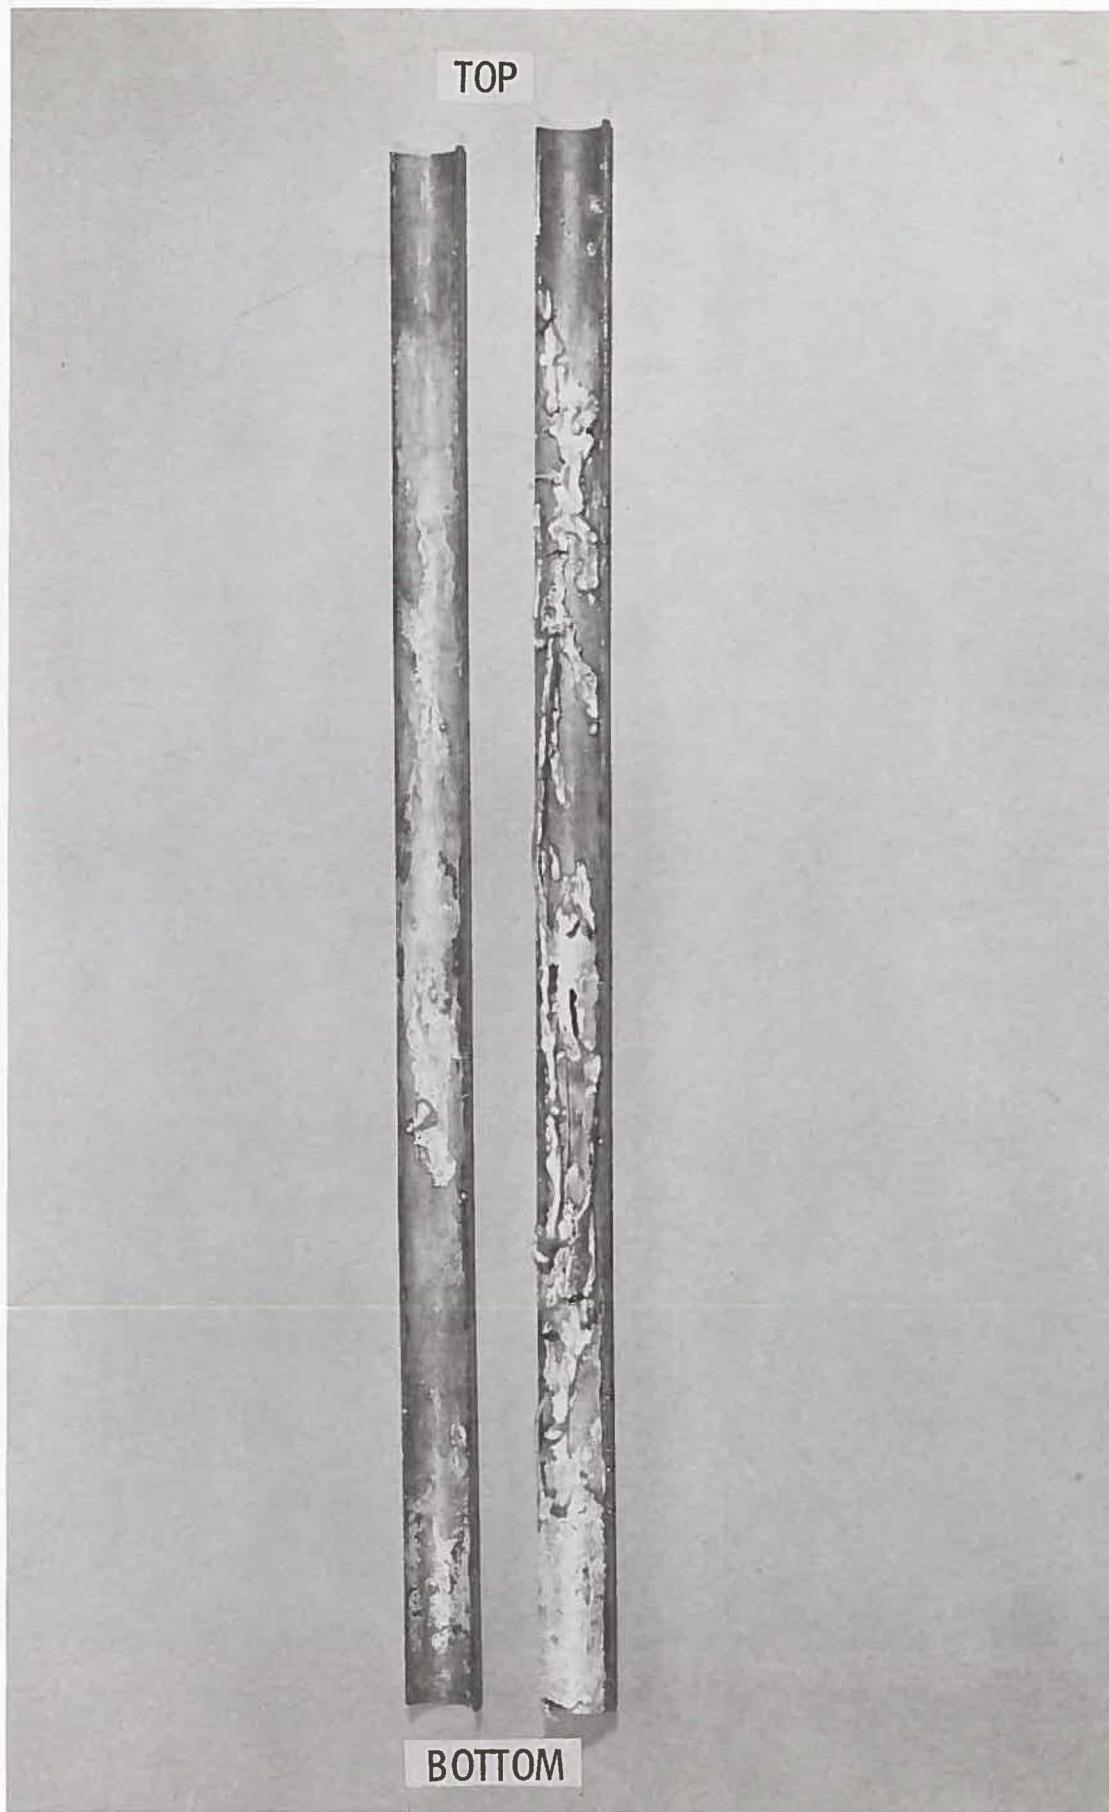
Fig. 70 Split Molybdenum Tube with Melted Stainless Steel on Inside Surface. Section 60-R5-36.5. Neg. No. MSD-185605.

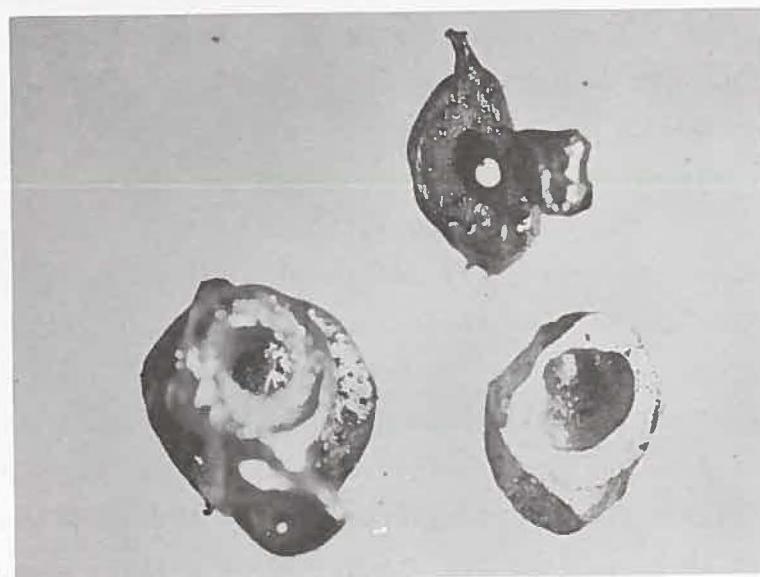
Fig. 74 Globules of Melted Steel
from Section 60-R5-36.5.
Neg. No. MSD-185638. 5X.

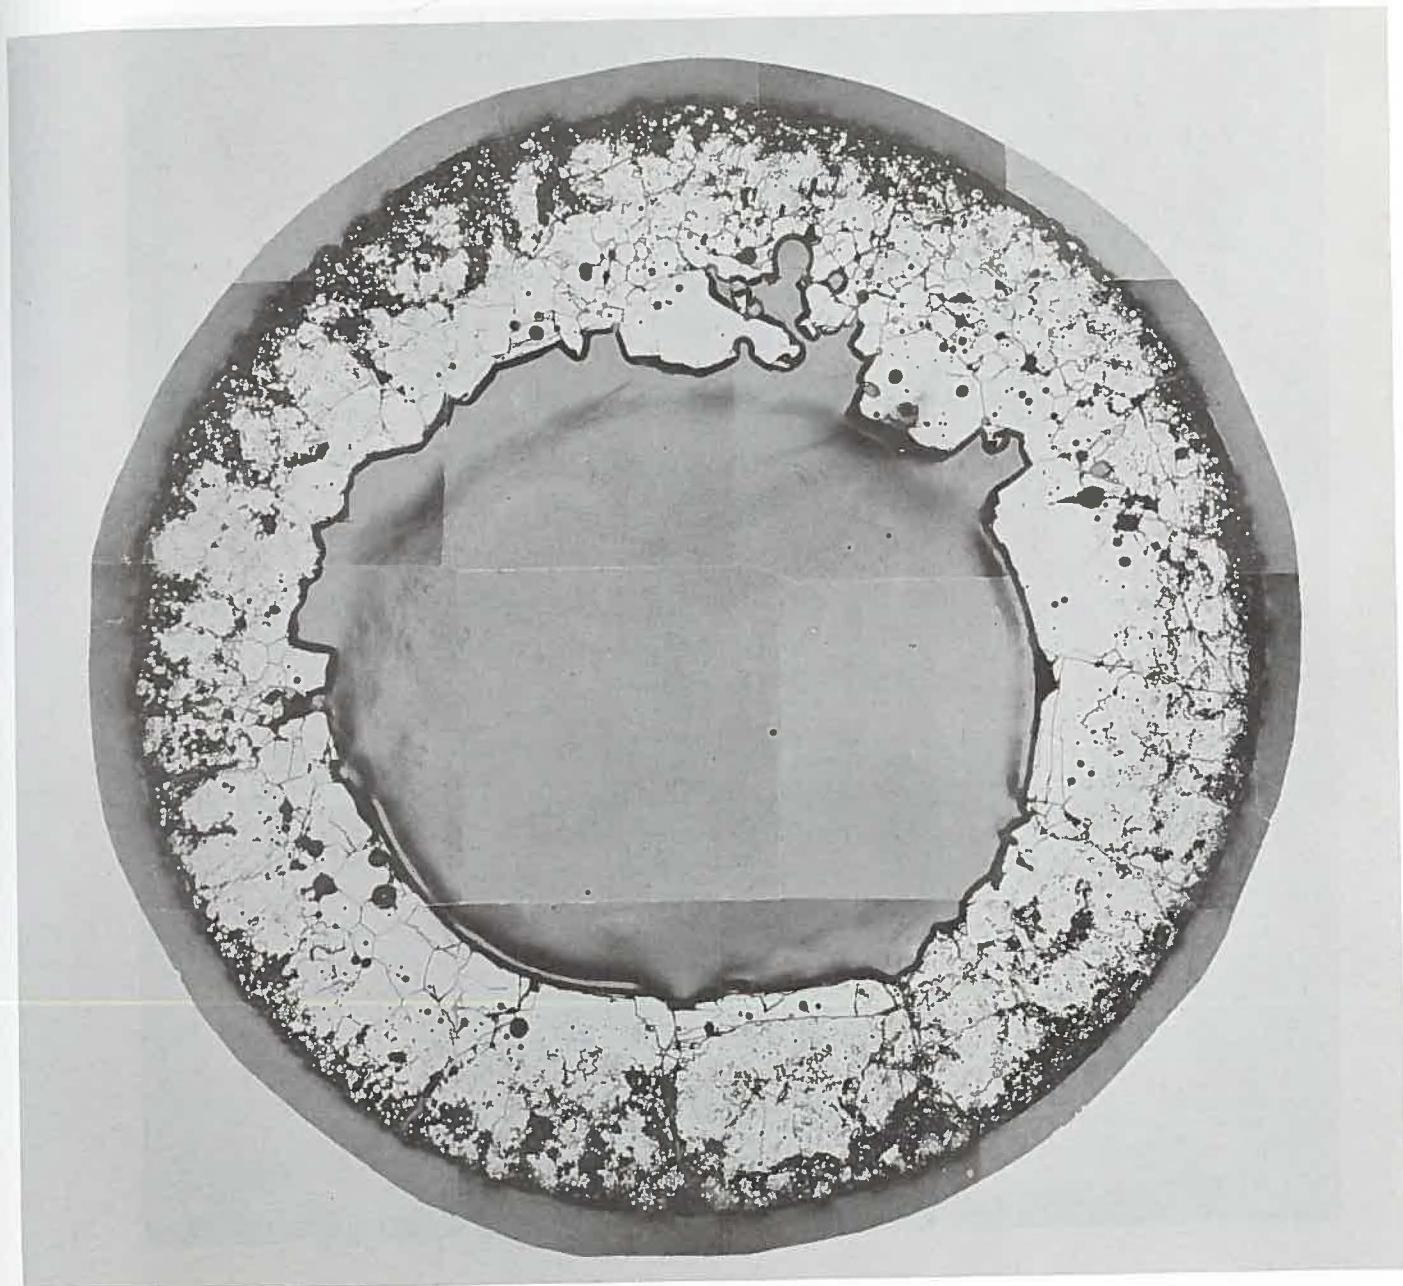
Fig. 75 Transverse Section of Fuel Pellet with Center Melting and Central Void. Neg. No. MSD-186350. ~30 X.

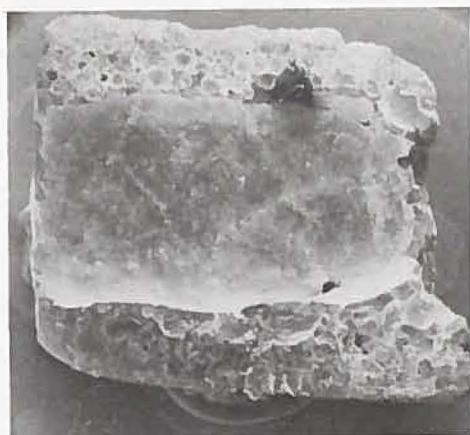
(a) Piece of a pellet showing surface of central void and bubbles on fractured surface
Mag. 12X

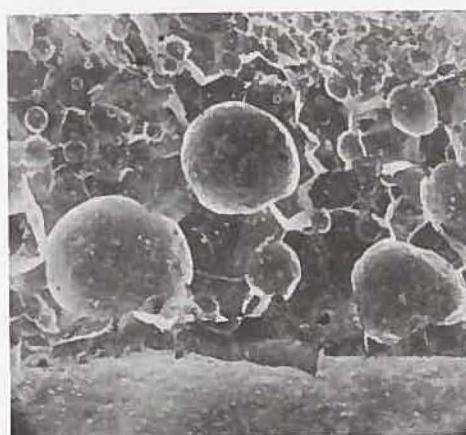
(b) Bubbles on fractured surface of fuel pellet.
Mag. 46X

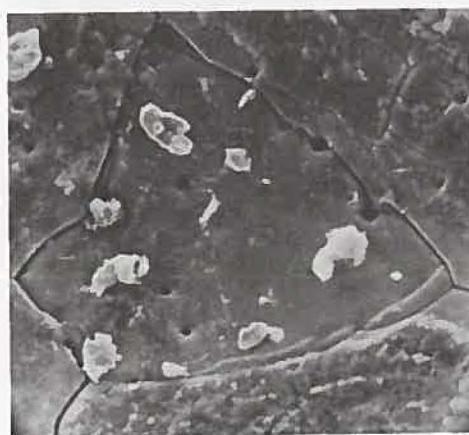
(c) Surface of a bubble in fuel showing "vent" holes.
Mag. 1300X

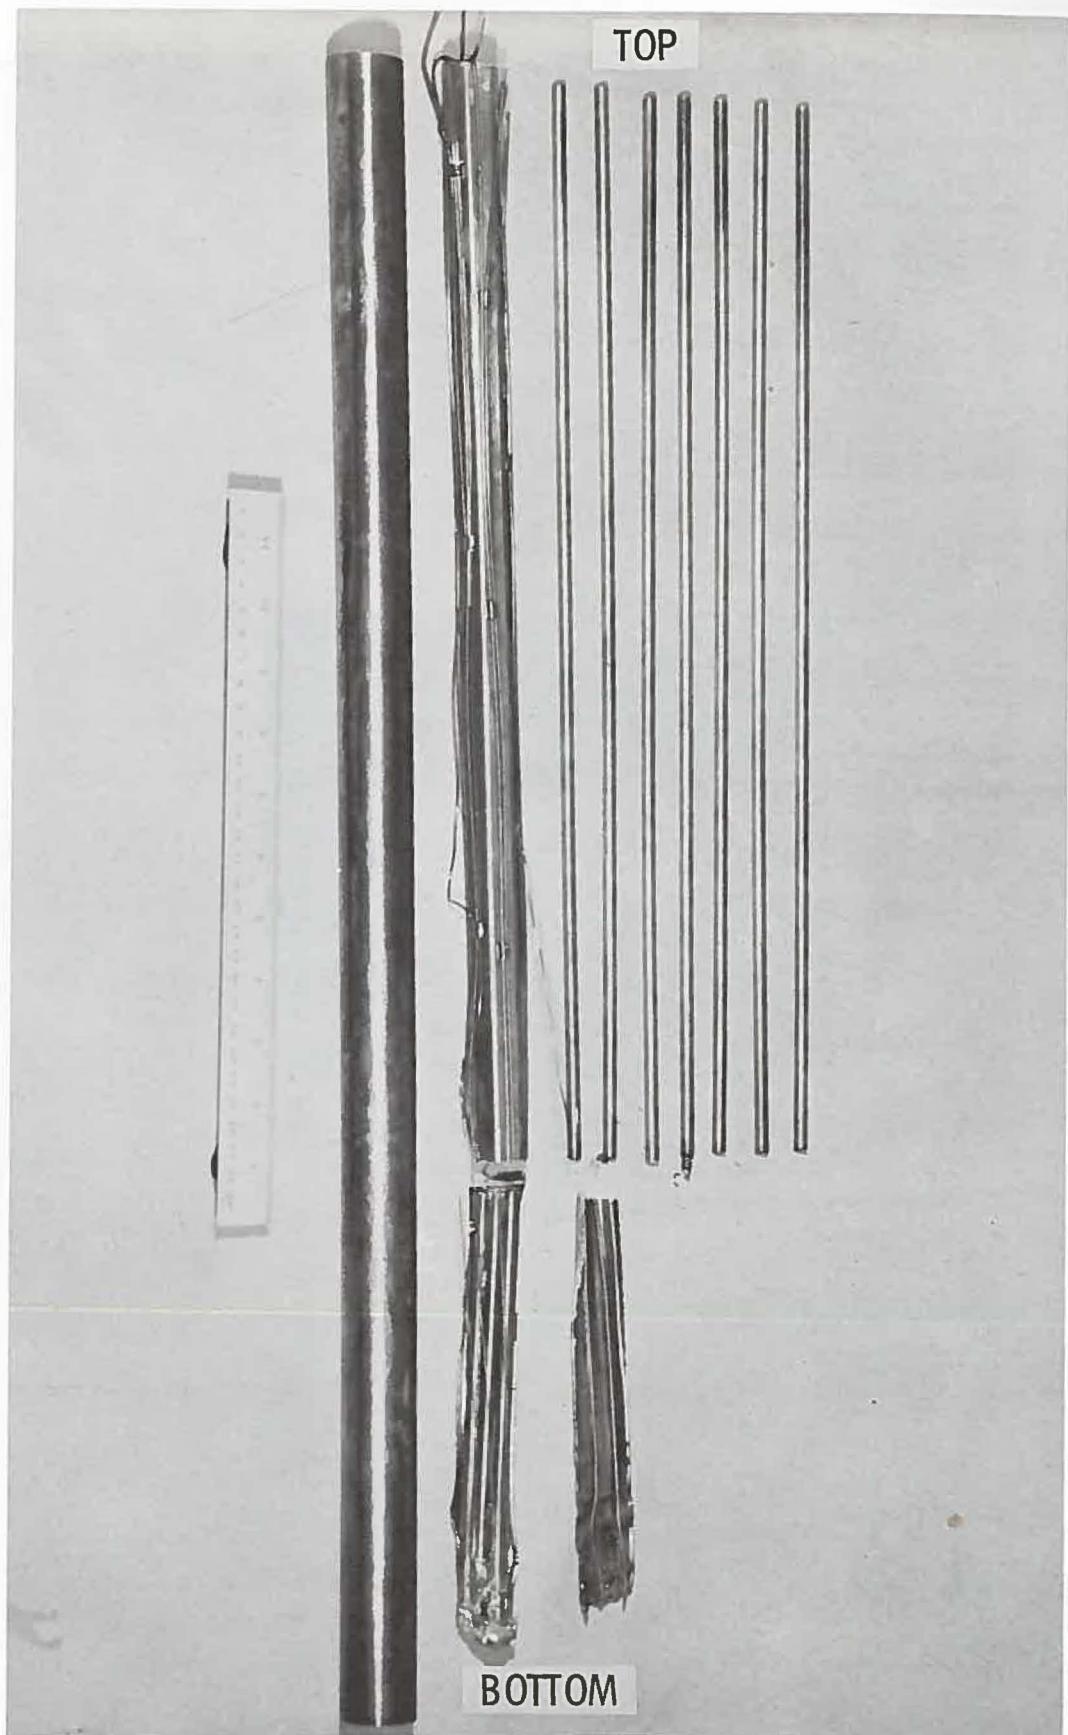
Fig. 81 Section 87-R5-60 Partly Disassembled.
Neg. No. MSD-185603.

It appears that the stainless steel from the hexagonal flow tube and the cladding and spacer wires of the elements completely melted over the upper two-thirds of the fuel columns and flowed downward, finally freezing around the lower portion of the fuel columns within the hexagonal tube. A plug of steel to a depth of 7 or 8 cm resulted from the flow of melted metal. Although the spaces between fuel columns are filled with melted steel at this location, the irregularities of the outline indicated that flow channels probably existed along the wall of the flow tube. The bottom blockage does not seem to have been complete.

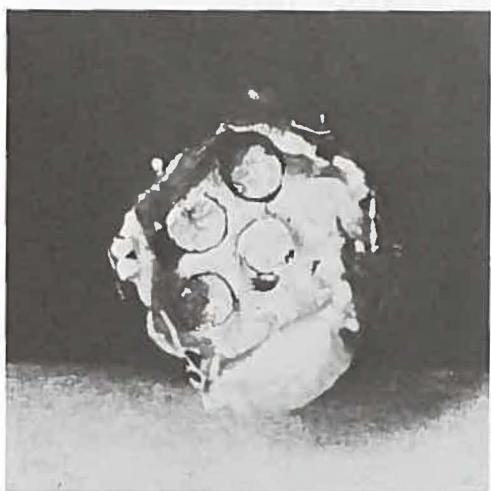
(a) Bottom view of upper blockage. 1 X.

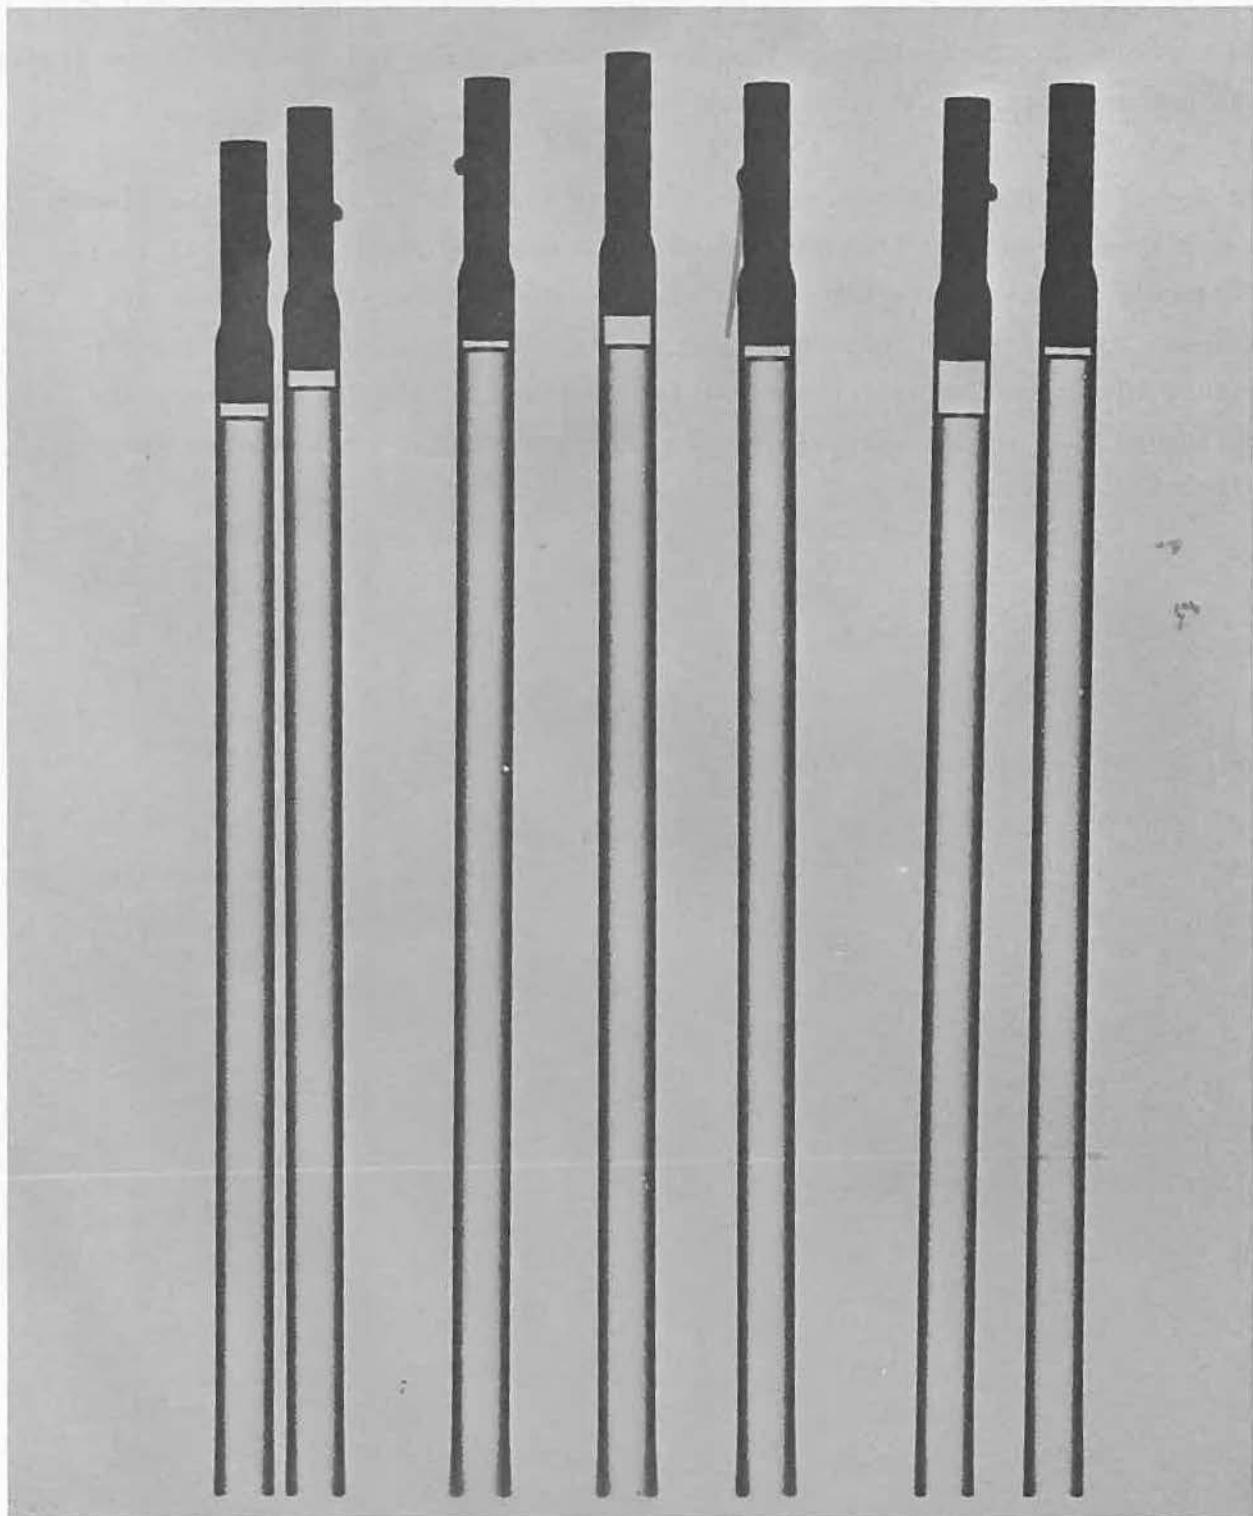
Fig. 87 X-ray Radiograph of the Tops of the Fuel Elements

An X-radiograph of the tops of the elements (Fig. 87) shows that the plenum tubes have moved away from the end cap by a maximum of 0.58 cm (0.23 in.). These displacements are matched in part by the relative displacement of insulator pellets and reflector rods in Fig. 88. Some sodium was found within the pins up around the reflector rods and in some cases around the springs. This sodium probably entered the pins during the cooldown stage after the test.

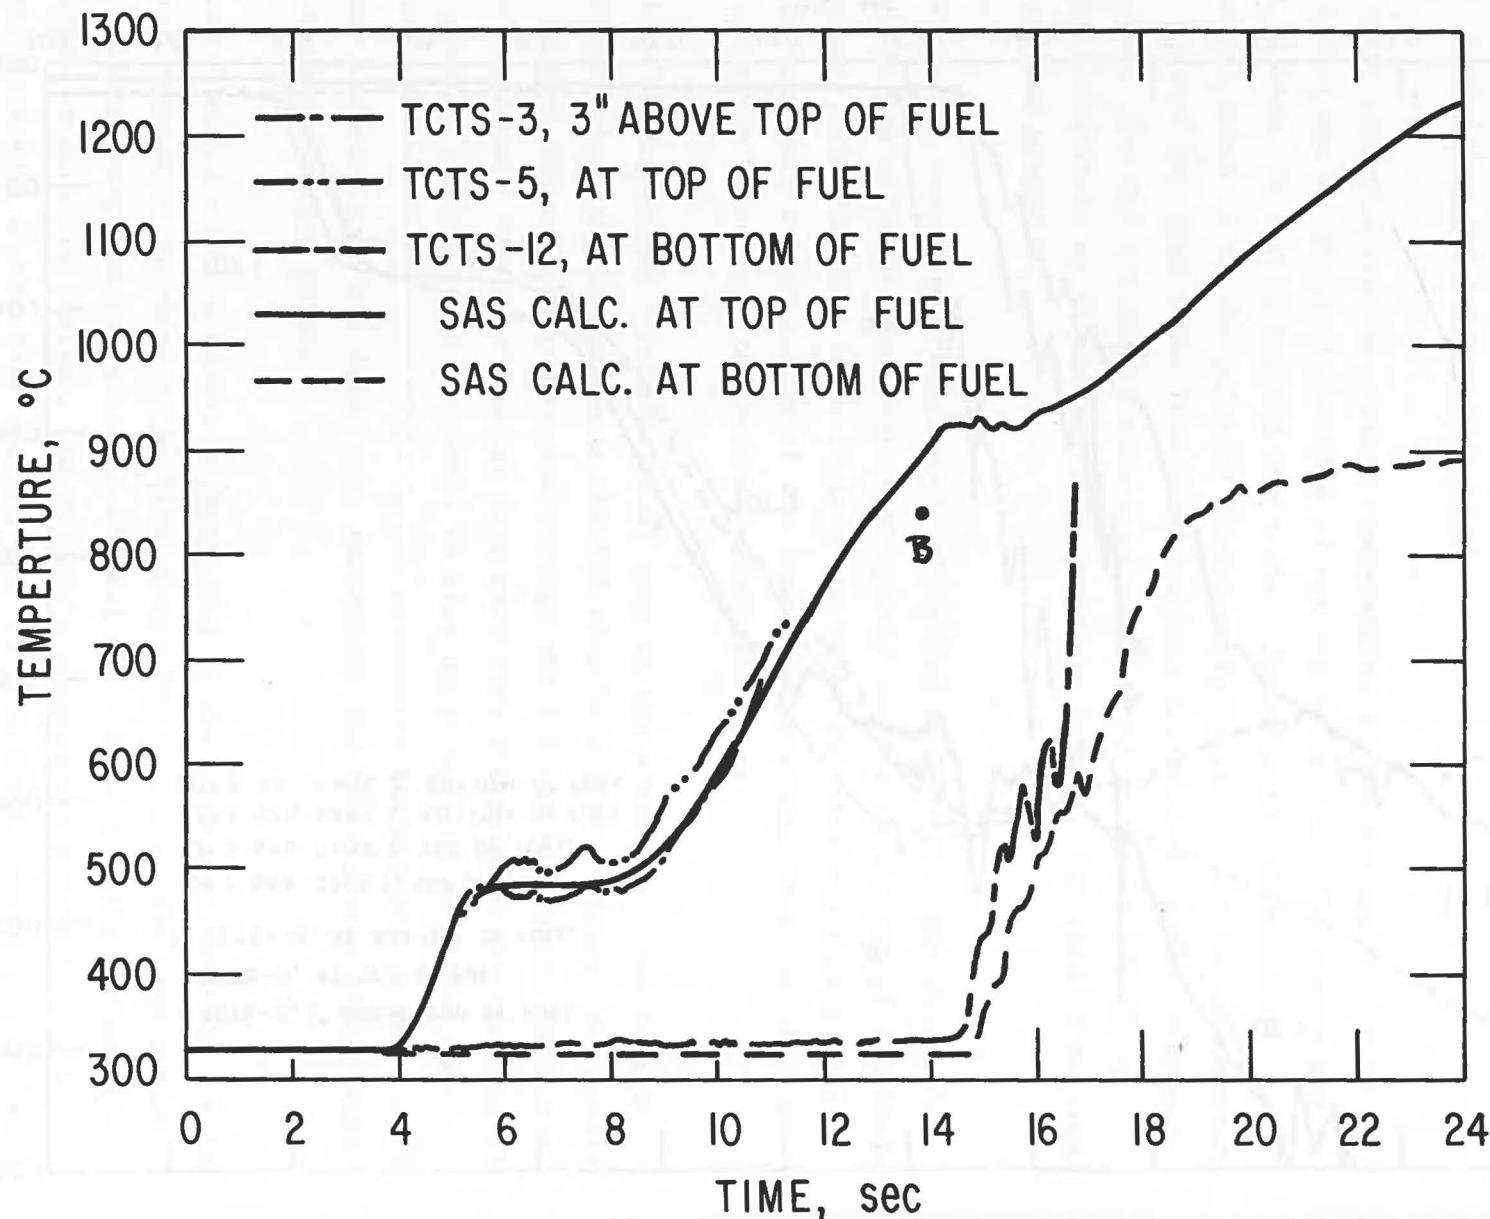
Fig. 93 R5 Coolant Temperature Comparison

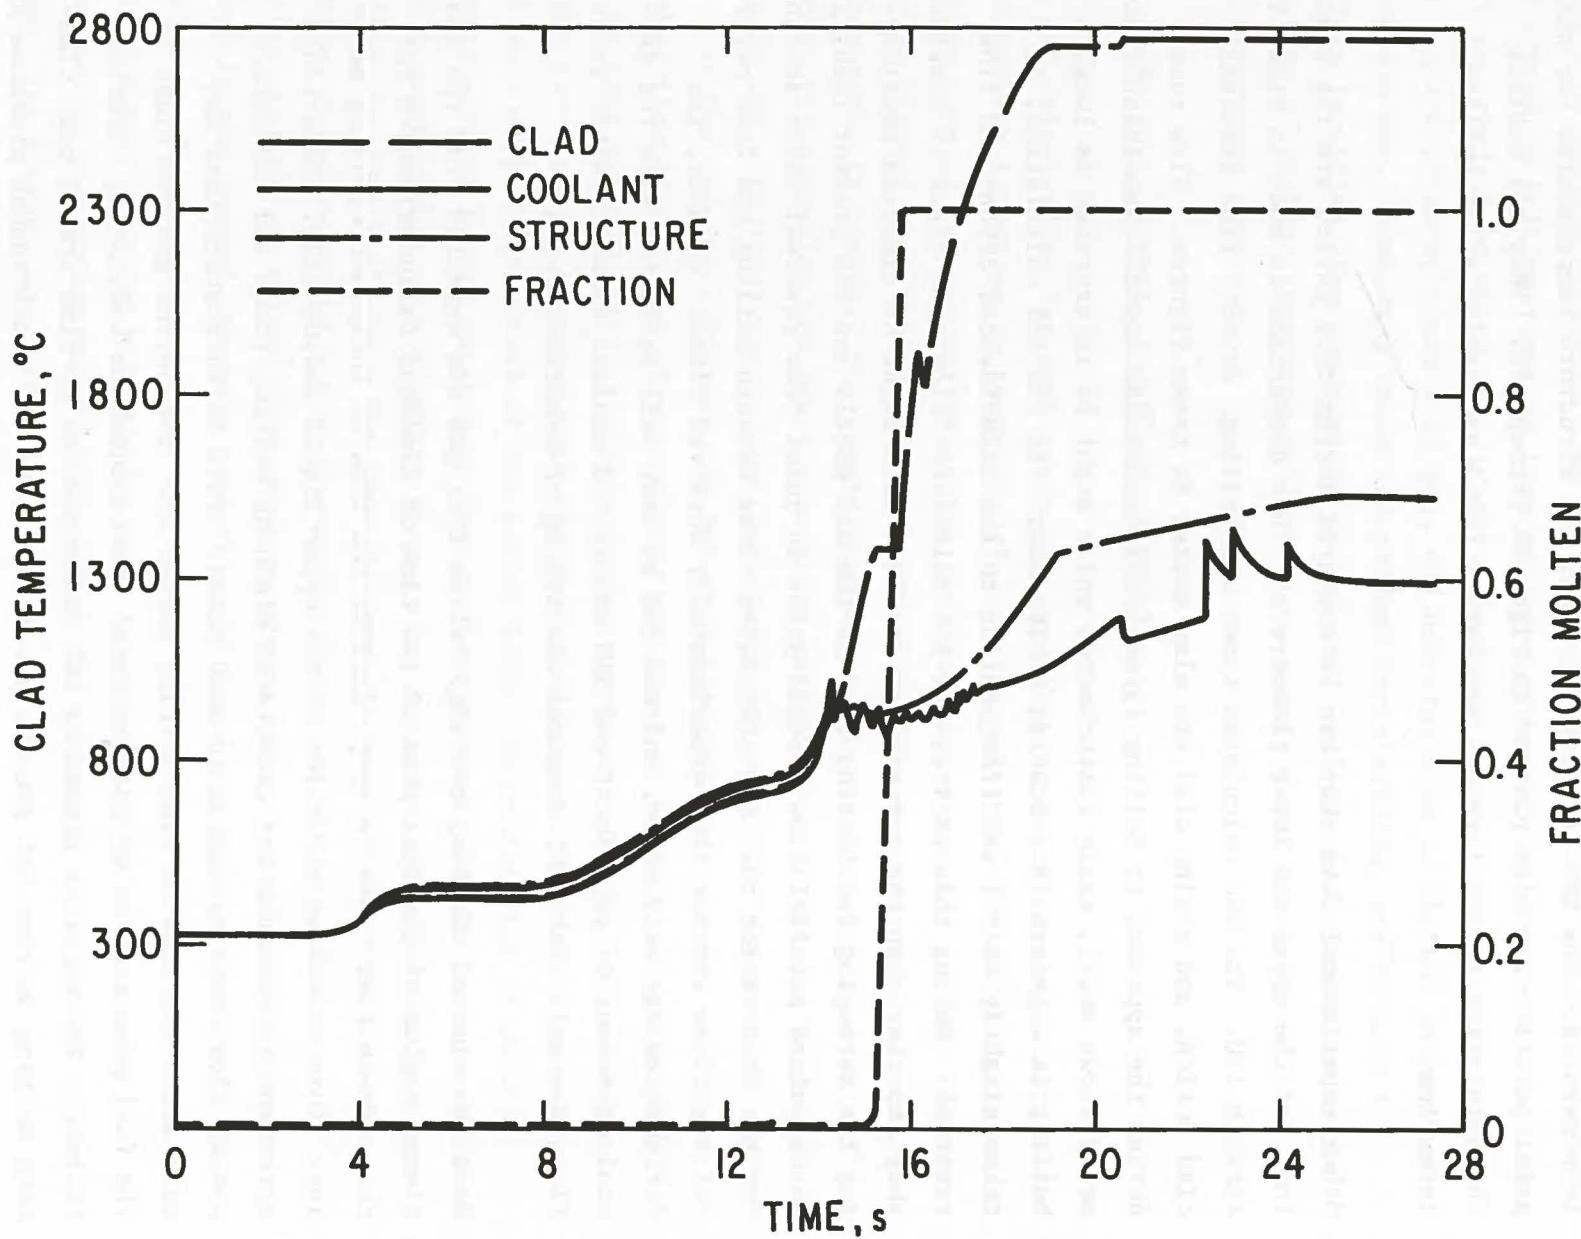
Fig. 94 R4 Temperature Conditions at 74.6 cm for SAS Case 1 (Low Heat Loss)

R4 ANALYSIS, 62MW=28KW/PIN, FM, CM, SLMP
CLAD CONDITIONS VS TIME
CHANNEL NUMBER 1 POSITION = 74.6

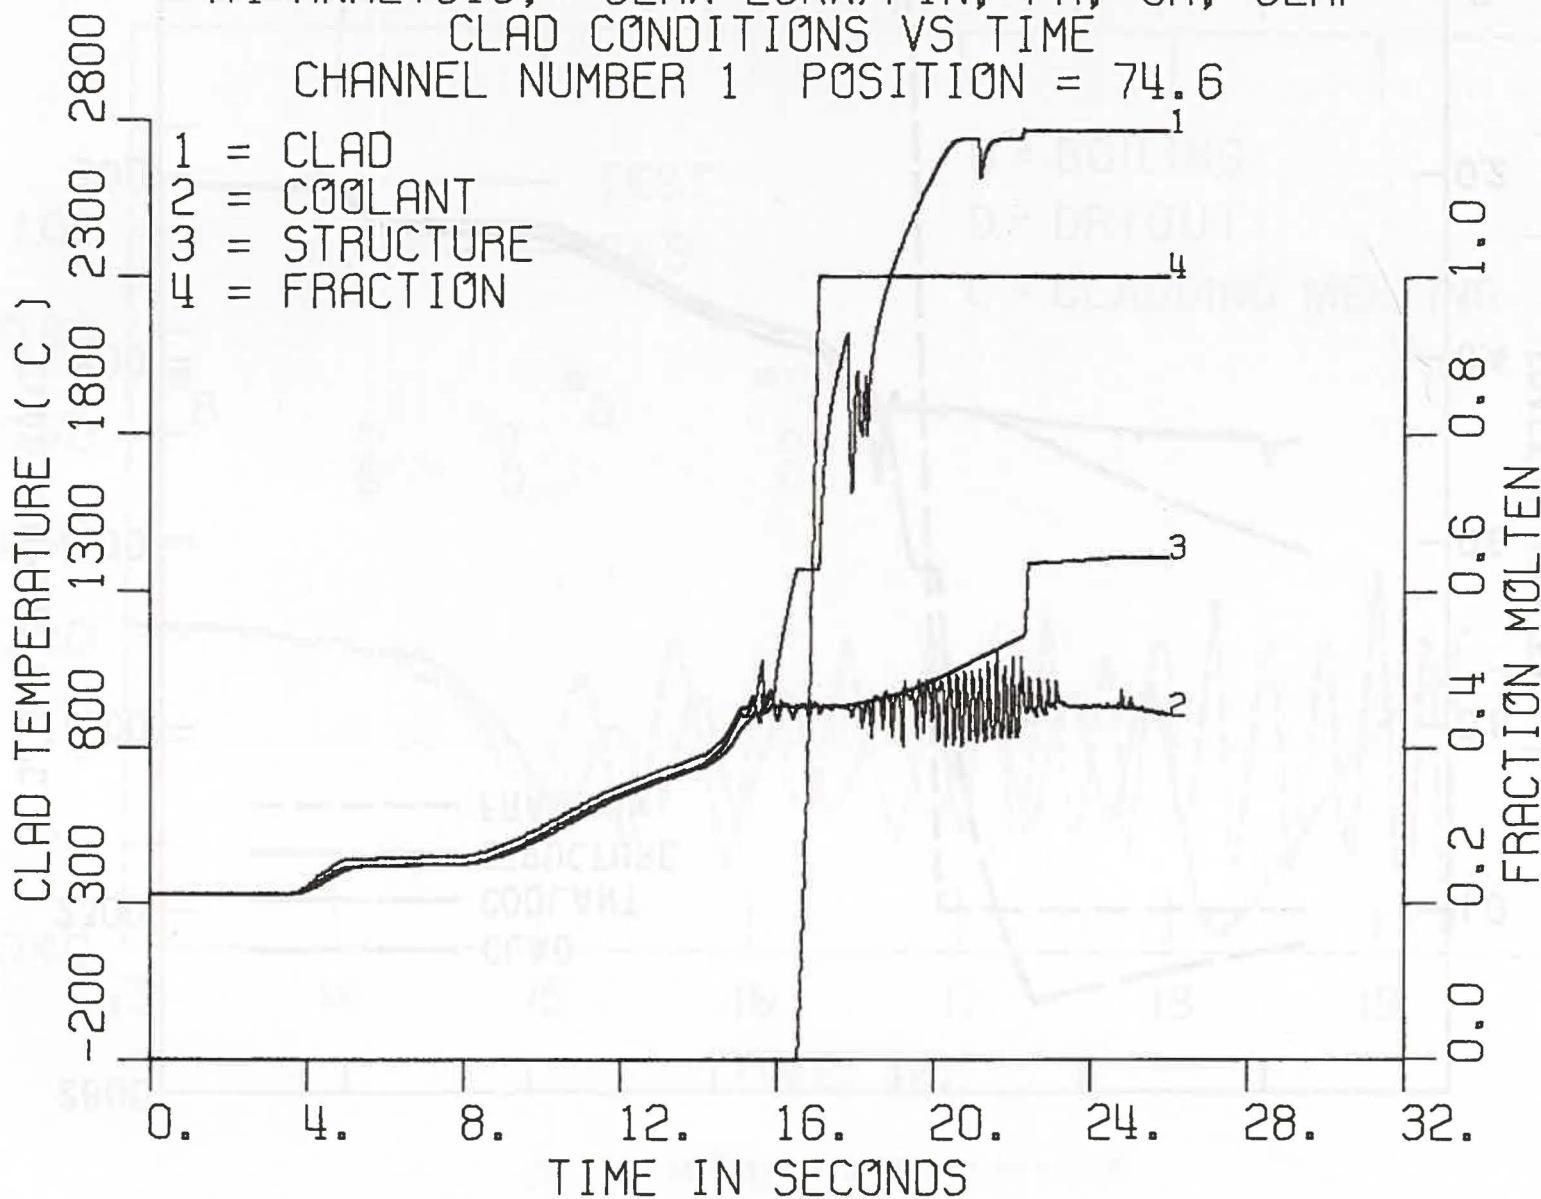
Fig. 95 R4 Temperature Conditions at 74.6 cm for SAS Case 2 (High Heat Loss)

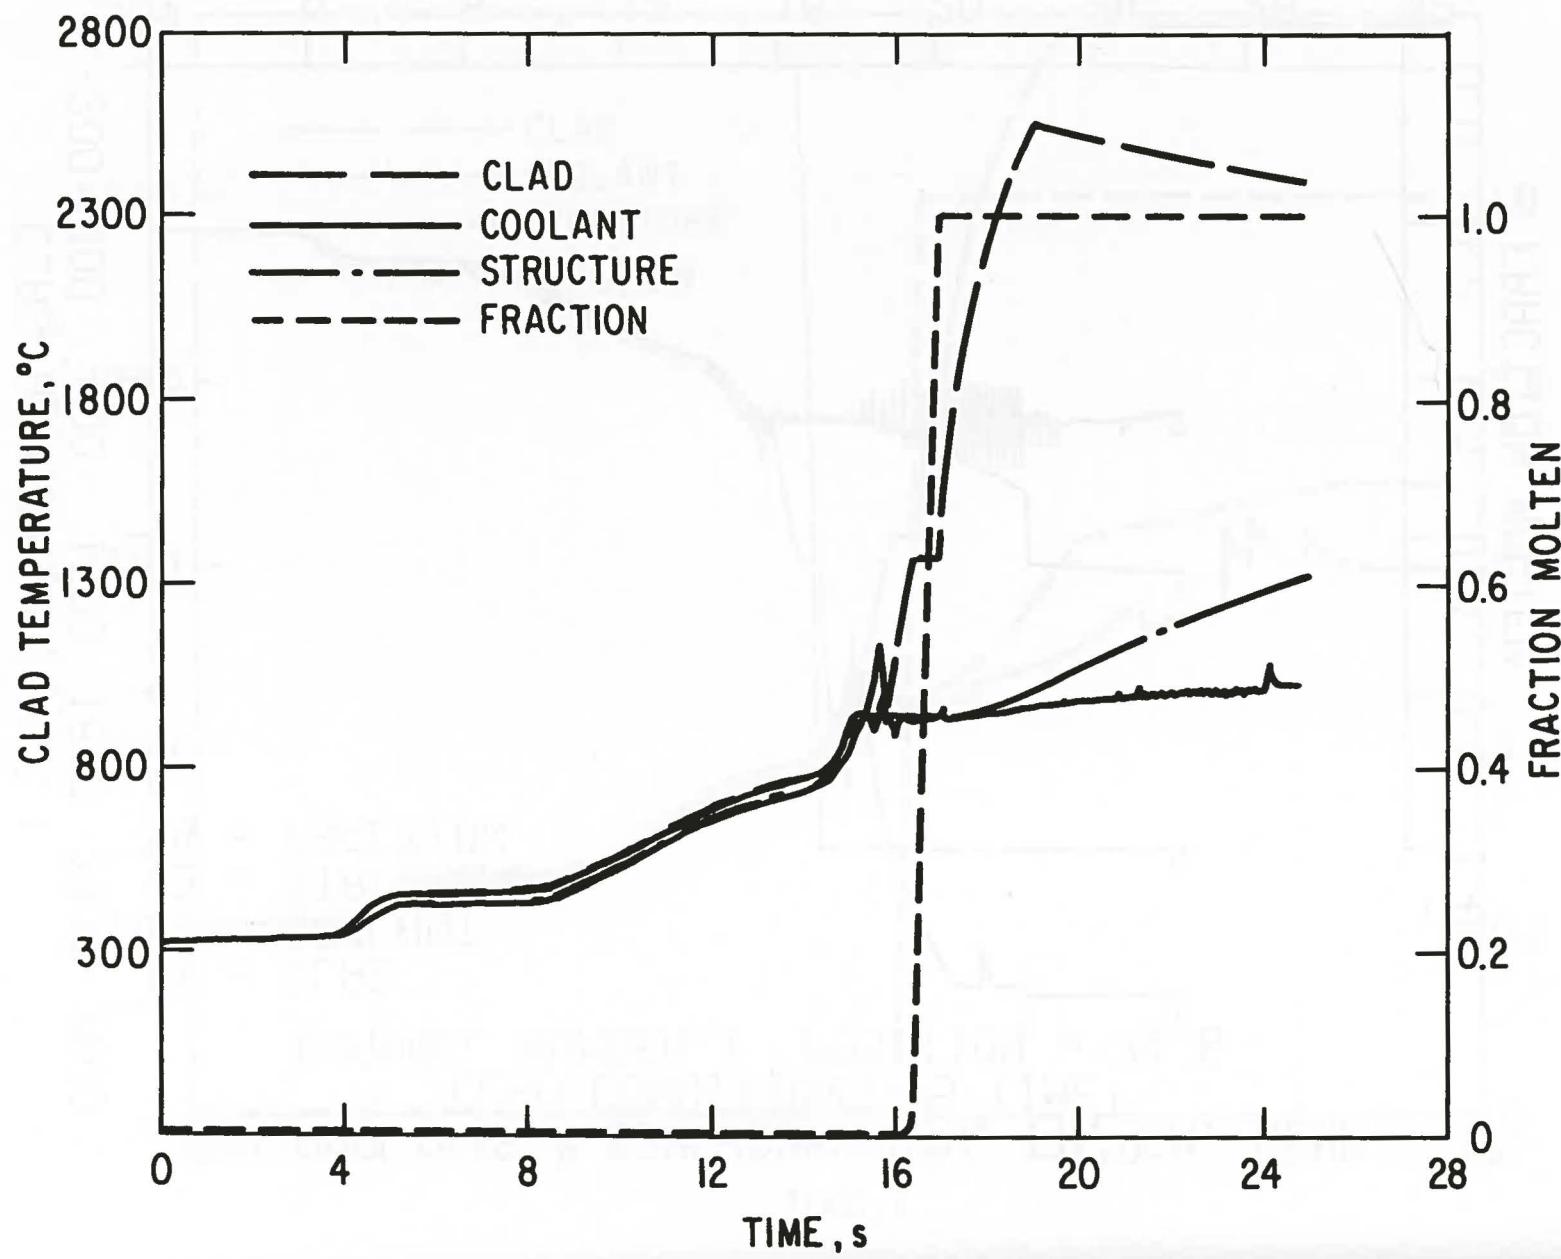
Fig. 96 R5 Temperature Conditions at 76.4 cm

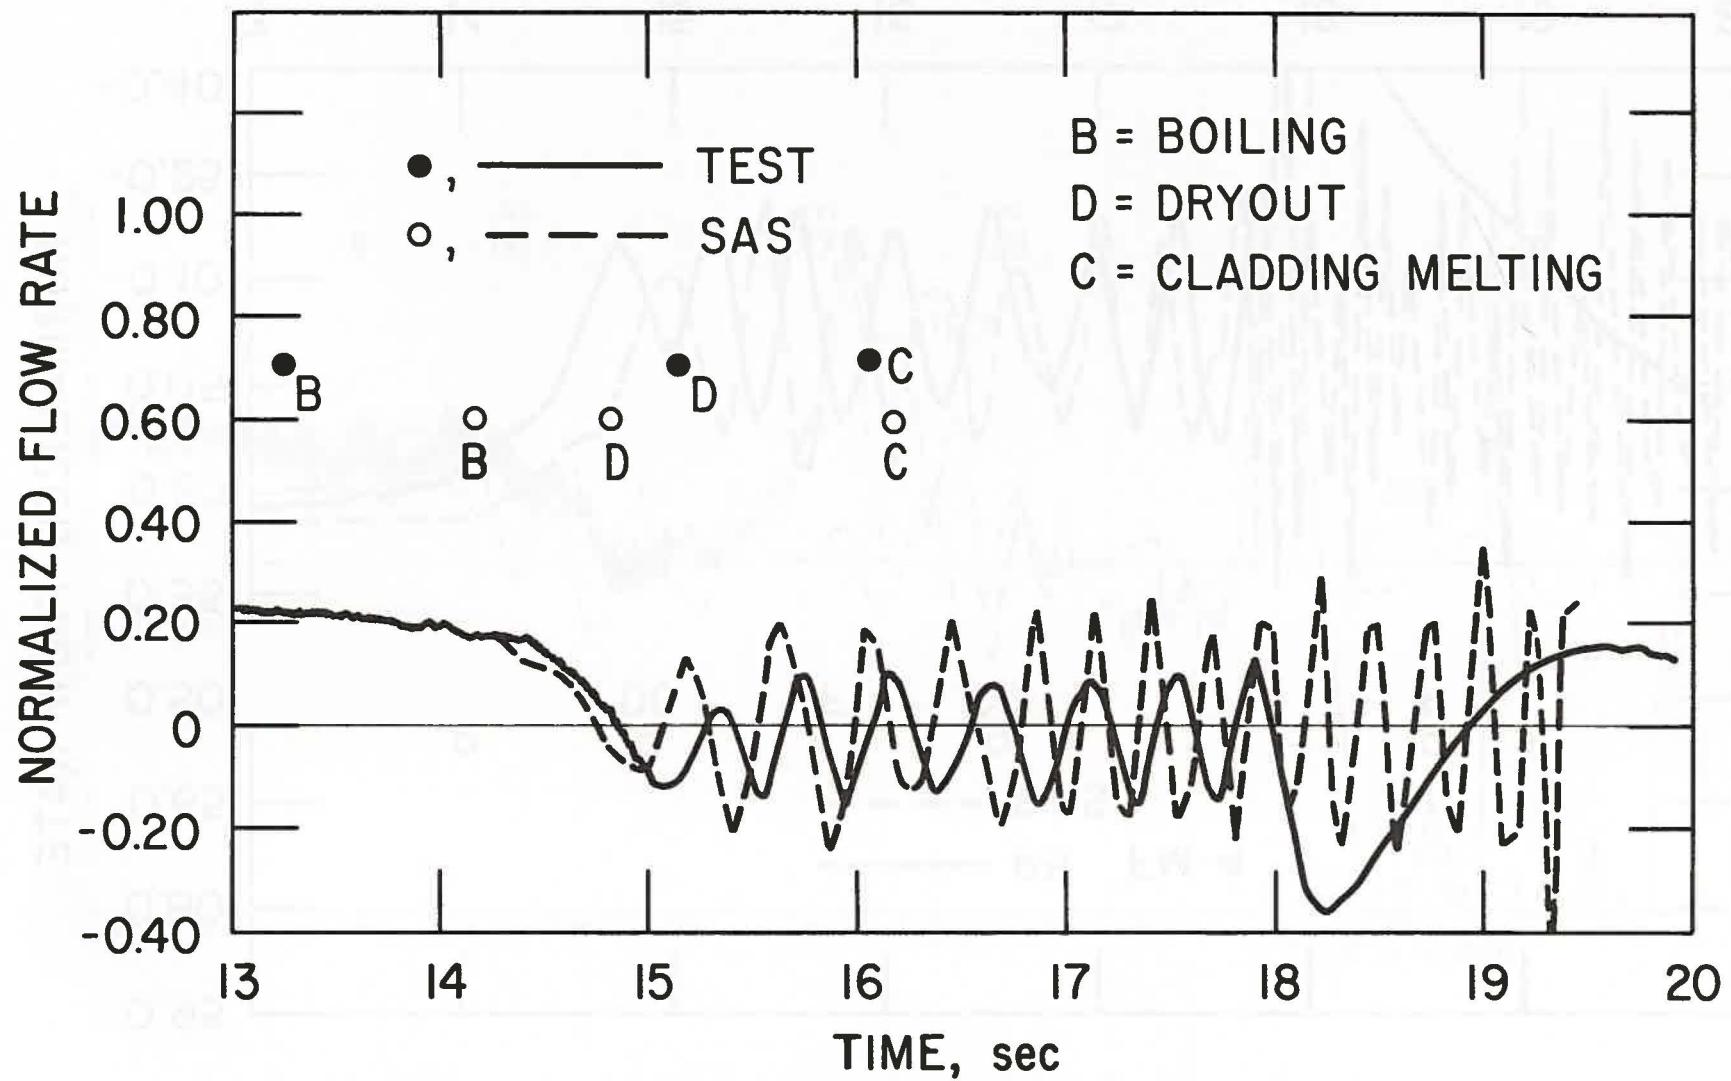
Fig. 97 R4 Inlet Flow Rate Comparison

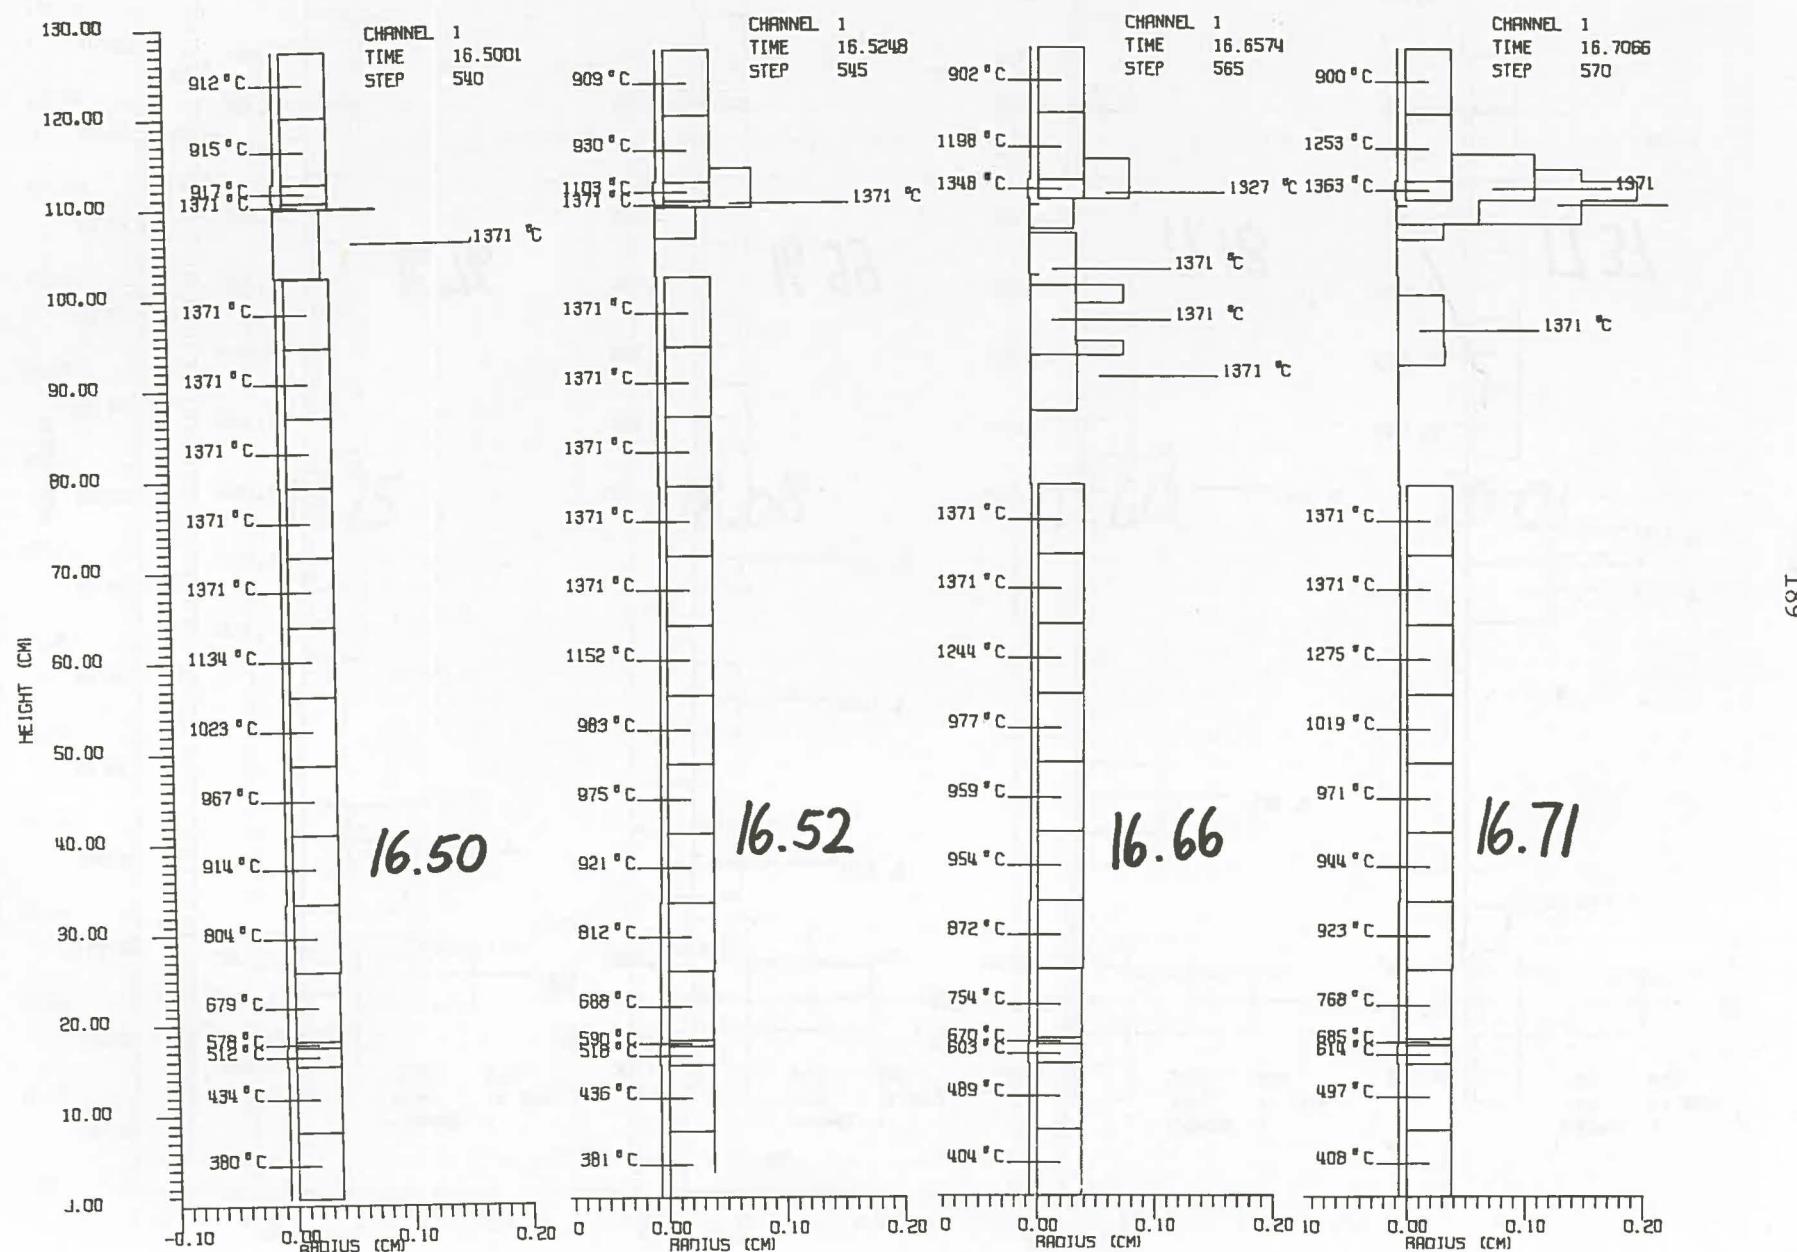
Fig. 104 R5 Cladding Motion Sequence, Initiation.
