Final Report on TREAT Tests R4 and R5;
Seven-pin, Loss-of-flow Tests with Full-length,
Unirradiated FFTF-type Fuel Pins

Reactor Analysis and Safety Division
ARGONNE NATIONAL LABORATORY
9700 S. Cass Avenue
Argonne, Illinois 60439

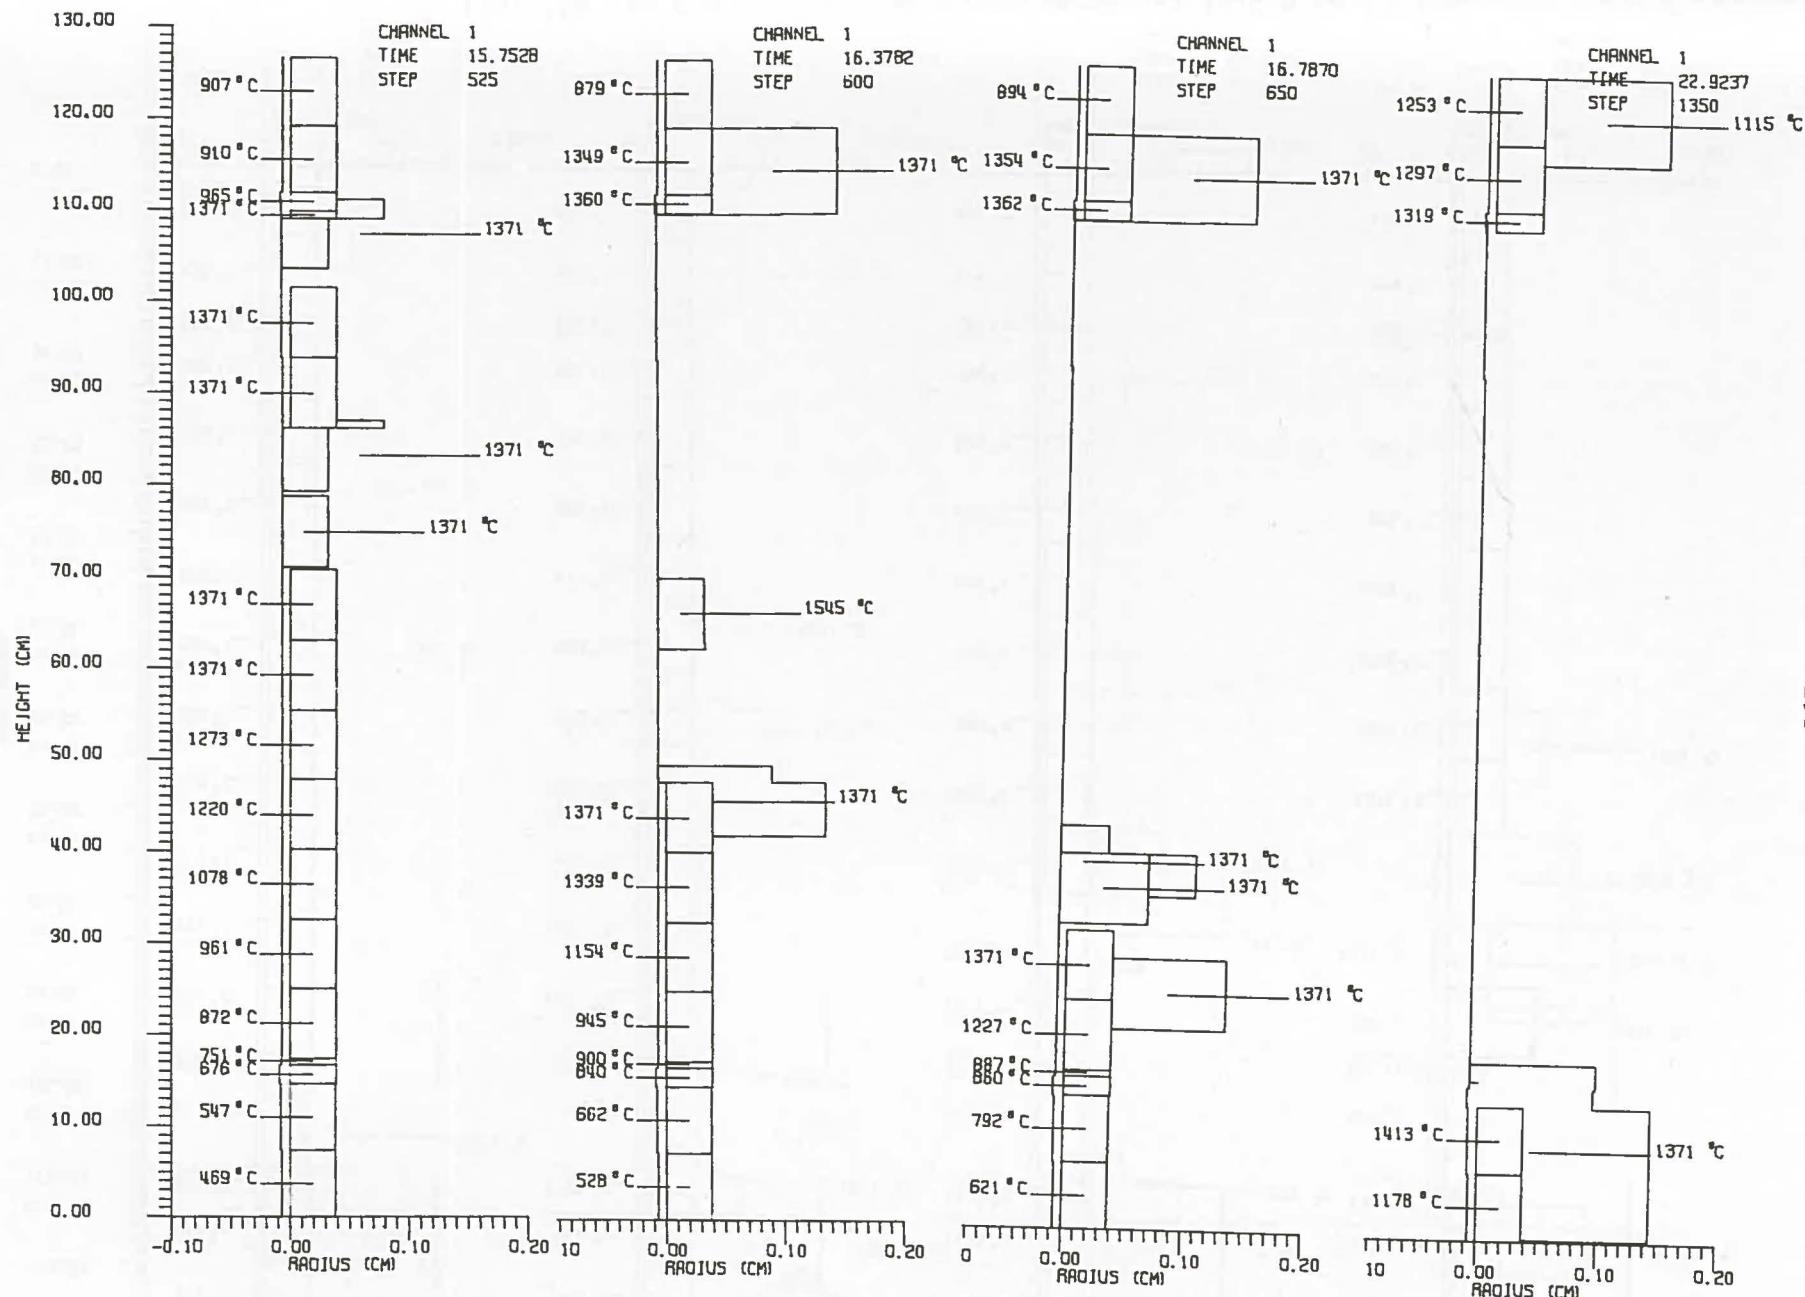
Fig. 107 R4 Case 1 Cladding Motion Sequence; 15.8 s to 22.9 s.

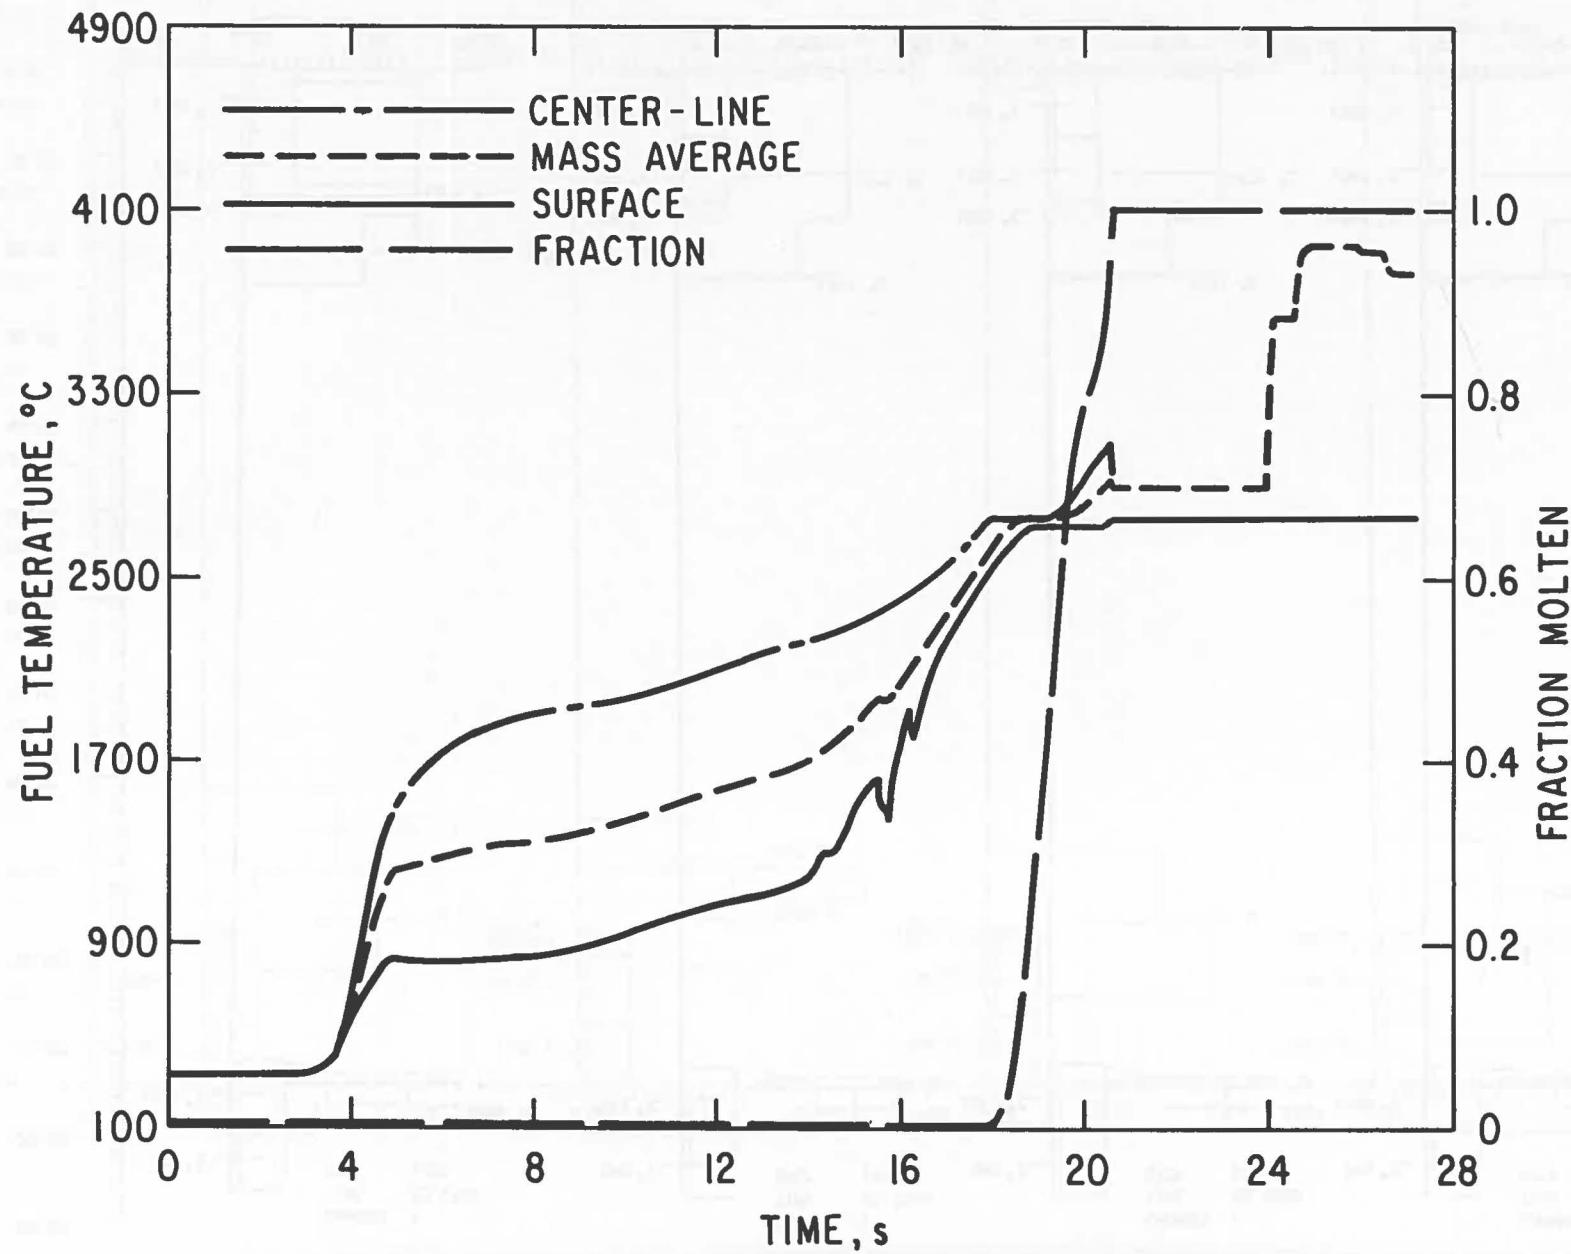
Fig. 112 R4 Fuel Temperature Conditions at 74.6 cm for SAS Case 1
(Low Heat Loss).

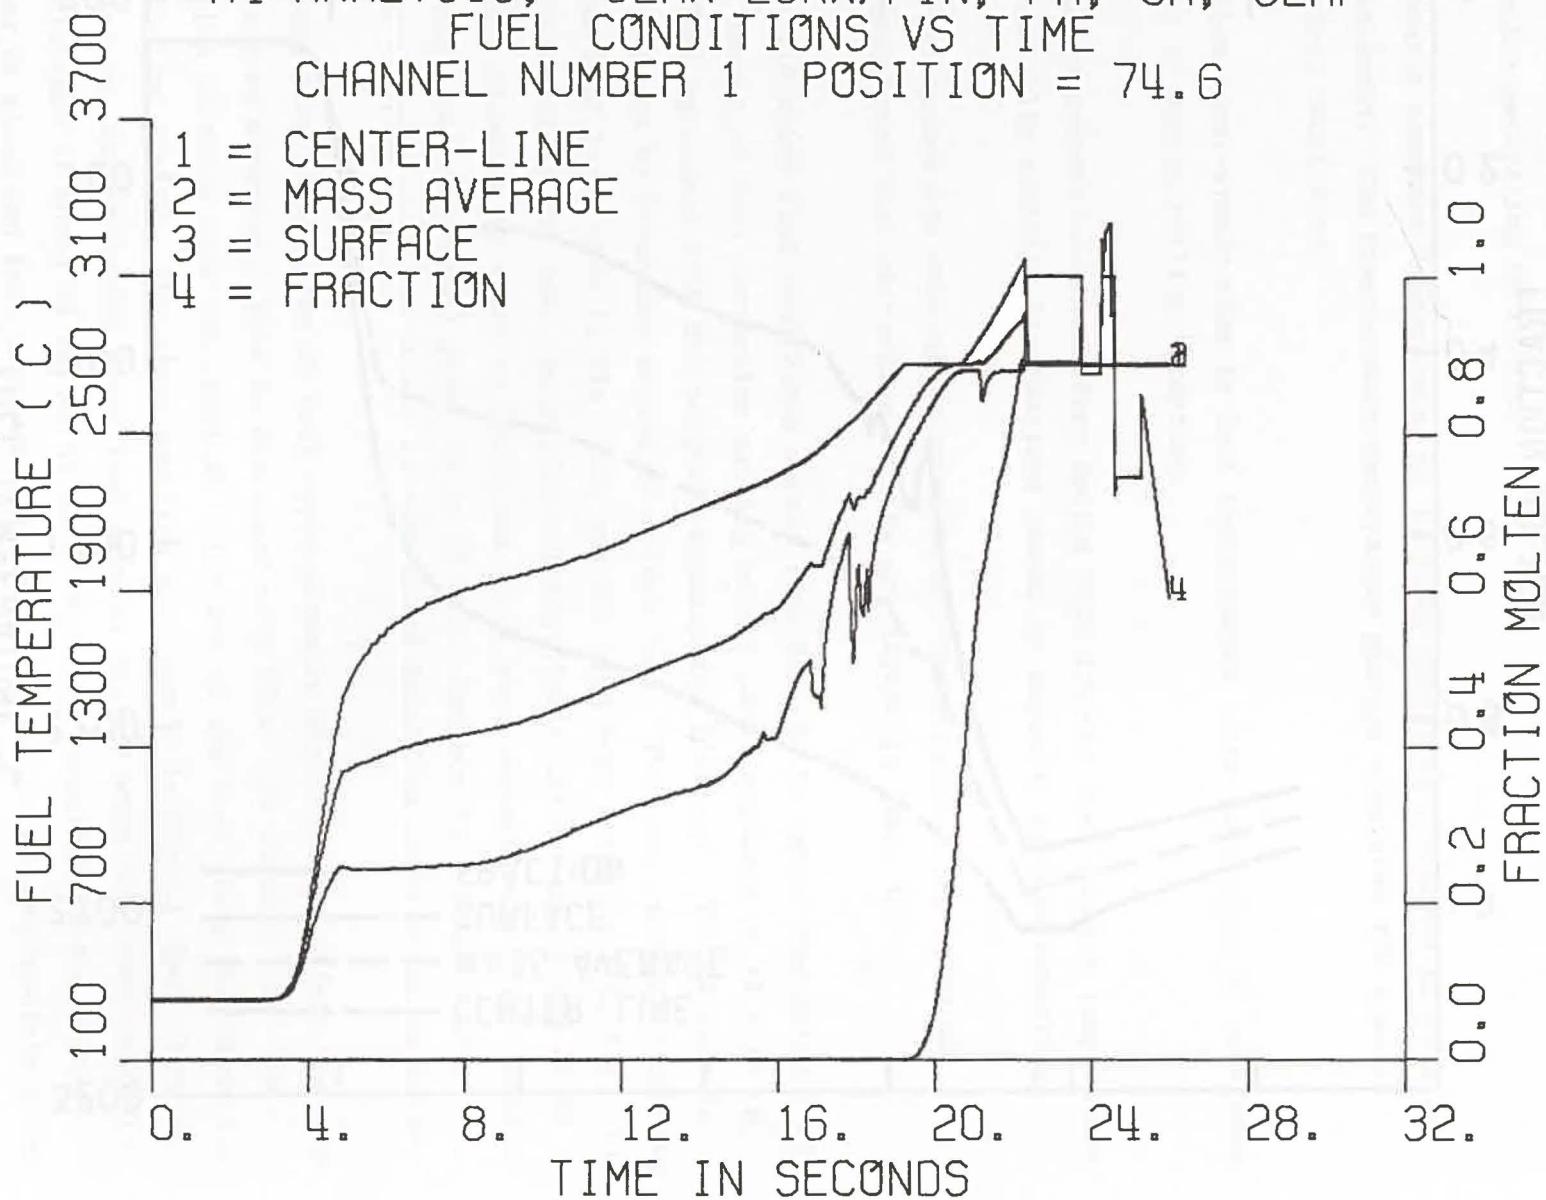
Fig. 113 R4 Fuel Temperature Conditions at 74.6 cm for SAS Case 2 (High Heat Loss)

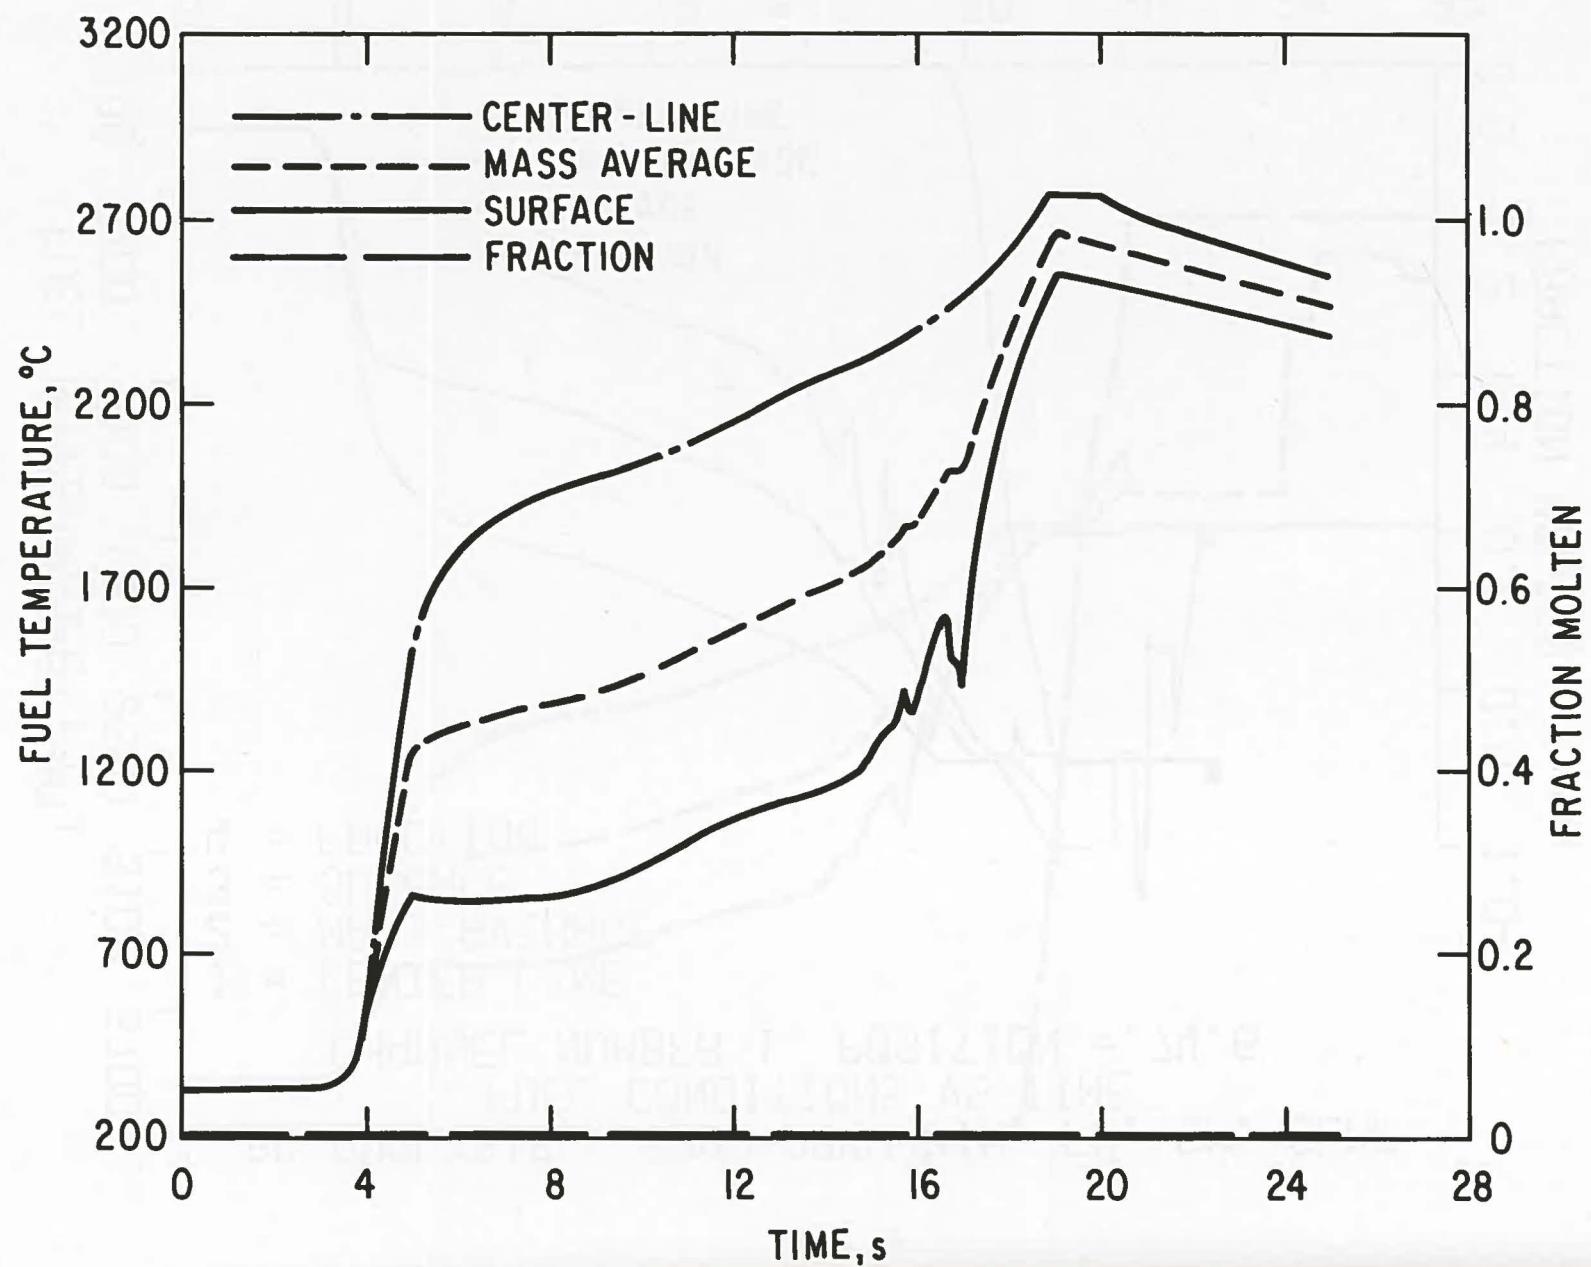
Fig. 114 R5 Fuel Temperature Conditions at 74.6 cm.

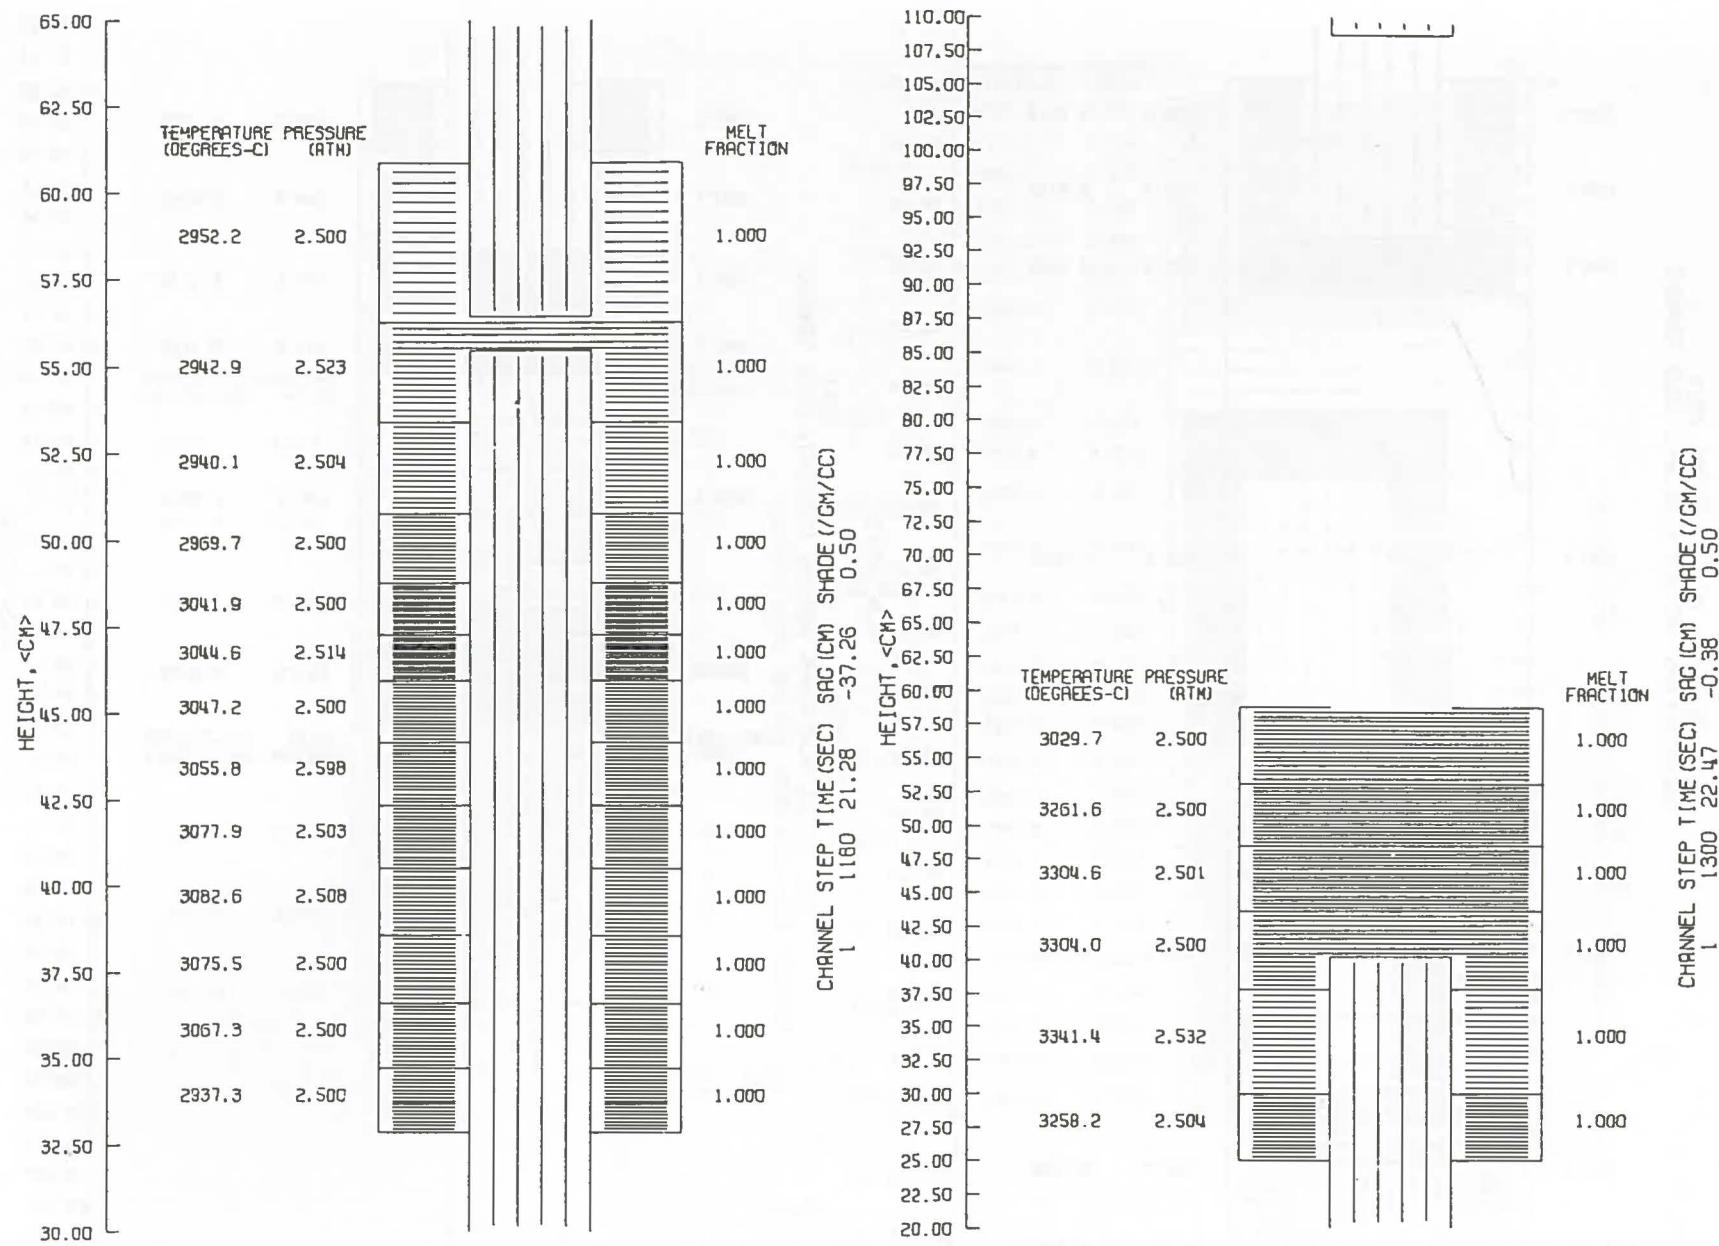
Fig. 115 R4 Case 1 Fuel Conditions at 21.3 and 22.5 s.

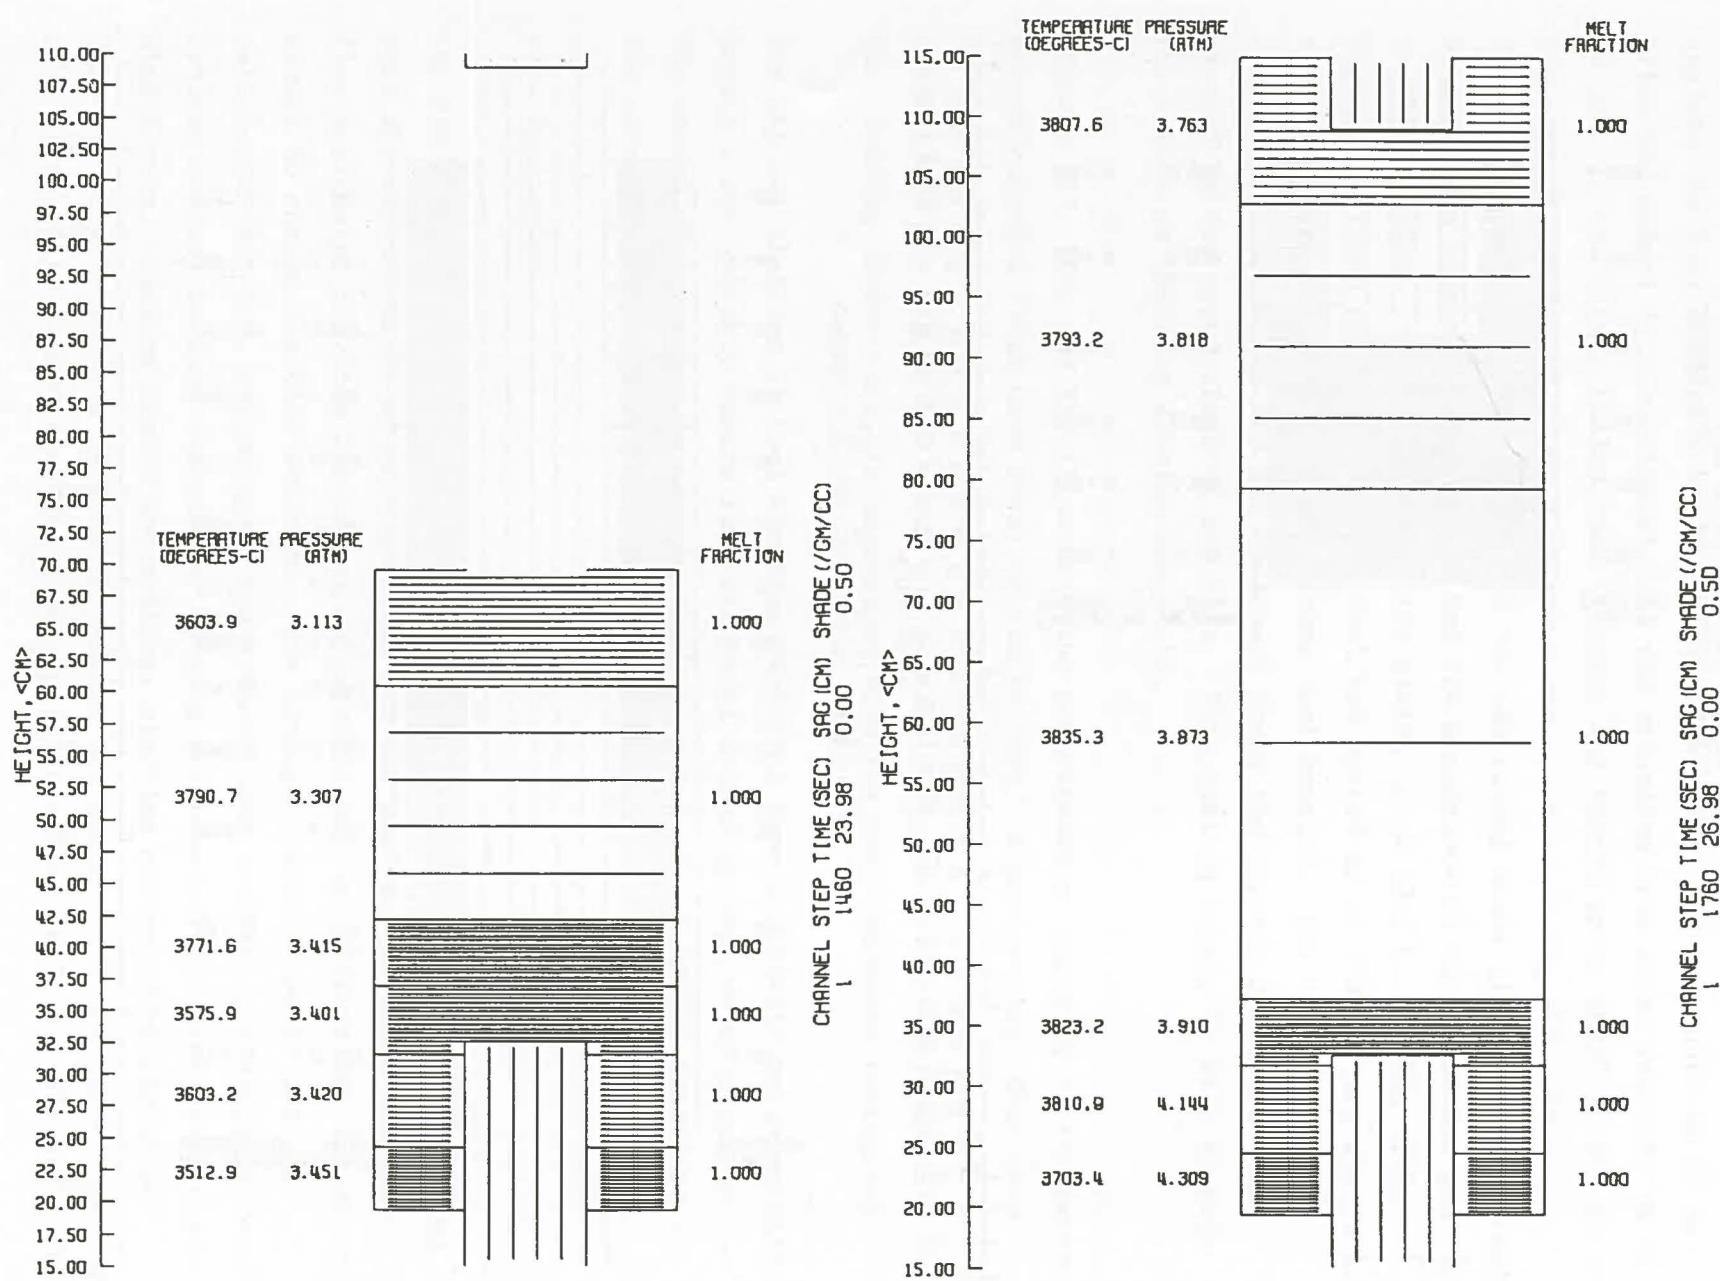
Fig. 116 R4 Case 1 Fuel Conditions at 24.0 and 27.0 s.

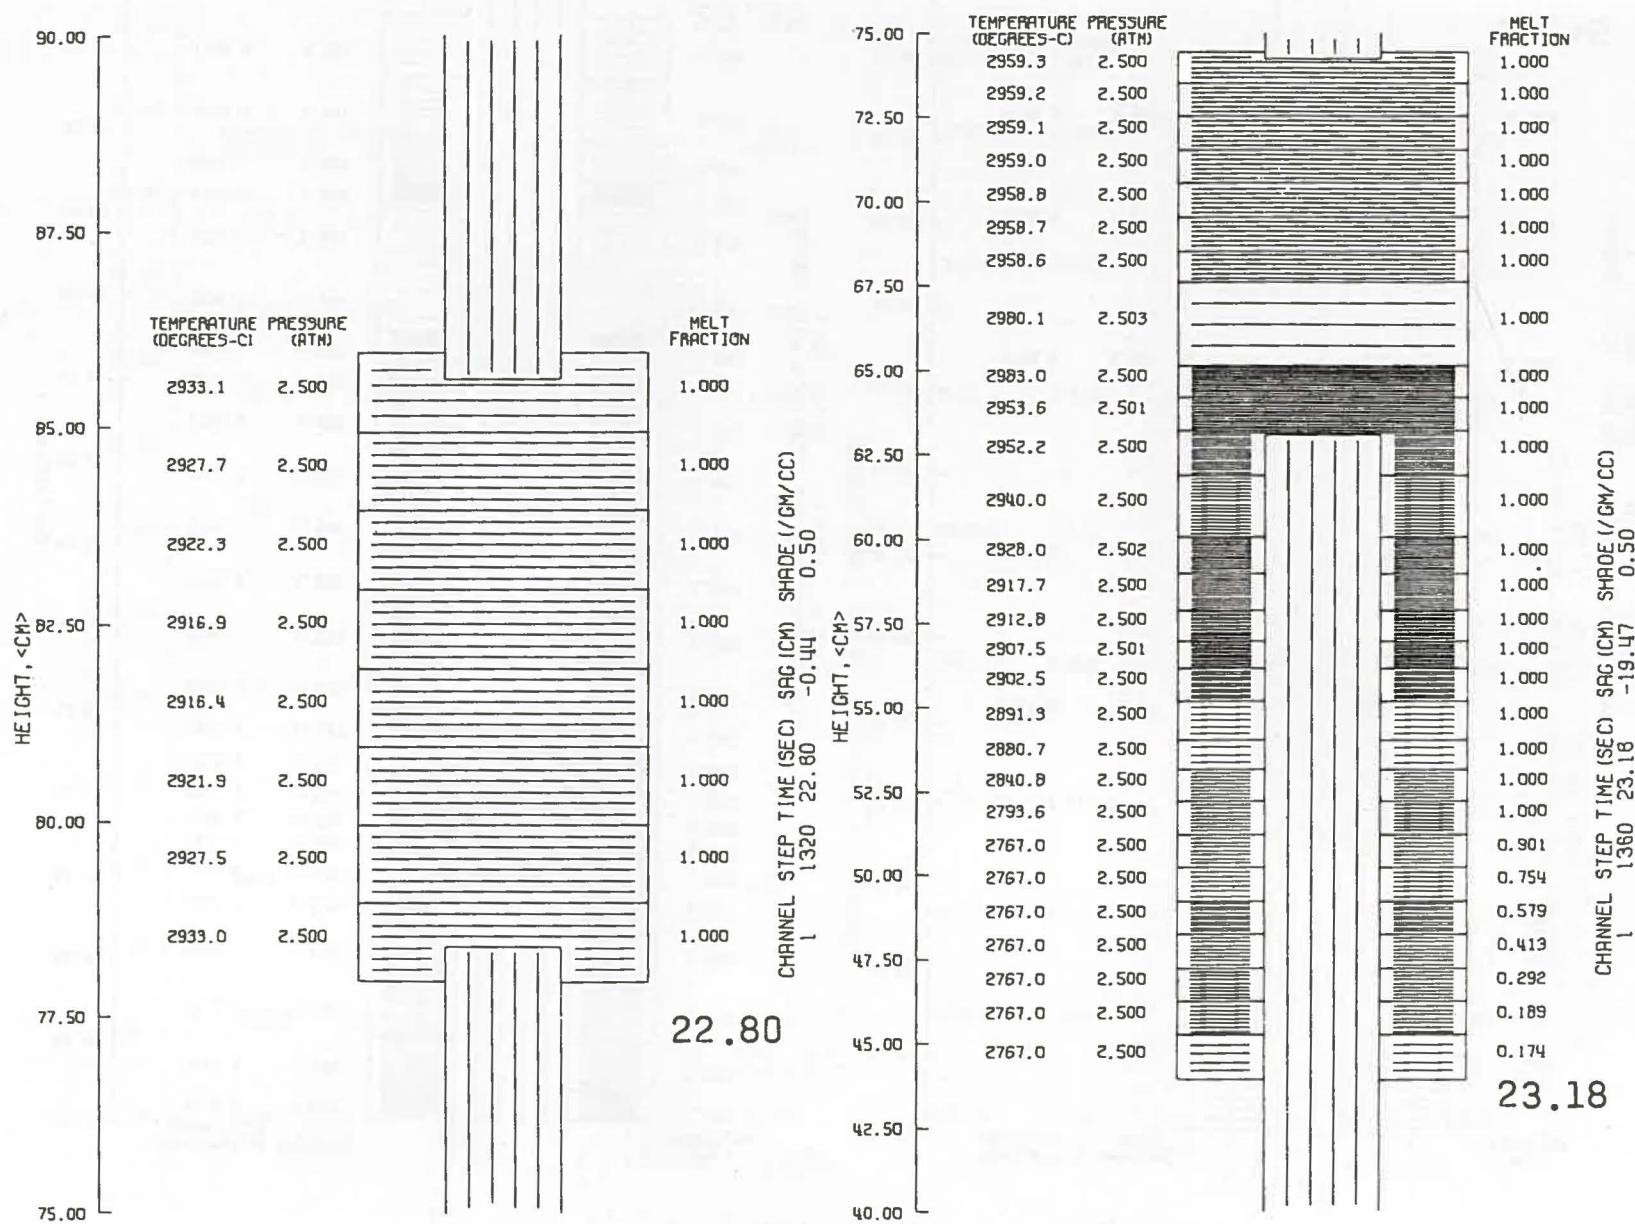
Fig. 117 R4 Case 2 Fuel Conditions at 22.8 and 23.2 s.

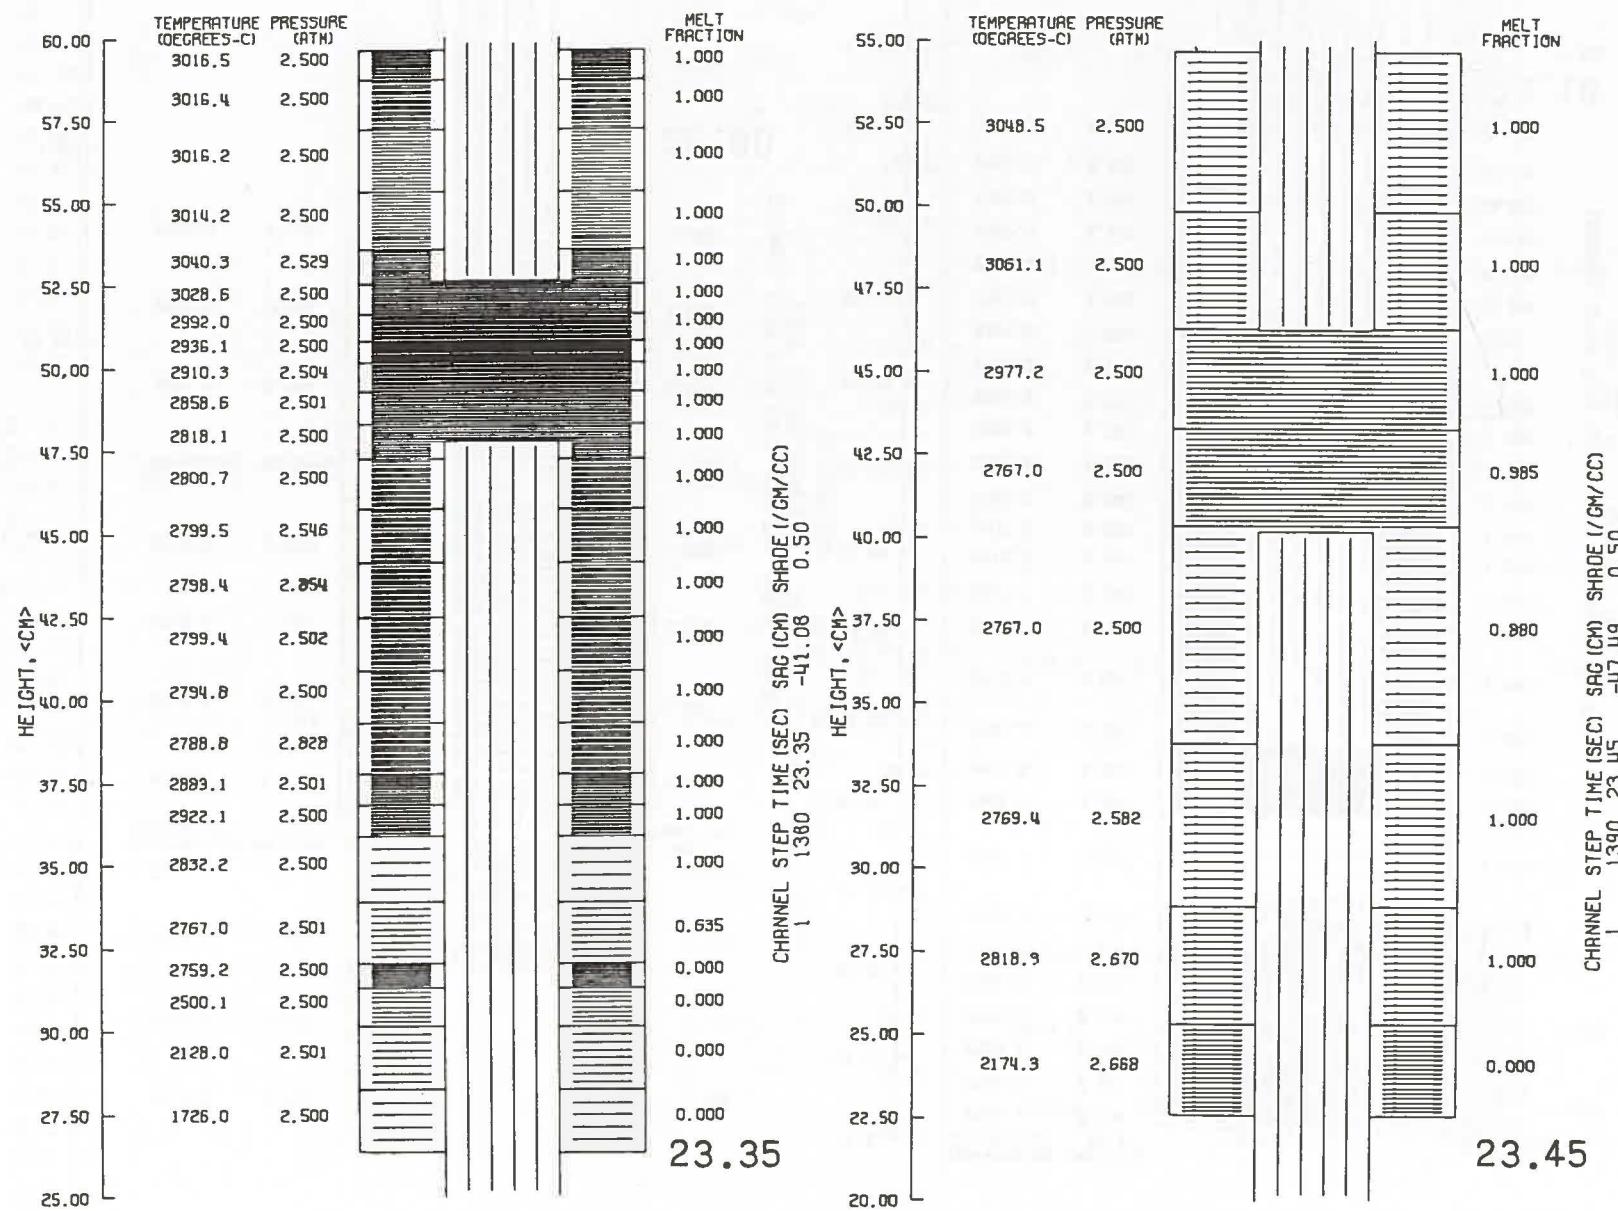
Fig. 118 R4 Case 2 Fuel Conditions at 23.35 and 23.45 s.

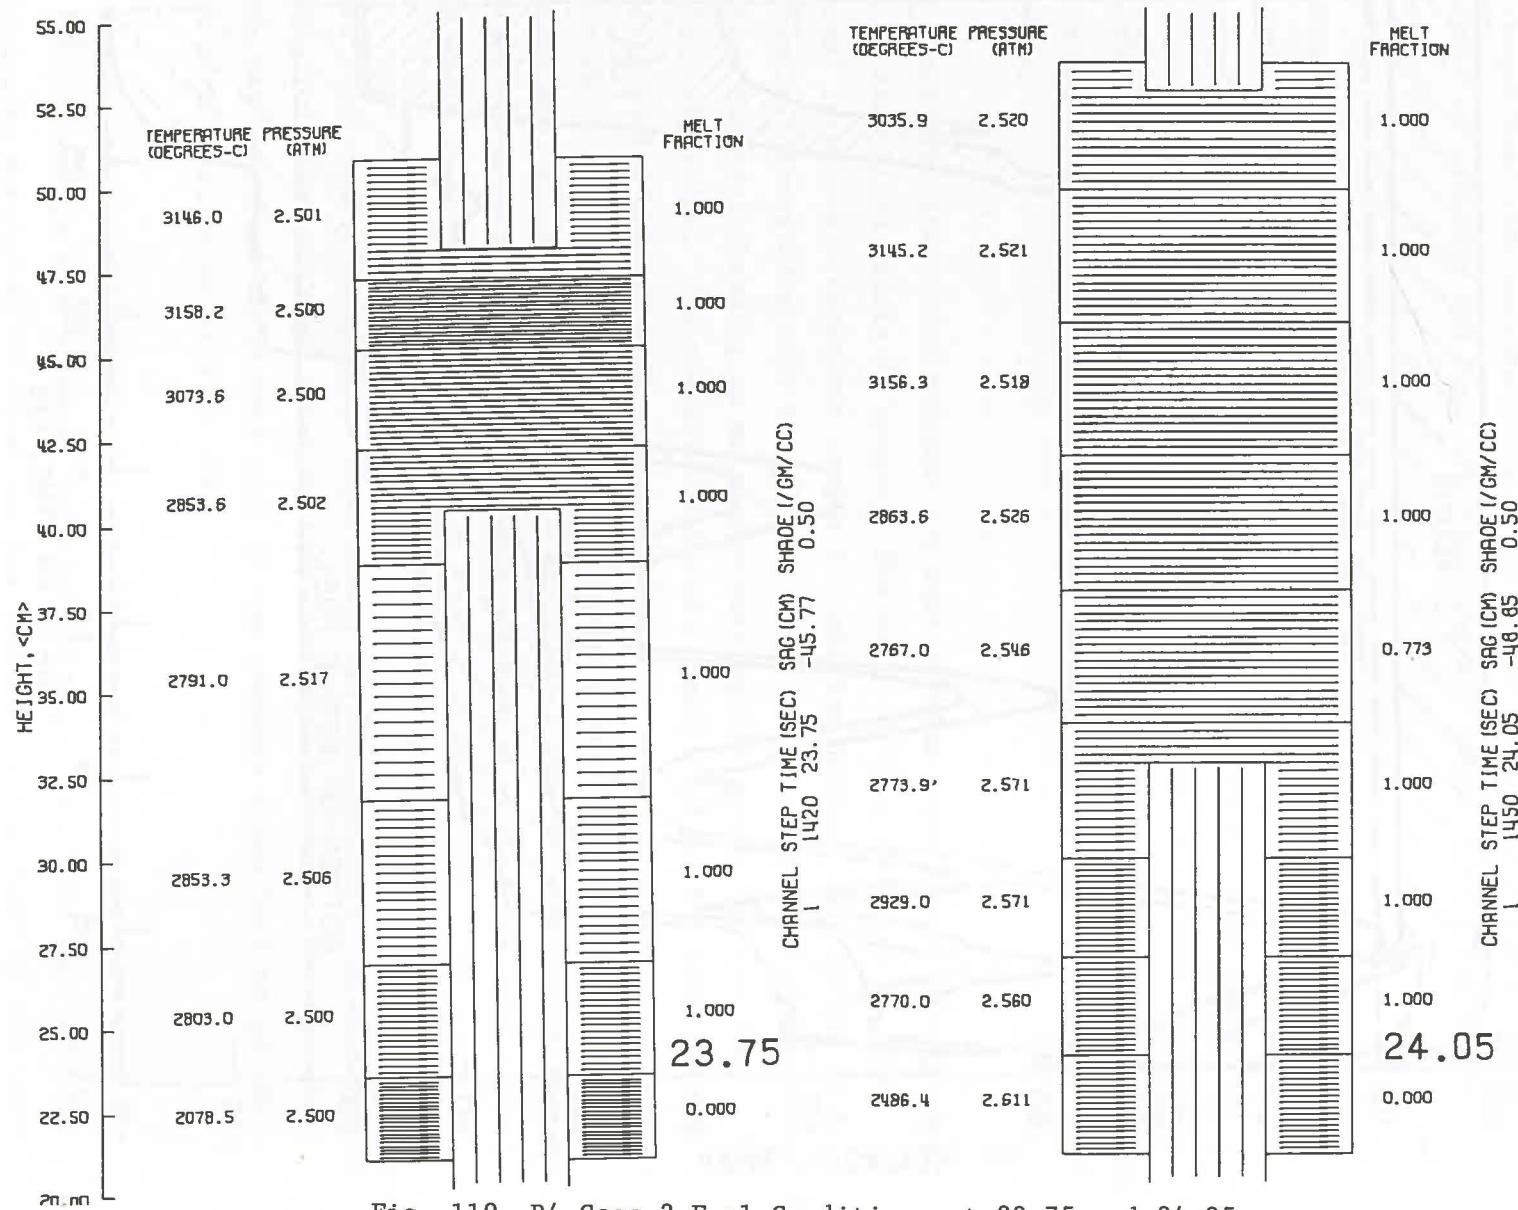
Fig. 119 R4 Case 2 Fuel Conditions at 23.75 and 24.05 s.

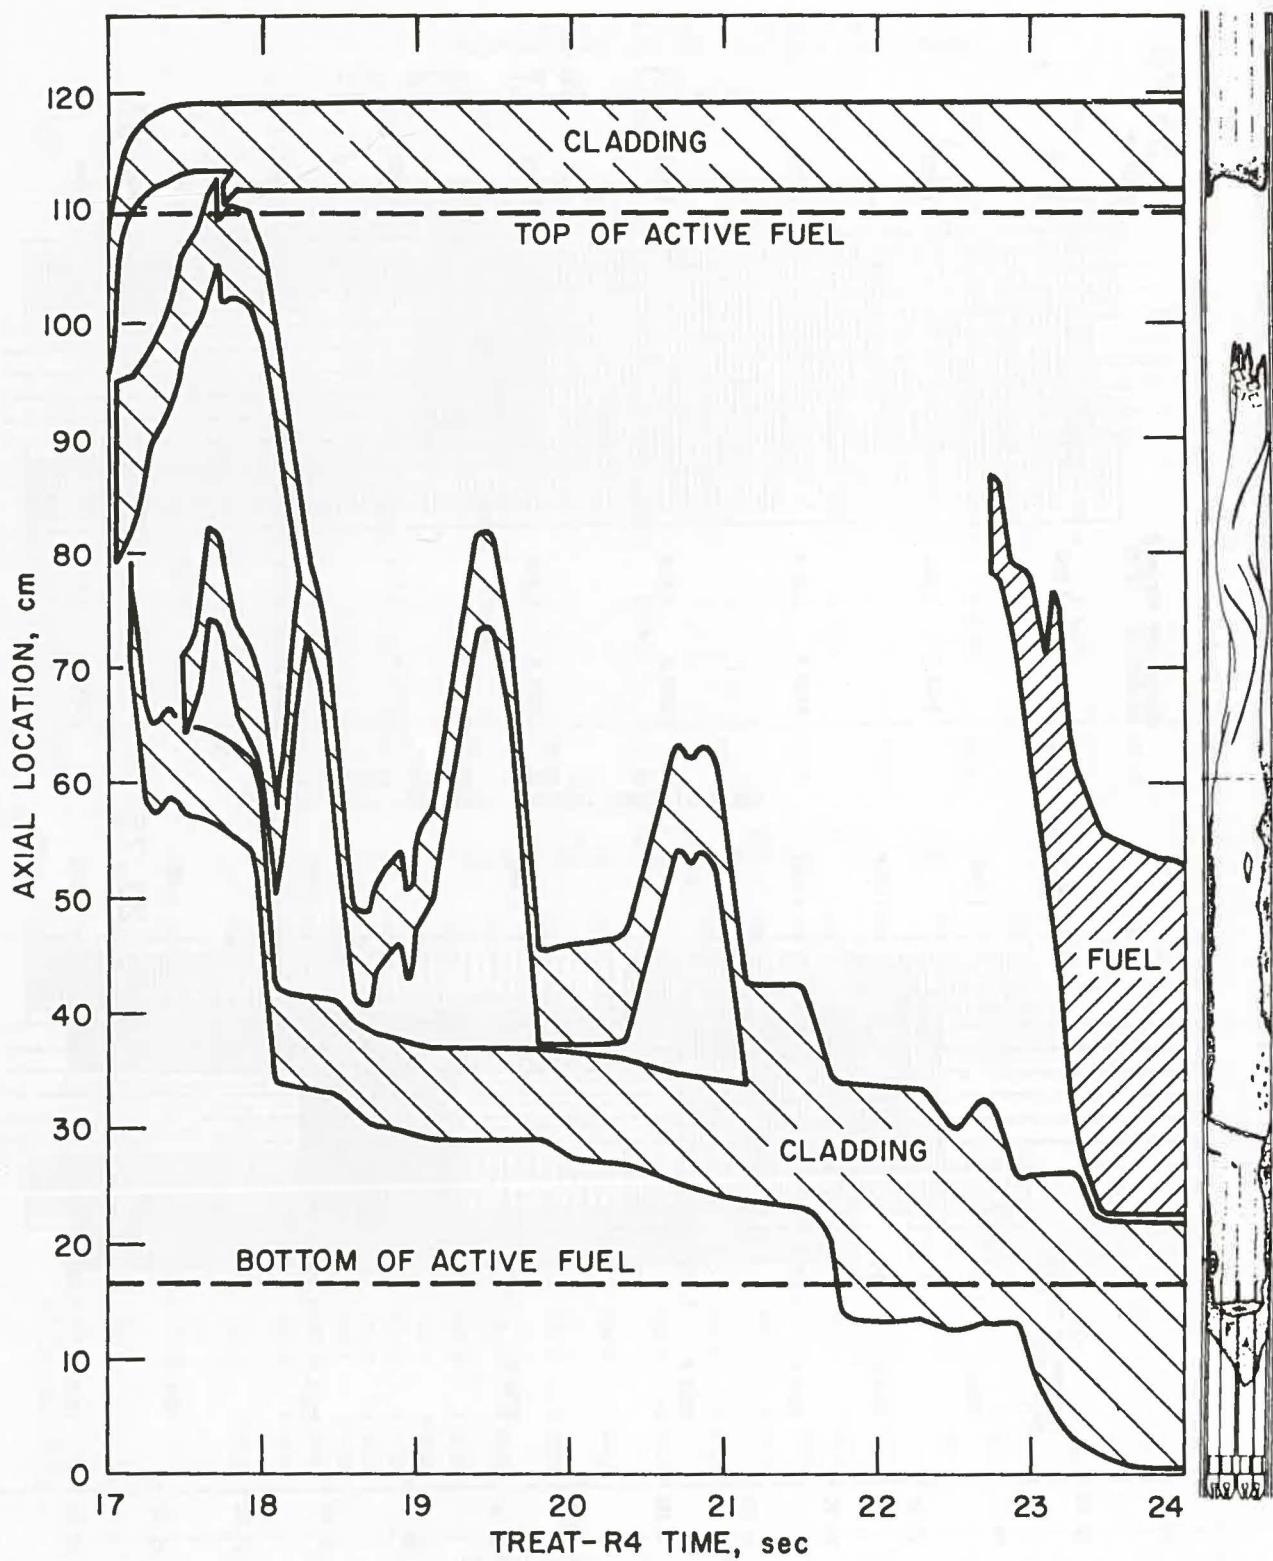
Fig. 120 R4 Case 2 Cladding and Fuel Motion Boundaries.

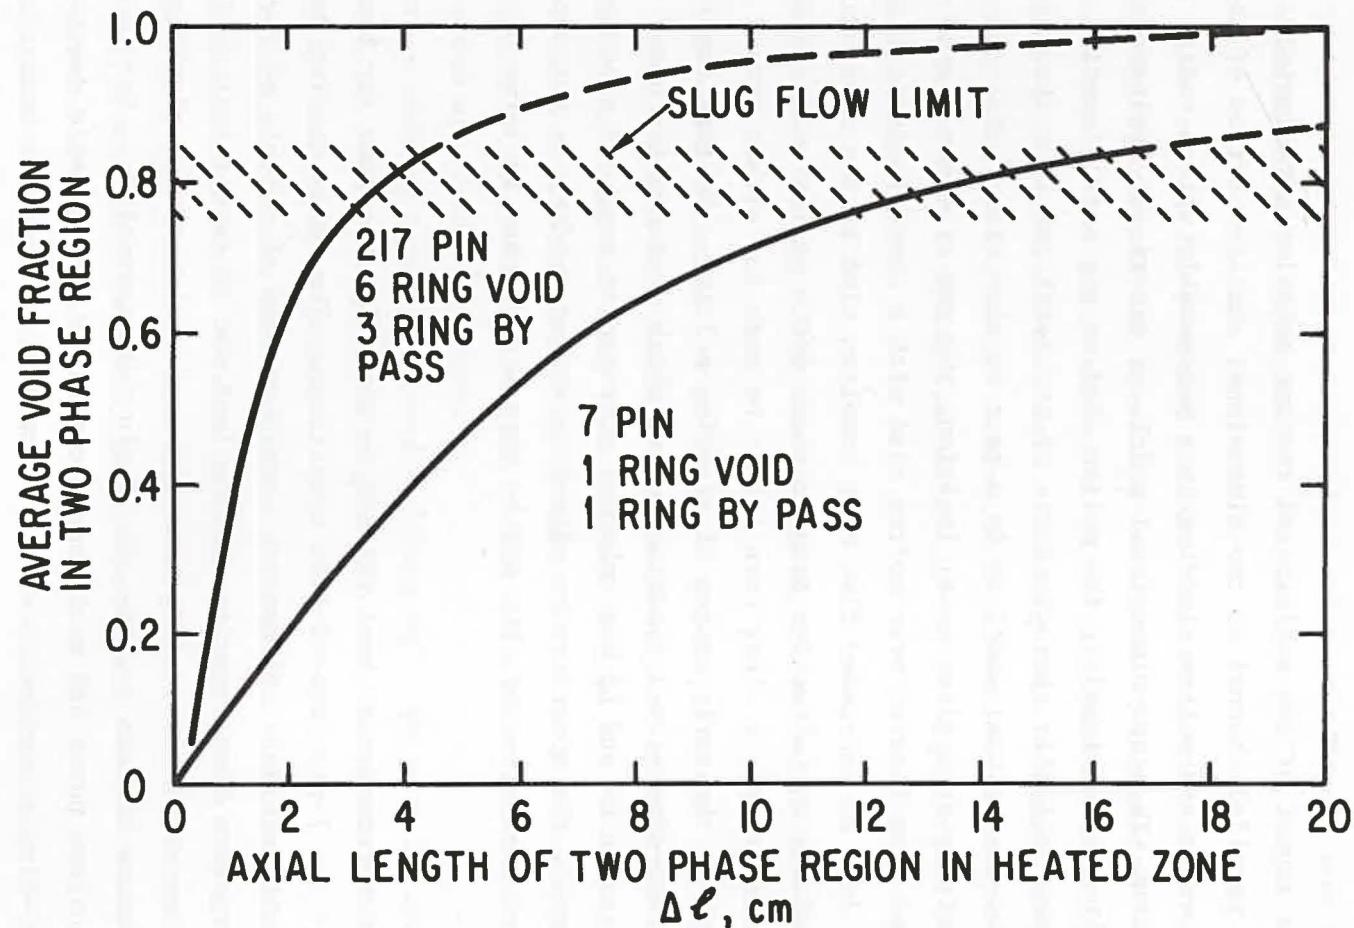
Fig. 121 Two-phase Void Fraction Required for Equal Pressure Gradient in Parallel Two-phase Flow with Liquid Bypass.
