Final Report on TREAT Tests R4 and R5;
Seven-pin, Loss-of-flow Tests with Full-length,
Unirradiated FFTF-type Fuel Pins

Reactor Analysis and Safety Division
ARGONNE NATIONAL LABORATORY
9700 S. Cass Avenue
Argonne, Illinois 60439

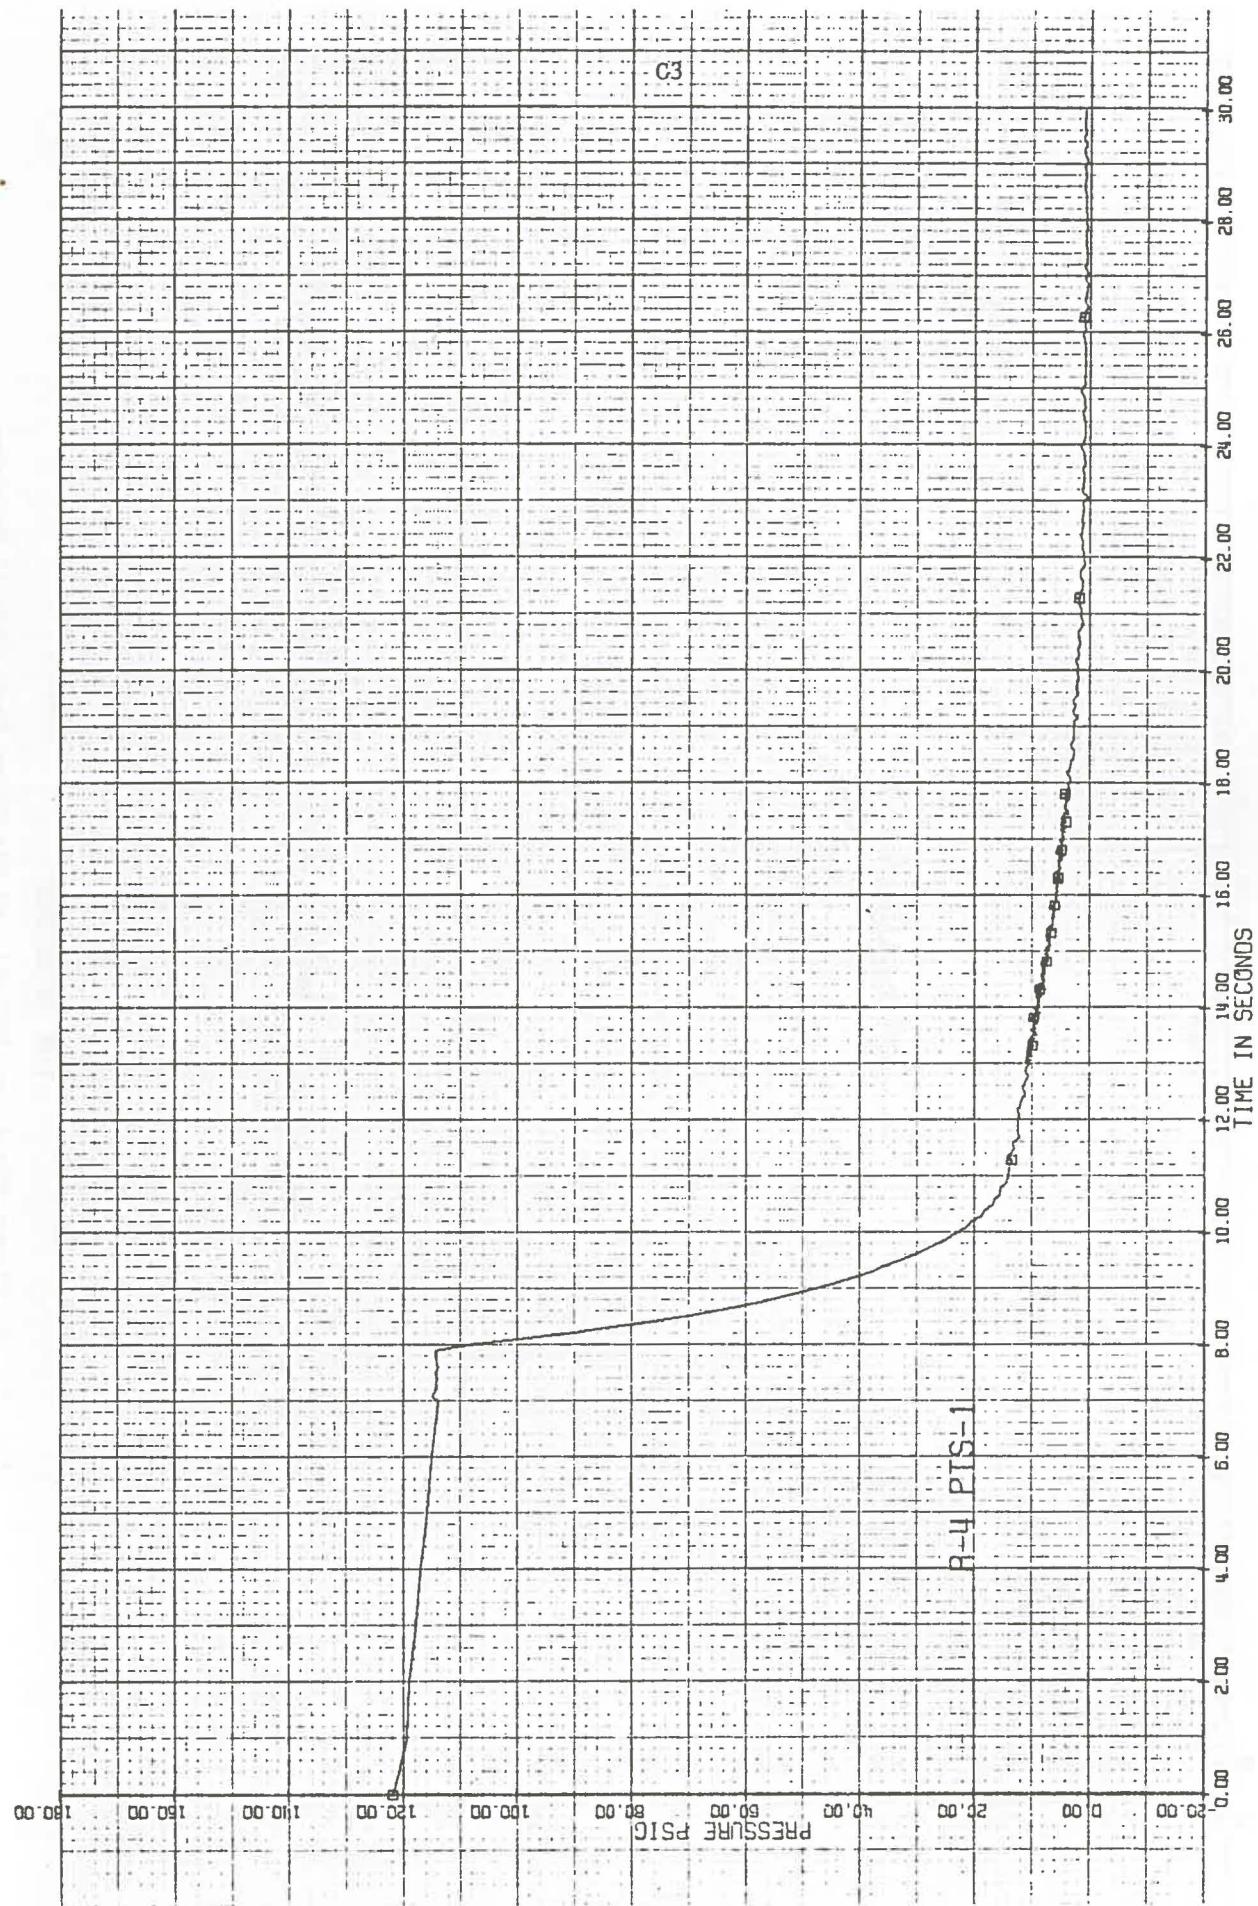
Fig. C2 R4 Supply Tank Pressure.

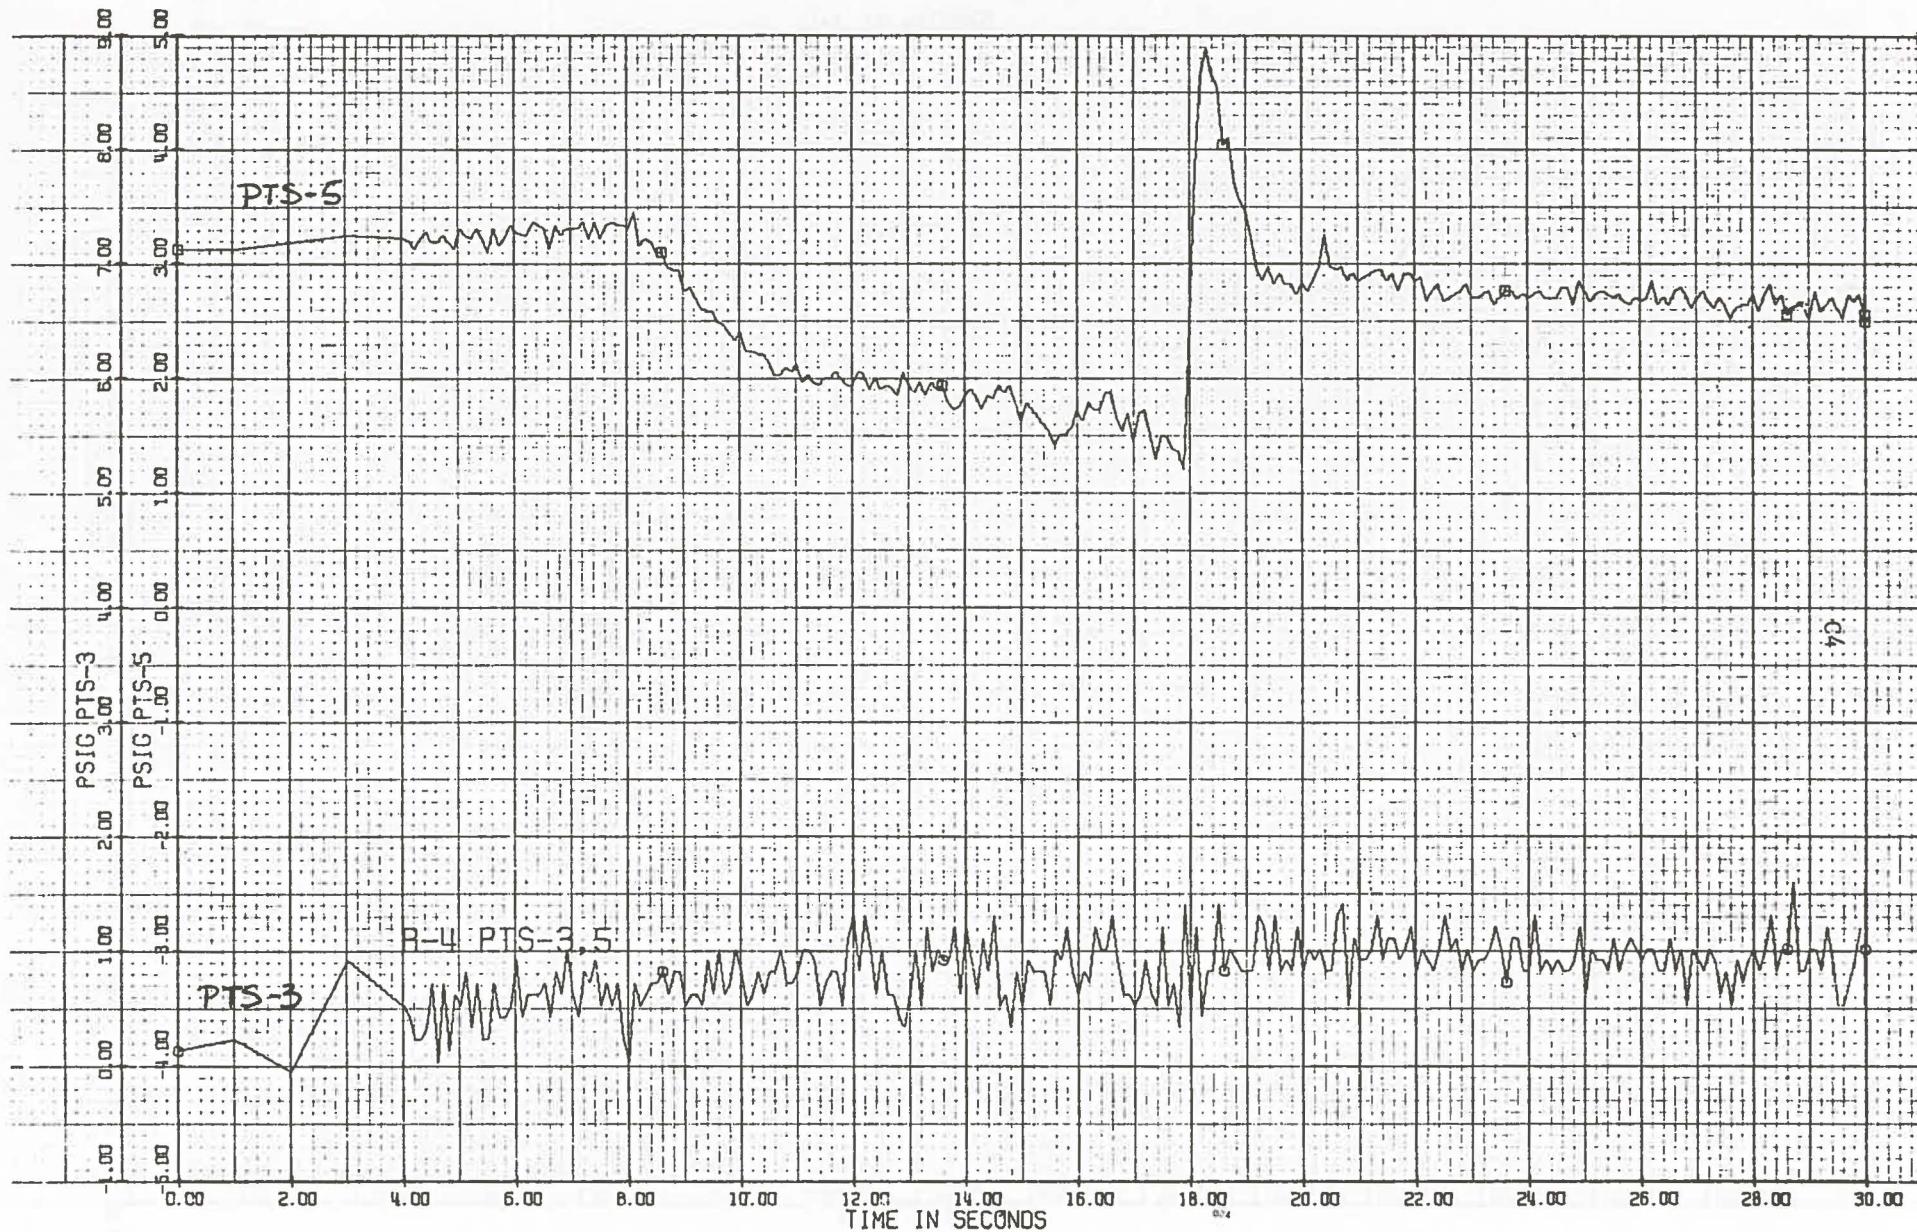
Fig. C3 R4 Plenum Simulator (PTS-5) and Discharge Tank (PTS-3) Pressure.

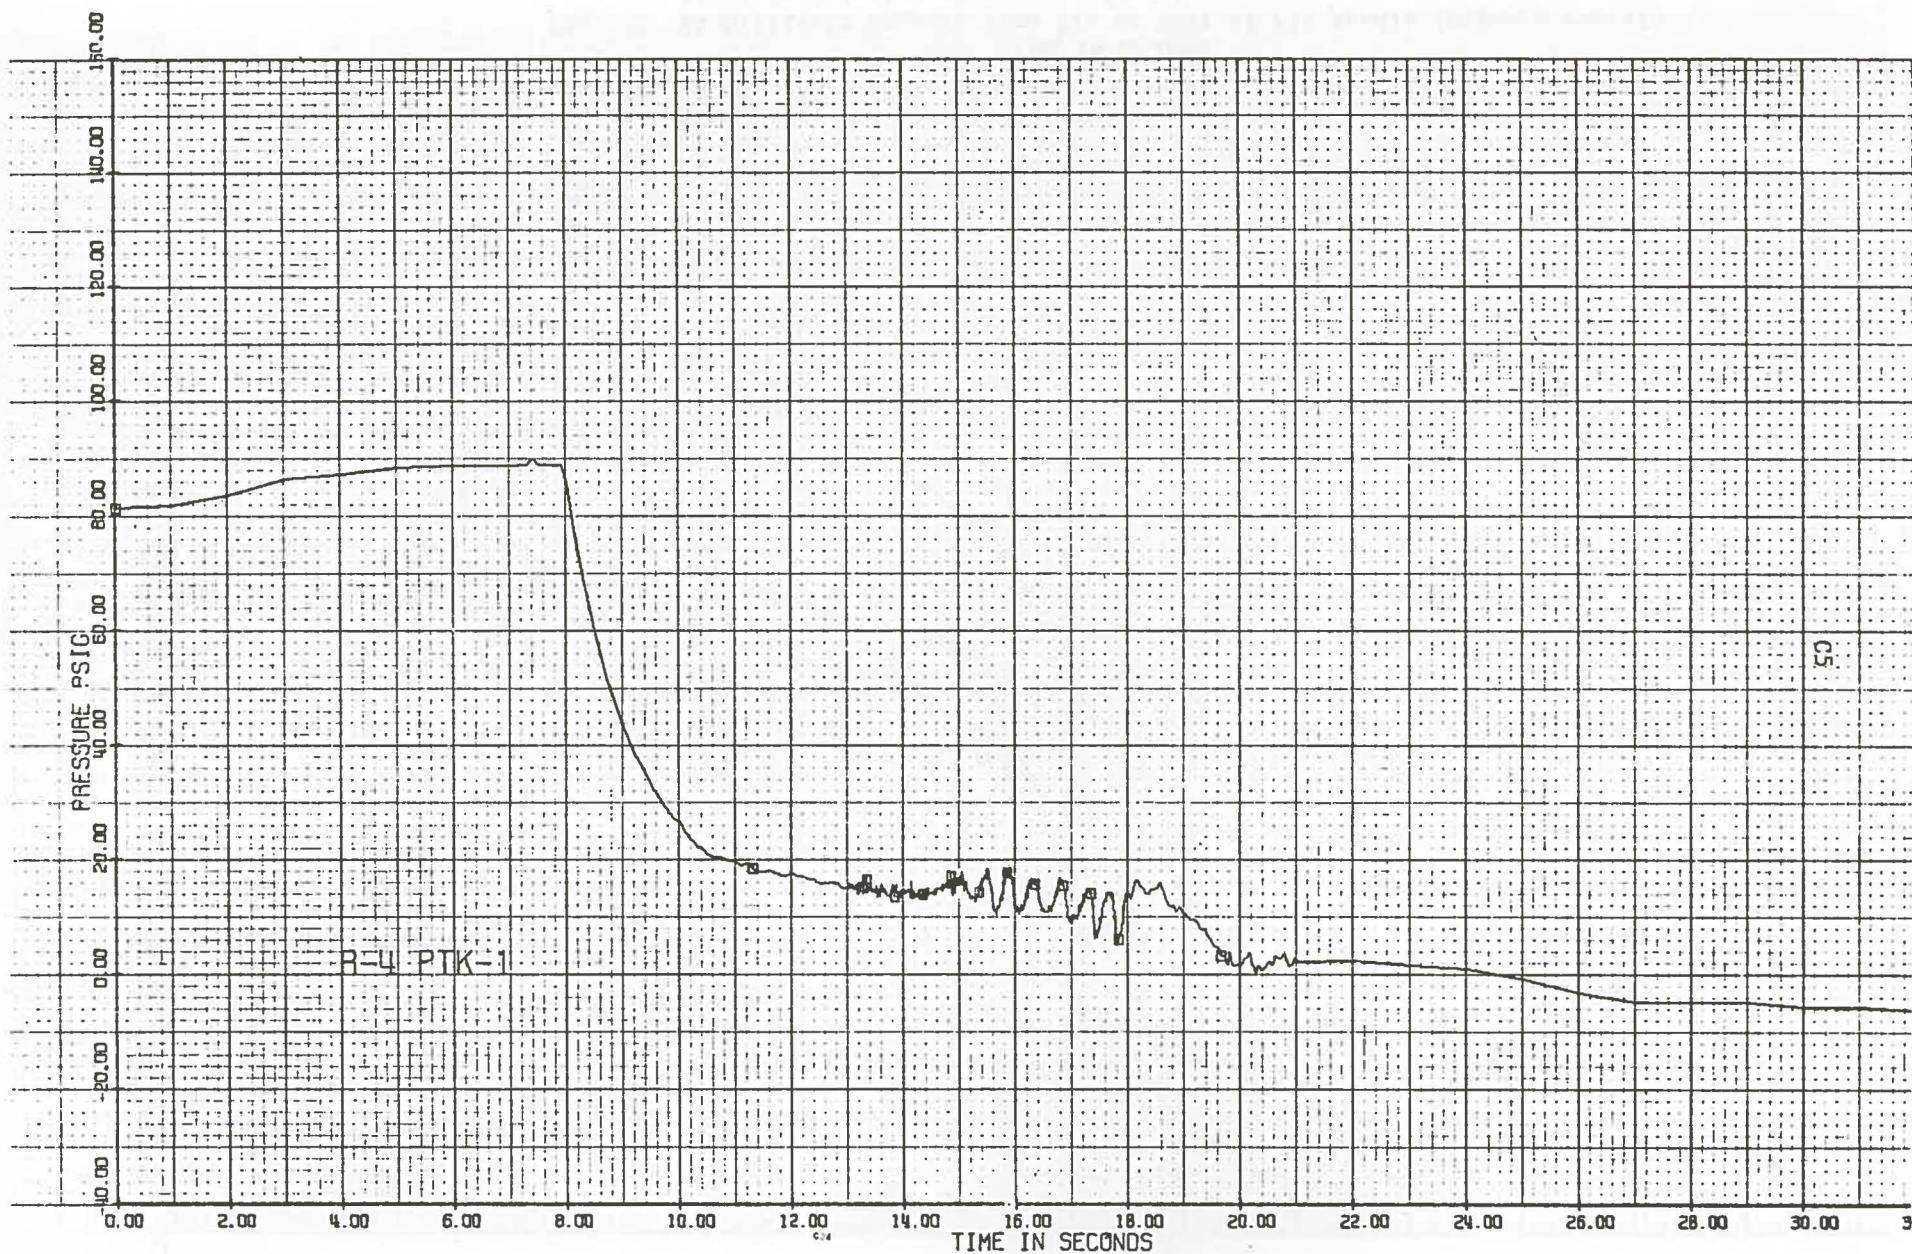
Fig. C4 R4 Pressure at Entrance to Pin Bundle.

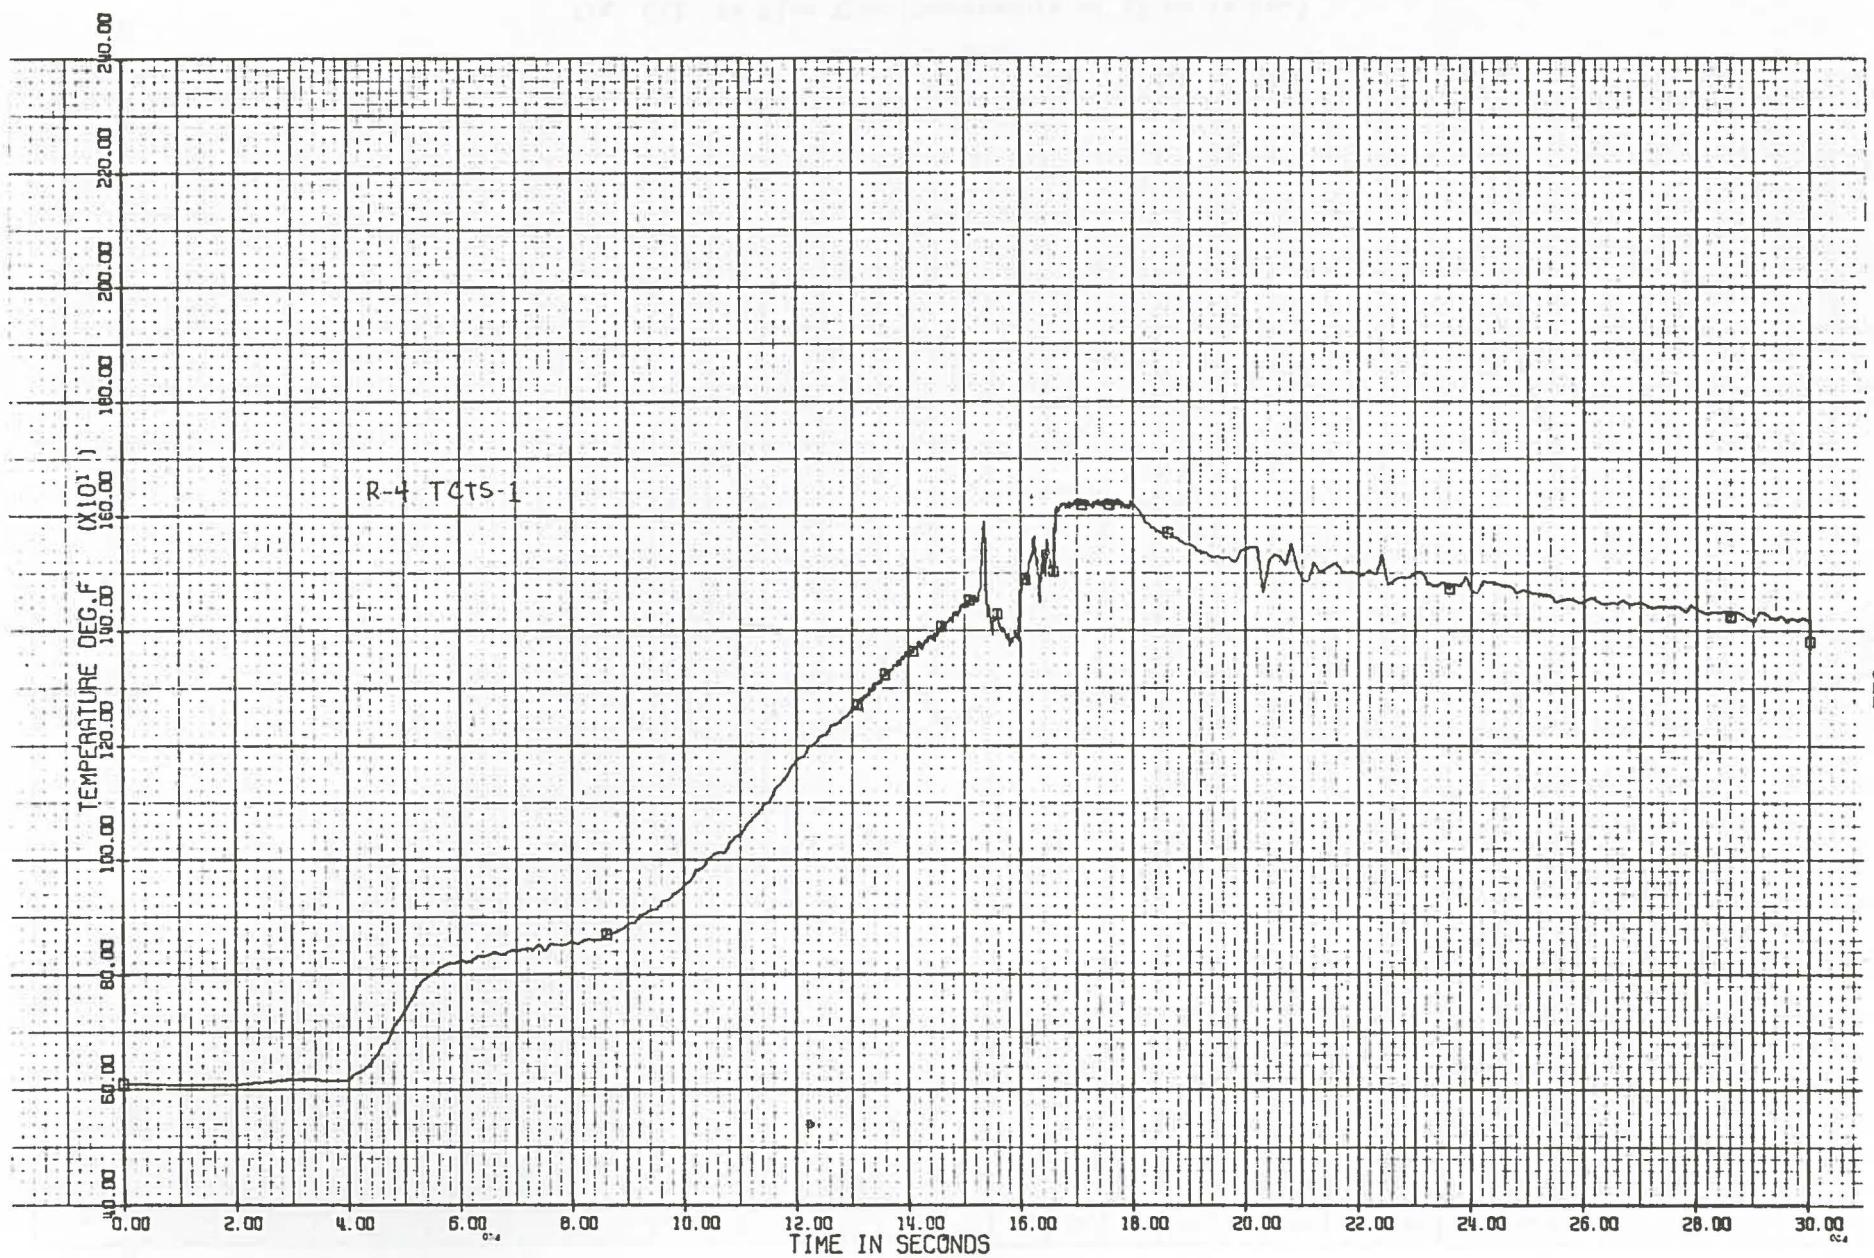
Fig. C10 R4 Flow Tube Temperature 30 cm (12 in.) Above Top of Active Fuel.

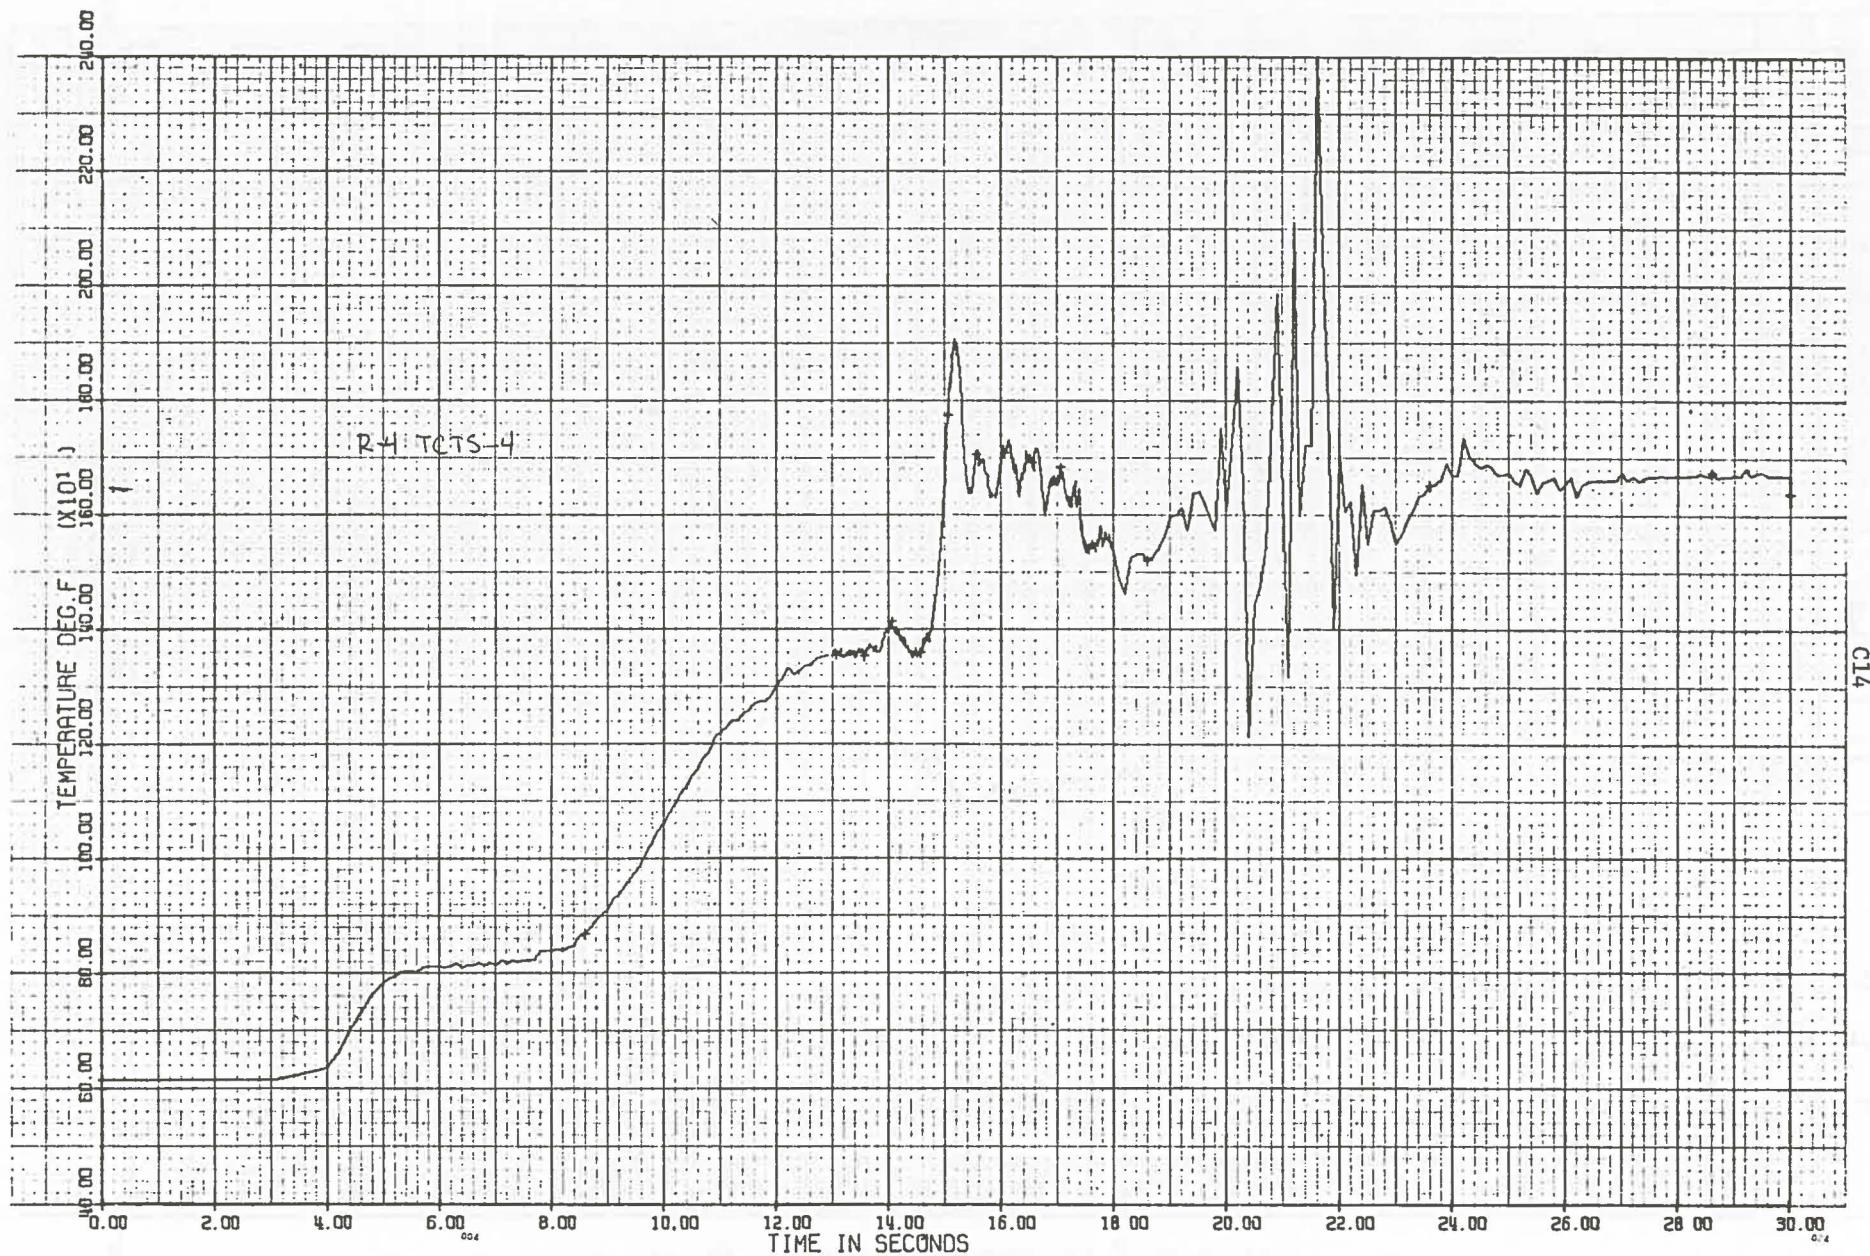
Fig. C13 R4 Flow Tube Temperature at 2.5 cm (1 in.)

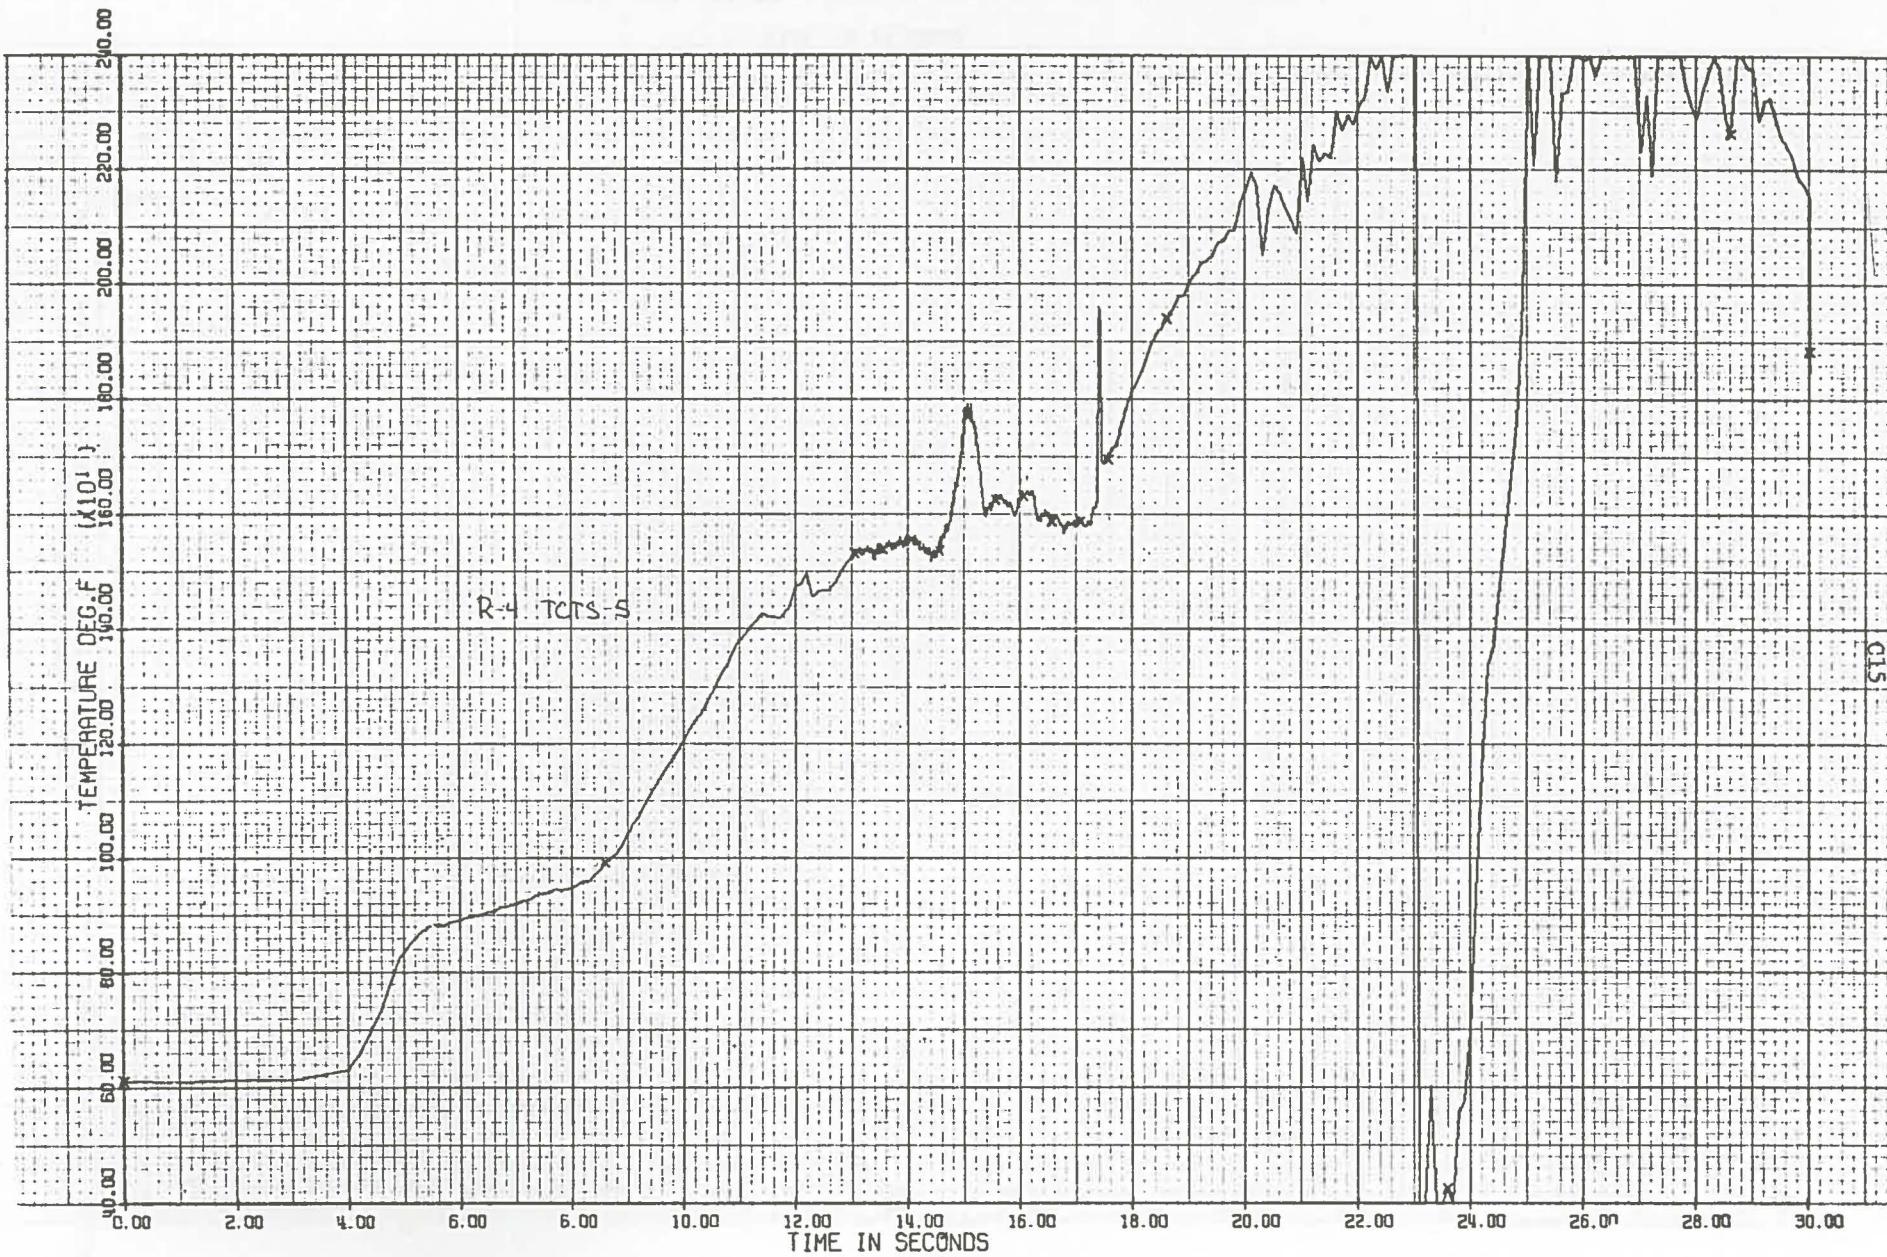
Fig. C14 R4 Flow Tube Temperature at Top of Active Fuel, 0 cm.

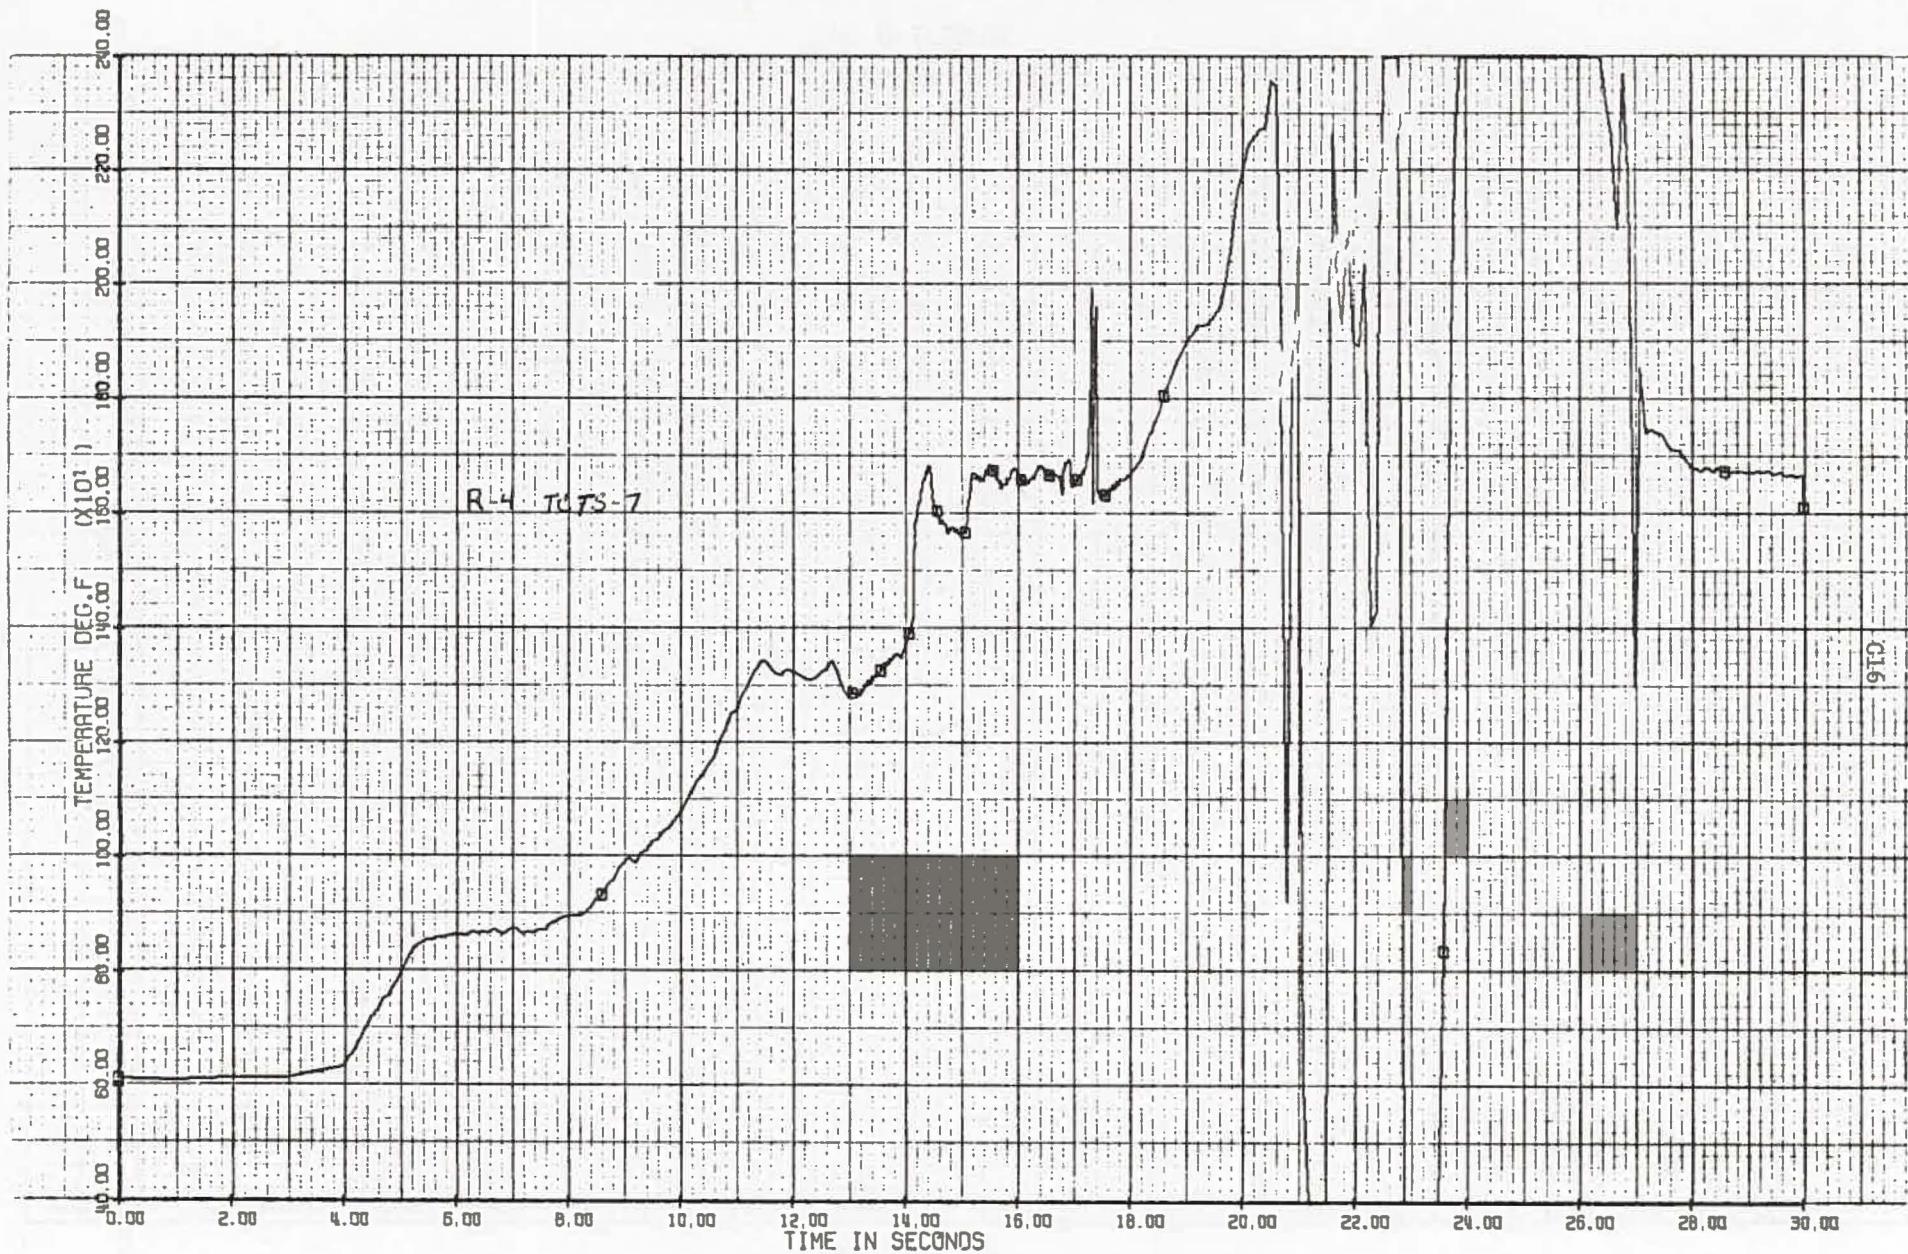
Fig. C15 R4 Flow Tube Temperature at -75 cm (-3 in.)

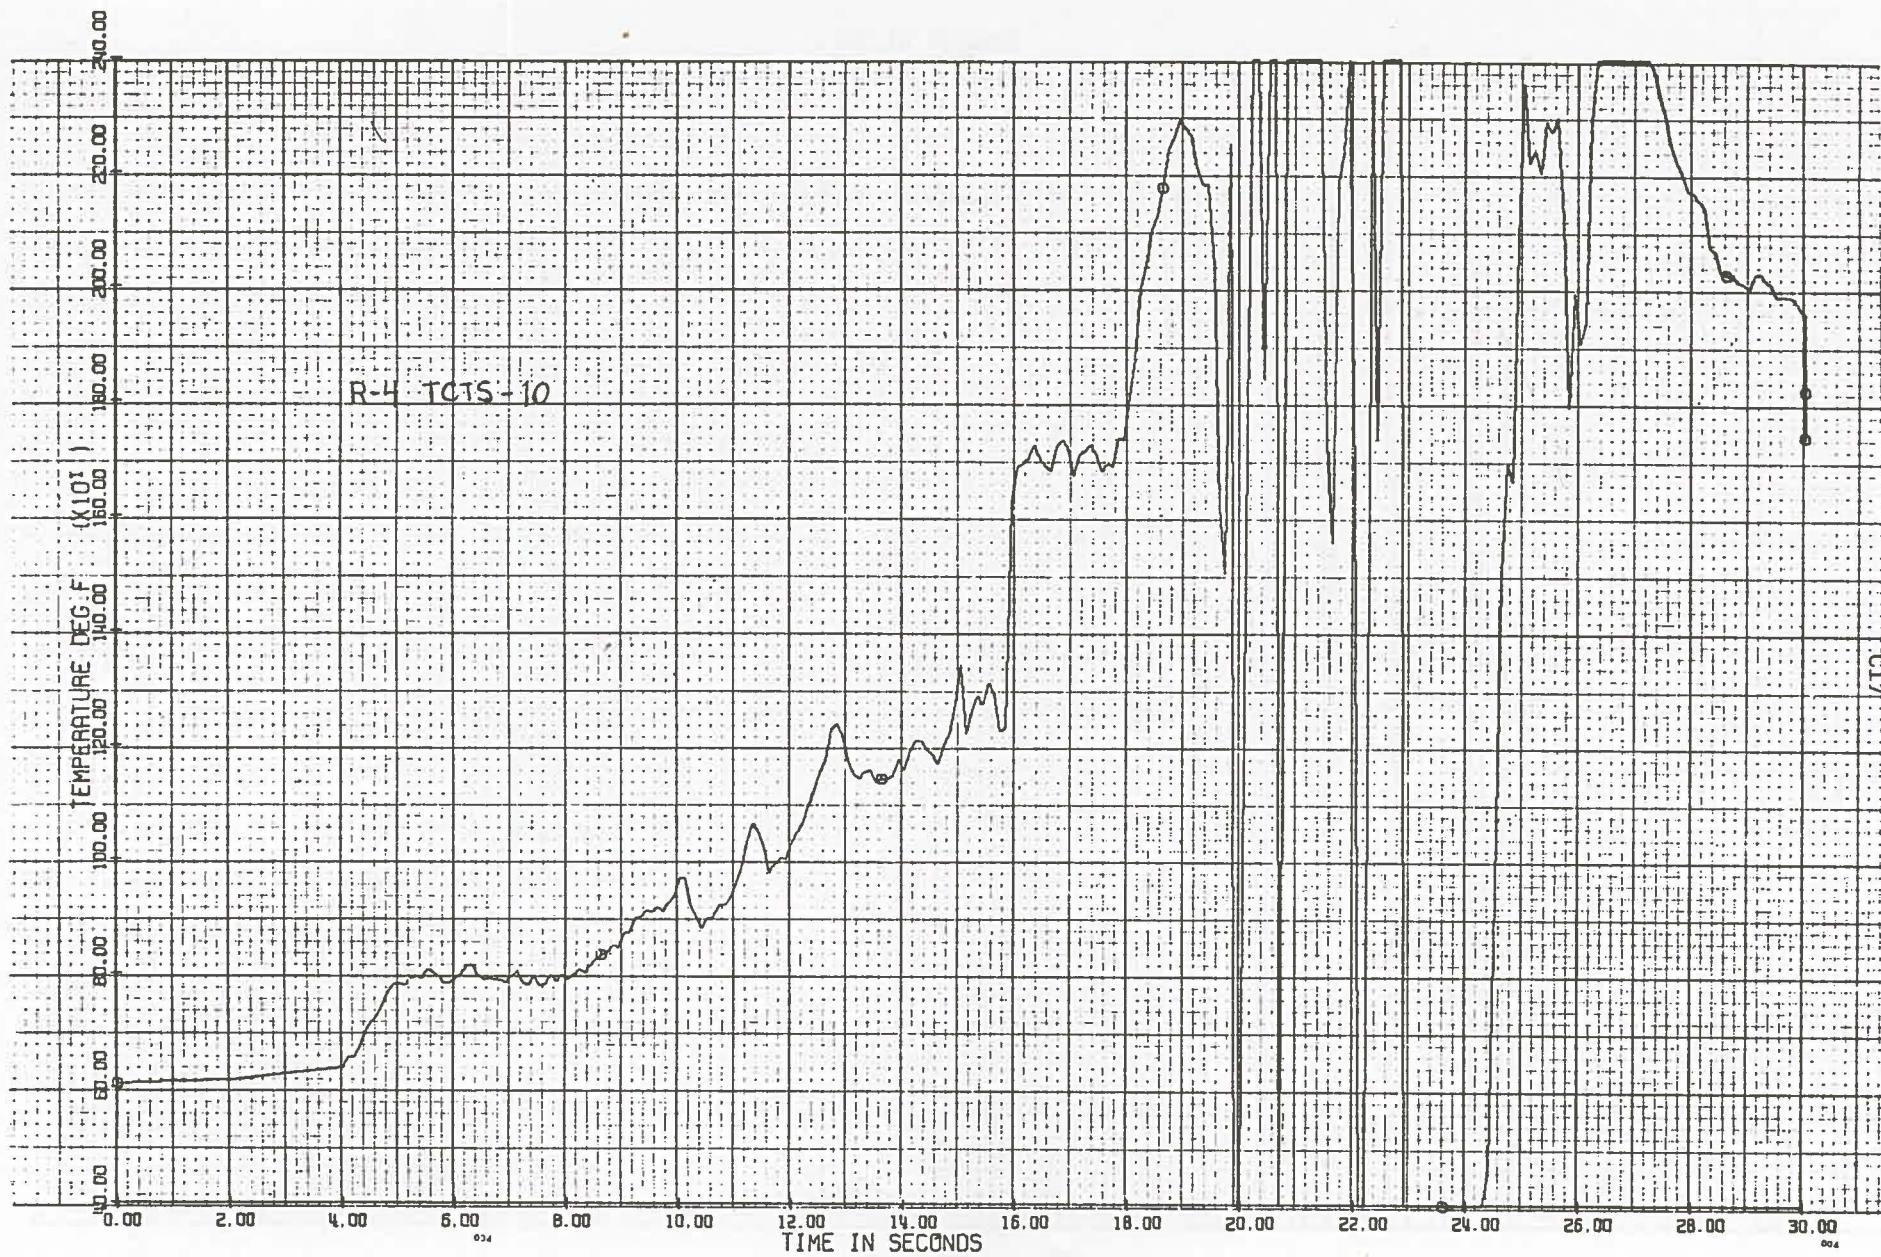
Fig. C16 Flow Tube Temperature at Active Fuel Midplane, -45 cm (-18 in.).

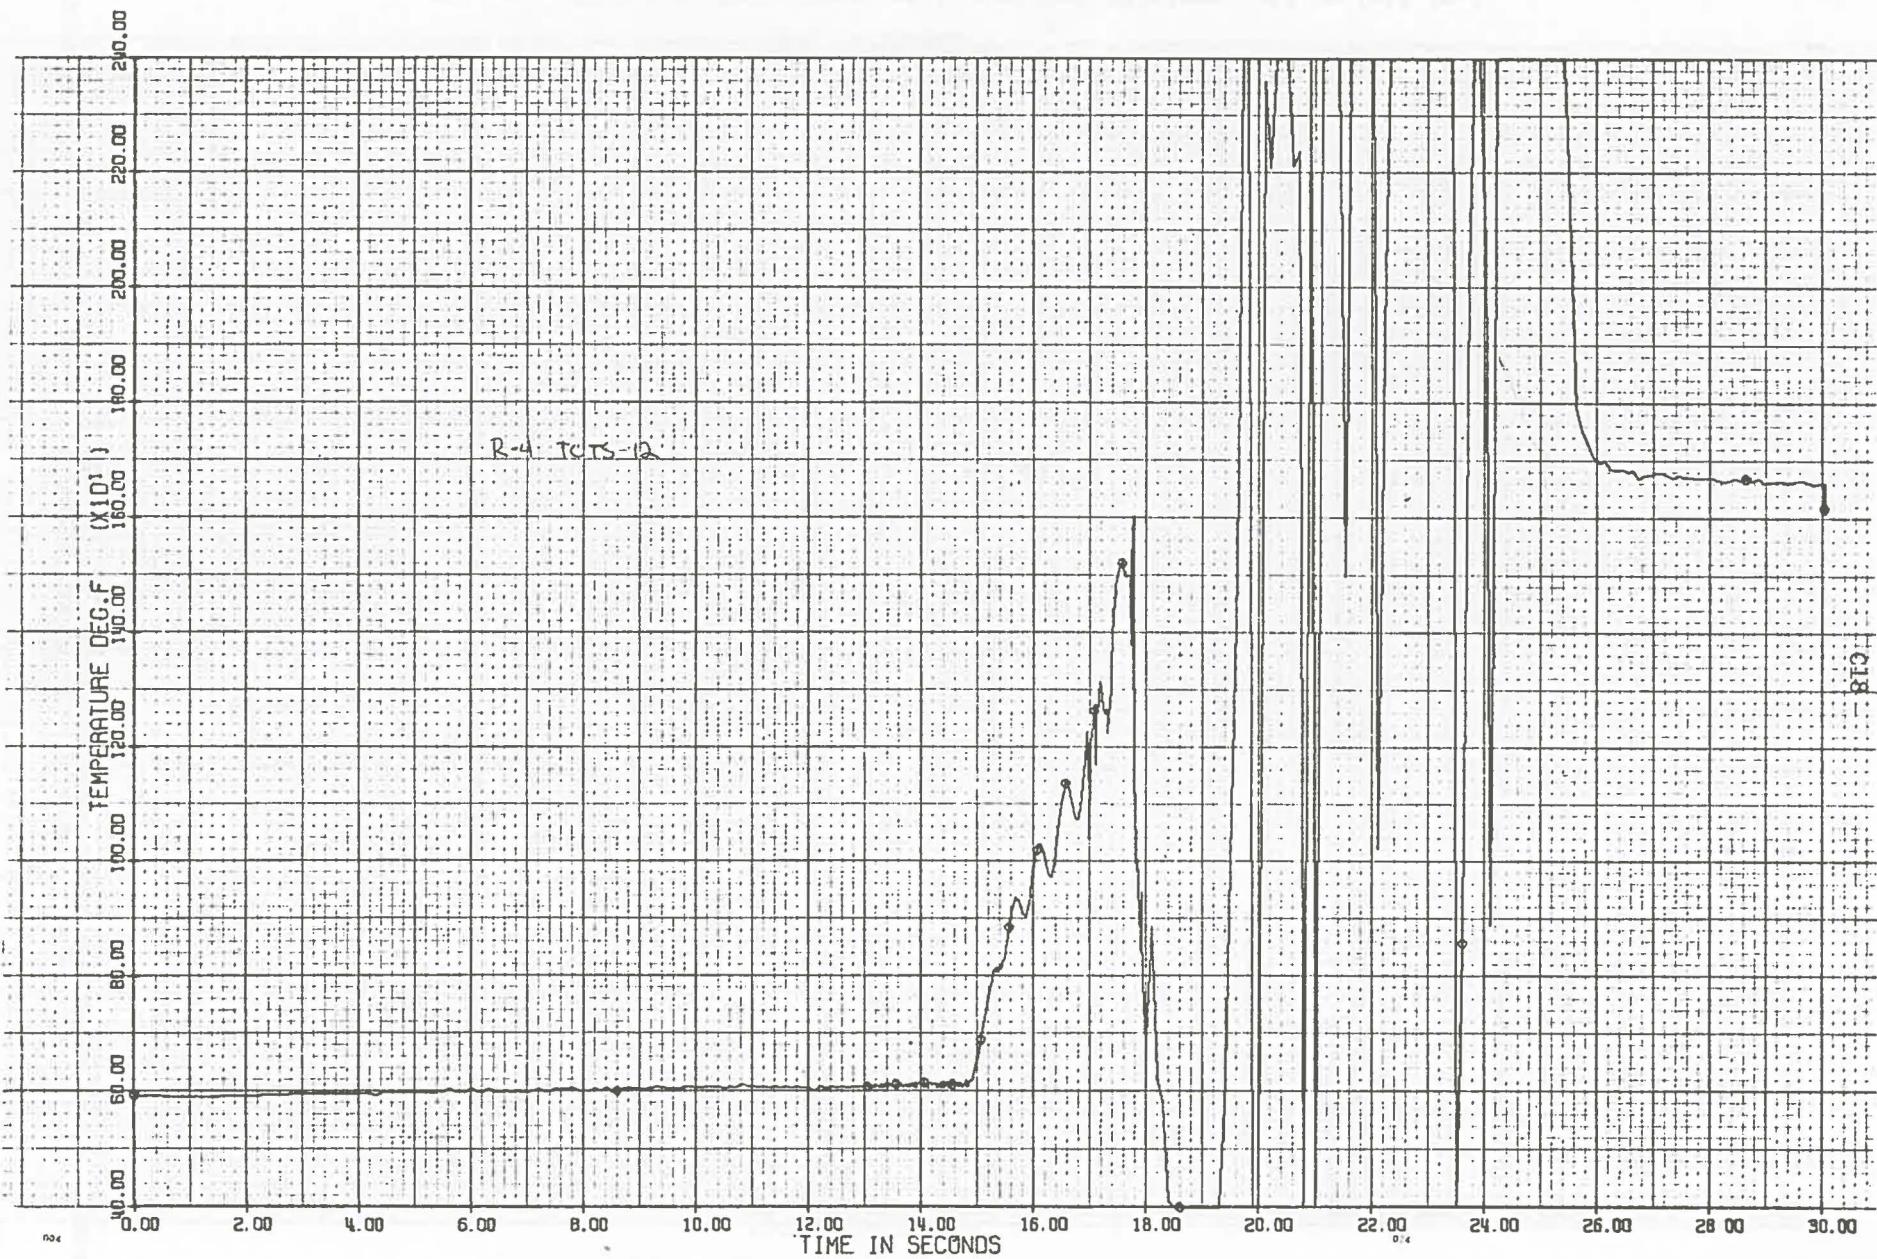
Fig. C17 R4 Flow Tube Temperature at Entrance to Active Fuel Region, -91 cm (-36 in.).
